RE: Hogan's Fountain Teepee Pavilion, Cherokee Park

**Re.** Cherokee Park Hogan's Fountain Pavilion

**Subject:** Cherokee Park, Hogan's Fountain Teepee Pavilion Reassessment

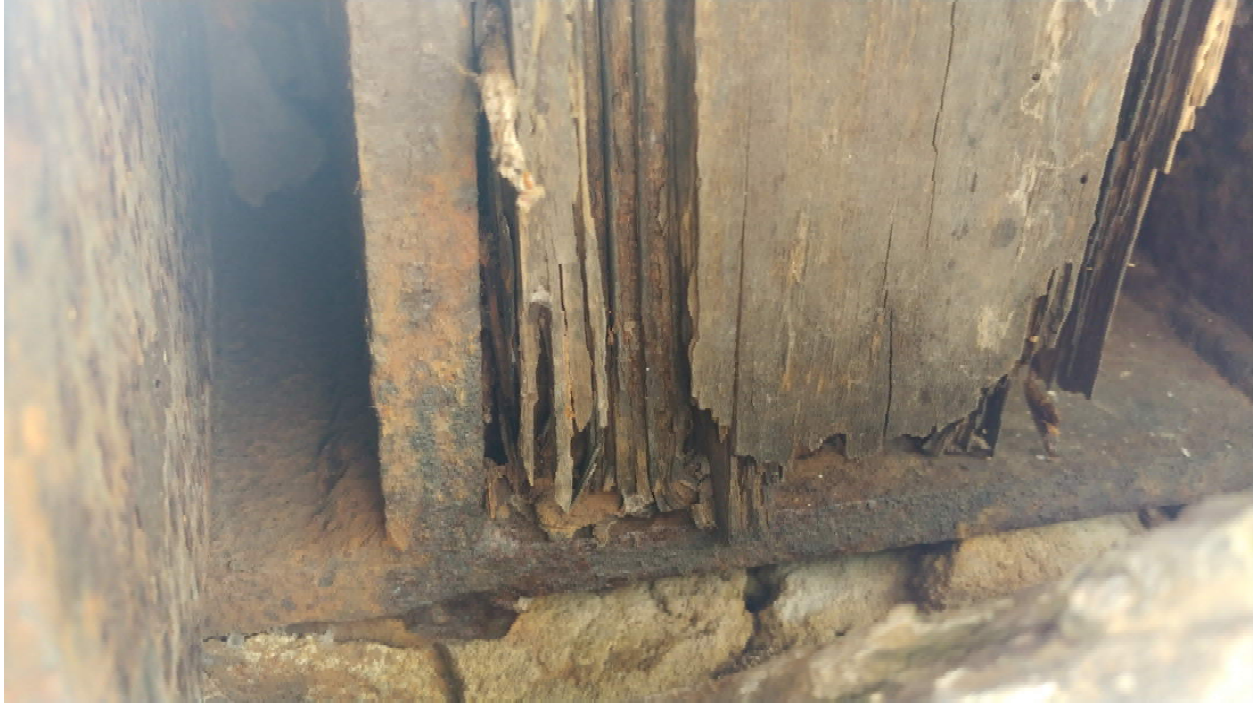
The current visual inspection was performed on the previously discussed eight glulam arches supporting the pavilion roof structure. Wood rot and severe deterioration of the wood was observed at the bases of the glulam arches at the concrete abutments (See Photo 1) as well as at the top of the steel casing near the connection of the horizontal roof framing members to the glulam arches (See Photo 2). Note that the condition of the glulam arch between the two ends of the steel casing could not be visually determined because of the steel casing itself. However, we suspect most of the glulam arch between the steel casing has similar wood deterioration.

Photo 1 – Wood rot and decay at base of glulam arch.

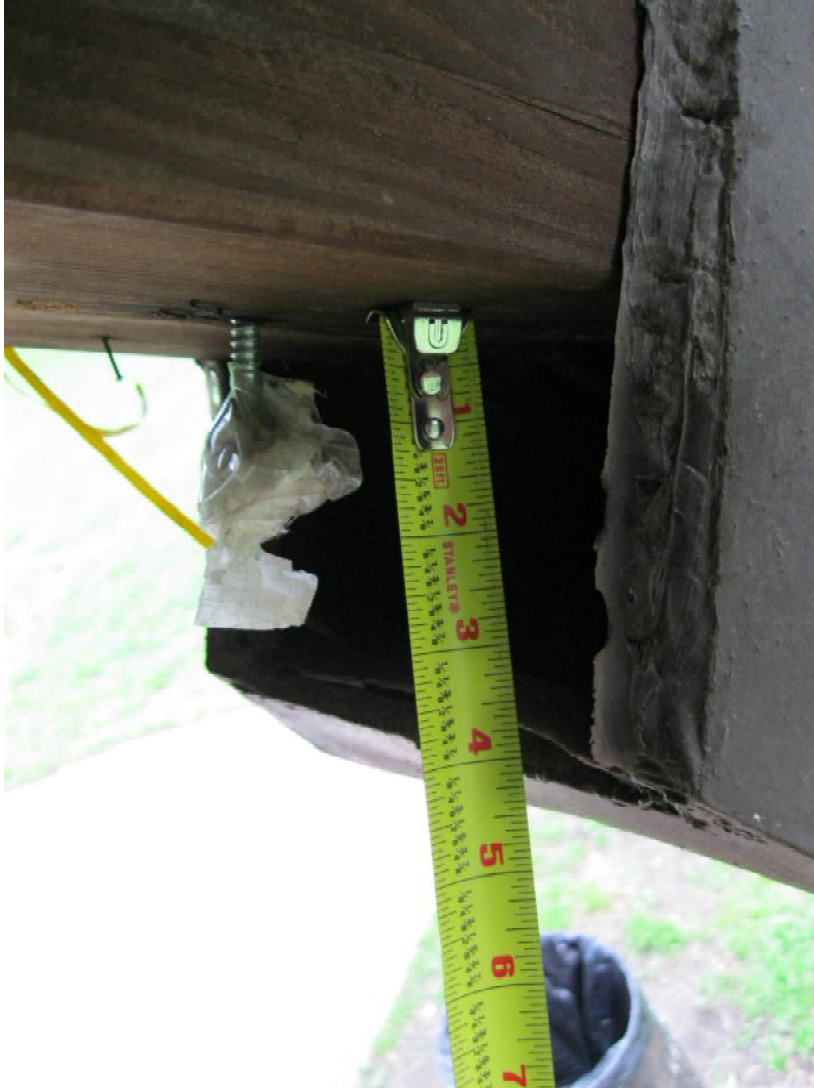
At the top of the steel casing at one of the originally repaired glulam arches, a 4-inch gap was observed between the bottom of the glulam arch and the bottom plate of the steel casing, indicating significant movement in the glulam arch (See Photo 3). At this location the wood was severely deteriorated (See Photo 4), exposing the top ¾ inch diameter rod between the steel casing sides (See Photo 5). Wood deterioration and exposure of the ¾ inch diameter rod at the top of the steel casing is particularly concerning since it was the upper zone of the steel casing that served as the area for the transfer of the forces in the glulam arch to the steel casing.

Photo 3 – Separation of the steel casing from glulam arch.

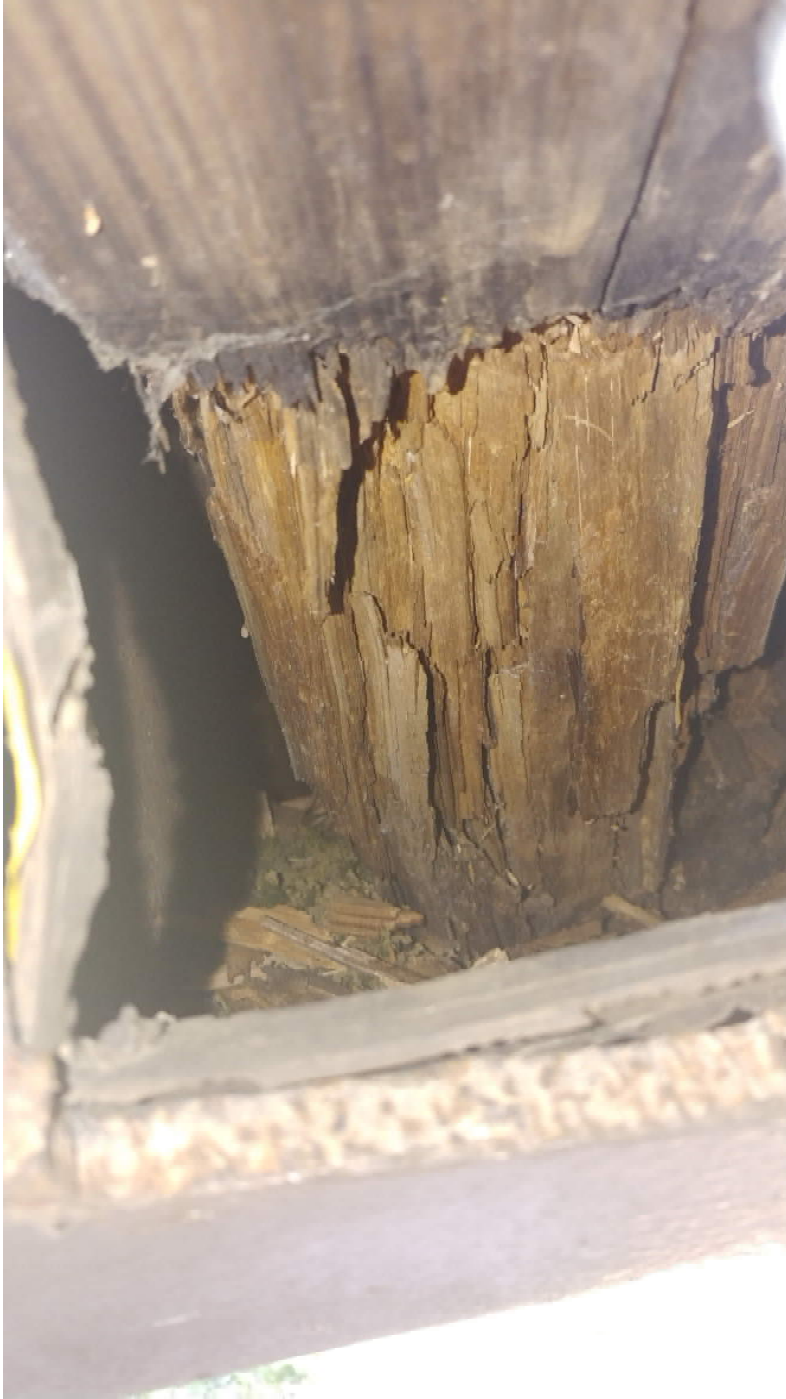
Photo 4 – Glulam arch wood deterioration near the top of the steel casing.

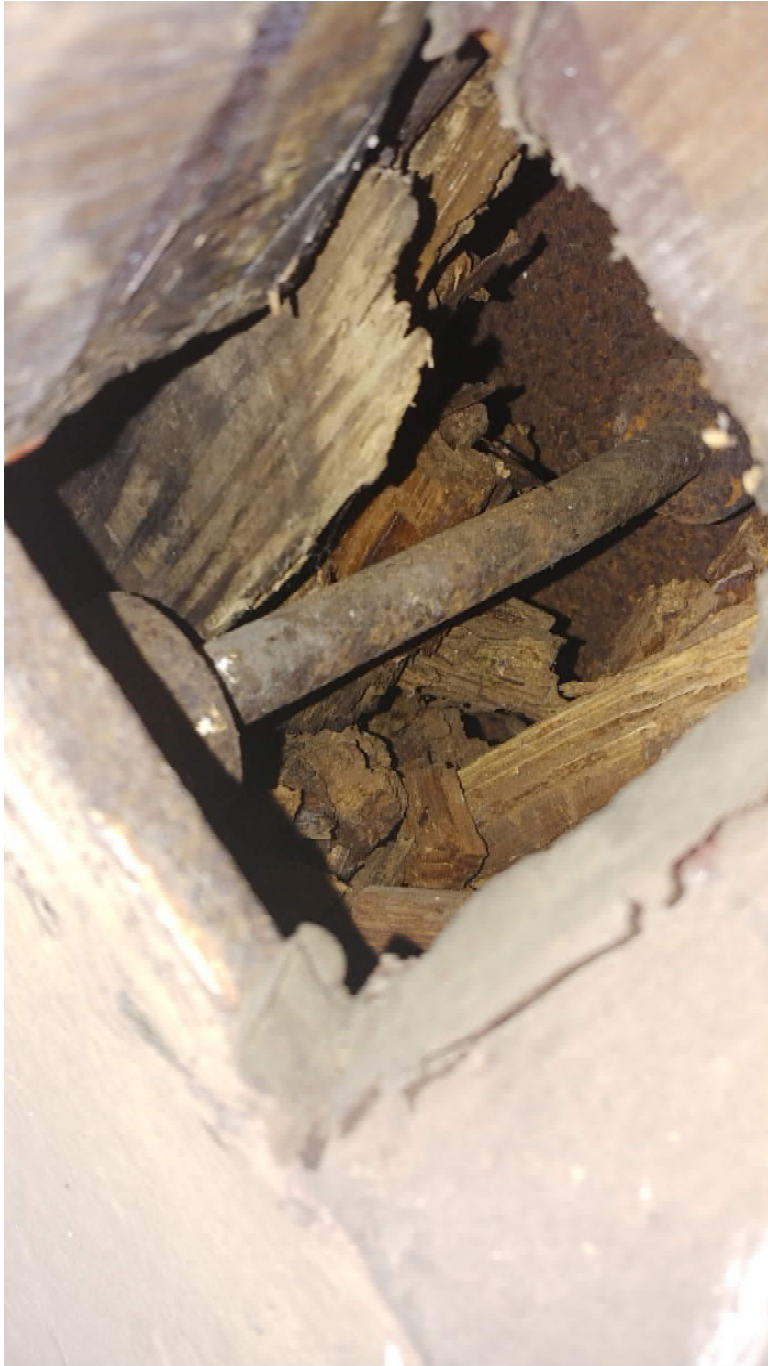
Photo 5 – Exposed  $\frac{3}{4}$ " diameter rods between the steel casing sides thru the deteriorated glulam arch.

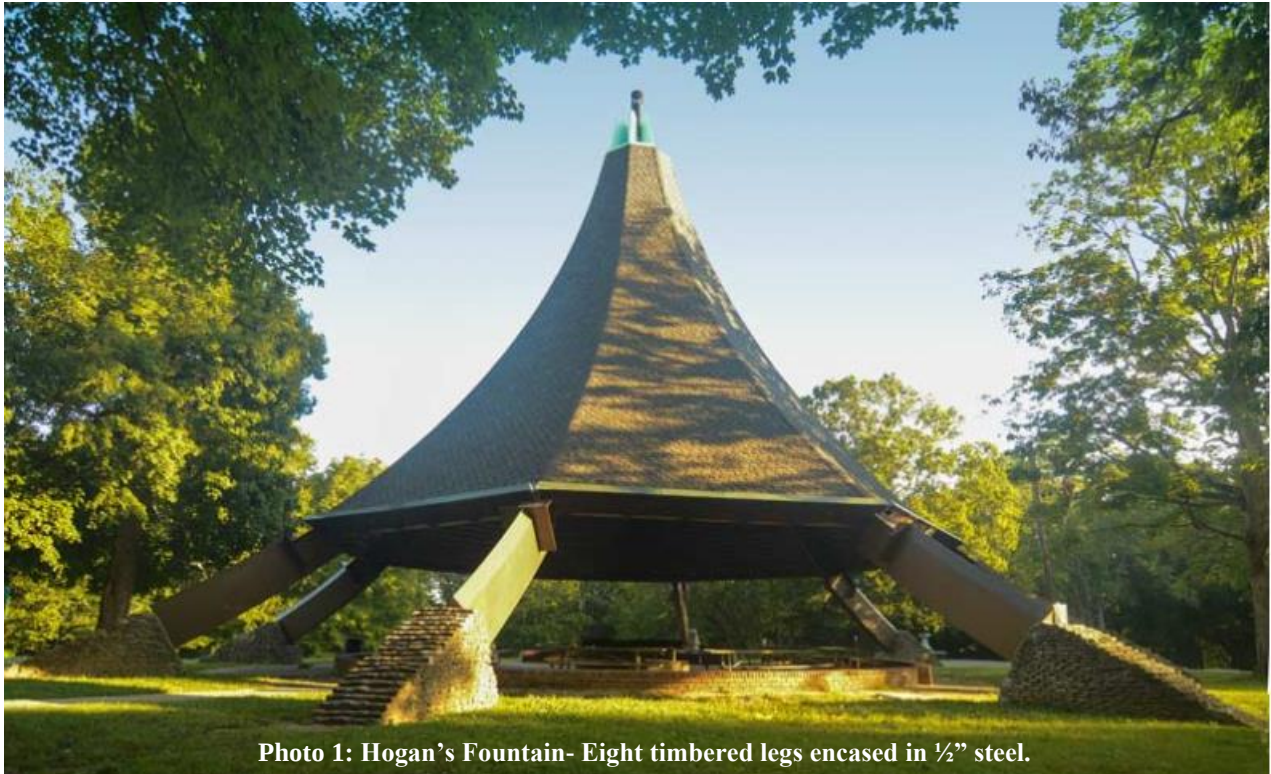
**Photo 1: Hogan's Fountain- Eight timbered legs encased in ½" steel.**

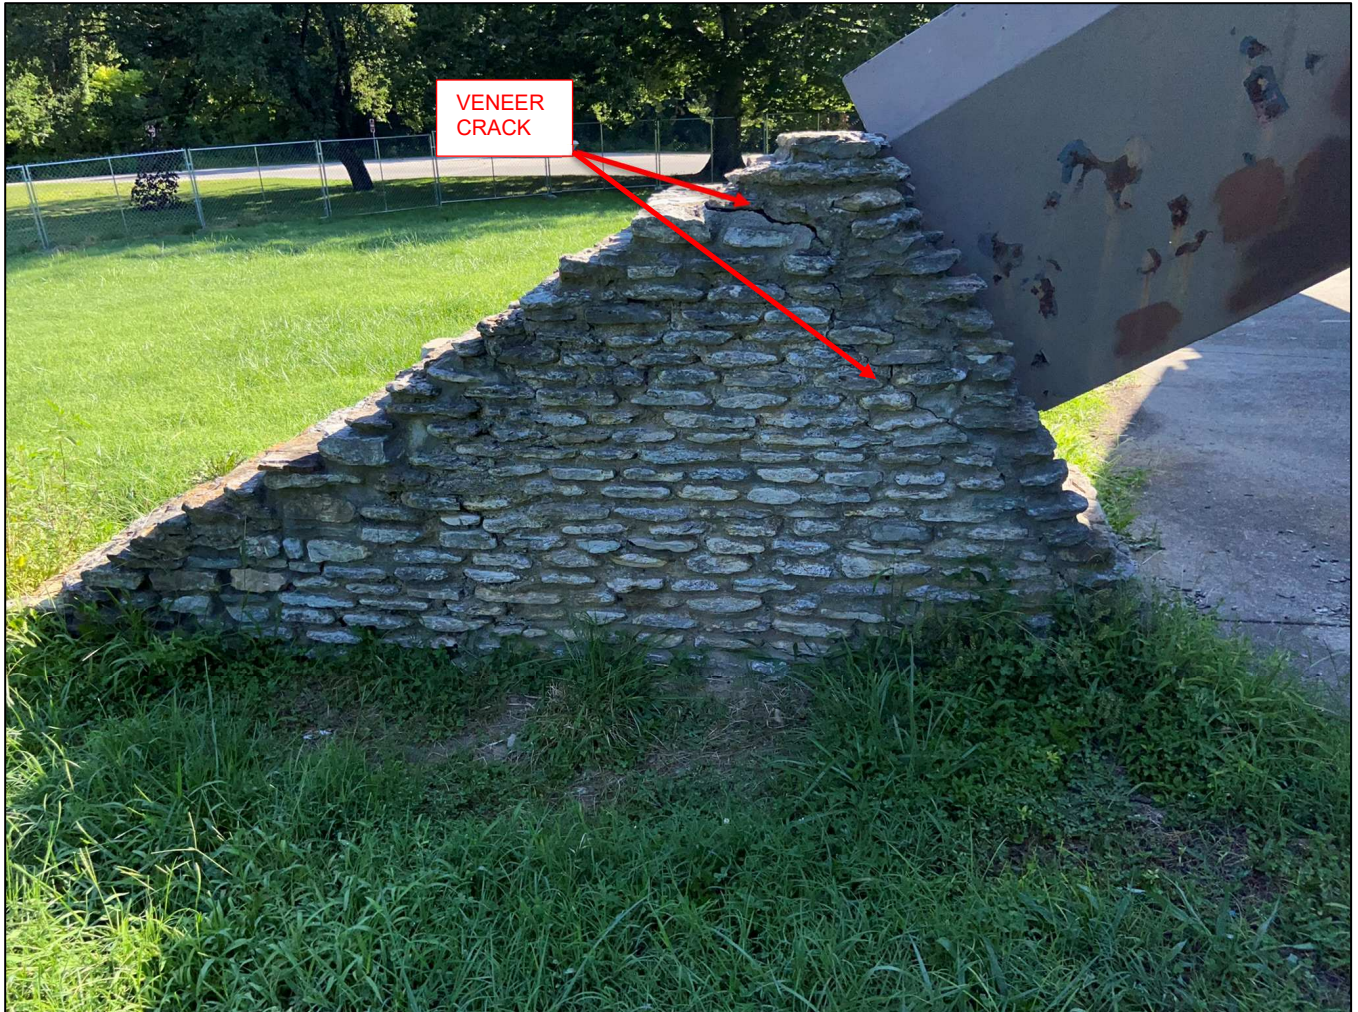
- The concrete foundation abutments are clad with stone veneer, so an assessment of the structural concrete was not performed. However, the condition of the concrete abutments does not change the conclusions or recommendations provided herein.
- Abutments 1, 4, 5, and 8 (**Photo 2**) have cracking in the stone veneer that could be an extension of cracking in the concrete abutment substrate. If this cracking is also in the concrete abutment, it may be caused by the change in load path from the steel casings. See discussion under glue-laminated wood beams about cantilever action for more on this.
- Cracks in the abutments are not a new discovery but now have a logical explanation since the condition of the wood beams inside the steel casings has been deemed not structurally sound.

**Photo 2: Abutment #8 Veneer Cracks**

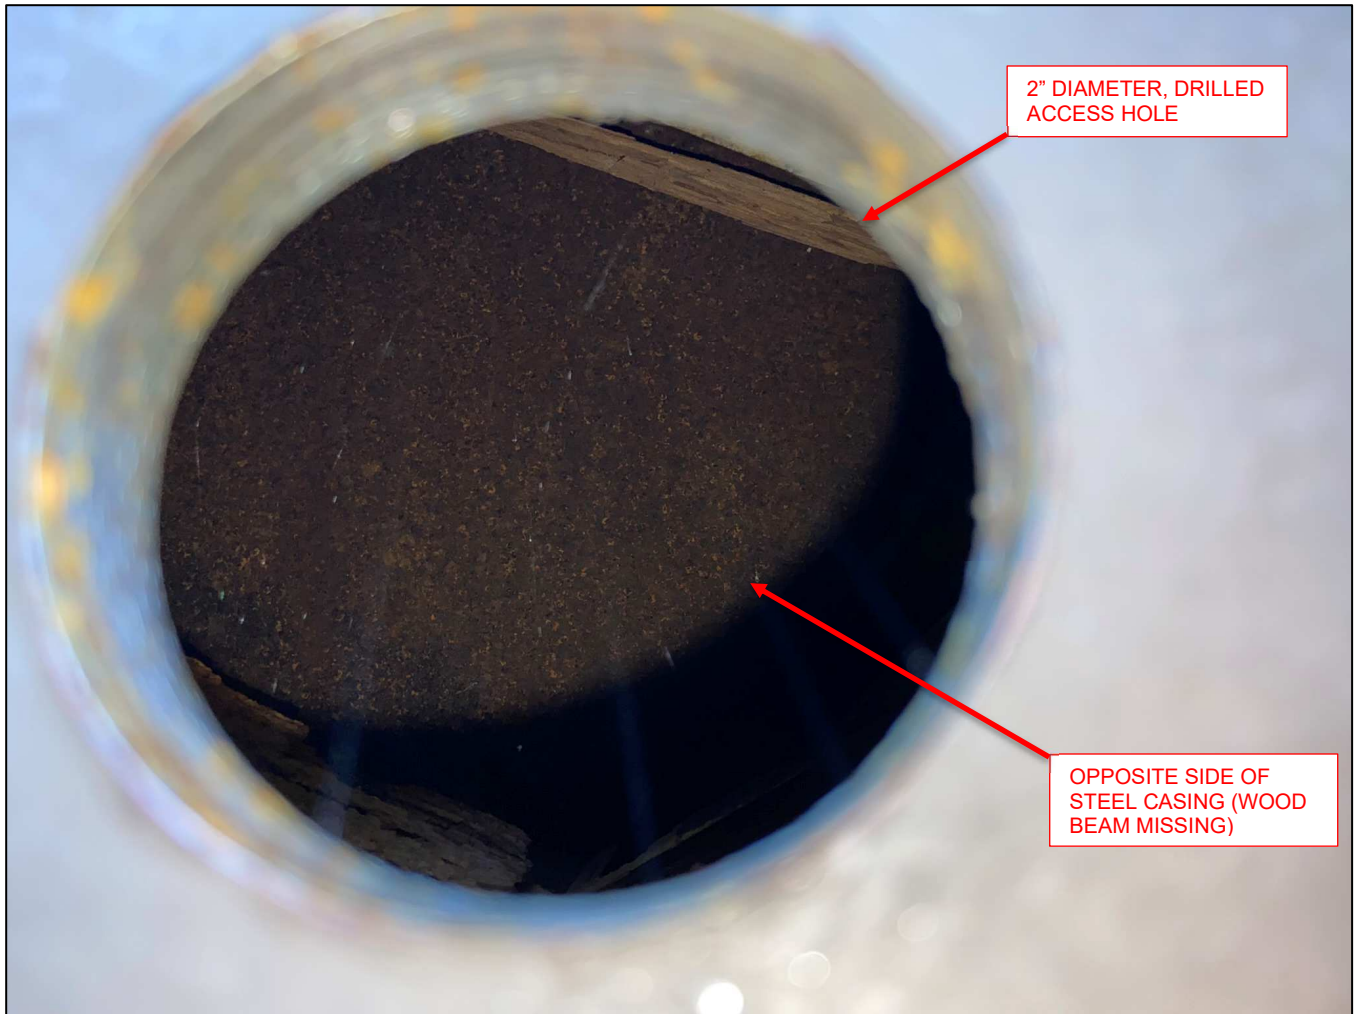
- Wood beams within the mid-section of the steel casings at locations 1, 2, 3, 4, 6, 8 (**Photo 3**) have so deteriorated that there is either no wood evident, the member section is partially lost, or the wood is so soft that it does not resist probing with an ice pick.
- Wood rot has been confirmed throughout most of the steel casing length on the majority of the beams.
- The retrofitted steel dowels in the casings are no longer providing the axial, bending, and shear load transfer to the steel casing that was designed to simulate a beam extension.
- The gap at beam #6 was measured and found to be about 4 ½" which is ½" more than previously documented in May (**Photo 4**). This side of the structure appears to be lifting.
- Lifting movement from beam #6 is pulling on the exhaust hood and lifting one side as seen in **Photo 5**.

**Photo 3: Steel Casing Access Hole at Location #1**

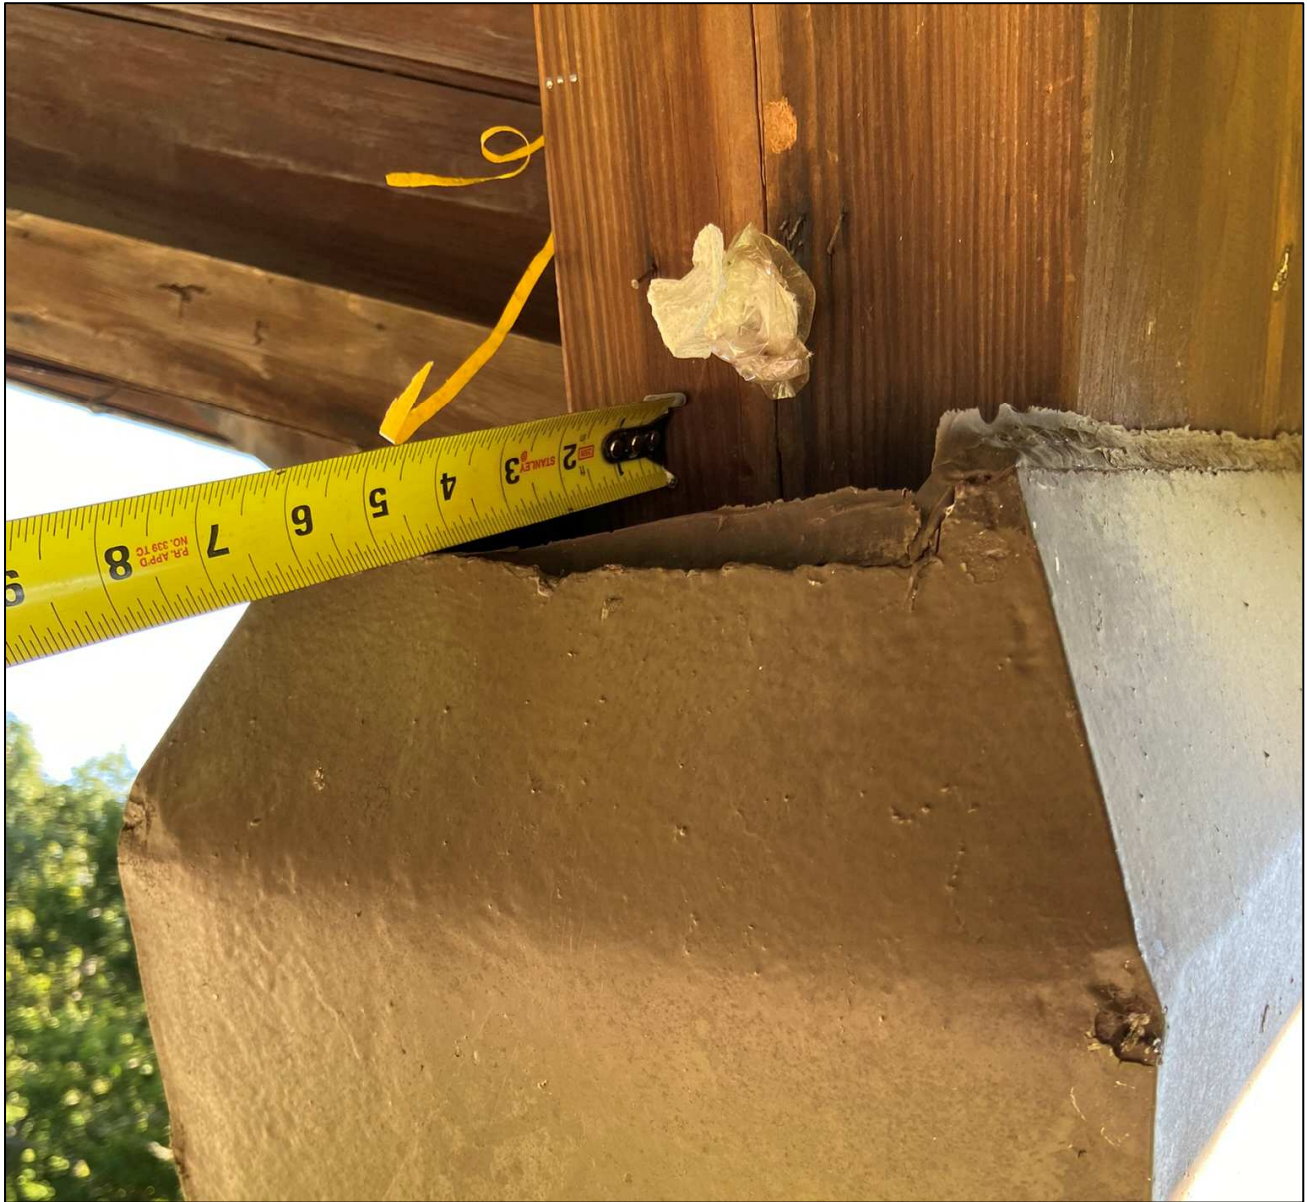
- The structure shows signs of downward and upward movement on opposite sides near locations #2 and #6, respectively (**Photo 4** and **Photo 6**).

**Photo 4: Measured Gap at Beam #6**

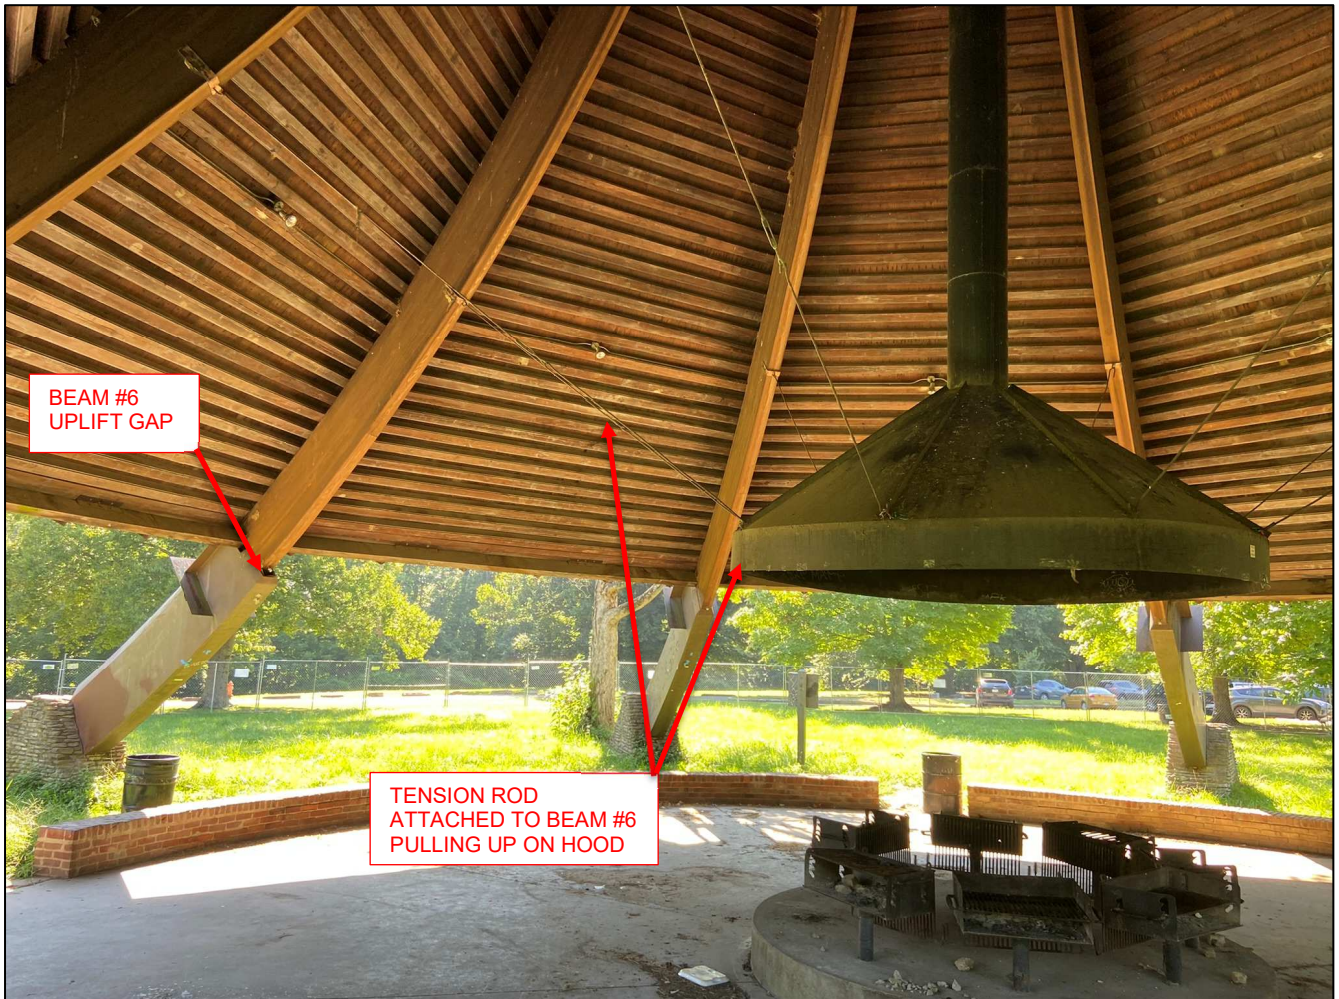
**Photo 5: Hood Lifting from Beam #6 Movement**

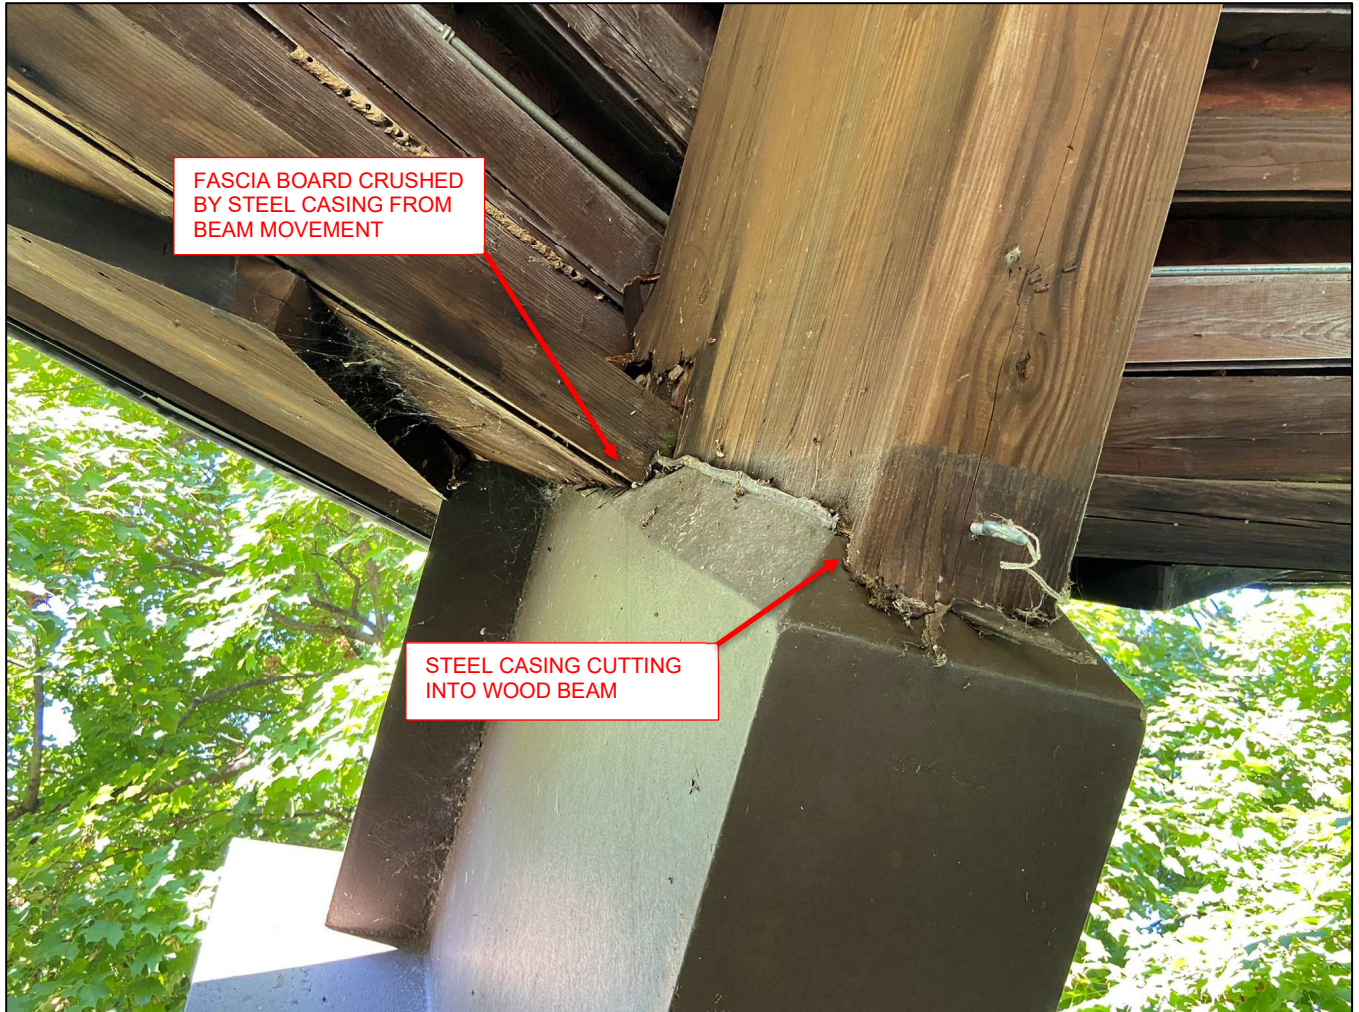
- Wood beams at locations 1 and 2 appear to be supported by the ends of the steel casing as evidenced by the steel casing digging into the wood beam and fascia boards (**Photo 6**). This side of the structure appears to be settling downward.
- The steel casings where the wood is mostly missing or rotten are likely acting as cantilever beams, fixed to the abutments, which was not how they or the foundation and connection were designed. This could be related to the stone veneer cracking, see the previous comment under foundation abutments (**Photo 2**).

**Photo 6: Steel Casing #2 Cutting into Wood Beam**

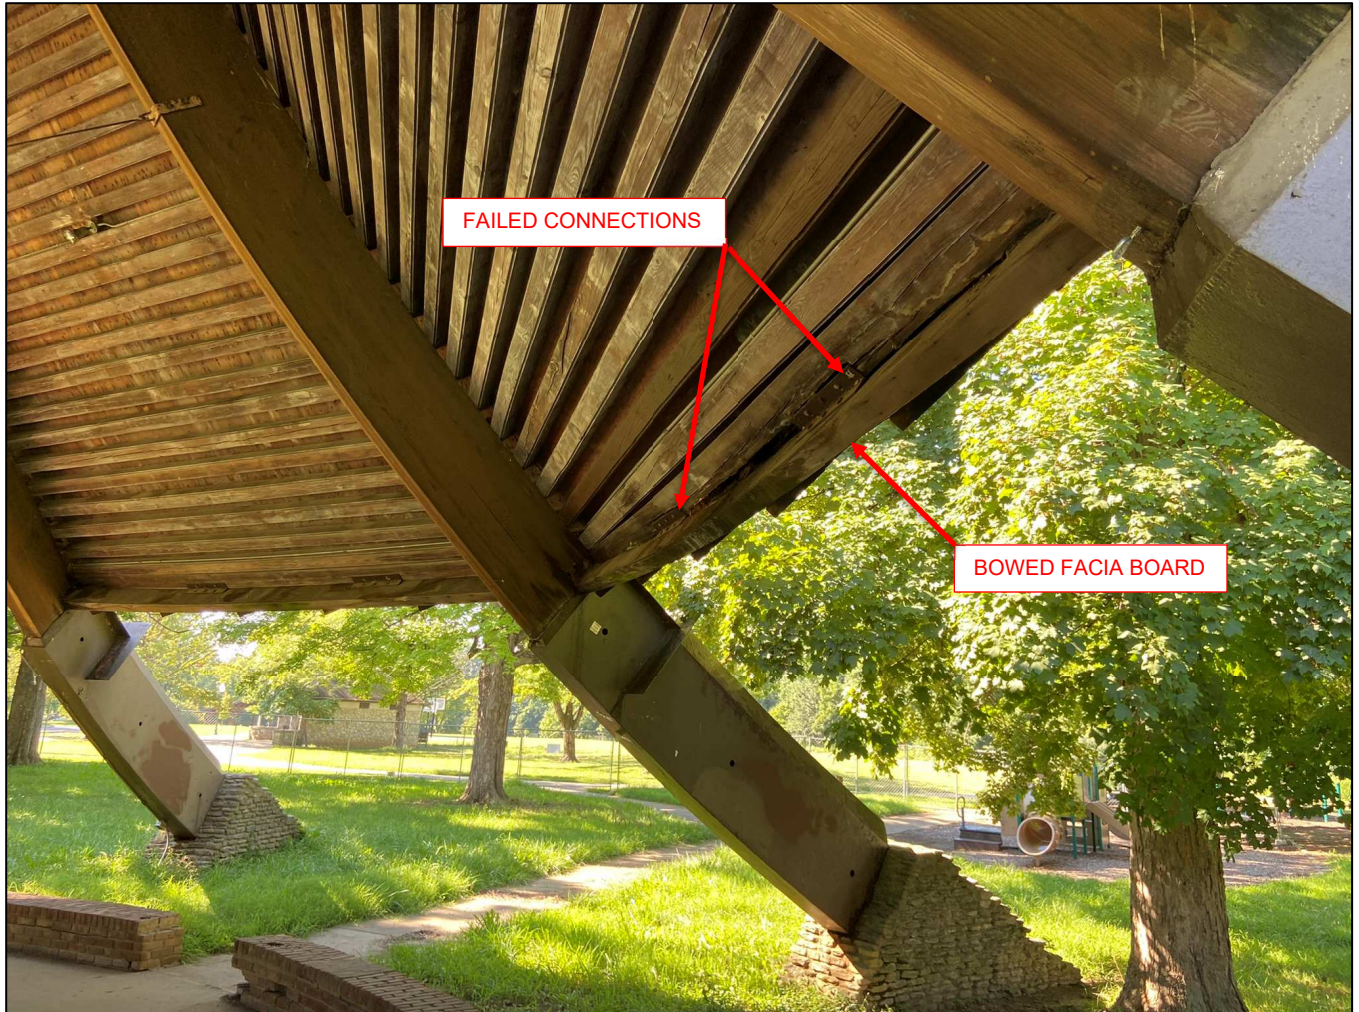
- The fascia beam between steel casing 1 and 2 has a severe bow in it that appears to be from compression forces and/or rot (**Photo 7**). There are two steel angle connections to the adjacent roof purlin that have failed. If there is a compression force on this beam member, it is the result of the downward and inward movement of the glue laminated beams #1 and #2.

**Photo 7: Bowed Fascia Board**
