**Subject: Water/Wetland Delineation Summary Report
Nash Road Property
Jefferson County, Kentucky
Redwing Project No.: 105853**

Reference: Pavement Evaluation Letter
Drum Trucking – Nash Road Pavement Evaluation
8315 Nash Road
Louisville, Jefferson County, Kentucky 40214
ECS Project No. 61-2707

ECS Southeast, LLP (ECS) has completed the pavement evaluation for the above-referenced project. Our services were performed in general accordance with ECS Proposal No. 61-P2658, dated March 18, 2022. It is our understanding that the existing asphalt pavement along Nash Road in Louisville, Jefferson County, Kentucky could experience an increase in traffic loading from semi-tractor trailers due to new construction along Nash Road. The existing pavement section is unknown. Therefore, the suitability of the existing pavement for an increase to 12 semi-tractor trailers loaded and unloaded daily was evaluated.

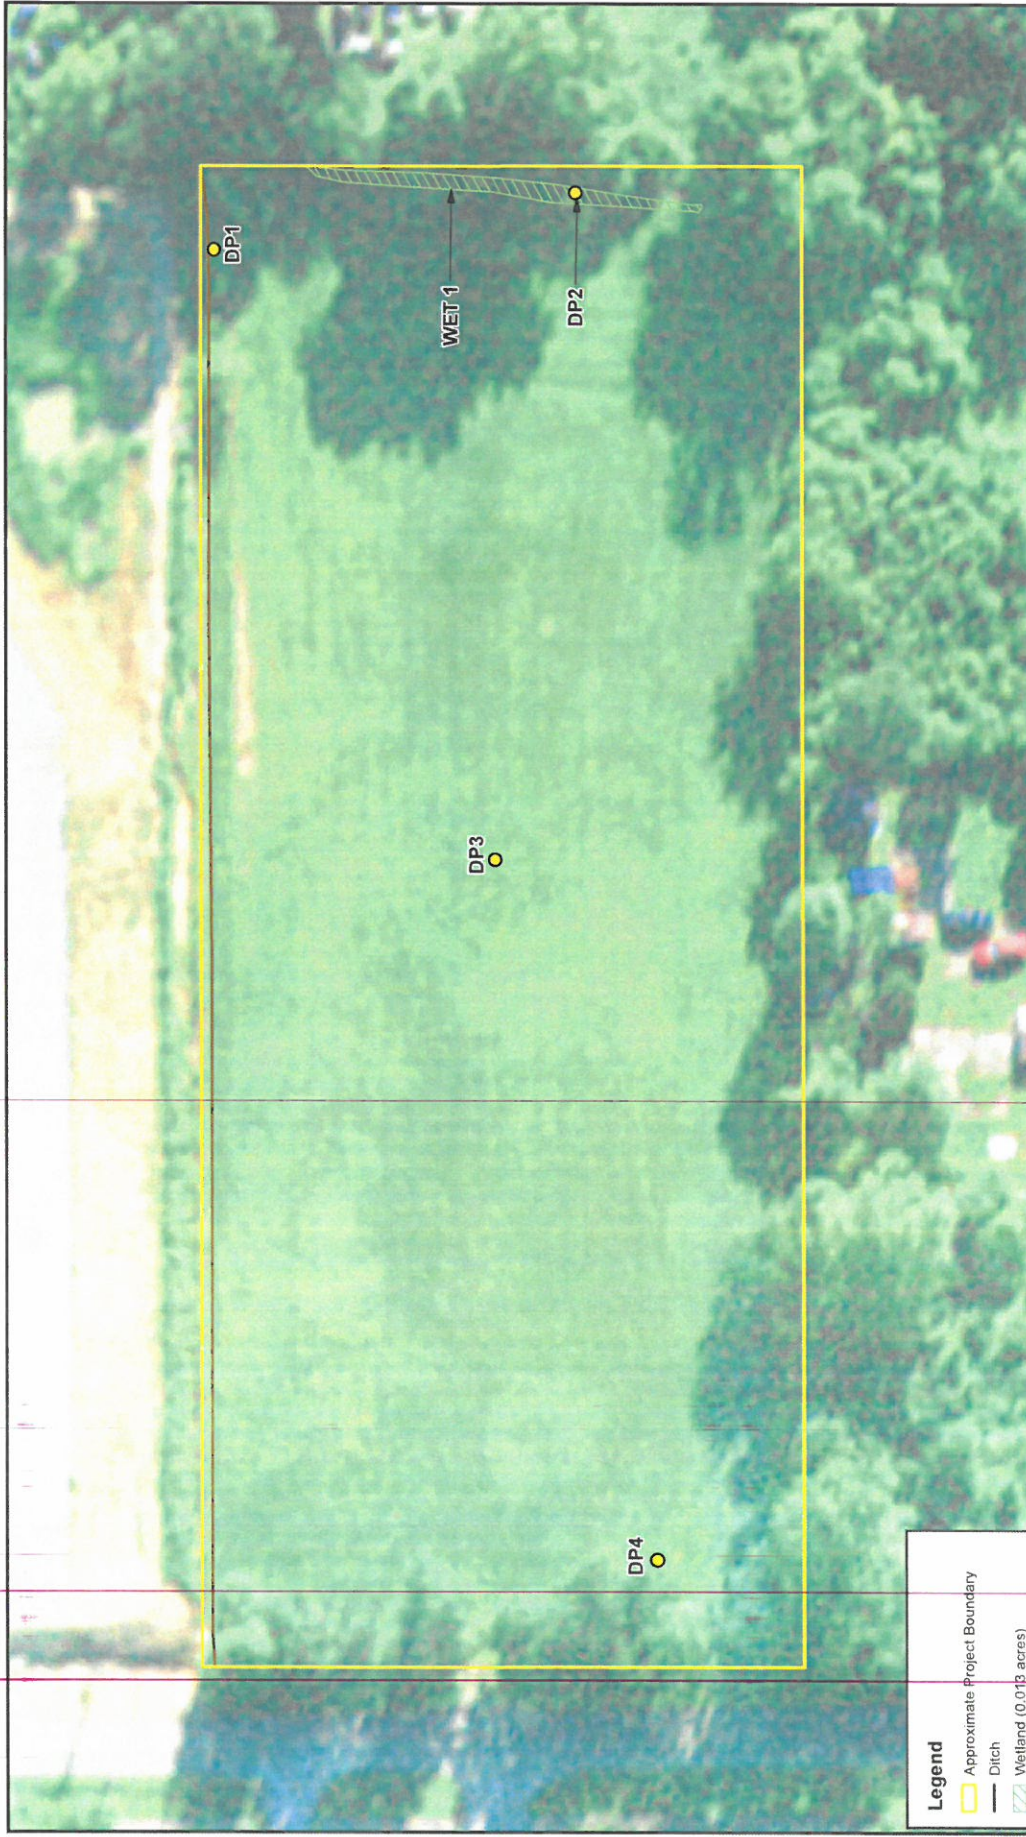
FIGURE 2
ZI-ZONE-0104

Habitat on the 2.3-acre site consists primarily of well-maintained open field with scattered trees and shrubs present along the property boundaries (Figure 2). Based on the delineation, jurisdictional waters present on the site are limited to one small scrub-shrub wetland measuring 0.013 acre, located in a drainage feature along the eastern property boundary. One fully channelized, concrete drainage ditch running along the northern project boundary is considered a non-jurisdictional feature. The water/wetland features delineated on-site are depicted on Figure 2 and summarized in the following table.

Wetland 1 is considered a jurisdictional water by the USACE because it exhibits a surface connection to downstream waters via its location in the FEMA 100-year floodplain of Southern Ditch. No additional water/wetland features were observed on site.

Because impacts to on-site jurisdictional water/wetland features would total less than 0.5 acre (Wetland 1 totals 0.013 acre), the project can be authorized under a NWP 39 with the USACE and no coordination with the KDOW would be required. NWPs typically take three to six months to receive. In addition, because impacts to Wetland 1 would be less than 0.1 acre, no compensatory mitigation would be required.

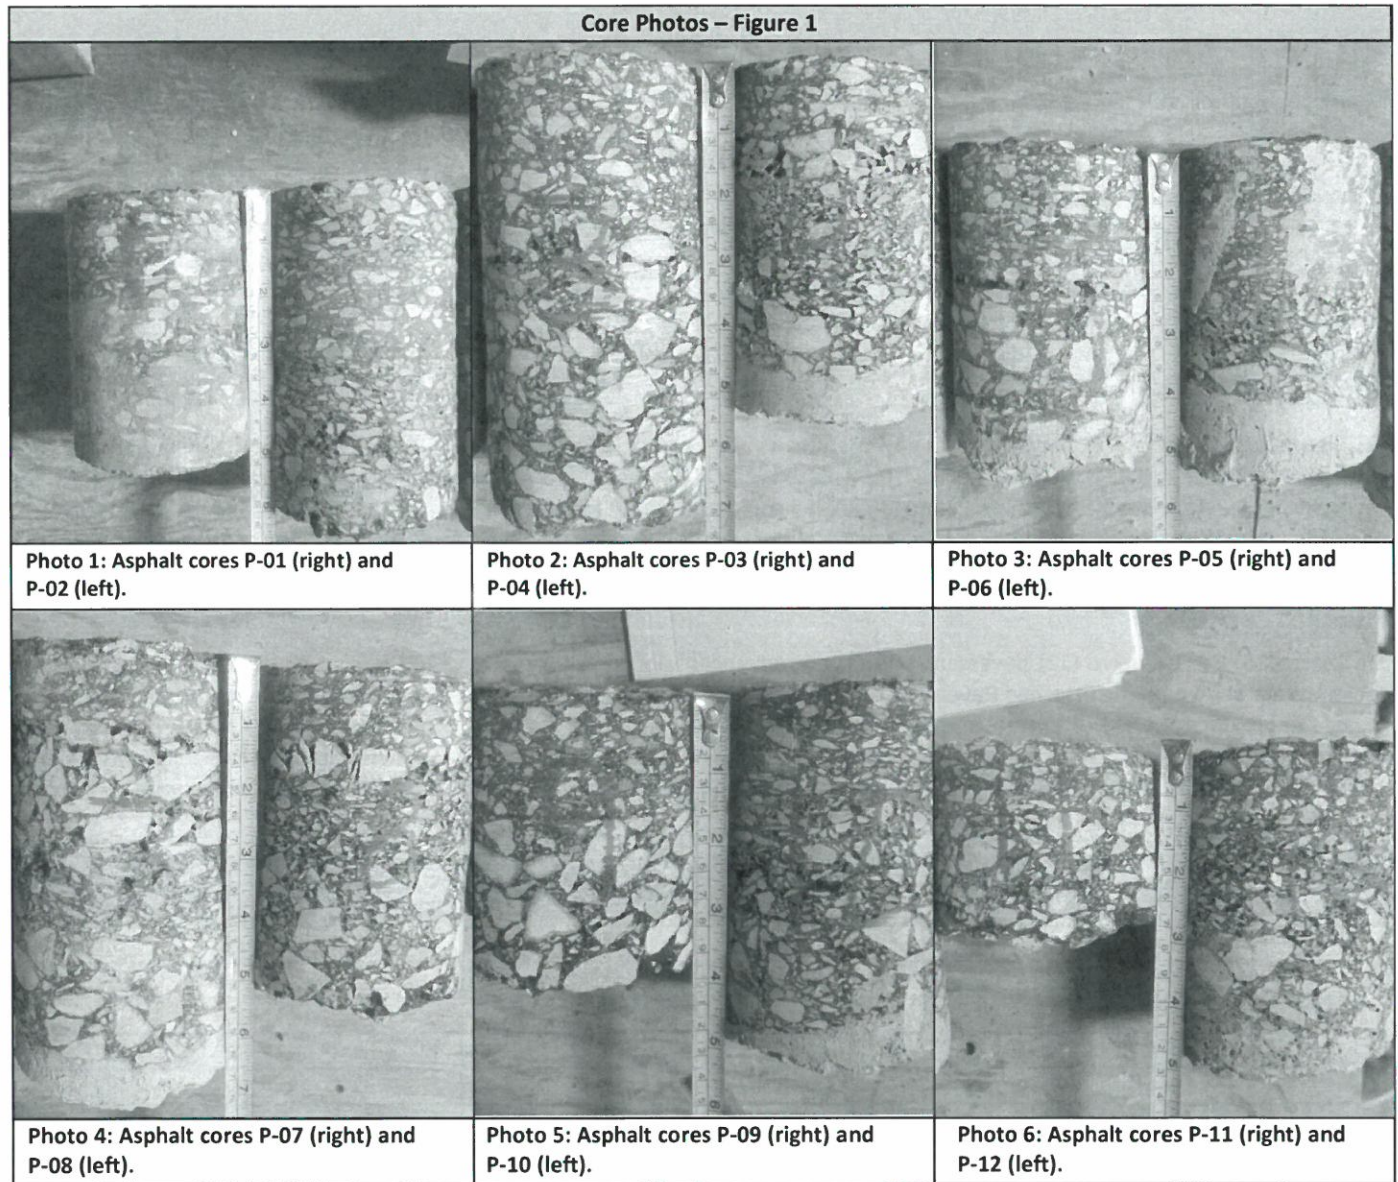
In general, the surface materials consisted of approximately 4 to 7 inches (average of approximately 5 ¼ inches) of asphalt pavement. However, approximately 2 ¾ inches of total asphalt thickness was encountered at P-11. The existing wearing base (surface asphalt) was approximately 1 to 4 inches with a binder or base (base asphalt) of approximately 1 to 6 inches. The existing asphalt was underlain by at least 8 inches of crushed stone and extended to more than 37 inches at P-01. Due to the depth of gravel and the limitations of the available equipment, the gravel base was not penetrated in any of the coring locations. The crushed typically consisted of fine to coarse grained gravel approximately ¼ to 1 ¼ inches with varying amounts of fines (sand to clay-sized material). No signs of significant distress were observed in the pavement cores. Refer to the **Core Photos - Figure 1** for photos of the cores recovered.

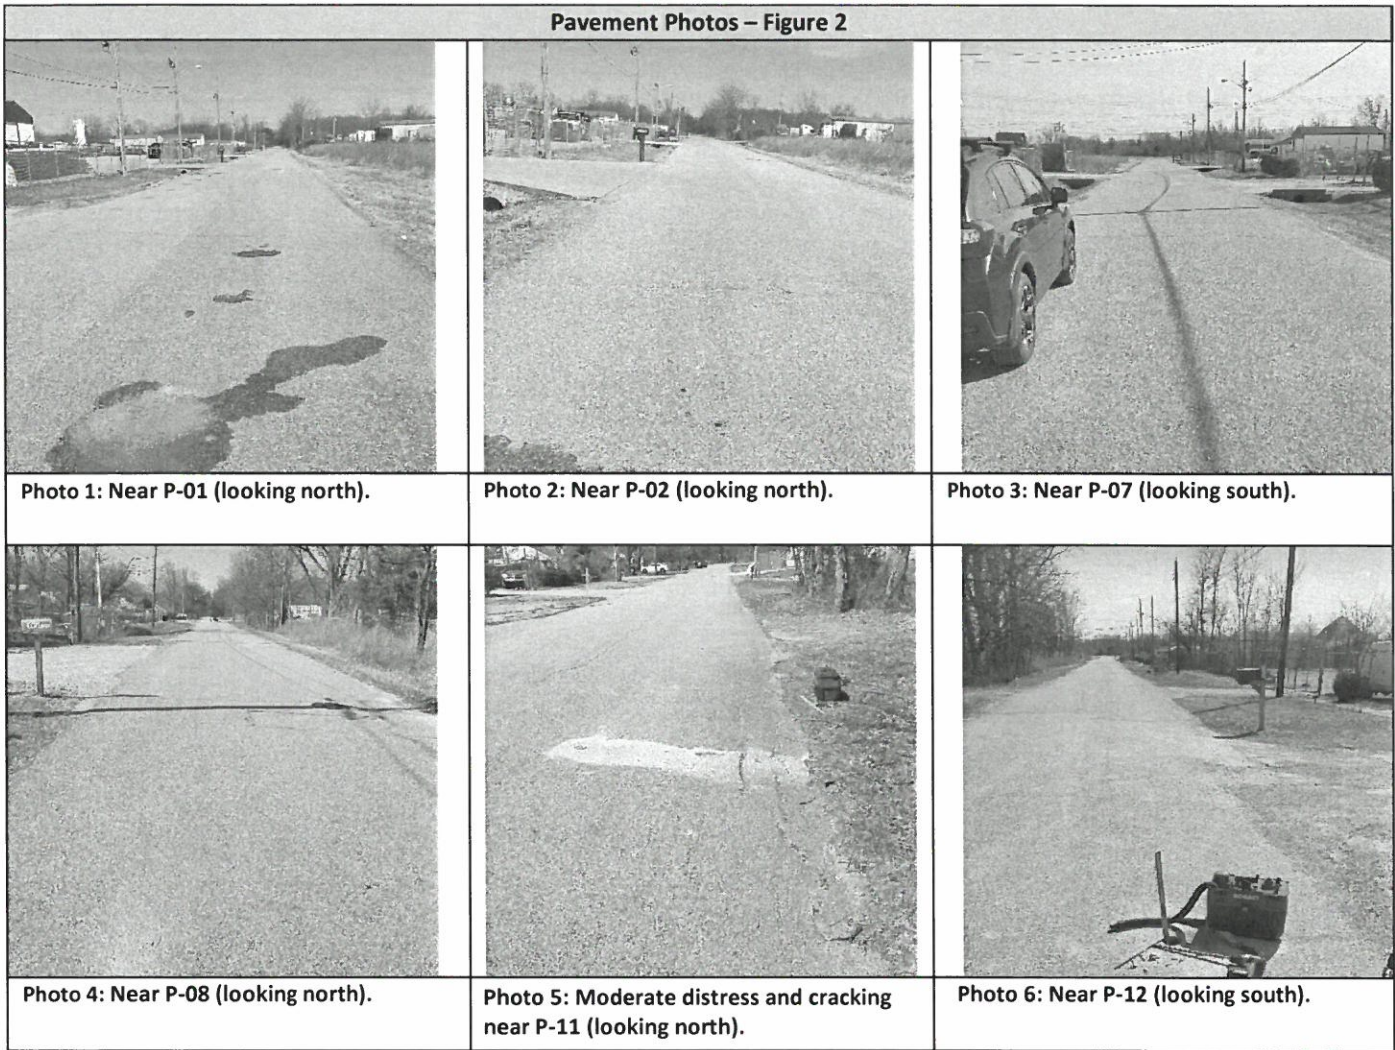
In general, isolated areas of slight transverse/longitudinal cracking, typical of in-use pavements, was observed over most areas and no significant cracks, rutting, or distress was observed over most areas evaluated. However, moderate cracking and degradation was observed in the area near P-11, specially along the east shoulder of the road. Refer to the **Pavement Photos - Figure 2** for photos of the areas cored.

Based on the conditions observed during the evaluation of the existing pavement, the condition of the pavement appeared to be in good condition compared to typical pavements of a similar age and usage. The existing asphalt pavements in most areas (excluding P-11) were observed to be slightly worn at the surface, but no significant cracks, rutting, or distress was observed over most areas evaluated.

The pavement sections encountered in the pavement coring appeared suitable for the volume of truck traffic (Daily Equivalent 18-kip Axle Loads of 30) based on the provided information (6 loaded and 6 unloaded additional trucks) and traffic conditions at the time of our exploration. However, based on the observed thickness and poor condition of the asphalt pavement near P-11, a 2-inch asphalt overlay should be considered in these areas.

Asphalt pavement, even when designed with an adequate structural section sometimes does not perform as desired under high demand, tight turn applications and requires additional maintenance and repairs. Sealing of the existing cracks (transverse and longitudinal) and seal coating of the asphalt pavement in all areas should be conducted. Crack sealing and seal coating should be performed every 3 to 5 years to maximize the life of the asphalt pavement. In addition, at a minimum an asphalt overlay within 2 to 3 years should be budgeted in all asphalt paved areas.

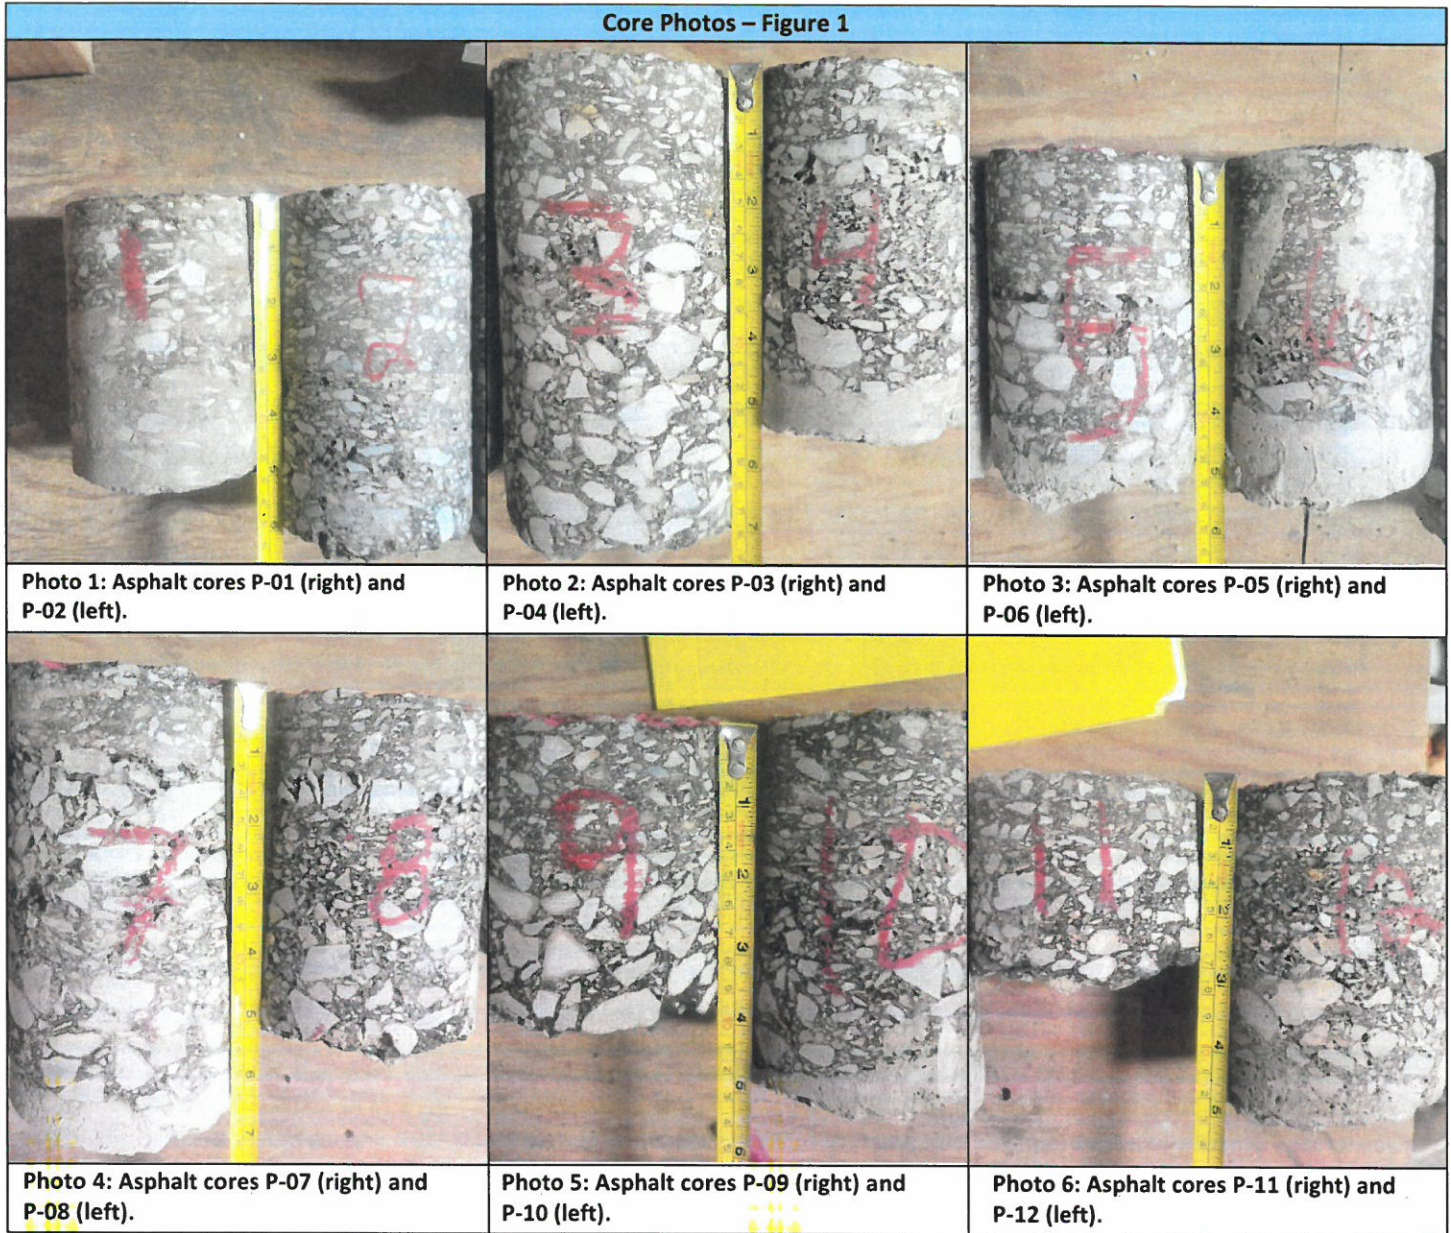
In general, the surface materials consisted of approximately 4 to 7 inches (average of approximately 5 ¼ inches) of asphalt pavement. However, approximately 2 ¾ inches of total asphalt thickness was encountered at P-11. The existing wearing base (surface asphalt) was approximately 1 to 4 inches with a binder or base (base asphalt) of approximately 1 to 6 inches. The existing asphalt was underlain by at least 8 inches of crushed stone and extended to more than 37 inches at P-01. Due to the depth of gravel and the limitations of the available equipment, the gravel base was not penetrated in any of the coring locations. The crushed typically consisted of fine to coarse grained gravel approximately ¼ to 1 ¼ inches with varying amounts of fines (sand to clay-sized material). No signs of significant distress were observed in the pavement cores. Refer to the **Core Photos - Figure 1** for photos of the cores recovered.
