## KARST RECONNAISSANCE SURVEY

HURSTBOURNE APARTMENTS DEVELOPMENT  
LOUISVILLE, KENTUCKY

SME Project No. 088601.00  
March 7, 2022

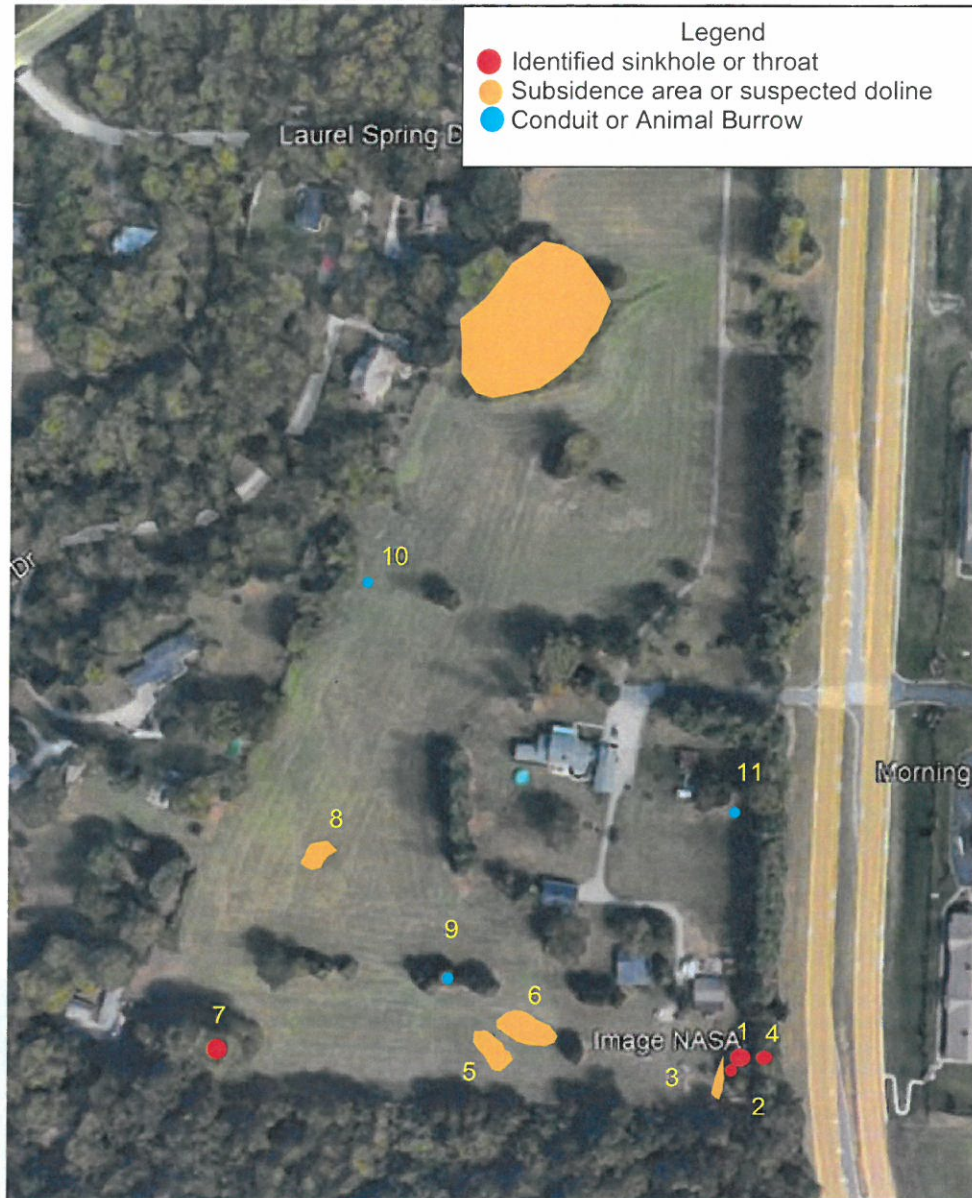
FIGURE 11 – IDENTIFIED FEATURES

Two of the sinkhole features, which were located within a small grove/tree cluster south of the garage and near the southeast site corner, appeared to be interconnected (and located directly adjacent to an elongated area of subsidence). An additional sinkhole feature was observed directly east of the referenced feature and adjacent to the eastern fence line. The fourth feature (Feature 7 in the table above) was located in the extreme southwest corner of the site within a tree grove. Multiple throats were observed within this feature in addition various debris. The presence of debris made it impractical to ascertain the feature dimensions, particularly the depth.

An elongated drainage feature extended southwest from the feature and off the project site. Three locally depressed areas (referenced in the previous section) where the vegetative surface cover differed from the adjacent area were observed along the southern portion of the site. These depressed areas may represent early “doline” activity. Doline is a term used to describe sinkholes that form slowly by subsidence of the ground surface. This downward movement can take years to occur before the surficial sinkhole is obvious.

A possible swallow hole or animal burrow was observed within a tree grove in the southern portion of the site. An additional depressed area (possible doline) was observed north of this feature and west of the barn near the western site boundary. An isolated hole was observed along the west-central portion of the site. A depressed area was observed adjacent to the east side of the original entrance drive. The depressed area was filled with leaves, which made the discerning approximate dimensions difficult. However, it is assumed this depressed area is an inlet for a culvert discharging on the west side of the driveway.

The pond (or perennial stream as identified on LOGIC) was mostly dry at the time of our evaluation, although the ground surface appeared to be soft. This area most likely a wetlands or ephemeral pond, which periodically holds water for some time during or following precipitation events. The pond area is relatively shallow, which suggest the area may have been infilled either by natural causes (e.g., erosion or siltation) or man-placed fill. Ponds typically form in low points in karst areas via plugging of the near-surface voids or fracture zones via siltation. However, impounding of water can over time initiate sinkhole activity, which may also explain the lack water within the pond (and in photographs from recent years).

At least four sinkholes (or open throats/conduits connected to a sinkhole feature) were identified on the project site. These sinkhole features, while relatively small and shallow, are obvious evidence of karst development at the site. The sinkhole feature identified in southwest corner of the site within a grove is depicted on the proposed site development plan (Feature 7, identified as a closed contour) within the footprint of a proposed 36-unit housing structure. Similarly, it appears two sinkhole and/or conduits (Features 1 and 2) are located within the footprint of a proposed 24-unit housing structure near the southeast corner of the site. Preliminarily, we estimate that sinkhole Feature 4 is outside the proposed footprint of the referenced 24-unit structure but near the east side of the building. Therefore, it will also impact development of this structure.

Do not construct over active or possible sinkholes without further exploration, analysis and remediation (if feasible and where sinkhole features are identified). Where possible, adjust or modify the site plan by shifting proposed structure locations away from identified sinkhole features is preferable. However, this is not always possible without significantly impacting the project. Sinkhole features identified within structural areas (i.e., building or pavements) will require remediation during construction or utilization of alternative foundation systems as directed by the Geotechnical Engineer of Record, assuming the proposed structure locations cannot be shifted. We recommend identified and suspected sinkhole features be evaluated prior to construction (ideally during the planning stage) to determine impacts on the proposed development. Characterization of identified anomalies can be performed by performance of additional test borings (beyond quantity per geotechnical evaluation scope), excavation, and/or geophysical surveys.

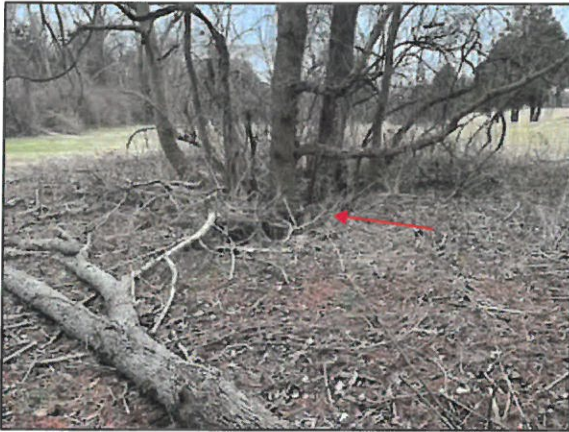
PHOTO NO. 1: Sinkhole in grove south of garage (Features 1 &2)

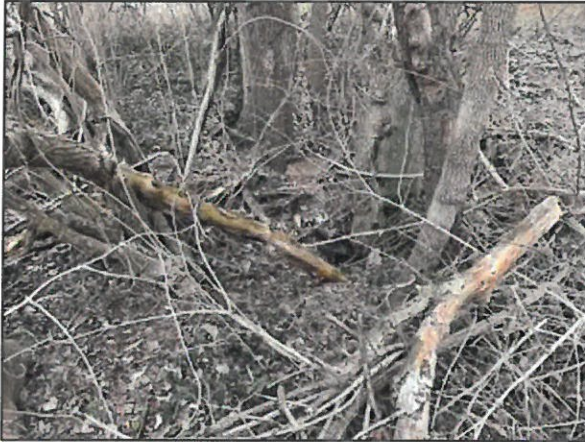
PHOTO NO. 2: Sinkhole (Feature 1)

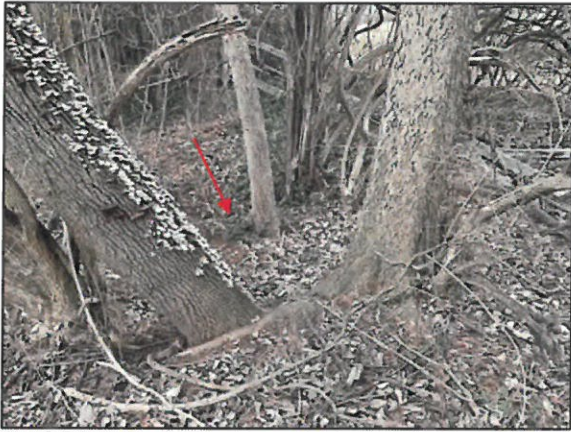
PHOTO NO. 4: Shallow sinkhole with throat (Feature 4)

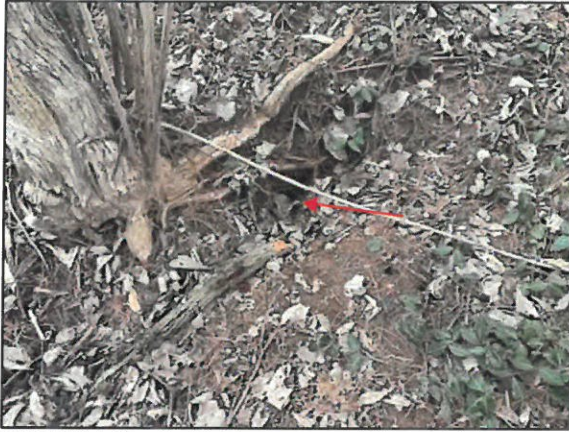
PHOTO NO. 5: Sinkhole conduit/throat (Feature 4)

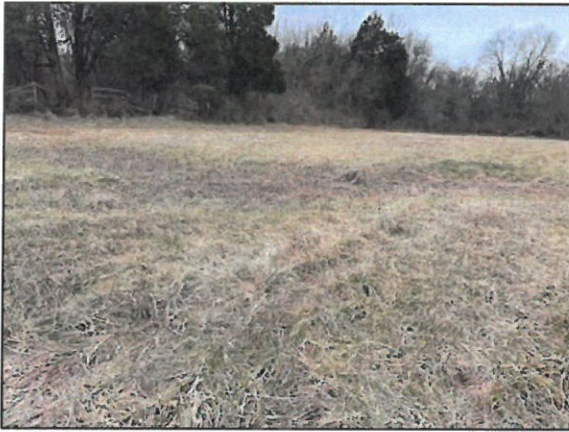
PHOTO NO. 6: Ground subsidence (Features 5 and 6)

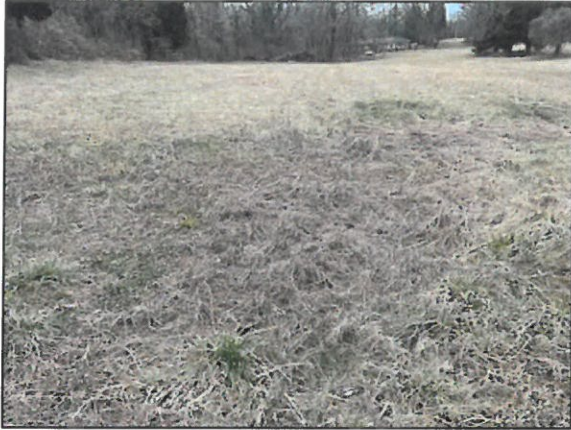
PHOTO NO. 7: Ground subsidence/differing vegetation (Feature 5)

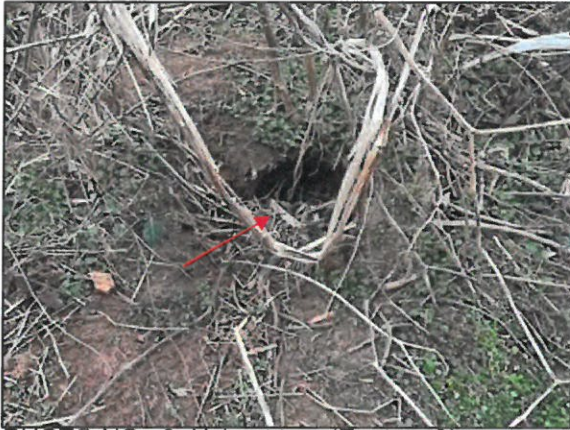
PHOTO NO. 8: Hole at tree (Feature 9)

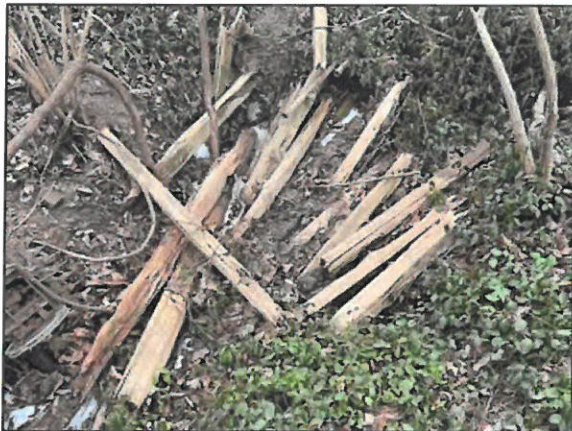
PHOTO NO. 9: Sinkhole at southwest corner (Feature 7)

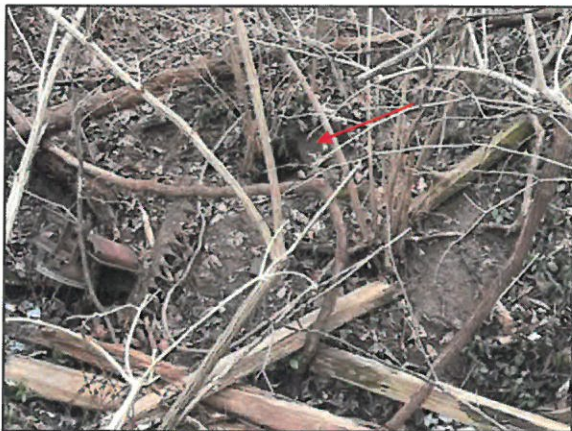
PHOTO NO. 10: Conduit/ swallow hole at Feature 7

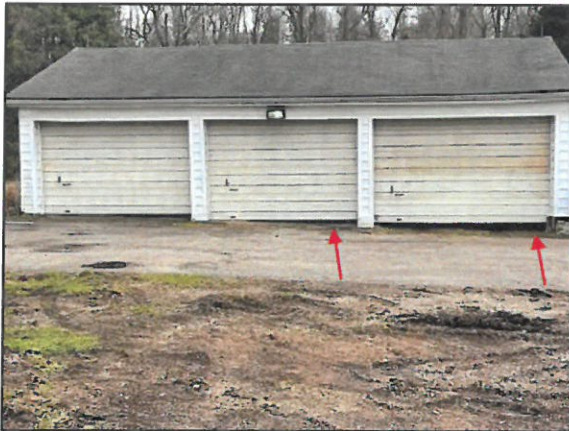
PHOTO NO. 11: Ground subsidence at garage

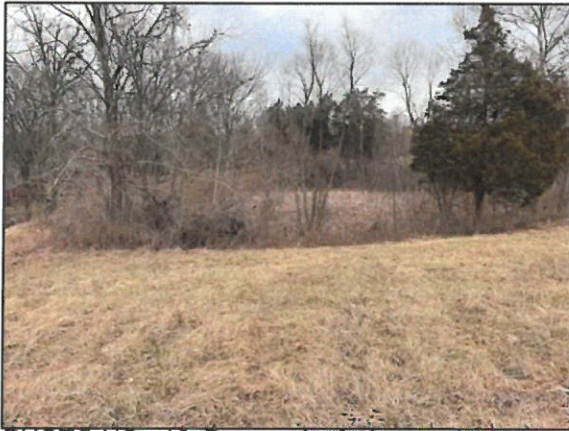
PHOTO NO. 12: Dry pond – facing north

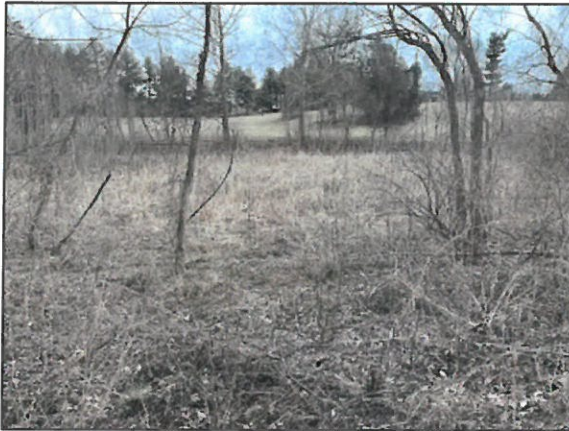
PHOTO NO. 13: Dry pond – facing southeast

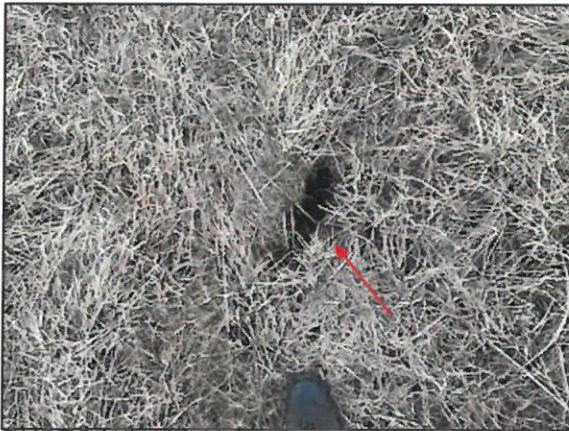
PHOTO NO. 14: Hole (Feature 10)
