KARST RECONNAISSANCE SURVEY

HURSTBOURNE APARTMENTS DEVELOPMENT
LOUISVILLE, KENTUCKY

SME Project No. 088601.00
March 7, 2022

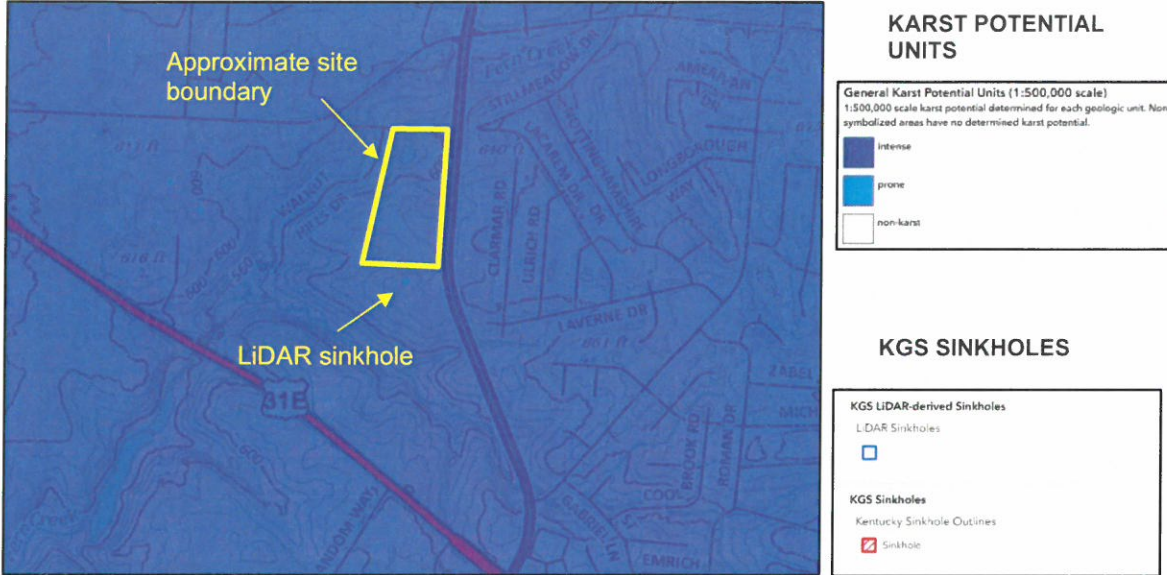
FIGURE 6 - KARST POTENTIAL MAP (1)

Our review of the referenced geological literature (including the KGS Karst Potential Map – see below) indicates the presence of a singular sinkhole as identified by LiDAR (represented by blue outline) directly adjacent to the southern parcel border. Older, well-defined sinkholes are defined by a red-hashed zone. However, the KGS map is a generalized tool for identifying sinkhole features and should not be considered as a suitable replacement for “boots on the ground” site evaluation.

The above-referenced map reflects the generalized existing site topography and documented sinkholes. Changes in site topography, including development of new sinkholes or absence of old sinkholes, may be observed when comparing newer geologic maps to older maps. However, our review of the original site geology map (Jeffersontown, 1972) did not indicate the presence of documented sinkholes within the project boundaries.

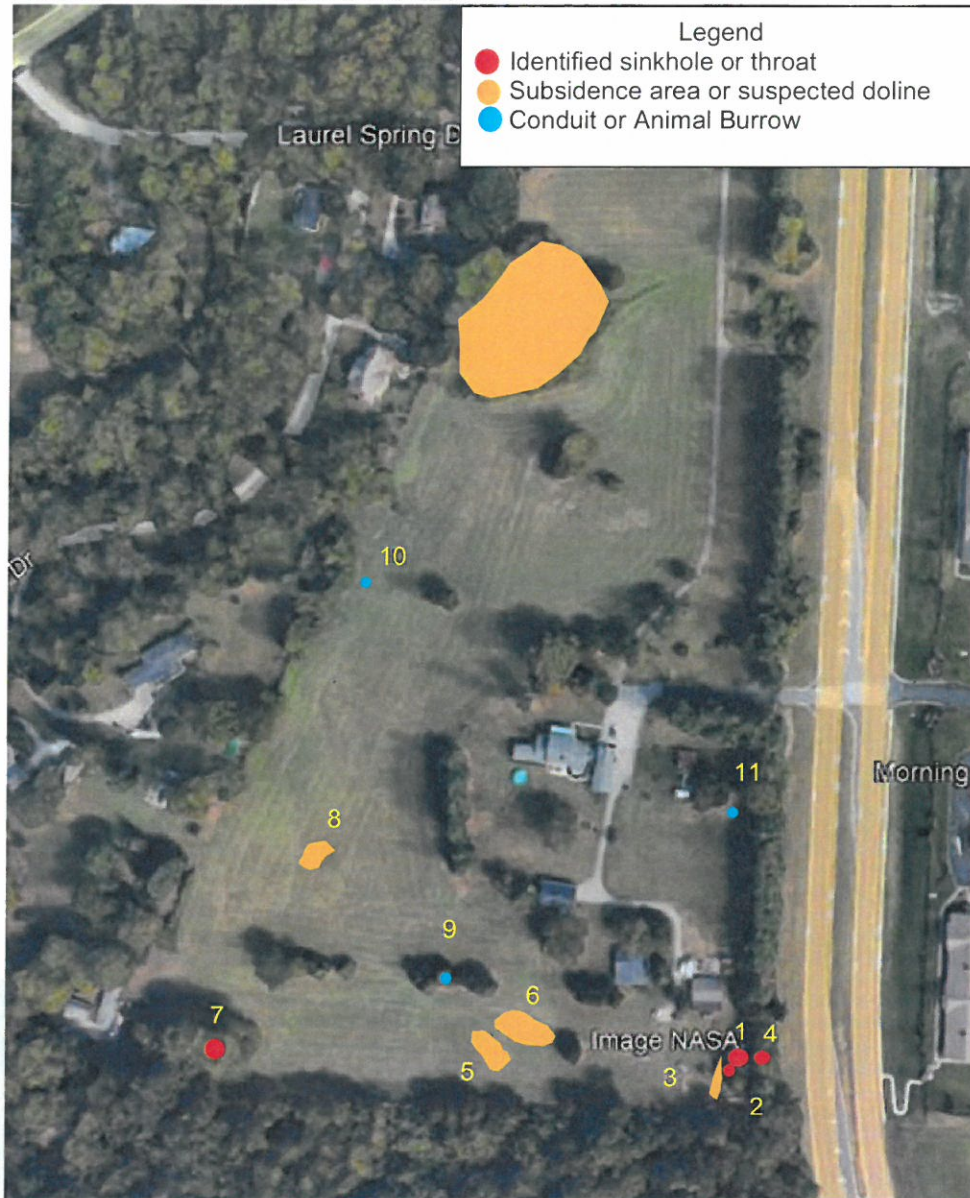
FIGURE 11 – IDENTIFIED FEATURES

Two of the sinkhole features, which were located within a small grove/tree cluster south of the garage and near the southeast site corner, appeared to be interconnected (and located directly adjacent to an elongated area of subsidence). An additional sinkhole feature was observed directly east of the referenced feature and adjacent to the eastern fence line. The fourth feature (Feature 7 in the table above) was located in the extreme southwest corner of the site within a tree grove. Multiple throats were observed within this feature in addition various debris. The presence of debris made it impractical to ascertain the feature dimensions, particularly the depth.

An elongated drainage feature extended southwest from the feature and off the project site. Three locally depressed areas (referenced in the previous section) where the vegetative surface cover differed from the adjacent area were observed along the southern portion of the site. These depressed areas may represent early “doline” activity. Doline is a term used to describe sinkholes that form slowly by subsidence of the ground surface. This downward movement can take years to occur before the surficial sinkhole is obvious.

A possible swallow hole or animal burrow was observed within a tree grove in the southern portion of the site. An additional depressed area (possible doline) was observed north of this feature and west of the barn near the western site boundary. An isolated hole was observed along the west-central portion of the site. A depressed area was observed adjacent to the east side of the original entrance drive. The depressed area was filled with leaves, which made the discerning approximate dimensions difficult. However, it is assumed this depressed area is an inlet for a culvert discharging on the west side of the driveway.

The pond (or perennial stream as identified on LOGIC) was mostly dry at the time of our evaluation, although the ground surface appeared to be soft. This area most likely a wetlands or ephemeral pond, which periodically holds water for some time during or following precipitation events. The pond area is relatively shallow, which suggest the area may have been infilled either by natural causes (e.g., erosion or siltation) or man-placed fill. Ponds typically form in low points in karst areas via plugging of the near-surface voids or fracture zones via siltation. However, impounding of water can over time initiate sinkhole activity, which may also explain the lack water within the pond (and in photographs from recent years).

At least four sinkholes (or open throats/conduits connected to a sinkhole feature) were identified on the project site. These sinkhole features, while relatively small and shallow, are obvious evidence of karst development at the site. The sinkhole feature identified in southwest corner of the site within a grove is depicted on the proposed site development plan (Feature 7, identified as a closed contour) within the footprint of a proposed 36-unit housing structure. Similarly, it appears two sinkhole and/or conduits (Features 1 and 2) are located within the footprint of a proposed 24-unit housing structure near the southeast corner of the site. Preliminarily, we estimate that sinkhole Feature 4 is outside the proposed footprint of the referenced 24-unit structure but near the east side of the building. Therefore, it will also impact development of this structure.

Do not construct over active or possible sinkholes without further exploration, analysis and remediation (if feasible and where sinkhole features are identified). Where possible, adjust or modify the site plan by shifting proposed structure locations away from identified sinkhole features is preferable. However, this is not always possible without significantly impacting the project. Sinkhole features identified within structural areas (i.e., building or pavements) will require remediation during construction or utilization of alternative foundation systems as directed by the Geotechnical Engineer of Record, assuming the proposed structure locations cannot be shifted. We recommend identified and suspected sinkhole features be evaluated prior to construction (ideally during the planning stage) to determine impacts on the proposed development. Characterization of identified anomalies can be performed by performance of additional test borings (beyond quantity per geotechnical evaluation scope), excavation, and/or geophysical surveys.

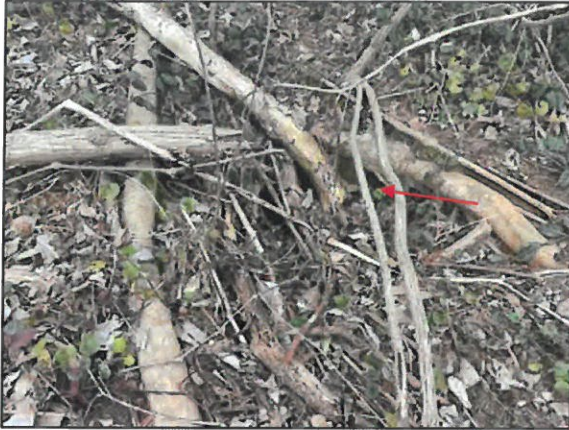
PHOTO NO. 3: Surficial swallow hole/ conduit (Feature 2)
