May 4, 2022

Reference: **Oak Grove Subdivision – Karst Survey**
10212 & 10302 Oak Grove Road
Louisville, Jefferson County, Kentucky 40291
ECS Project No. 61-2724

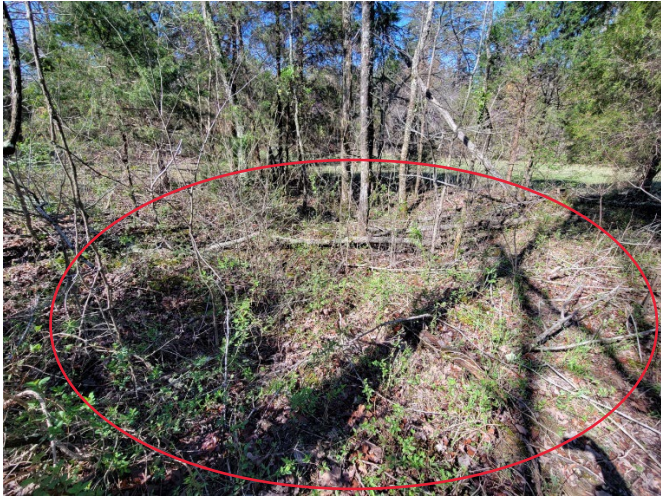
Feature	Description	Approximate Dimensions	Approximate Depth
F-1	Oval-shaped closed depression containing three (3) smaller closed depressions. Soil sidewalls, no visible throats.	30' Diameter	3'
F-2	Oval-shaped closed depression underlain by an apparent spring. Audible running water observed below soil bottom. Soil sidewalls observed. Three (3) open throats encountered.	35' Diameter	3'
F-3	Trenchlike closed depression with soil sidewalls and a partially closed throat encountered at the bottom of the depression.	3' Wide 25' Long	3.5'
F-4	Oval-shaped closed depression with soil sidewalls and two partially closed throats encountered at the bottom of the depression. Exposed metal pipes observed at the bottom of the depression.	17' Diameter	2.5'
F-5	Oval-shaped closed depression with soil sidewalls and a partially closed throat encountered at the bottom of the depression. Probe rod extended to apparent rock approximately 3 feet below the bottom of the depression.	7' Wide 17' Long	4'

Photo 1 – View of F-1.

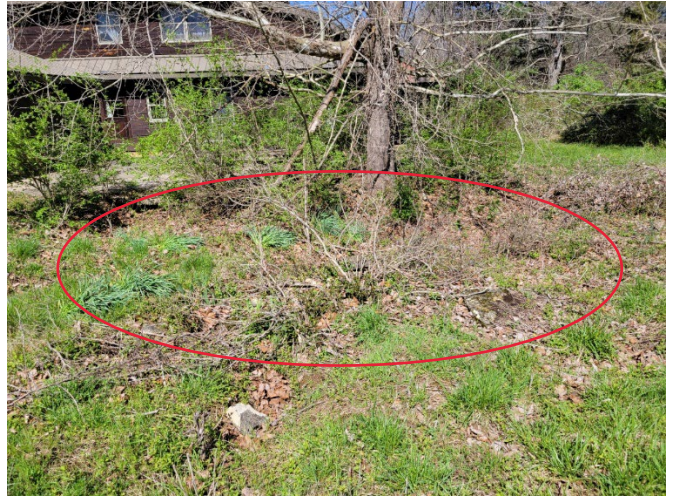
Photo 2 – View of F-2.

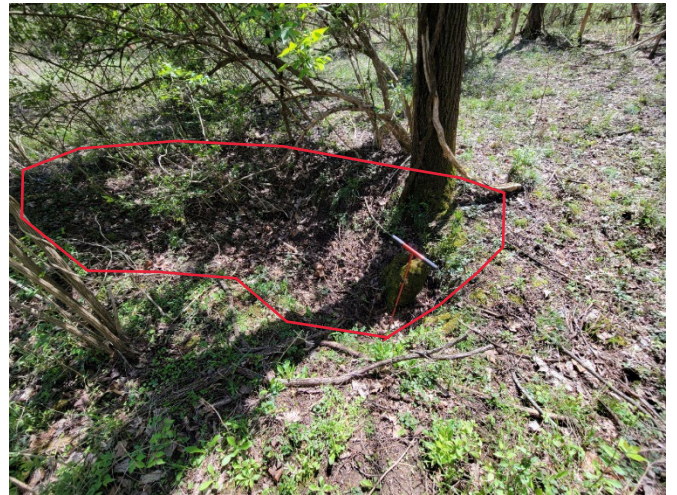
Photo 4 – View of F-4.

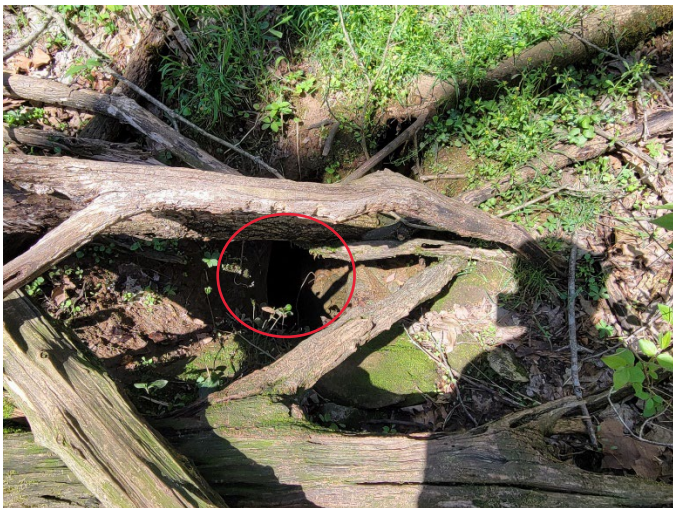
Photo 5 – View of F-5.

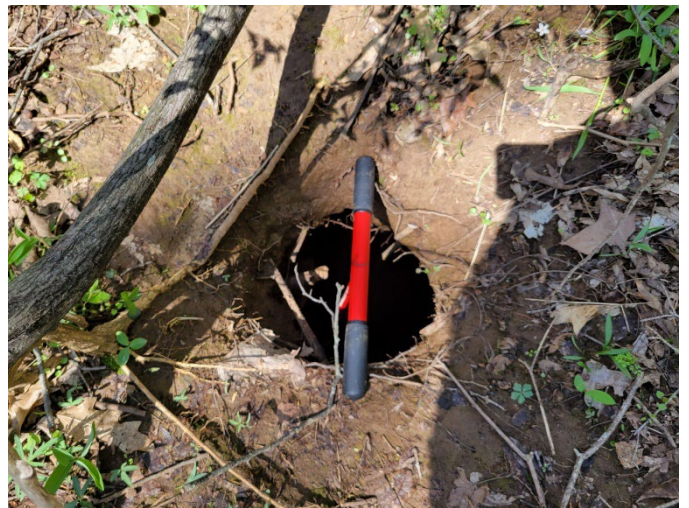
Feature	Description	Approximate Dimensions	Approximate Depth
F-6	Small opening with rock sidewalls/bottom. Visible water observed at the bottom of the opening.	1' Diameter	> 4'
F-7	Small opening with rock sidewalls/bottom. Visible water observed on the walls of the opening.	2' Diameter	> 4'
F-8	Spring, surrounded by outcropped rock, observed in a hillside. 1-2" of running water observed.	6' Wide 11' Long	3'
F-9	Small opening with soil sidewalls. Visibly wet.	1' Diameter	3'
F-10	Oval-shaped closed depression with soil sidewalls.	2' Diameter	2'
F-11	Spring observed in a hillside. Spring forks into 2 separate drainage channels, which drain to Cedar Creek approximately 40-50 feet to the west. 1'2" of running water observed.	5' Wide 20-30' Long	6'
F-12	Oval-shaped closed depression with soil sidewalls. Outcropped rock visible within the center of the depression.	12' Diameter	4'
F-13	Oval-shaped closed depression with soil sidewalls. Outcropped rock visible within the center of the depression.	16' Diameter	3'

Photo 6 – View of F-6.

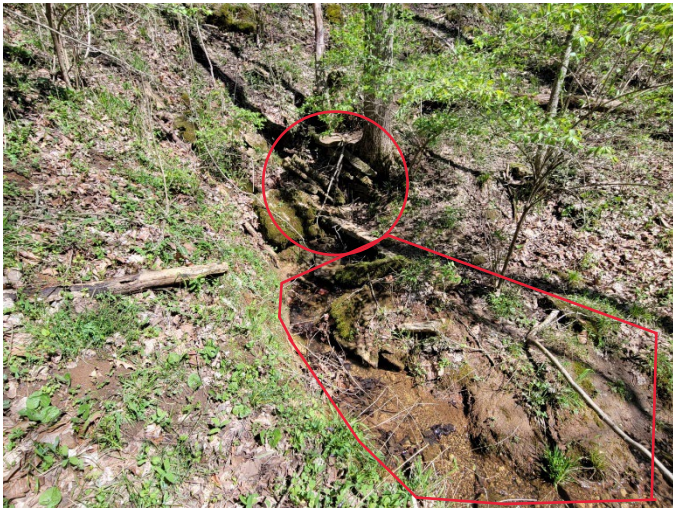
Photo 7 – View of F-8

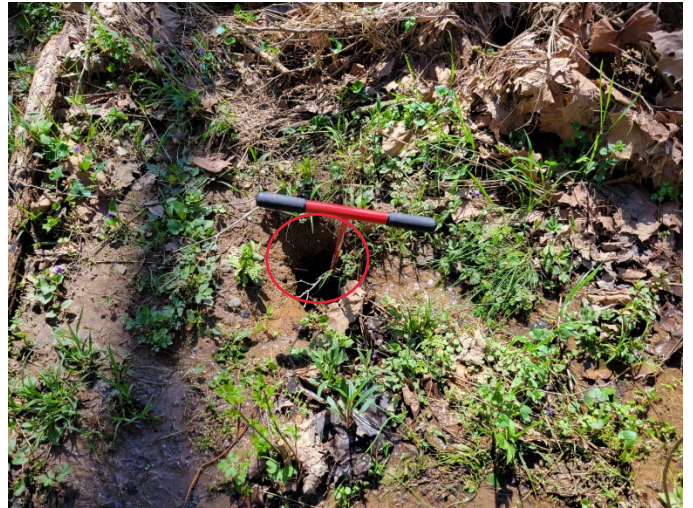
Photo 8 – View of F-9

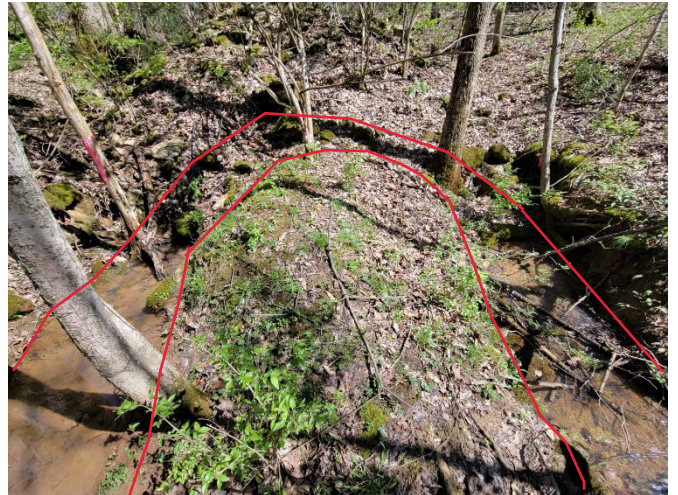
Photo 10 – View of F-11

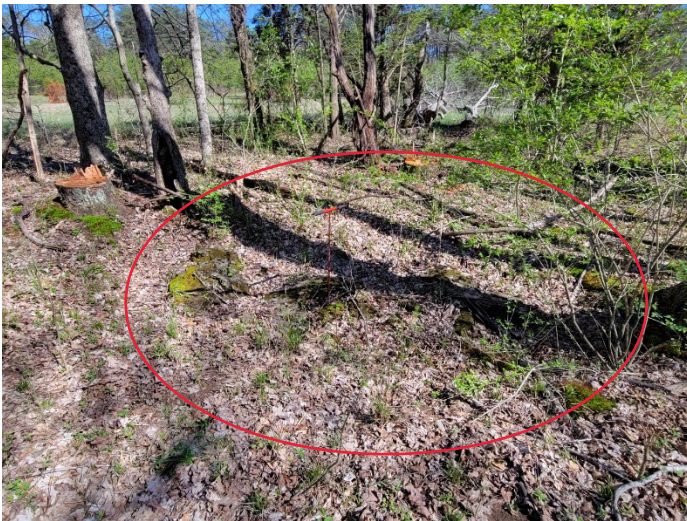
Photo 11 – View of F-12

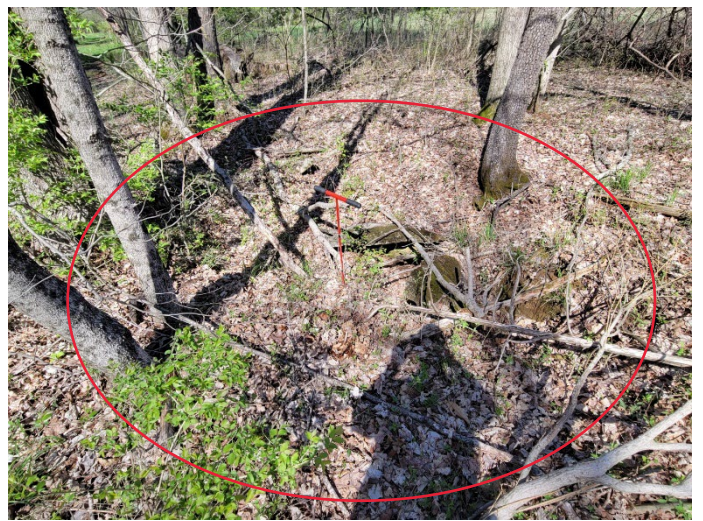
Photo 12 – View of F-13

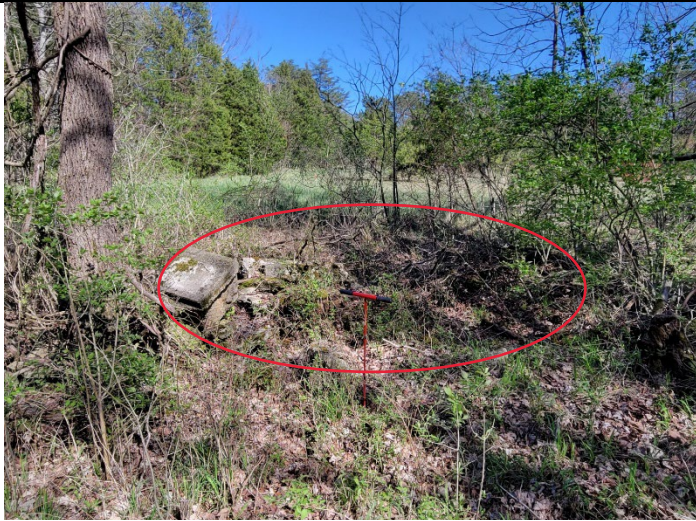
F-14	Oval-shaped closed depression with soil sidewalls. Depression was filled with debris.	22' Diameter	3'
F-15	Oval-shaped closed depression with soil sidewalls and a partially closed throat encountered at the bottom of the depression.	2.5' Diameter	4'
F-16	Small opening with soil and rock sidewalls, with apparent rock probed at the bottom of the opening.	1' Diameter	2'
F-17	Small opening with soil sidewalls. Apparent rock probed at the bottom of the opening.	6" Diameter	1.5'
F-18	Oval-shaped closed depression with soil sidewalls. Probe rod extended to apparent rock approximately 6 inches below the bottom of the depression.	4' Diameter	2'
F-19	Small opening with soil and rock sidewalls. Probe rod extended to apparent rock approximately 1 foot below the bottom of the opening.	2' Diameter	3'
F-20	Possible oval-shaped closed depression with rock and soil sidewalls. Probe rod extended to apparent rock approximately 6 inches below the bottom of the depression. Evidence of apparent human disturbance with perimeter of depression lined with stone blocks.	9' Diameter	3'

Photo 13 – View of F-14

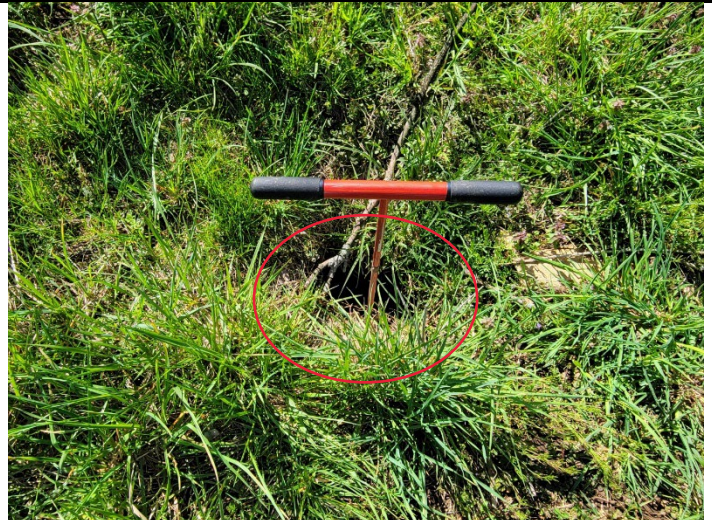
Photo 14 – View of F-15

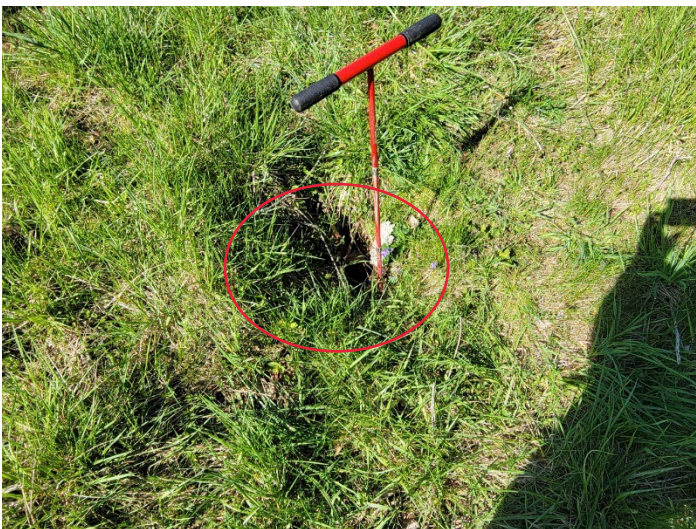
Photo 15 – View of F-16

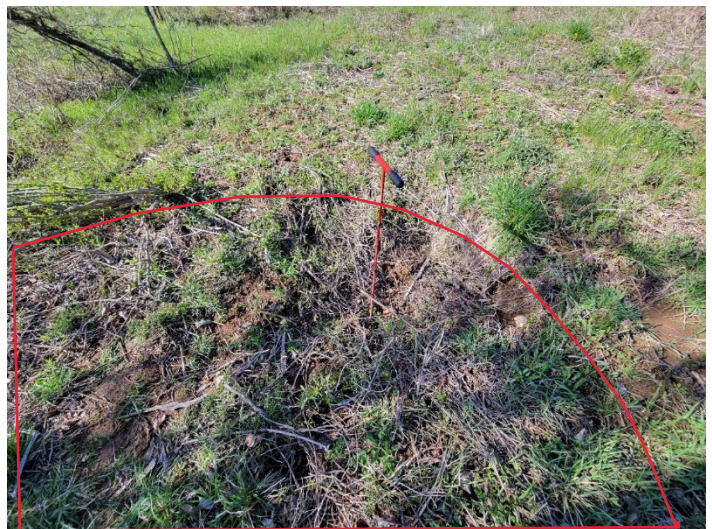
Photo 16 – View of F-18

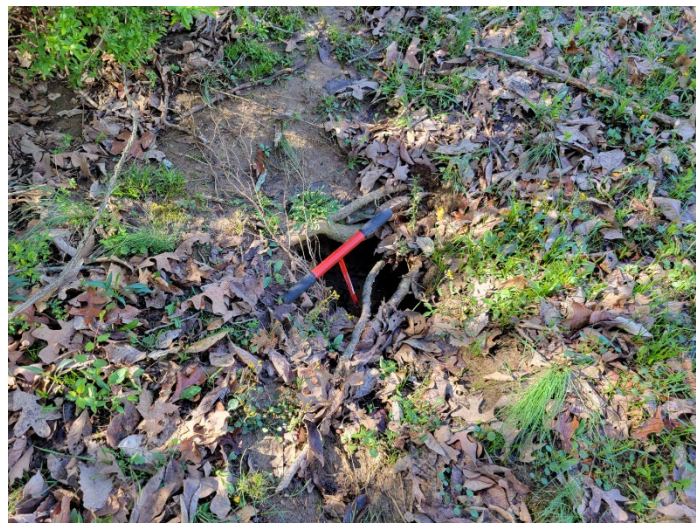
Photo 17 – View of F-19

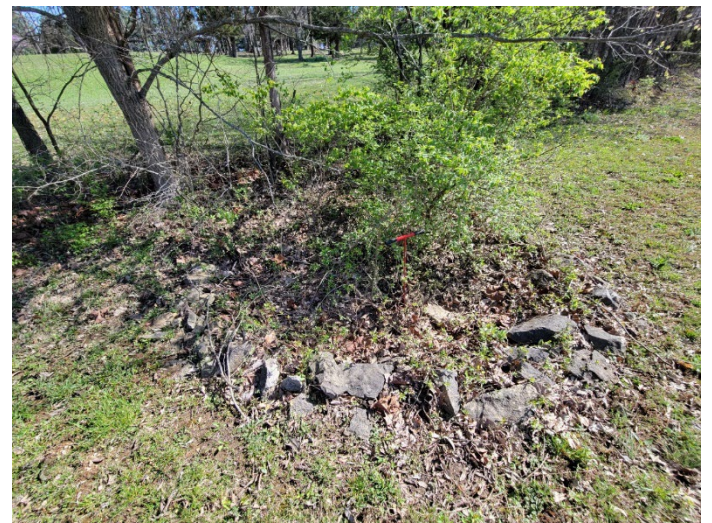
Photo 18 – View of F-20

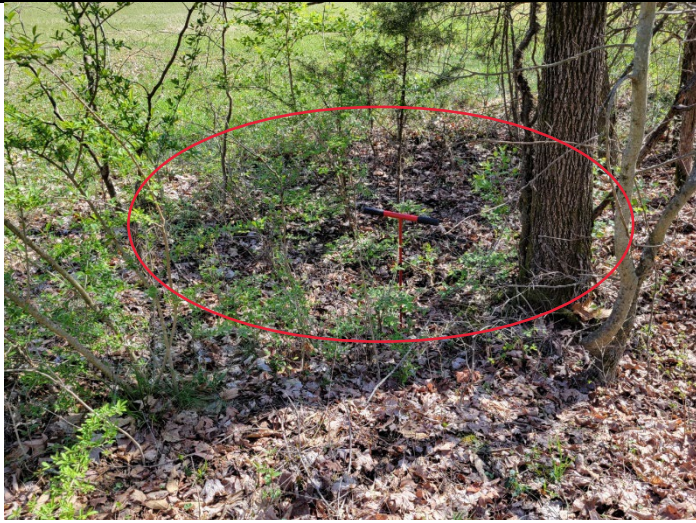
F-21	Oval-shaped closed depression with soil sidewalls and a partially closed throat encountered at the bottom of the depression. Probe rod extended to apparent rock approximately 1 foot below the bottom of the depression.	10' Diameter	2.5'
F-22	Oval-shaped closed depression with soil sidewalls. Depression was filled with debris.	17' Diameter	3.5'
F-23	Oval-shaped closed depression with soil sidewalls. Probe rod extended to apparent rock approximately 3 feet below the bottom of the depression.	7' Diameter	4'

Photo 19 – View of F-21

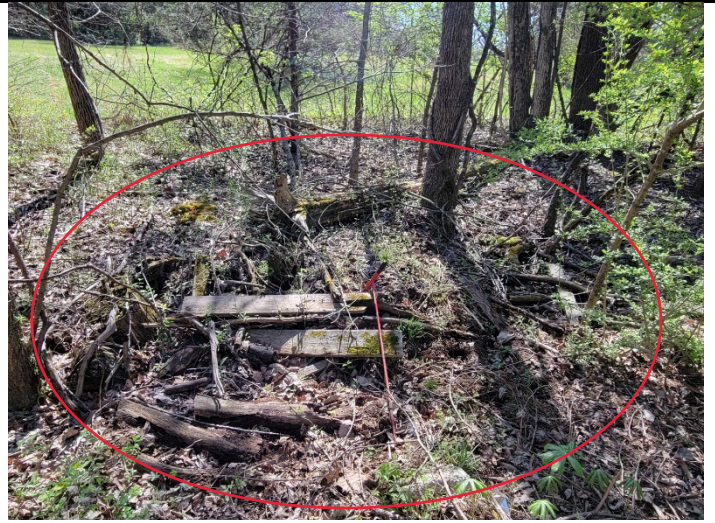
Photo 20 – View of F-22

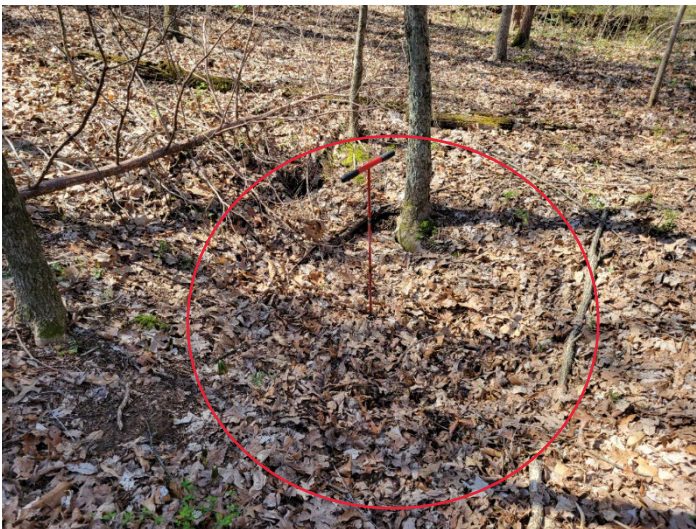
Photo 21 – View of F-23

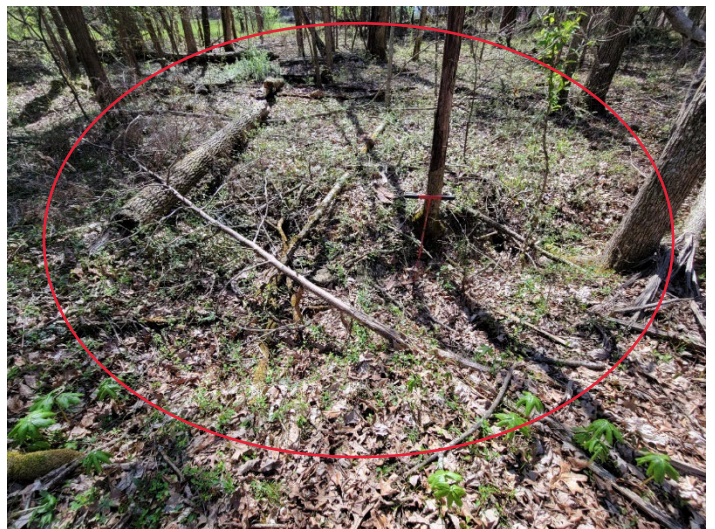
Feature	Description		Approximate Dimensions	Approximate Depth
F-24	A karst basin that contained two smaller closed depressions.		30' Diameter	3'
	A	Trenchlike closed depression with soil and rock sidewalls. Probe rod extended to apparent rock approximately 2 feet below the bottom of the depression.	4' Wide 22' Long	3'
	B	Oval-shaped closed depression with soil and rock sidewalls.	6' Diameter	4'
F-25	Oval-shaped closed depression with soil sidewalls. Probe rod extended to apparent rock approximately 3 feet below the bottom of the depression.		7' Diameter	3'
F-26	Oval-shaped closed depression with soil sidewalls and an open throat (1' diameter, > 4' deep) observed at the bottom of the depression. Visible moisture on rock walls of open throat.		10' Diameter	2.5'
F-27	Oval-shaped closed depression with soil sidewalls.		5' Diameter	3'
F-28	Oval-shaped closed depression with soil sidewalls.		6' Diameter	3'

Photo 22 – View of F-24

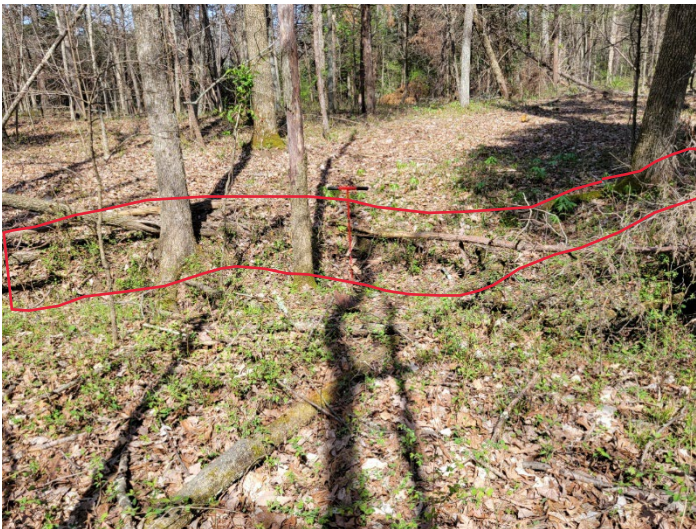
Photo 23 – View of F-24A

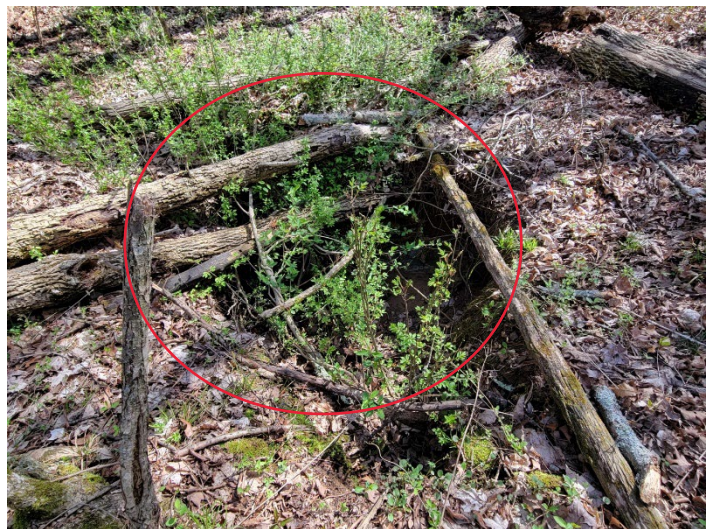
Photo 24 – View of F-24B

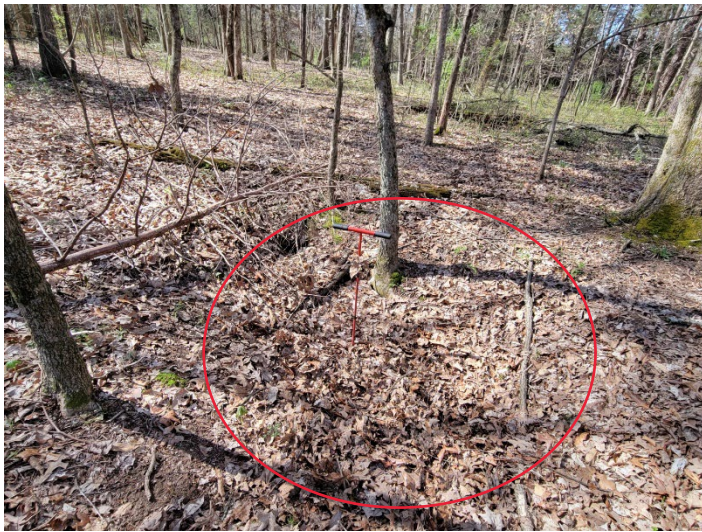
Photo 25 – View of F-25

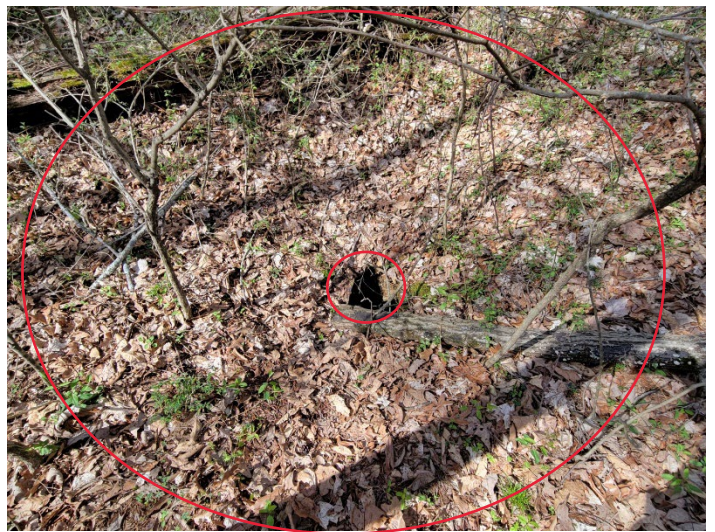
Photo 26 – View of F-26

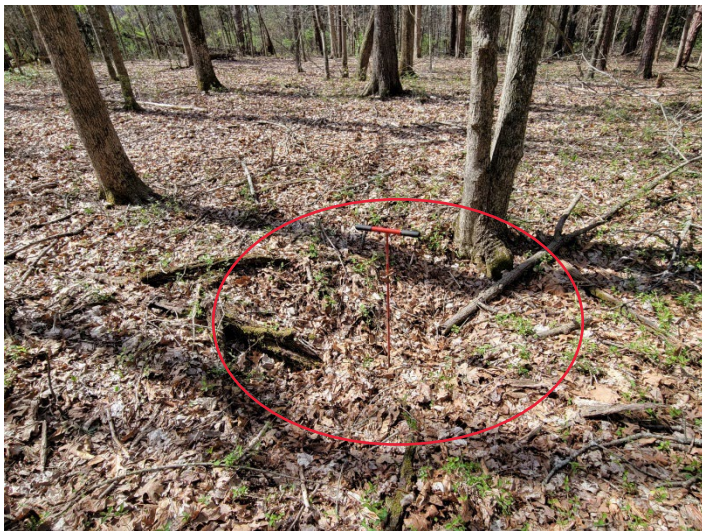
Photo 27 – View of F-27

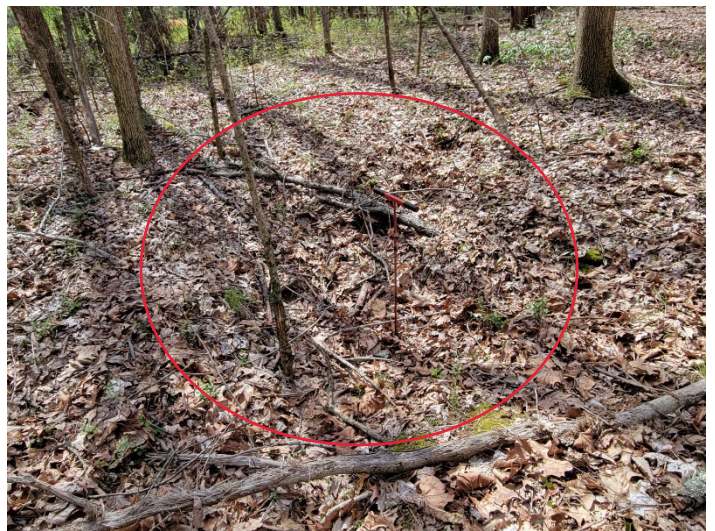
Photo 28 – View of F-28

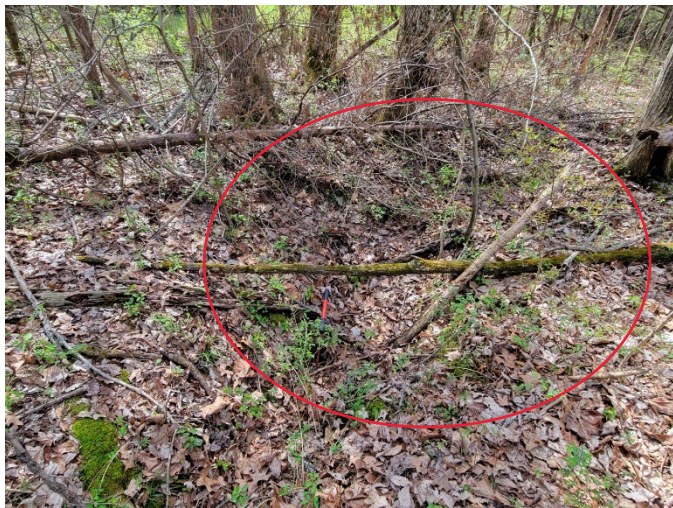
F-29	Oval-shaped closed depression with soil sidewalls. A partially closed throat with rock sidewalls and bottom (6" diameter, 2' deep) was encountered at the bottom of the depression.		6' Diameter	5'
F-30	Oval-shaped closed depression with soil sidewalls. Probe rod extended to apparent rock approximately 1 foot below the bottom of the depression.		7' Diameter	2'
F-31	Oval-shaped closed depression with soil sidewalls. Probe rod extended to apparent rock approximately 2 feet below the bottom of the depression. A metal pipe (debris) was observed within the depression.		4' Diameter	2'
F-32	Oval-shaped closed depression with soil sidewalls. Probe rod extended to apparent rock approximately 6 inches below the bottom of the depression.		5' Diameter	2'
F-33	Oval-shaped closed depression with soil sidewalls. Probe rod extended to apparent rock approximately 6 inches below the bottom of the depression.		4' Diameter	2'

Photo 29 – View of F-29

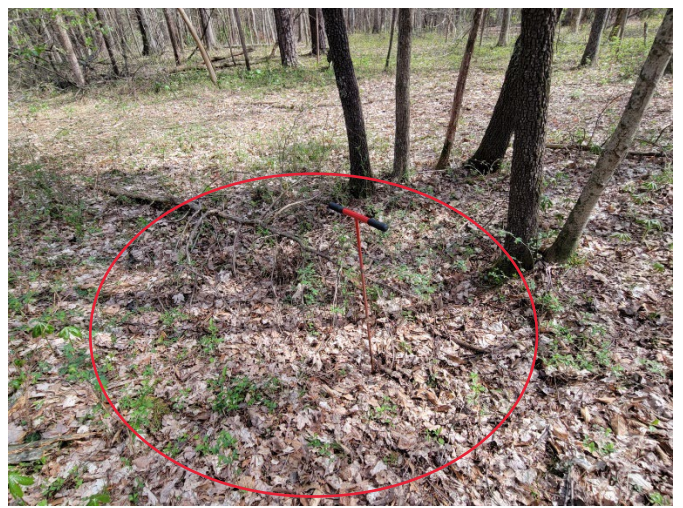
Photo 30 – View of F-30

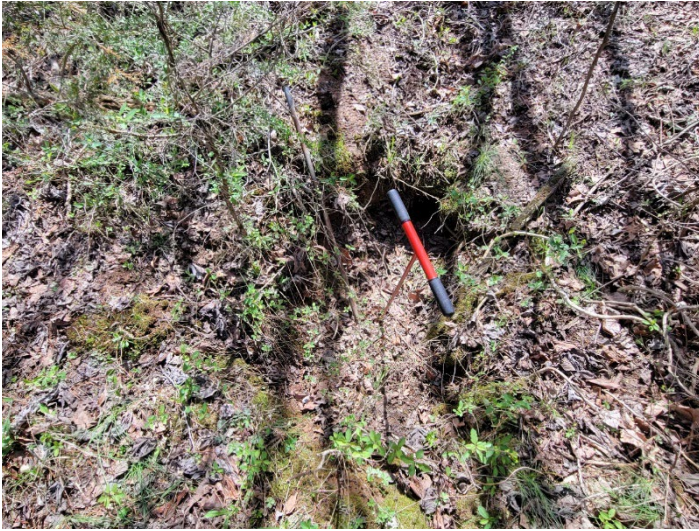
Photo 31 – View of F-31

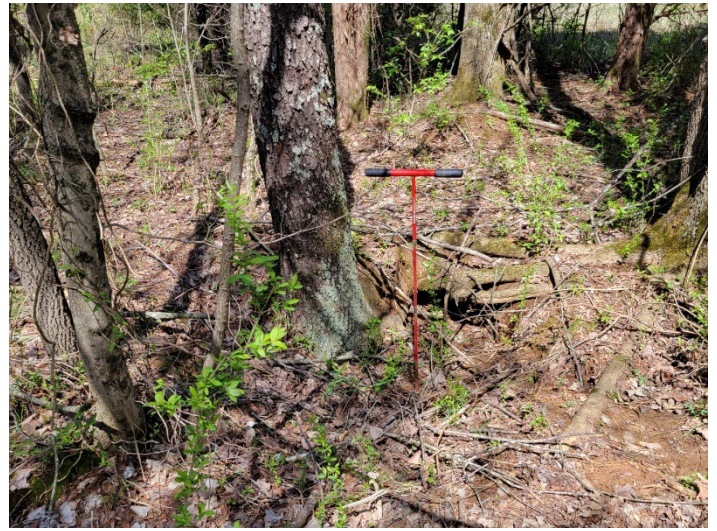
Photo 32 – View of F-32

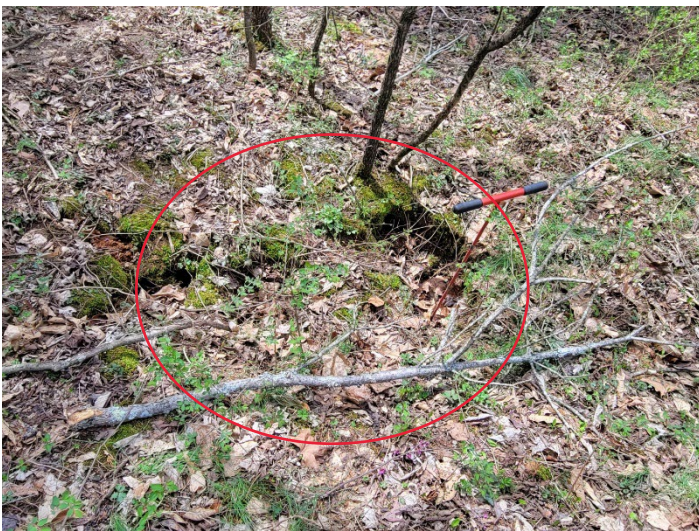
Photo 33 – View of F-33

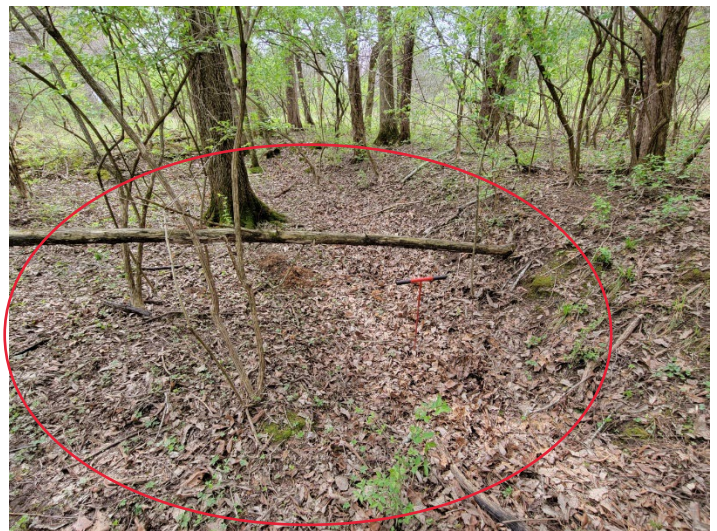
F-34	Oval-shaped closed depression with soil sidewalls, surrounded by small rock outcroppings. Probe rod extended to apparent rock approximately 1 foot below the bottom of the depression.		24' Diameter	5'
F-35	Apparent spring observed in a hillside. No water observed, rock outcroppings found throughout outlet area.		4' Wide 6-8' Long	2-3'
F-36	Oval-shaped closed depression with soil sidewalls.		9' Diameter	6'
F-37	Oval-shaped closed depression with soil sidewalls. Probe rod extended to apparent rock approximately 1 foot below the bottom of the depression.		5' Diameter	2'
F-38	Trenchlike closed depression with rock sidewalls. Depression was filled with debris.		4' Wide 38' Long	3'
F-39	Spring observed in a hillside. Rock overhang present at outlet area. Less than 1 inch of running water observed.		4' Wide 5-8' Long	3'

Photo 34 – View of F-34

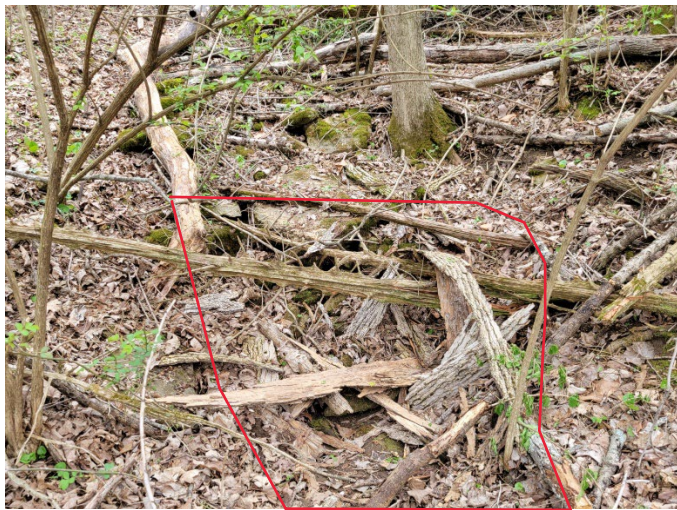
Photo 35 – View of F-35

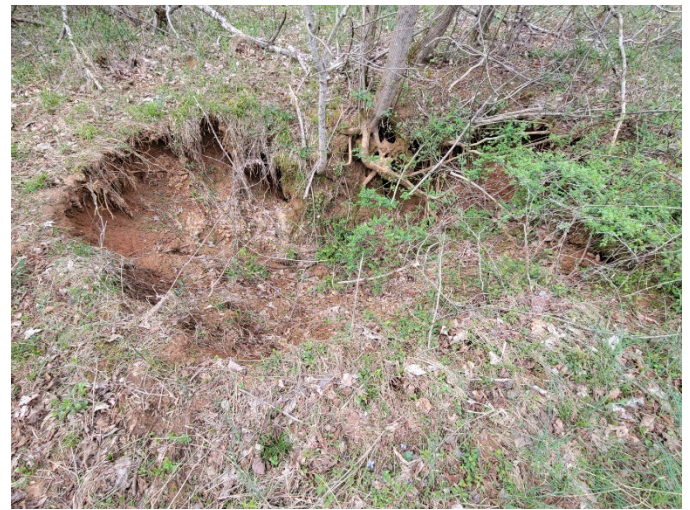
Photo 36 – View of F-36

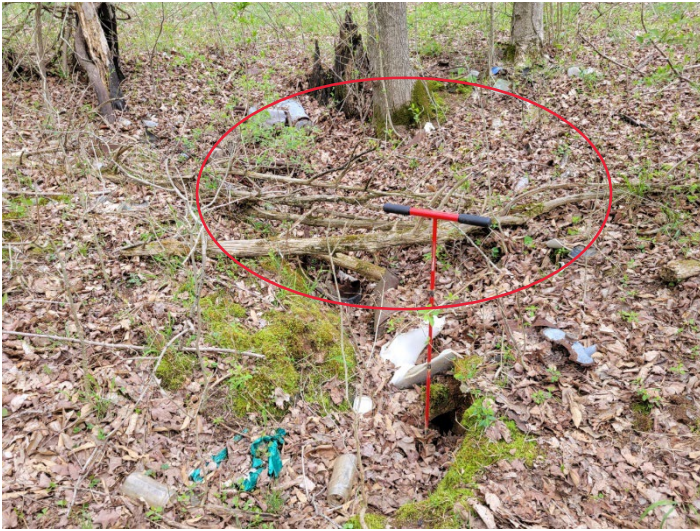
Photo 37 – View of F-37

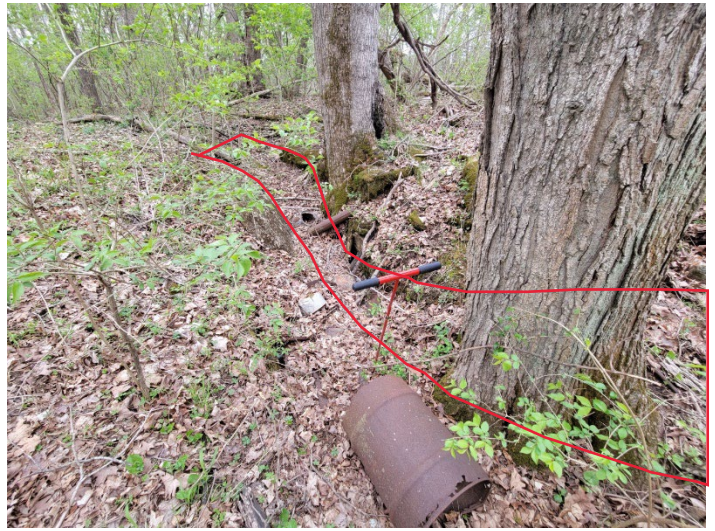
Photo 38 – View of F-38

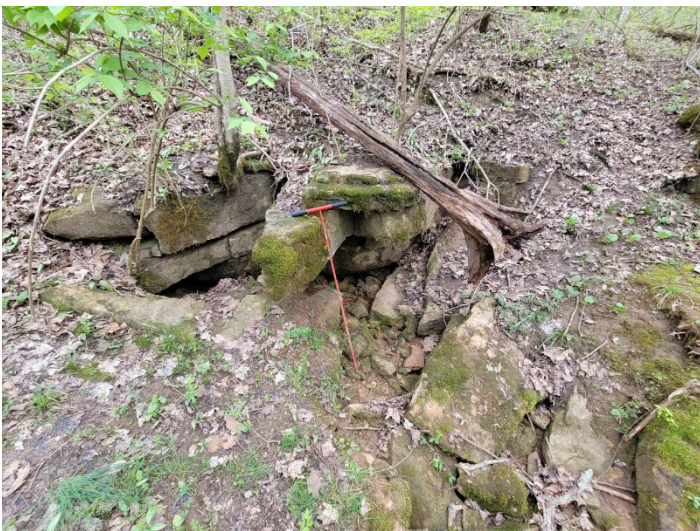
Photo 39 – View of F-39

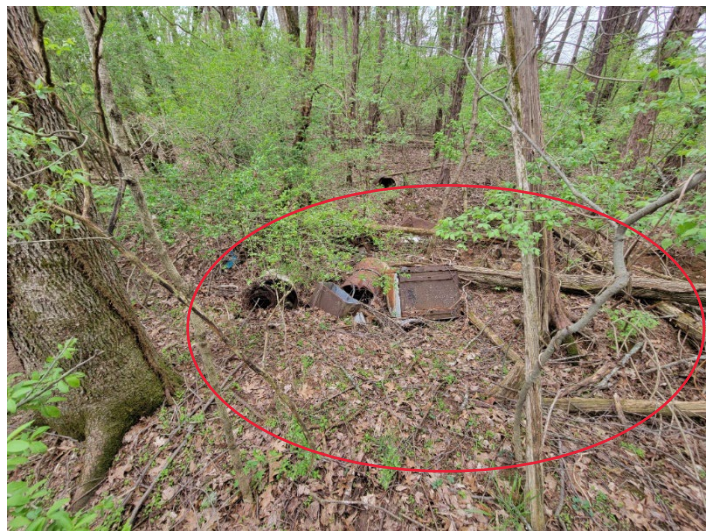
Feature	Description	Approximate Dimensions	Approximate Depth
F-40	Oval-shaped closed depression with soil sidewalls. Depression was filled with debris.	22' Diameter	4'
F-41	Oval-shaped closed depression with soil sidewalls and a partially closed throat observed at the bottom of the depression. Depression was partially filled with debris.	8' Diameter	5'
F-42	Oval-shaped closed depression with soil and rock sidewalls.	6' Diameter	4'
F-43	Oval-shaped closed depression with soil and rock sidewalls. Bottom of depression was visibly wet. A partially closed throat was encountered on the bottom of the depression.	4' Diameter	3'
F-44	Oval-shaped closed depression with soil and rock sidewalls. Probe rod extended to apparent rock approximately 1.5 feet below the bottom of the depression.	5' Diameter	3'
F-45	Oval-shaped closed depression with soil sidewalls. Probe rod extended to apparent rock approximately 3.5 feet below the bottom of the depression.	7' Diameter	3'

Photo 40 – View of F-40

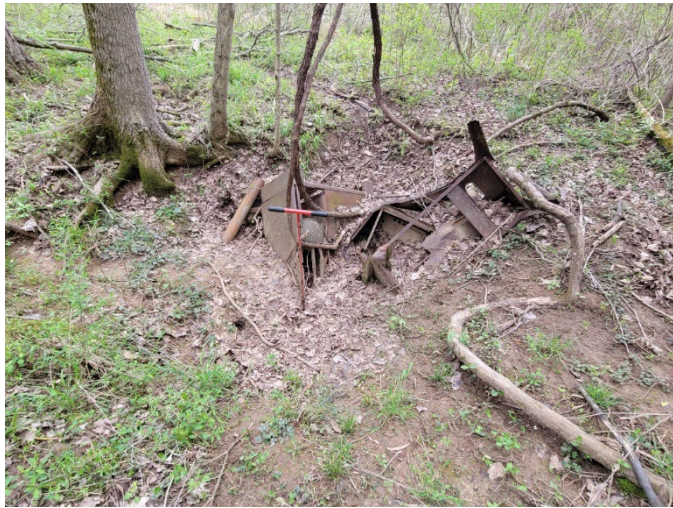
Photo 41 – View of F-41

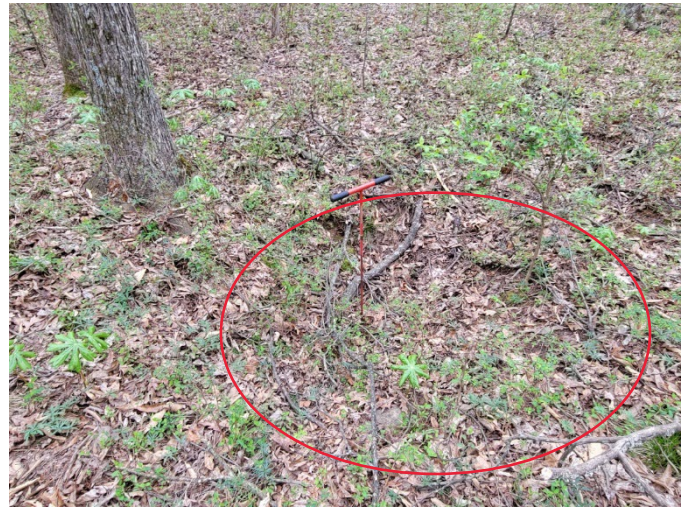
Photo 42 – View of F-42

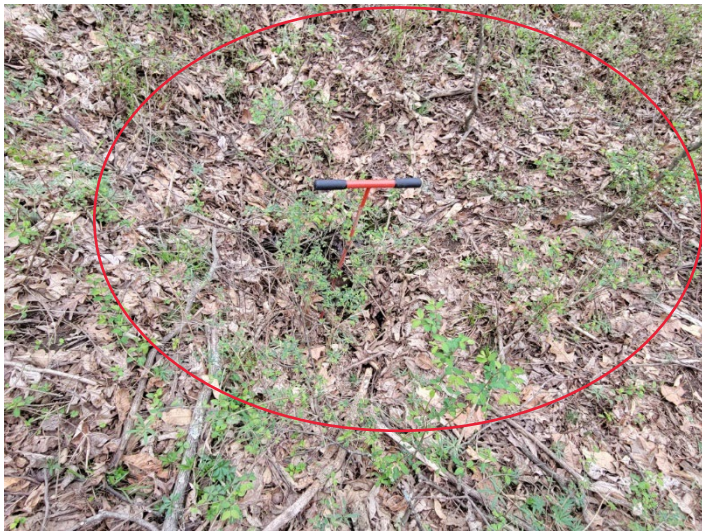
Photo 43 – View of F-43

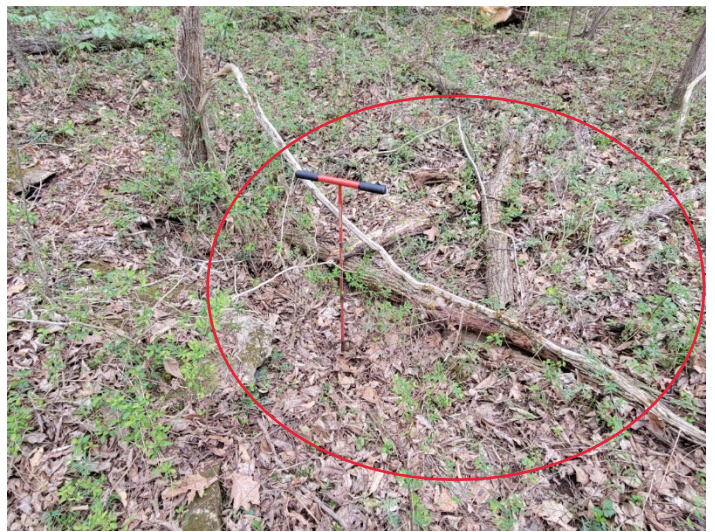
Photo 44 – View of F-44

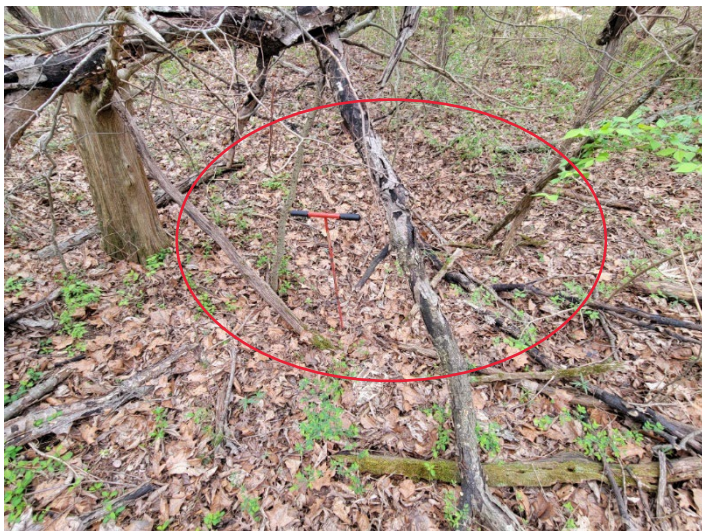
Photo 45 – View of F-45

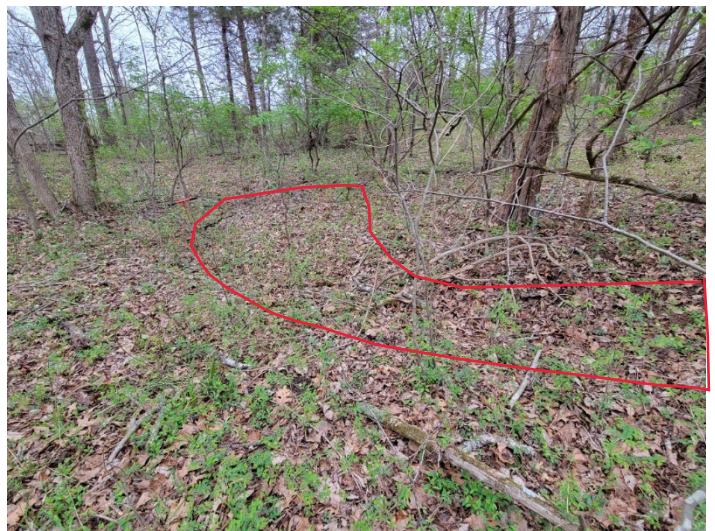
F-46	Trenchlike closed depression with soil and rock sidewalls.	3' Wide 40' Long	2'
F-47	Trenchlike closed depression with soil and rock sidewalls.	2' Wide 7' Long	5'
F-48	Oval-shaped closed depression with soil sidewalls.	4' Diameter	2'
F-49	Trenchlike closed depression with soil and rock sidewalls.	4' Wide 8' Long	3'
F-50	Oval-shaped closed depression with soil sidewalls. Probe rod extended to apparent rock approximately 2.5 feet below the bottom of the depression.	7' Diameter	4'
F-51	Small opening with soil sidewalls and a partially closed throat observed at the bottom of the opening.	1' Diameter	3'
F-52	Oval-shaped closed depression with soil and rock sidewalls and a rock bottom. Walls and bottom of depression were visibly wet.	2.5' Diameter	3.5'
F-53	Oval-shaped closed depression with soil sidewalls. Depression was filled with debris.	7' Diameter	4'
F-54	Oval-shaped closed depression with soil sidewalls. An open throat (6 inches to 1 foot diameter, 3' deep) with a rock bottom was observed at the bottom of the depression.	4' Diameter	3'

Photo 46 – View of F-46

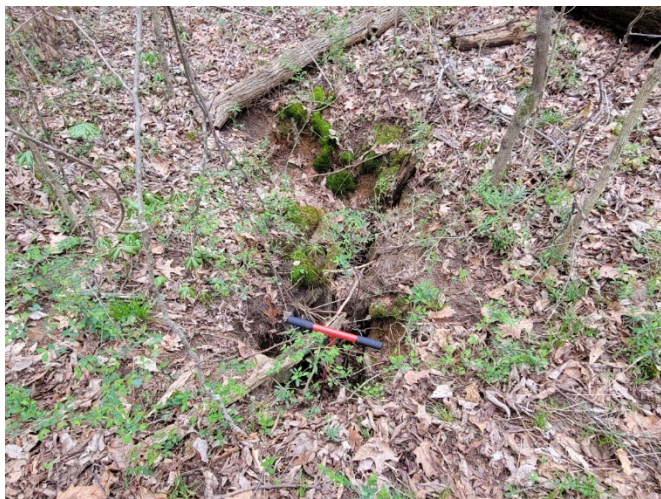
Photo 47 – View of F-47

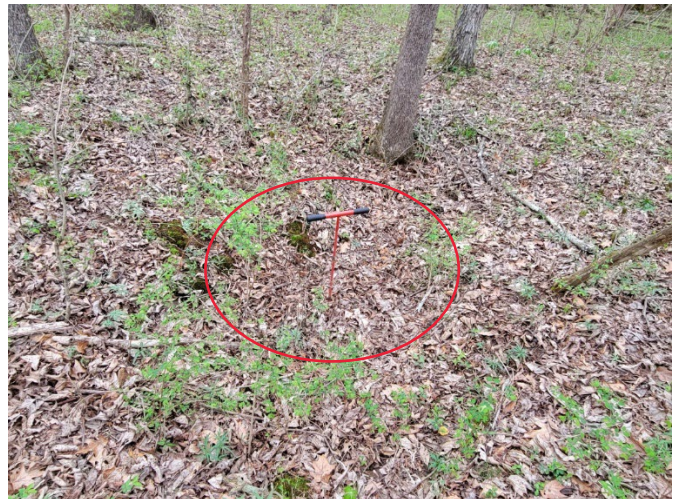
Photo 48 – View of F-48

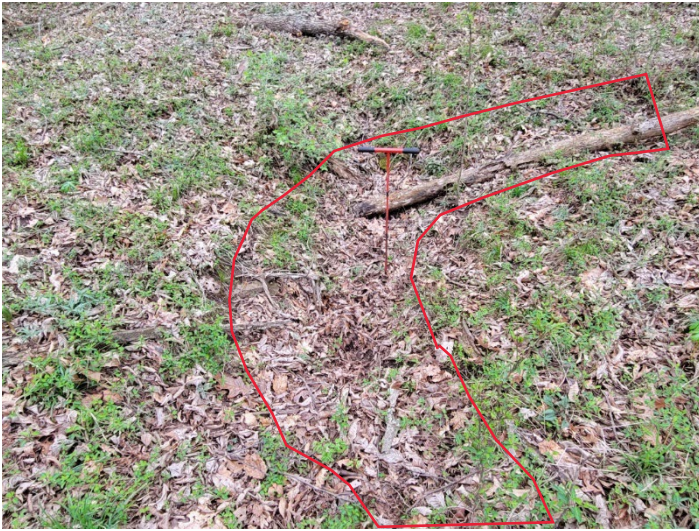
Photo 49 – View of F-49

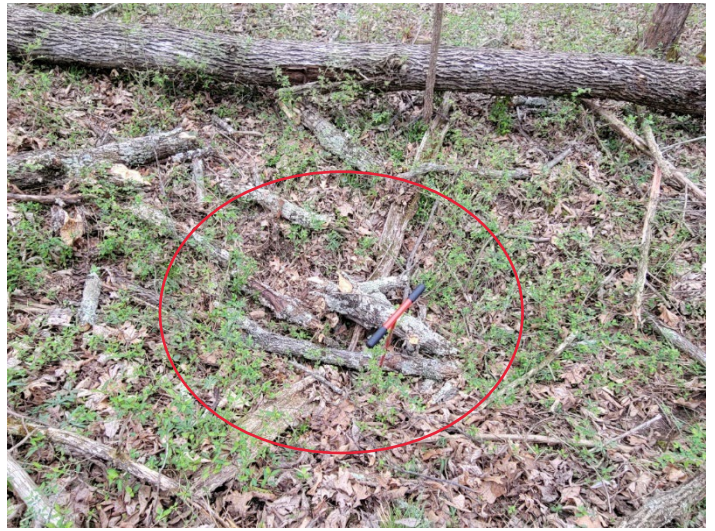
Photo 50 – View of F-50

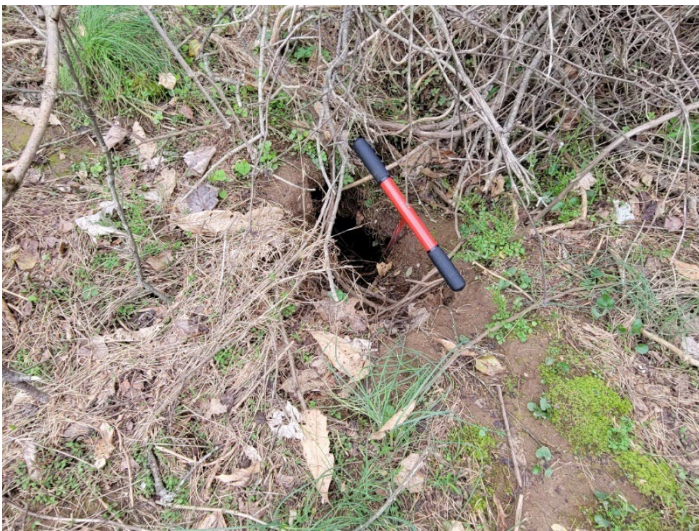
Photo 51 – View of F-51

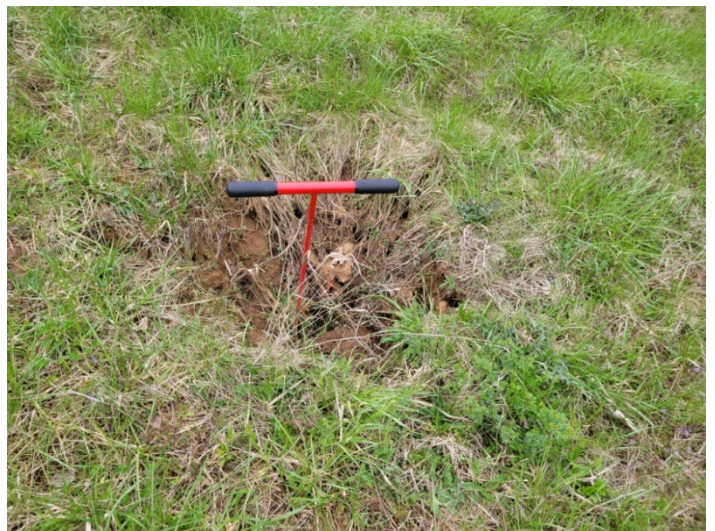
Photo 52 – View of F-52

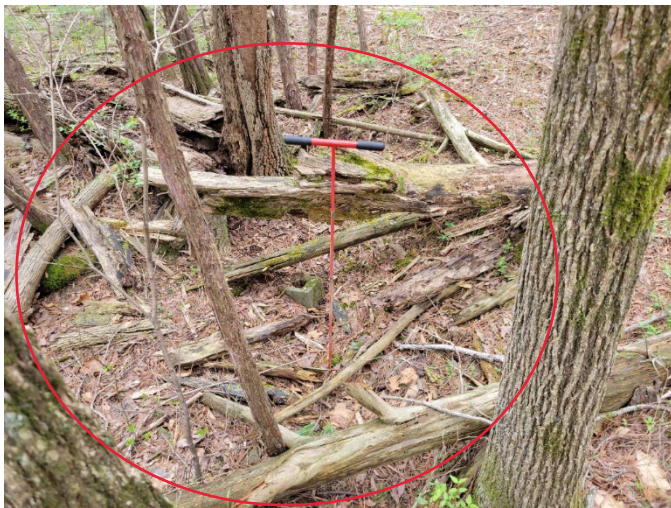
Photo 53 – View of F-53

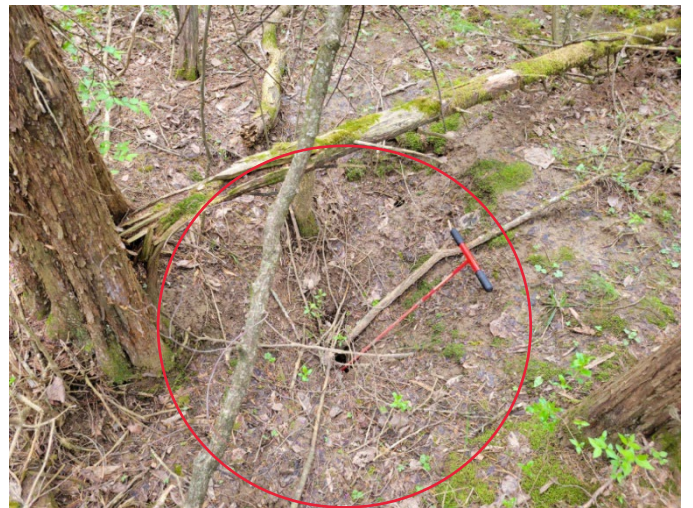
Photo 54 – View of F-54
