# “THE **WRONG** HOUSE!”

BENJAMIN ROBBINS, AIA

TRADITIONAL ARCHITECTURE SPECIALIST

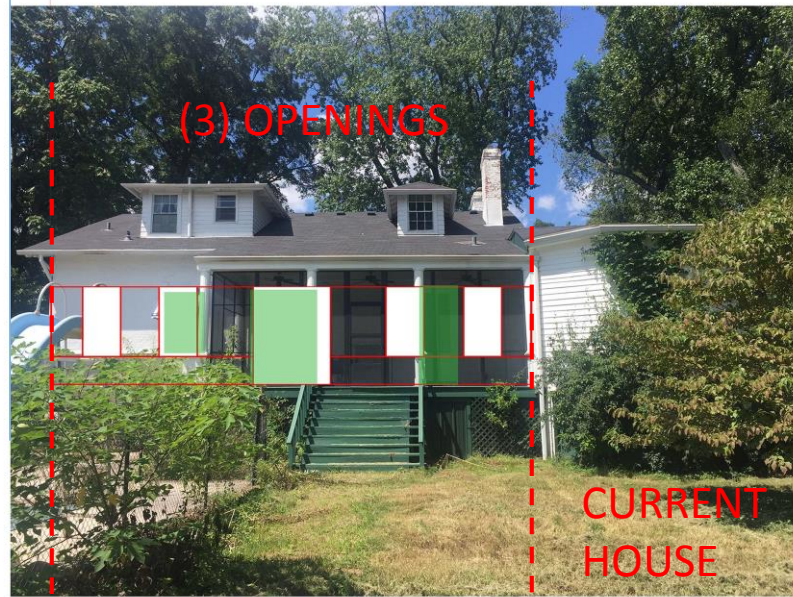
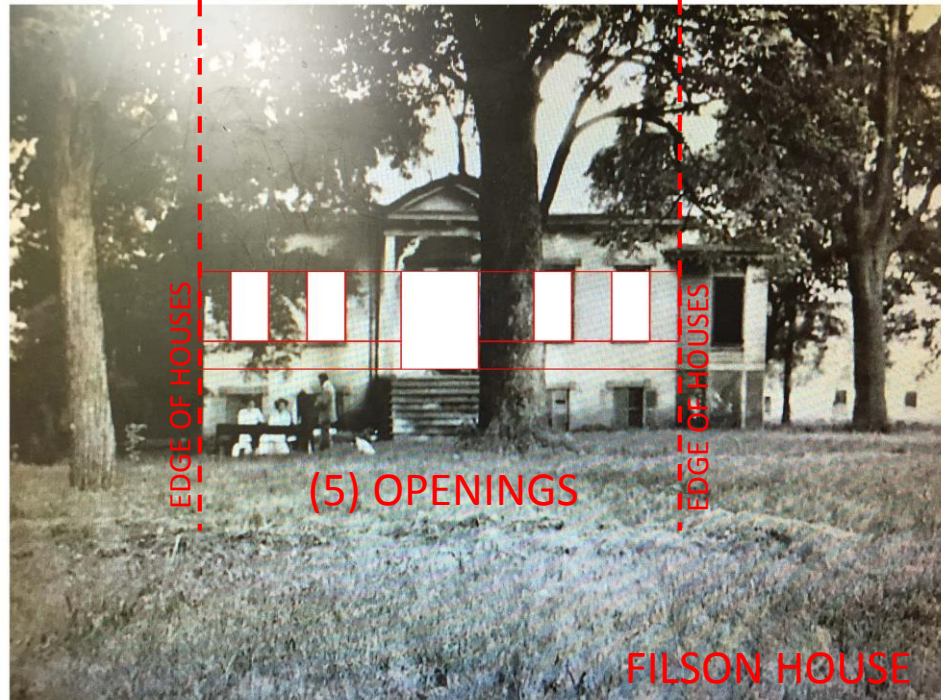
## FRONT ELEVATION COMPARISON: **WRONG HOUSE!**

- **GREEN** - CURRENT OPENINGS (3)
- **WHITE** - FILSON PICTURE OPENINGS (5)
- THERE IS NO EVIDENCE OF WINDOW OPENING RELOCATION IN BRICK
- **NO EVIDENCE OF THE LOWER WINDOWS EXISTING**

THE WINDOWS ARE NOT THE SAME IN NUMBER, (3) VS (5), OR IN THE CORRECT LOCATION. WHERE DID LOWER WINDOWS GO?

**CONCLUSION – WRONG HOUSE!**

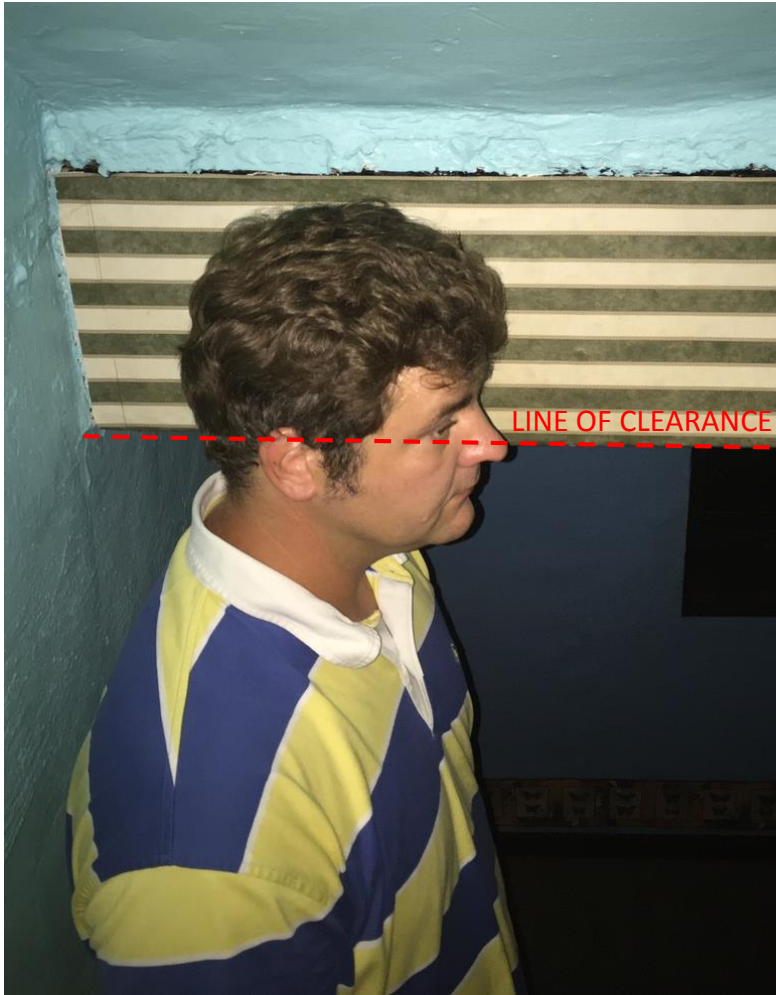
STAIRS TO BASEMENT DO NOT COME CLOSE TO MEETING HEAD ROOM REQUIREMENTS – WHICH ARE 6'-8" MINIMUM. I AM 6'-4" TALL. IN ORDER FOR STAIRS TO WORK THEY WOULD HAVE TO BE RIPPED OUT AND REDESIGNED IN A DIFFERENT LOCATION. **THIS IS NOT A EASY TASK AND WOULD REQUIRE SIGNIFICATANT ALTERATIONS TO EXISTING HOUSE.**

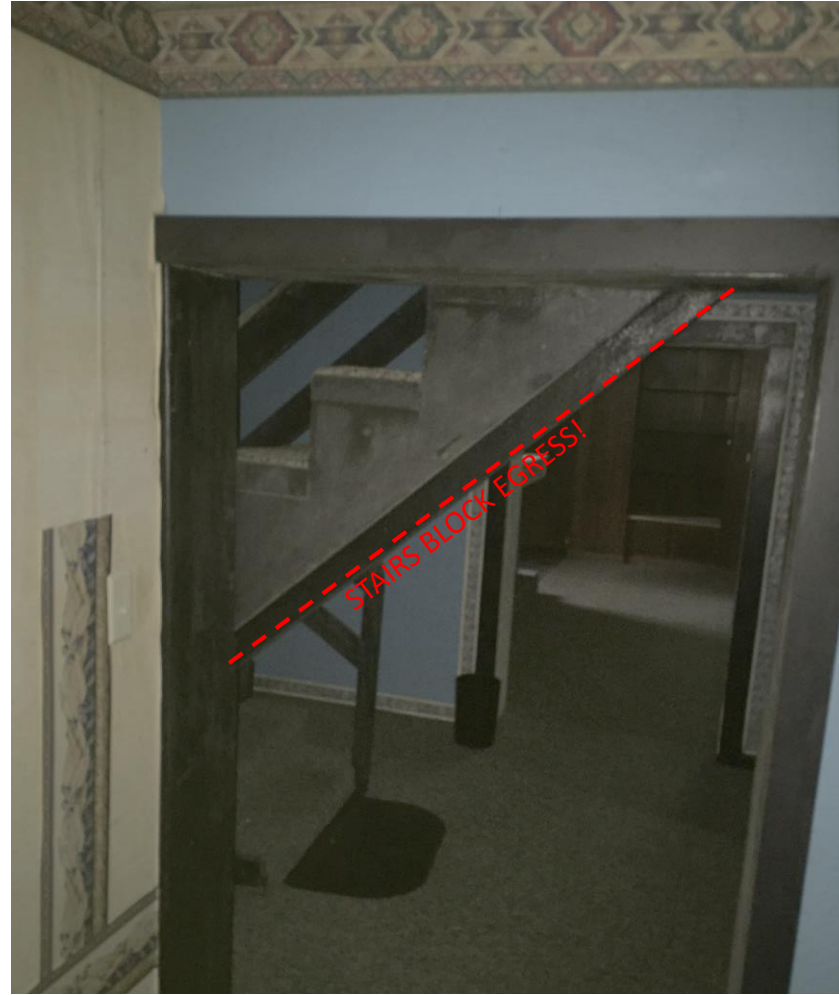
STAIRS TO BASEMENT BLOCK ACCESS FROM ONE SIDE OF BASEMENT TO THE OTHER. **THIS IS A MAJOR ISSUE THAT IS NOT EASILY SOLVED WITHOUT MOVING STAIR TO DIFFERENT LOCATION.**

- HEAD HEIGHT ON STAIRS TO BASEMENT DOES MEET CODE AND **BLOCKS EGRESS**
- RISER HEIGHTS **DO NOT MEET CODE** AND ARE NOT CONSISTENT
- TRADITIONALLY THE STAIRS ARE CLOSE TO THE FRONT DOOR OF THE HOUSE
- THE CURRENT STAIR LOCATION WOULD MAKE THE CURRENT REAR OF THE HOUSE THE FRONT
- THE FRONT AND REAR ENTRANCE STAIRS ARE ROTTEN AND ARE FALLING APART

**PUTTING CODE COMPLIANT STAIRS TO THE BASEMENT AND SECOND FLOOR IS IMPOSSIBLE.**

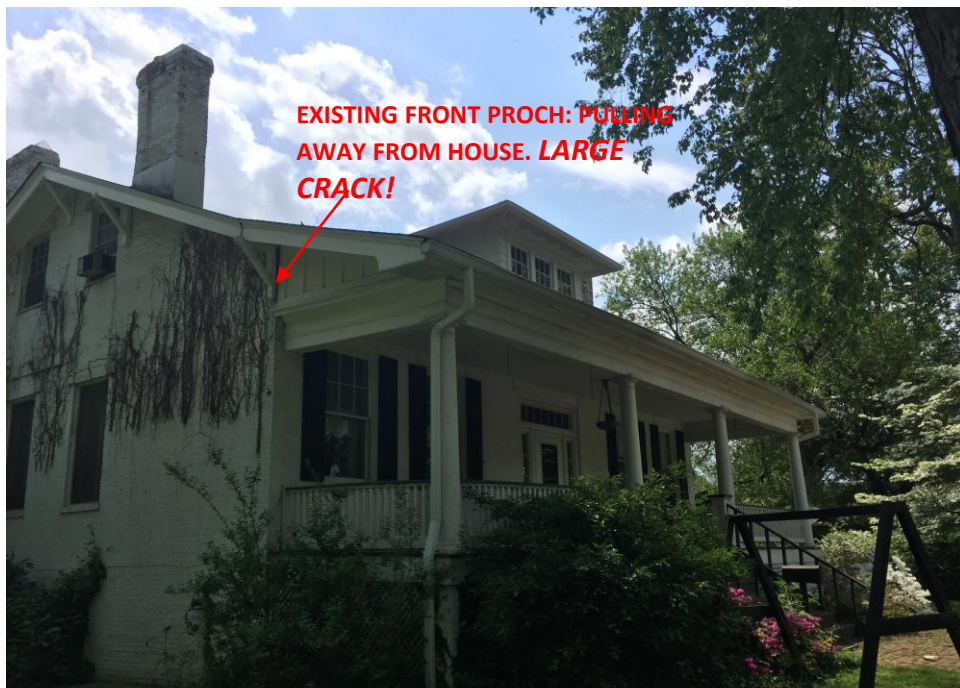
# FRONT AND REAR PORCH FAILURES

- THE ENTIRE FRONT PORCH IS PULLING AWAY THE HOUSE BECAUSE THE STRUCTURAL FAILING OF MEMBERS. ***IT IS UNSAFE.***
- BOTH PORCHS WILL HAVE TO BE COMPLETELY REBUILT – STRUCTURE, DECKING, COLUMNS AND ROOF. IT IS COMPLETELY FALLING APART.
