**GREENBAUM ASSOCIATES, INC.**  
GEOTECHNICAL & MATERIALS ENGINEERS

## **Introduction**

We were contracted by Elite Homes, Inc. to provide recommendations for dealing with construction on slopes with grades greater than 30 percent. Work was coordinated through Mr. Jim Mims, P.E. of Elite Homes, Inc.

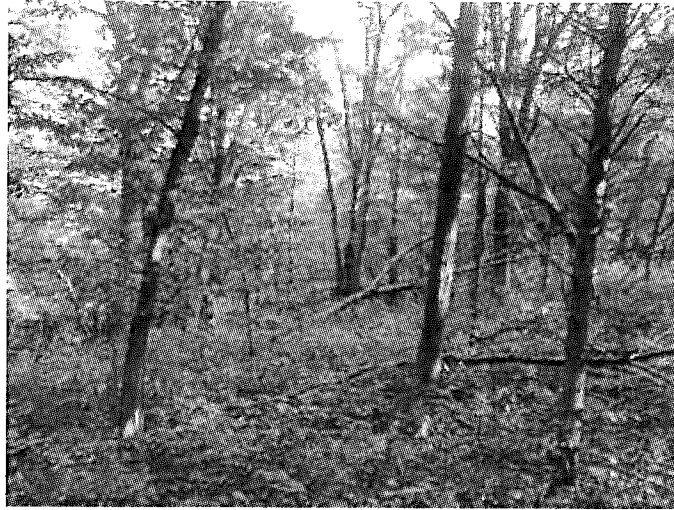
**Lots 84 and 85**

The area of lot 84 and 85 slope downward to the northwest. The slope across the lots is about 15 percent and steepens to the west of these lots. There is no evidence of slope movement, i. e. no scarp, leaning trees consistent with a slide, erosion of the slope, tension cracks, etc.
