Fuller  
Mossbarger  
Scott &  
May

August 14, 1997

Re: Sinkhole Review  
Lots 21, 22, 23 and 28  
Blankenbaker Commerce Centre  
Jefferson County, Kentucky

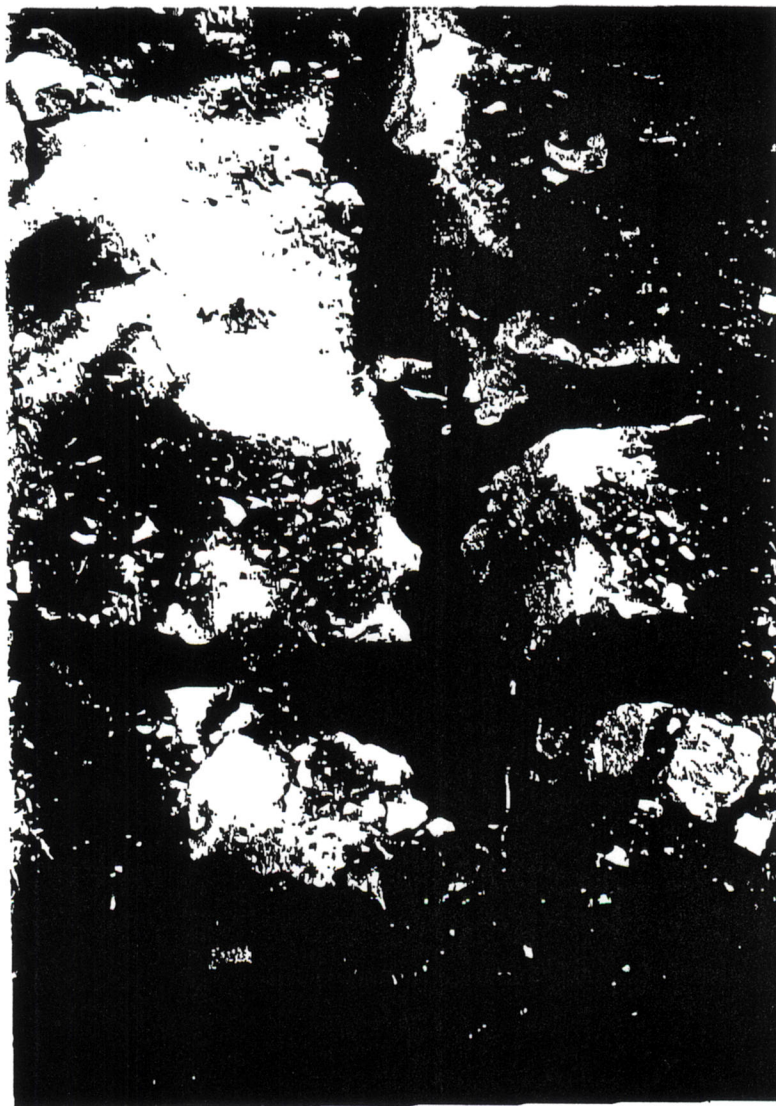
An approximate 10-foot by 20-foot by 5-foot deep excavation had been made to the rock surface. This sinkhole is labeled as Sinkhole 2 on the attached portion of the plan view. It is located at the extreme east side of the lot. The eastern half of this sinkhole is located in a 15-foot wide sewer and drainage easement, and it appears to extend just into Lot 22. An approximate six-inch wide crevice is present in the sinkhole running in an east-west direction. This crevice was probed and an open throat extended to a depth of five feet below the rock surface in several locations. This excavation will need to be extended to the east and west to define the limits of the crevice prior to treatment.

Photo 2 - Crevice at Sinkhole No. 2 - Lot 23

The method of treatment for the sinkholes will require that the rock surface be exposed to identify any voids or crevice features in the bedrock (the rock surface has already been exposed at Sinkholes 1 and 2). The voids or crevices should be cleaned and filled with No. 2 or 3 crushed stone up to the rock surface. Additional crushed stone wrapped in KDOH Type IV geotextile fabric would then be placed to provide a cap or a seal over the void or crevice. Normal fill placement can then take place to reach final grades. A Geotechnical Engineer should be present to review treatment of the sinkholes in conjunction with the proposed construction and grades so that any changes or adjustments can be made.

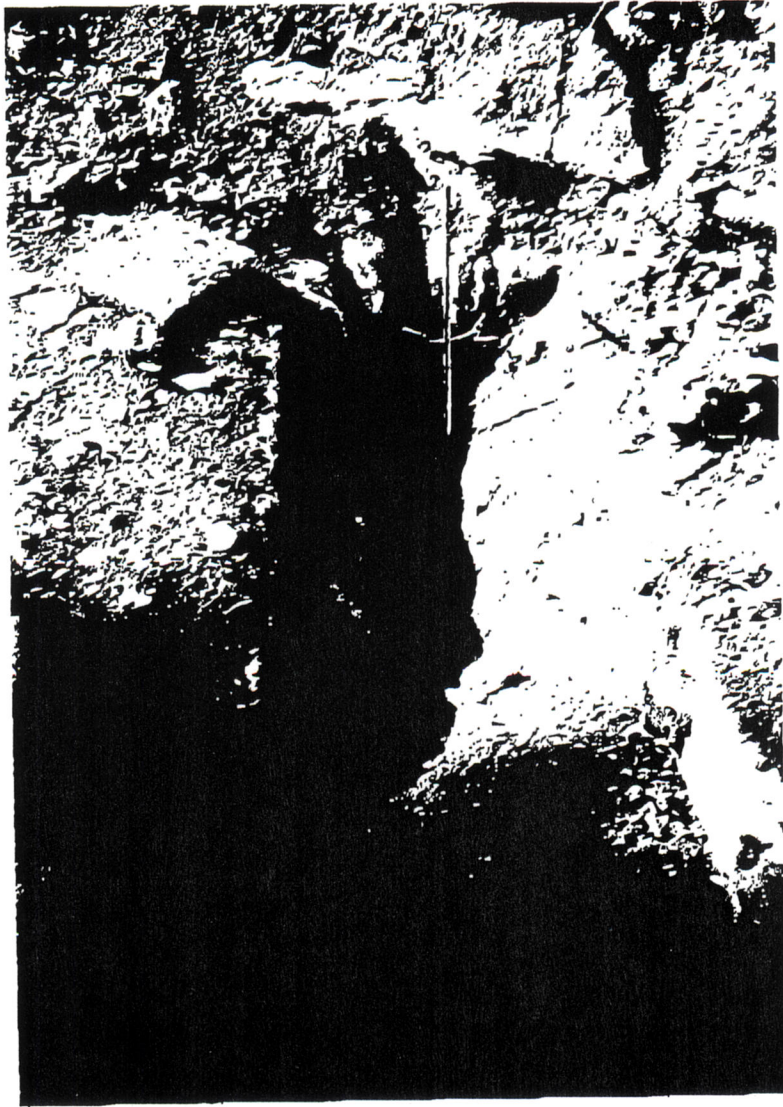
An approximate 10-foot by 10-foot by 4-foot deep excavation had been made to the rock surface. This sinkhole is labeled as Sinkhole 1 on the attached portion of the plan view drawing. It is located at the south-central area of the lot. A one to two-foot wide crevice was observed in the rock surface running in a north-south direction. On the north side of the excavation, the crevice had been cleaned to a depth of about three feet and was clay-filled below this depth. The crevice had not been cleaned on the south side of the excavation. Prior to any treatment, the excavation will need to be extended to the south to determine the limits of the crevice.

Photo 1 - Crevice at Sinkhole No. 1 - Lot 22
