# Landmarks Certificate of Appropriateness & Overlay District Permit

Project Name: MARTIN GARAGE

Project Address / Parcel ID: 1524 - 1530 So 2nd St ; 40208  
033D 0090 0000

Subject: 1524 S Second Street Garages  
Louisville, KY 40203

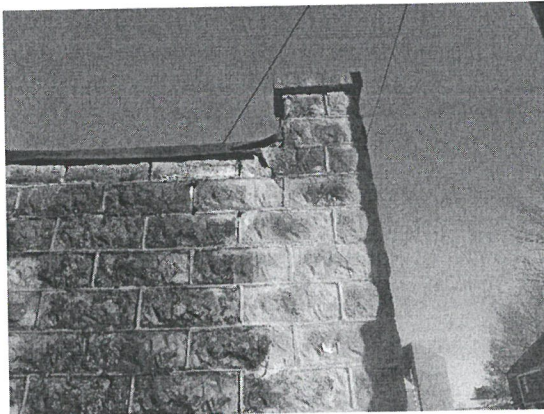
1. The perimeter walls have various amounts of settlement which has caused stress cracking in the block. The most significant movement is at both sides. The movement is directly related to changes in moisture content of the soil at the footing level over the life of the structure. The likely shallow condition allows the changes to occur more readily. The walls are not considered unstable but have both vertical and lateral movements which have affected wall plumbness and caused cracking. The pictures indicate the most significant displacements noted in the building. The displacements affect the appearance which cannot be improved and require tuckpointing at numerous locations to close off the gaps at the mortar joints.

SW corner side rotation

3. A membrane roof system is suggested over the concrete.
4. The cracked block and mortar joints in the walls can be tuckpointed both inside and outside. The crack repair will not repair the displacements that have occurred.

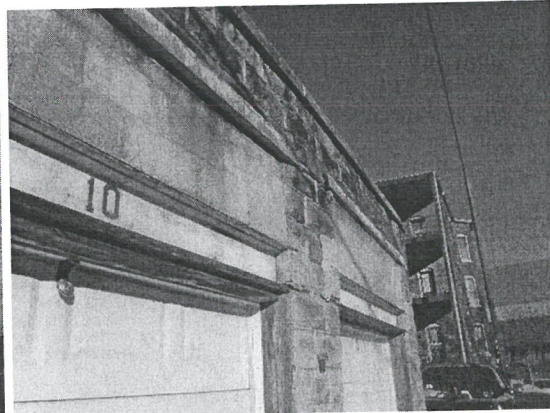
South side rotation at center column

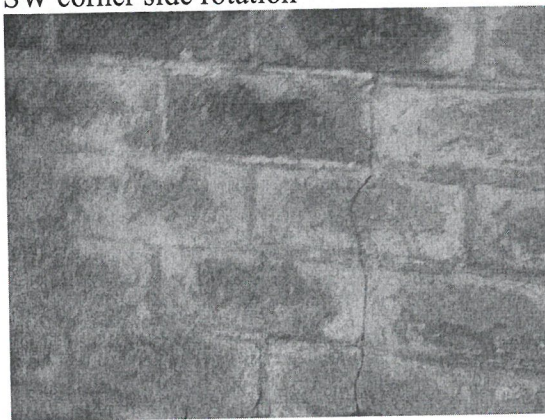
SE rear wall

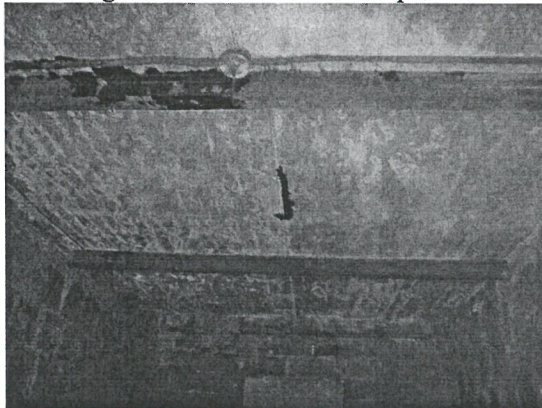
2. The roof is built in the following manner. There are 3 steel beams between the wall walls which support wood runners at about 30 inch spacing. The runners support a wire mesh which the concrete was placed upon. A plaster coat was added to the surface for appearance. Over the years due to roof leakage the metal lath has corroded and allowed failure of the material. The concrete above is not reinforced and has virtually no support when the material has broken and allowed the entire area between steel supports to fall. Each unit was observed, and some are in fair condition, some have deterioration at the low end of the roof where apparent leakage has caused the deterioration and 3 units which need complete replacement. A sketch is attached to this report which indicates the deteriorated areas by circles and notes. Units 3, 4, and 5 need replacement due to failed lath. Other units have deterioration and at some future snow load condition could have a stress failure of the lath which could cause a similar failure to Unit 3. The roof currently is not considered to be rated for the current allowable load condition due to the deterioration of the metal lath.

#3 Beam and ceiling deteriorated

1. The sections noted above with damage concrete roof should be removed down to the steel. Those units with severe rust at the steel beams should have the member replaced, surface scale is not a reason to replace, flaking of the steel is one that should be replaced. The roof can be replaced in sections from wall to wall of those units with minor deterioration. #4 and #5 have steel which should be replaced. For ease of installation and longevity of the structure with more than  $\frac{1}{2}$  of the structure needing repair and reduced load capacity a complete replacement is suggested.

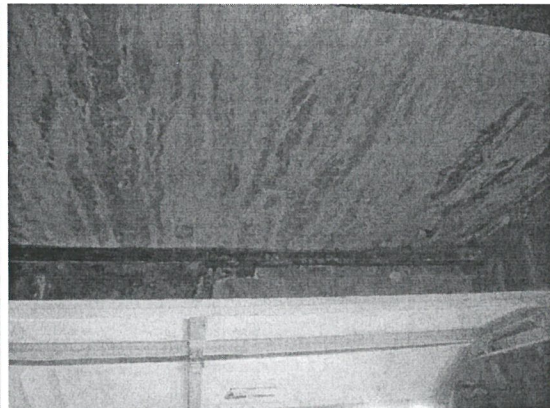
West side above door deteriorated

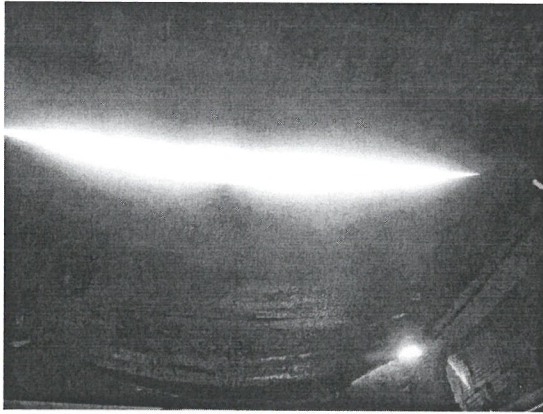
#4 failed

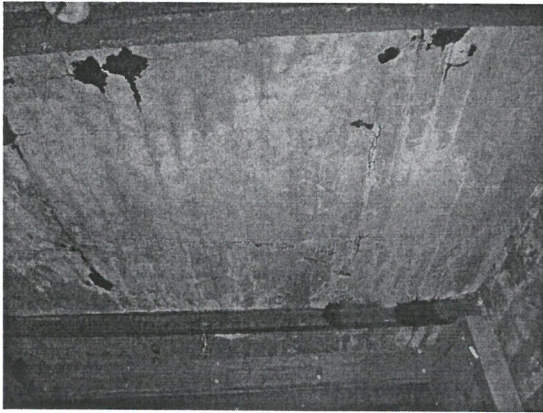
#5 spot breakage Not failed but close

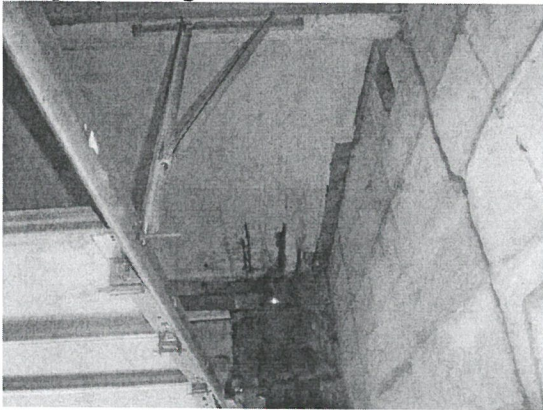
#6 failed at NW corner
