## KARST RECONNAISSANCE SURVEY

HURSTBOURNE APARTMENTS DEVELOPMENT  
LOUISVILLE, KENTUCKY

SME Project No. 088601.00  
March 7, 2022

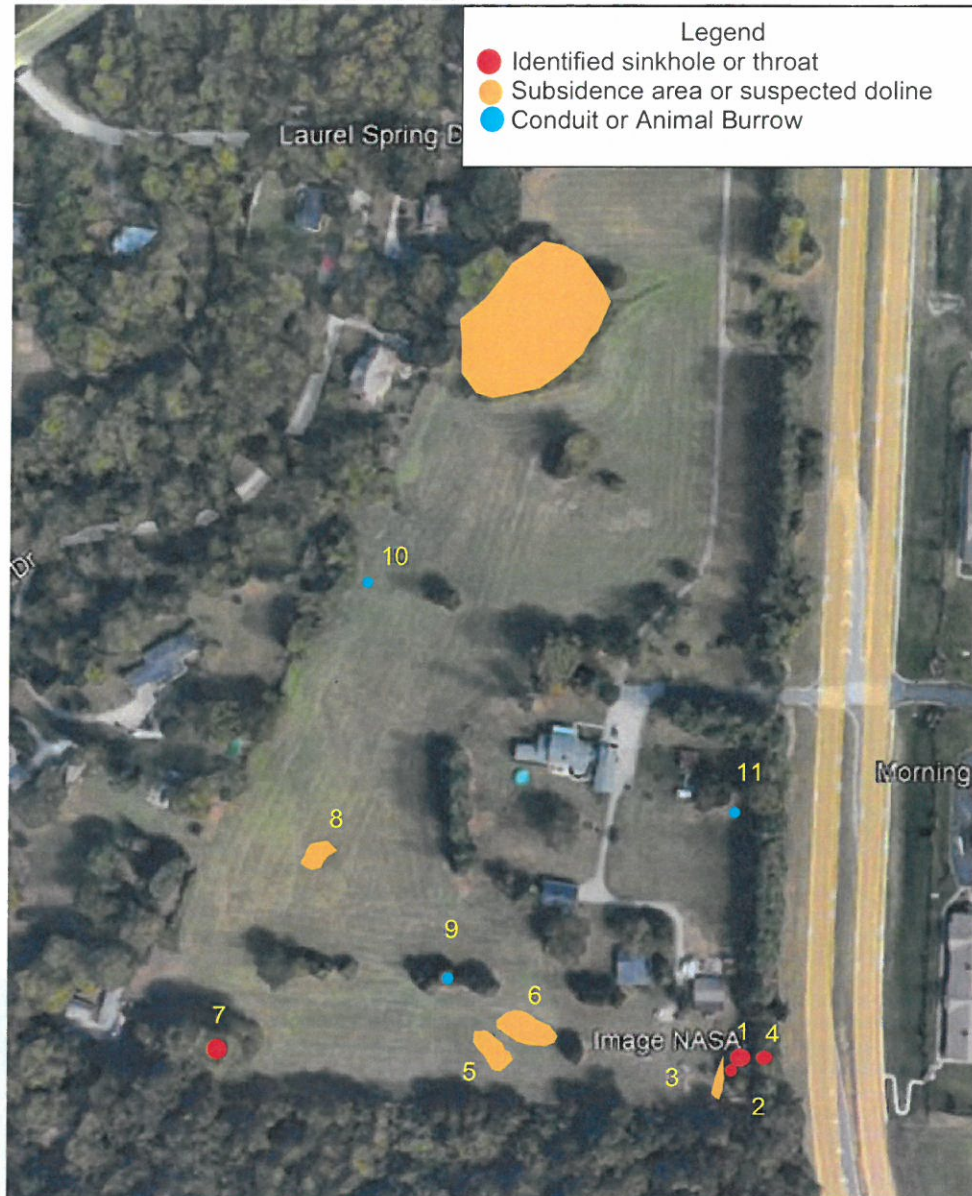
**FIGURE 11 – IDENTIFIED FEATURES**

Two of the sinkhole features, which were located within a small grove/tree cluster south of the garage and near the southeast site corner, appeared to be interconnected (and located directly adjacent to an elongated area of subsidence). An additional sinkhole feature was observed directly east of the referenced feature and adjacent to the eastern fence line. The fourth feature (Feature 7 in the table above) was located in the extreme southwest corner of the site within a tree grove. Multiple throats were observed within this feature in addition various debris. The presence of debris made it impractical to ascertain the feature dimensions, particularly the depth.

An elongated drainage feature extended southwest from the feature and off the project site. Three locally depressed areas (referenced in the previous section) where the vegetative surface cover differed from the adjacent area were observed along the southern portion of the site. These depressed areas may represent early “doline” activity. Doline is a term used to describe sinkholes that form slowly by subsidence of the ground surface. This downward movement can take years to occur before the surficial sinkhole is obvious.

A possible swallow hole or animal burrow was observed within a tree grove in the southern portion of the site. An additional depressed area (possible doline) was observed north of this feature and west of the barn near the western site boundary. An isolated hole was observed along the west-central portion of the site. A depressed area was observed adjacent to the east side of the original entrance drive. The depressed area was filled with leaves, which made the discerning approximate dimensions difficult. However, it is assumed this depressed area is an inlet for a culvert discharging on the west side of the driveway.

The pond (or perennial stream as identified on LOGIC) was mostly dry at the time of our evaluation, although the ground surface appeared to be soft. This area most likely a wetlands or ephemeral pond, which periodically holds water for some time during or following precipitation events. The pond area is relatively shallow, which suggest the area may have been infilled either by natural causes (e.g., erosion or siltation) or man-placed fill. Ponds typically form in low points in karst areas via plugging of the near-surface voids or fracture zones via siltation. However, impounding of water can over time initiate sinkhole activity, which may also explain the lack water within the pond (and in photographs from recent years).

At least four sinkholes (or open throats/conduits connected to a sinkhole feature) were identified on the project site. These sinkhole features, while relatively small and shallow, are obvious evidence of karst development at the site. The sinkhole feature identified in southwest corner of the site within a grove is depicted on the proposed site development plan (Feature 7, identified as a closed contour) within the footprint of a proposed 36-unit housing structure. Similarly, it appears two sinkhole and/or conduits (Features 1 and 2) are located within the footprint of a proposed 24-unit housing structure near the southeast corner of the site. Preliminarily, we estimate that sinkhole Feature 4 is outside the proposed footprint of the referenced 24-unit structure but near the east side of the building. Therefore, it will also impact development of this structure.

The sinkhole identified on the geologic map adjacent to the southern property boundary was not observed in the field. However, review of the site survey/development plan indicates a closed depression in this area, which corroborates the geologic map. It is unclear whether the pond has experienced karstification or is at significant risk of a drop out occurring. We recommend avoiding development of structures in the immediate area of the pond. Additionally, subsidence observed at the exiting garage area (as observed by uneven ground contact of the garage bay doors with the ground) suggest karst related subsidence may have occurred in this area.

Do not construct over active or possible sinkholes without further exploration, analysis and remediation (if feasible and where sinkhole features are identified). Where possible, adjust or modify the site plan by shifting proposed structure locations away from identified sinkhole features is preferable. However, this is not always possible without significantly impacting the project. Sinkhole features identified within structural areas (i.e., building or pavements) will require remediation during construction or utilization of alternative foundation systems as directed by the Geotechnical Engineer of Record, assuming the proposed structure locations cannot be shifted. We recommend identified and suspected sinkhole features be evaluated prior to construction (ideally during the planning stage) to determine impacts on the proposed development. Characterization of identified anomalies can be performed by performance of additional test borings (beyond quantity per geotechnical evaluation scope), excavation, and/or geophysical surveys.

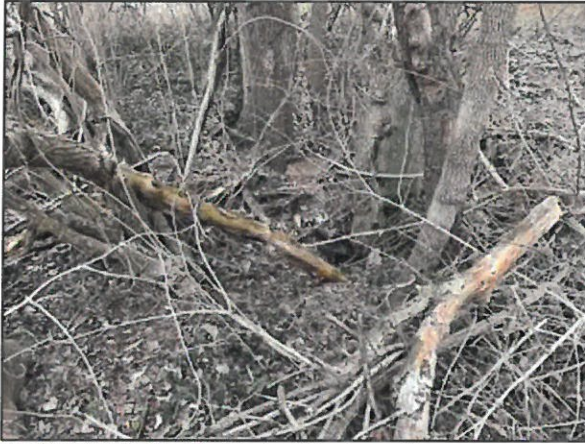
PHOTO NO. 2: Sinkhole (Feature 1)

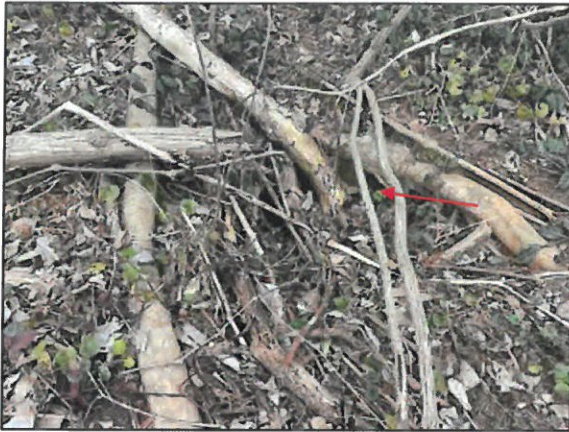
PHOTO NO. 3: Surficial swallow hole/ conduit (Feature 2)

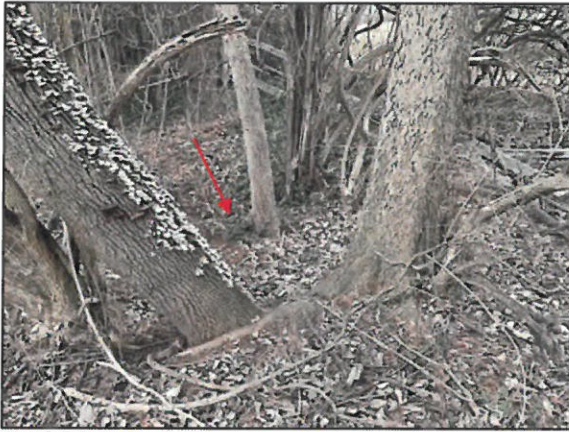
PHOTO NO. 4: Shallow sinkhole with throat (Feature 4)

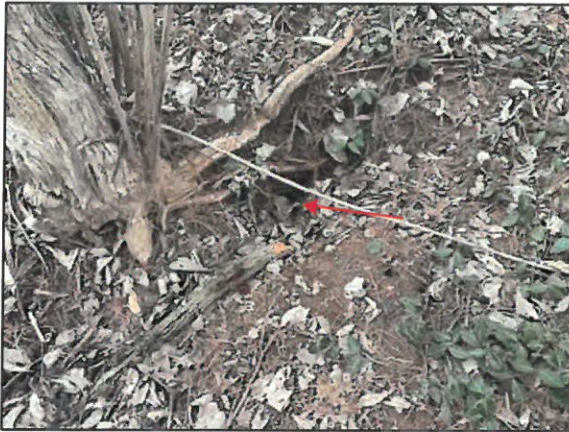
PHOTO NO. 5: Sinkhole conduit/throat (Feature 4)

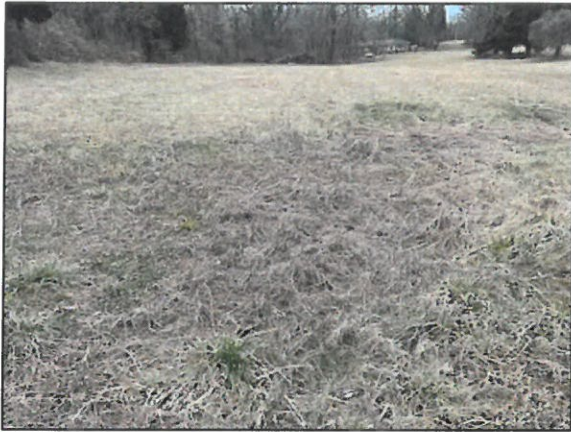
PHOTO NO. 7: Ground subsidence/differing vegetation (Feature 5)

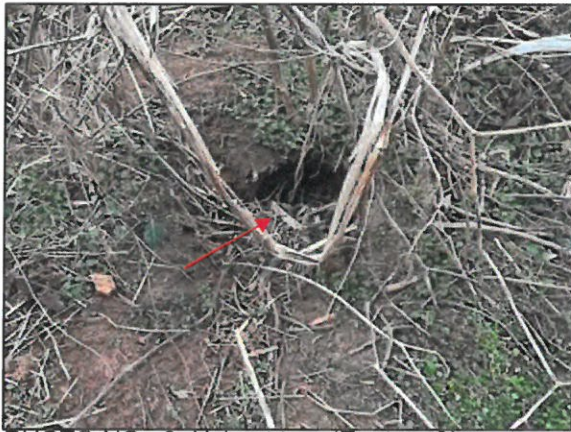
PHOTO NO. 8: Hole at tree (Feature 9)

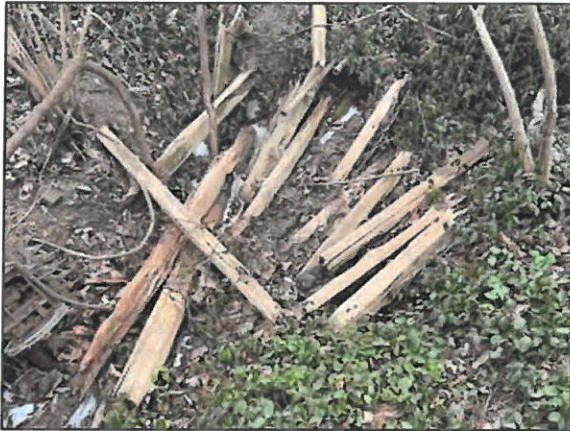
PHOTO NO. 9: Sinkhole at southwest corner (Feature 7)

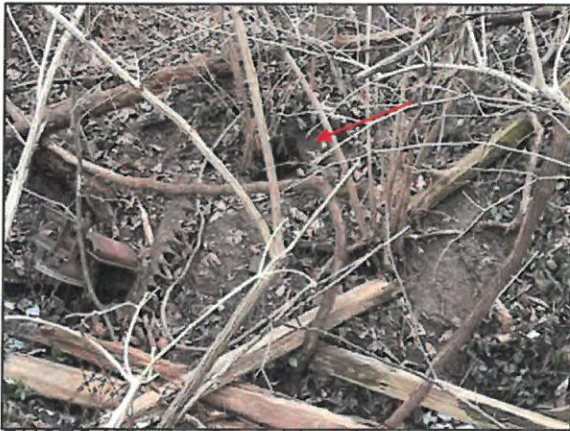
PHOTO NO. 10: Conduit/ swallow hole at Feature 7

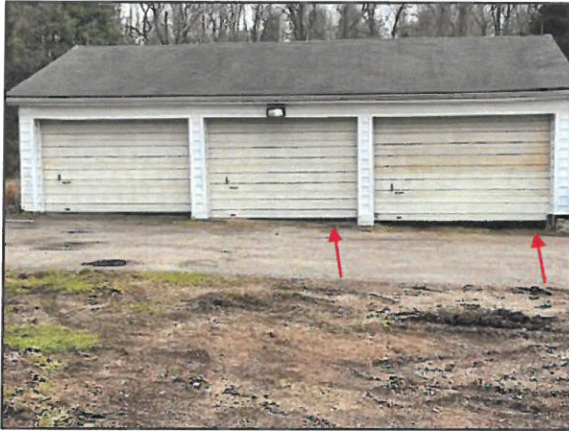
PHOTO NO. 11: Ground subsidence at garage

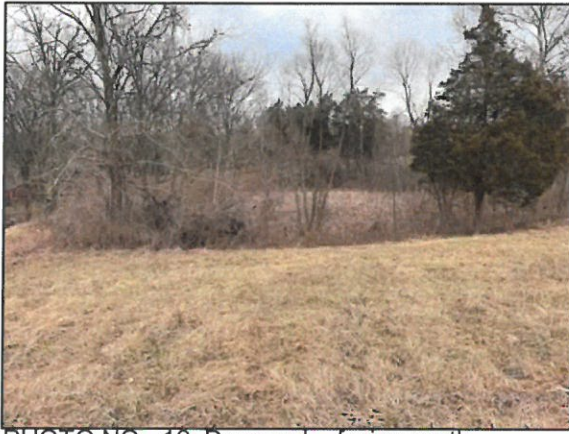
PHOTO NO. 12: Dry pond – facing north

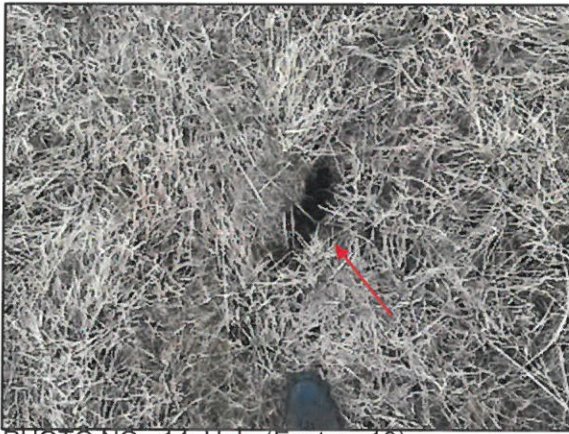
PHOTO NO. 14: Hole (Feature 10)
