STRUCTURAL ASSESSMENT REPORT

Date: June 11, 2020

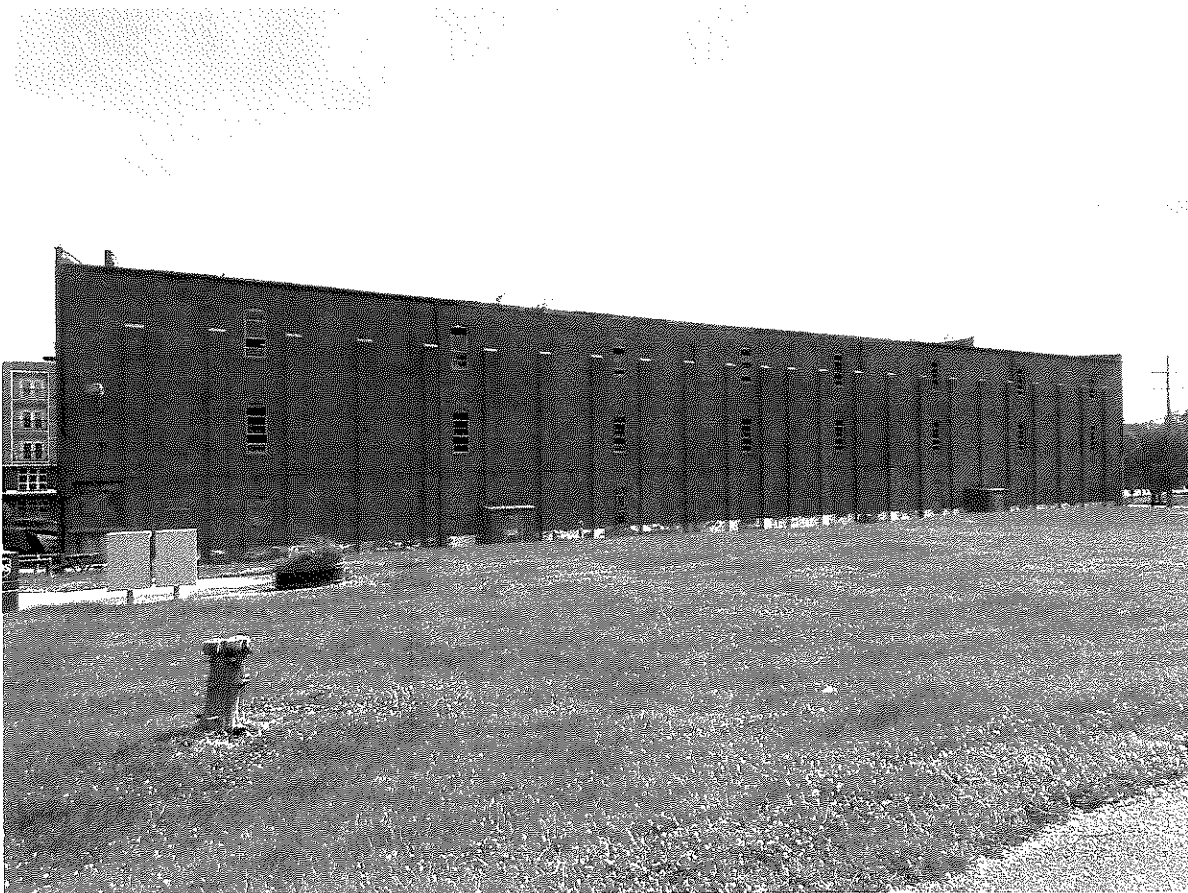
Scope: Assess the structural condition of the building.

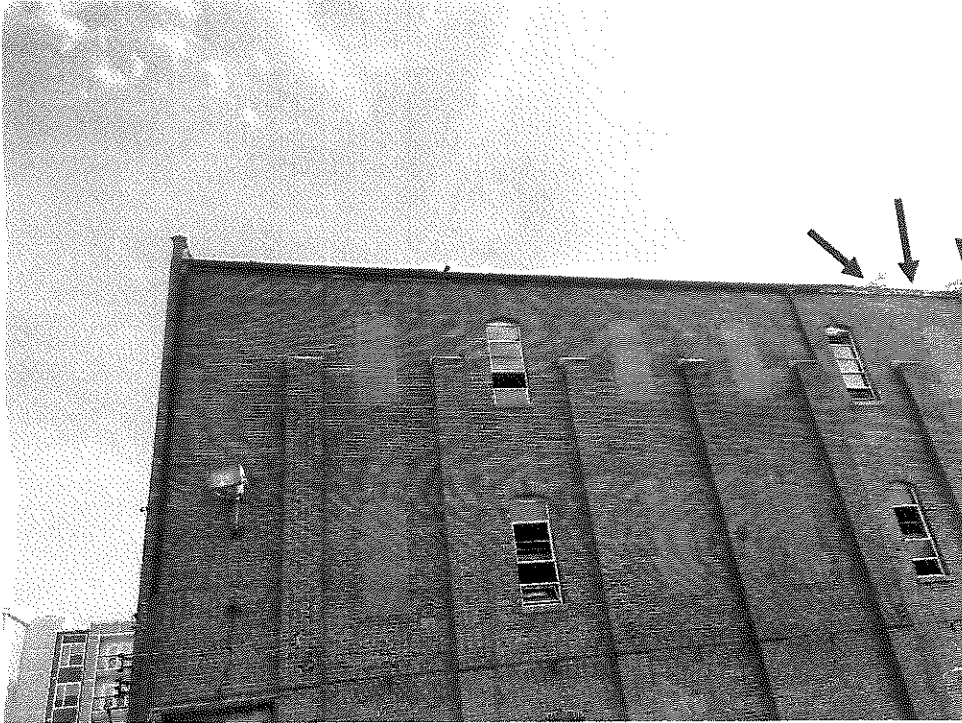
Photo 1 - South side of the southwest corner. Large plant growth is visible. Missing gutters from deteriorated roof framing.

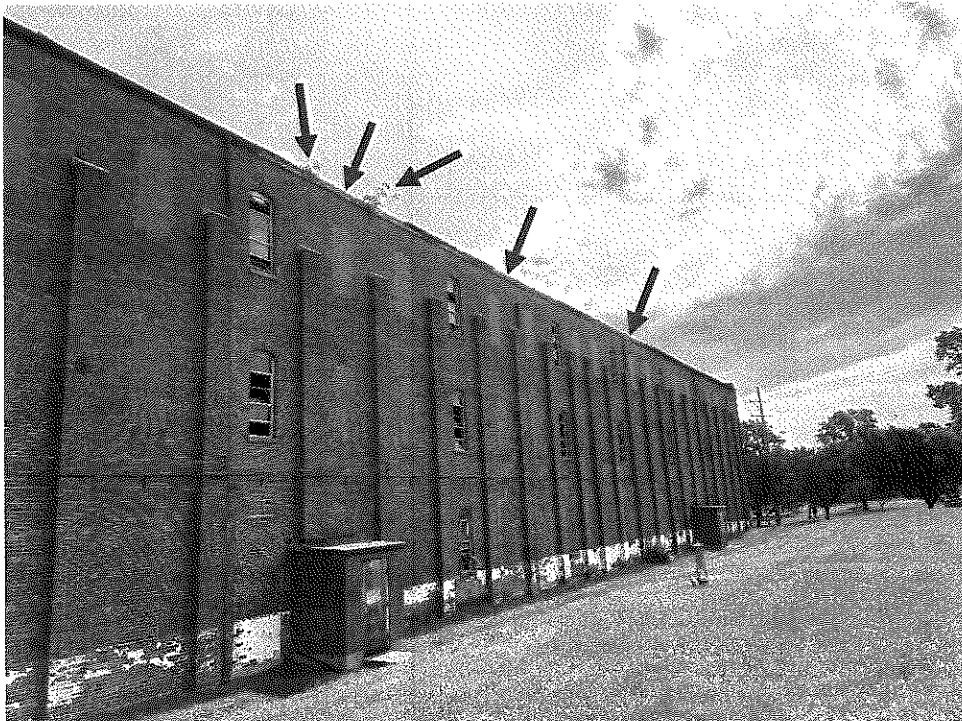
Photo 2 - South wall of the building. Large plant growth is visible. Missing gutters from deteriorated roof framing.

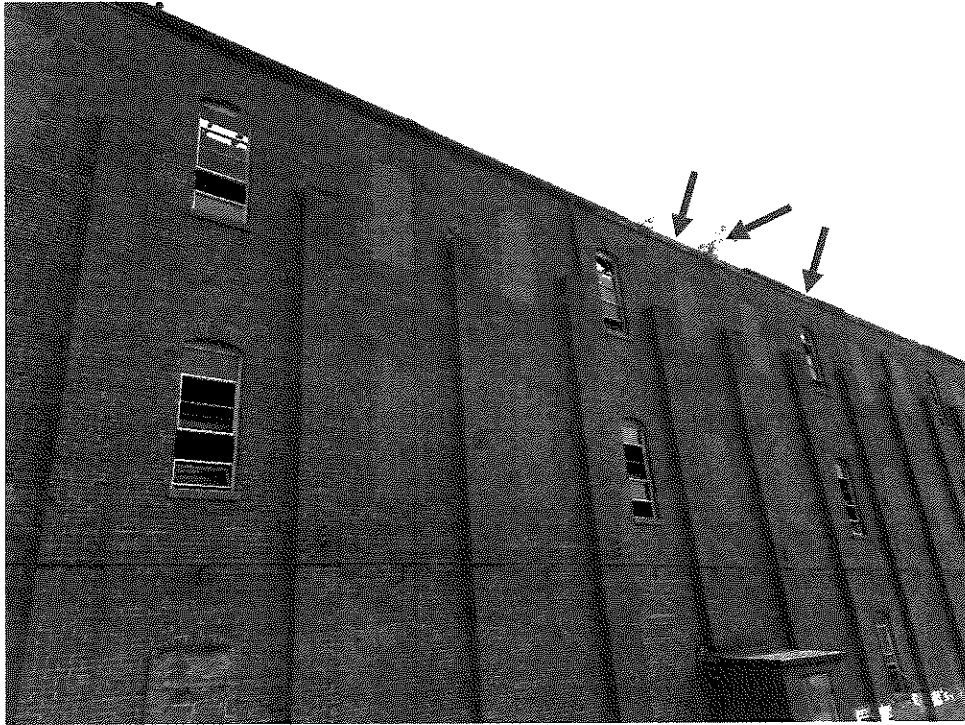
Photo 3 - South side of building. Large plant growth is visible. Missing gutters from deteriorated roof framing. White spots in upper windows are areas where the roof has collapsed.

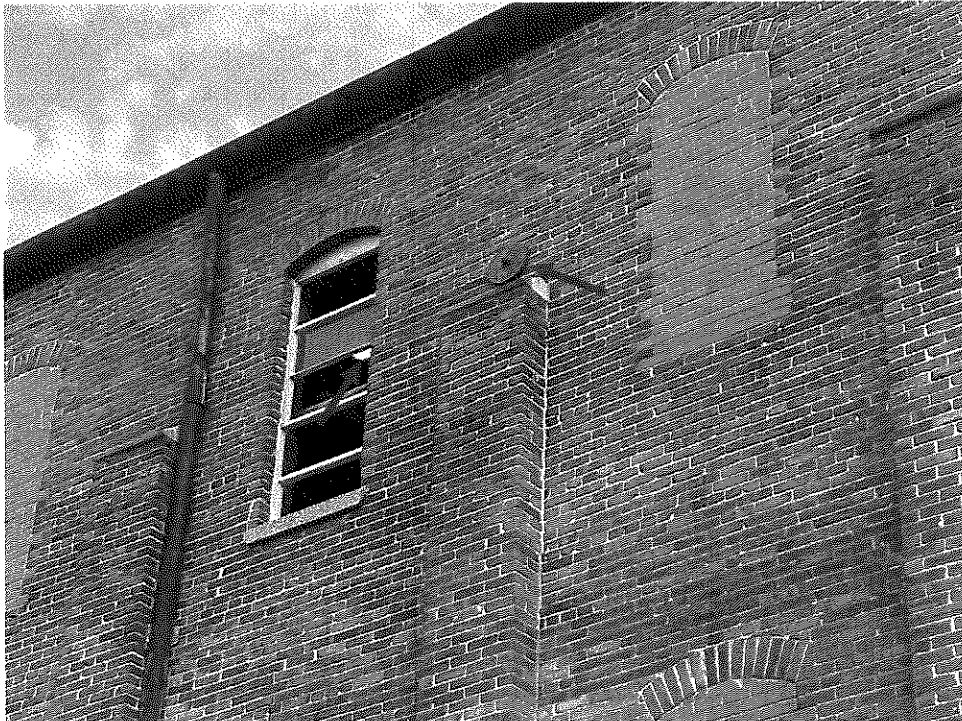
Photo 4 - South side of building. Tension cable plate is not flush to the face of the brick wall. White spot in window is the edge of an area of collapsed roof.

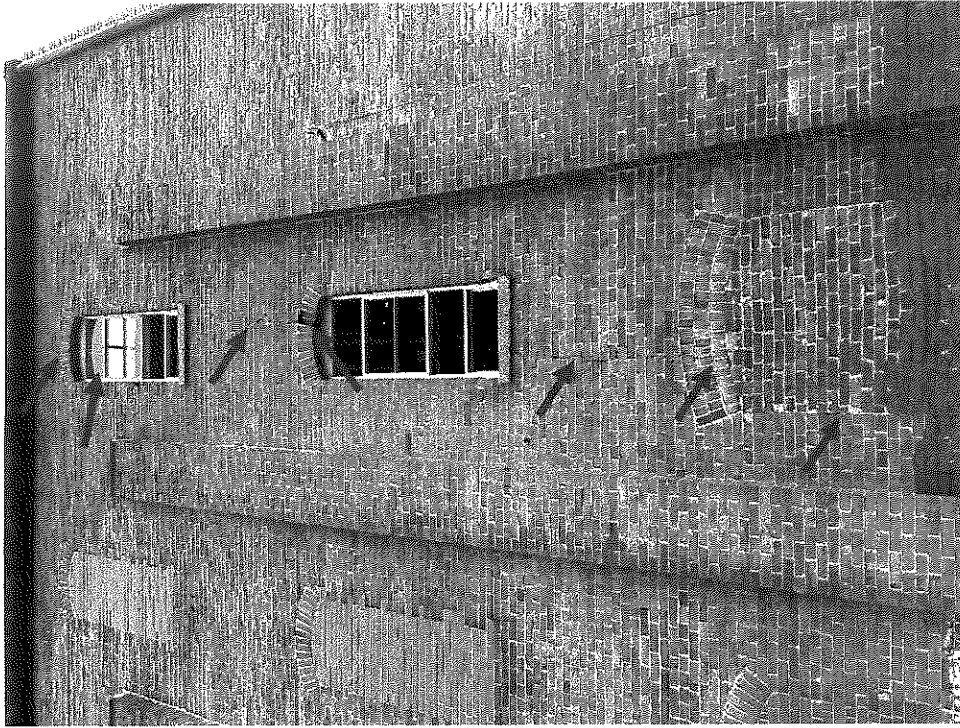
Photo 5 - South side of the southeast corner of the building. Past pointing work has cracked at top arch top window and cracking extends down wall. Dislodged brick in lower arch top window is about to fall. Blue in top window is collapsed roof.

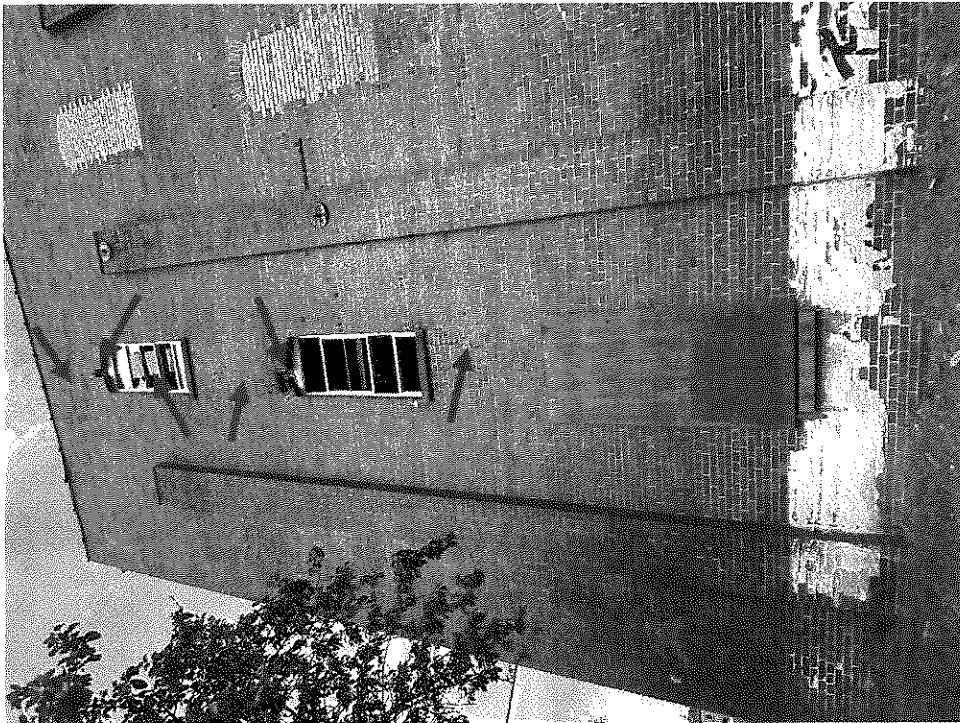
Photo 6 - East side of the southeast corner of the building. Bricks have fallen out of the tops of the arch top windows and crack in the brick wall extends down to the ground. Blue in top window is collapsed roof.

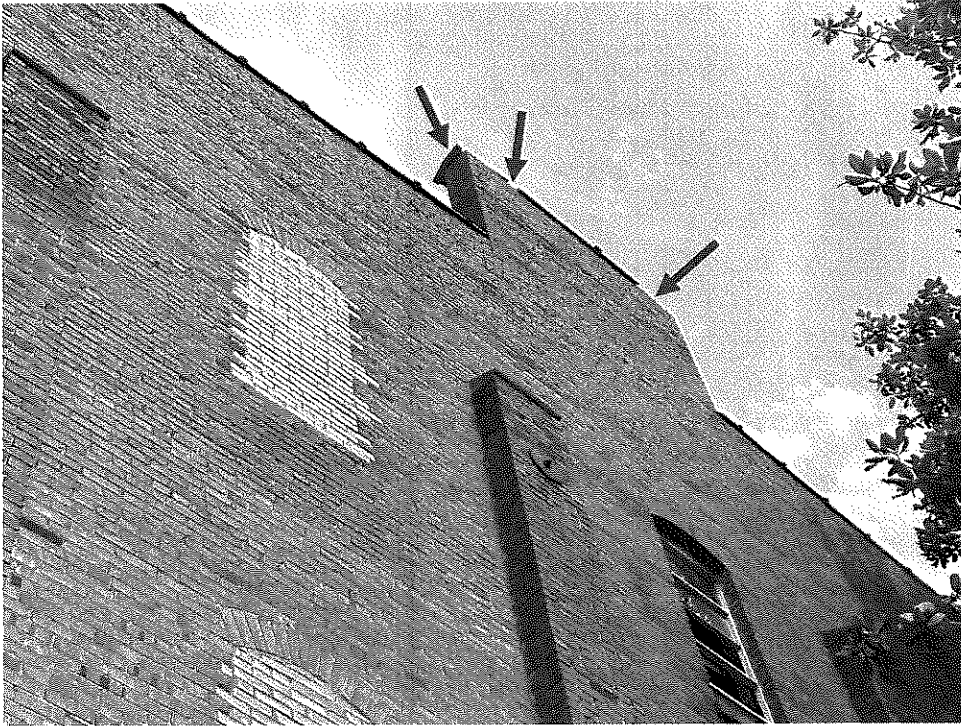
Photo 7 – East wall cap is missing and dislodged.

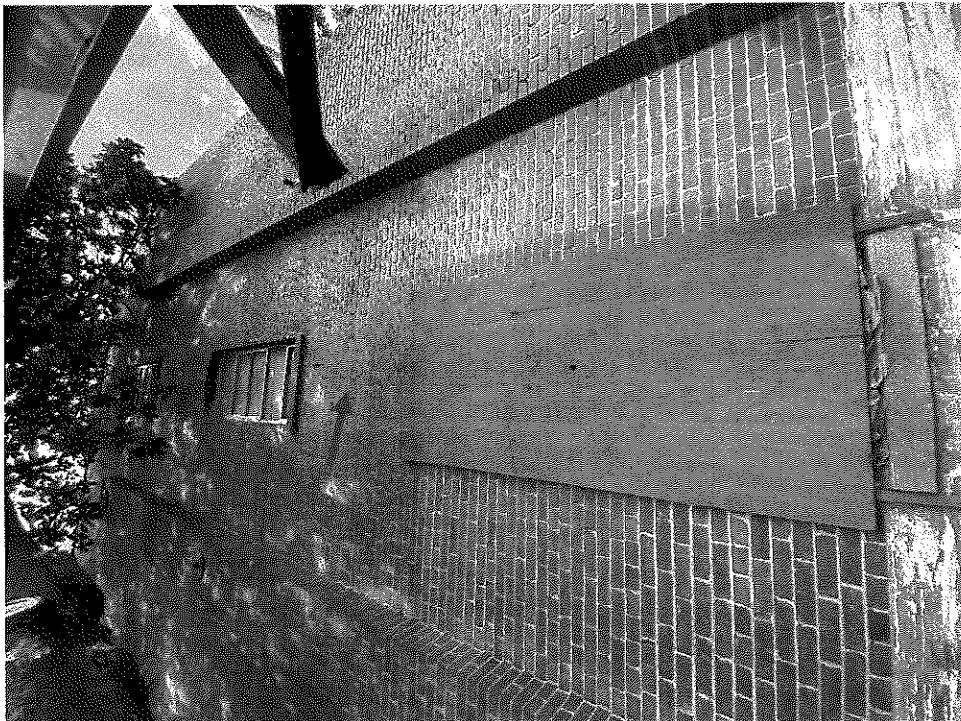
Photo 8 - East side of the northeast corner of the building. Cracks extending up the height of the wall and loose bricks over the lower arch top window.

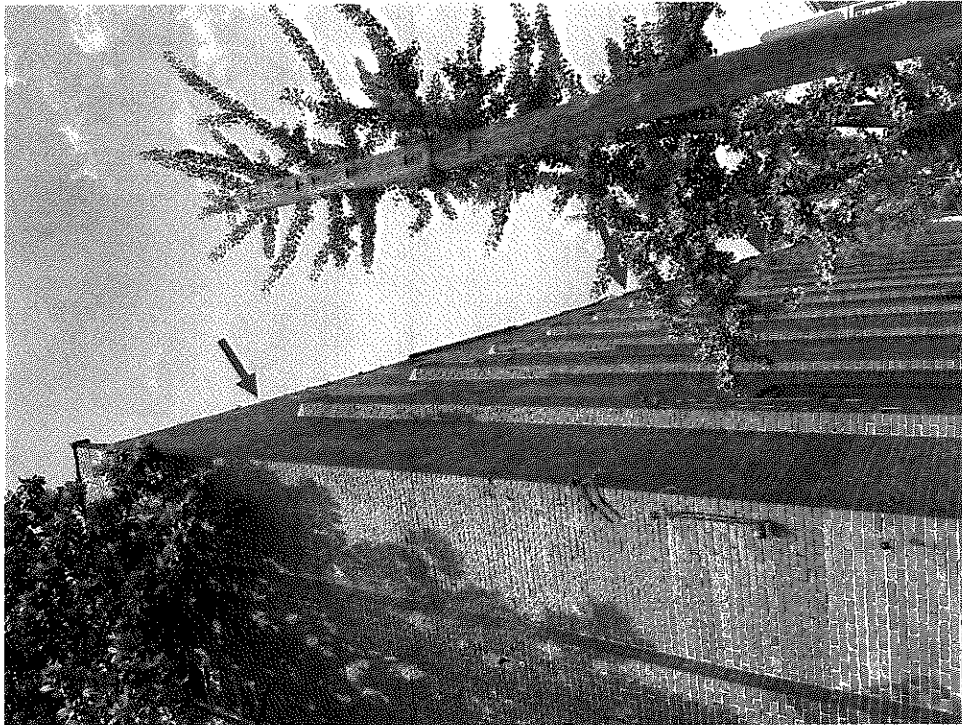
Photo 9 – Northeast corner of the building. Missing gutters along most of the length of this wall due to deteriorated roof framing.

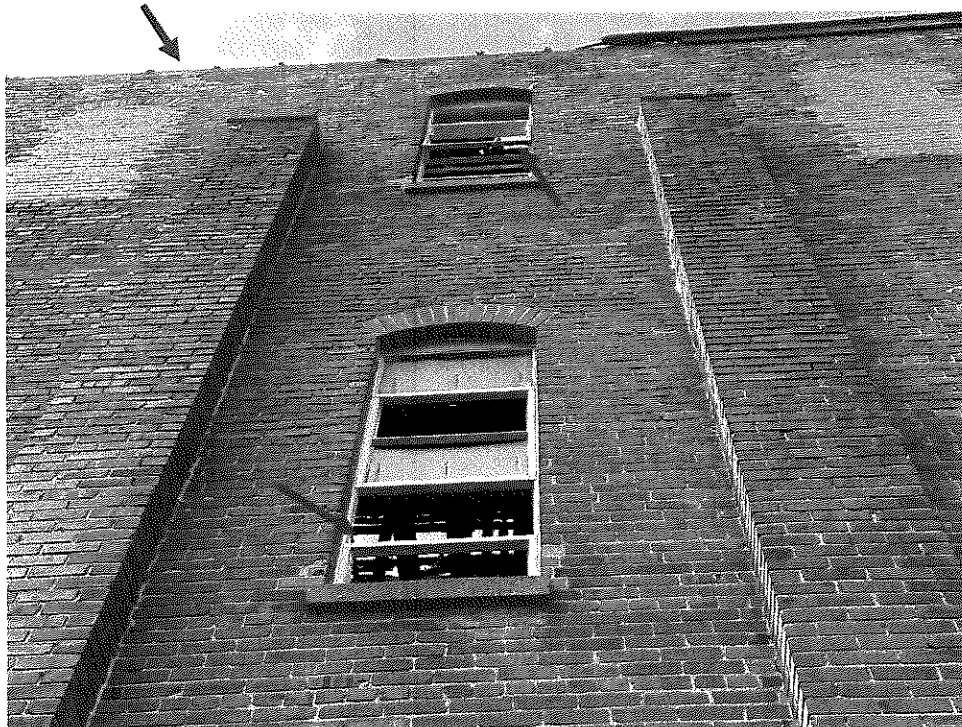
Photo 10 – North wall of the building. Missing gutters along most of the length of this wall due to deteriorated roof framing. Blue color in windows is collapsed sections of roof.

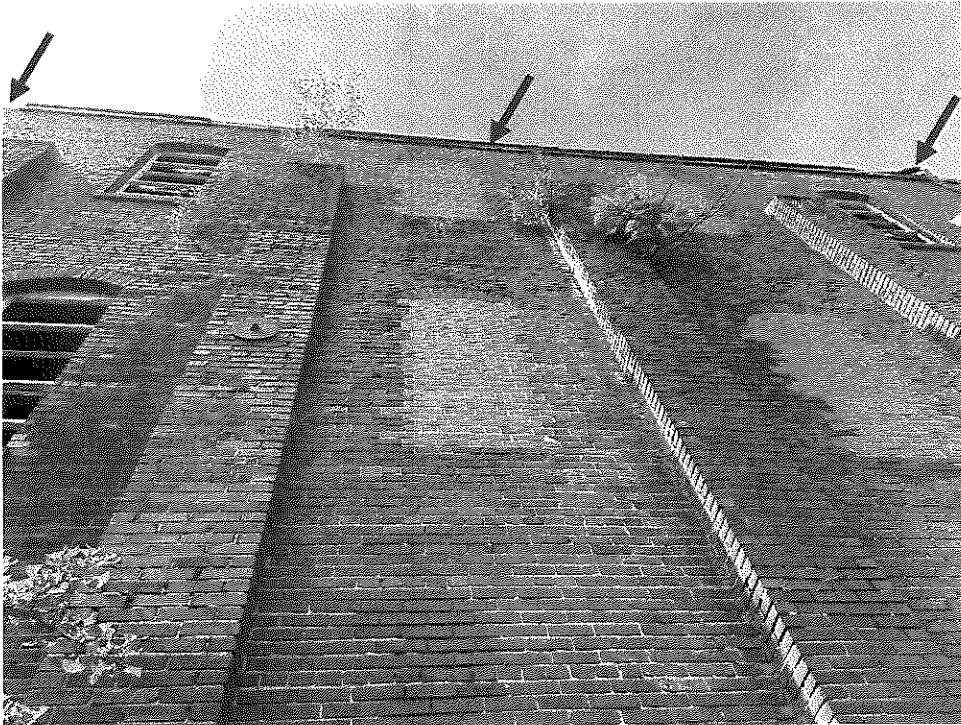
Photo 11 – North wall of the building. Missing gutters along most of the length of this wall due to deteriorated roof framing. Large amount of plant growth out of the masonry wall.

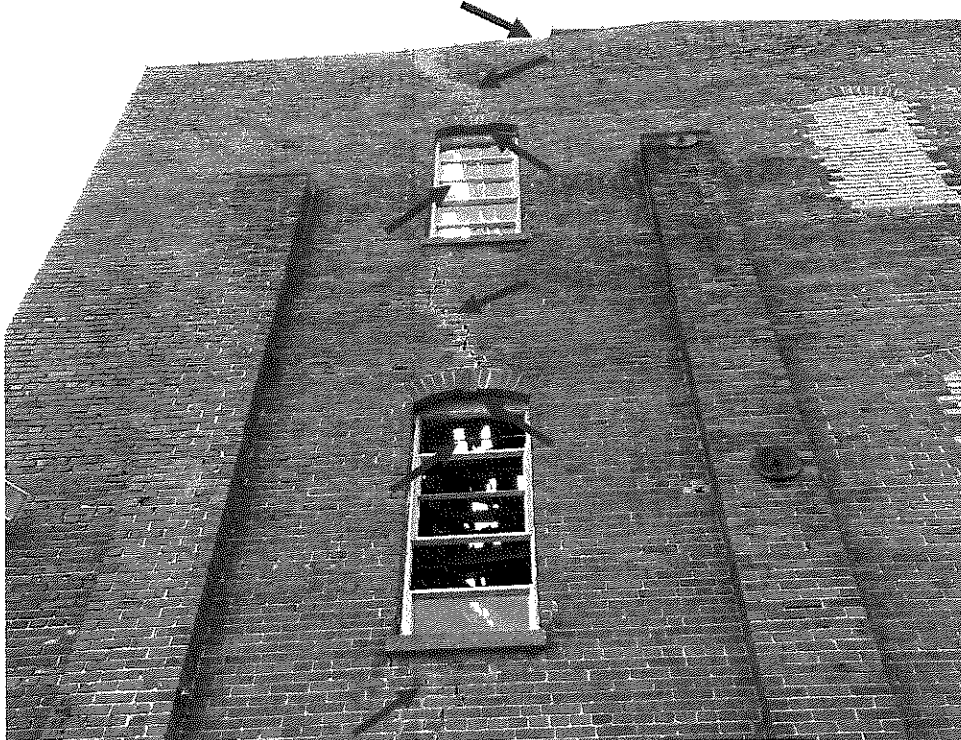
Photo 12 – West side of the northwest corner of the building. Missing cap at top of wall, cracks in old pointing repairs, and bricks in the arch tops of the windows about to fall. White spots seen in the windows are areas of collapsed roof.

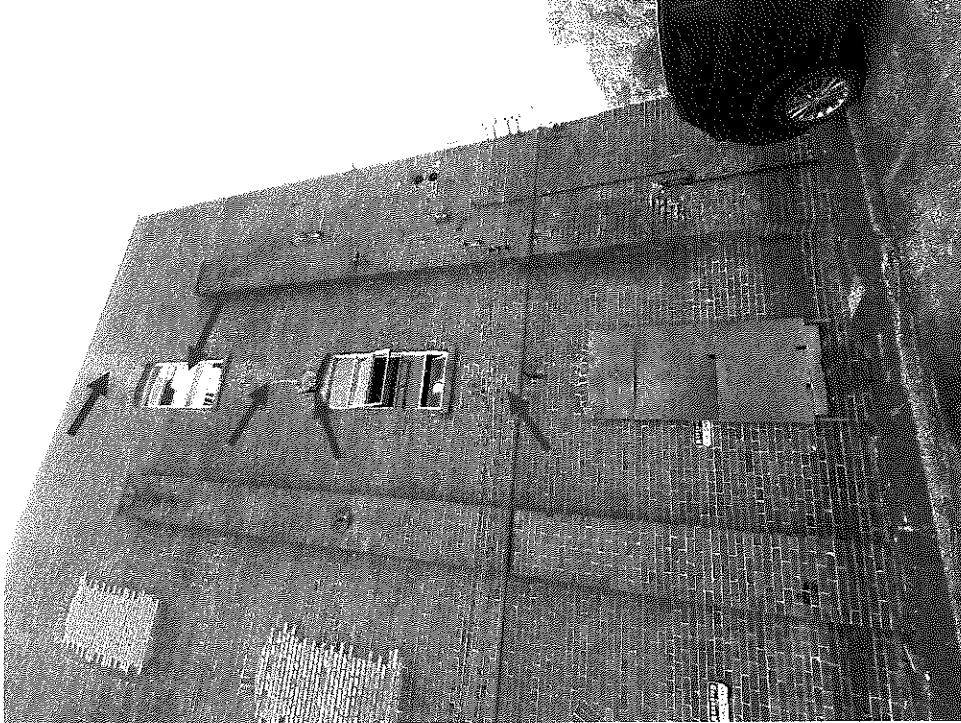
Photo 13 – West side of the southwest corner of the building. Old pointing repair is cracked open again with loose bricks over the lower arch top window. White color in the upper window is a collapsed section of roof.

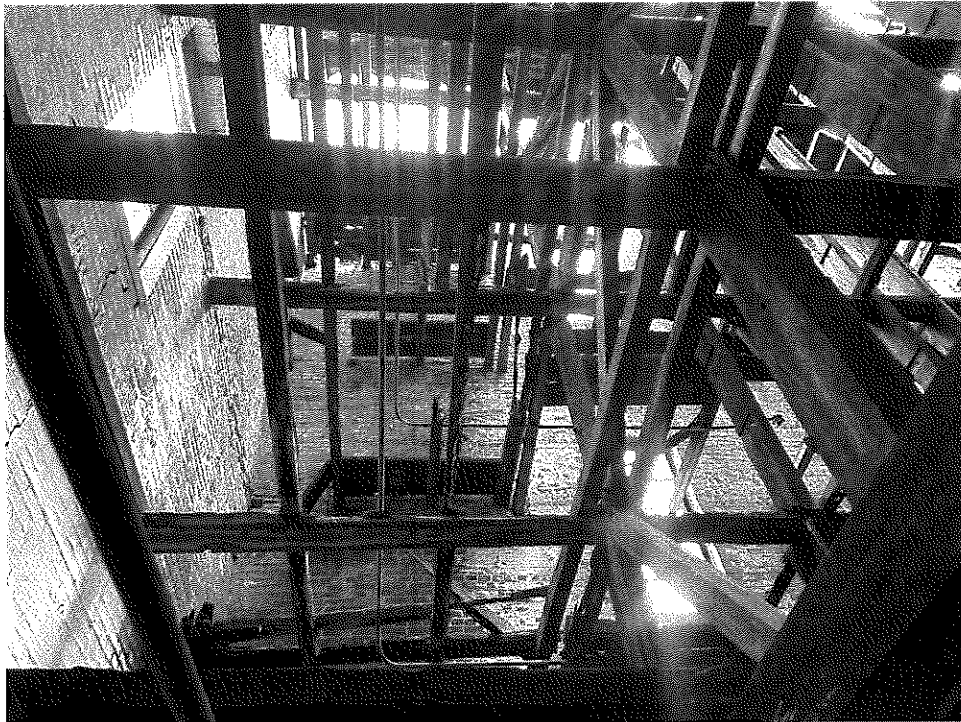
Photo 14 – Interior wood framing with deteriorated and molded wood. Large area of collapsed roof is visible.

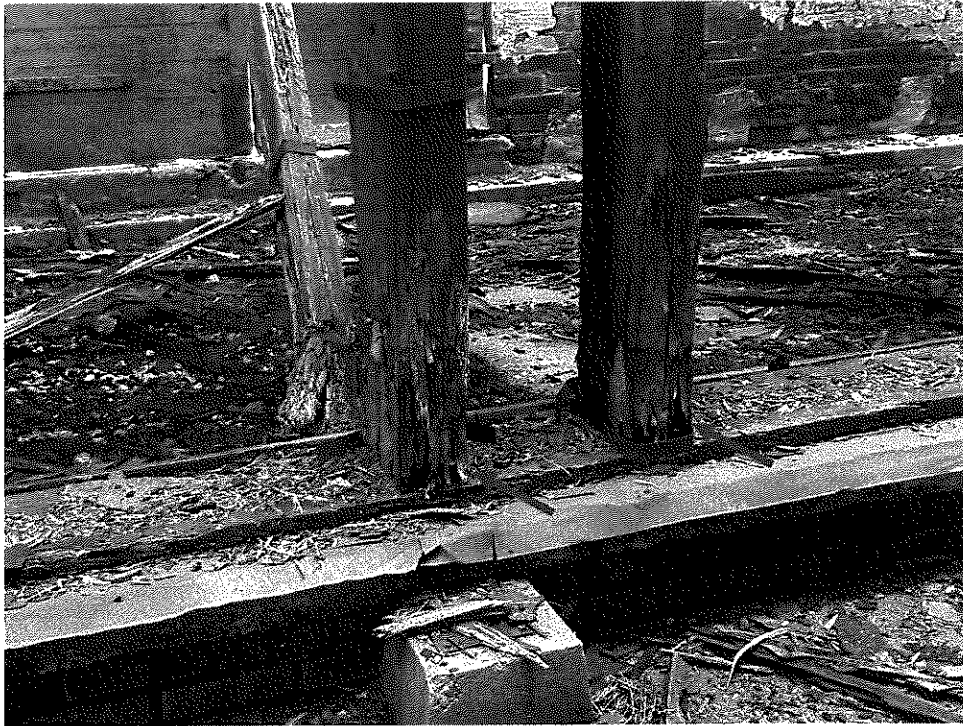
Photo 15 – Collapsed beam and severe deterioration at the base of two (2) posts.

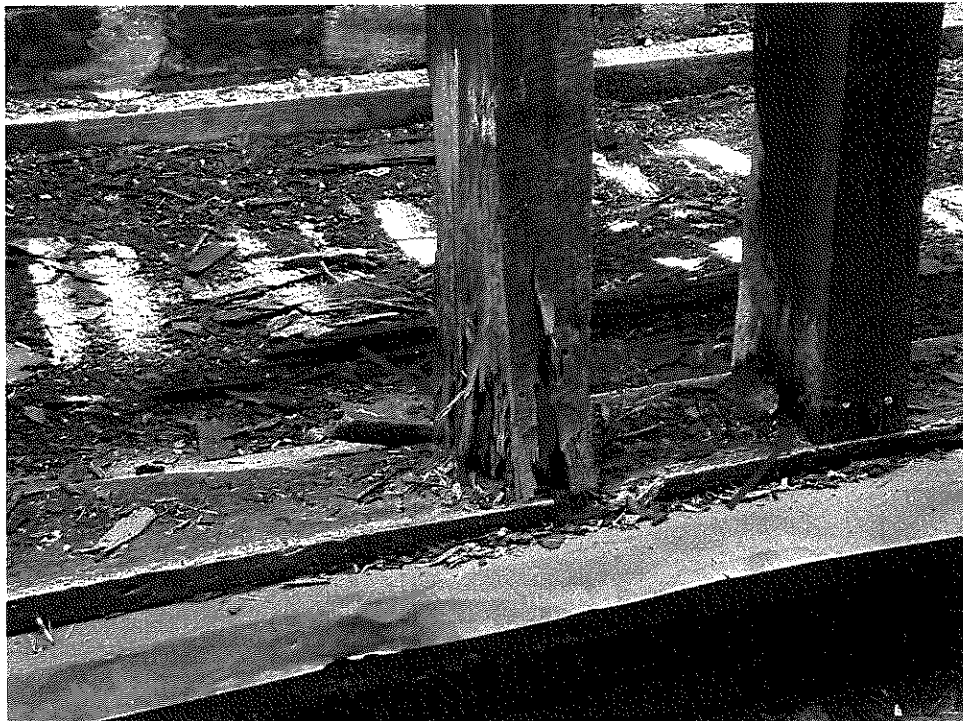
Photo 16 – More deteriorated column bases. Nails from the toenail connection is visible in the right column. They are becoming exposed due to deterioration of the wood material.

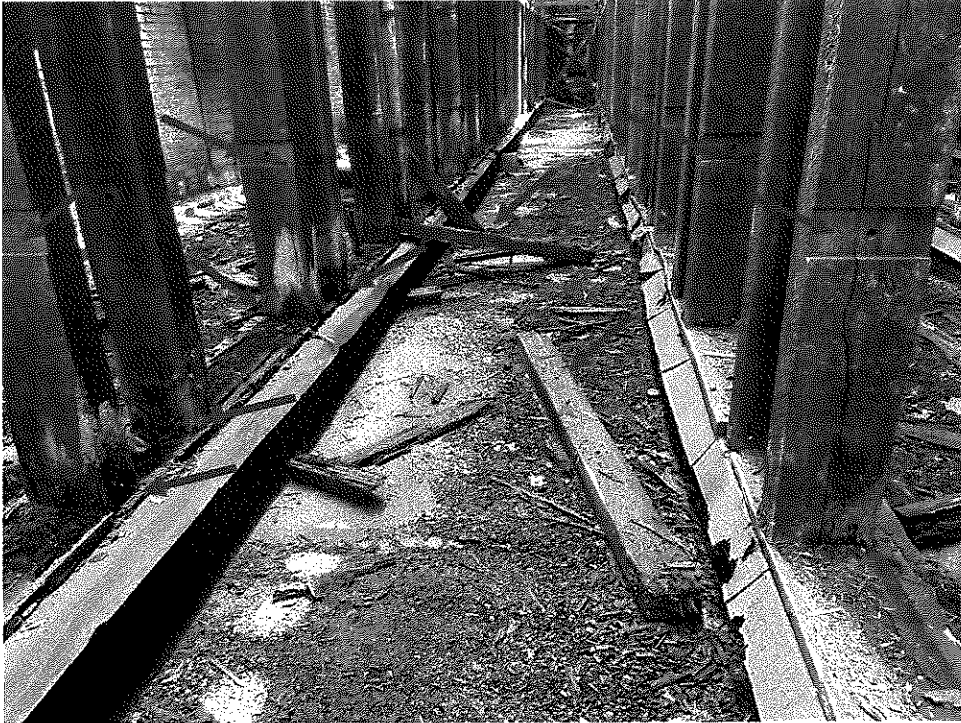
Photo 17 – Deteriorated post bases and debris from collapsed roof above. The notches in the posts with the hole in them are the locations where the 4x4 dunnage should be.

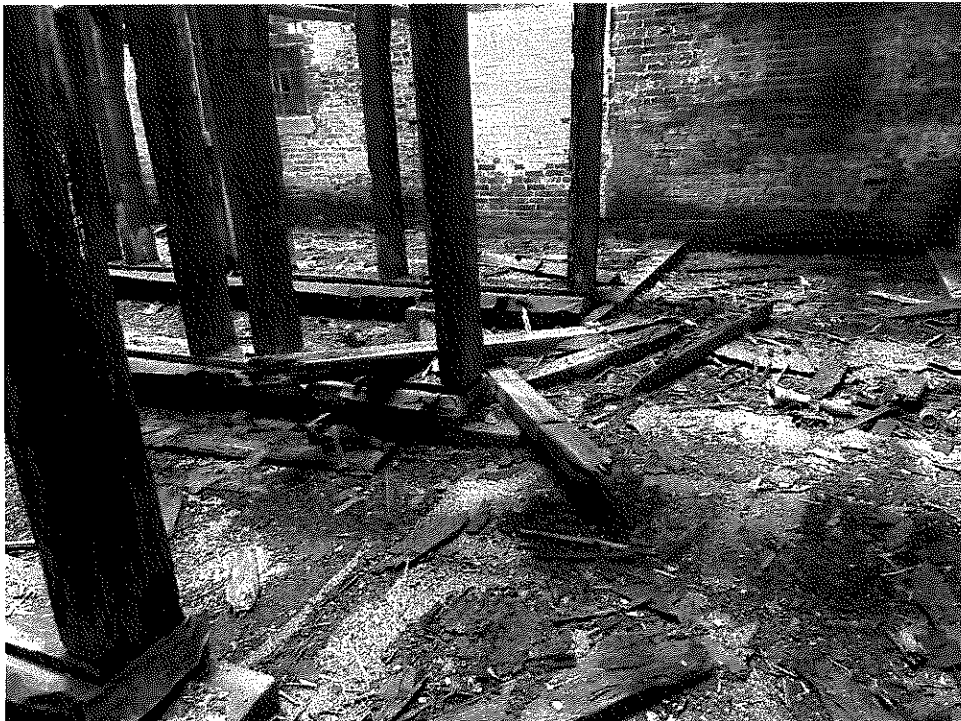
Photo 18 – More debris from collapsed roof. Most of the light in this area is from the collapsed roof.

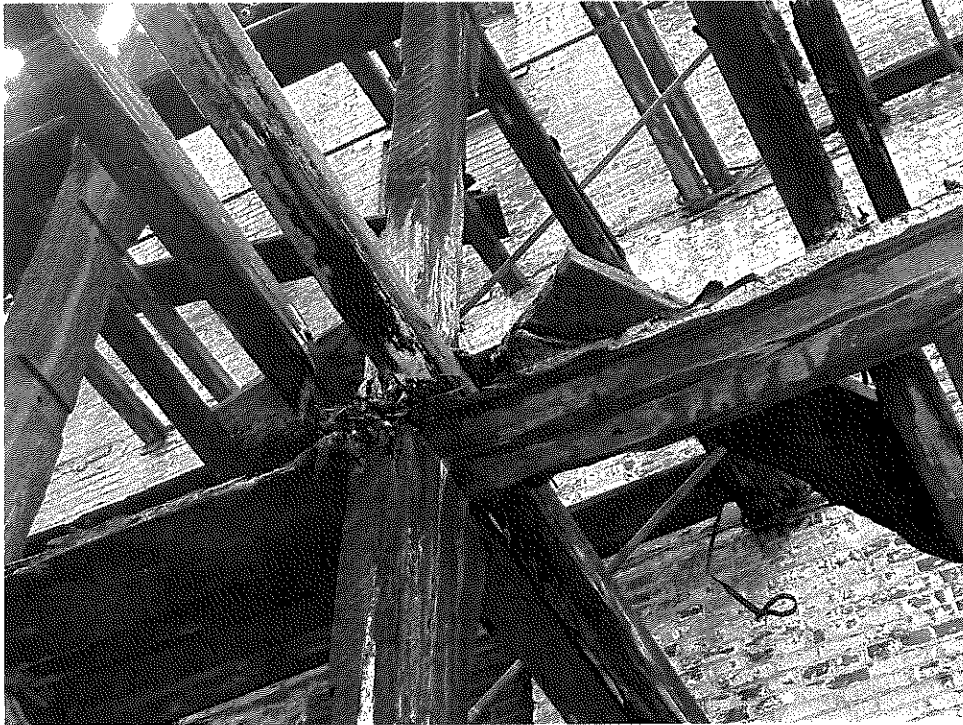
Photo 19 – Example of deteriorated framing above the ground level. Wood also has white mold growth.

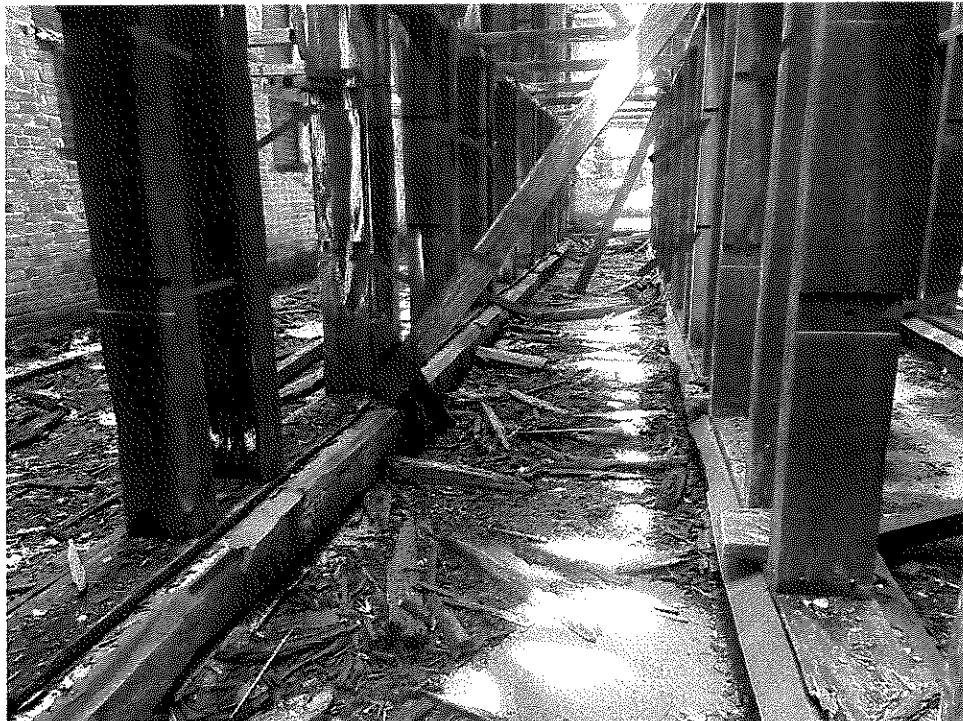
Photo 20 – Collapsed framing and debris from collapsed roof. Missing dunnage locations are easily visible. Third column on left has severe mold growth.

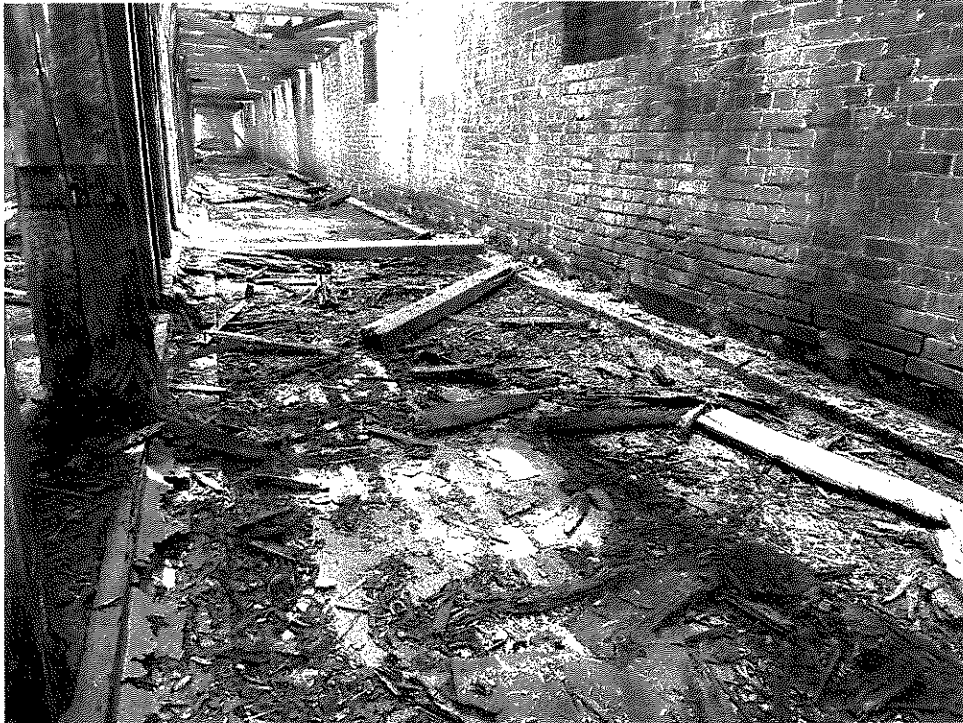
Photo 21 – Debris from collapsed framing on the floor and has broken a framing member at the next level up. Base of column is severely deteriorated.

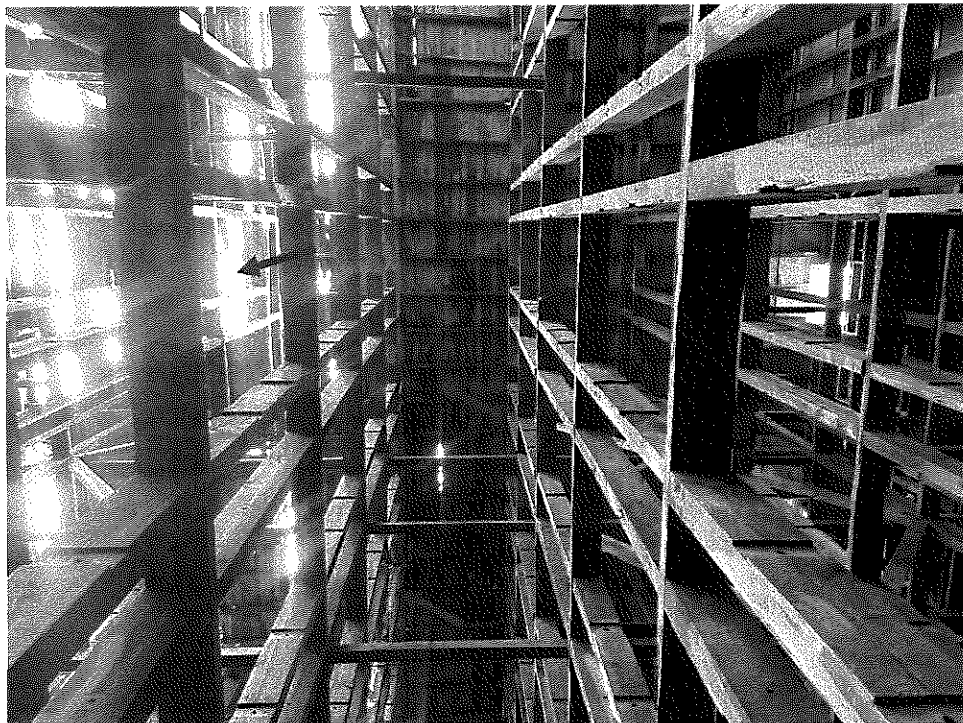
Photo 22 – Large area of collapsed roof. Deteriorated column in upper level of wood framing with severe mold growth. A better section of the visible roof with severe water damage. No 4x4 dunnage framing is visible; therefore, the posts are laterally unstable side-to-side.

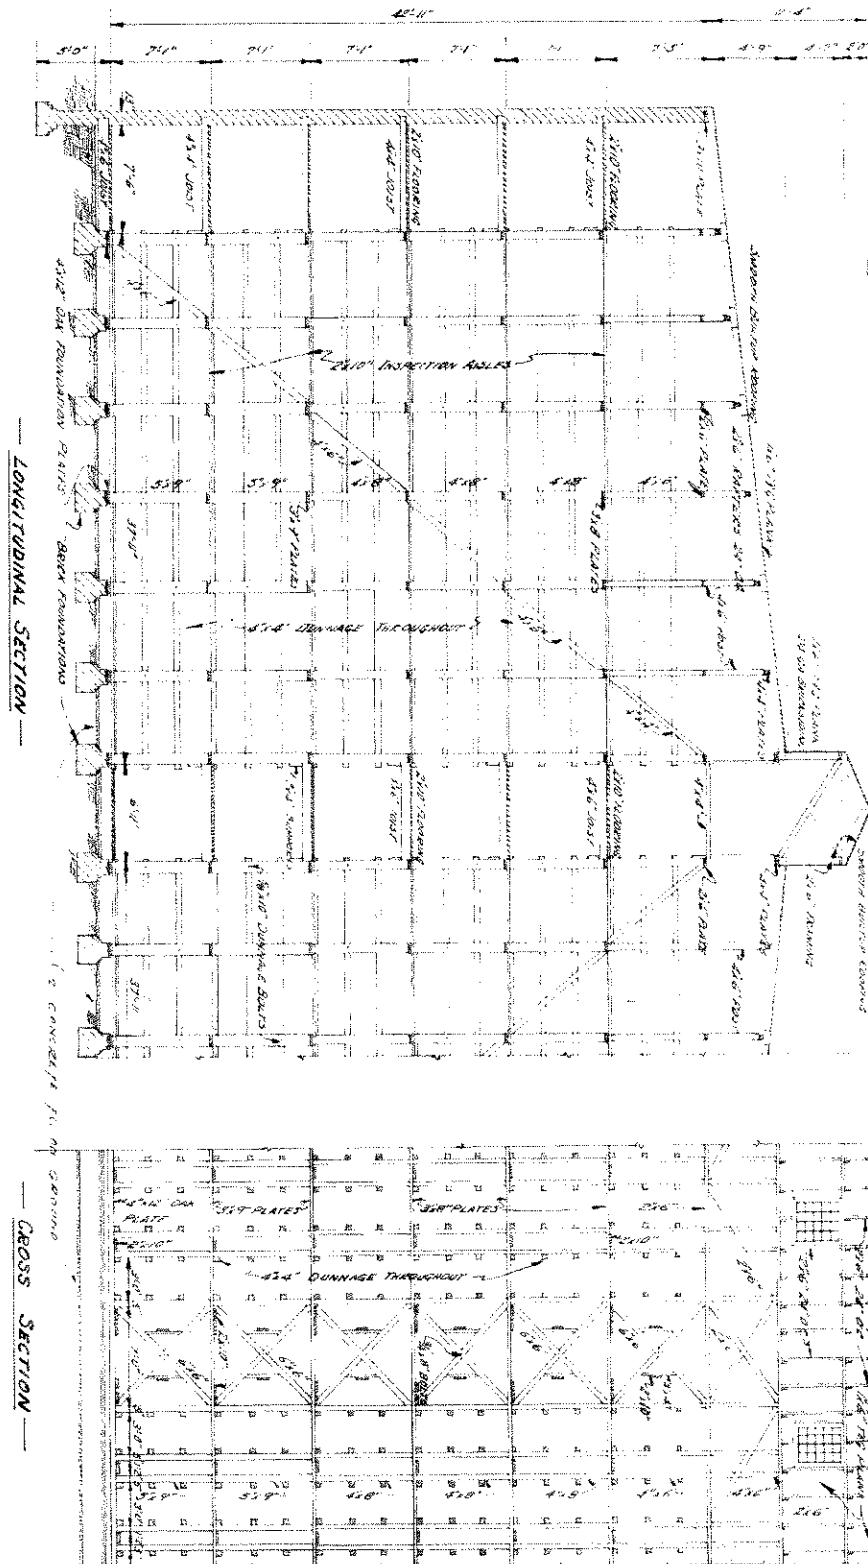
Figure 1 - Reference framing section from original plans
