100 Distillery Commons

Owner Presentation in Opposition to Local Landmark Designation

12/17/2020

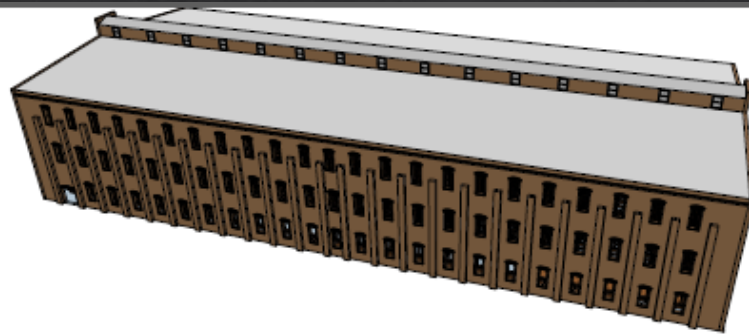
The Building as Currently Constructed

The building is in poor structural condition, but has mostly intact exterior walls, roofing, and racking system on the interior.

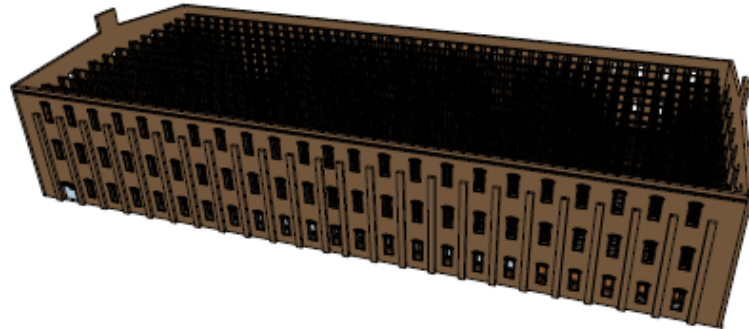
The First Phase of Demolition

The first phase of demolition will require the removal of the roof, which is supported by the interior racking system. Removal of the racking system would cause the roof to collapse without additional support or prior removal.

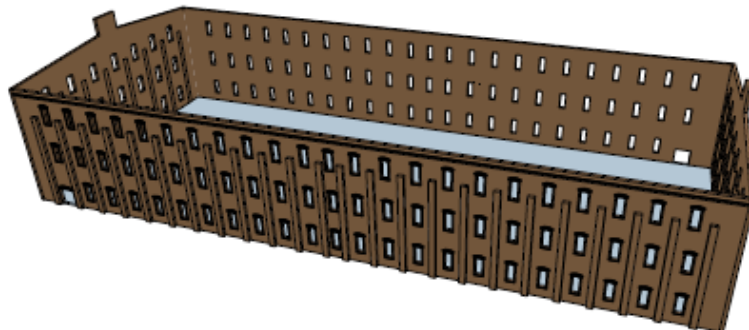
The Final Phase of Demolition Prior to Construction

At some point during demolition, even with temporary interior supports, the entirety of the building will only consist of the exterior walls. At this point the only remaining historic materials will be the exterior brick walls.

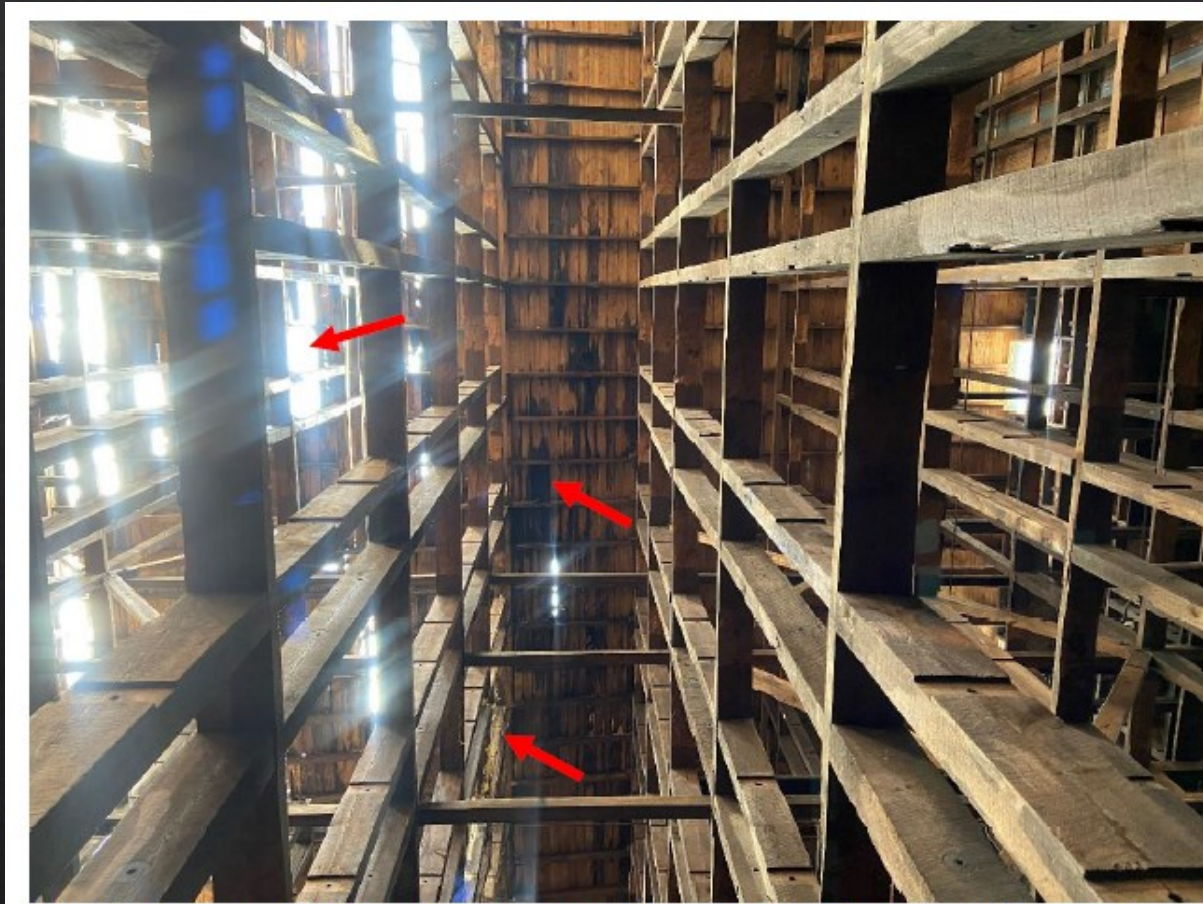
Photo 22 – Large area of collapsed roof. Deteriorated column in upper level of wood framing with severe mold growth. A better section of the visible roof with severe water damage. No 4x4 dunnage framing is visible; therefore, the posts are laterally unstable side-to-side.

1. Based on the widespread collapse of the roof, the deteriorated condition of the existing interior framing, the missing dunnage framing throughout, and the continued movement and cracking of the exterior walls, it is my opinion that the building should be demolished.

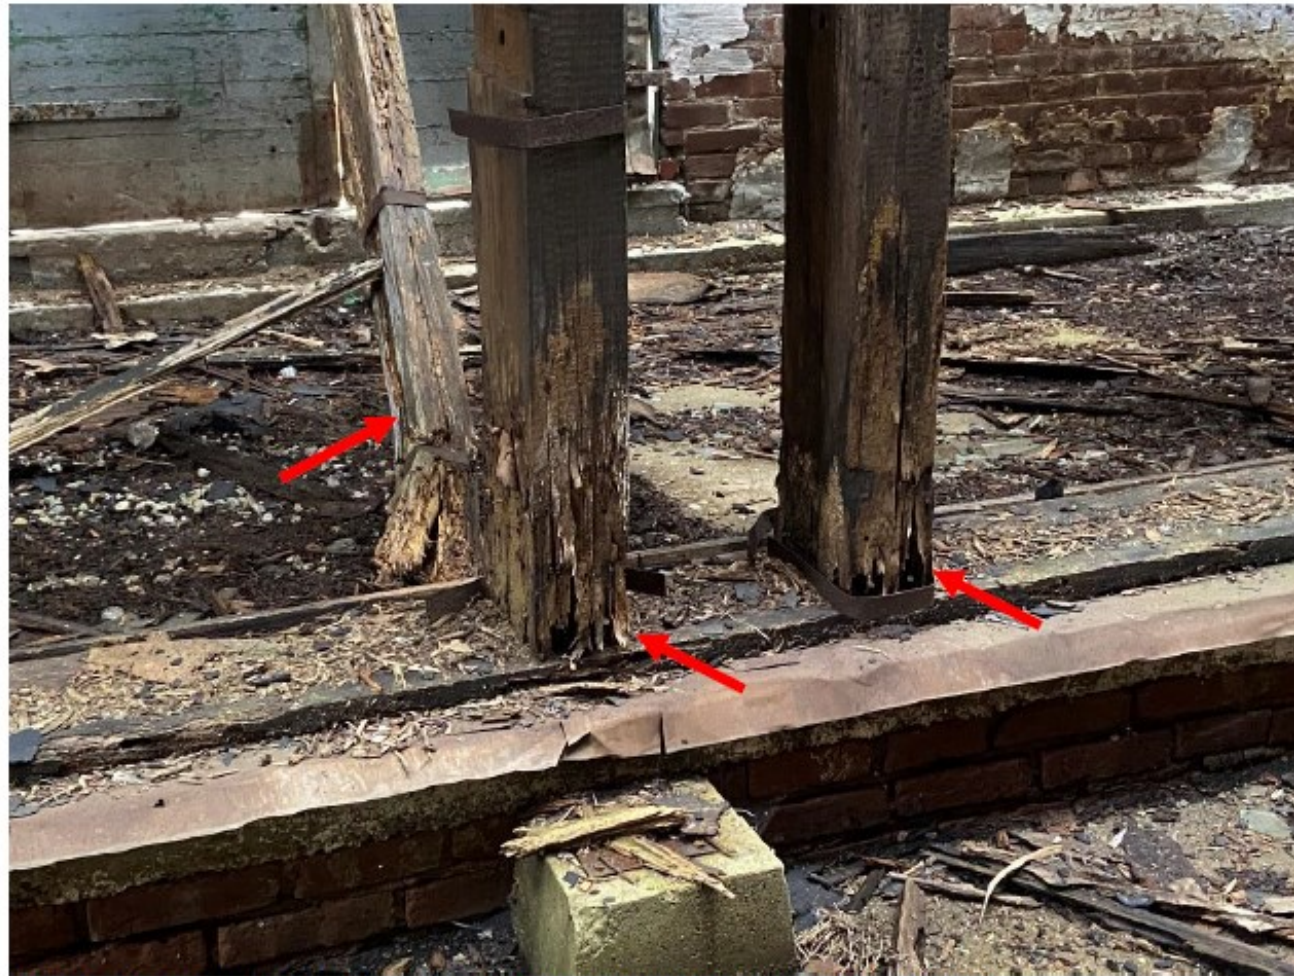
Photo 15 – Collapsed beam and severe deterioration at the base of two (2) posts.

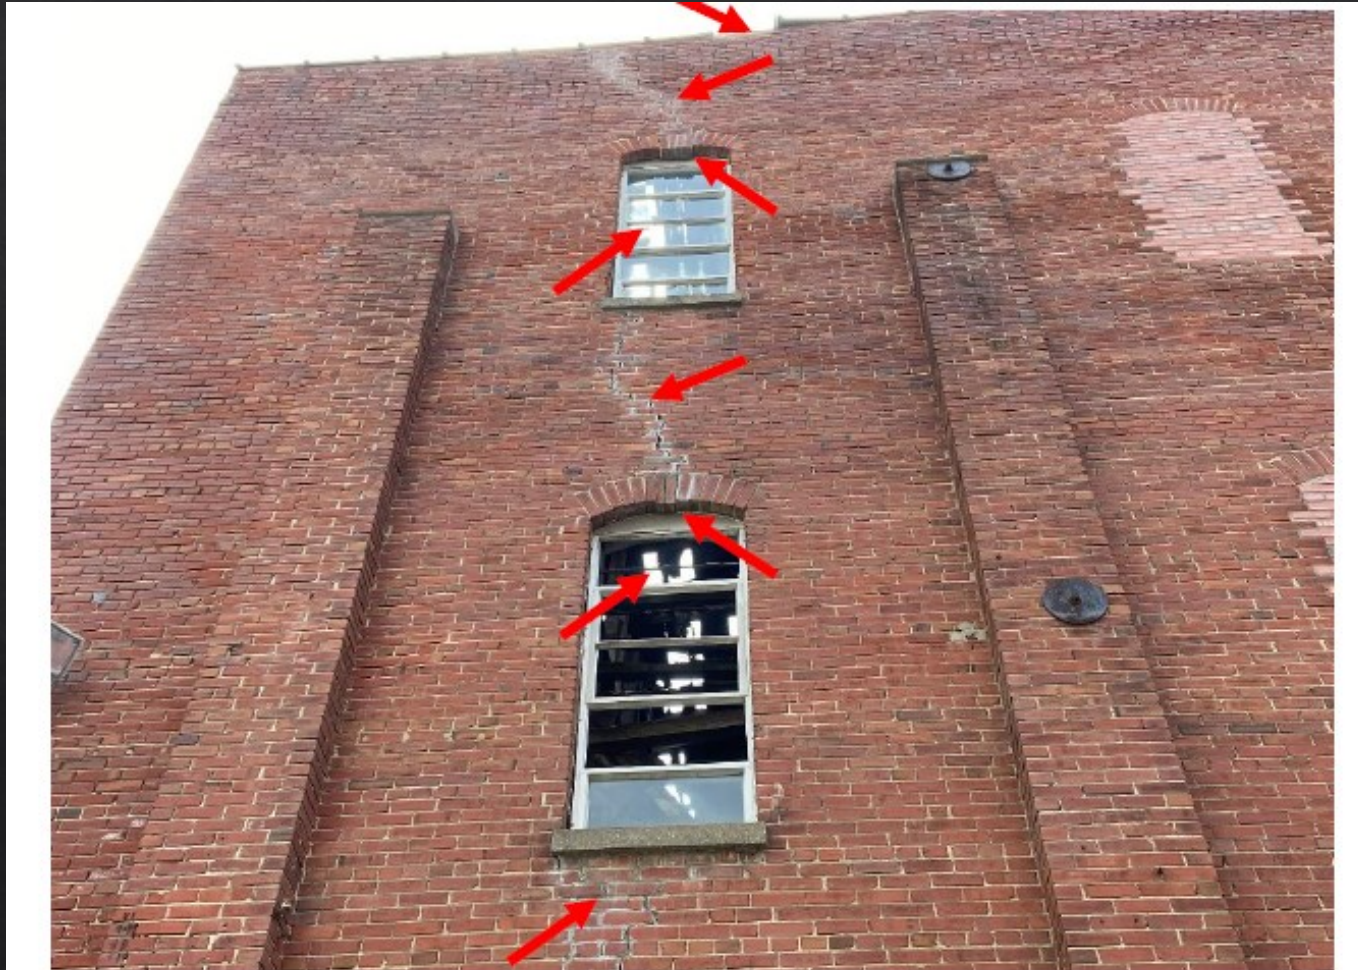
Photo 12 – West side of the northwest corner of the building. Missing cap at top of wall, cracks in old pointing repairs, and bricks in the arch tops of the windows about to fall. White spots seen in the windows are areas of collapsed roof.
