# 100 Distillery Commons

Owner Presentation in Opposition to Local Landmark Designation

12/17/2020

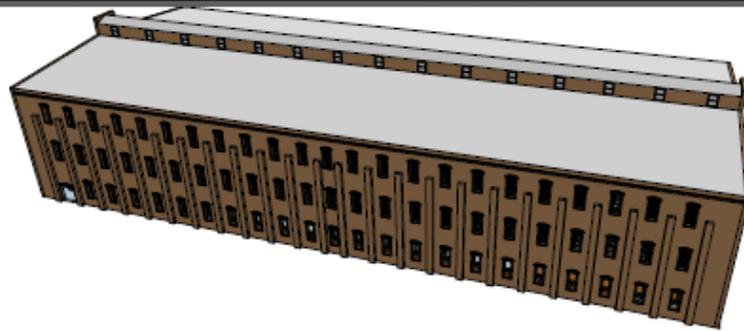
## **The Building as Currently Constructed**

The building is in poor structural condition, but has mostly intact exterior walls, roofing, and rack system on the interior.

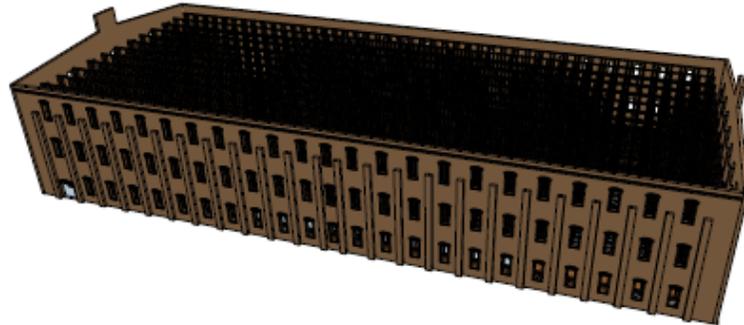
## **The First Phase of Demolition**

The first phase of demolition will require the removal of the roof, which is supported by the interior racking system. Removal of the racking system would cause the roof to collapse without additional support or prior removal.

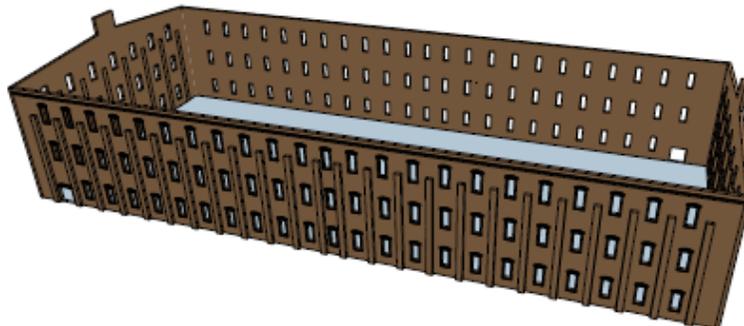
## **The Final Phase of Demolition Prior to Construction**

At some point during demolition, even with temporary interior supports, the entirety of the building will only consist of the exterior walls. At this point the only remaining historic materials will be the exterior brick walls.

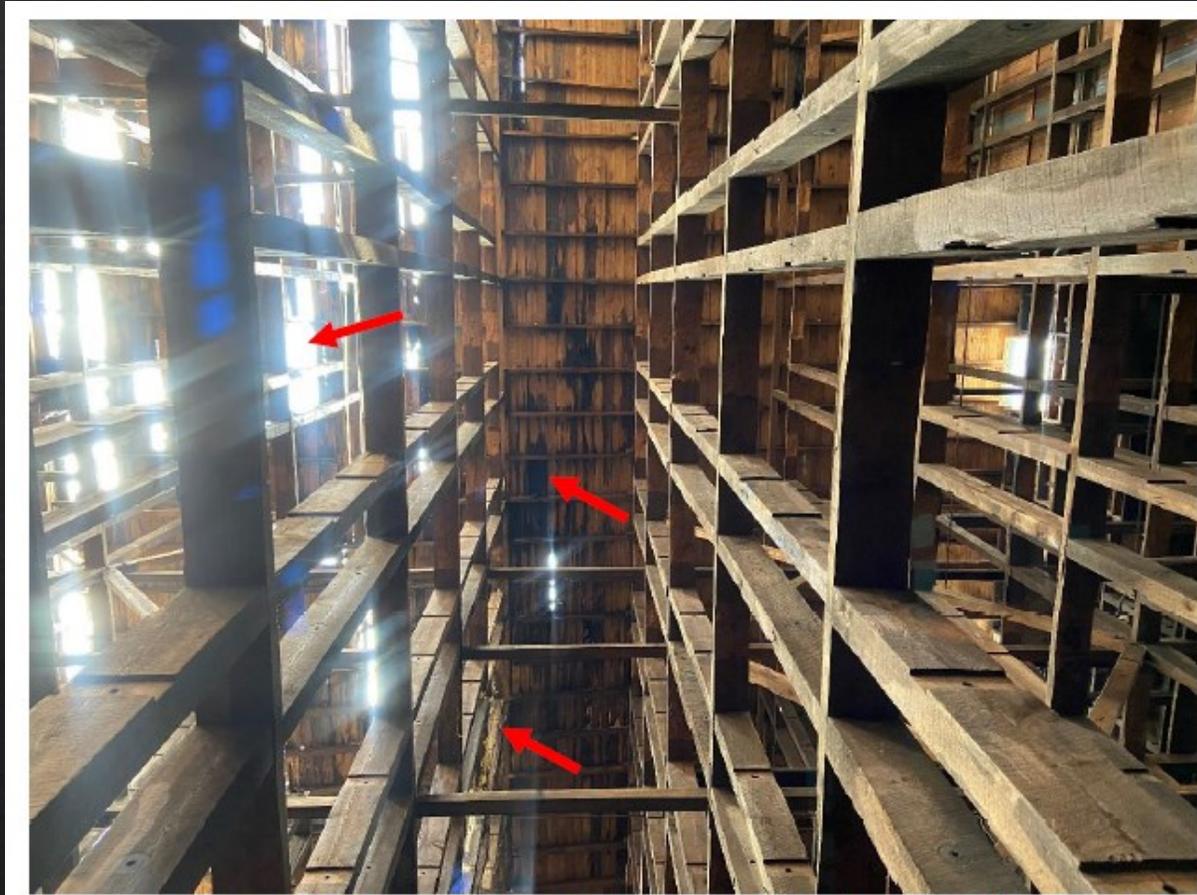
*Photo 22 – Large area of collapsed roof. Deteriorated column in upper level of wood framing with severe mold growth. A better section of the visible roof with severe water damage. No 4x4 dunnage framing is visible; therefore, the posts are laterally unstable side-to-side.*

1. Based on the widespread collapse of the roof, the deteriorated condition of the existing interior framing, the missing dunnage framing throughout, and the continued movement and cracking of the exterior walls, it is my opinion that the building should be demolished.

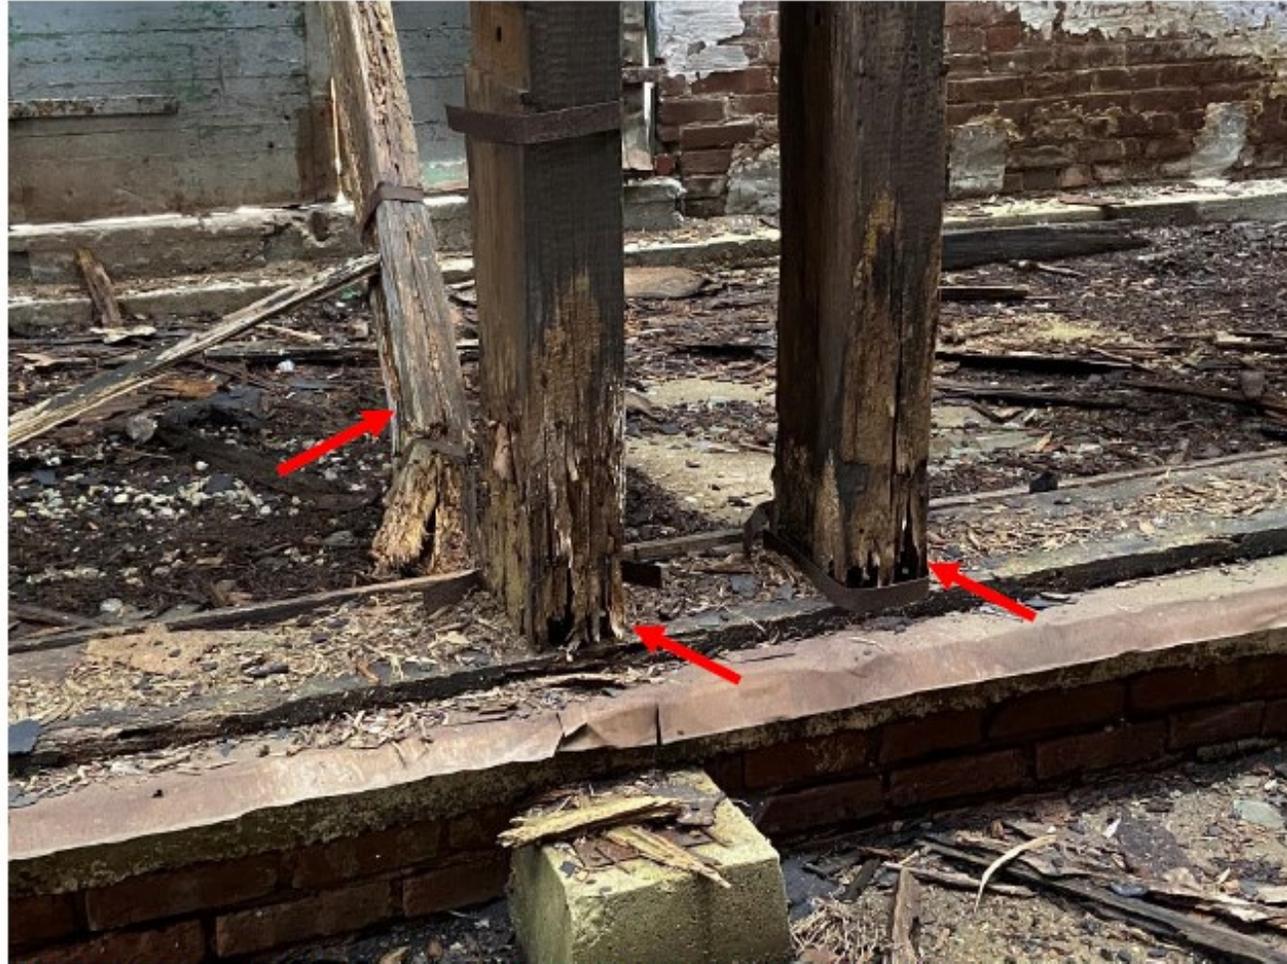
*Photo 15 – Collapsed beam and severe deterioration at the base of two (2) posts.*

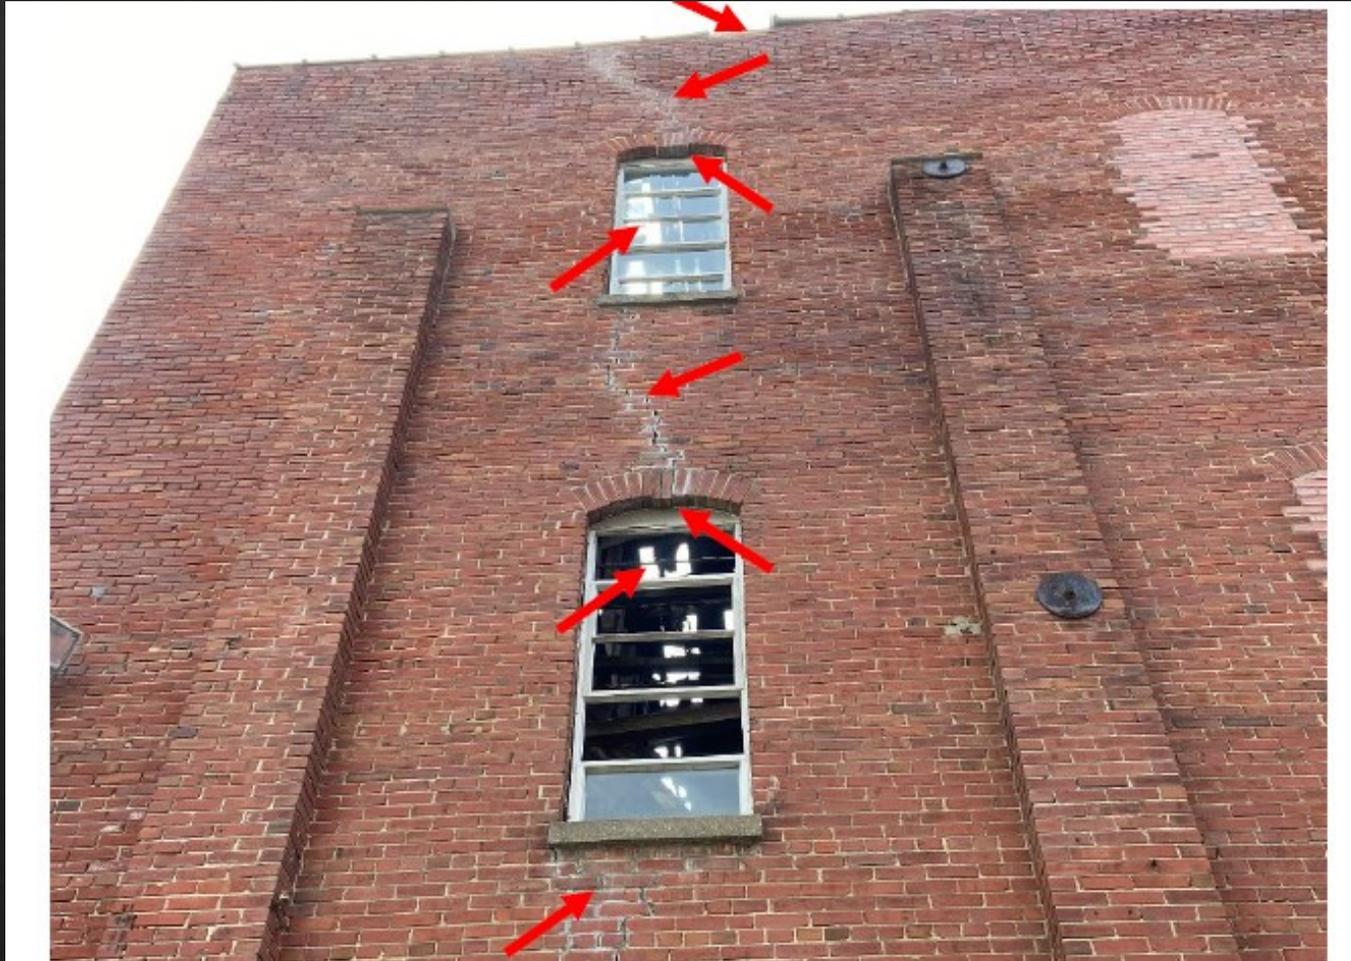
*Photo 12 – West side of the northwest corner of the building. Missing cap at top of wall, cracks in old pointing repairs, and bricks in the arch tops of the windows about to fall. White spots seen in the windows are areas of collapsed roof.*
