**Historic Landmarks and Preservation Districts
Commission**

Report to the Committee

Case No: 19COA1024
Classification: Committee Review

Property Address: 142 Pope Street

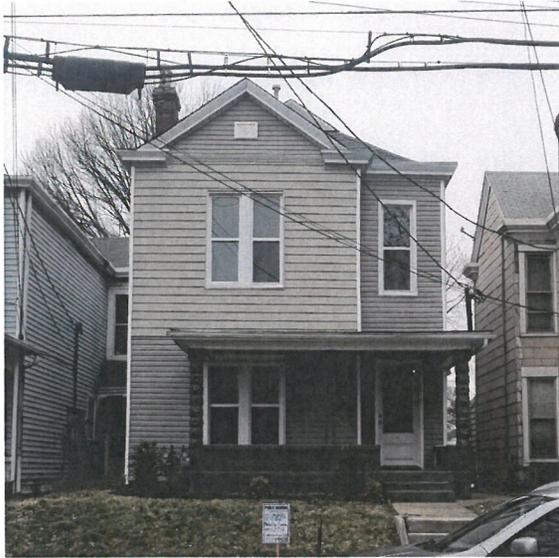
2. Applicant's photo: door & shutter alterations as recommended by staff in 19COA1025

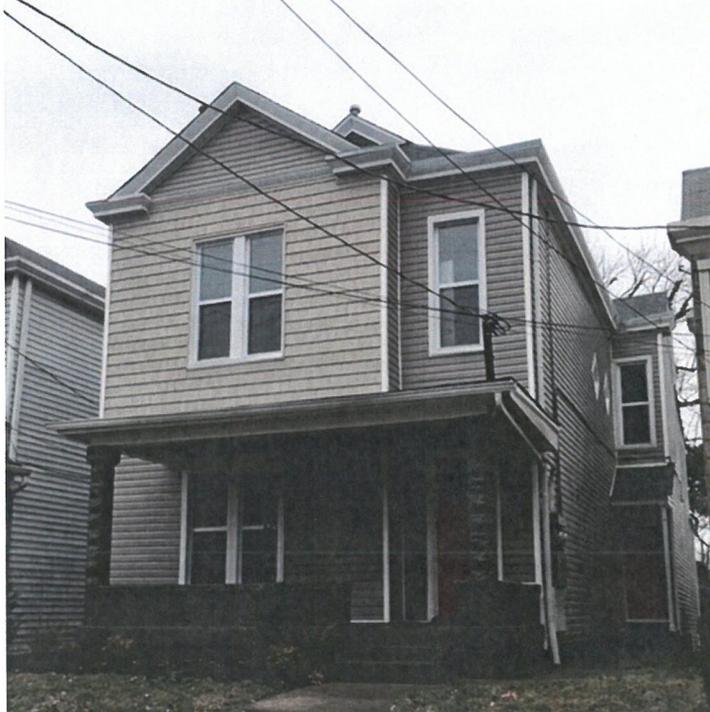
3. Staff photo from February 20, 2019.

The project does not meet the Clifton design guidelines for **Siding and Trim**. Based on photographic research performed by staff with documentation from 2012 and 2017 the house was clad in a 4" traditional lap vinyl siding on all four sides. The photos also show that window openings have been altered and/or covered on the rear façade. The current siding is a 4" dutch-lap siding with a woodgrain texture and is installed on all four facades. Staff finds that this material does not meet design guideline **SD9** and partially does not meet **SD8**. Design guideline **SD9** states that "*Fiber cement, vinyl or aluminum siding should match the profile and dimensions of the original wood siding. A smooth-faced, narrow profile siding (3" or 4" reveal) is acceptable for installation. Historic fabric, trim, or corner boards should project slightly beyond the vinyl siding, wherever possible without causing damage.*" Staff finds that the profile of the dutch-lap and faux cedar shake siding, both with the woodgrain texture, are inappropriate sheathing choices as a historic precedent for dutch-lap and cedar shake does not exist or has yet to be proven. Staff finds that the request only partially meets guidelines **SD8** as the condition of the underlying materials is uncertain and the historic water table board was further obscured. The water table board and trim details are distinguishing characteristics for structures of this period.

the visual appearance of the windows on the front façade appear to be wood. The glass to sash dimensions and ratios as well as the existing storm windows suggests the presence of historic wood windows. Additionally, staff photographs from 2012 and a Google photo from 2015 show two sets of two casement windows on the rear façade of the structure at the second story. Based on documentation provided by the applicant, the windows on the rear have been removed and the windows on all sides of the structure have been replaced. Staff finds that the replacement of historic wood windows on a primary façade without ARC approval and the installation of vinyl windows does not meet guideline W1. Staff finds that the removal and siding over of the two sets of two casement windows on the rear façade does not meet guideline W9. Guideline W9 states that window openings on a street-facing façade should not be altered. The two sets of two casement windows were removed and sided over. Staff does find that the replacement of all side and rear windows, as replaced, with the new vinyl windows does meet design guideline W2, W3, and W4. The windows on the sides and rear were replaced to increase efficiency and they are consistent in operation to their historic counterparts. Additionally, these windows appear to fit the historic openings.

1. **The applicant shall obtain any necessary building permits.**
2. **All dutch-lap and faux cedar shake siding shall be removed and replaced with 4" traditional lap siding with smooth face.**

3. **There shall be corner boards on all corners and trim around all openings.**
4. **The historic water table board shall be exposed or replaced with in-kind materials of a comparable width and profile.**

5. **The 6 windows on the address facing façade shall be replaced with double-hung wood or clad-wood windows with one-over-one configuration.**
6. **Applicant shall work with staff to determine where intact historic trim exists and to determine the appropriate removal of the aluminum flashing.**

7. **Window openings on the rear, as previously removed, shall be re-framed in a comparable size and scale to convey the historic significance.**
8. **If the design changes, the applicant shall contact staff for review and approval.**
