Subject: Geotechnical Slope Evaluation Report
Proposed Echo Trail Subdivision
2605 Echo Trail, Eastwood Fisherville Road
Louisville, Kentucky 40245
ECS Project No. 61-1893

Subject: Geotechnical Slope Evaluation Report – Addendum 1
Proposed Echo Trail Subdivision
2605 Echo Trail, Eastwood Fisherville Road
Louisville, Kentucky 40245
ECS Project No. 61-1893

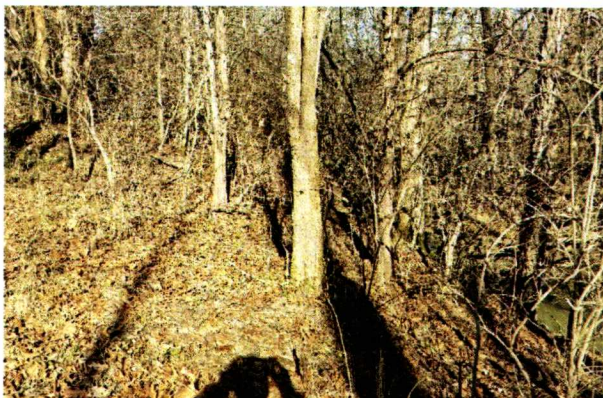
Three areas shown on the Plan as >30% slopes would be disturbed during site development for new road construction (Area 01 and 02) and new home construction (Area 03 / Lot 29). See attached Visual Slope Reconnaissance Plan for approximate locations. A visual reconnaissance of these areas was conducted on December 19, 2018. Photos of the conditions observed at these areas are shown below. Similar conditions were observed in most areas. The slopes primarily were wooded with many small to large trees. Brush, vines, and other low vegetation also was present. No rock outcrops were observed along hillsides with the exception of occasional, small, isolated cobbles and boulders. Flag stones were observed along the bottom and banks of swales and small streams. Some indications of erosion were observed including occasional patches of bare soil and small gullies, primarily along the swales and small streams. No indications of large, wide-scale scale erosion were noted. No visual indications of slope instability were observed. In particular, none of the following were noted: unusual tilting or fallen trees, tension cracks, scarps, displaced soil, or mounds of soil in lower areas.

Steep slope at Area 01

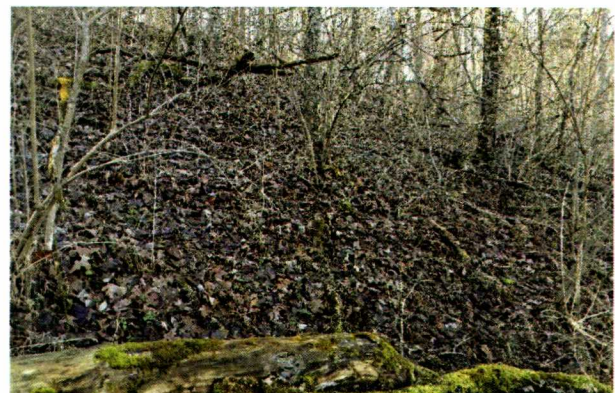
Steep slope at Area 02

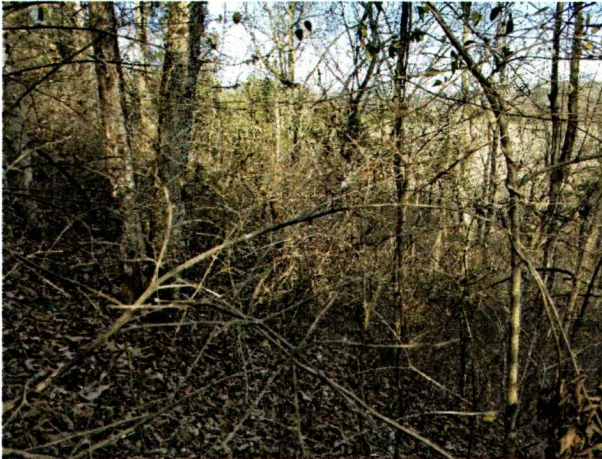
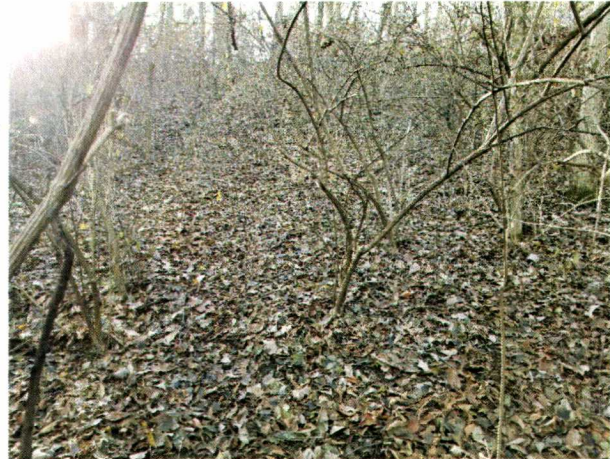
Steep Slope Area 03

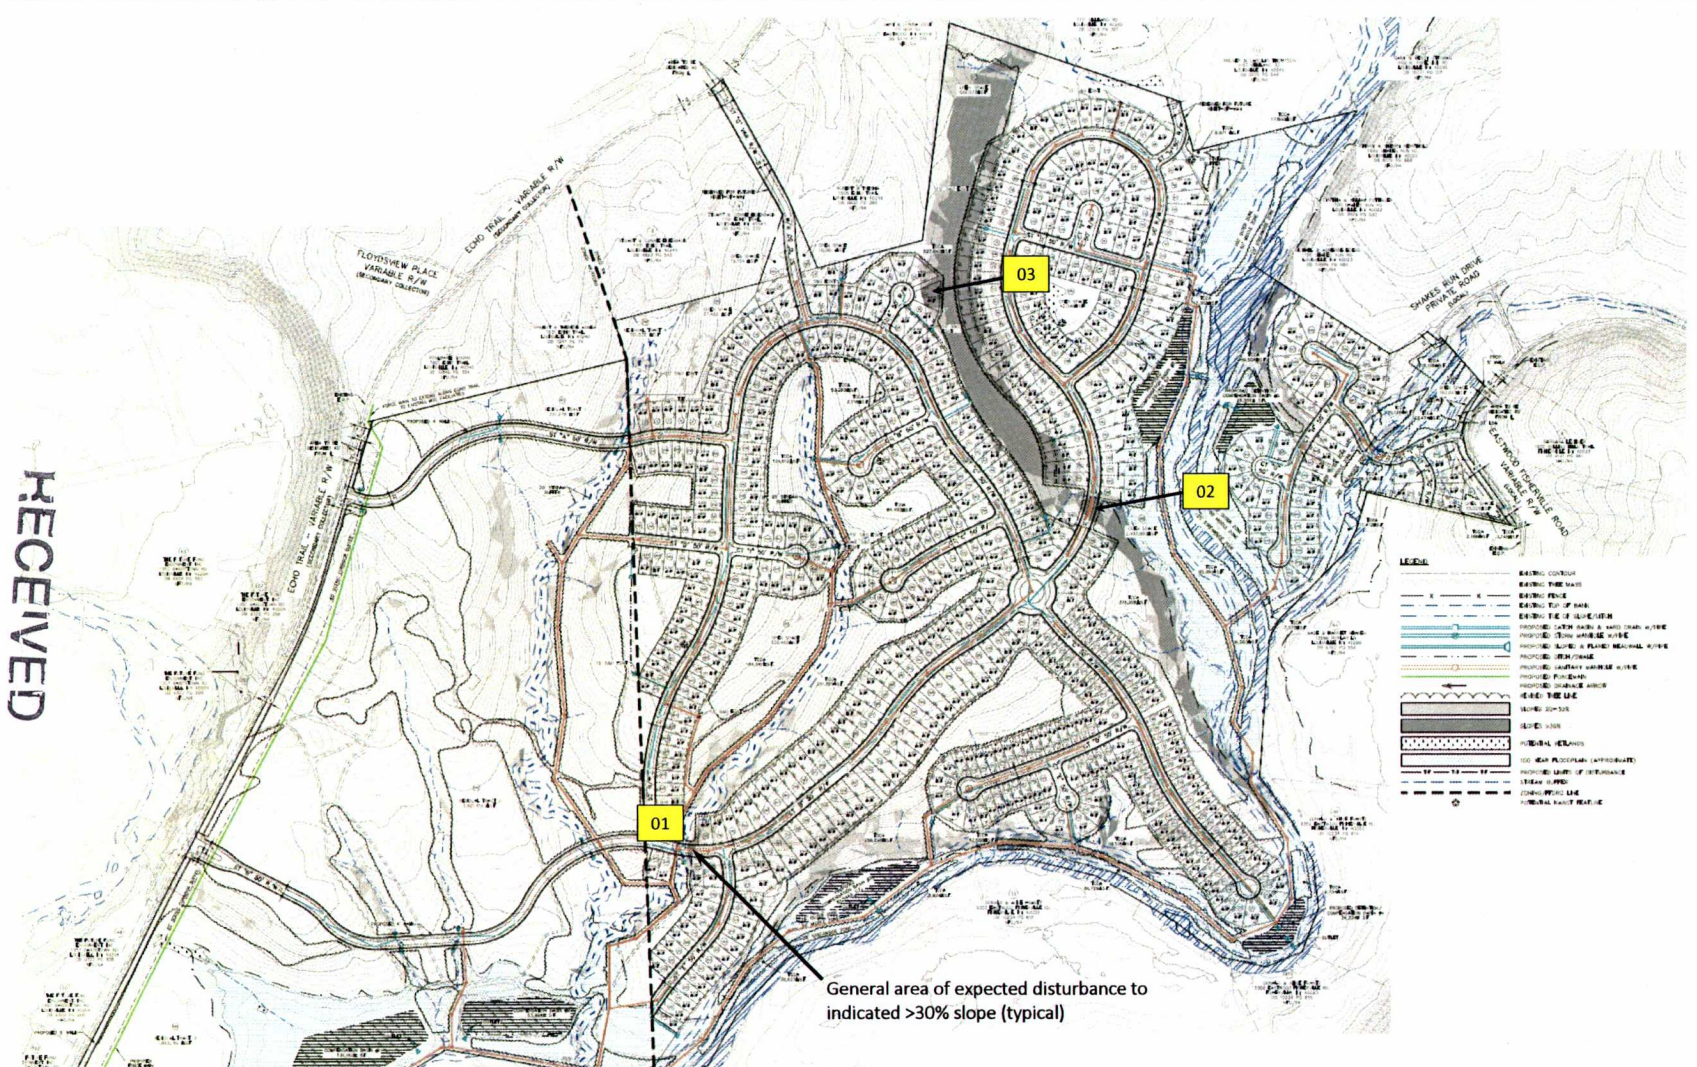
Visual Slope Reconnaissance Plan
 Proposed Echo Trail Subdivision
 2605 Echo Trail
 Louisville, Kentucky 40245
 ECS Project No. 61-1893

General area of expected disturbance to indicated >30% slope (typical)

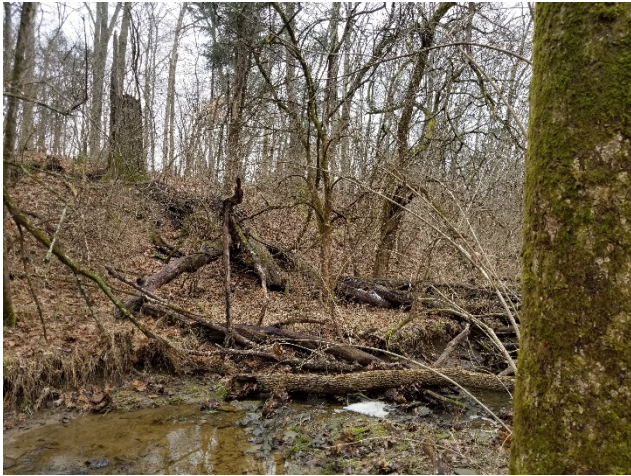
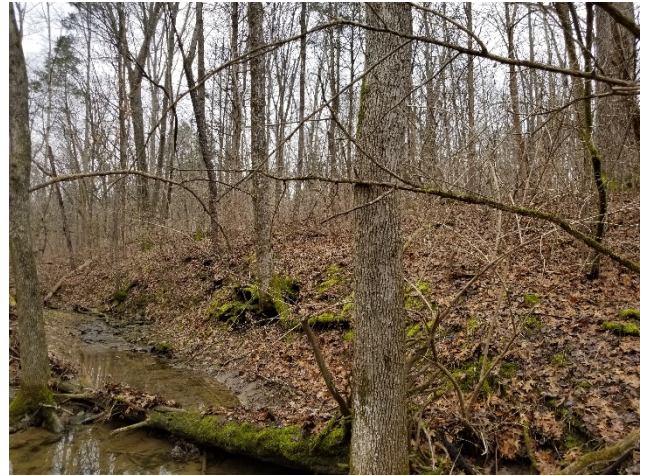
Area 4: Lot 341

The slopes primarily were wooded with many small to large trees. Brush, vines, and other low vegetation also was present. No rock outcrops were observed along hillsides with the exception of occasional, small, isolated cobbles and boulders. Flag stones were observed along the bottom and banks of the small stream. Some indications of erosion were observed including occasional patches of bare soil and small gullies primarily along the small stream. No indications of large, wide-scale erosion were noted. No visual indications of slope instability were observed. In particular, none of the following were noted: unusual tilting or fallen trees, tension cracks, scarps, displaced soil, or mounds of soil in lower areas.

Typical slope at Area 04

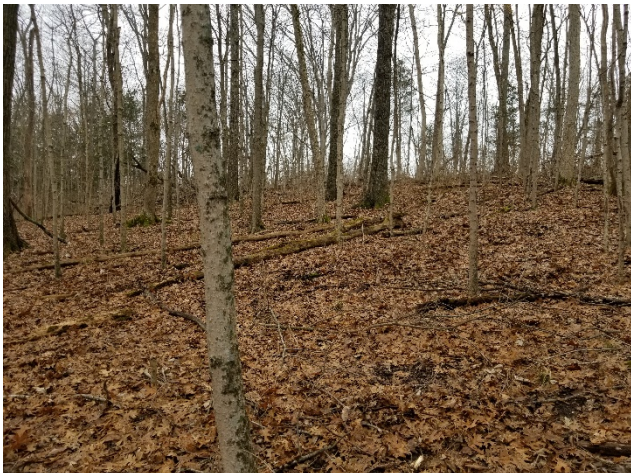
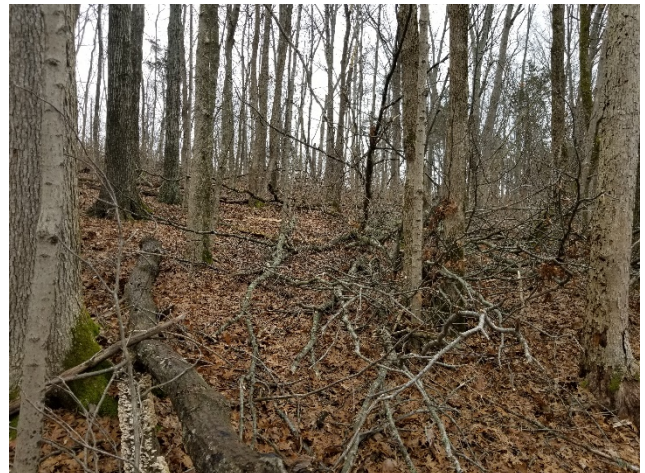
Area 5: Lots 310 – 312

The slopes primarily were wooded with many small to large trees. Brush, vines, and other low vegetation also was present. No rock outcrops were observed along hillsides with the exception of occasional, small, isolated cobbles and boulders. No indications of large, wide-scale scale erosion were noted. No visual indications of slope instability were observed. In particular, none of the following were noted: unusual tilting or fallen trees, tension cracks, scarps, displaced soil, or mounds of soil in lower areas.

Typical slope at Area 05

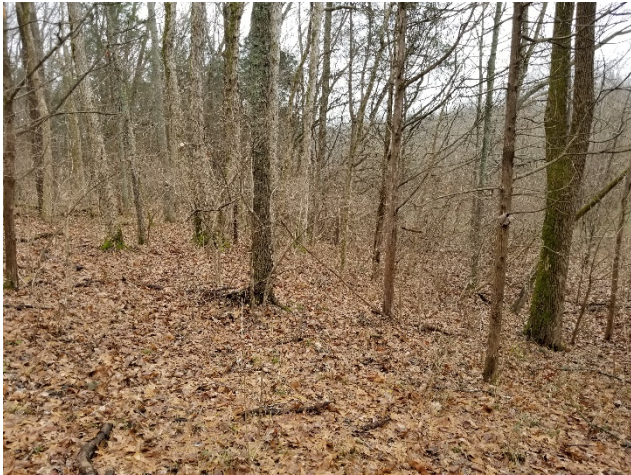
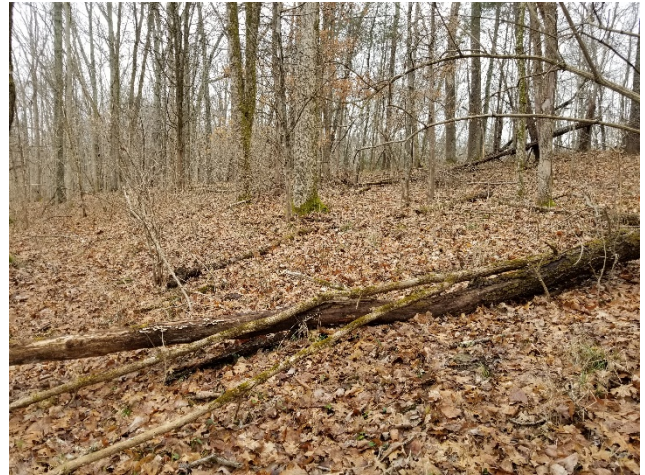
Area 6: Lots 221 – 223

The slopes primarily were wooded with many small to large trees. Brush, vines, and other low vegetation also was present. No rock outcrops were observed along hillsides with the exception of occasional, small, isolated cobbles and boulders. No indications of large, wide-scale scale erosion were noted. No visual indications of slope instability were observed. In particular, none of the following were noted: unusual tilting or fallen trees, tension cracks, scarps, displaced soil, or mounds of soil in lower areas.

Typical slope at Area 06

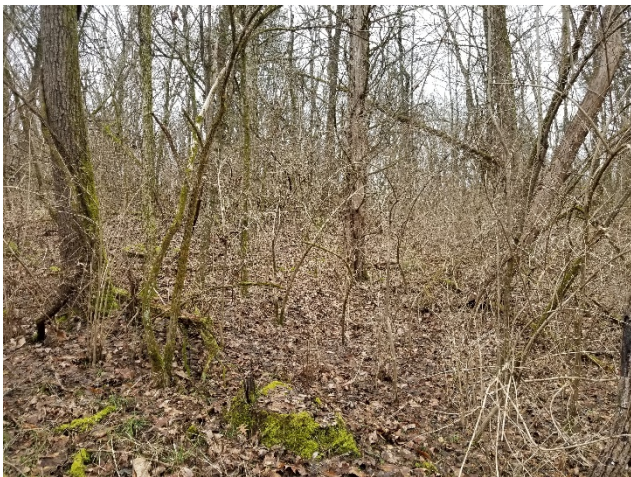
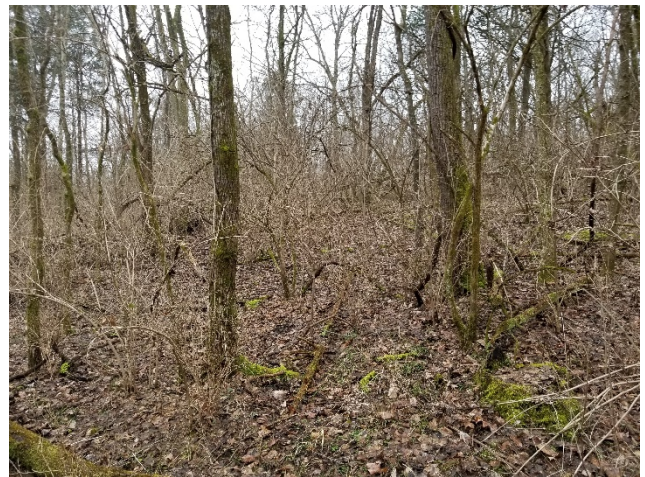
Typical slope at Area 07

The slopes primarily were wooded with many small to large trees. Dense brush, vines, and other low vegetation also was present. No rock outcrops were observed along hillsides with the exception of occasional, small, isolated cobbles and boulders. No indications of large, wide-scale scale erosion were noted. No visual indications of slope instability were observed. In particular, none of the following were noted: unusual tilting or fallen trees, tension cracks, scarps, displaced soil, or mounds of soil in lower areas.

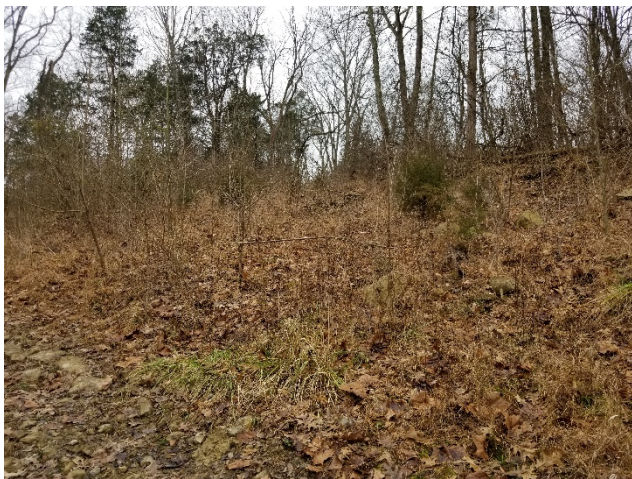
The slopes primarily were wooded with many small to large trees. Brush, vines, and other low vegetation also was present. No rock outcrops were observed along hillsides with the exception of occasional, small, isolated cobbles and boulders. Weathered rock appeared to be exposed along the access road located within the eastern half of Lot 54. Significant erosion was observed along the access road including erosion rills and gullies and several areas of exposed soil and weathered rock. No visual indications of slope instability were observed. In particular, none of the following were noted: unusual tilting or fallen trees, tension cracks, scarps, displaced soil, or mounds of soil in lower areas.

Typical slope at Area 08

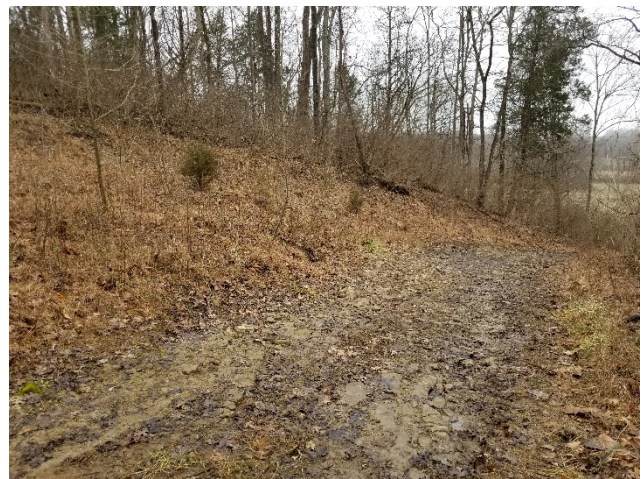
Access road and erosion at Lot 54

The erosion observed on the eastern half of Lot 54 appeared to be the result of the use of the area as an access road for farming operations and was likely the result of large equipment disturbing the surface and the lack of ground cover in the area. Restoration in the area of the access road can be achieved by: removing equipment traffic from the area, re-grading the area to remove deep erosion rills, and establishing a vegetative cover for erosion protection.

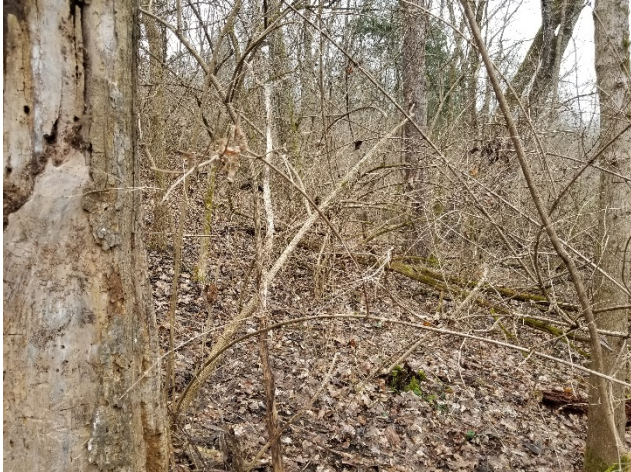
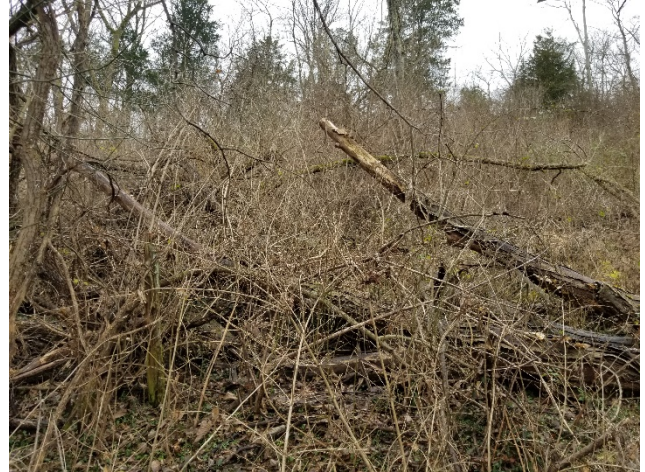
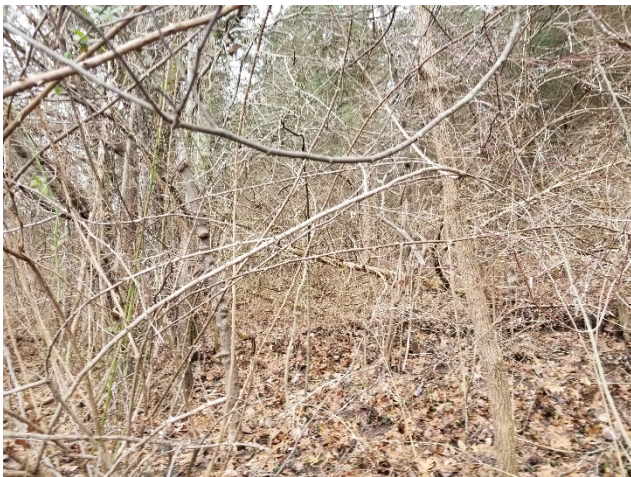
The slopes primarily were wooded with many small to large trees. Very dense brush, vines, and other low vegetation also was present across most of the area with only isolated areas where most of the ground surface was visible. No rock outcrops were observed along hillsides with the exception of occasional, small, isolated cobbles and boulders. Some indications of erosion were observed including occasional patches of bare soil and small gullies along the hillsides. No indications of large, wide-scale scale erosion were noted. No visual indications of slope instability (unusual tilting or fallen trees, tension cracks, scarps, displaced soil, or mounds of soil in lower areas) were observed over the majority of Area 9. However, a mound of soil was observed in the mid-slope area in Lot 68. In addition, a bent tree was observed in the area of the soil mound. Each are indicators of past slope instability. The soil mound was observed to be approximately 35 to 40 feet in length and less than 2 feet in height, traversing the lot primarily in the north-south direction.

Typical slope at Area 09 (south)

Typical slope at Area 09 (central)

Typical slope at Area 09 (north)

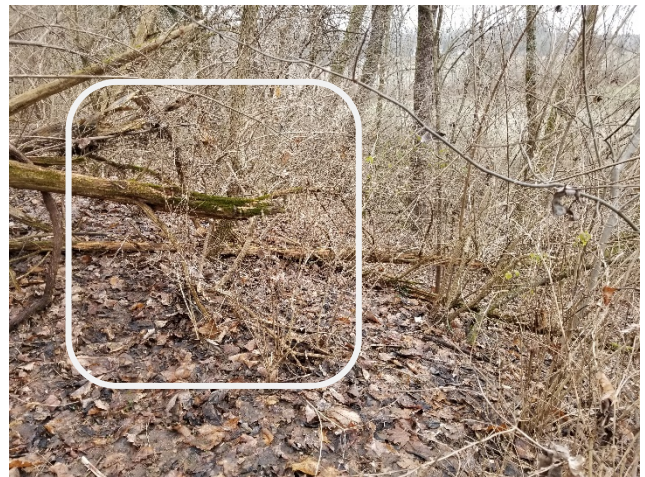
Bent tree and soil mound along the slope at Lot 68

The observed indications of past slope instability on the western portion of Lot 68 appeared to be the result of slope movement that occurred several years prior to this site visit based the tilt and bow of a tree in the area of the mounded soil, the lack of any obvious tension cracks or scarps along the slope surface, and the presence of dense brush and other vegetation on the surface. The presence of very dense vegetation across most of Area 9 prevented a through observation

of the slopes. While additional evidence of slope instability was not observed, it is possible that the dense ground cover obscured the presence of slope instability. Once areas where site disturbance for grading and/or utility installation have been cleared of dense vegetation, ECS should be retained to further evaluate those slopes. Significant disturbance of the steeper slopes along the western portions of Lots 68 – 82 should be avoided if possible. If large excavations or significant re-grading in those areas are to occur, ECS should be contacted for guidance.
