# KARST RECONNAISSANCE SURVEY

HURSTBOURNE APARTMENTS DEVELOPMENT  
LOUISVILLE, KENTUCKY

SME Project No. 088601.00  
March 7, 2022

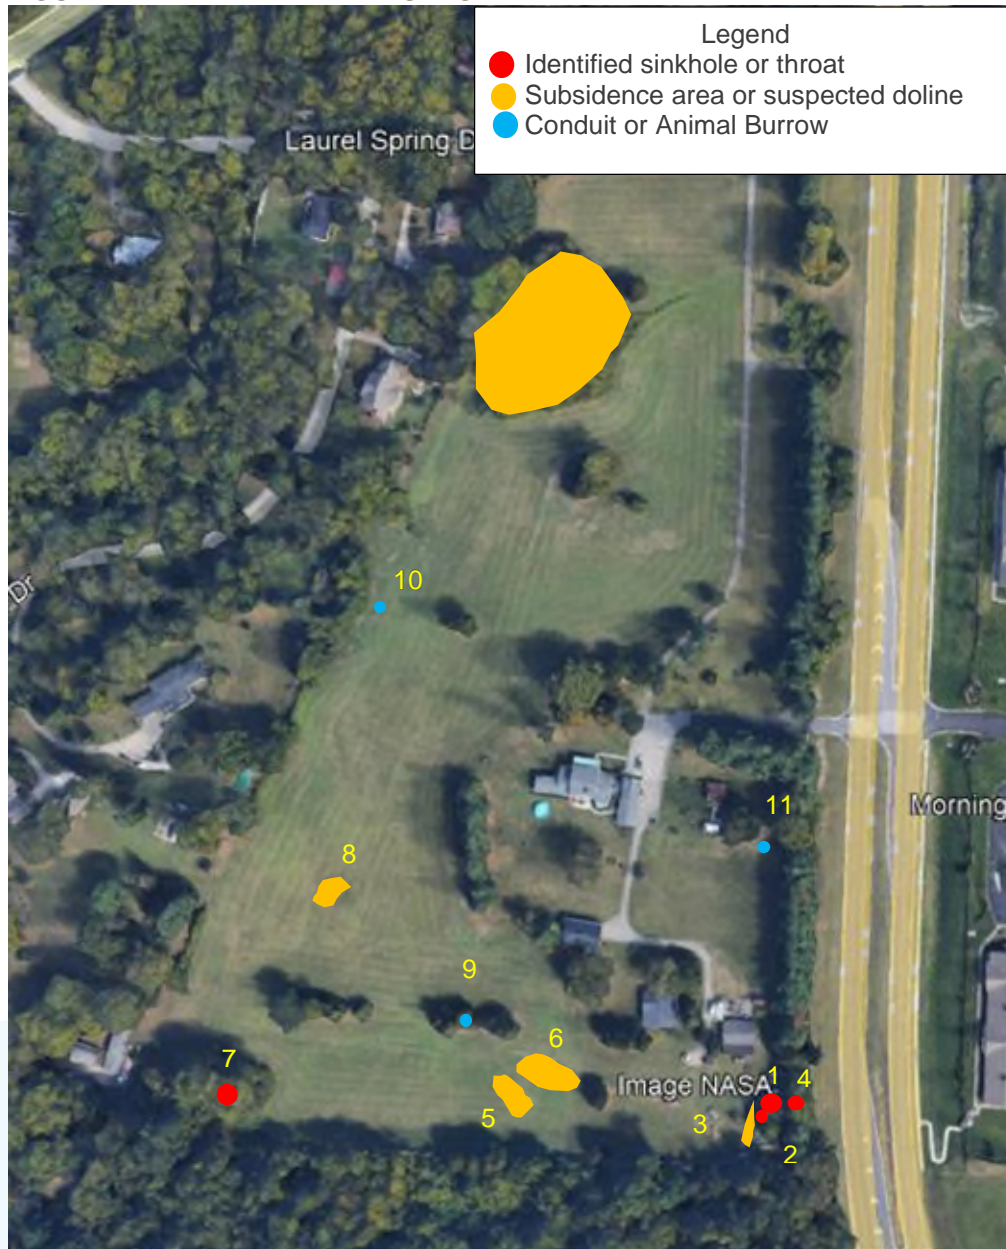
**FIGURE 11 – IDENTIFIED FEATURES**

Two of the sinkhole features, which were located within a small grove/tree cluster south of the garage and near the southeast site corner, appeared to be interconnected (and located directly adjacent to an elongated area of subsidence). An additional sinkhole feature was observed directly east of the referenced feature and adjacent to the eastern fence line. The fourth feature (Feature 7 in the table above) was located in the extreme southwest corner of the site within a tree grove. Multiple throats were observed within this feature in addition various debris. The presence of debris made it impractical to ascertain the feature dimensions, particularly the depth.

An elongated drainage feature extended southwest from the feature and off the project site. Three locally depressed areas (referenced in the previous section) where the vegetative surface cover differed from the adjacent area were observed along the southern portion of the site. These depressed areas may represent early “doline” activity. Doline is a term used to describe sinkholes that form slowly by subsidence of the ground surface. This downward movement can take years to occur before the surficial sinkhole is obvious.

A possible swallow hole or animal burrow was observed within a tree grove in the southern portion of the site. An additional depressed area (possible doline) was observed north of this feature and west of the barn near the western site boundary. An isolated hole was observed along the west-central portion of the site. A depressed area was observed adjacent to the east side of the original entrance drive. The depressed area was filled with leaves, which made the discerning approximate dimensions difficult. However, it is assumed this depressed area is an inlet for a culvert discharging on the west side of the driveway.

The pond (or perennial stream as identified on LOGIC) was mostly dry at the time of our evaluation, although the ground surface appeared to be soft. This area most likely a wetlands or ephemeral pond, which periodically holds water for some time during or following precipitation events. The pond area is relatively shallow, which suggest the area may have been infilled either by natural causes (e.g., erosion or siltation) or man-placed fill. Ponds typically form in low points in karst areas via plugging of the near-surface voids or fracture zones via siltation. However, impounding of water can over time initiate sinkhole activity, which may also explain the lack water within the pond (and in photographs from recent years).

At least four sinkholes (or open throats/conduits connected to a sinkhole feature) were identified on the project site. These sinkhole features, while relatively small and shallow, are obvious evidence of karst development at the site. The sinkhole feature identified in southwest corner of the site within a grove is depicted on the proposed site development plan (Feature 7, identified as a closed contour) within the footprint of a proposed 36-unit housing structure. Similarly, it appears two sinkhole and/or conduits (Features 1 and 2) are located within the footprint of a proposed 24-unit housing structure near the southeast corner of the site. Preliminarily, we estimate that sinkhole Feature 4 is outside the proposed footprint of the referenced 24-unit structure but near the east side of the building. Therefore, it will also impact development of this structure.

The sinkhole identified on the geologic map adjacent to the southern property boundary was not observed in the field. However, review of the site survey/development plan indicates a closed depression in this area, which corroborates the geologic map. It is unclear whether the pond has experienced karstification or is at significant risk of a drop out occurring. We recommend avoiding development of structures in the immediate area of the pond. Additionally, subsidence observed at the exiting garage area (as observed by uneven ground contact of the garage bay doors with the ground) suggest karst related subsidence may have occurred in this area.

Do not construct over active or possible sinkholes without further exploration, analysis and remediation (if feasible and where sinkhole features are identified). Where possible, adjust or modify the site plan by shifting proposed structure locations away from identified sinkhole features is preferable. However, this is not always possible without significantly impacting the project. Sinkhole features identified within structural areas (i.e., building or pavements) will require remediation during construction or utilization of alternative foundation systems as directed by the Geotechnical Engineer of Record, assuming the proposed structure locations cannot be shifted. We recommend identified and suspected sinkhole features be evaluated prior to construction (ideally during the planning stage) to determine impacts on the proposed development. Characterization of identified anomalies can be performed by performance of additional test borings (beyond quantity per geotechnical evaluation scope), excavation, and/or geophysical surveys.

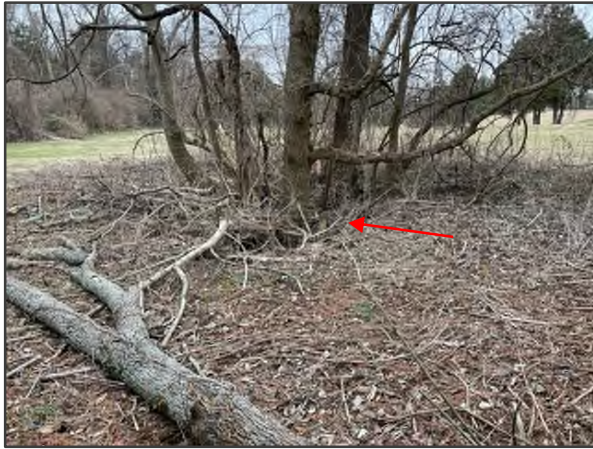
PHOTO NO. 1: Sinkhole in grove south of garage (Features 1 &2)

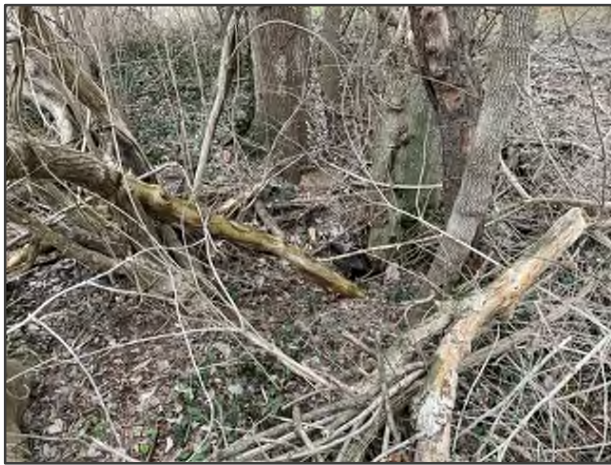
PHOTO NO. 2: Sinkhole (Feature 1)

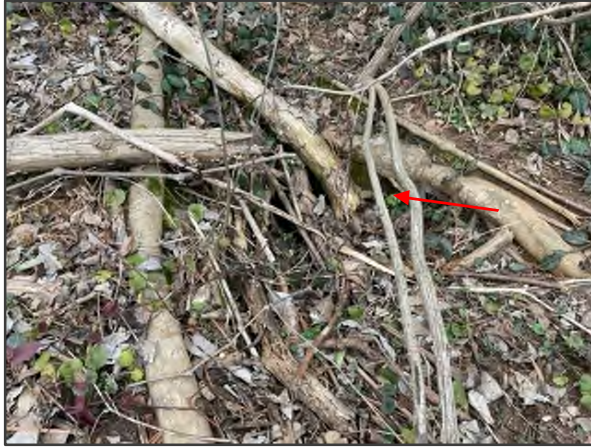
PHOTO NO. 3: Surficial swallow hole/ conduit (Feature 2)

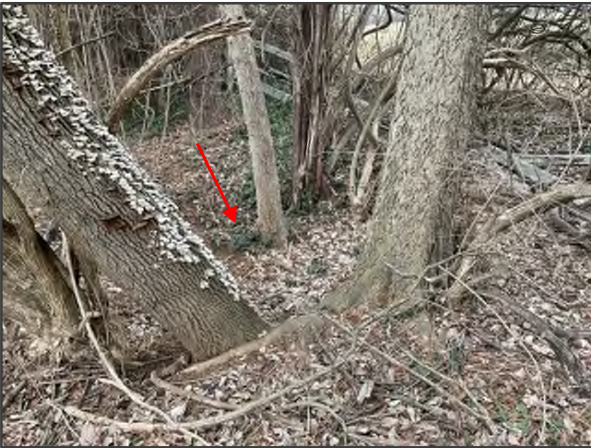
PHOTO NO. 4: Shallow sinkhole with throat (Feature 4)

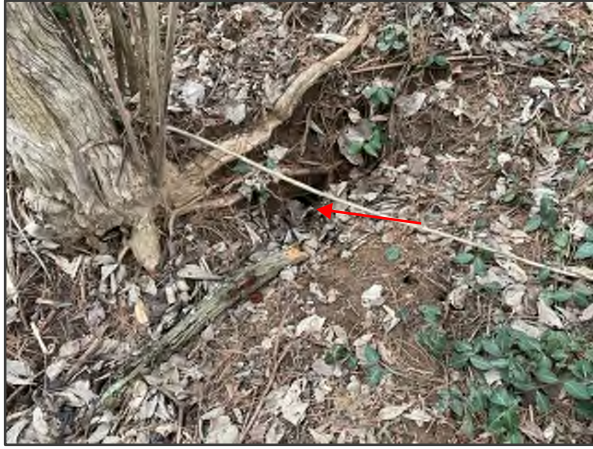
PHOTO NO. 5: Sinkhole conduit/throat (Feature 4)

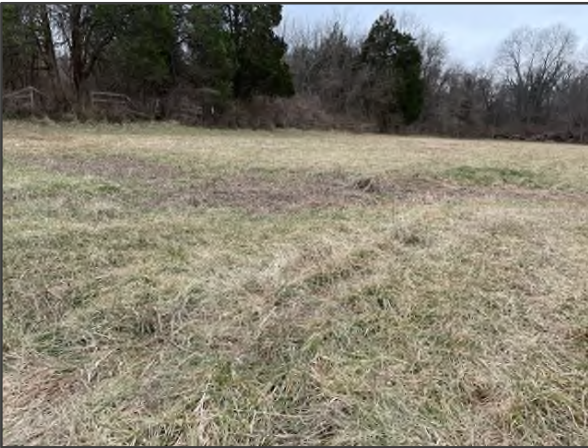
PHOTO NO. 6: Ground subsidence (Features 5 and 6)

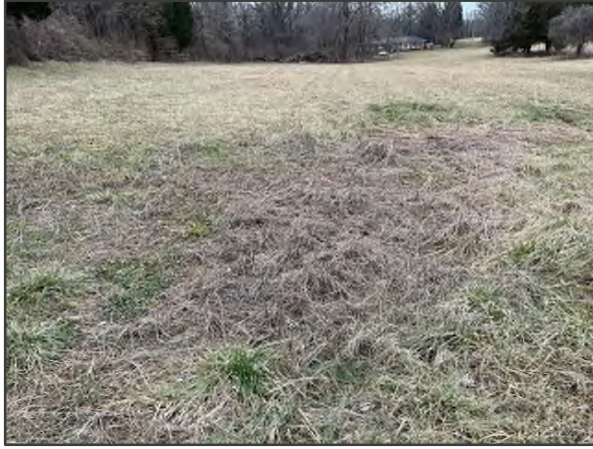
PHOTO NO. 7: Ground subsidence/differing vegetation (Feature 5)

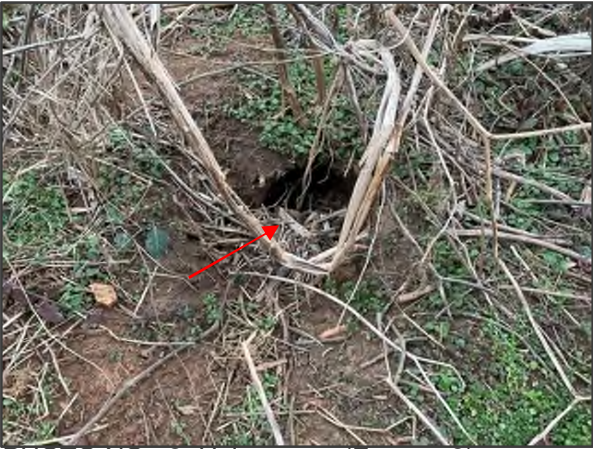
PHOTO NO. 8: Hole at tree (Feature 9)

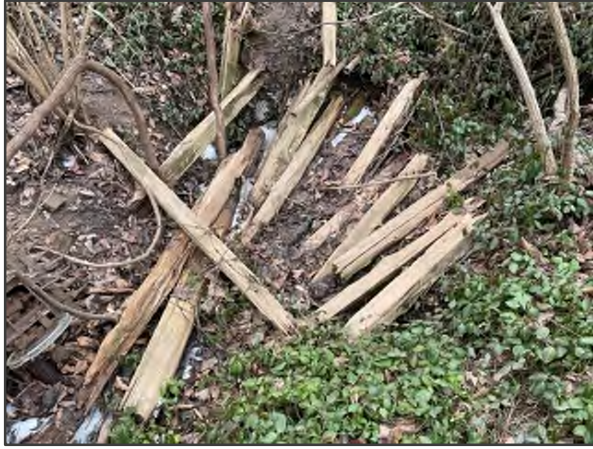
PHOTO NO. 9: Sinkhole at southwest corner (Feature 7)

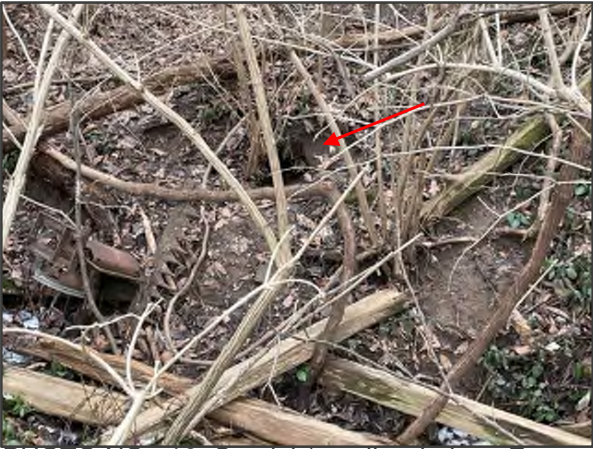
PHOTO NO. 10: Conduit/ swallow hole at Feature 7

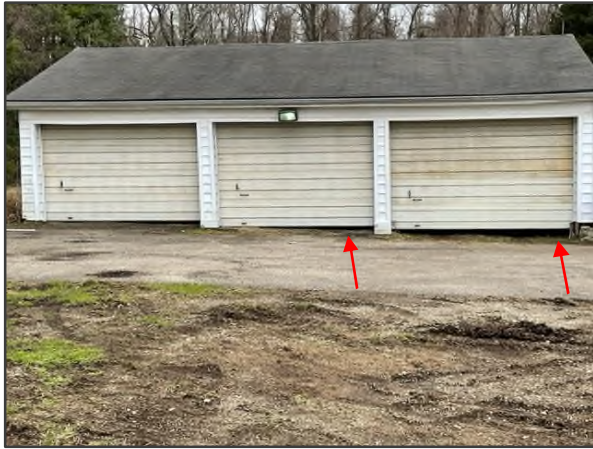
PHOTO NO. 11: Ground subsidence at garage

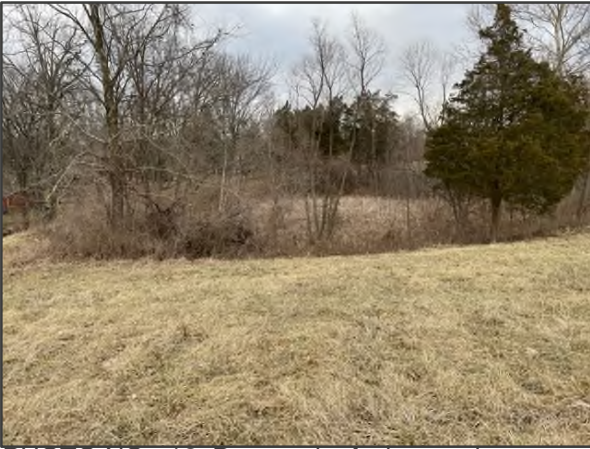
PHOTO NO. 12: Dry pond – facing north

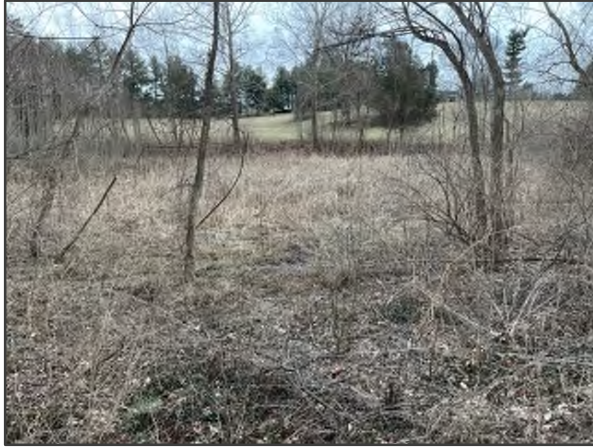
PHOTO NO. 13: Dry pond – facing southeast

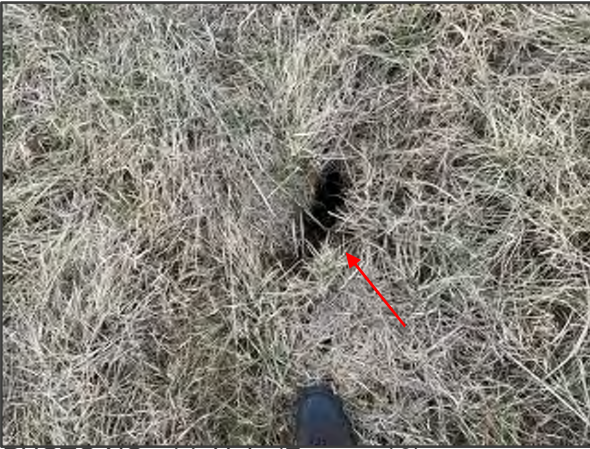
PHOTO NO. 14: Hole (Feature 10)
