# 2130 New Main Street Urban Greenspace

2130 New Main Street

Clifton, Louisville KY

Seeking permission to demolish shotgun & salvage material due to excessive cost of rehab

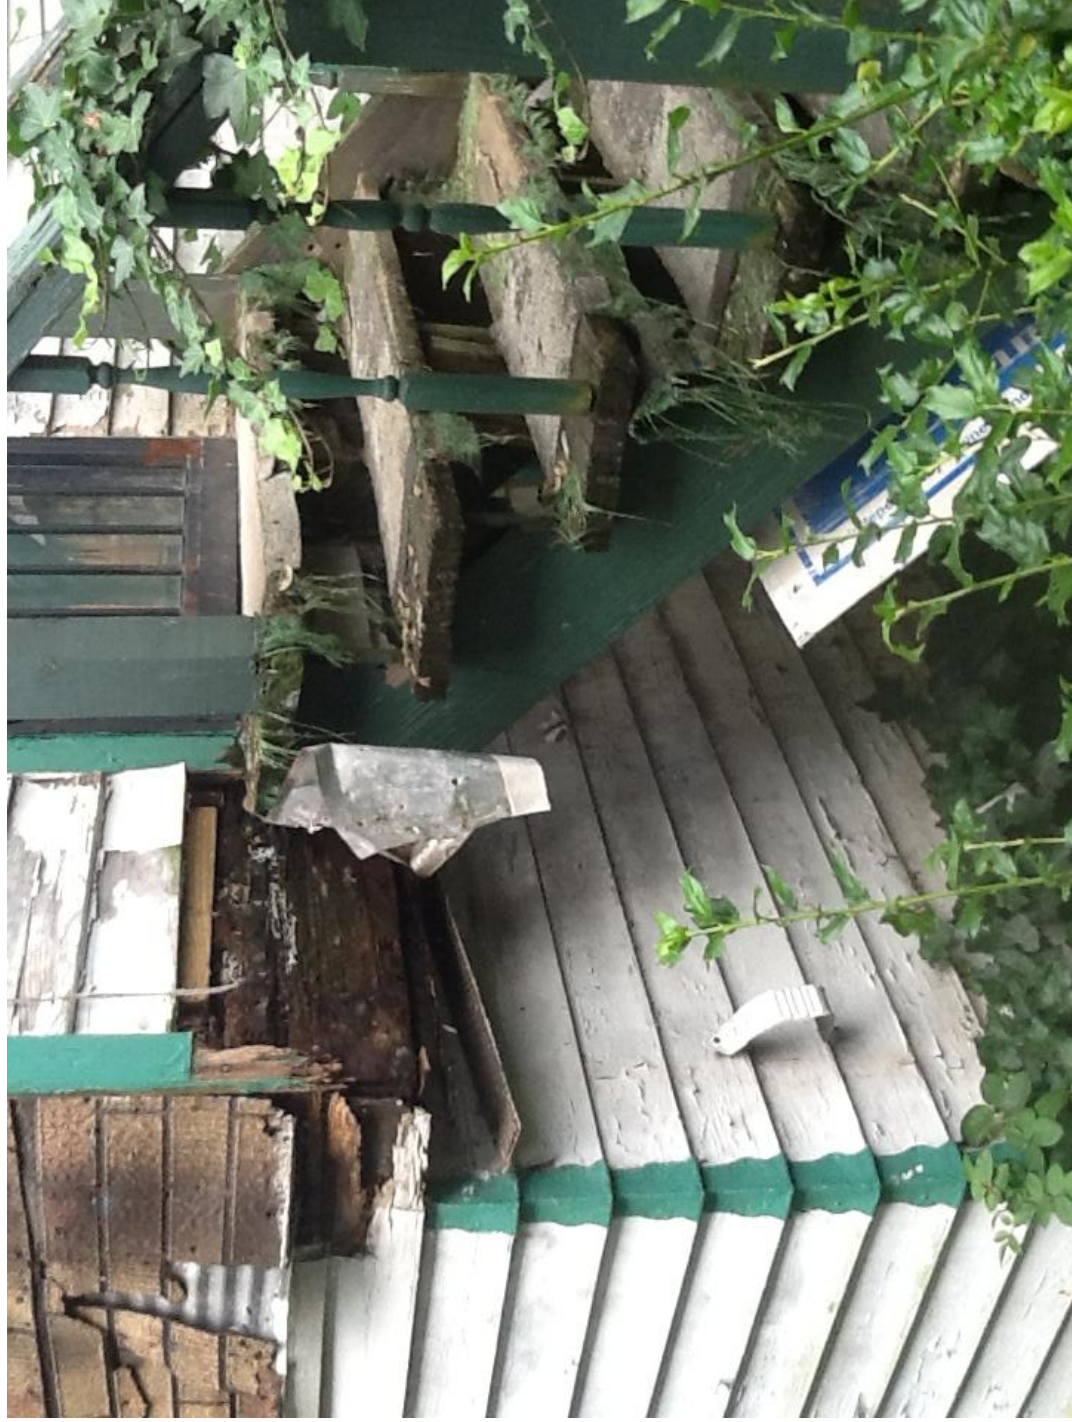
The SW  
(back)  
corner,  
after  
removing  
some  
aluminum  
siding.

Rot and  
mold.

This SW  
corner was  
the newest  
and driest  
corner of the  
structure.

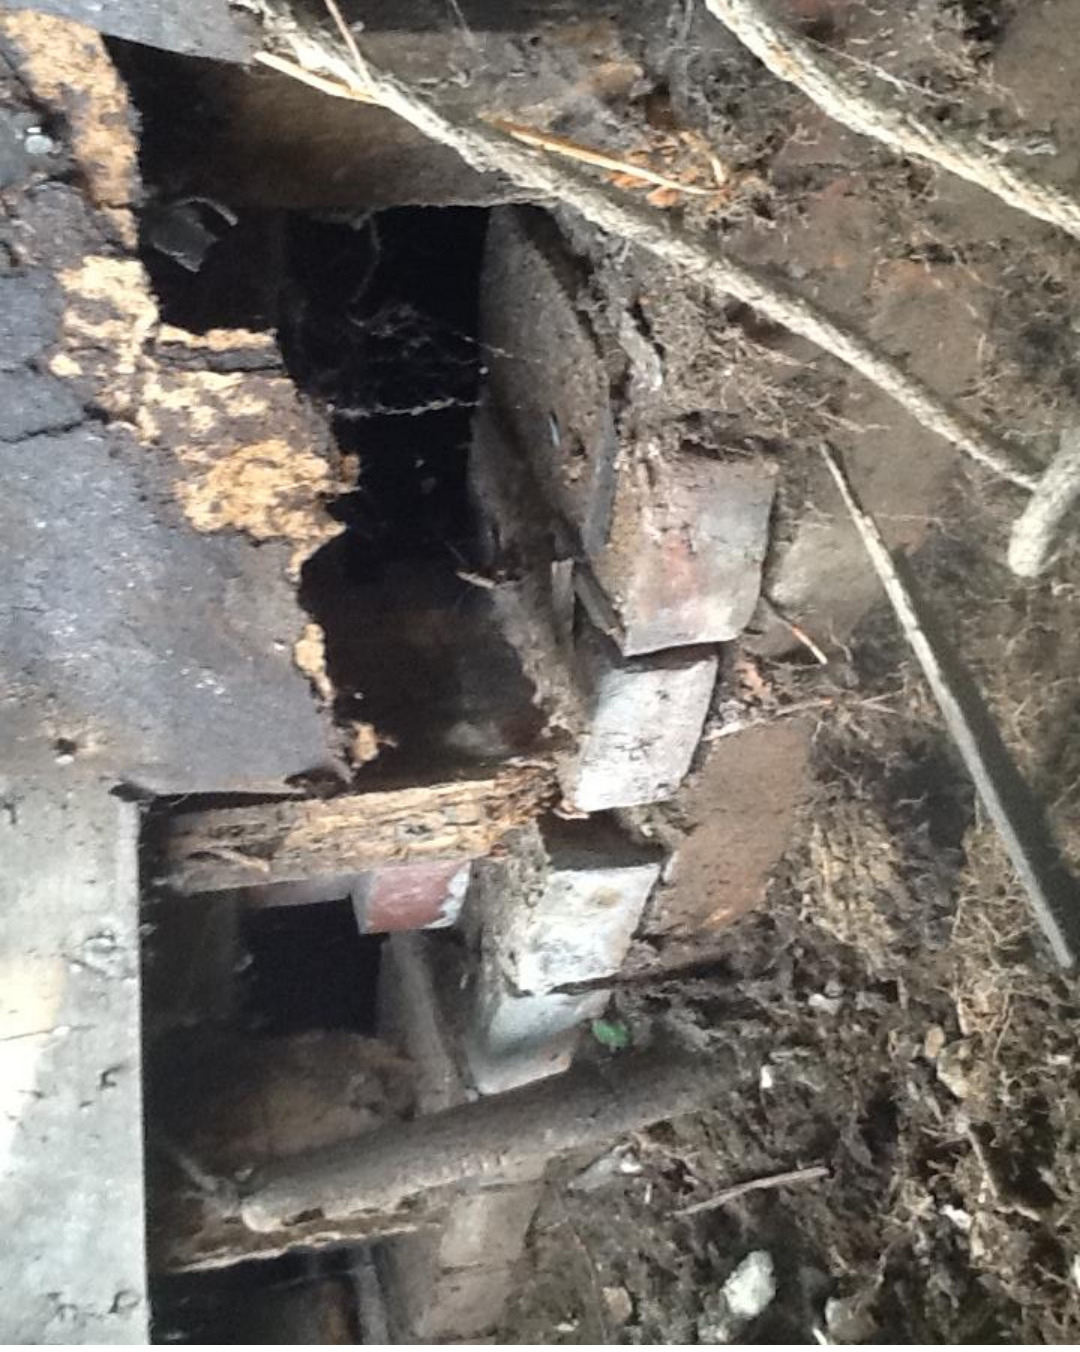
Note the  
lack of  
mortar  
between  
bricks.

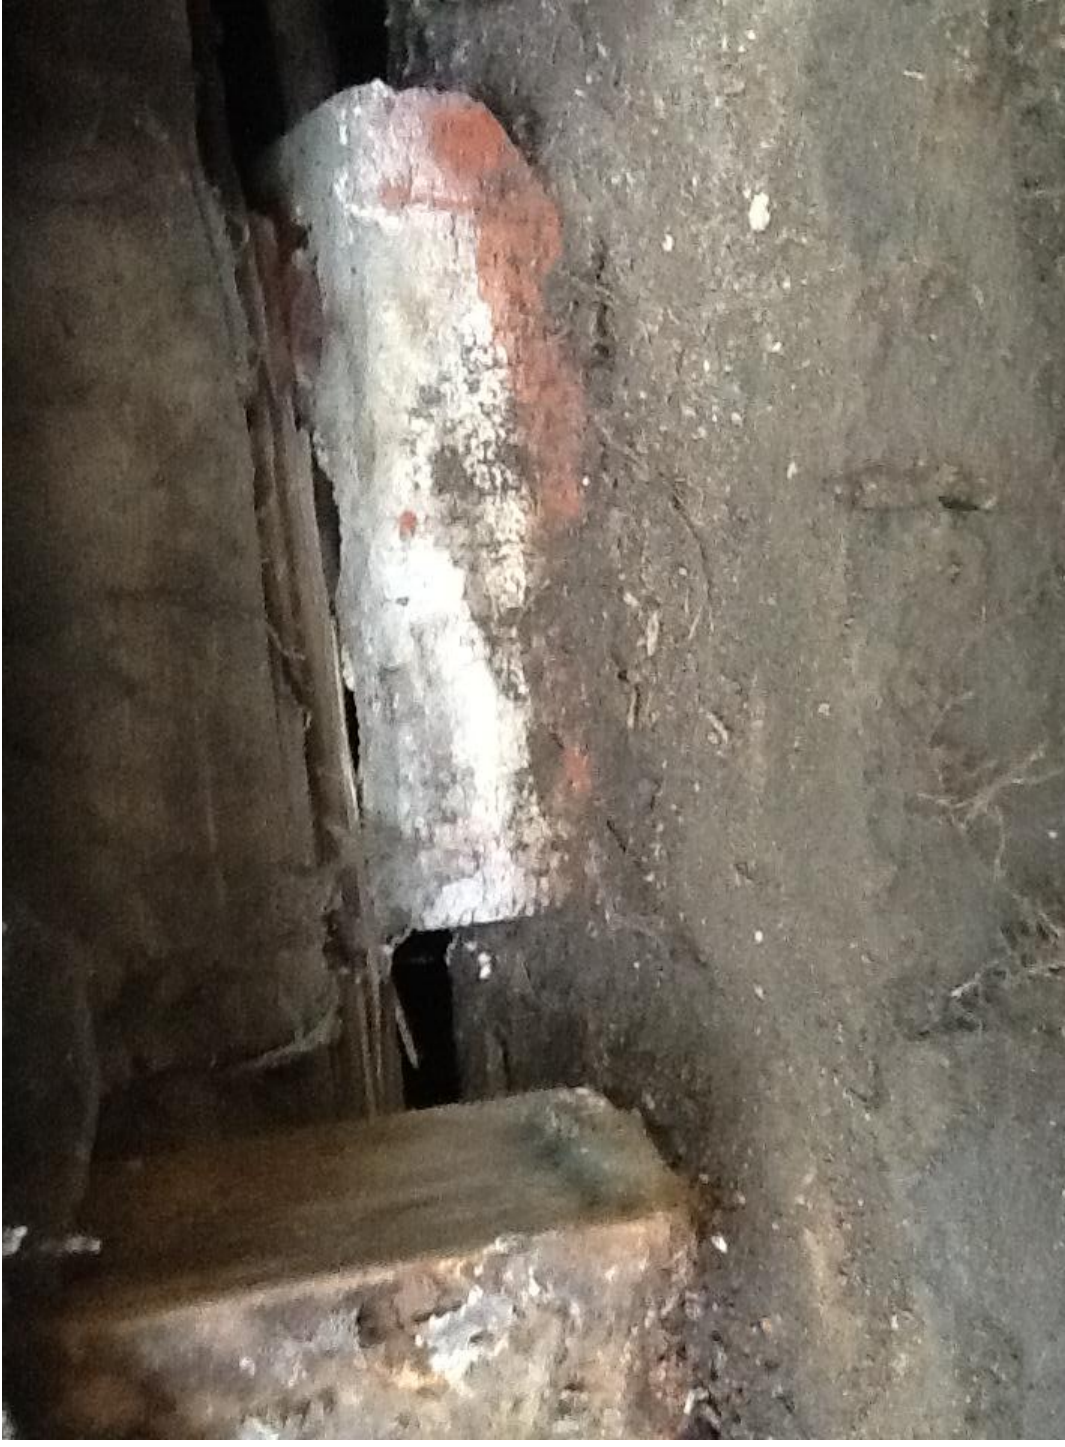
Even the floor joists are rotted away, left suspended above the well intentioned brick.

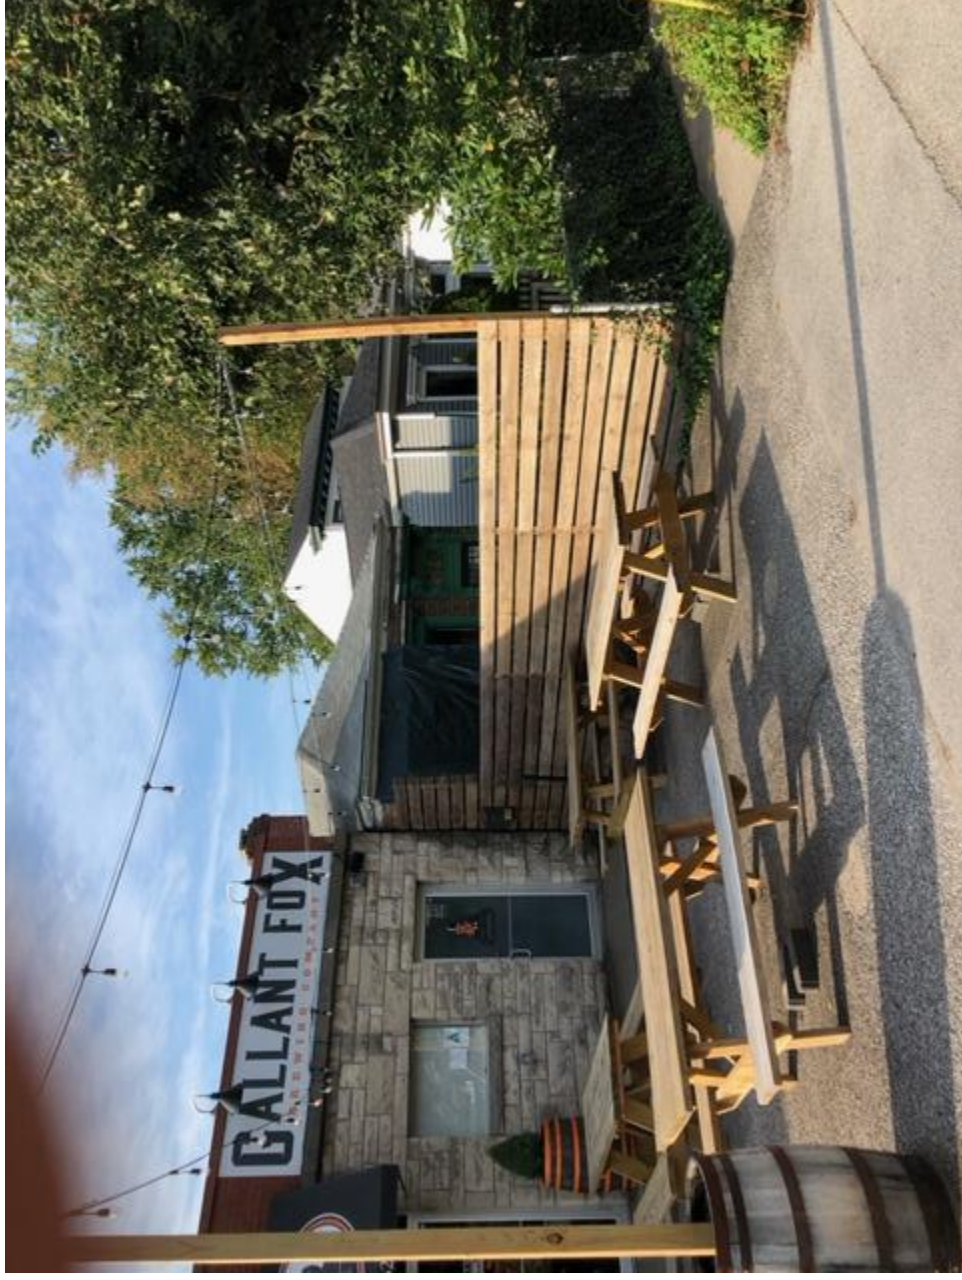
The USPO was built @1950. The distance between the two structures is about two inches. For years the slope of the shotgun's roof directed rainwater between the two structures.

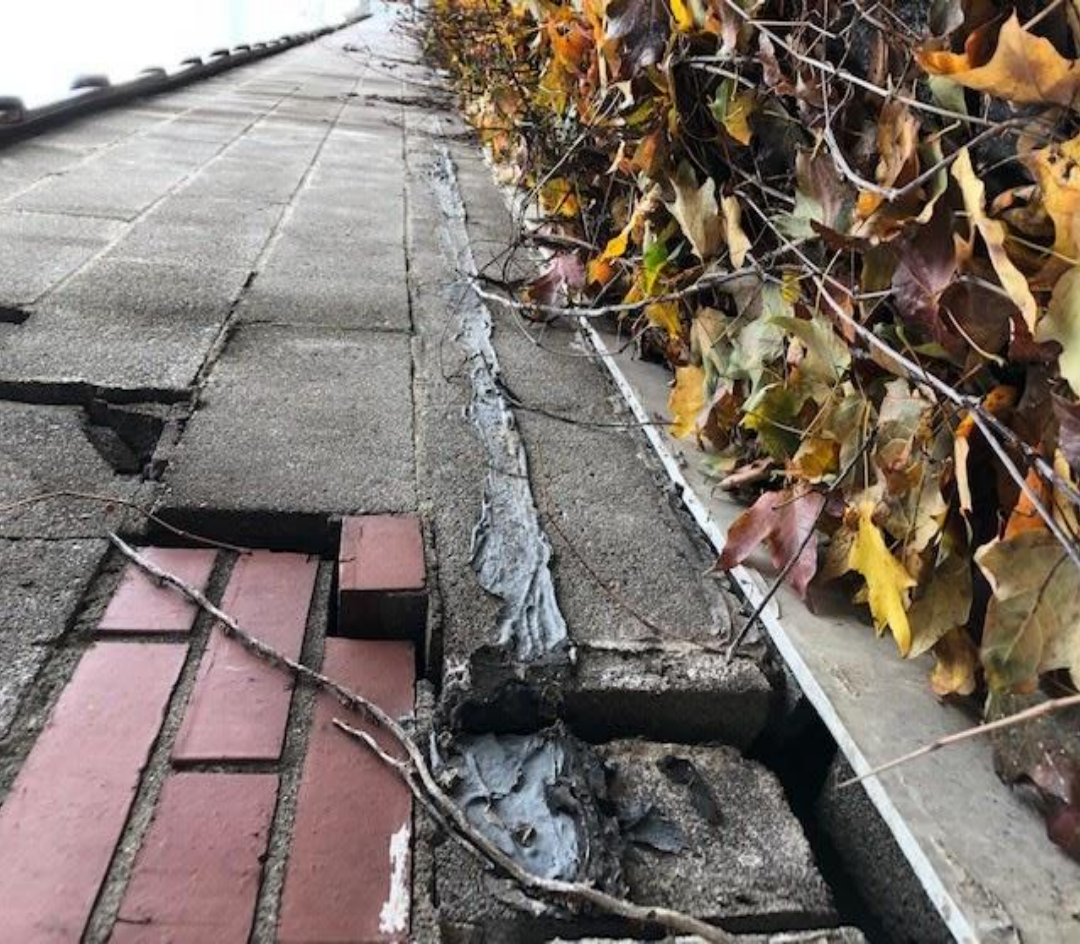
This close up shows a horizontal line of roofing tar running parallel with the roof line of the shotgun. That line suggests some structural feature - perhaps an earlier effort to protect from water damage. A failed effort.

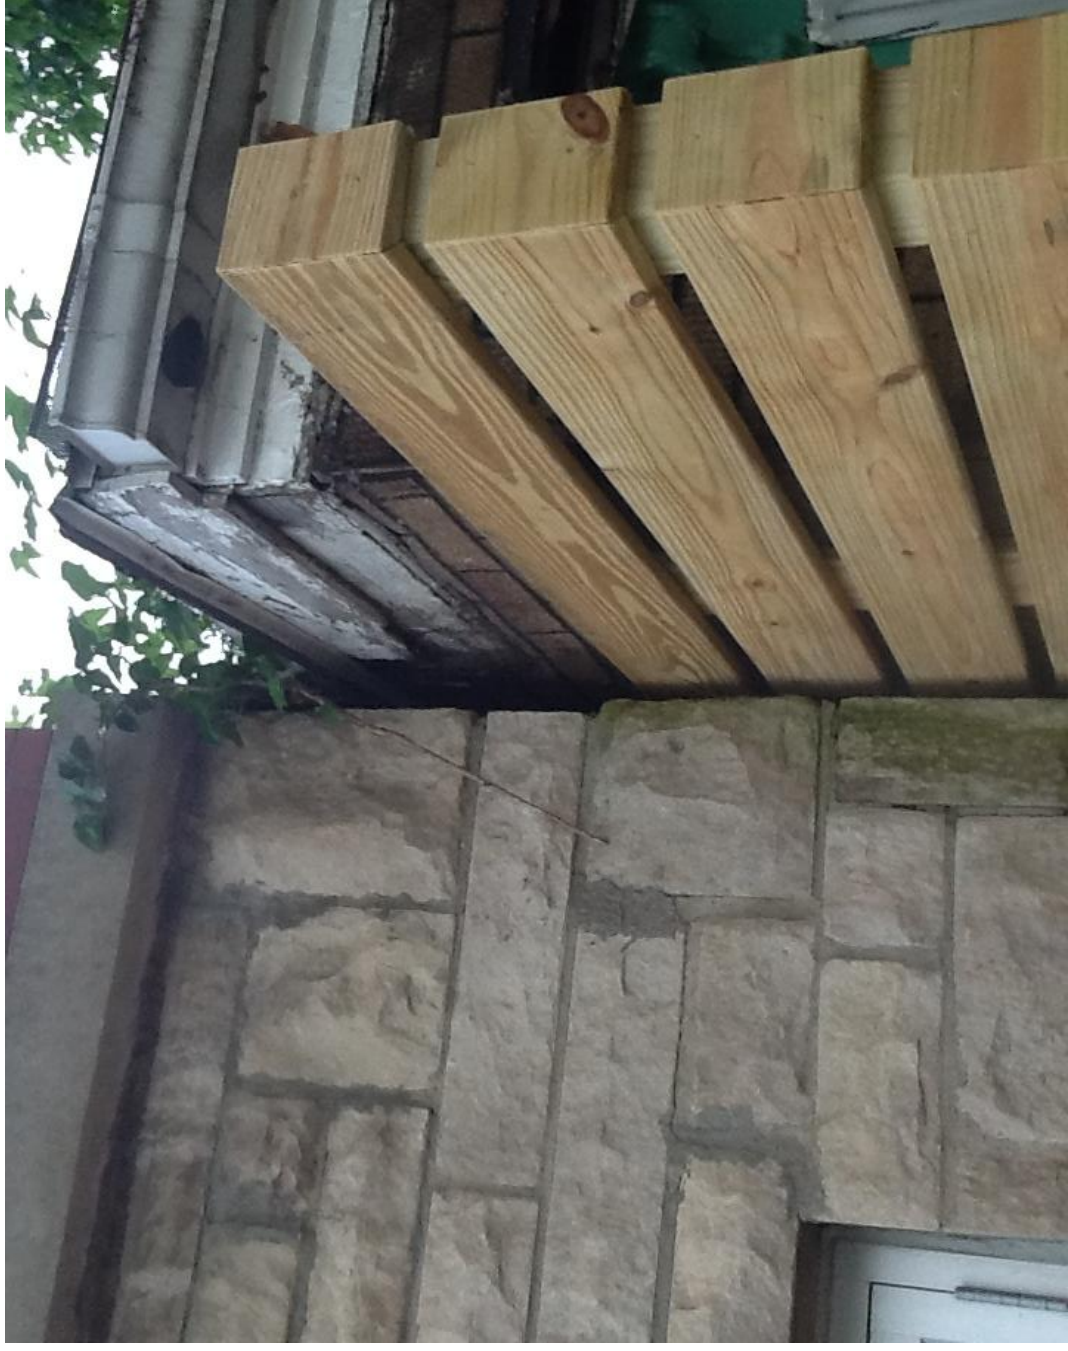
Note the  
green growth  
and damage  
to the  
limestone in  
the next  
couple of  
slides.

Replacing the missing mortar of the brick and the stone can be done only on the accessible north wall. The west wall is inaccessible..

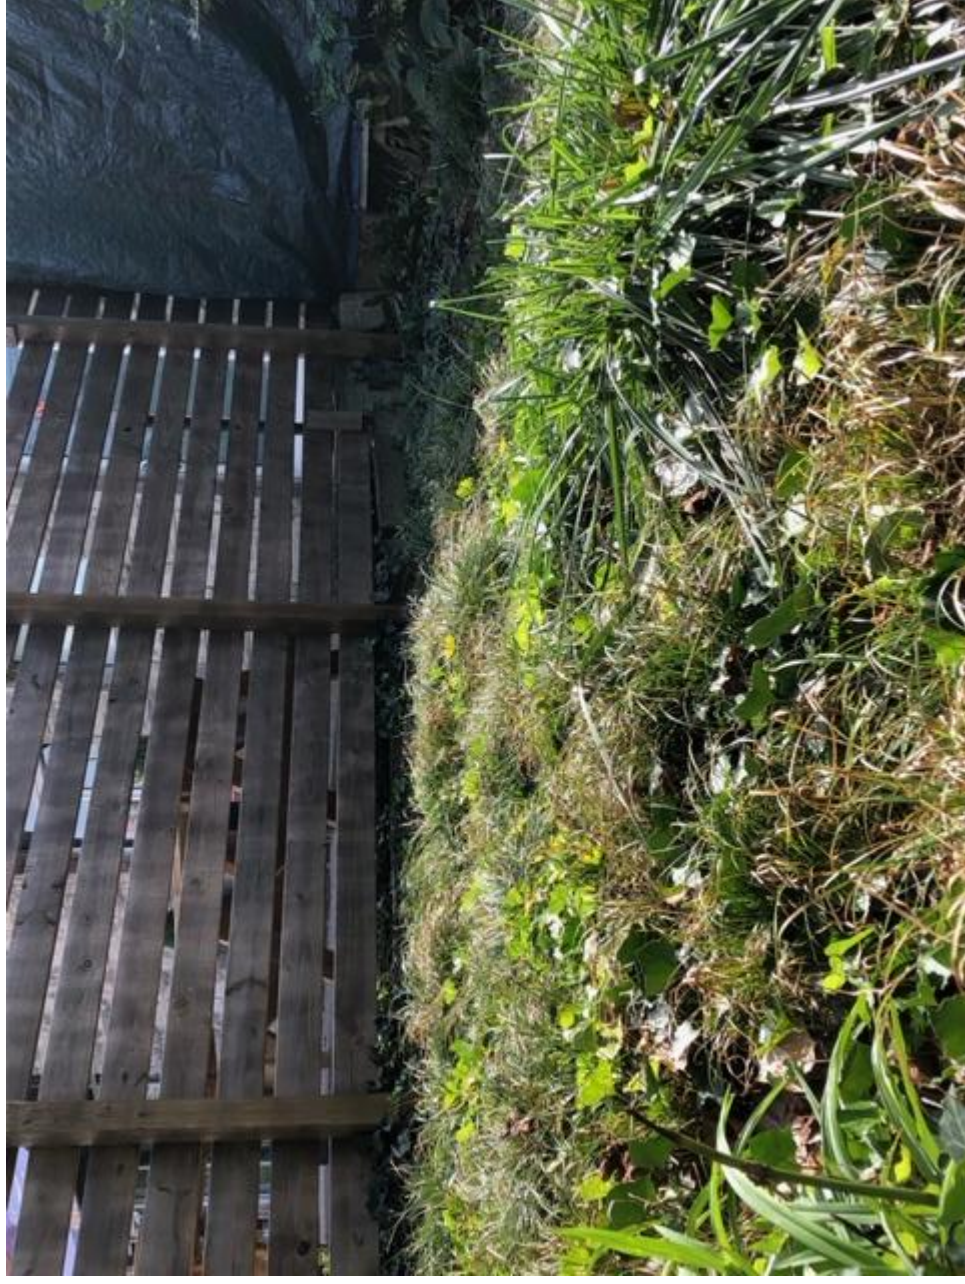
The bottom of the USPO door is the shiny horizontal line seen between the fence slats. Note how much lower the yard is.

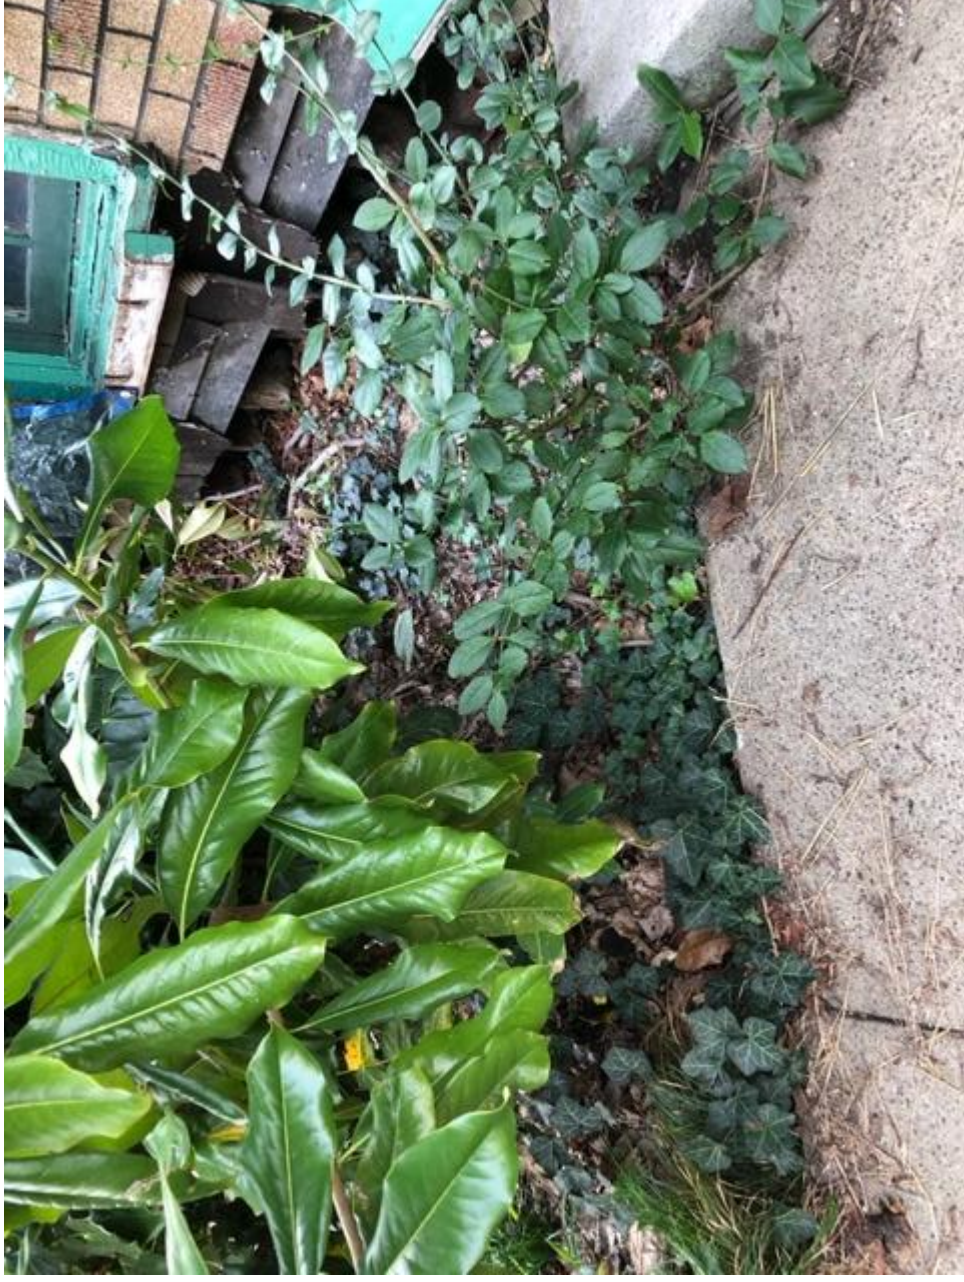
The front yard has begun to sink lower than the walk leading to the front door. Along with the rain and melted snow, the soil is infiltrating the basement.
