RE: Hogan's Fountain Teepee Pavilion, Cherokee Park

## Memo

**Re.** Cherokee Park Hogan's Fountain Pavilion

**Subject:** Cherokee Park, Hogan's Fountain Teepee Pavilion Reassessment

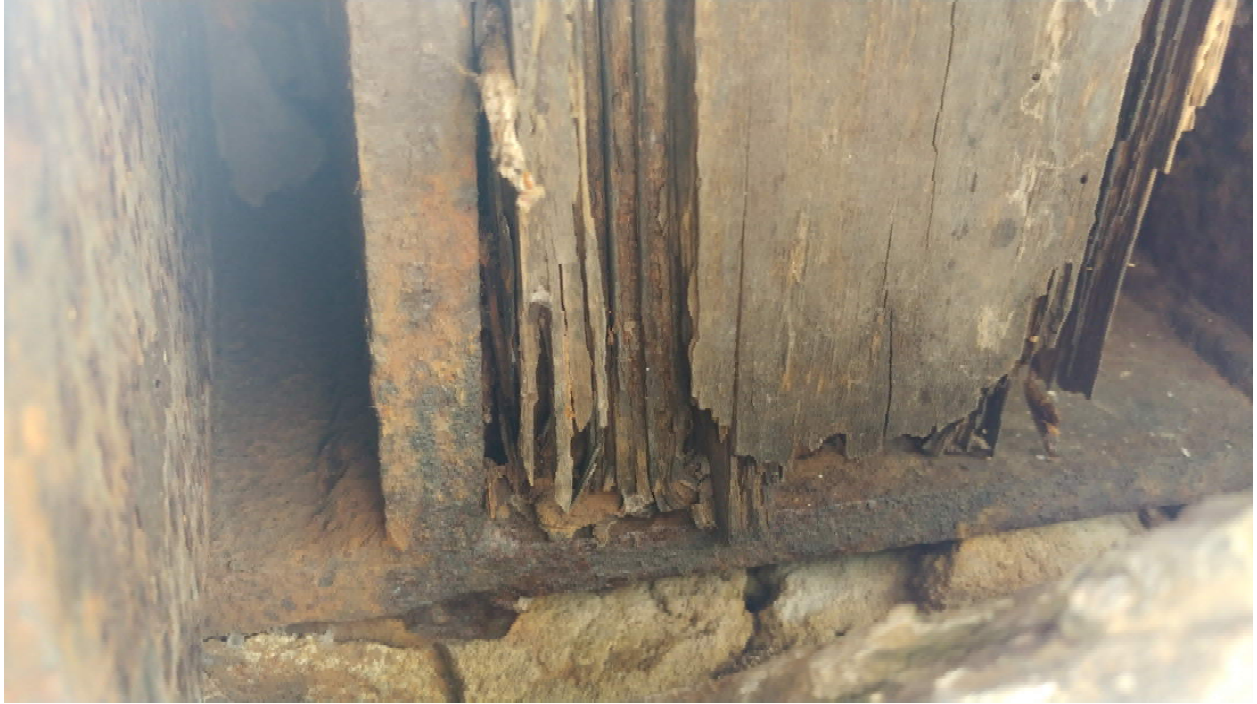
The current visual inspection was performed on the previously discussed eight glulam arches supporting the pavilion roof structure. Wood rot and severe deterioration of the wood was observed at the bases of the glulam arches at the concrete abutments (See Photo 1) as well as at the top of the steel casing near the connection of the horizontal roof framing members to the glulam arches (See Photo 2). Note that the condition of the glulam arch between the two ends of the steel casing could not be visually determined because of the steel casing itself. However, we suspect most of the glulam arch between the steel casing has similar wood deterioration.

Photo 1 – Wood rot and decay at base of glulam arch.

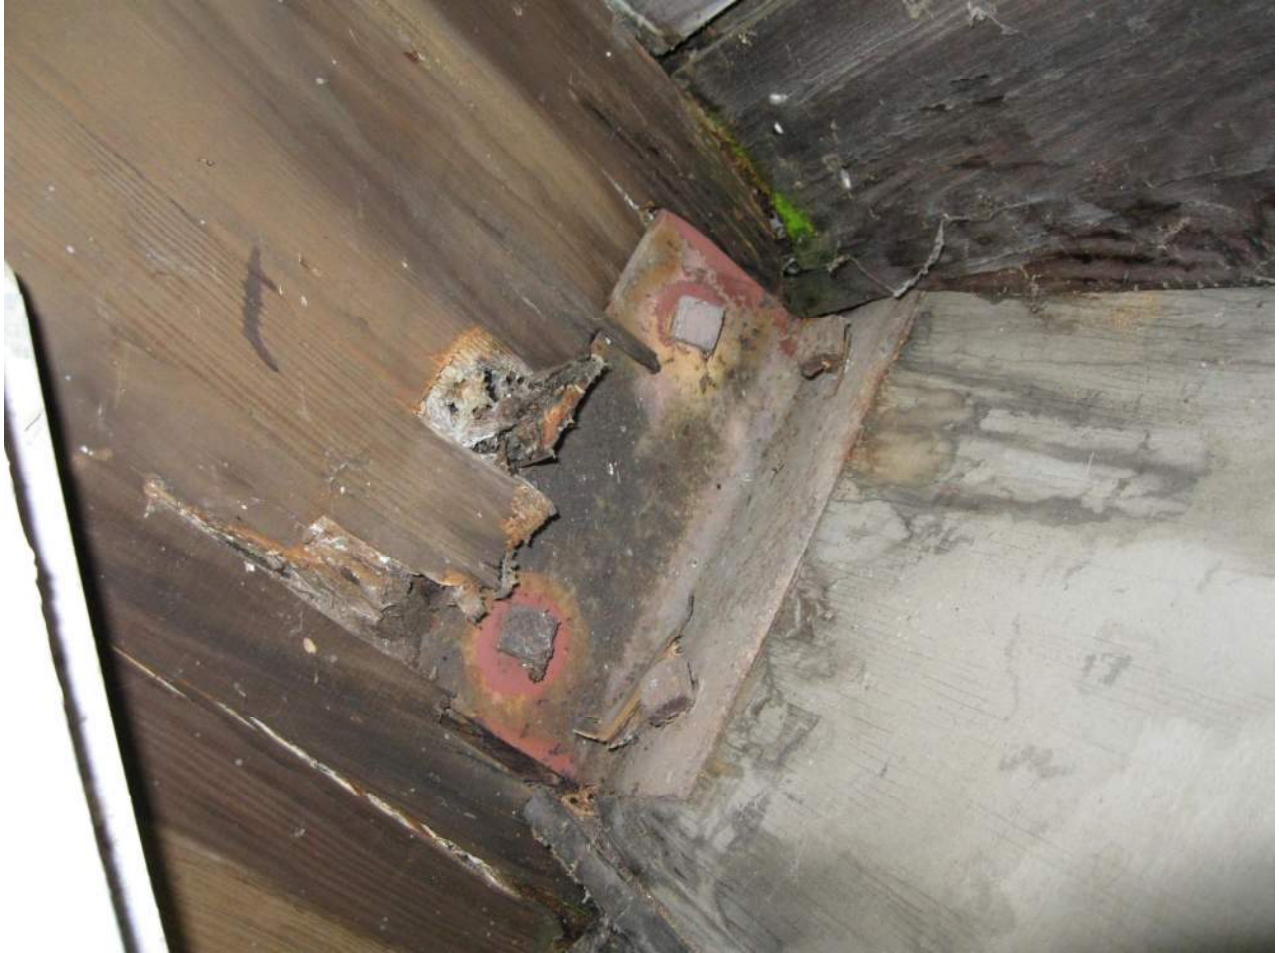
Photo 2 – Glulam arch wood decay near the connection of the horizontal roof framing members.

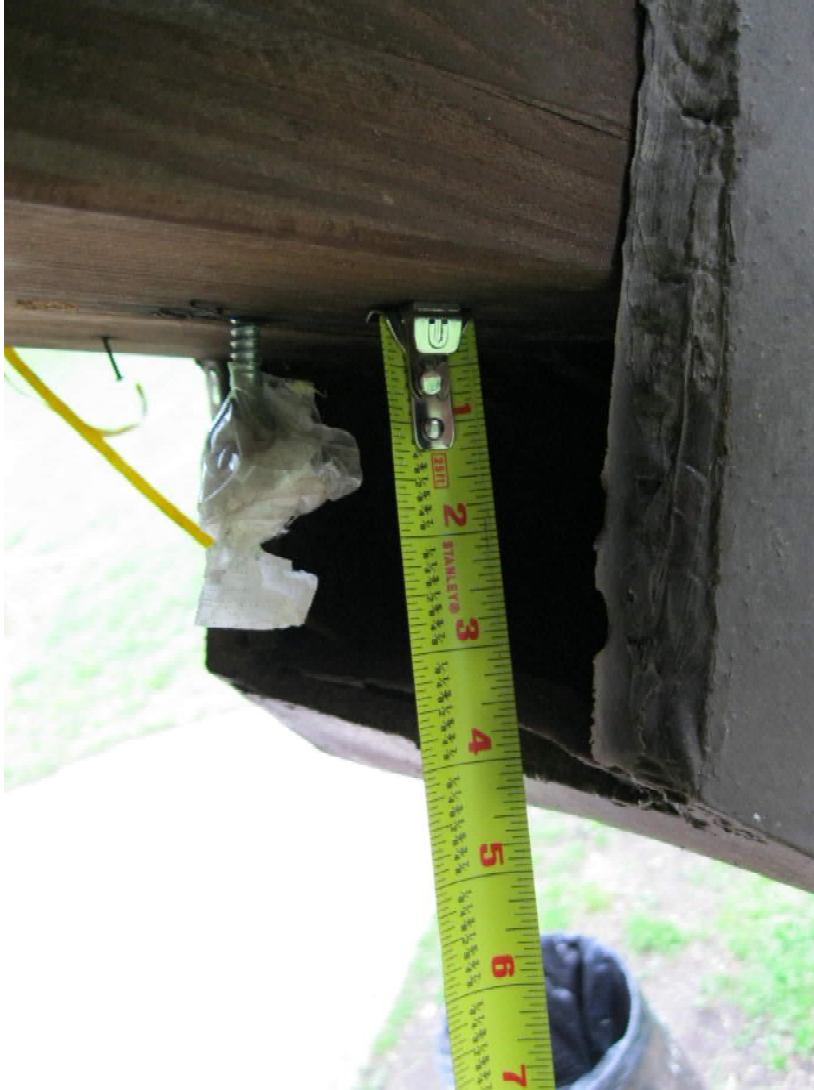
At the top of the steel casing at one of the originally repaired glulam arches, a 4-inch gap was observed between the bottom of the glulam arch and the bottom plate of the steel casing, indicating significant movement in the glulam arch (See Photo 3). At this location the wood was severely deteriorated (See Photo 4), exposing the top ¾ inch diameter rod between the steel casing sides (See Photo 5). Wood deterioration and exposure of the ¾ inch diameter rod at the top of the steel casing is particularly concerning since it was the upper zone of the steel casing that served as the area for the transfer of the forces in the glulam arch to the steel casing.

Photo 3 – Separation of the steel casing from glulam arch.

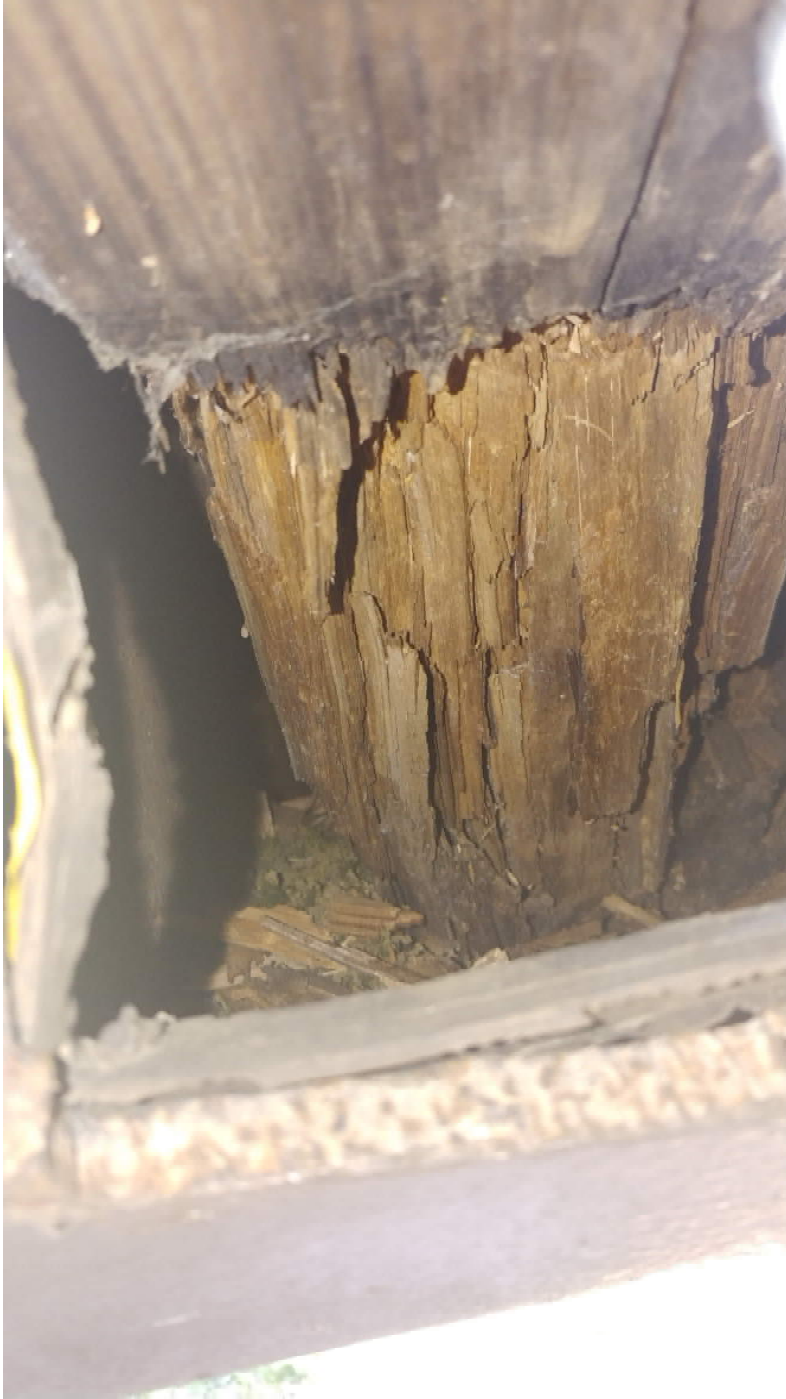
Photo 4 – Glulam arch wood deterioration near the top of the steel casing.

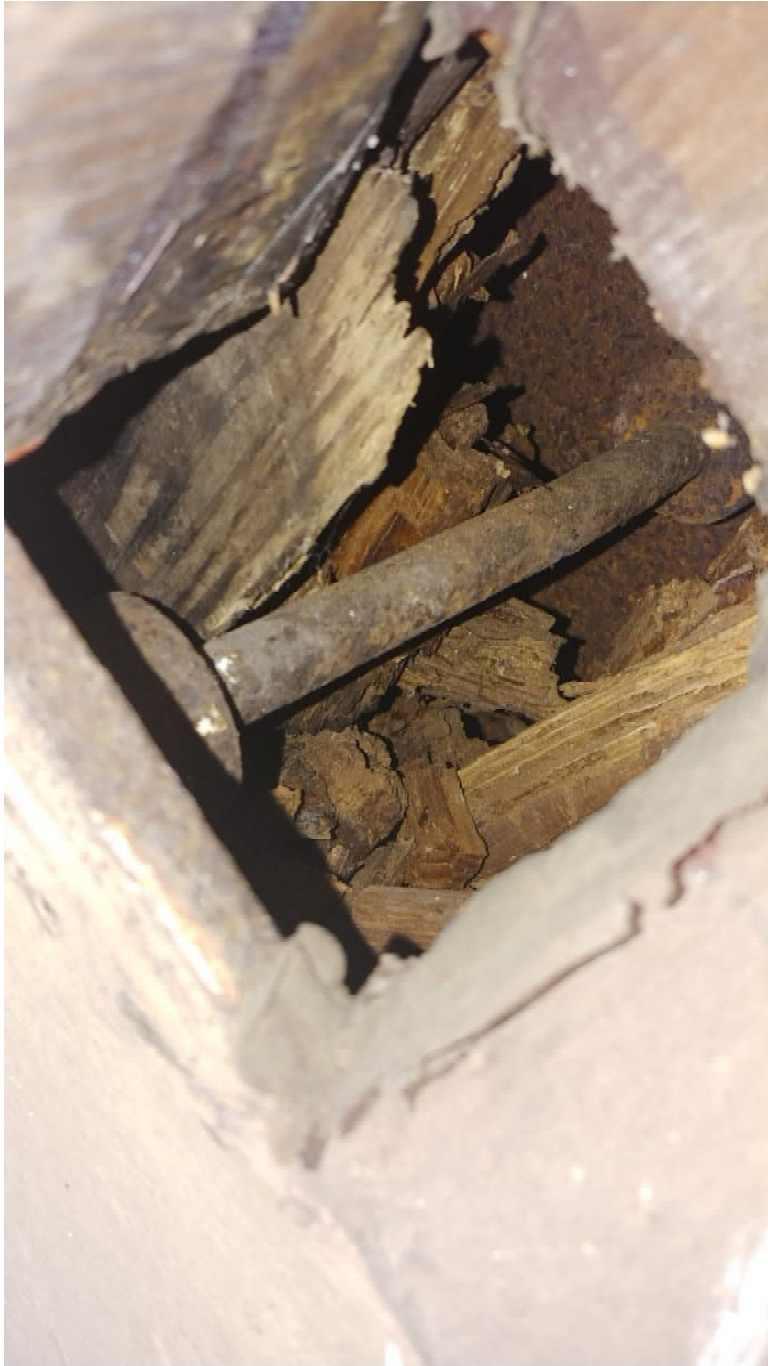
Photo 5 – Exposed  $\frac{3}{4}$ " diameter rods between the steel casing sides thru the deteriorated glulam arch.

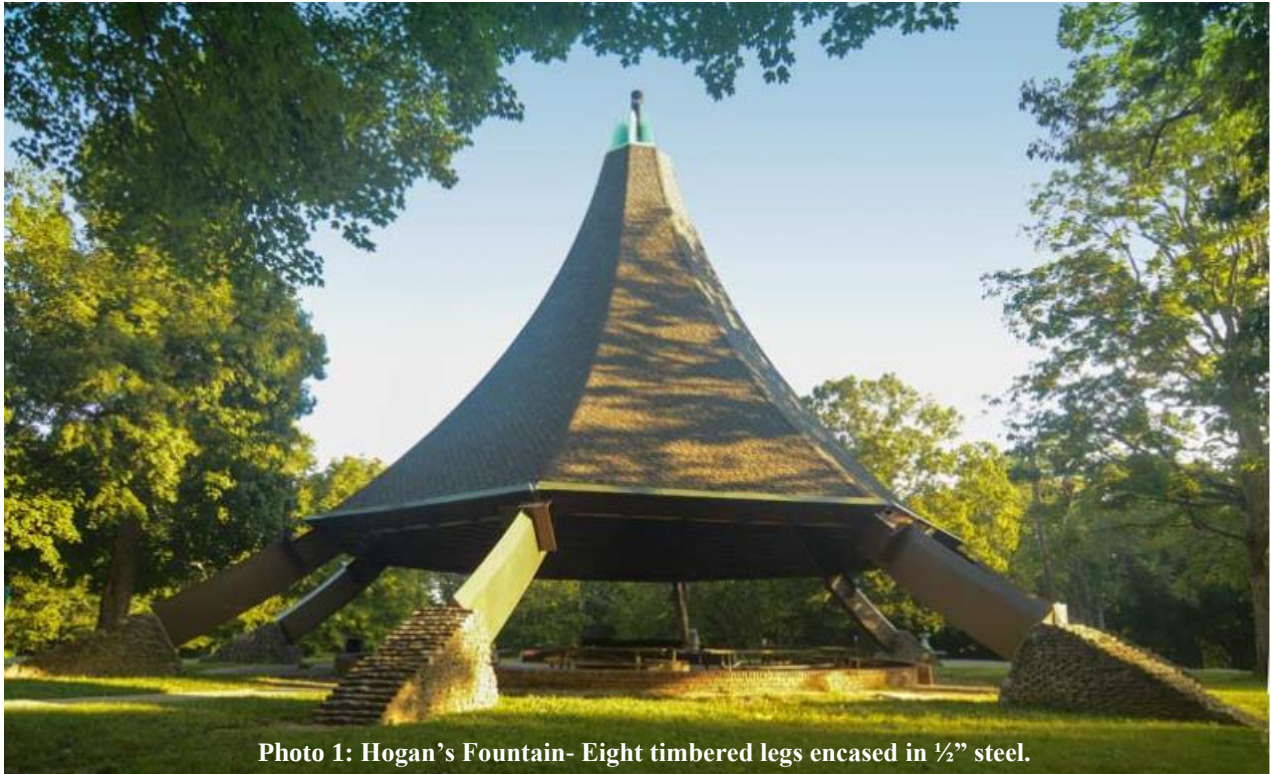
**Photo 1: Hogan's Fountain- Eight timbered legs encased in  $\frac{1}{2}$ " steel.**

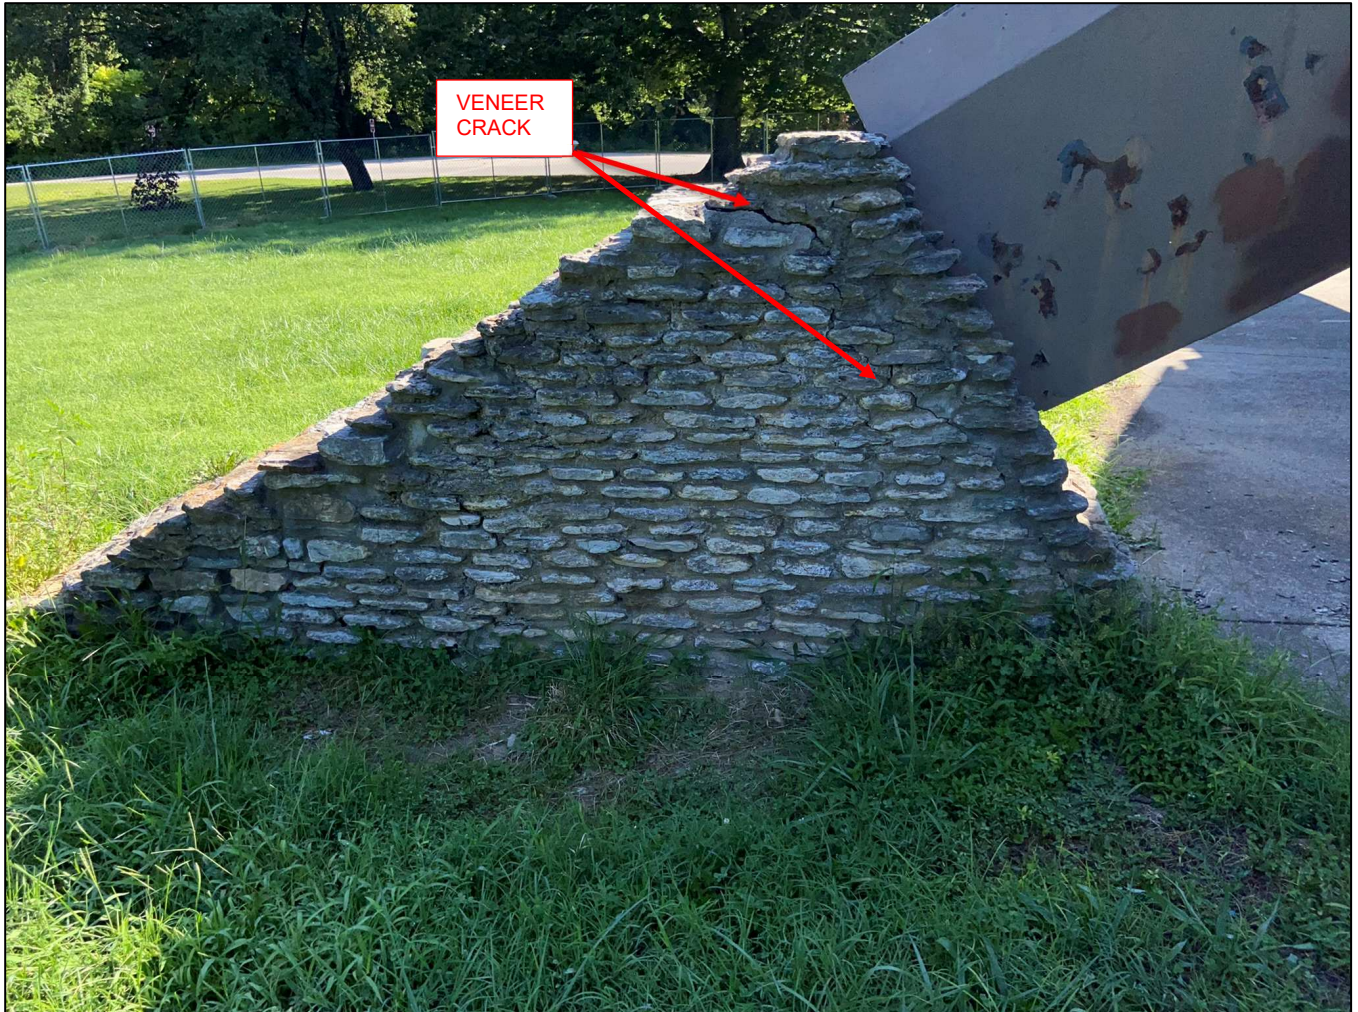
- The concrete foundation abutments are clad with stone veneer, so an assessment of the structural concrete was not performed. However, the condition of the concrete abutments does not change the conclusions or recommendations provided herein.
- Abutments 1, 4, 5, and 8 (**Photo 2**) have cracking in the stone veneer that could be an extension of cracking in the concrete abutment substrate. If this cracking is also in the concrete abutment, it may be caused by the change in load path from the steel casings. See discussion under glue-laminated wood beams about cantilever action for more on this.
- Cracks in the abutments are not a new discovery but now have a logical explanation since the condition of the wood beams inside the steel casings has been deemed not structurally sound.

**Photo 2: Abutment #8 Veneer Cracks**

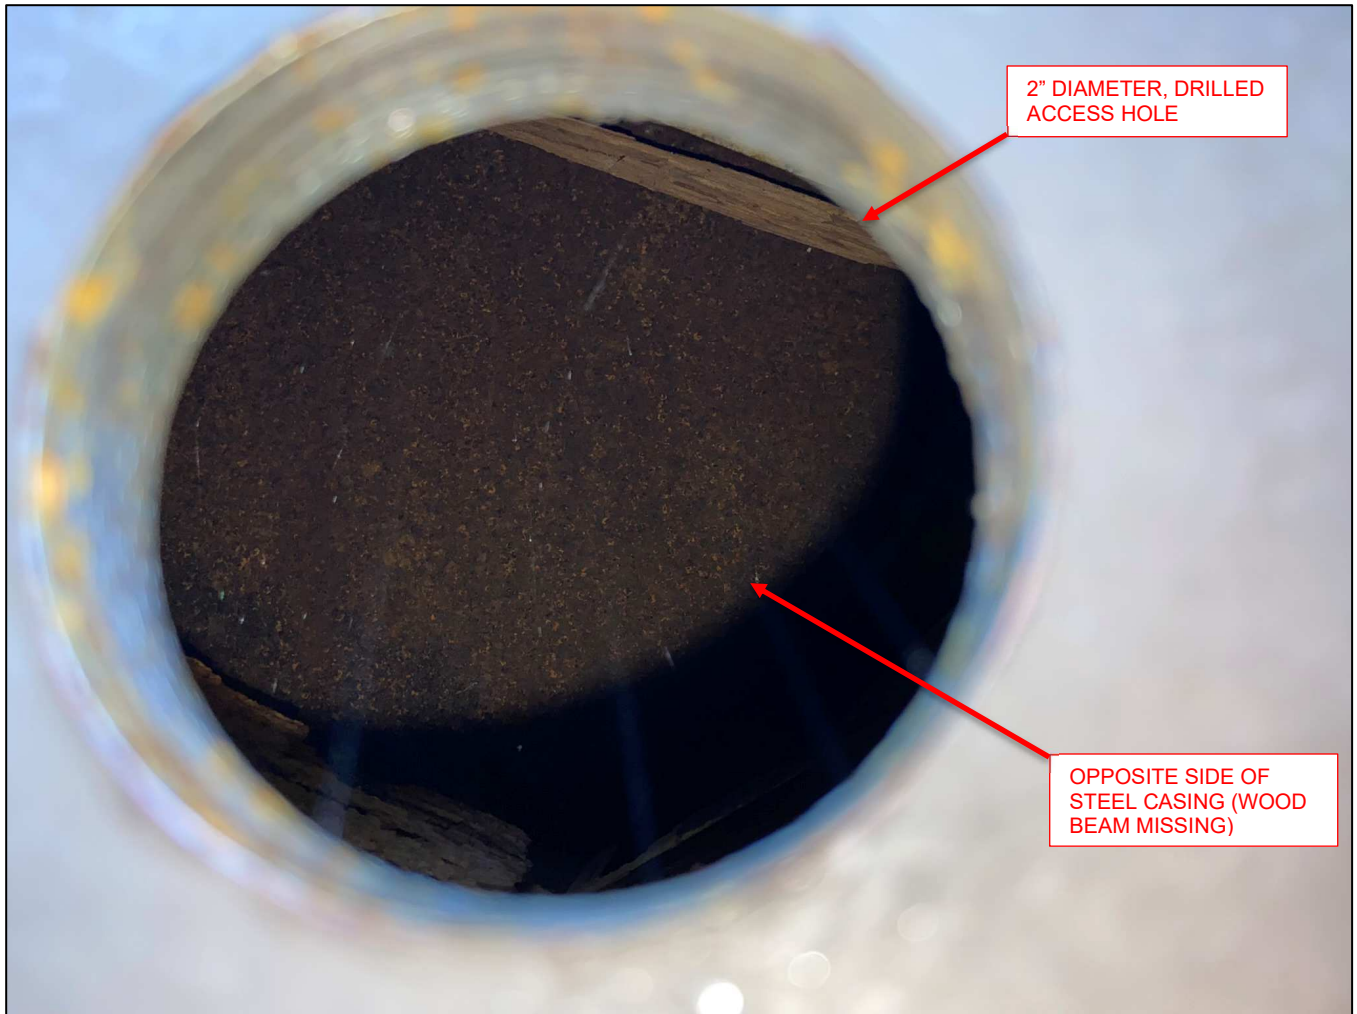
- Wood beams within the mid-section of the steel casings at locations 1, 2, 3, 4, 6, 8 (**Photo 3**) have so deteriorated that there is either no wood evident, the member section is partially lost, or the wood is so soft that it does not resist probing with an ice pick.
- Wood rot has been confirmed throughout most of the steel casing length on the majority of the beams.
- The retrofitted steel dowels in the casings are no longer providing the axial, bending, and shear load transfer to the steel casing that was designed to simulate a beam extension.
- The gap at beam #6 was measured and found to be about 4 ½" which is ½" more than previously documented in May (**Photo 4**). This side of the structure appears to be lifting.
- Lifting movement from beam #6 is pulling on the exhaust hood and lifting one side as seen in **Photo 5**.

**Photo 3: Steel Casing Access Hole at Location #1**

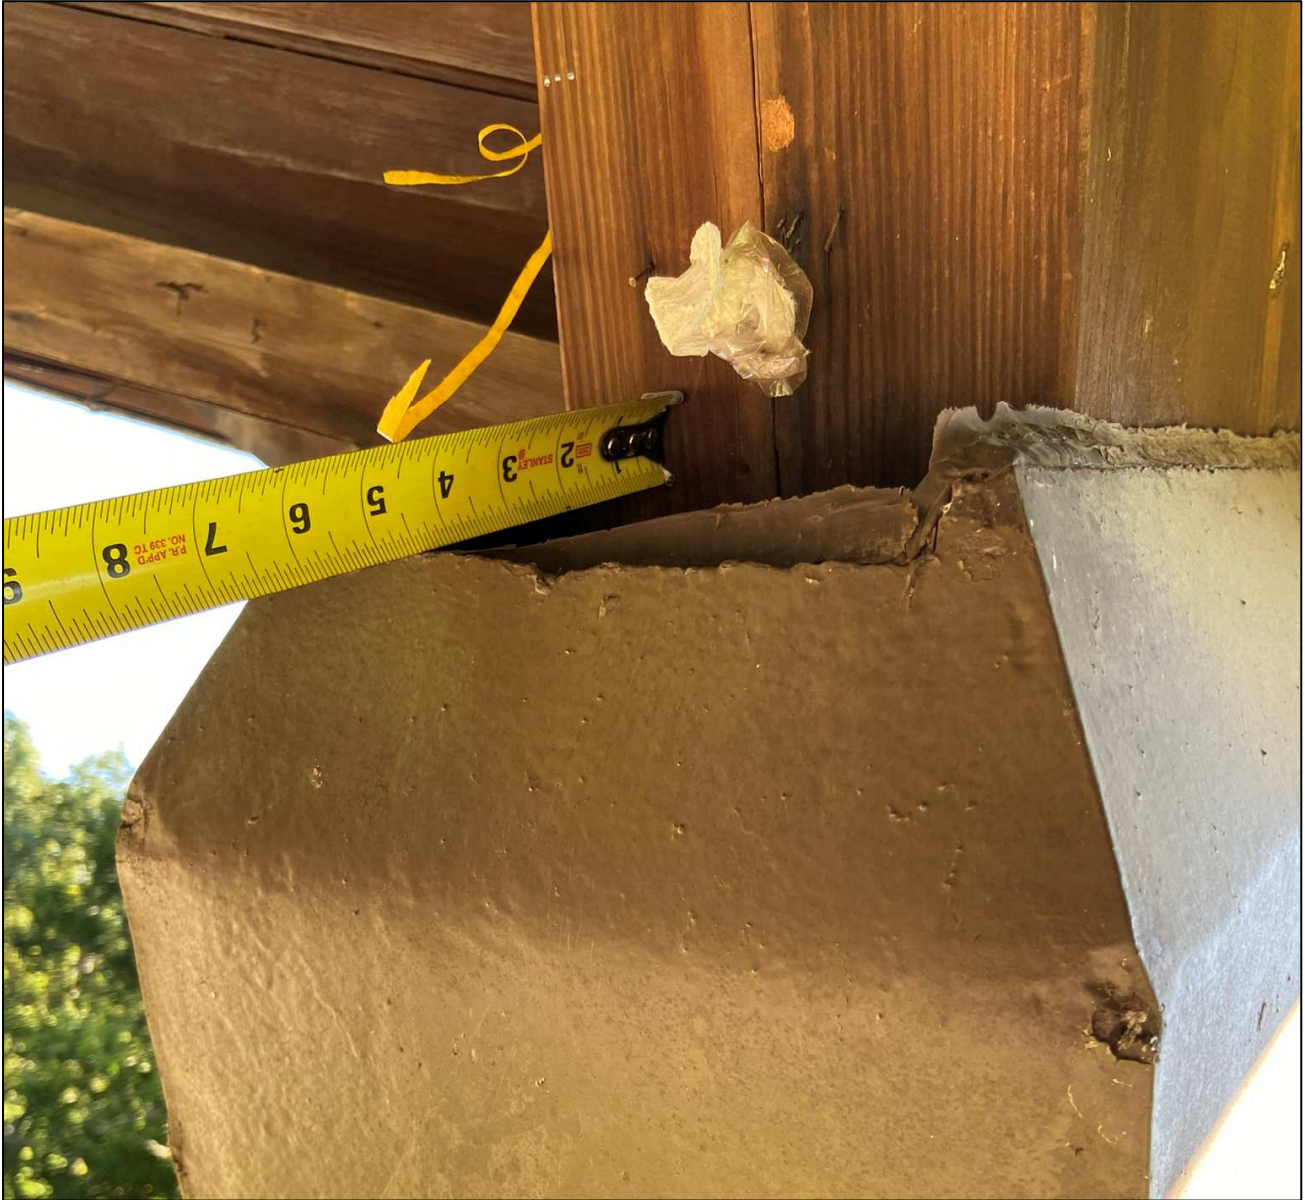
- The structure shows signs of downward and upward movement on opposite sides near locations #2 and #6, respectively (**Photo 4** and **Photo 6**).

**Photo 4: Measured Gap at Beam #6**

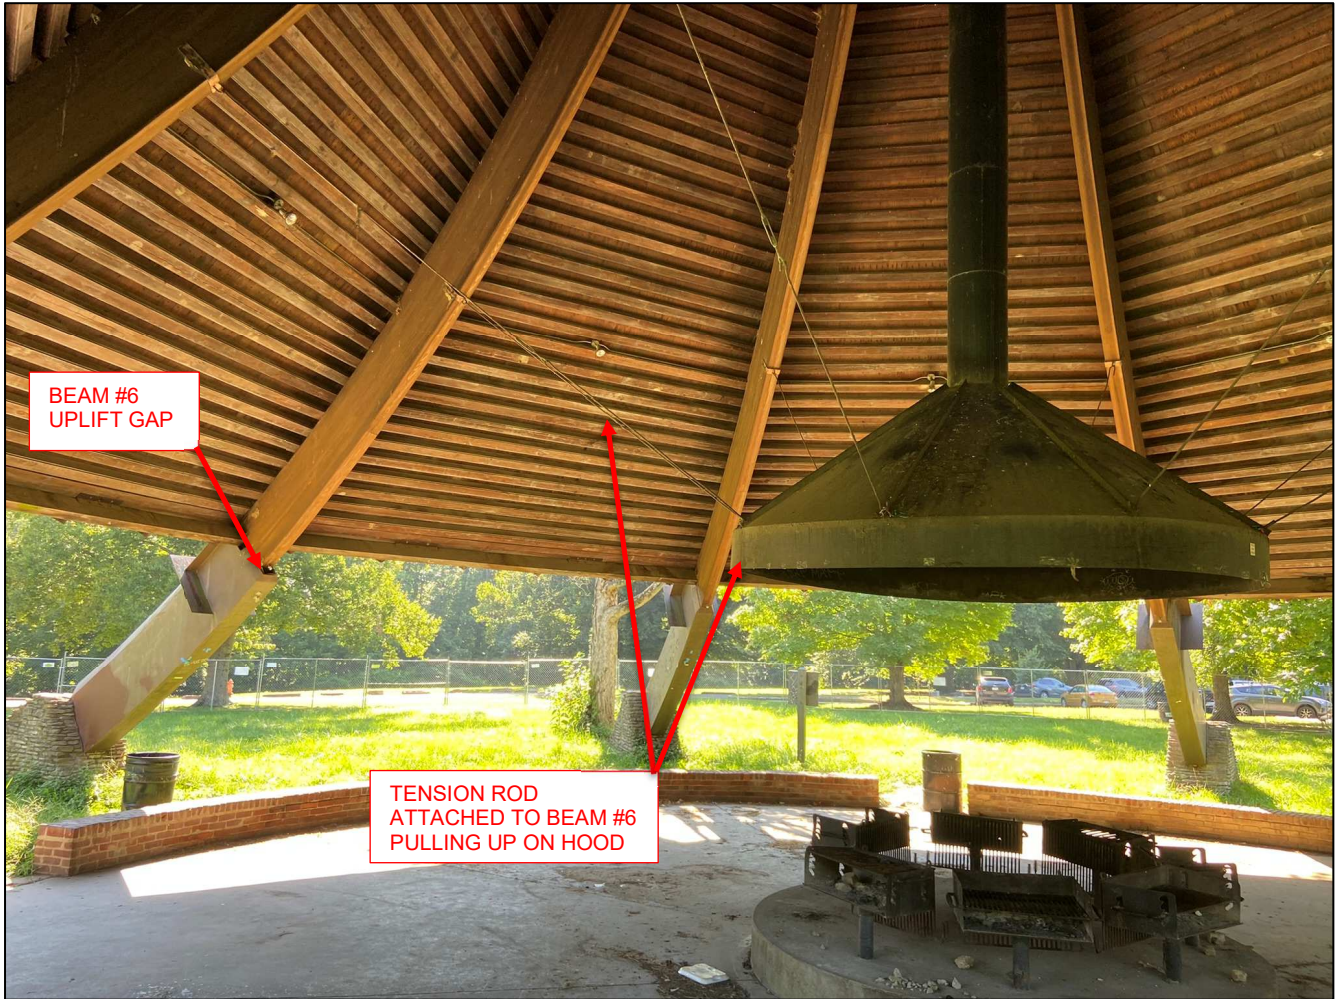
**Photo 5: Hood Lifting from Beam #6 Movement**

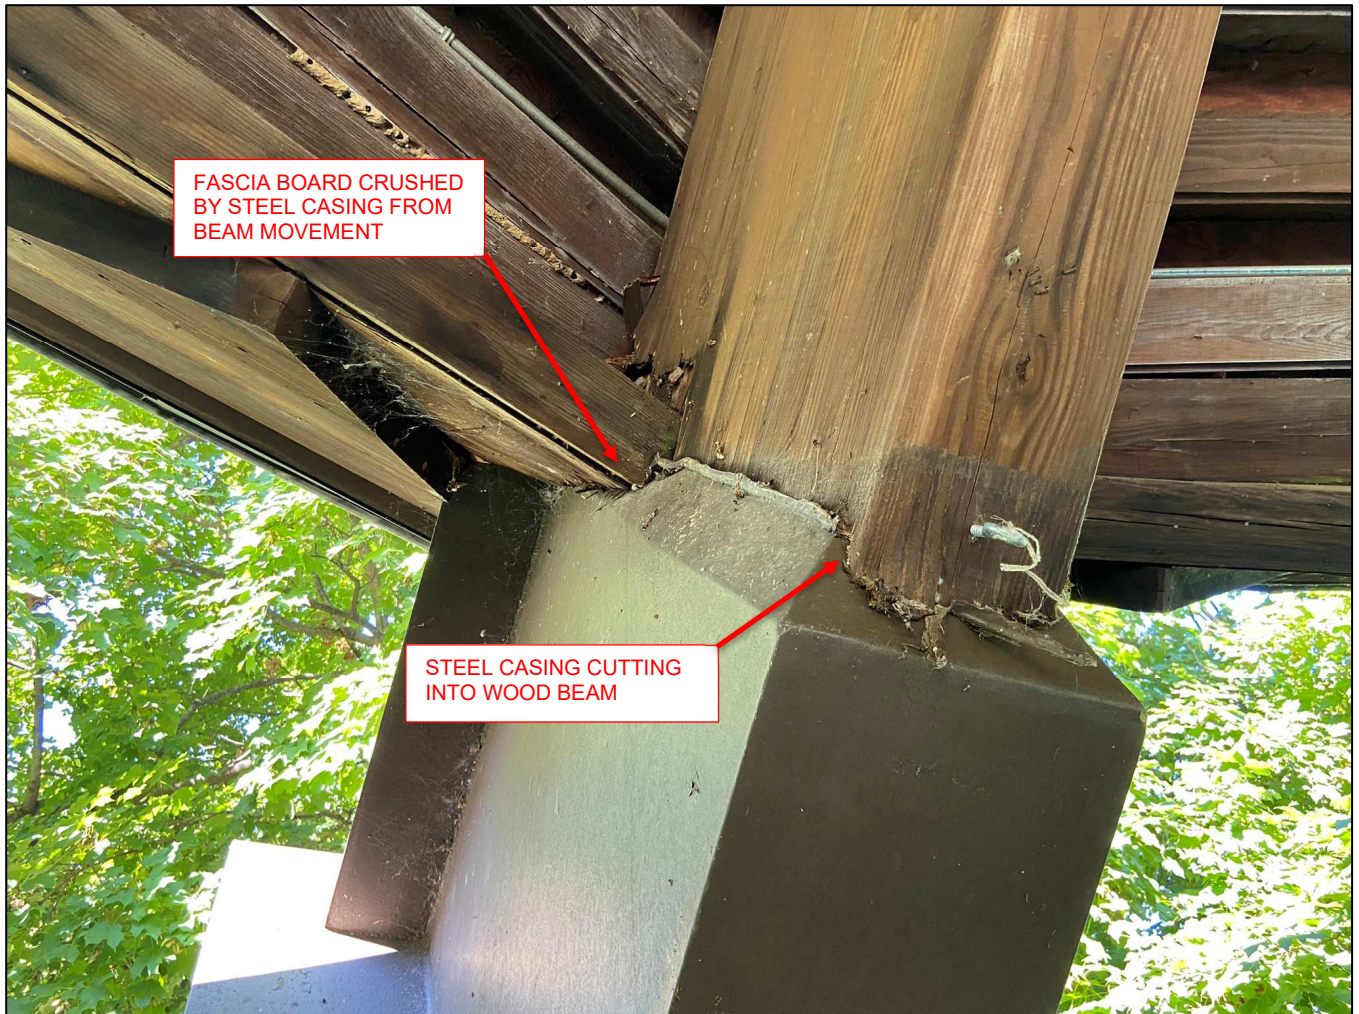
- Wood beams at locations 1 and 2 appear to be supported by the ends of the steel casing as evidenced by the steel casing digging into the wood beam and fascia boards (**Photo 6**). This side of the structure appears to be settling downward.
- The steel casings where the wood is mostly missing or rotten are likely acting as cantilever beams, fixed to the abutments, which was not how they or the foundation and connection were designed. This could be related to the stone veneer cracking, see the previous comment under foundation abutments (**Photo 2**).

FASCIA BOARD CRUSHED  
BY STEEL CASING FROM  
BEAM MOVEMENT

STEEL CASING CUTTING  
INTO WOOD BEAM

**Photo 6: Steel Casing #2 Cutting into Wood Beam**

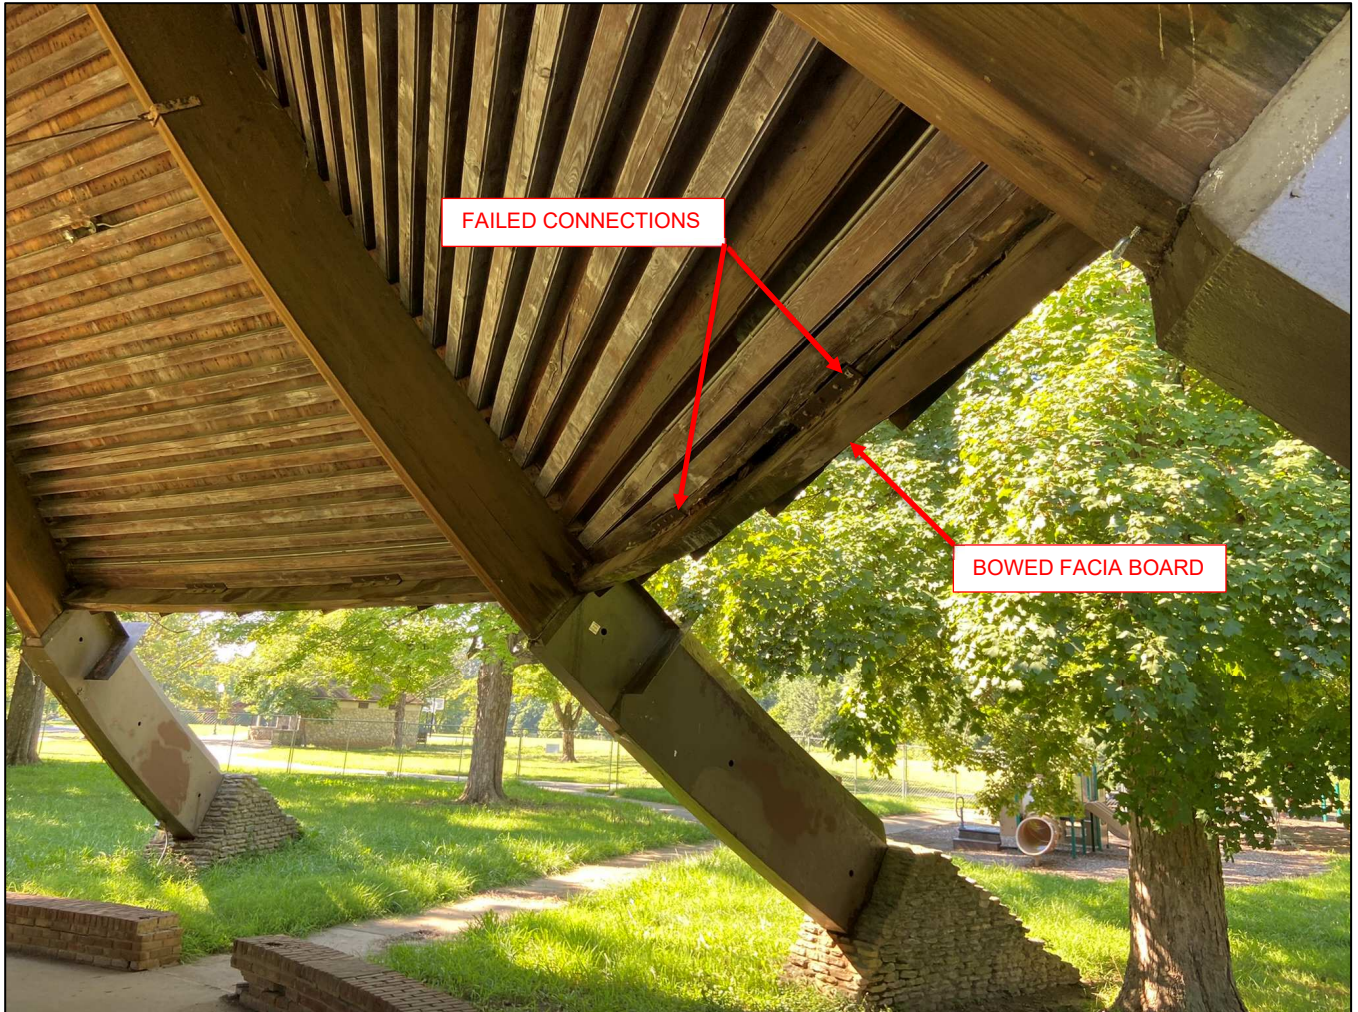
- The fascia beam between steel casing 1 and 2 has a severe bow in it that appears to be from compression forces and/or rot (**Photo 7**). There are two steel angle connections to the adjacent roof purlin that have failed. If there is a compression force on this beam member, it is the result of the downward and inward movement of the glue laminated beams #1 and #2.

**Photo 7: Bowed Fascia Board**
