**STRUCTURAL SERVICES, INC.**

January 8, 2018

Re: Structural Review  
1737 Payne St.  
Louisville, KY 40206

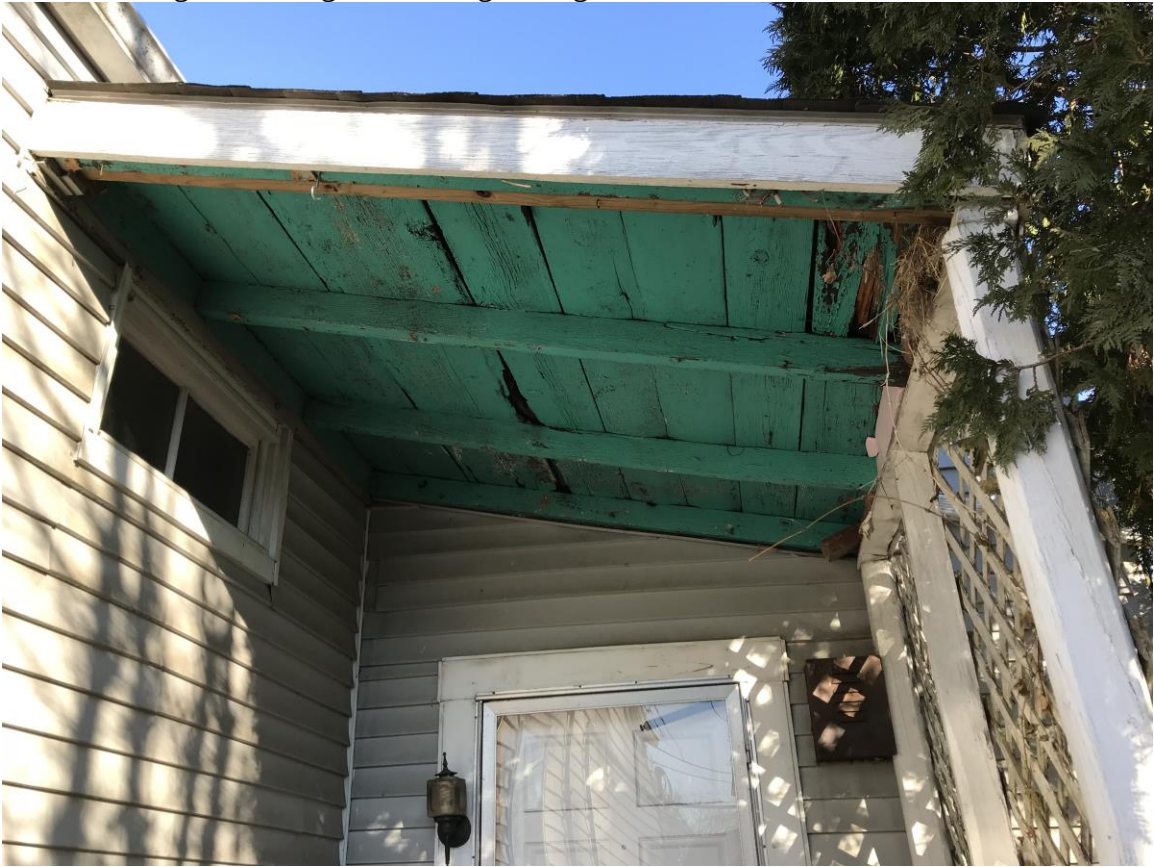
While the majority of wall and roof framing was not visible during our inspection it should be noted that there was evidence of water infiltration as seen in the water staining in ceiling. Roof framing located above the side door was not framed in accordance with current building codes and showed signs of disrepair. With the evidence of termites in the floor framing it should be noted that there is a good possibility of other hidden areas of termite damage.

Side door porch roof framing.

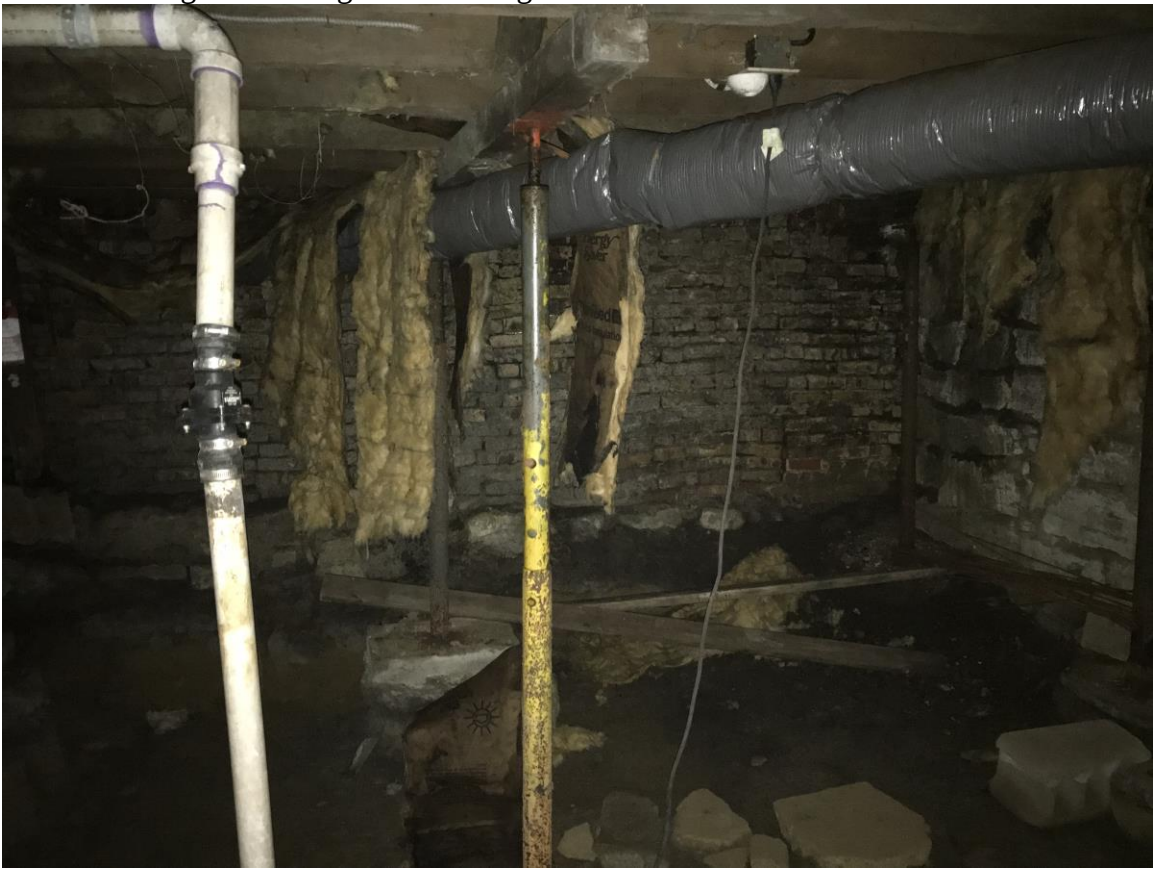
Upon review the main level floor structure was severely out of level in several areas of the house. This was due to the deteriorated condition of the framing. Upon entering the basement the moisture levels were extremely high. The floor framing was moist to the touch. In several areas there was damage due to the past presence of termites. There were several locations where steel posts were added to shore the existing structure. It should be noted that most of the attempted repairs do not meet Kentucky Building Code requirements.

Steel posts placed to shore the existing floor framing.
