# Landmarks Certificate of Appropriateness & Overlay District Permit

Project Name: Demo 1310 S. Floyd St.

## STRUCTURAL ASSESSMENT REPORT

**Location:** 1310 South Floyd Street  
Louisville, KY 40208

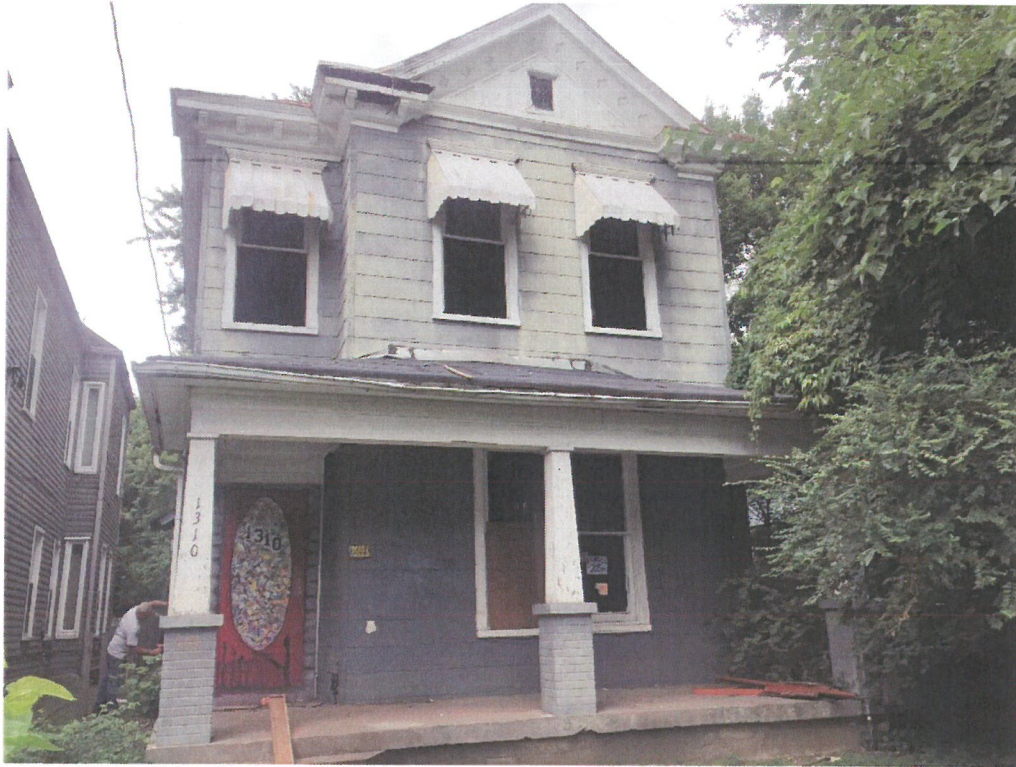
Photo 1 – View of the front of the home

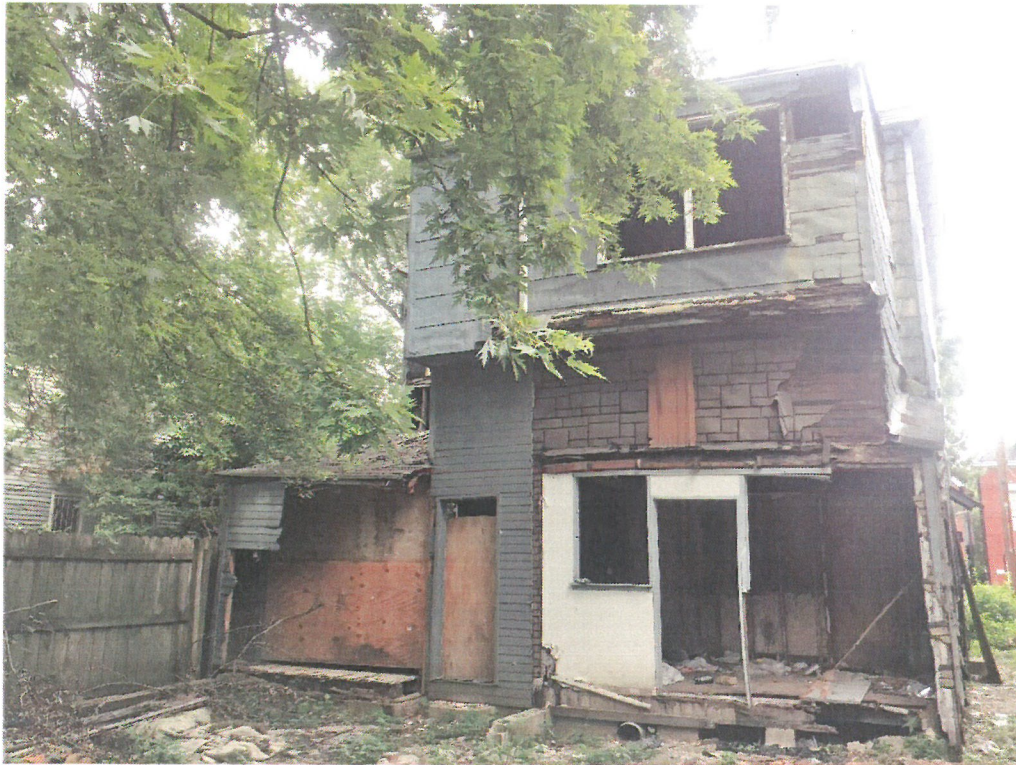
Photo 2 – View of the rear of the home

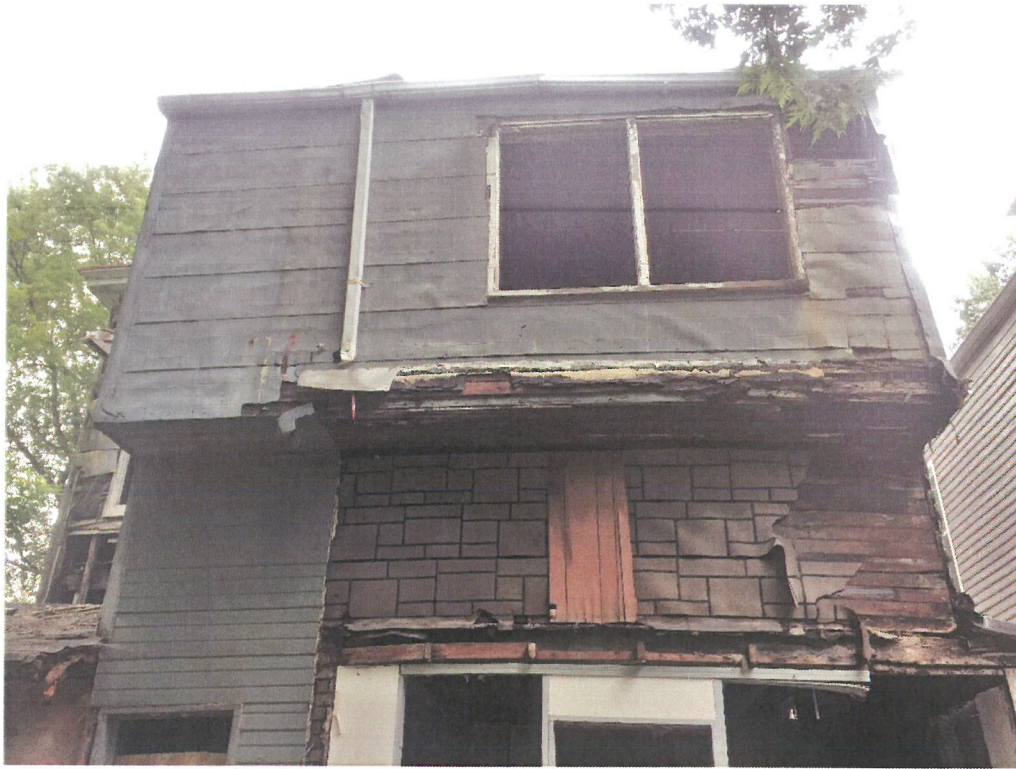
Photo 5 – View of the 2<sup>nd</sup> Floor left side of the rear of the home. Note the deterioration of the 2<sup>nd</sup> Floor framing on the overhang and lack of support structure on the 1<sup>st</sup> Floor.

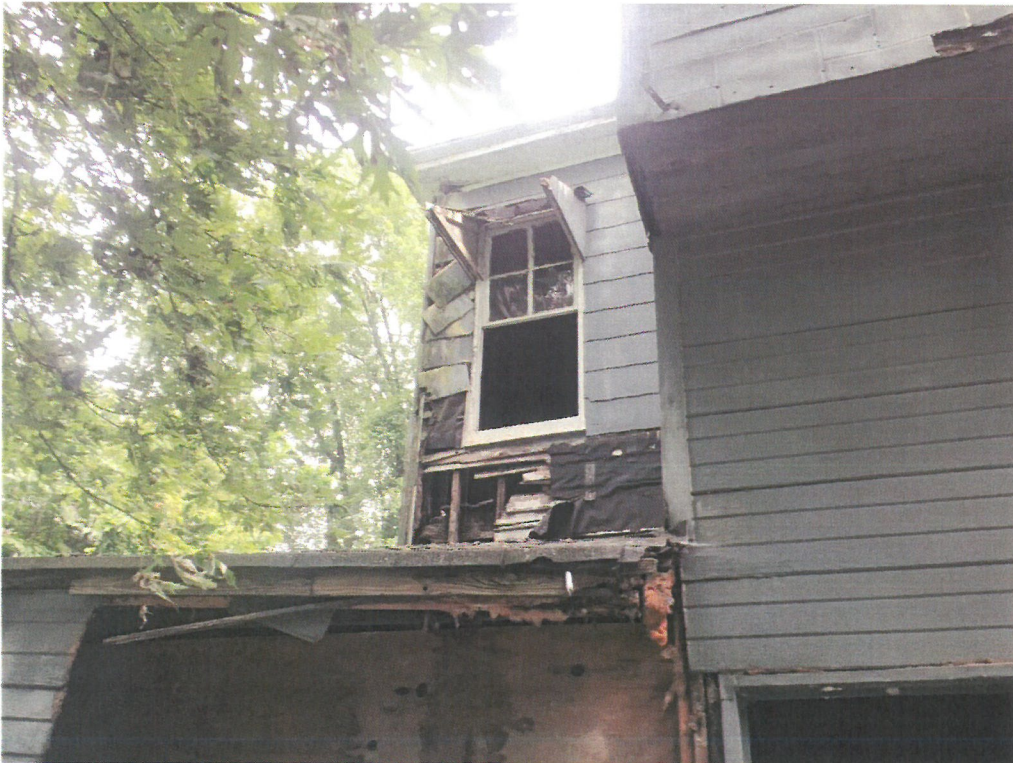
8. The siding in these deteriorated wall areas was severely deteriorated as well.
9. Several additions appeared to have been constructed on the rear of the home at various times. Most of these additions had either been demolished or were in extreme disrepair.

Photo 6 – View of the 2<sup>nd</sup> Floor left side of the rear of the home. Note the severe deterioration of the wall framing and siding.

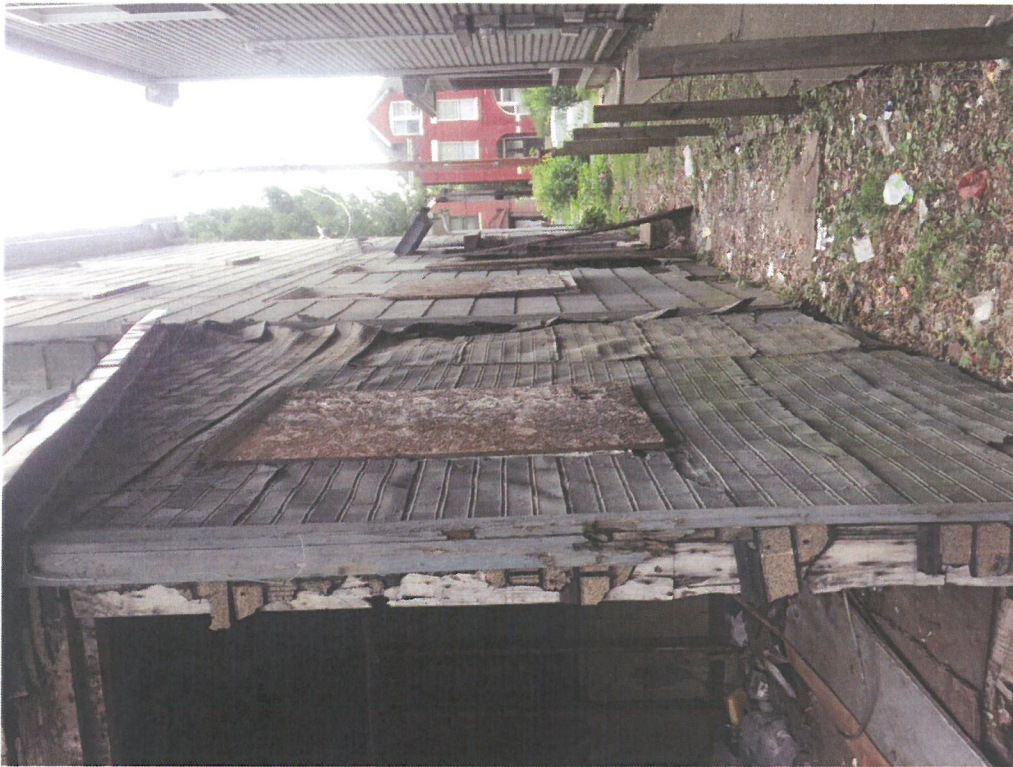
Photo 7 – View of the left side of the home from the rear corner

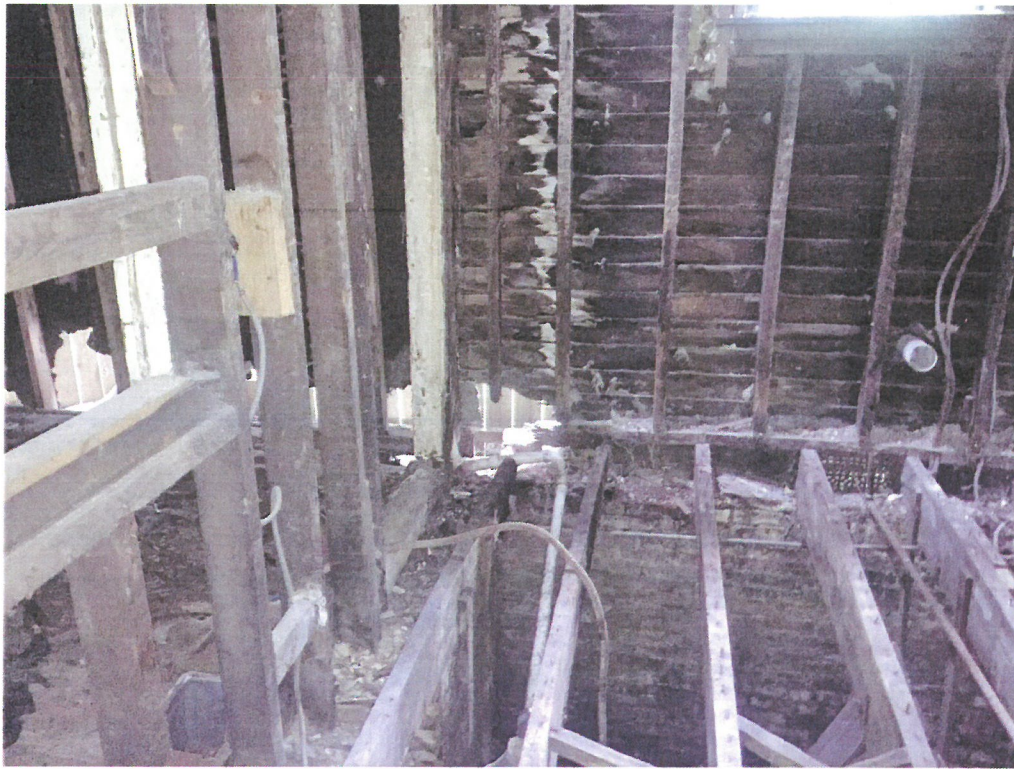
7. The sole plate and bottoms of the wall studs were severely deteriorated or missing entirely due to water intrusion and termite damage in many areas throughout the structure. Some of these areas encompassed most if not all of the length of the wall and many of these walls were load bearing walls. These areas were also observed on the 2<sup>nd</sup> Floor.

*Photo 9 – Bottom of the right-side wall is rotted and missing. Ends of the joists are rotted as well.*

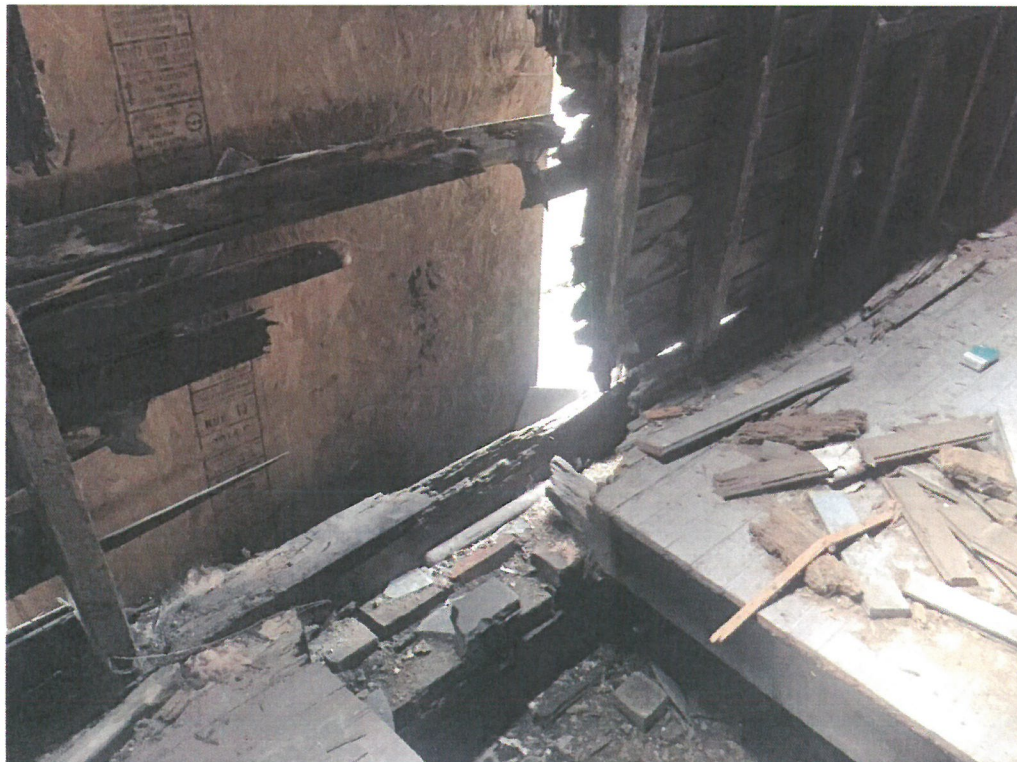
*Photo 10 – Severe deterioration of the left side wall near the side door.*

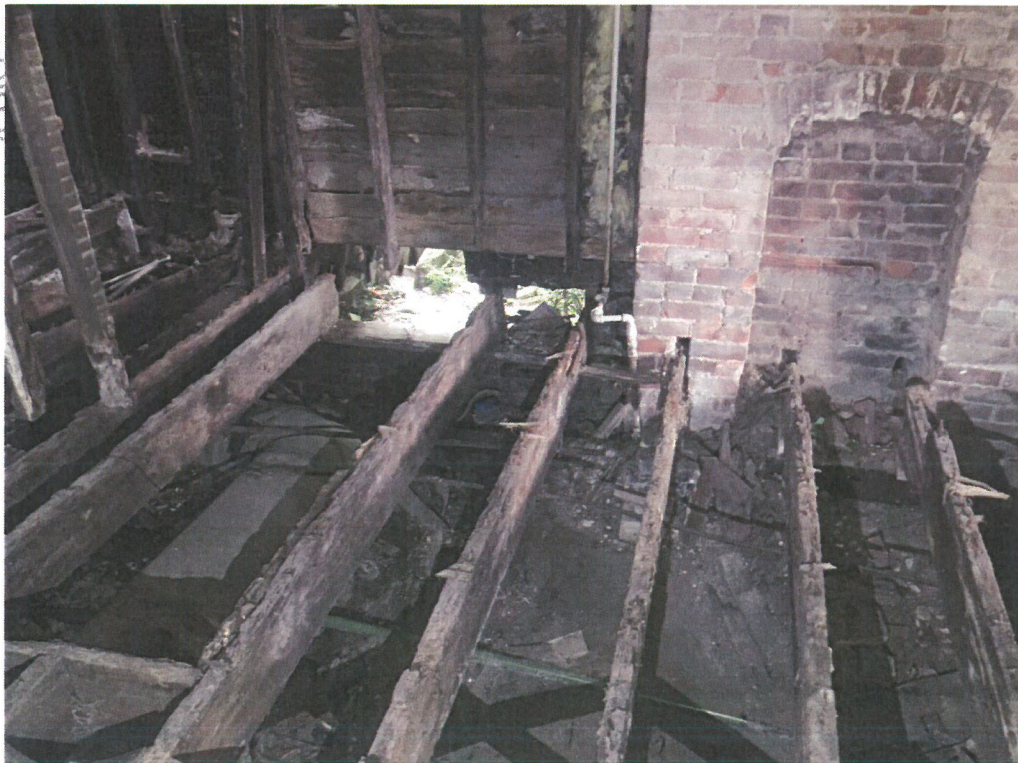
Photo 12 – More severe deterioration of the 1<sup>st</sup> Floor joists and wall framing along the right wall in the front of the home

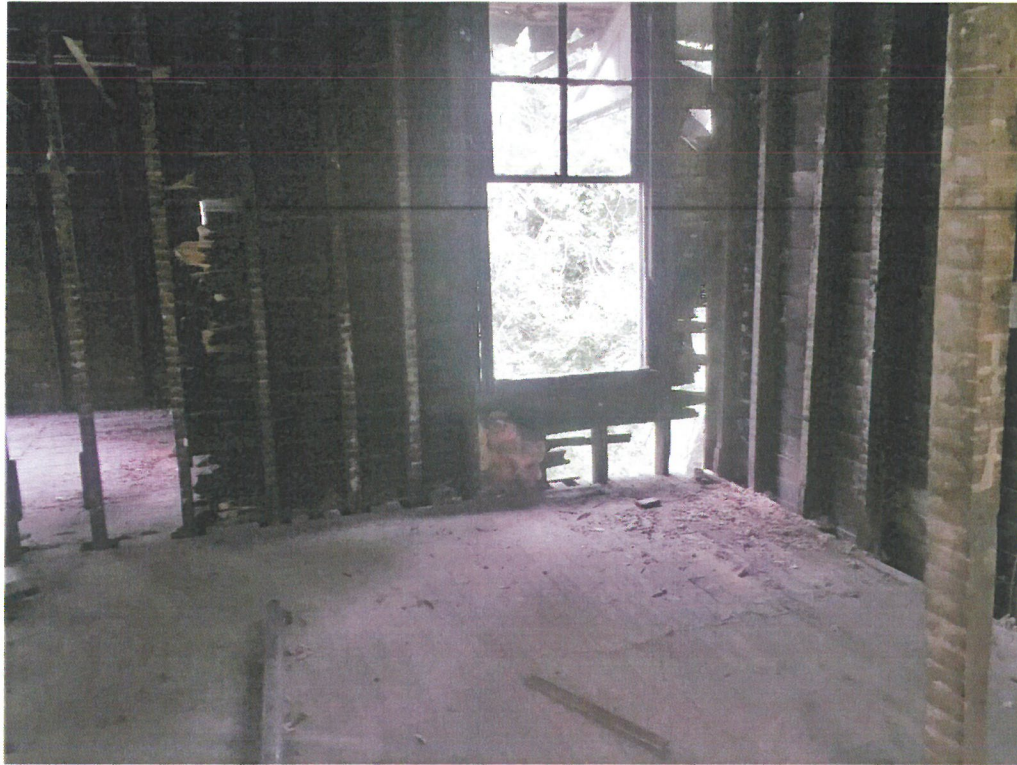
*Photo 15 – View of the 2<sup>nd</sup> Floor right rear corner deteriorated wall framing*
