**REPORT OF KARST FEATURE SURVEY**

**PROPOSED BALL HOMES DEVELOPMENT  
ST. JOSEPH ORPHANAGE SITE  
FACTORY LANE  
LOUISVILLE, JEFFERSON COUNTY, KENTUCKY**

**CARDNO ATC PROJECT NO. Z027000112**

**JUNE 4, 2015**

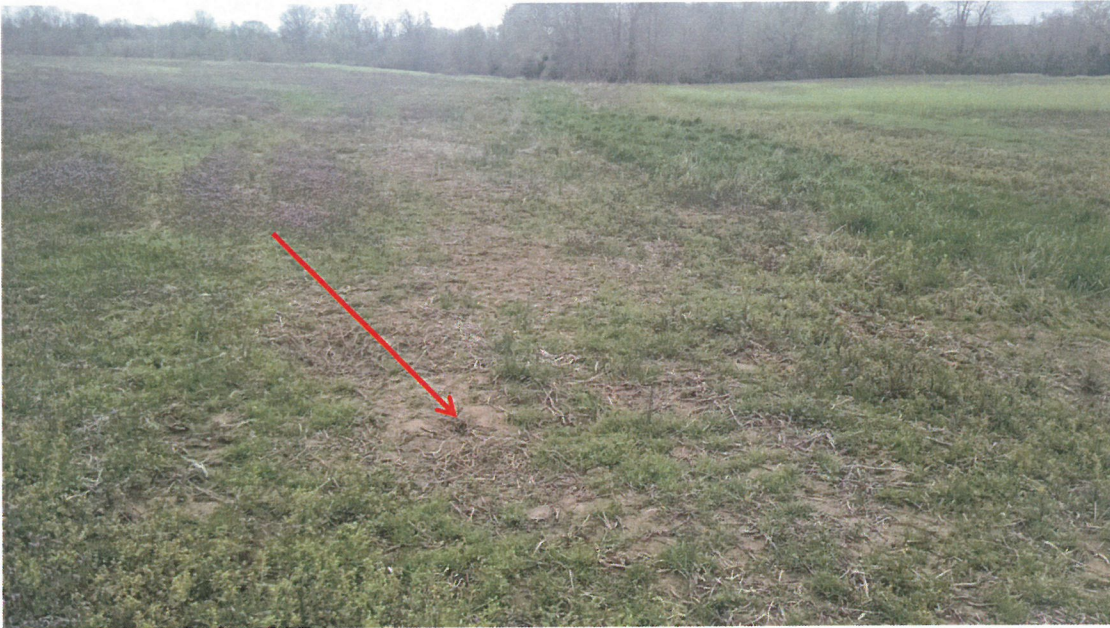
Photograph No. 1: Feature SH-1 Photo taken facing southwest along swale.

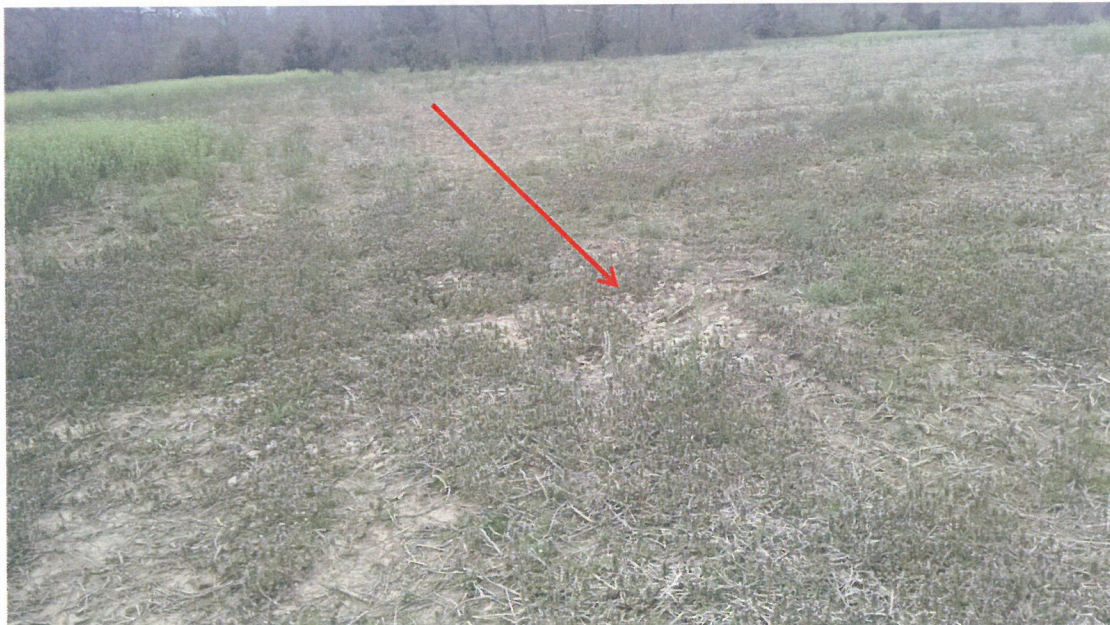
Photograph No. 2: Feature SH-2: Photo taken facing west.

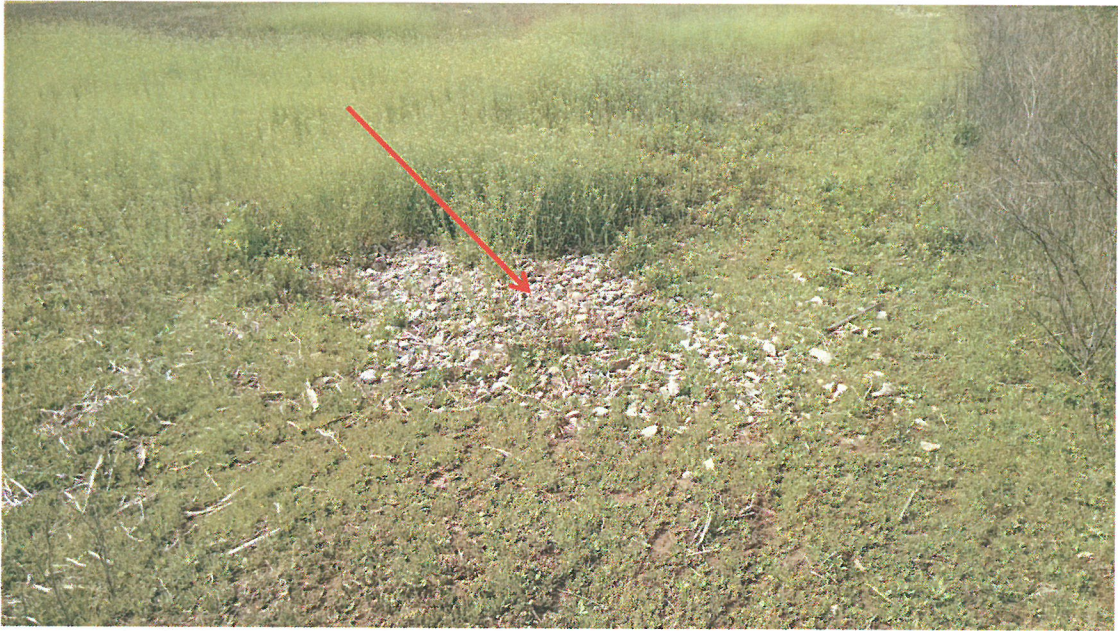
Photograph No. 3: Feature SH-3: Photo taken facing north

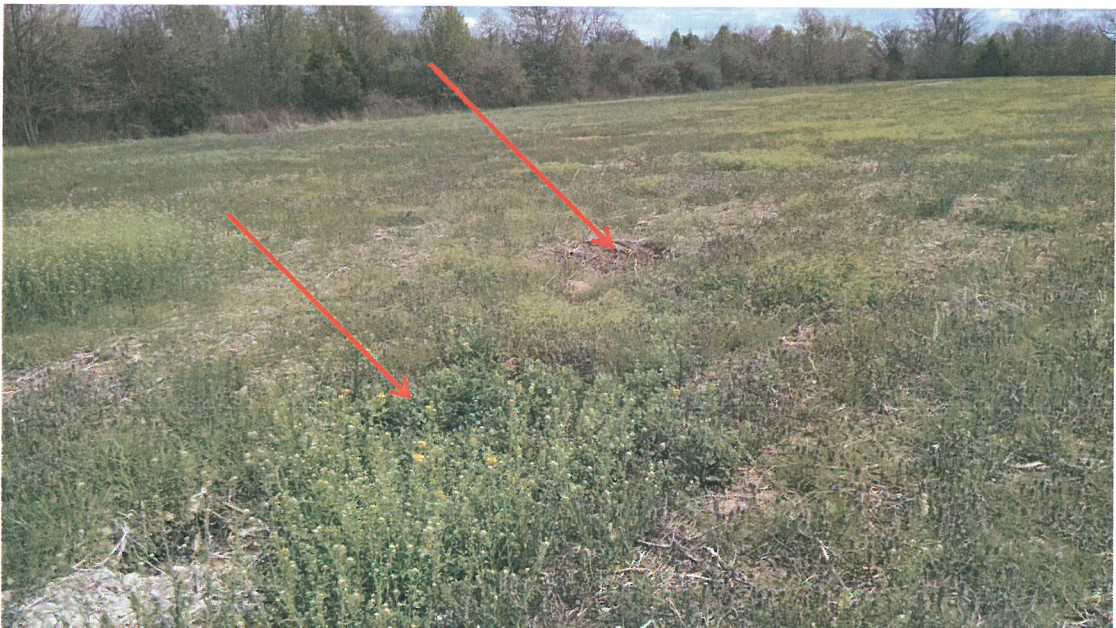
Photograph No. 4: Features SH-4: Photo taken facing southeast

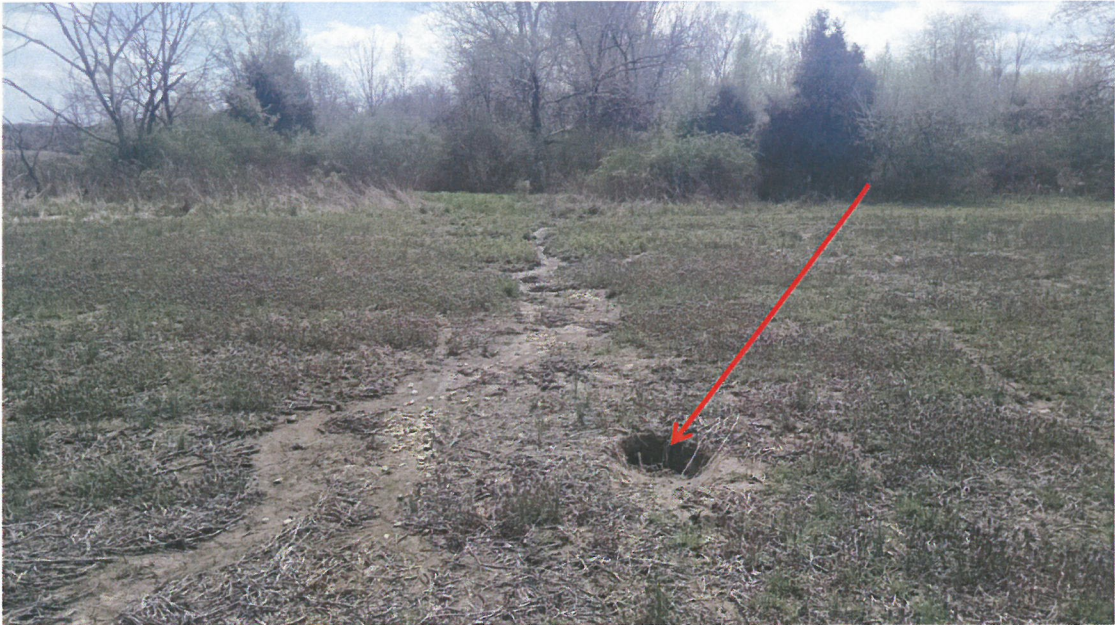
Photograph No. 5 Feature SH-5: Photo taken facing south along swale

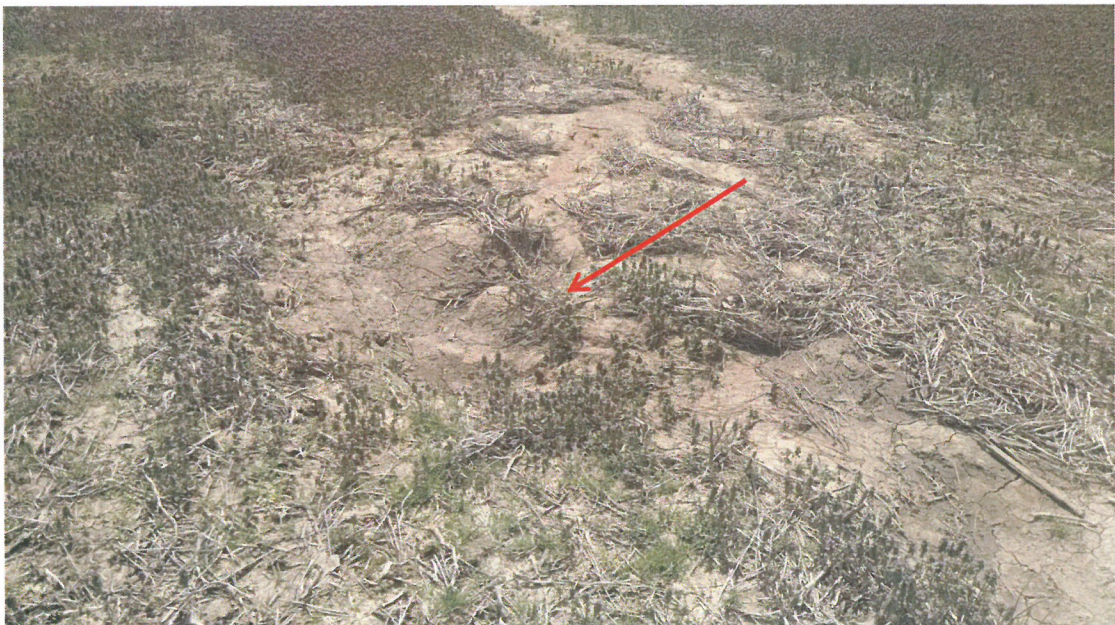
Photograph No. 6: Feature SH-6: Photo taken facing northeast along swale

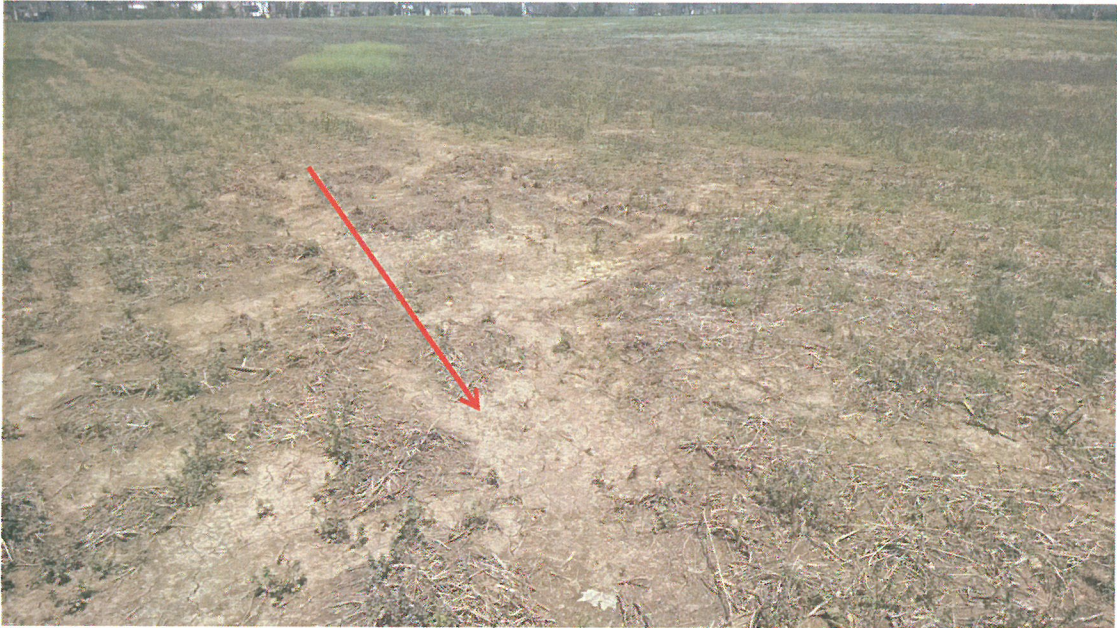
Photograph No. 7: Feature CD-7: Photo taken facing northeast along swale

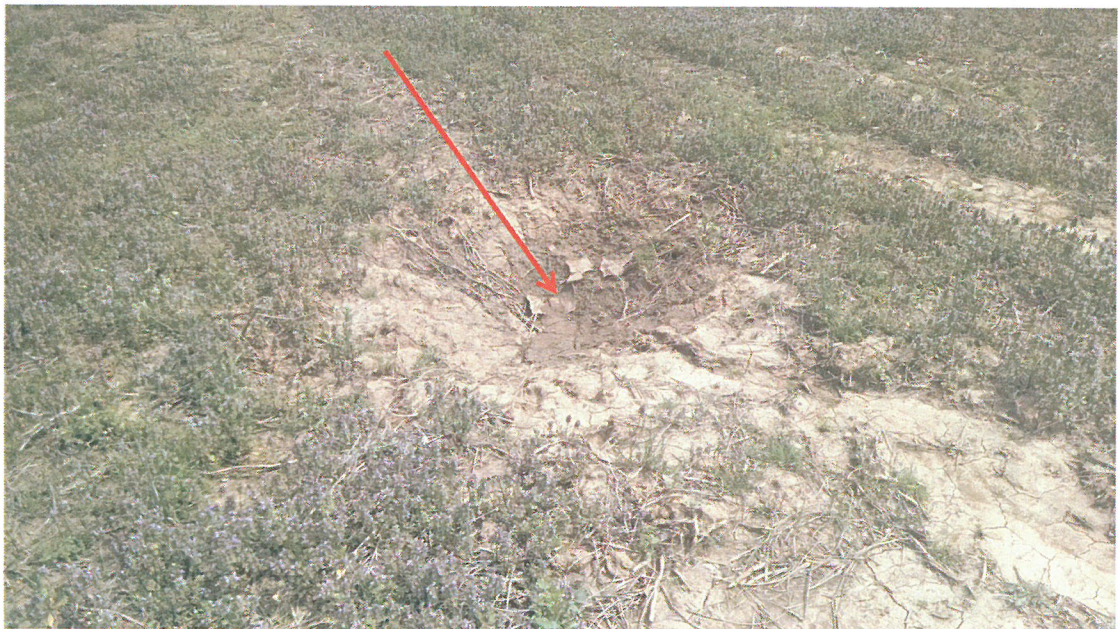
Photograph No. 8: Feature SH-8: Photo taken facing northeast along swale

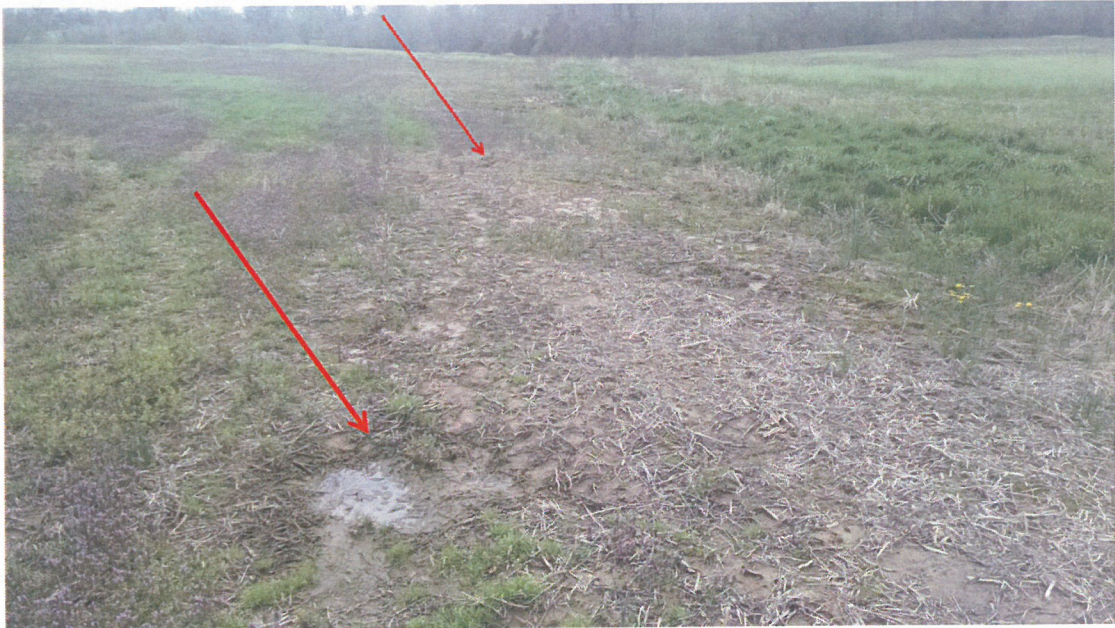
Photograph No. 9: Feature SH-9: Photo taken facing southeast along swale

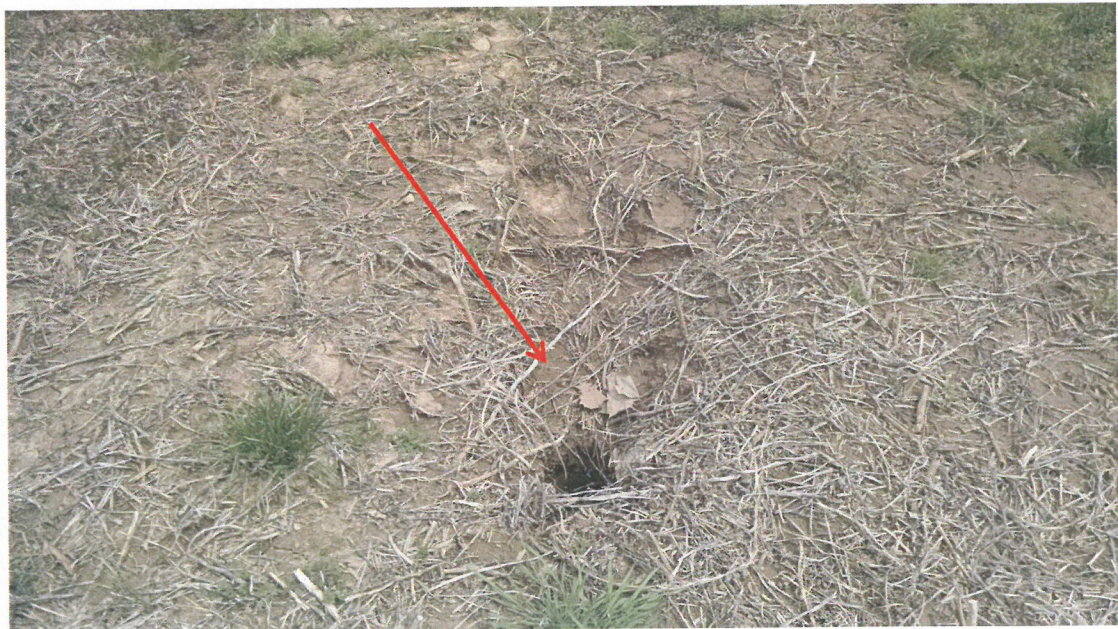
Photograph No. 10: Feature SH-10: Photo taken facing north

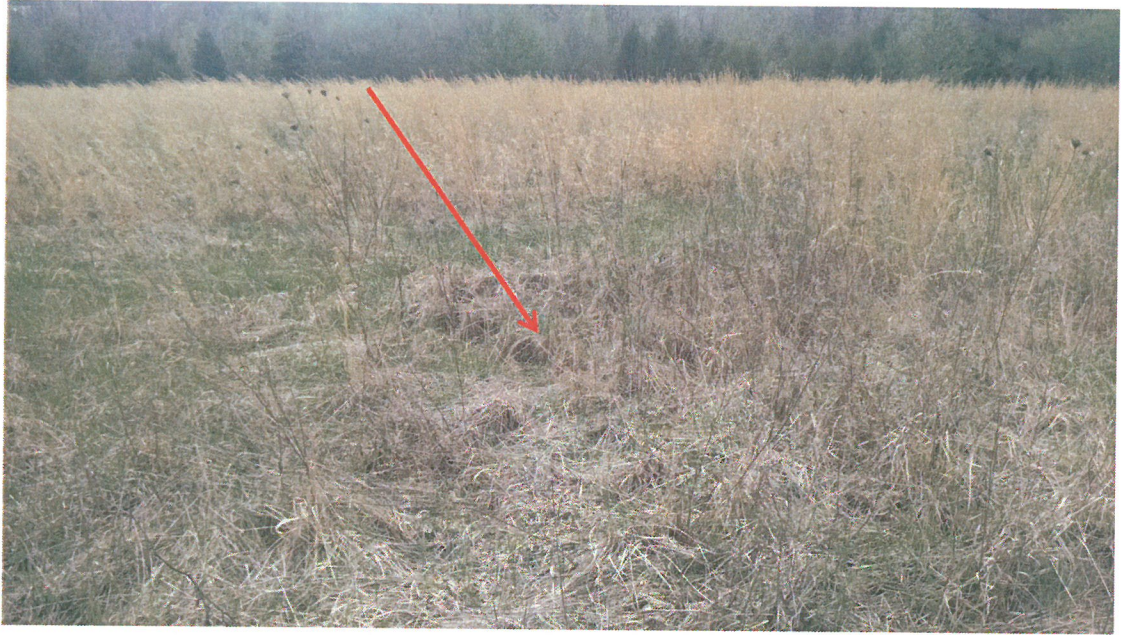
Photograph No. 11: Feature SH-12: Photo taken facing south

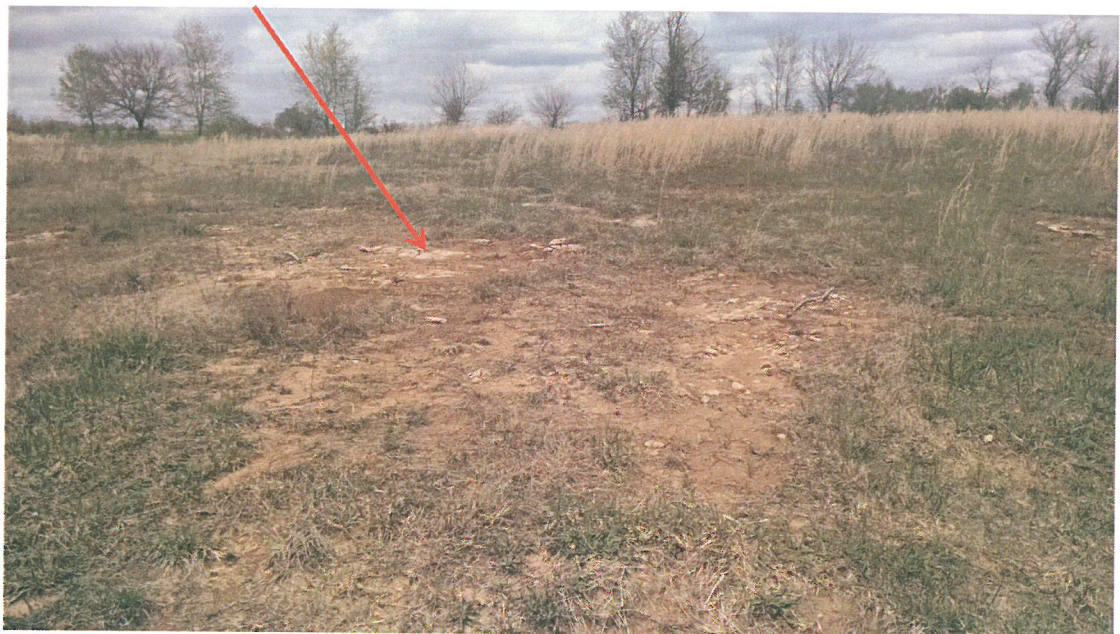
Photograph No. 12: Feature VR-13: Photo taken facing north

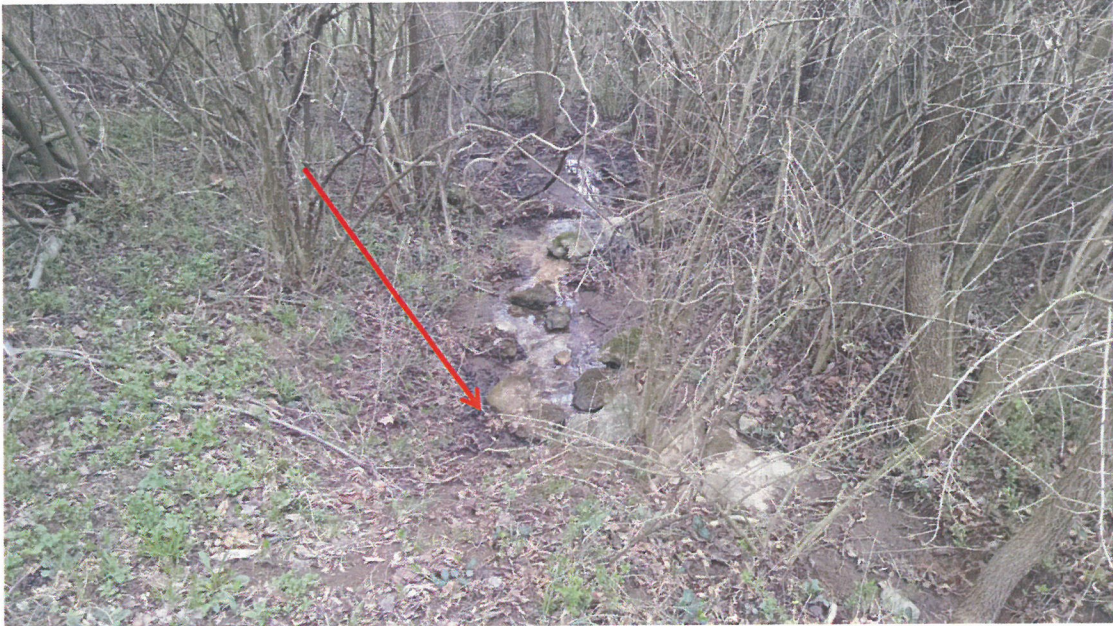
A sinking stream and groundwater spring as indicated by the respective feature designations of SS-14 and GS-19 appear located outside of the proposed development area and within the proposed conservation area near the unnamed perennial stream along the southern portion of the site. The shale present in the Waldron Shale formation located at the base of the Louisville Limestone formation is generally more resistant to dissolution and likely represents a lower boundary or limit to Karst activity in the rock units underlying the site. Therefore, these features are not expected to require additional consideration during planning and development.

Photograph No. 13: Feature SS-14: Photo taken facing north

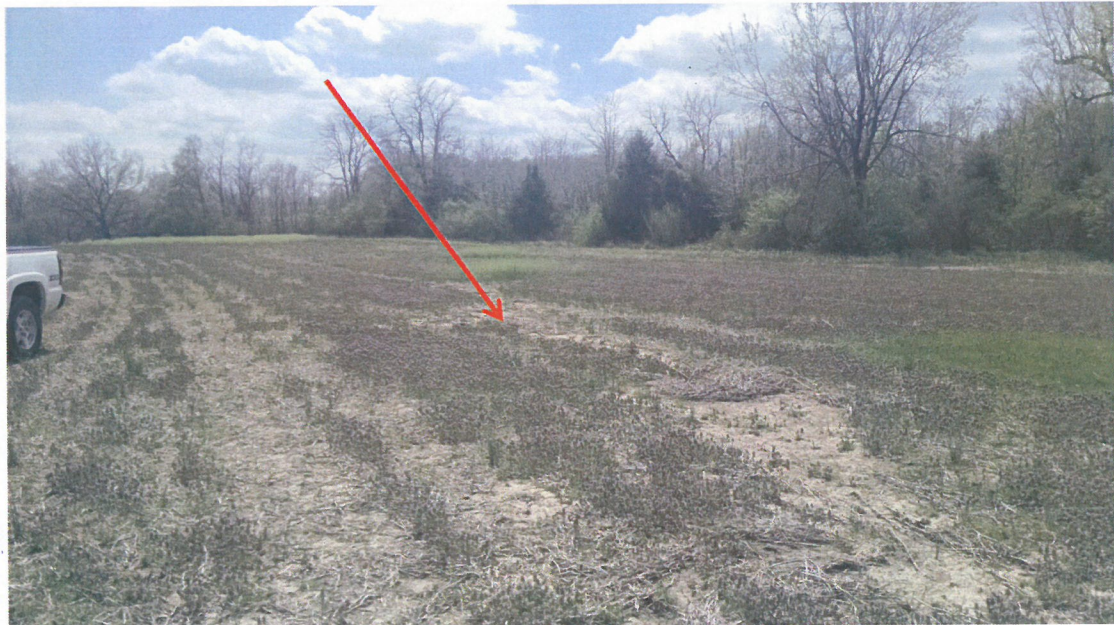
Photograph No. 14: Feature CD-15: Photo taken facing southwest along swale

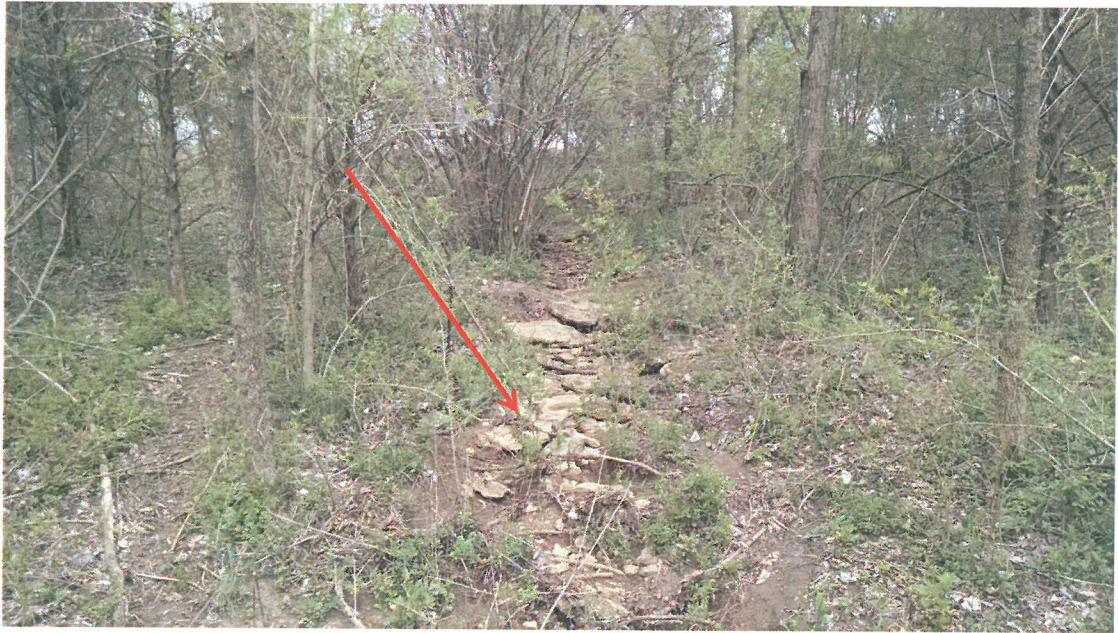
Photograph No. 15: Feature VR-16: Photo taken facing northeast

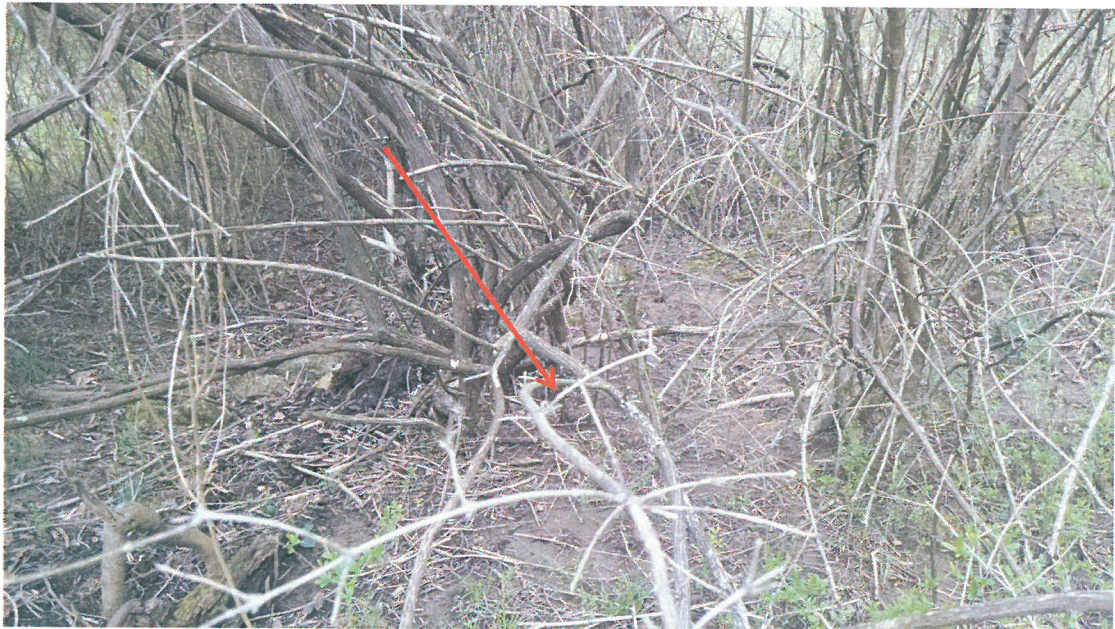
Photograph No. 16: Feature SH-17: Photo taken facing southwest

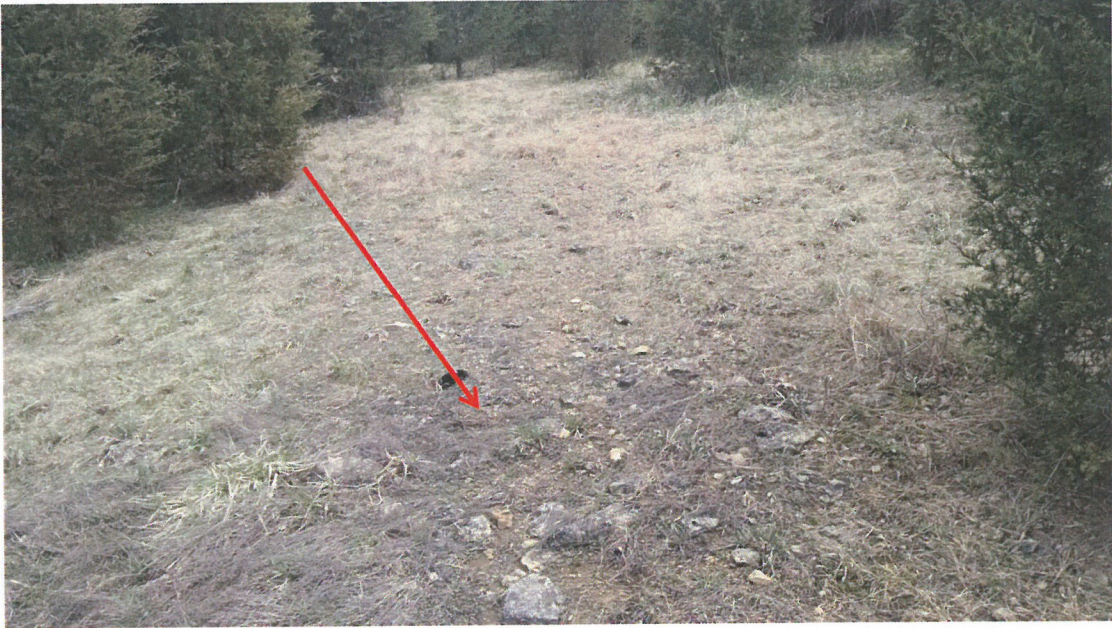
Photograph No. 17: Feature VR-18: Photo taken facing east

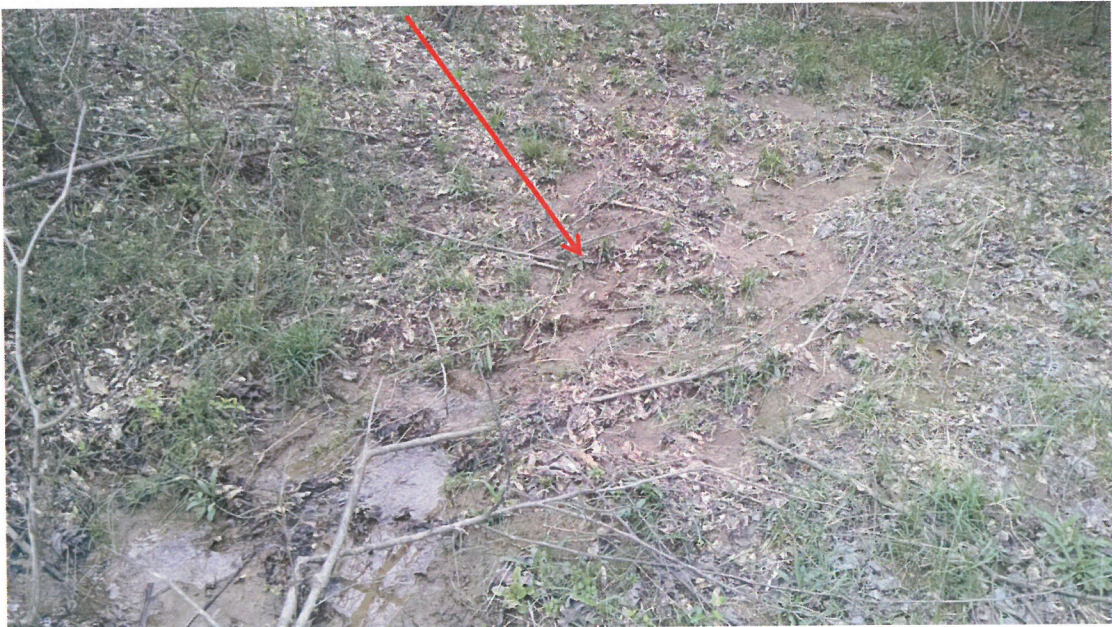
Photograph No. 18: Feature GS-19: Photo taken facing north

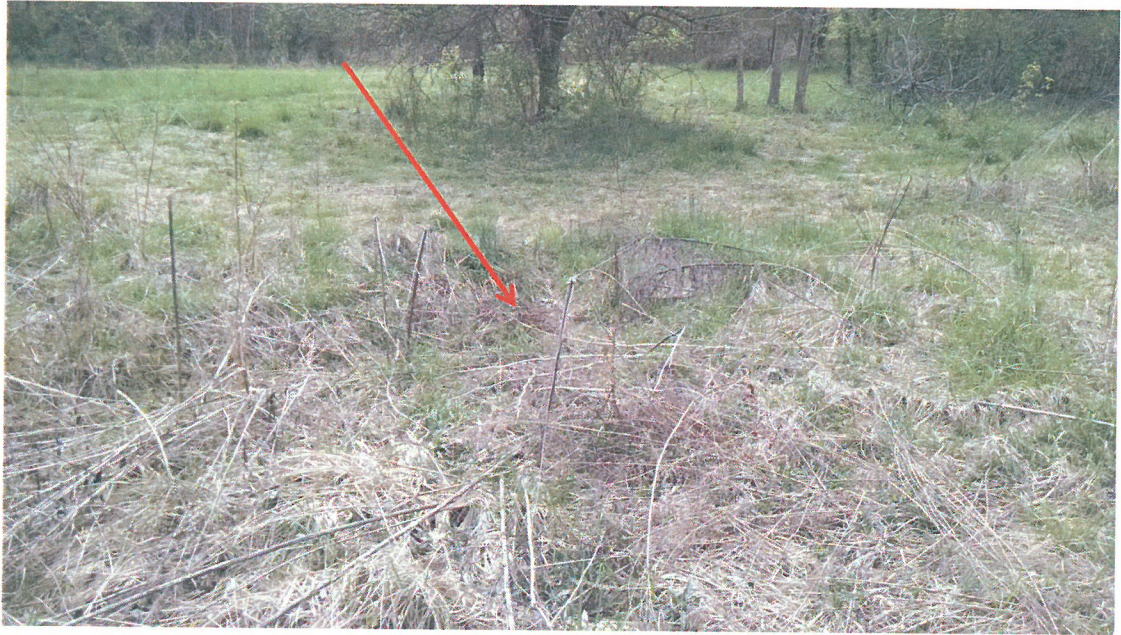
Photograph No. 19: Feature CD-7: Photo taken facing northwest
