Docket No. 21-ZONE-0164  
Zone Change from C-2 to M-2 to allow a  
tractor trailer parking facility on property  
located at 8315 Nash Road

Reference: Pavement Evaluation Letter  
Drum Trucking – Nash Road Pavement Evaluation  
8315 Nash Road  
Louisville, Jefferson County, Kentucky 40214  
ECS Project No. 61-2707

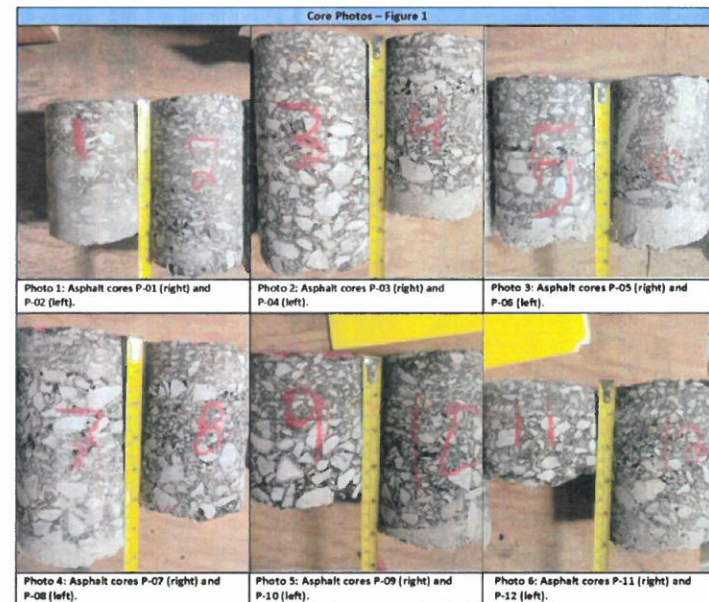
In general, the surface materials consisted of approximately 4 to 7 inches (average of approximately 5 1/4 inches) of asphalt pavement. However, approximately 2 1/4 inches of total asphalt thickness was encountered at P-11. The existing wearing base (surface asphalt) was approximately 1 to 4 inches with a binder or base (base asphalt) of approximately 1 to 6 inches. The existing asphalt was underlain by at least 8 inches of crushed stone and extended to more than 37 inches at P-01. Due to the depth of gravel and the limitations of the available equipment, the gravel base was not penetrated in any of the coring locations. The crushed typically consisted of fine to coarse grained gravel approximately 1/4 to 1 1/4 inches with varying amounts of fines (sand to clay-sized material). No signs of significant distress were observed in the pavement cores. Refer to the **Core Photos - Figure 1** for photos of the cores recovered.

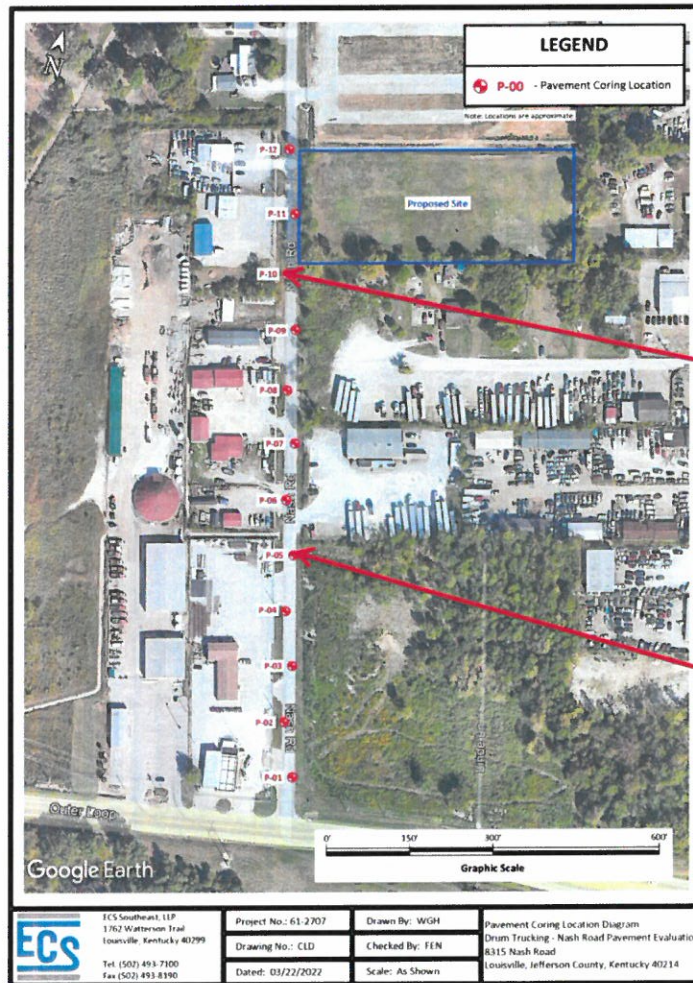
Locations of core samplings

In general, isolated areas of slight transverse/longitudinal cracking, typical of in-use pavements, was observed over most areas and no significant cracks, rutting, or distress was observed over most areas evaluated. However, moderate cracking and degradation was observed in the area near P-11, specially along the east shoulder of the road. Refer to the **Pavement Photos - Figure 2** for photos of the areas cored.

Roadway width minimum is 20.2 ft at sampling locations

The pavement sections encountered in the pavement coring appeared suitable for the volume of truck traffic (Daily Equivalent 18-kip Axle Loads of 30) based on the provided information (6 loaded and 6 unloaded additional trucks) and traffic conditions at the time of our exploration. However, based on the observed thickness and poor condition of the asphalt pavement near P-11, a 2-inch asphalt overlay should be considered in these areas.

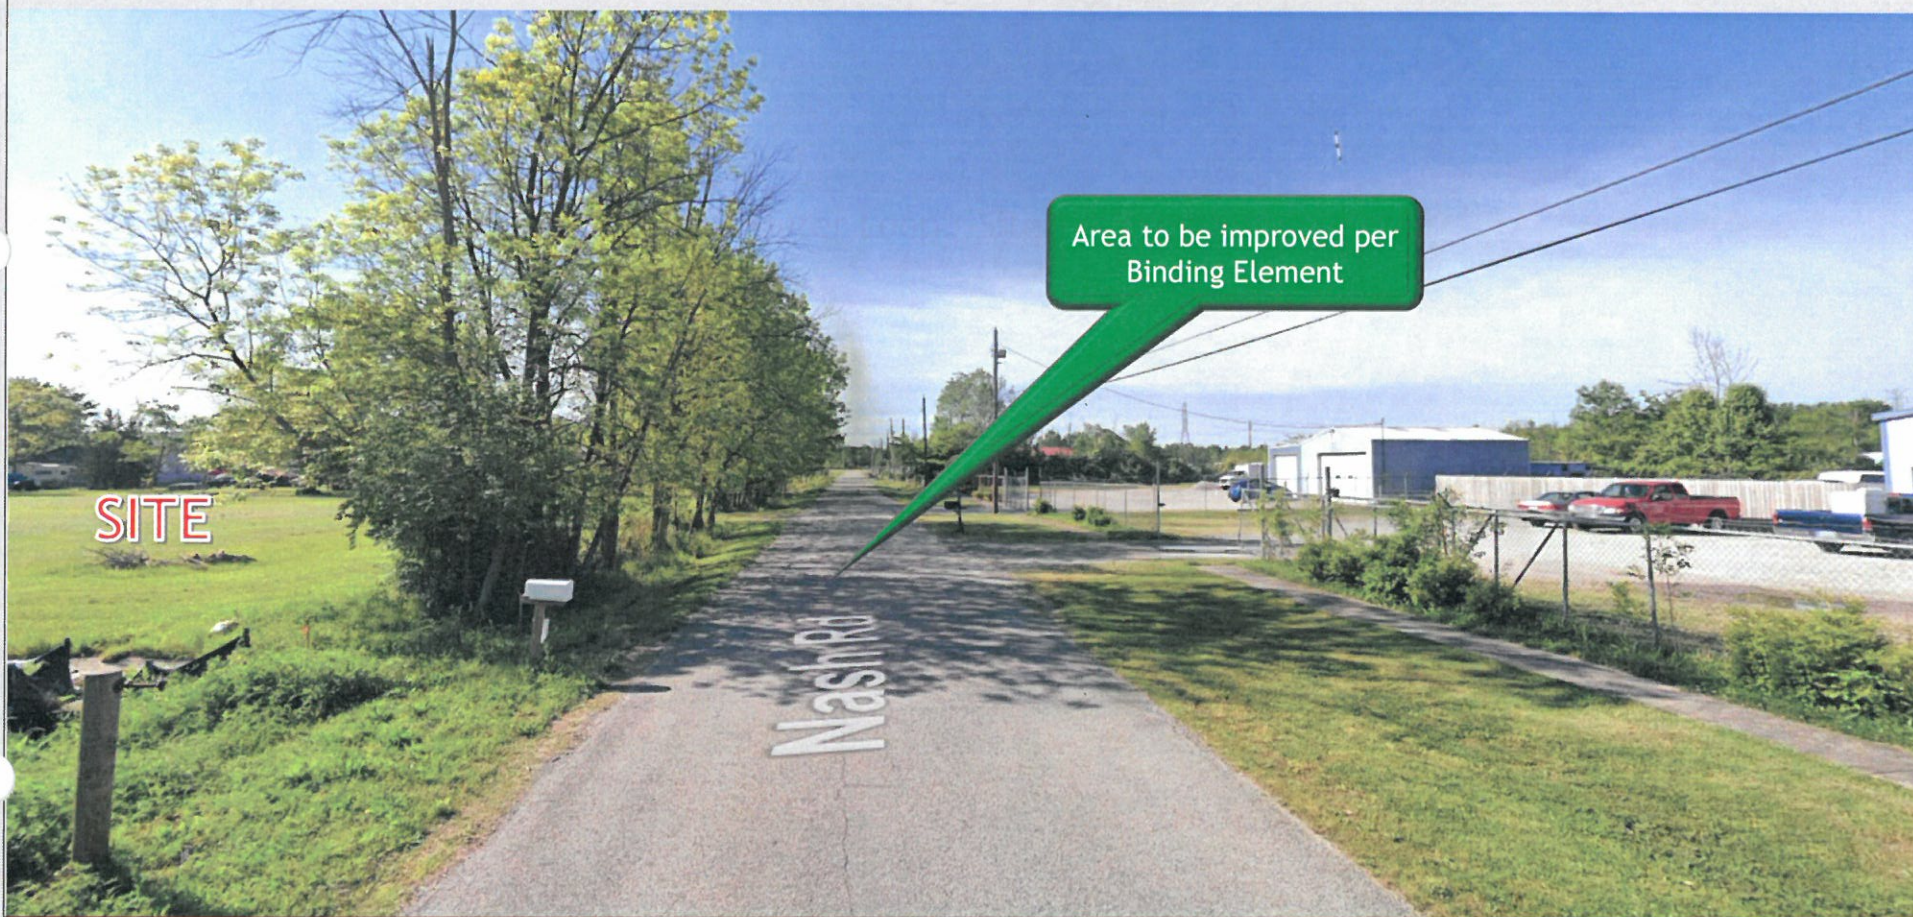
Area to be improved per  
Binding Element

- Applicant to reconstruct Nash Road adjacent to the proposed site to include at minimum 6 inches of asphalt. The work shall include the removal of asphalt and stone 6 inches deep, proof roll the area, and add 4 inches of base, and 2 inches of surface, in the area shown on the Pavement Evaluation Report (being approximately 100' x 20' wide).

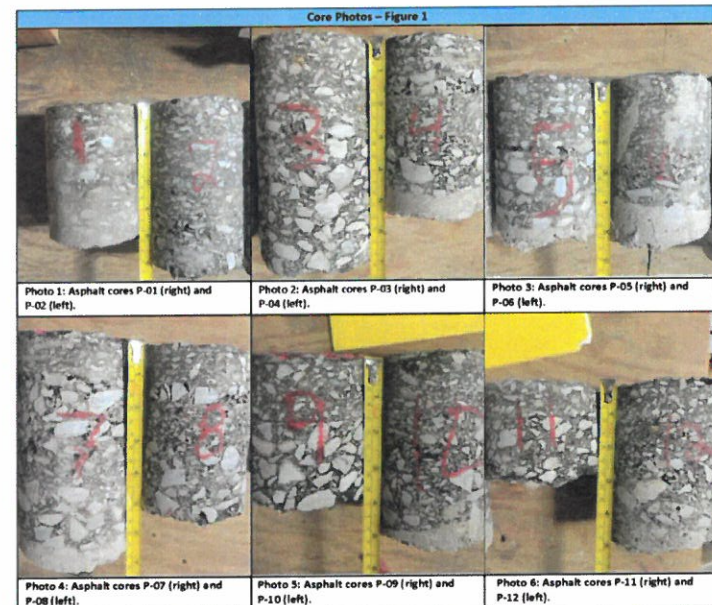
In general, the surface materials consisted of approximately 4 to 7 inches (average of approximately 5 1/4 inches) of asphalt pavement. However, approximately 2 1/4 inches of total asphalt thickness was encountered at P-11. The existing wearing base (surface asphalt) was approximately 1 to 4 inches with a binder or base (base asphalt) of approximately 1 to 6 inches. The existing asphalt was underlain by at least 8 inches of crushed stone and extended to more than 37 inches at P-01. Due to the depth of gravel and the limitations of the available equipment, the gravel base was not penetrated in any of the coring locations. The crushed typically consisted of fine to coarse grained gravel approximately 1/4 to 1 1/4 inches with varying amounts of fines (sand to clay-sized material). No signs of significant distress were observed in the pavement cores. Refer to the **Core Photos - Figure 1** for photos of the cores recovered.

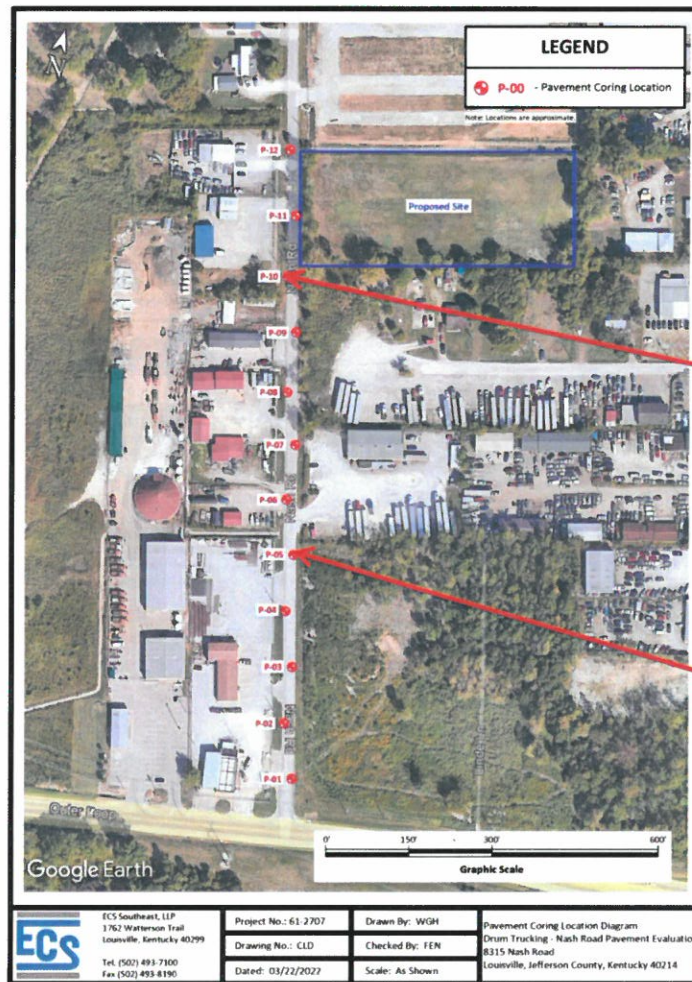
Locations of core samplings

In general, isolated areas of slight transverse/longitudinal cracking, typical of in-use pavements, was observed over most areas and no significant cracks, rutting, or distress was observed over most areas evaluated. However, moderate cracking and degradation was observed in the area near P-11, specially along the east shoulder of the road. Refer to the **Pavement Photos - Figure 2** for photos of the areas cored.

Roadway width minimum is 20.2 ft at sampling locations

The pavement sections encountered in the pavement coring appeared suitable for the volume of truck traffic (Daily Equivalent 18-kip Axle Loads of 30) based on the provided information (6 loaded and 6 unloaded additional trucks) and traffic conditions at the time of our exploration. However, based on the observed thickness and poor condition of the asphalt pavement near P-11, a 2-inch asphalt overlay should be considered in these areas.
