# Demolition Request

## 2130 New Main Street

# Objective: Urban Greenspace 2130 New Main Street

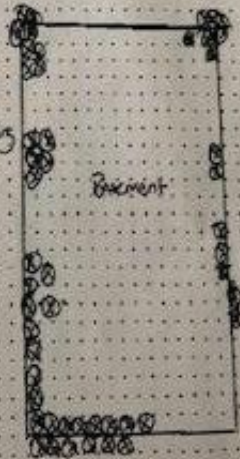
⊗ = Termite + Moisture Damage  
to floor joist, sill plate, foundation  
subfloor, window sills, wall studs  
paint + dry wall, term, ground terming

The termite and moisture inspection graph indicates termite damage throughout the perimeter. Note how much damage is along the east/left wall, adjacent to the USPO, and inaccessible.

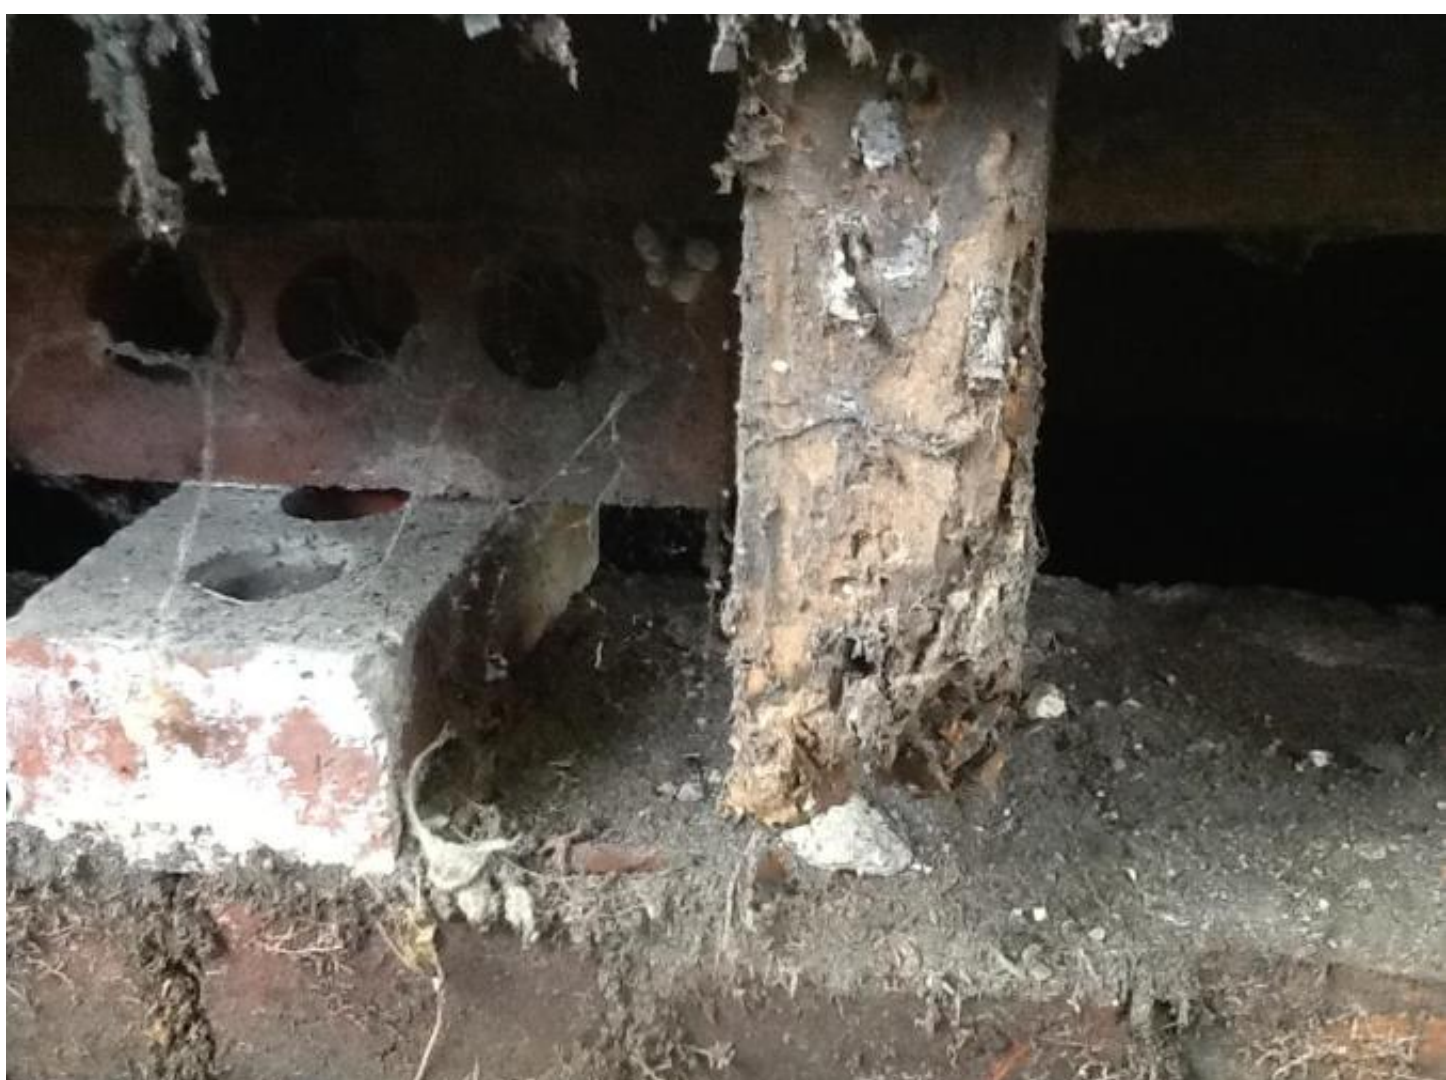
Note the  
lack of  
mortar  
between  
bricks.

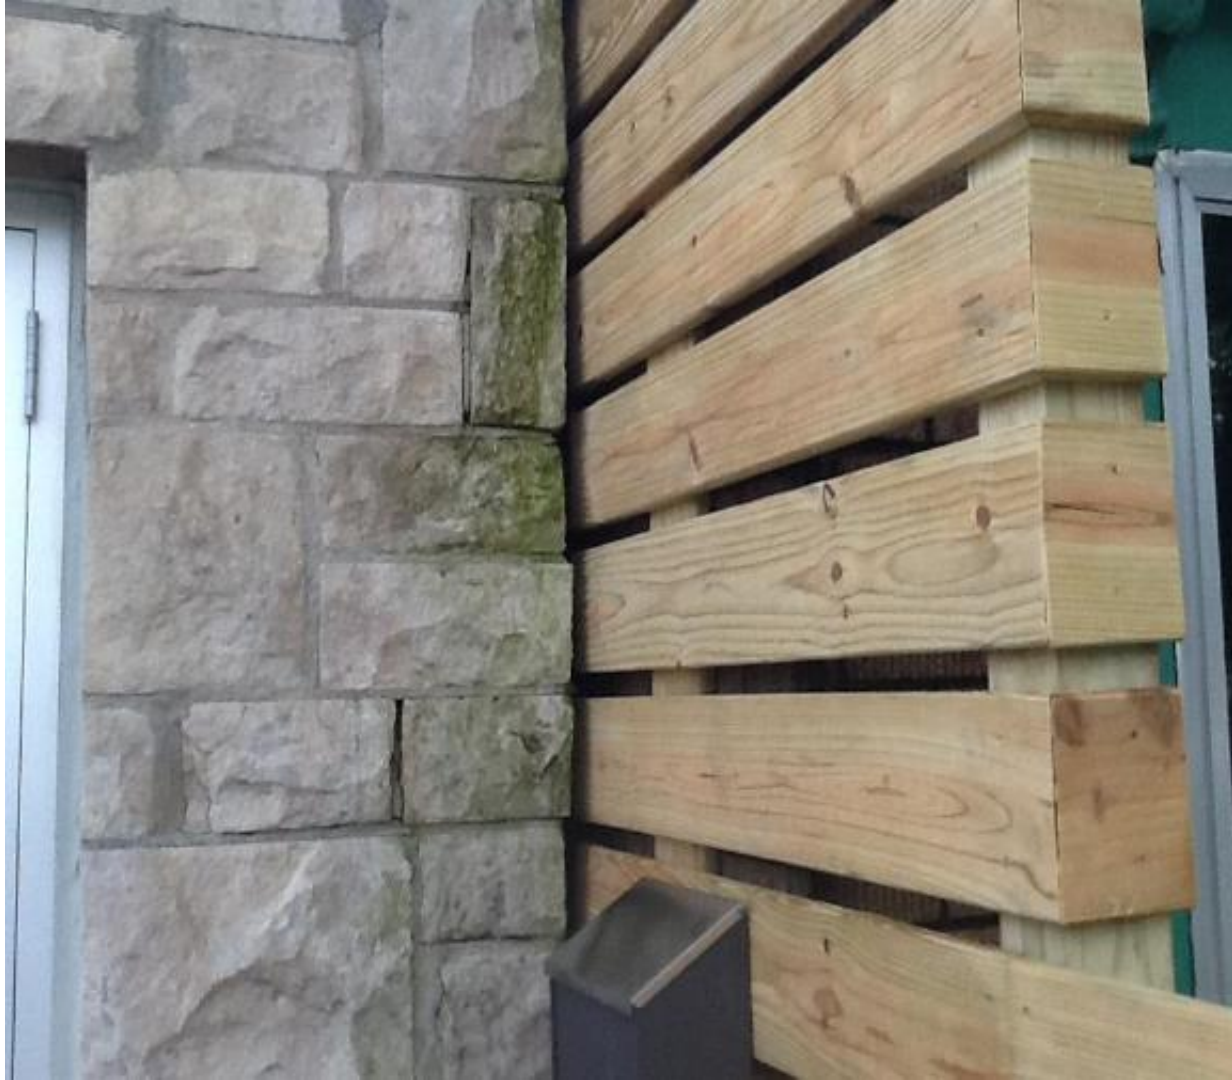
Note the green growth and damage to the mortar and limestone in the next couple of slides.

Replacing the missing mortar can be done only on the accessible north wall. The west wall damage is inaccessible.

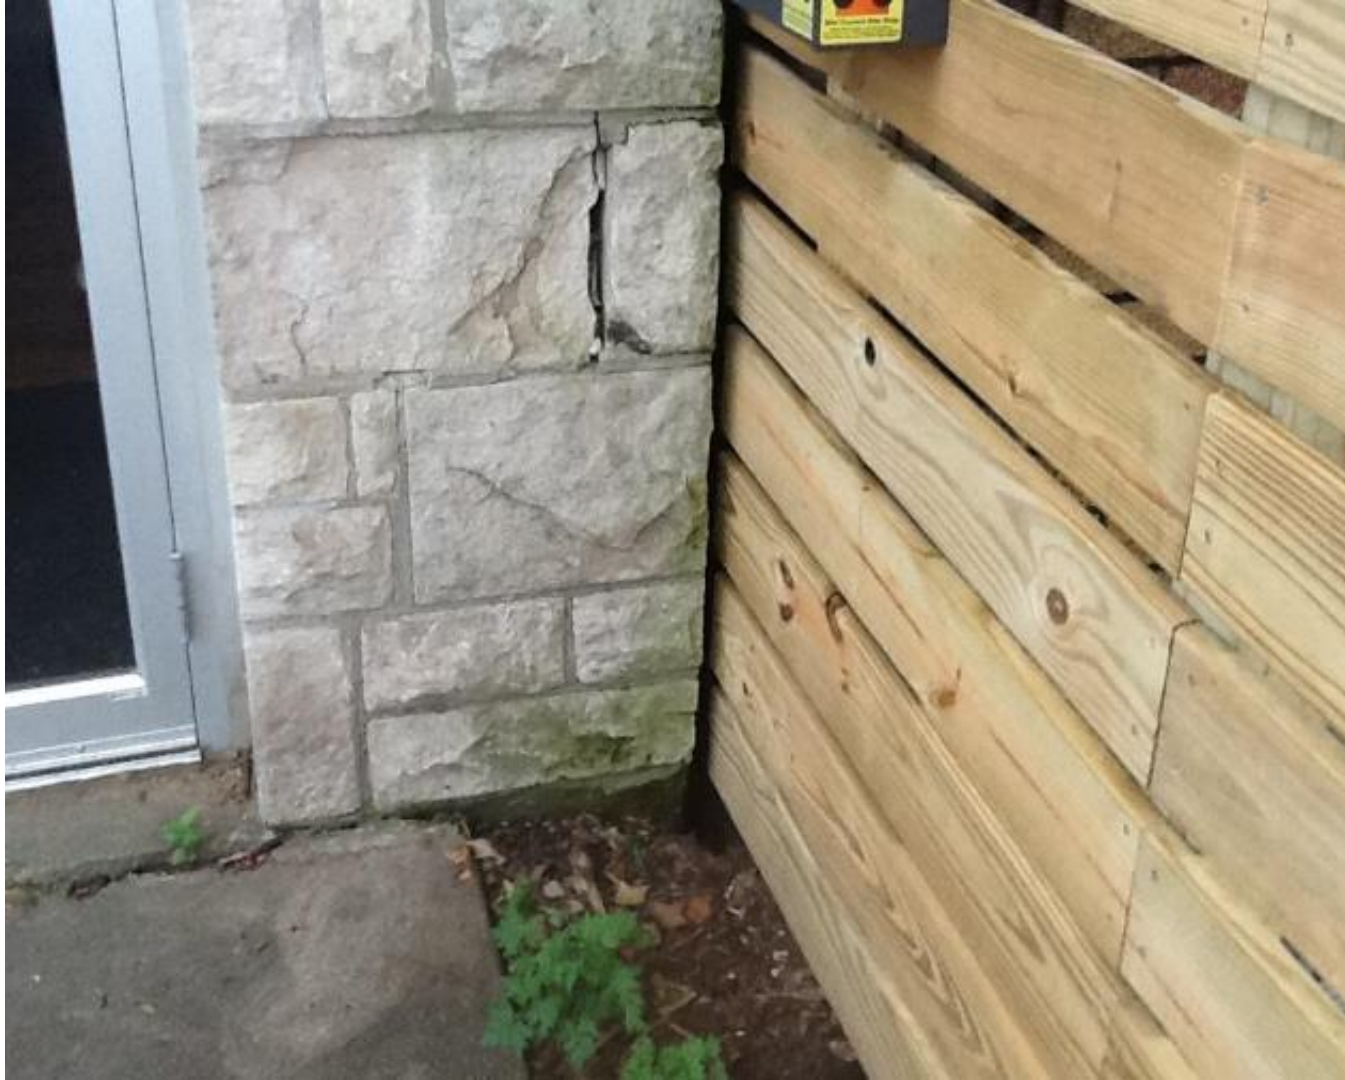
The damage to the north wall of the USPO is mostly cosmetic. Let's take a look at the west wall above the roofline.

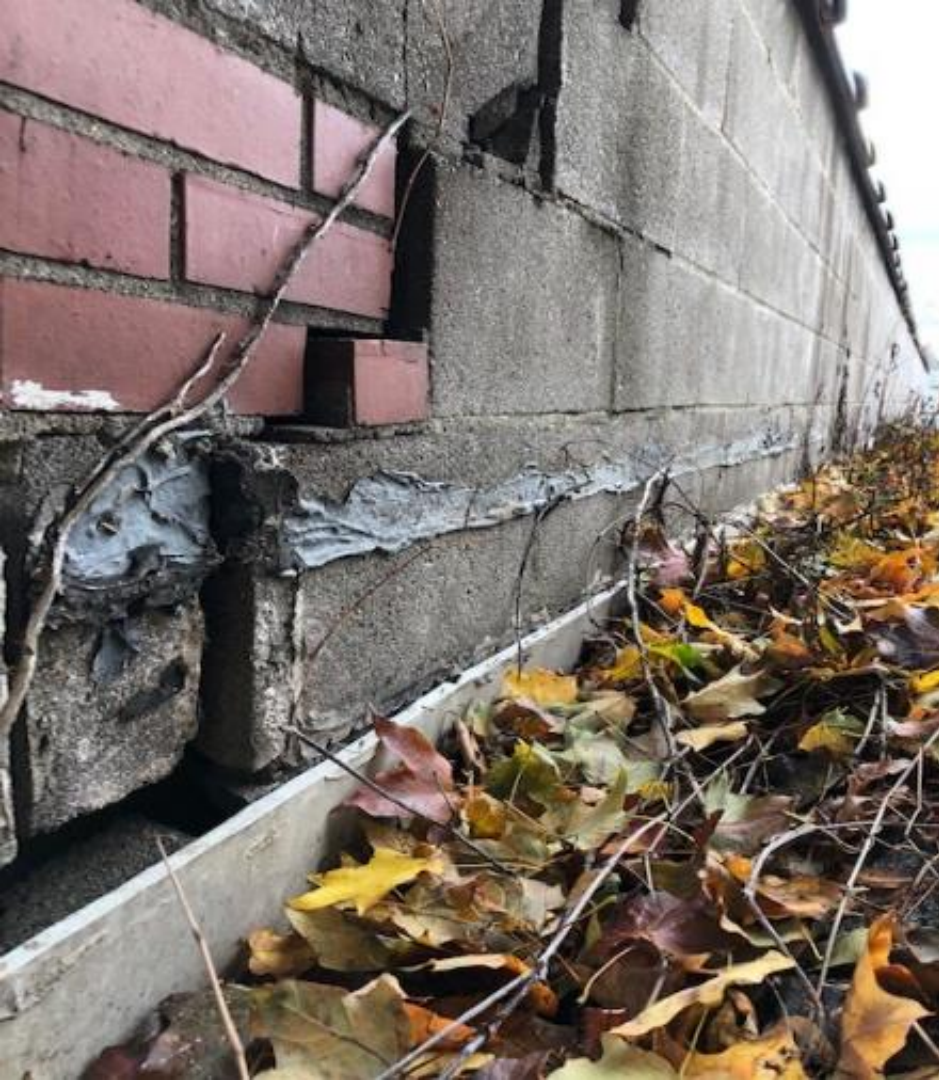
This close up shows a horizontal line of roofing tar running parallel with the roof line of the shotgun. That tar line suggests some structural feature - an earlier effort to protect from water damage. A failed effort.

The west wall and foundation of the USPO need to be accessible below the 'valley'. The only way to gain access is by demolishing the east wall of the shotgun.

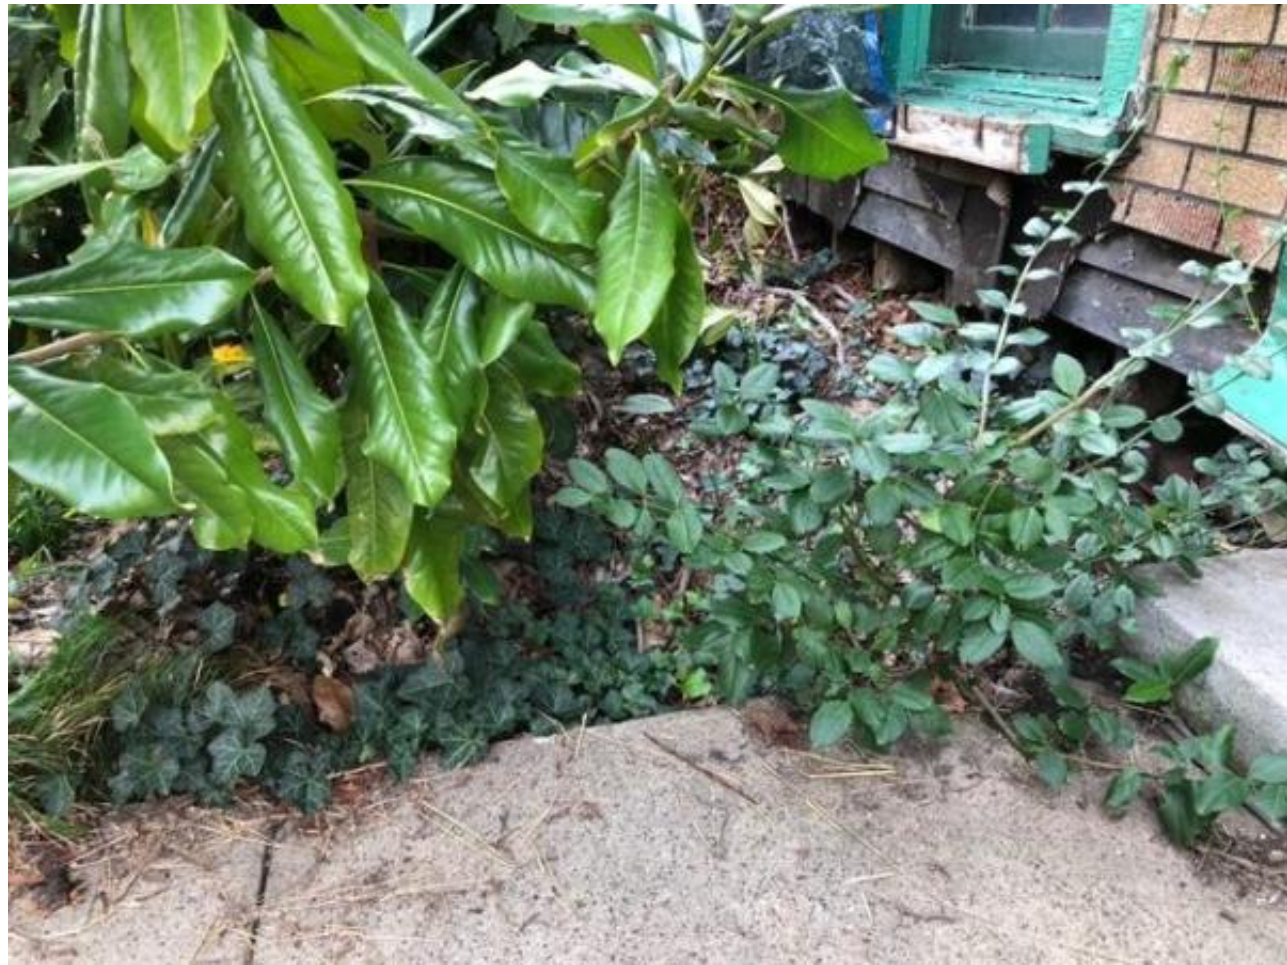
The front yard has begun to sink lower than the walk leading to the front door. Along with the rain and melted snow, the soil is infiltrating the basement.
