Karst Survey Report

Forsee Investments LLC
Lots 11+12 Blankenbaker Station II
Wood Project No. 7382213423

Re: Karst Survey
Blankenbaker Station II Lots 11+12
Schutte Station Place, Jefferson County, KY
Wood Project Number: 7382213423

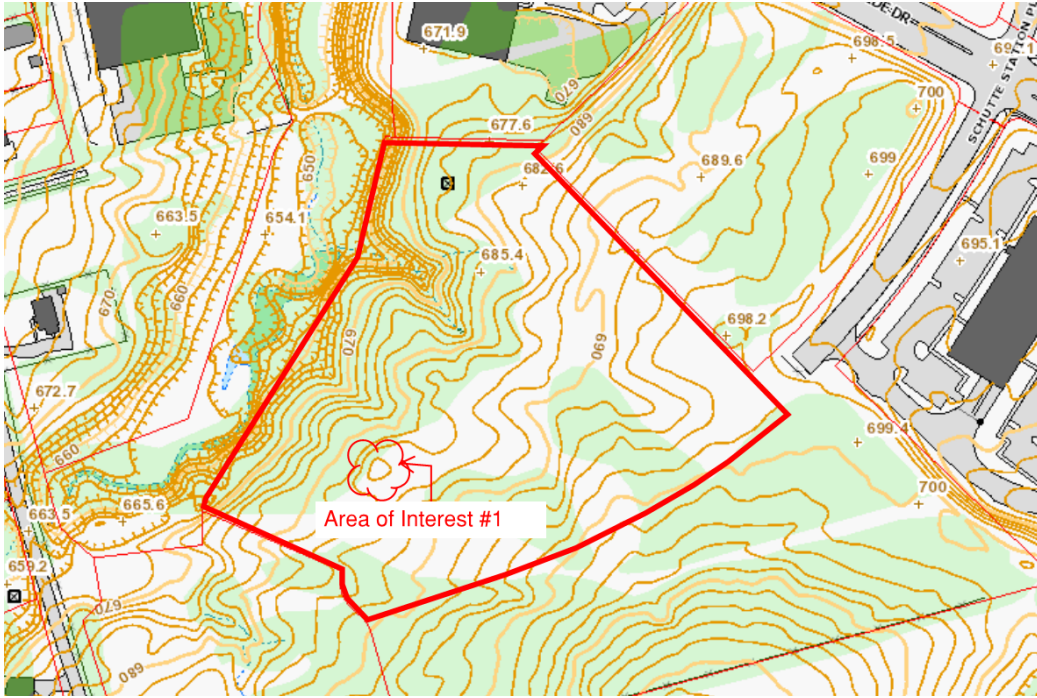
Figure 6. Lojic Topographic Map

The site ground surface ranges in elevation from 660 feet to 700 feet, generally draining to the southwest towards a ravine/creek along the west property line. Topographic mapping was reviewed for indications of surficial Karst which is often illustrated by closed topographic depressions. The image below shows the LOJIC topographic map, with one closed loop topographic area highlighted.

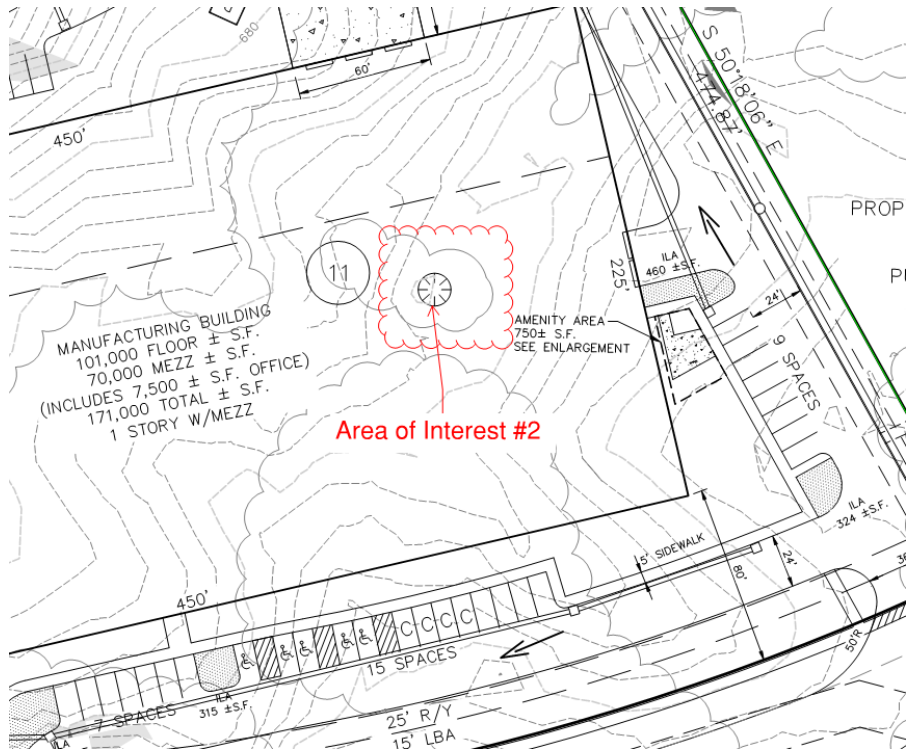
Figure 7. Pre-Application Plan Area of Interest

Additionally, the Pre-application site plan indicated one additional closed topographic depression area.

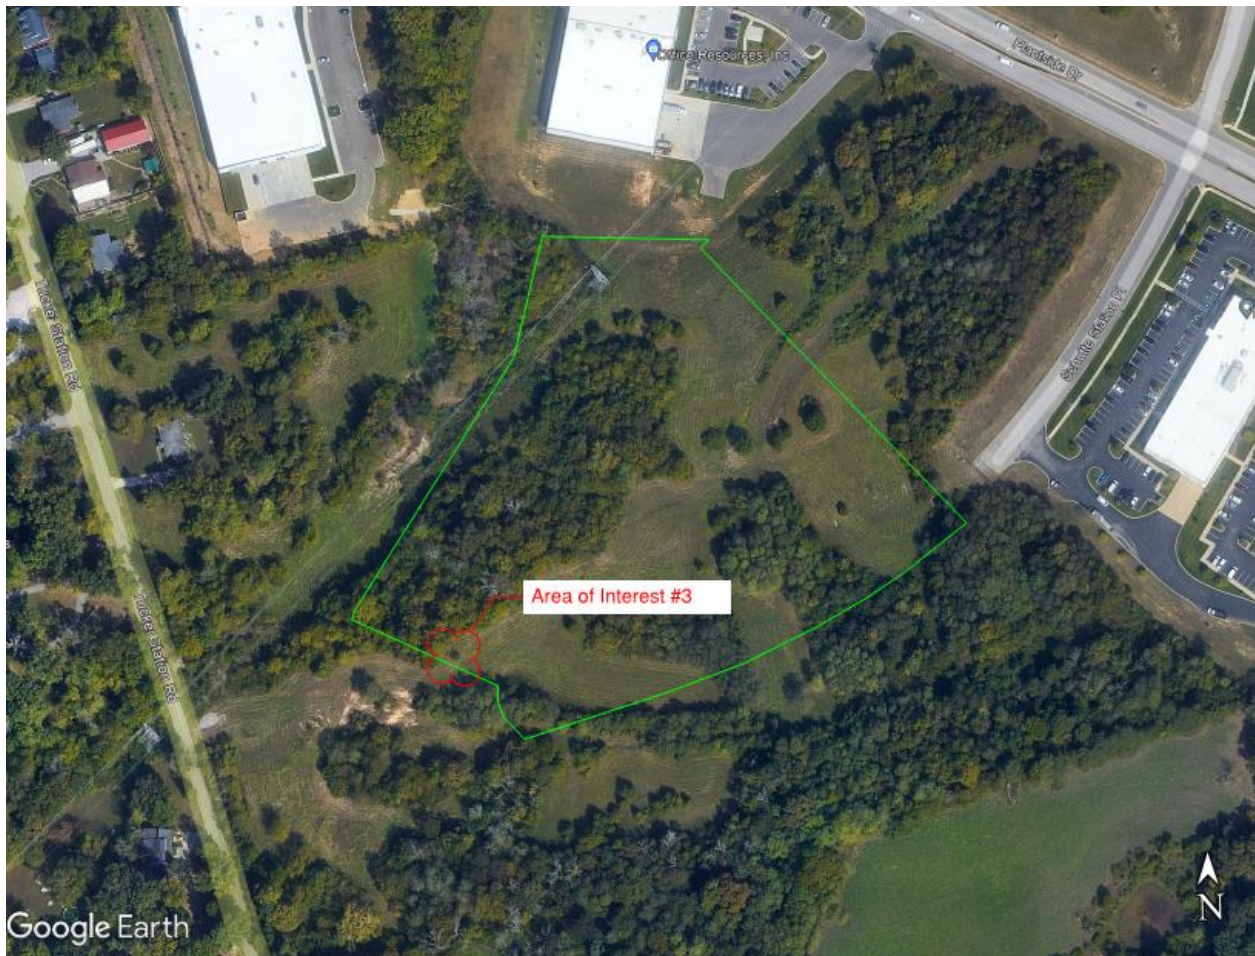
Figure 8. Area of interest 3 - location

A third area of interest was observed during our field visit. This area is confirmed to be an open throat of a karst feature. The feature is located at 38.209299, -85.527179. The location is shown in Figure 8. The feature has the following characteristics. It is an approximately 8ft long by 4ft wide open throat, with a visible depth of about 6 feet. The throat is of low significance, meaning that it can be cleaned and plugged. No rock is visible from the surface, however bedrock is generally shallow at the site. It is estimated that depth to bedrock at this feature is less than 10 feet. A photo of the feature is included in Figure 8 below. Additional site photos are included in the Appendix.

Area of interest #3 was confirmed as an open throat Karst feature. The location of this feature using handheld GPS equipment with an approximate accuracy of 20 feet, indicates under the current development plan, this feature will be situated under a landscaping/parking area, and should not directly affect the proposed structure. This feature may be repaired in the following manner:

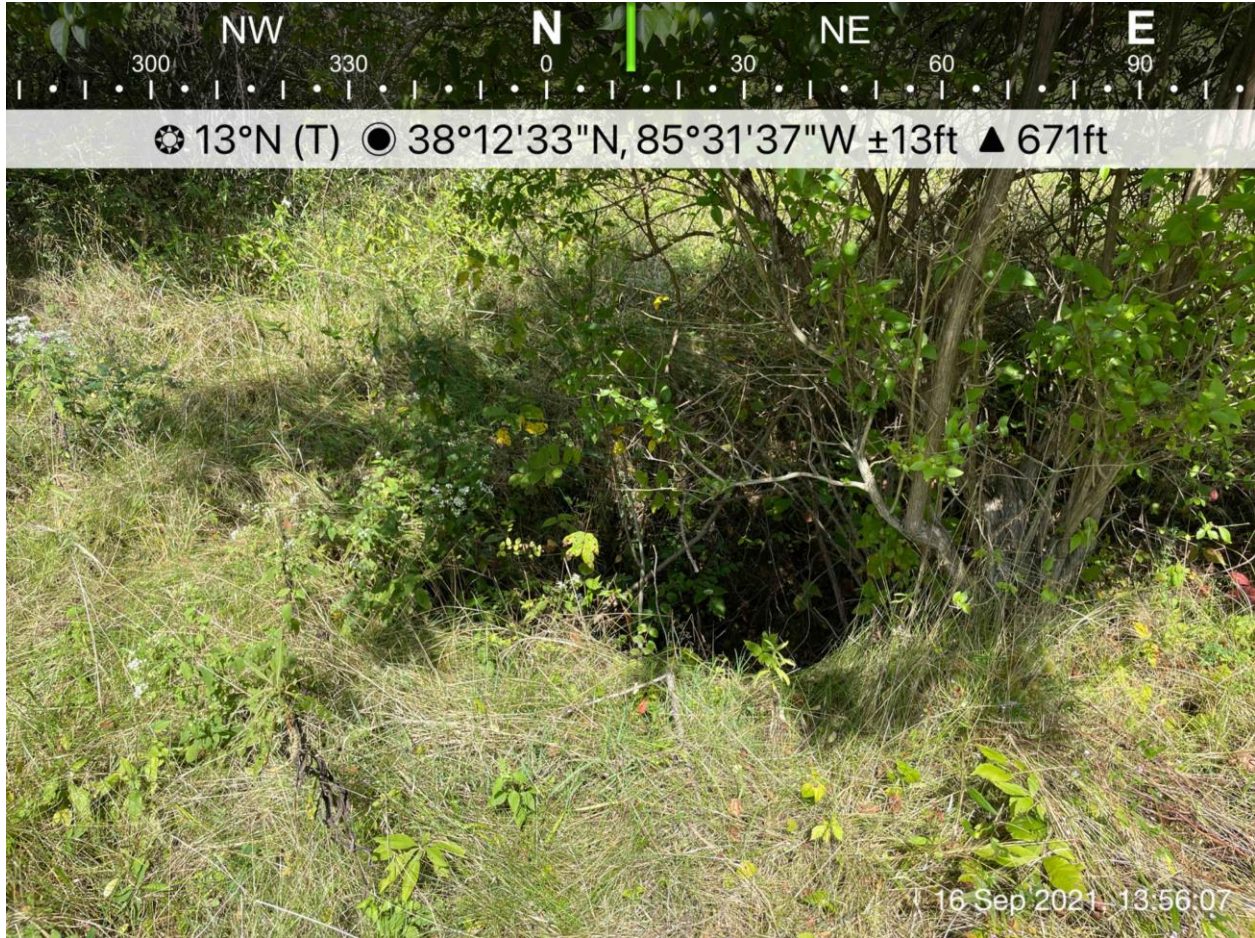
Figure 9. Site photo at Area of Interest #3 - Open Throat

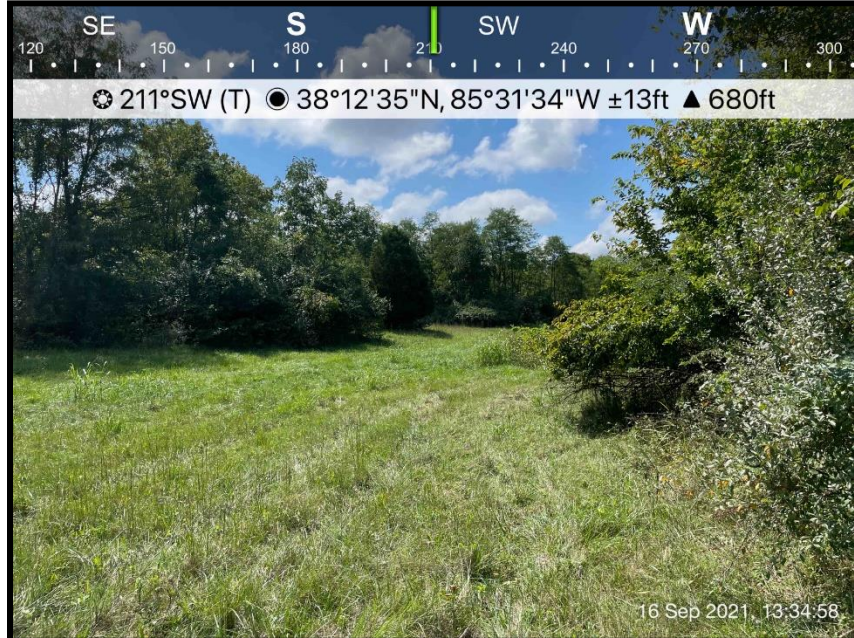
Photo 4: Middle of property looking South towards Area of Interest #1

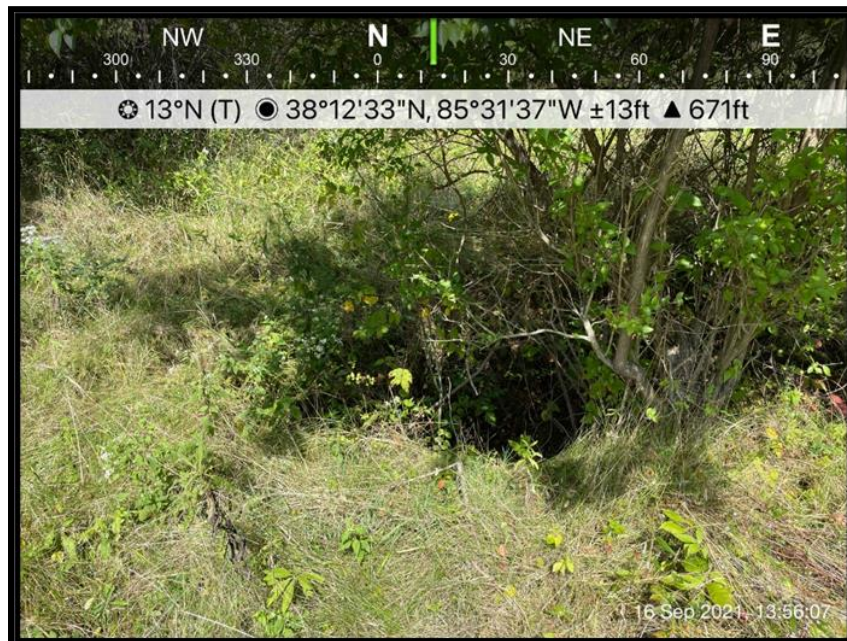
Photo 5: Area of Interest #3 – Open Throat

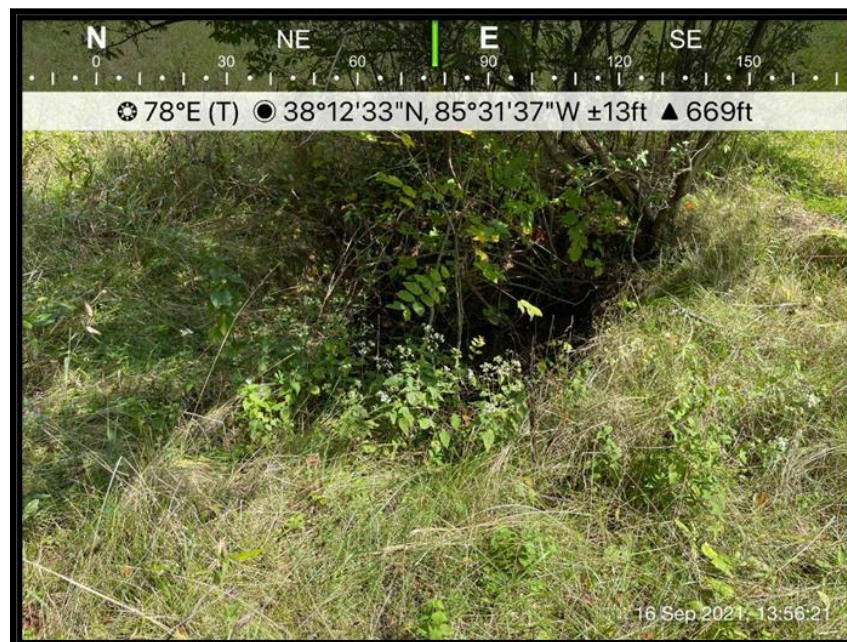
Photo 6: Area of Interest #3 – Open Throat – Alternate View

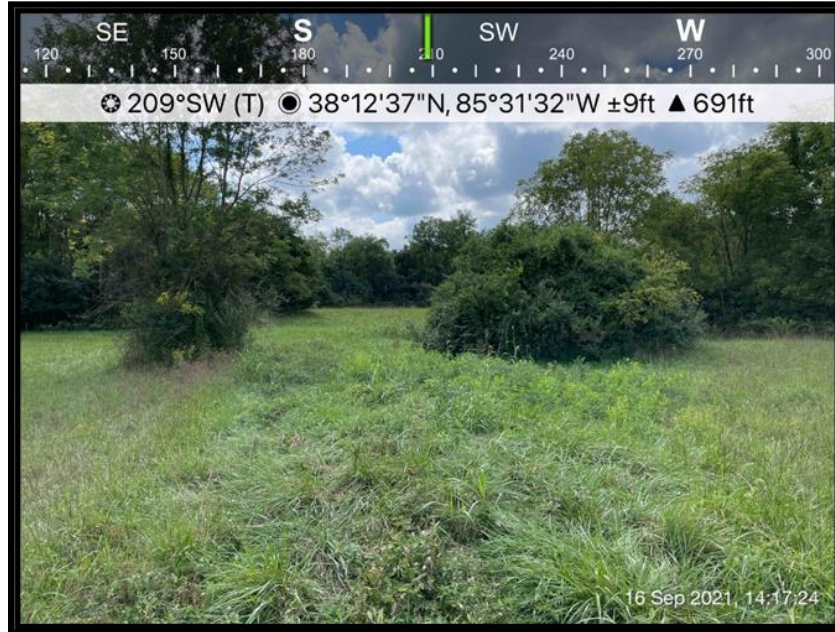
Photo 7: Area of interest #2

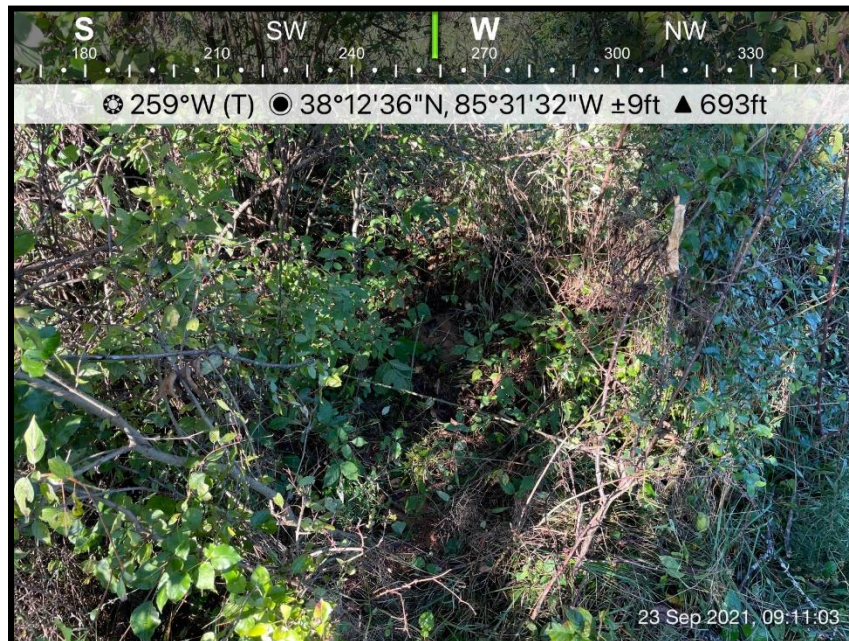
A field visit was completed by William Modrall on September 16th, 2021. William walked the site looking for any signs of potential karst activity. Special attention was given to areas of concern as discussed in the document review above. The attached photo log provides a general site overview, as well as photos of specific features. The closed loop labeled Area of Interest 1 from the topographic map review was observed to be a highpoint, and therefore not a depression of an active karst feature. Area of Interest 2 from the provided application plan was observed, and it is not an active karst feature. Historic grading and road cut, terminates at this location causing an abrupt grade change, but this is due to site grading, not karst.

Photo 8: Area of interest #2 – Road Grading Ridge
