# Former Holy Name School and Convent Evaluation for Use as New Catholic Charities Office Building 8-29-19

# Former Holy Name School Building 3

# Former Holy Name Convent – Building 4

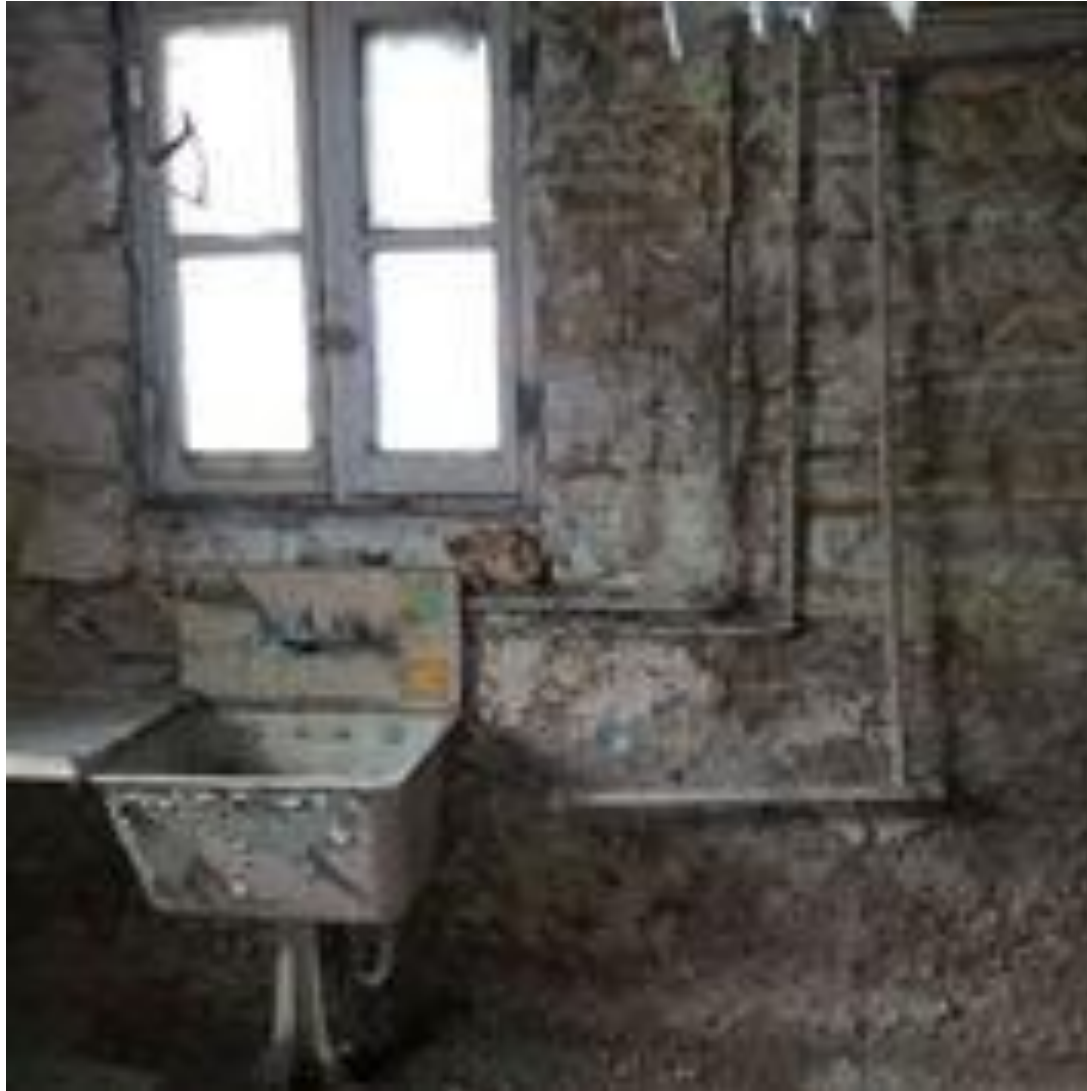
- ICON report – water infiltration

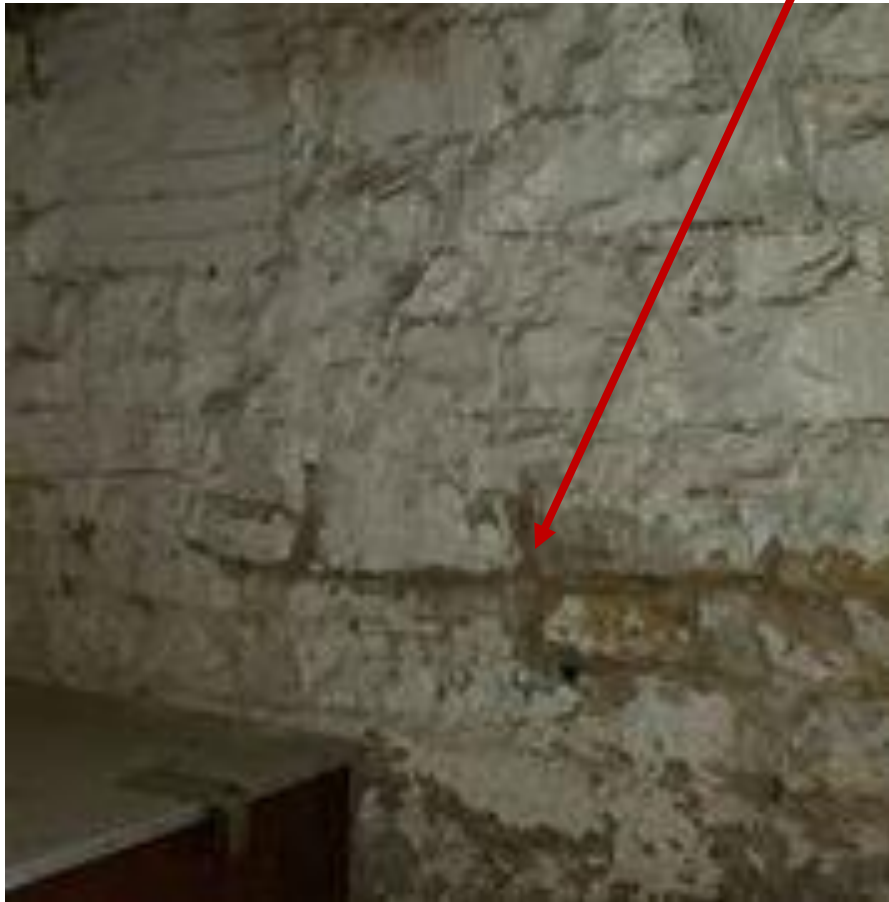
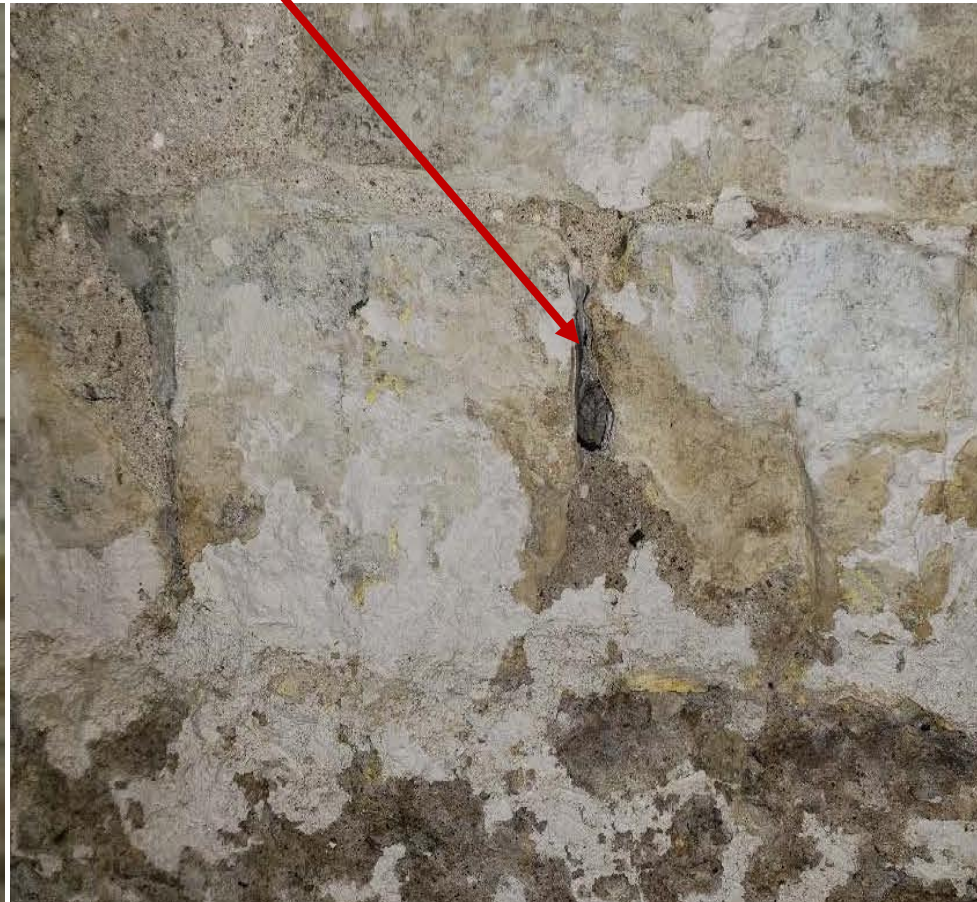
- Mortar deterioration

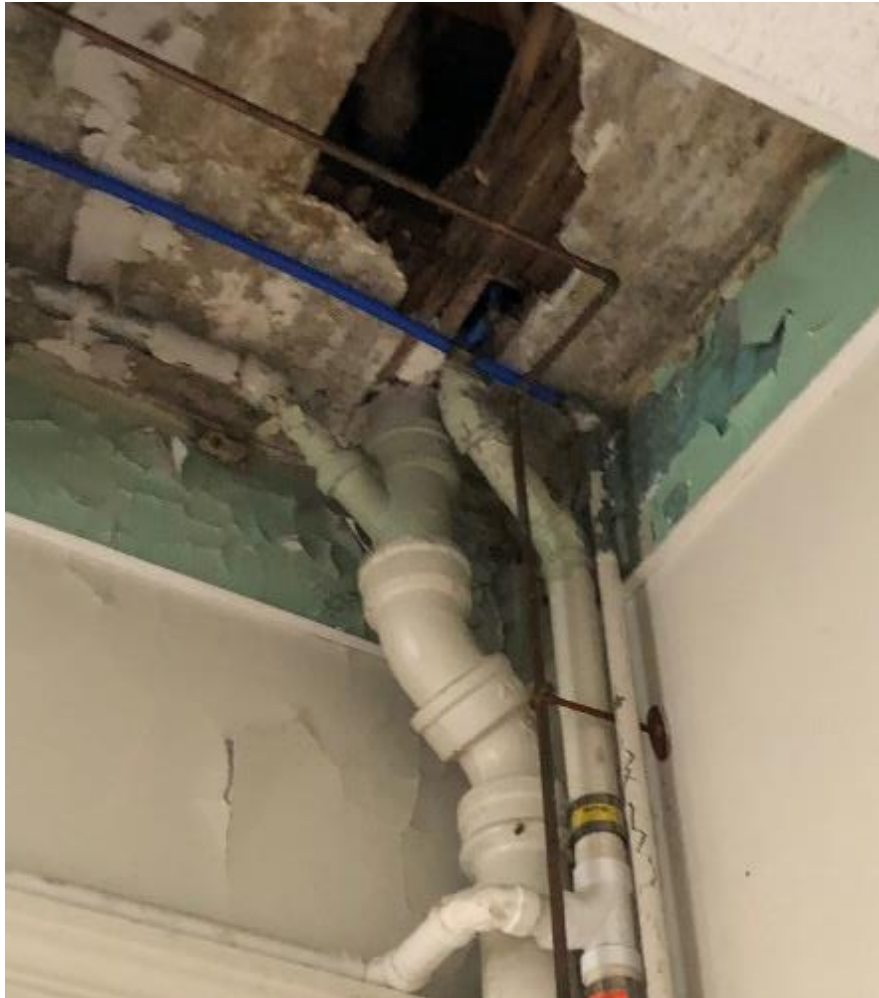
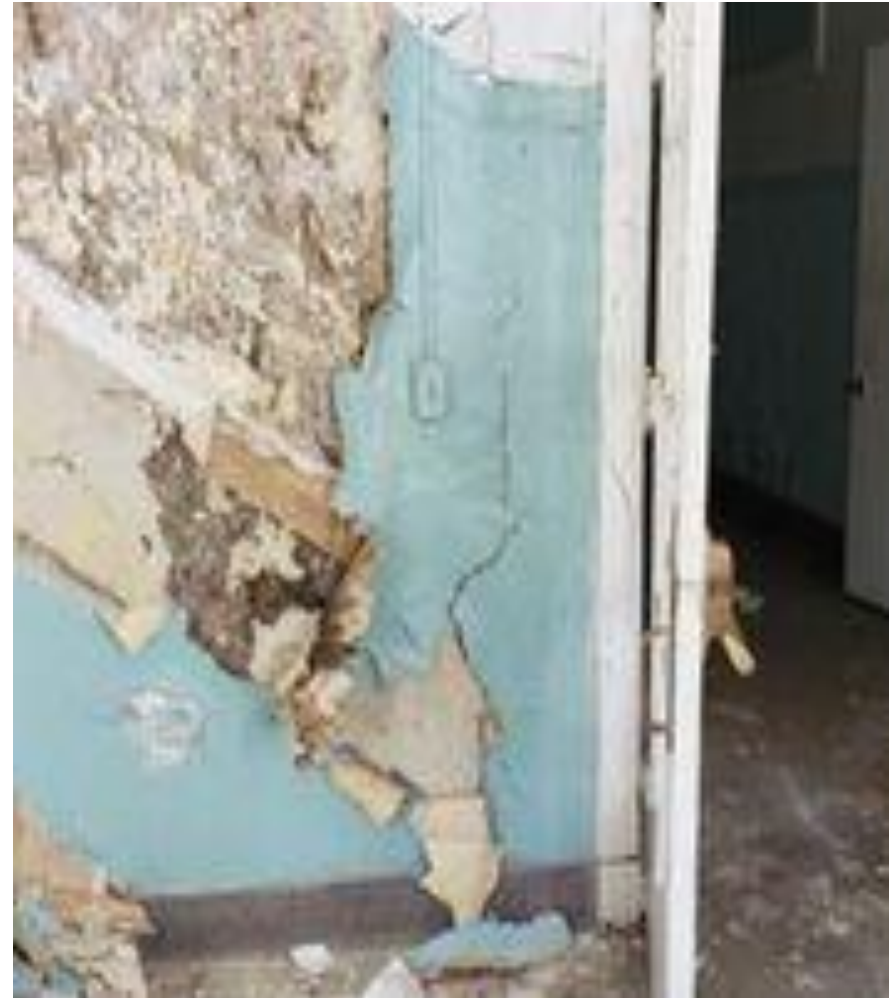
- Building damage due to water infiltration

The floor systems of the existing building were found to be highly inadequate to carry the required floor live loads and partition allowance required by the current building codes. In addition, there is significant damage to the wood structure due to prolonged exposure to infiltrated water. It is our opinion that upgrading the floor system to meet the loading requirements would require complete replacement of the internal structural system and foundations.

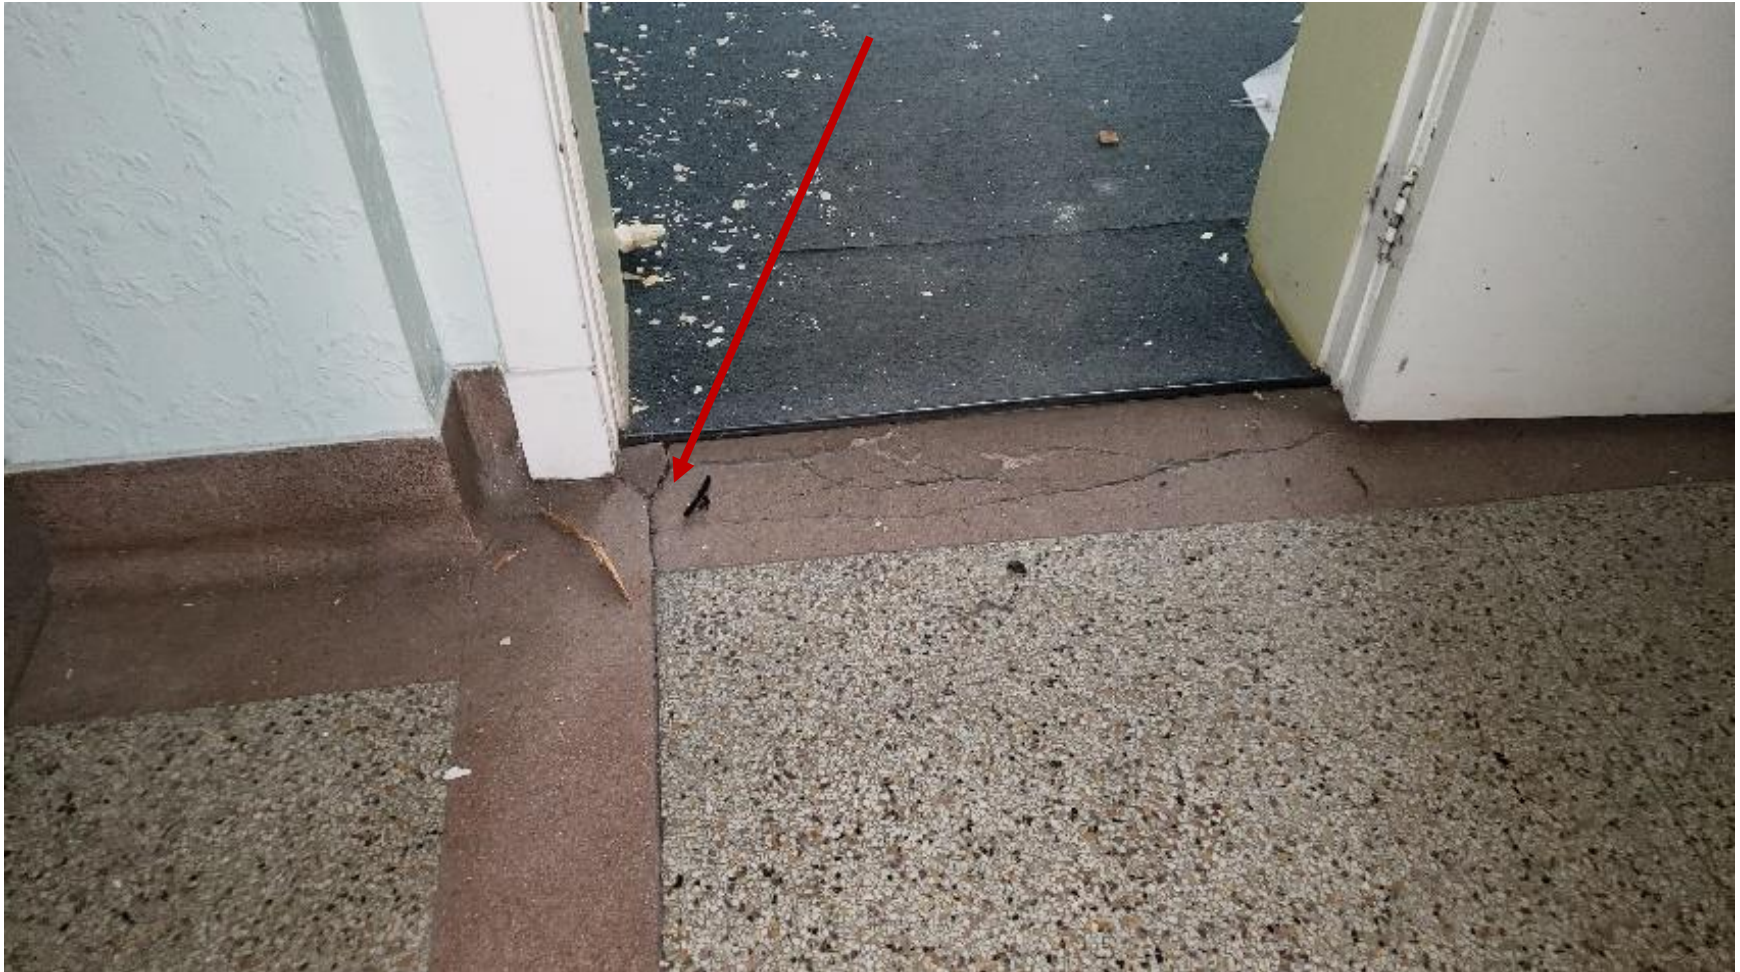
- Differential settlement at building addition

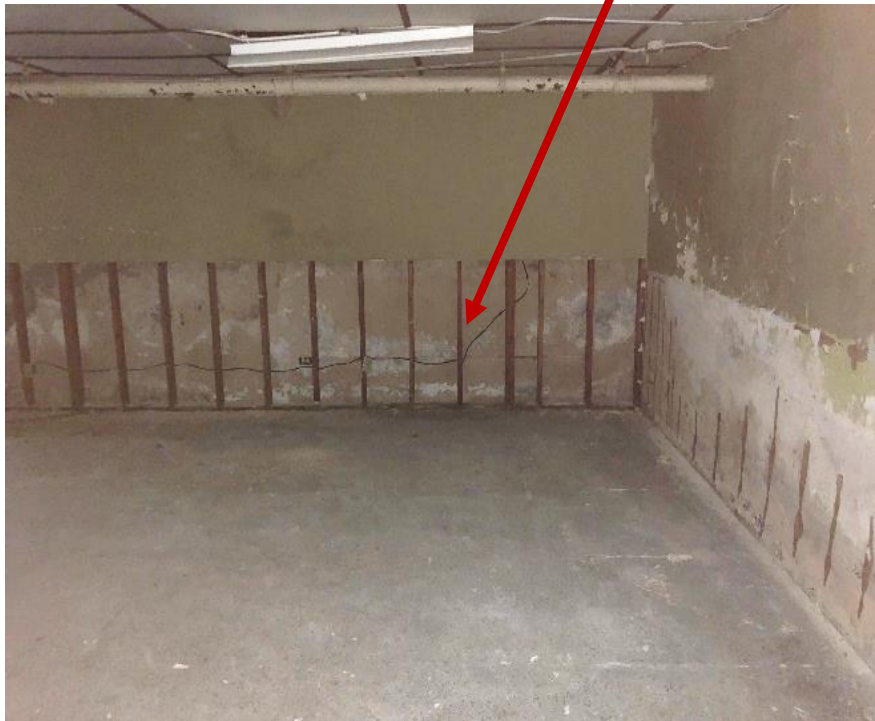
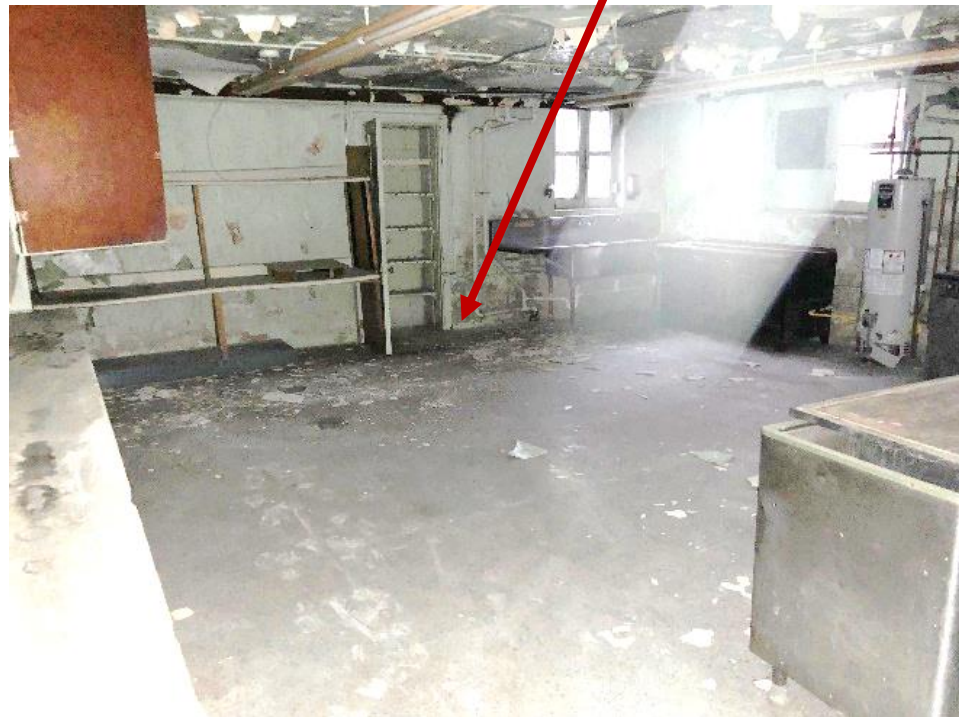
- Water Damage and mold build up

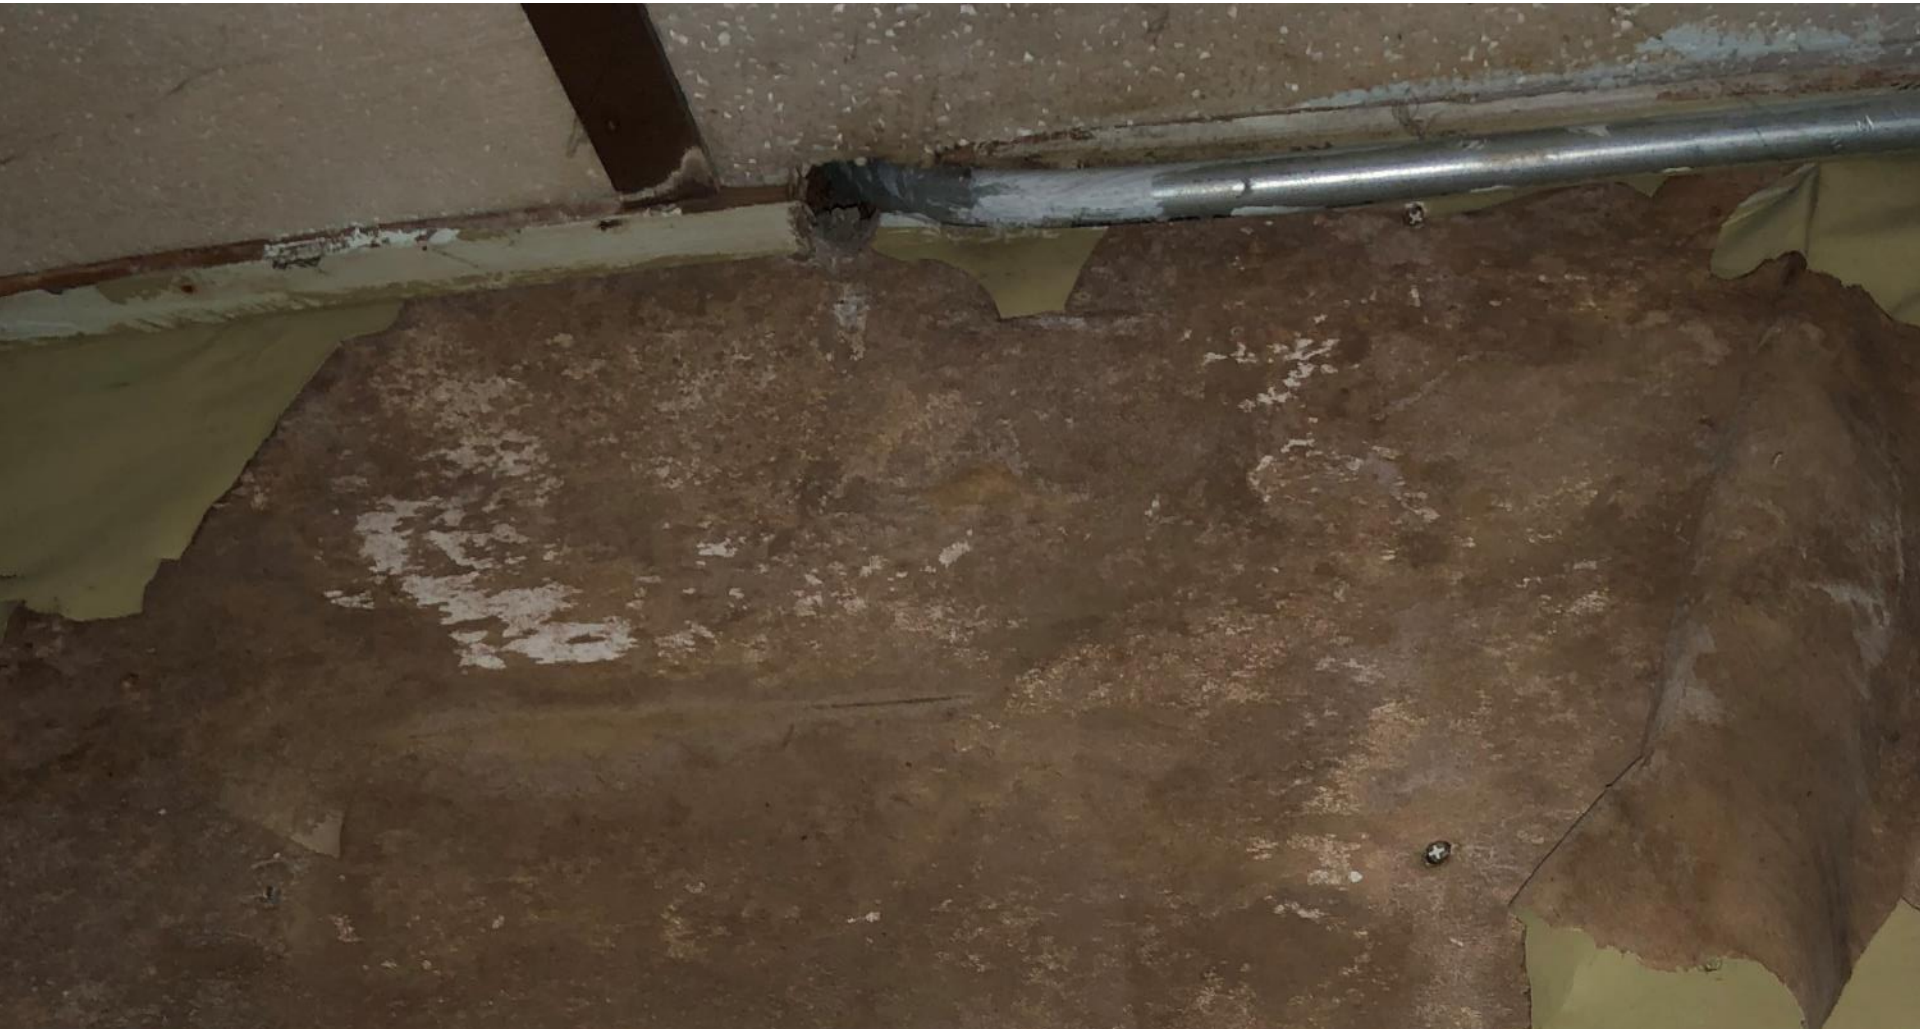
- Mold identified is *Aspergillus Penicillinium* and *Cladosporium*

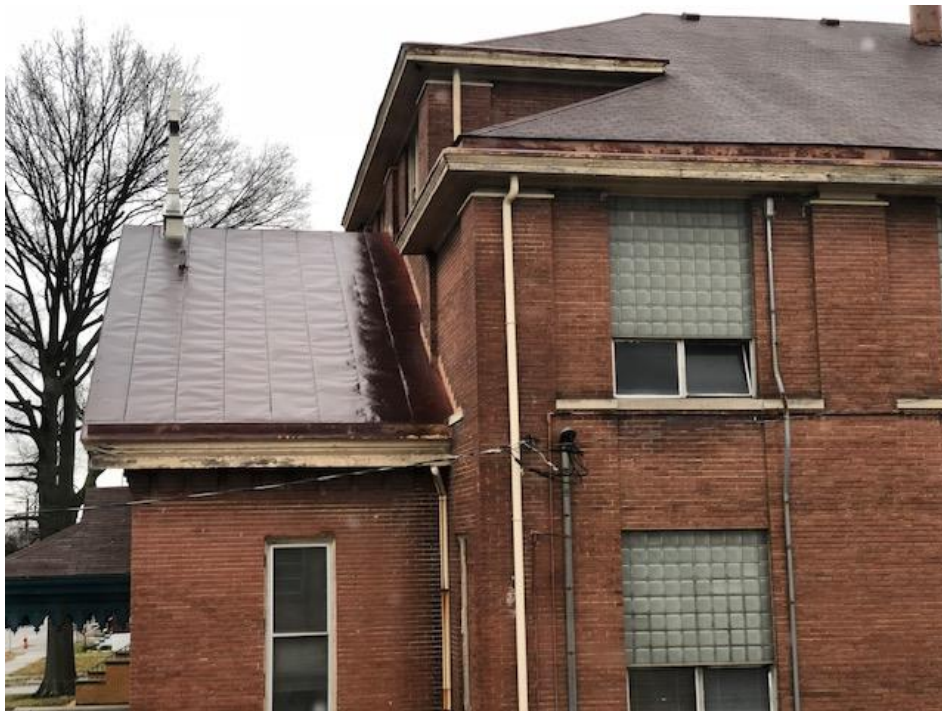
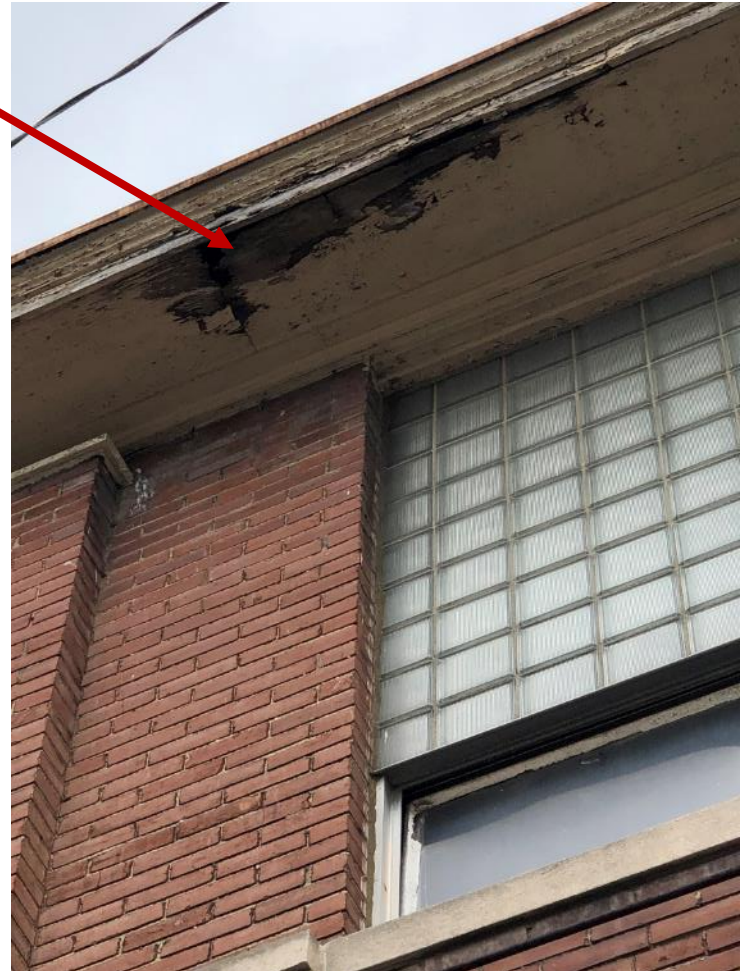
- Replace roof, fascia, and soffit need replacement

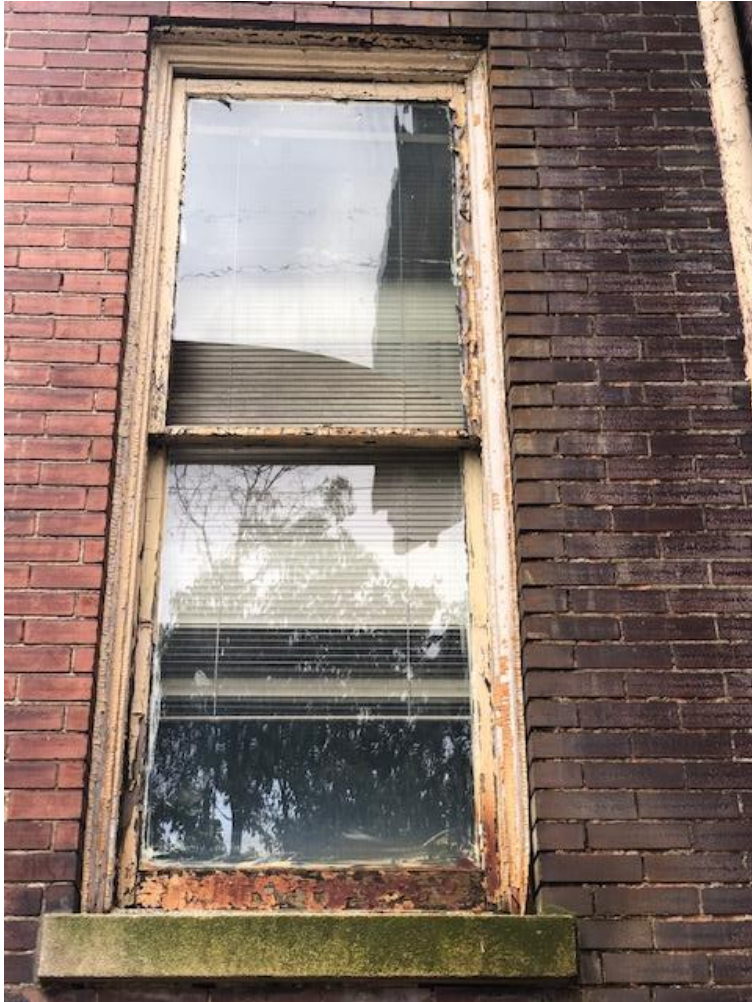
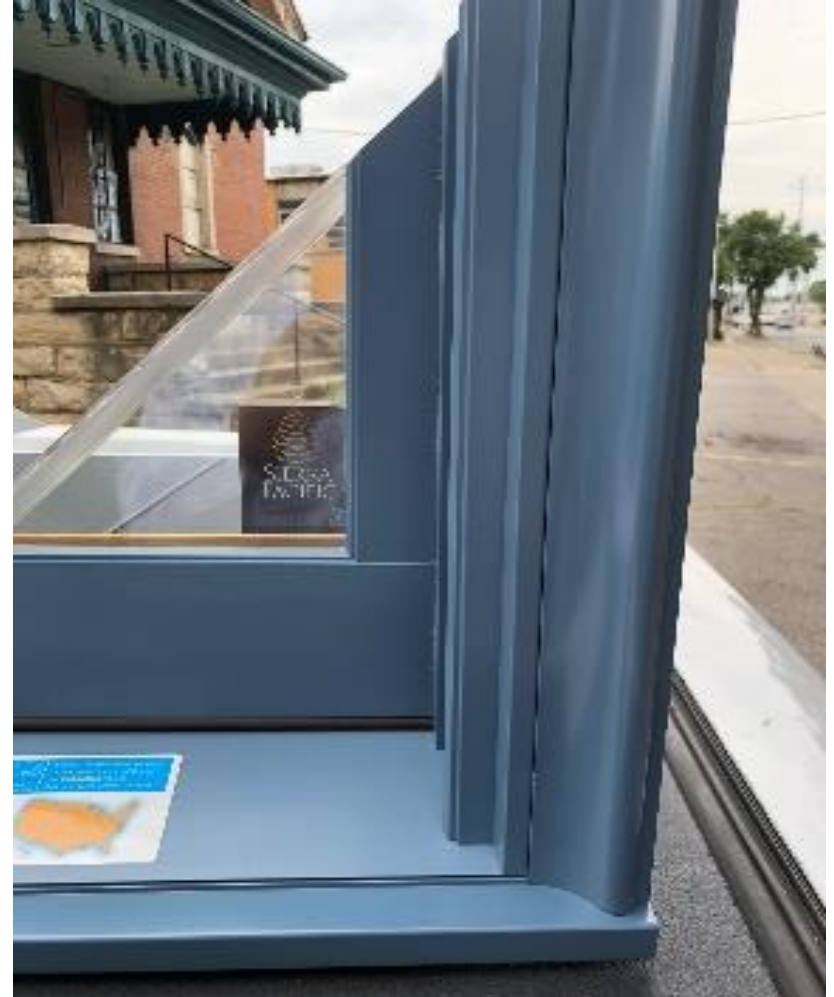
- Windows need replacement

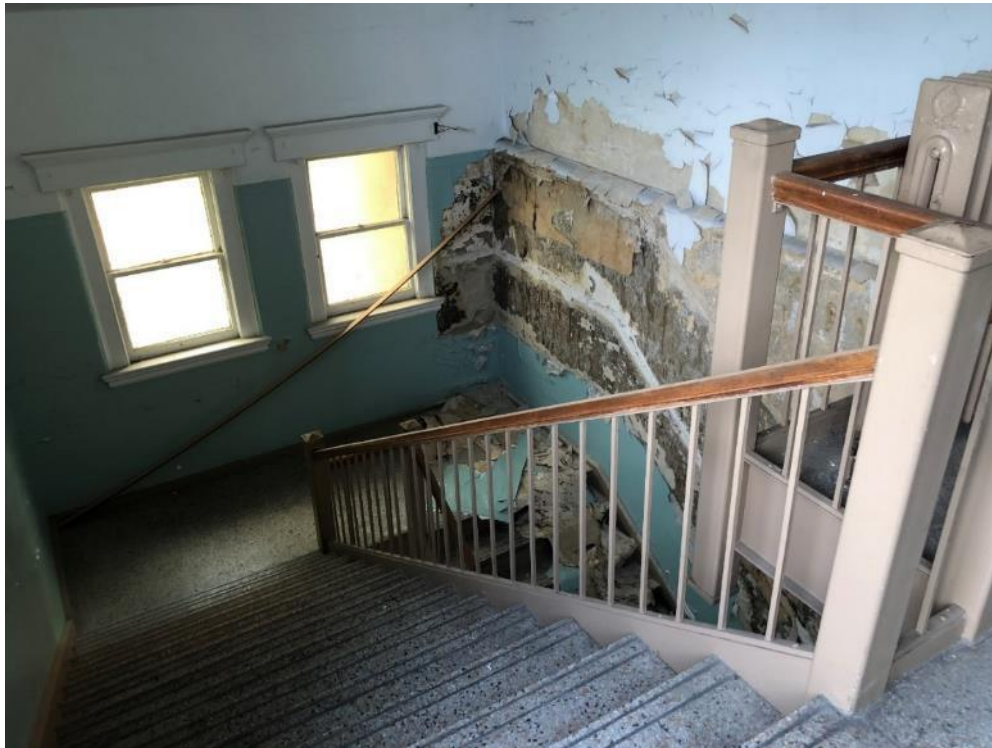
- Exit stairs treads and rails non-compliant
  - Guardrail and Handrails at 32" high need to be replaced
  - Riser non-ADA compliant and tripping hazard

Stair nosing does not meet  
ADA requirements

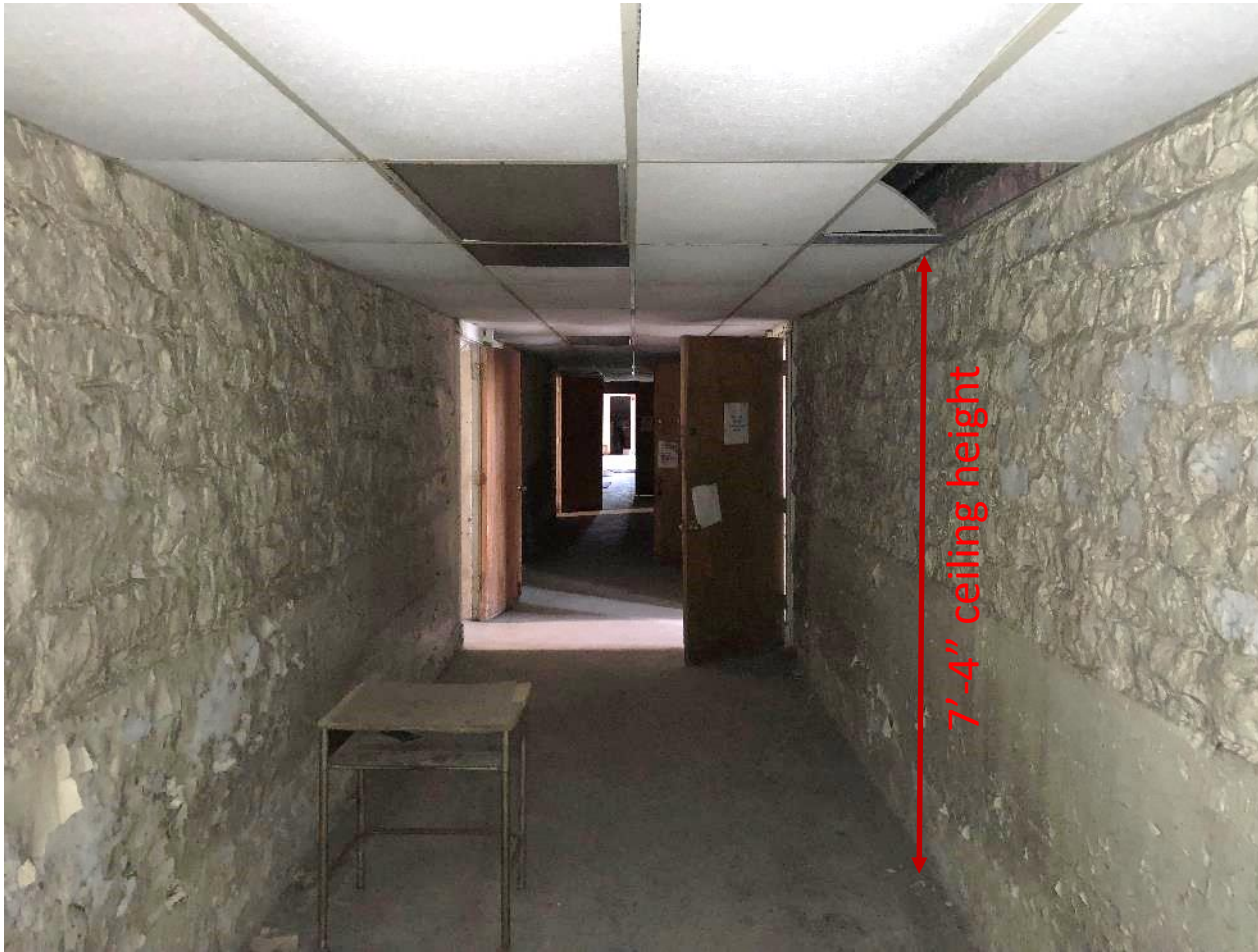
- Non usable lower level – ceiling height does not meet code

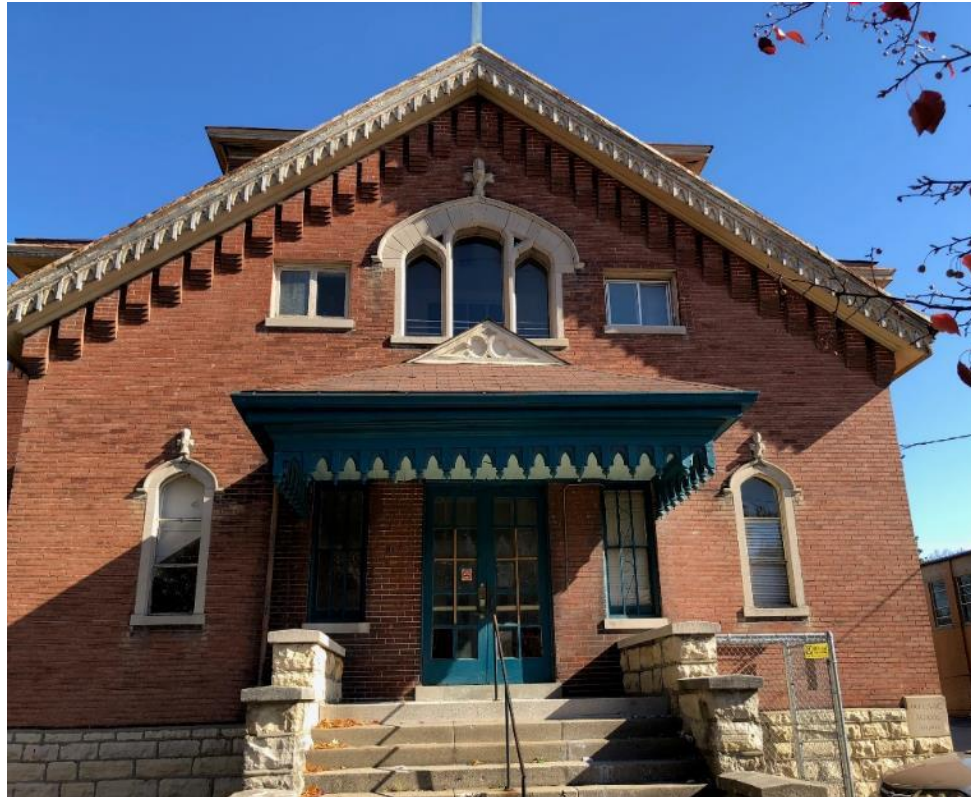
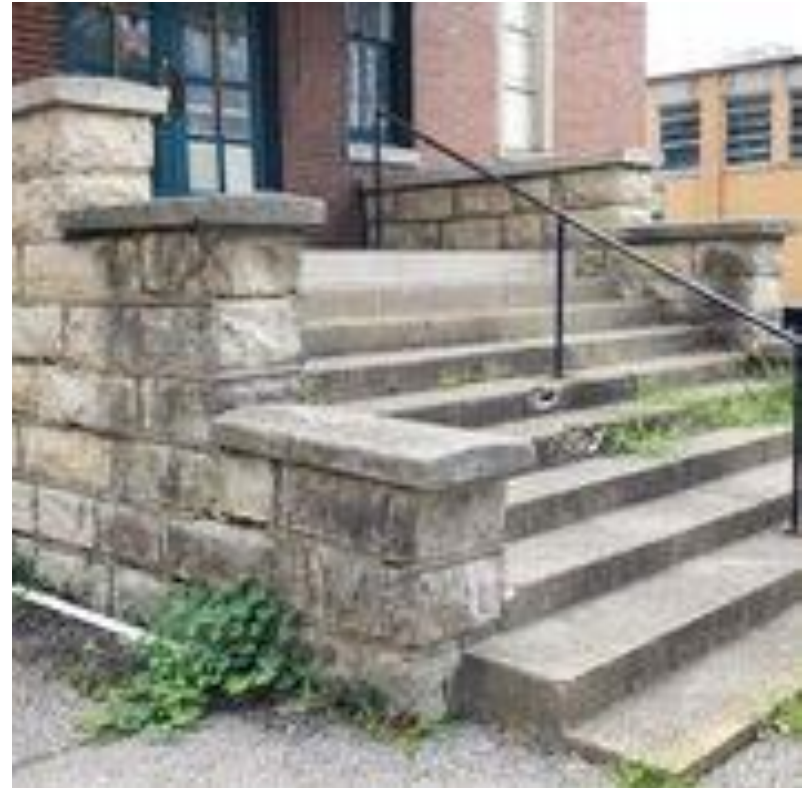
- Building is not accessible, fire exits not accessible, no elevator

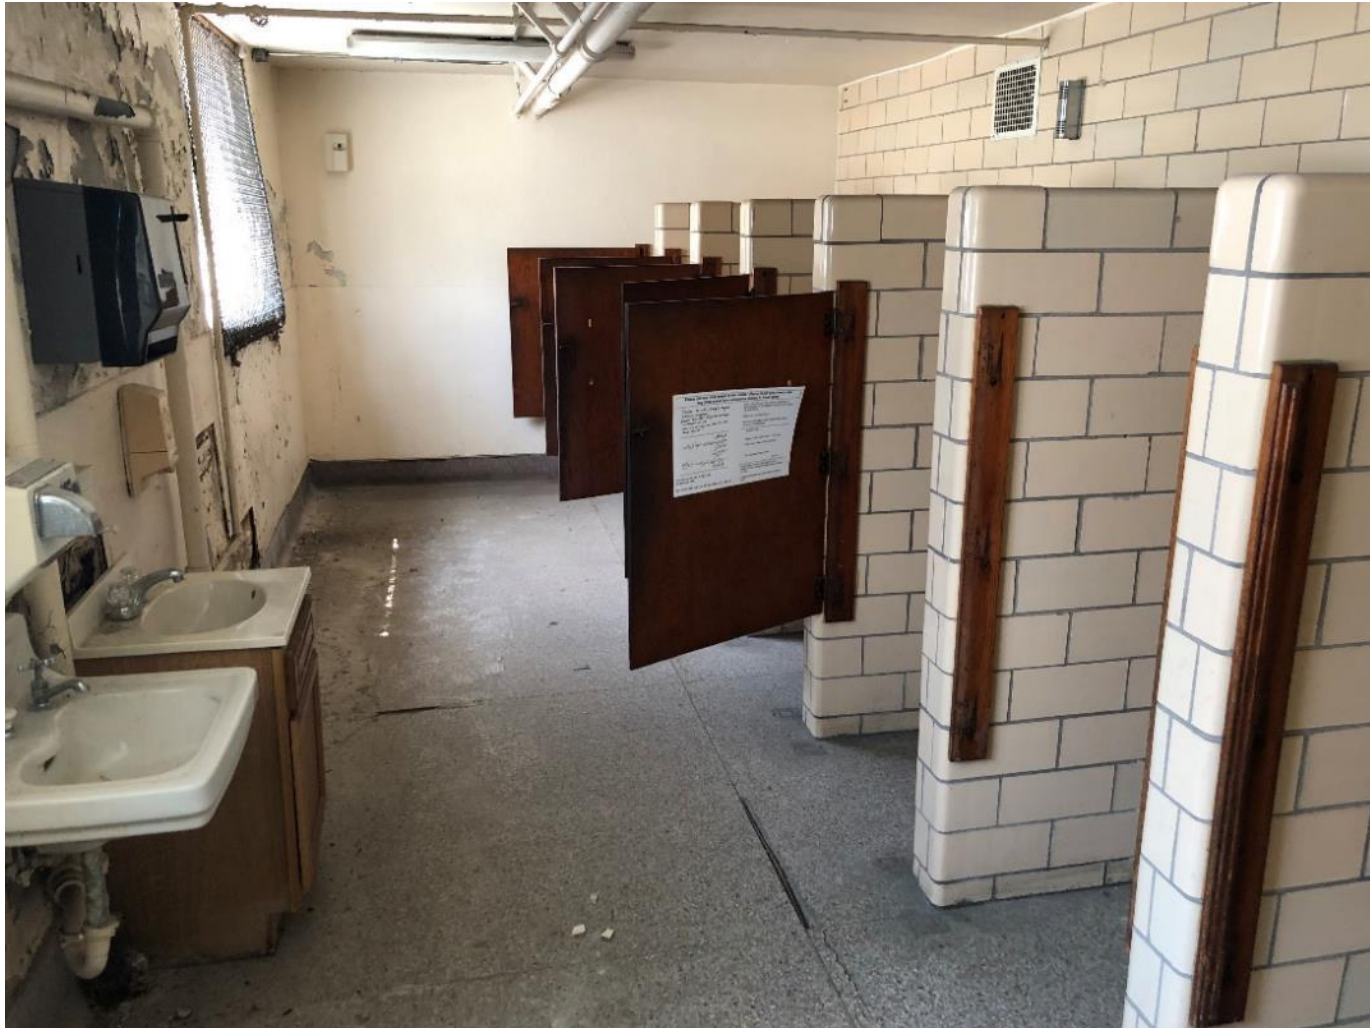
- No Elevator
- Restrooms non- ADA compliant

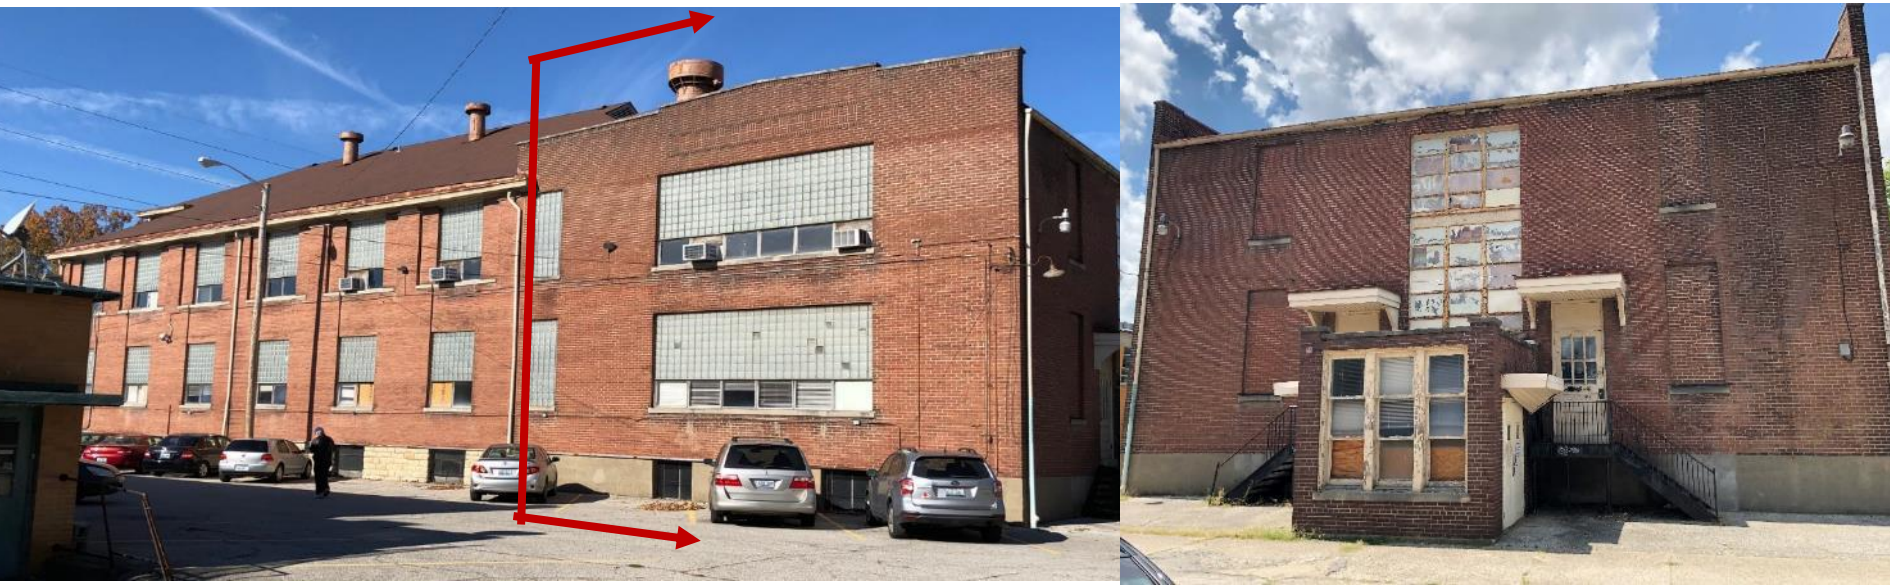
- Original Building has already had an addition to the rear
- Original exterior design integrity has been compromised by the absence of integrity
- Addition has no recess at juncture, changed the window type and proportion, changed roof configuration, and dominates the side facades

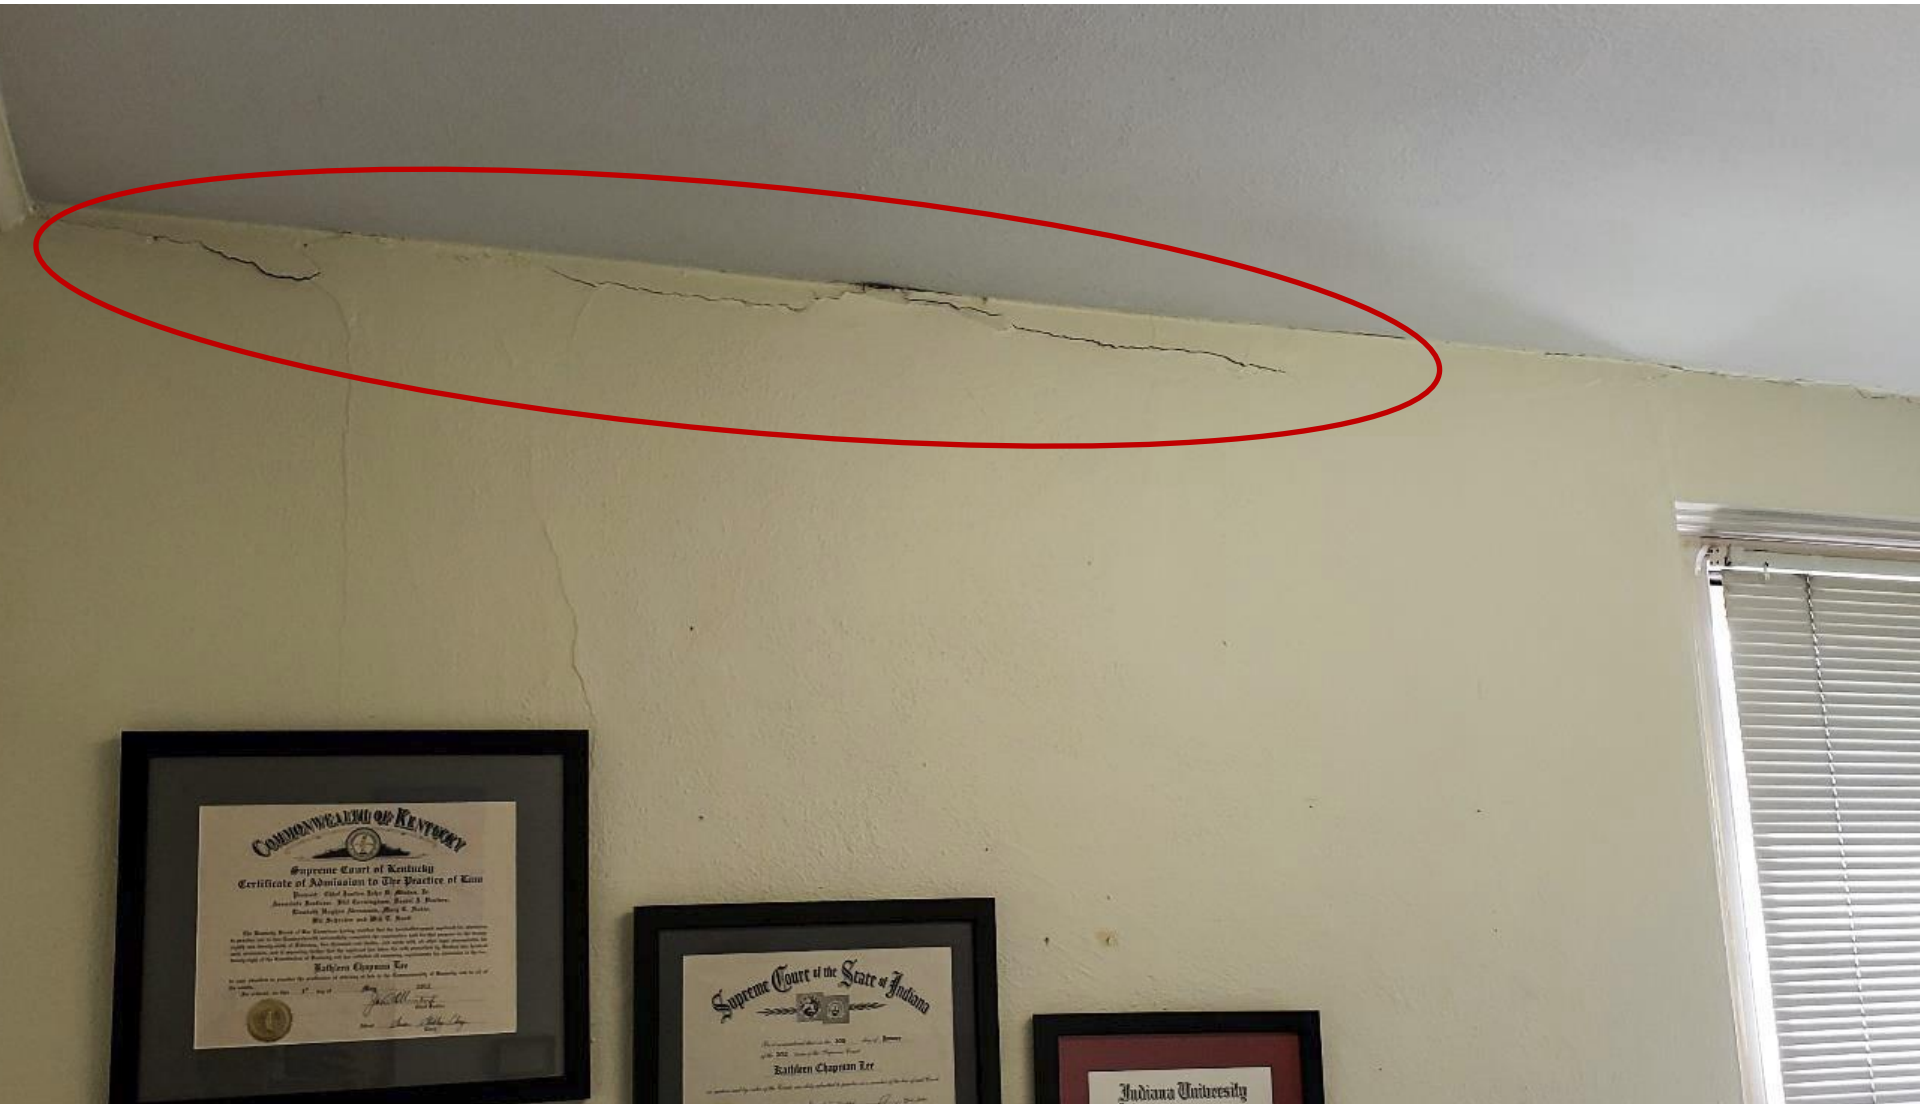
- ICON report - cracks indicating wall movement

The extent of the interior cracking and outward movement of the bearing wall observed in the basement, indicates substantial movements in the foundation system. The fact that some cracks had repeated repairs indicated the presents of bearing soils that are sensitive to seasonal moisture content resulting both permanent and cyclical settlements. With the exterior veneer wythe of the wall being non-interlaced with the inner bearing portion of the wall, not all interior cracking observed has translated to the exterior although the cracks are present in the foundation system.
