# Former Holy Name School and Convent Evaluation for Use as New Catholic Charities Office Building 8-29-19

# Former Holy Name School Building 3

# Former Holy Name Convent – Building 4

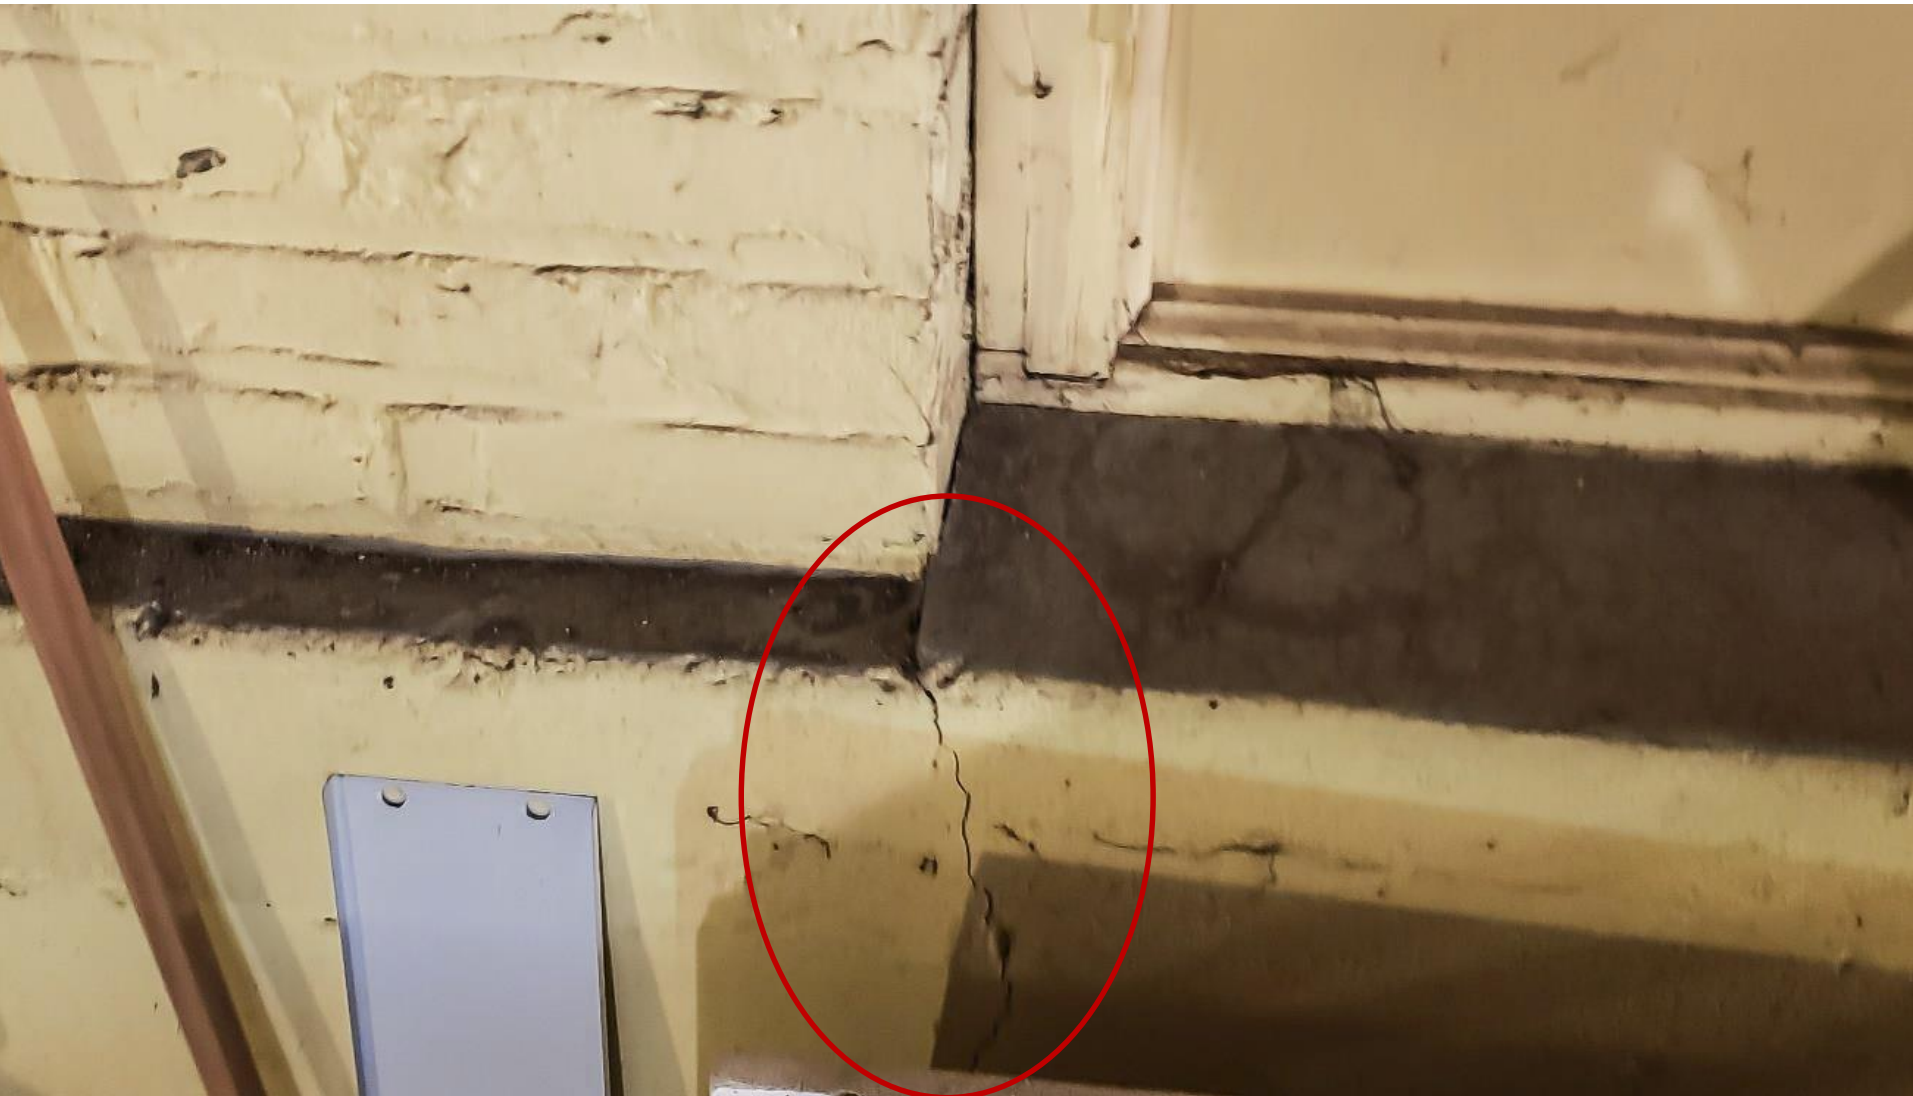
- Foundation movement

The extent of the interior cracking and outward movement of the bearing wall observed in the basement, indicates substantial movements in the foundation system. The fact that some cracks had repeated repairs indicated the presents of bearing soils that are sensitive to seasonal moisture content resulting both permanent and cyclical settlements. With the exterior veneer wythe of the wall being non-interlaced with the inner bearing portion of the wall, not all interior cracking observed has translated to the exterior although the cracks are present in the foundation system.

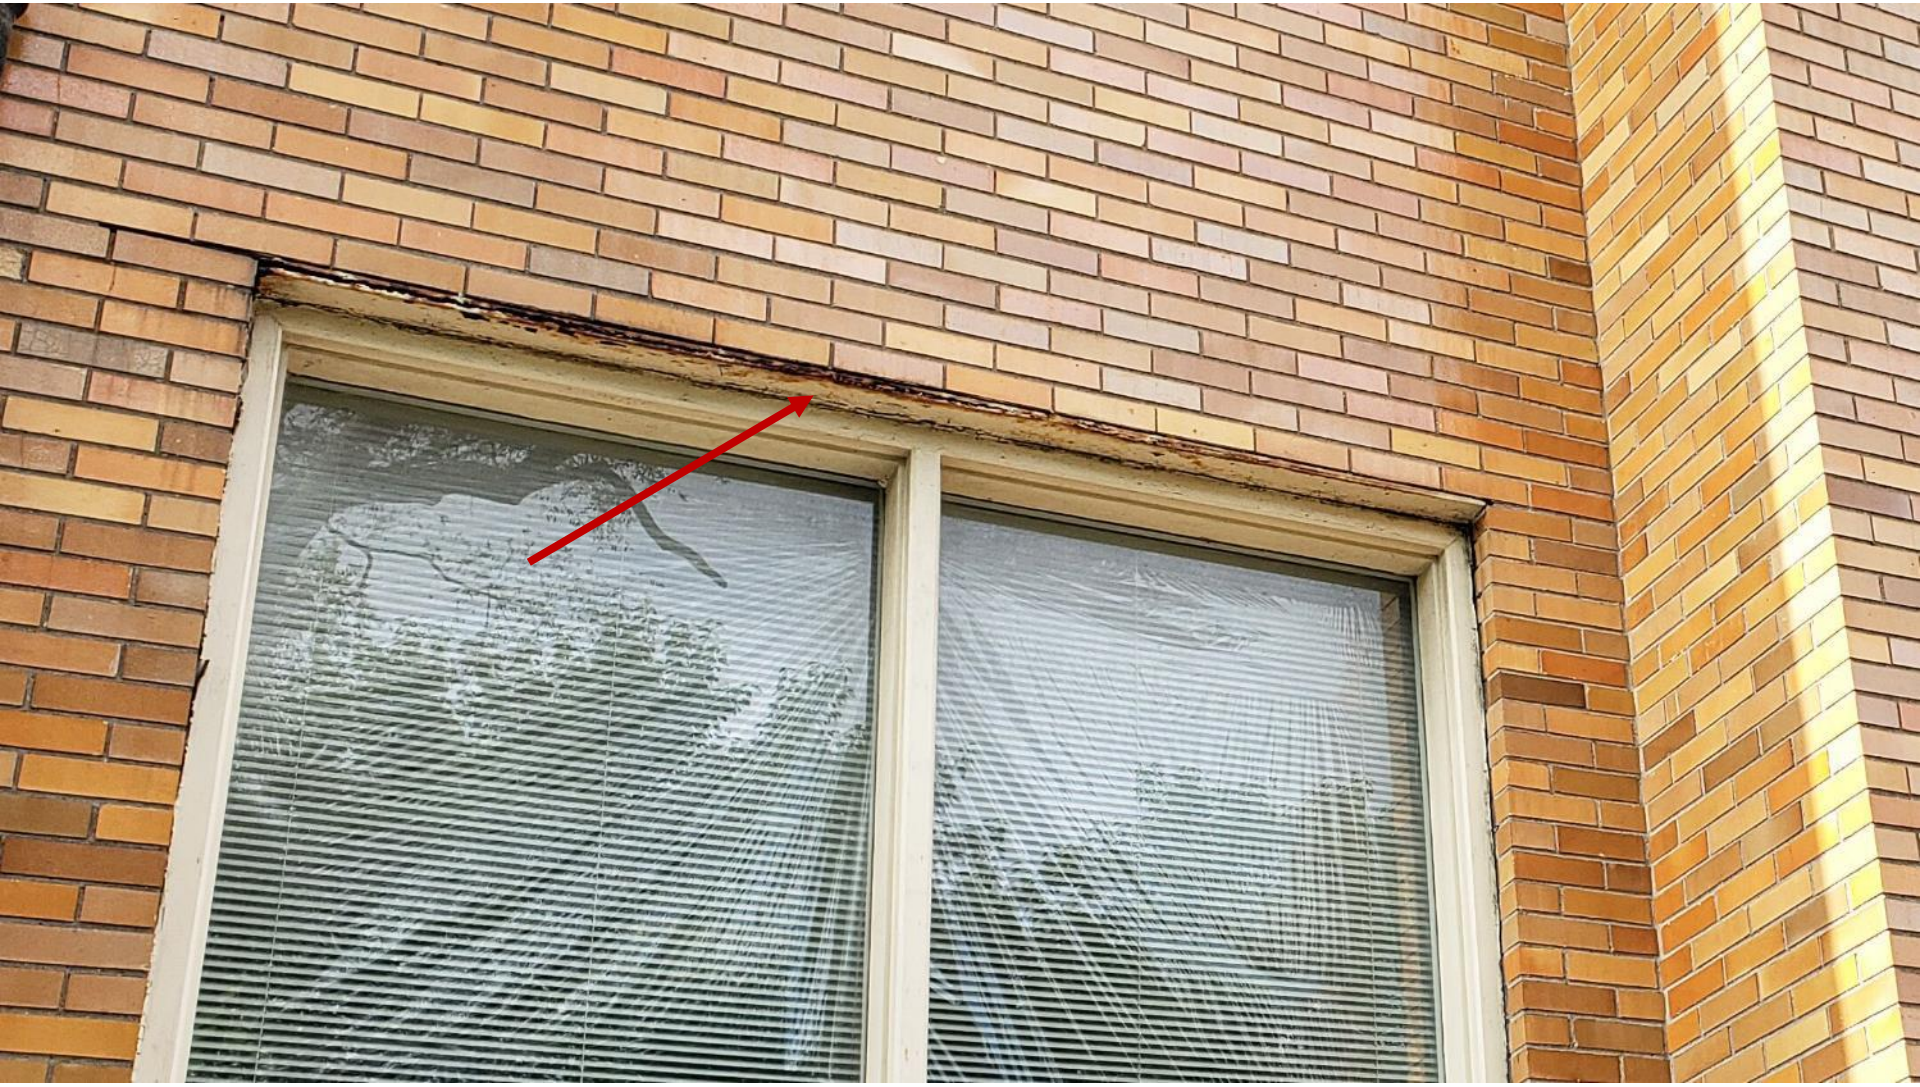
- masonry movement - Rust Jacking

Rust jacking was prevalent throughout the exterior of the building. Rust jacking results from water infiltration of the exterior brick veneer and water collects/pools at the lintels rusting the lintels over time. The jacking comes from the expansion of the oxidized steel and literally lifts the brick.

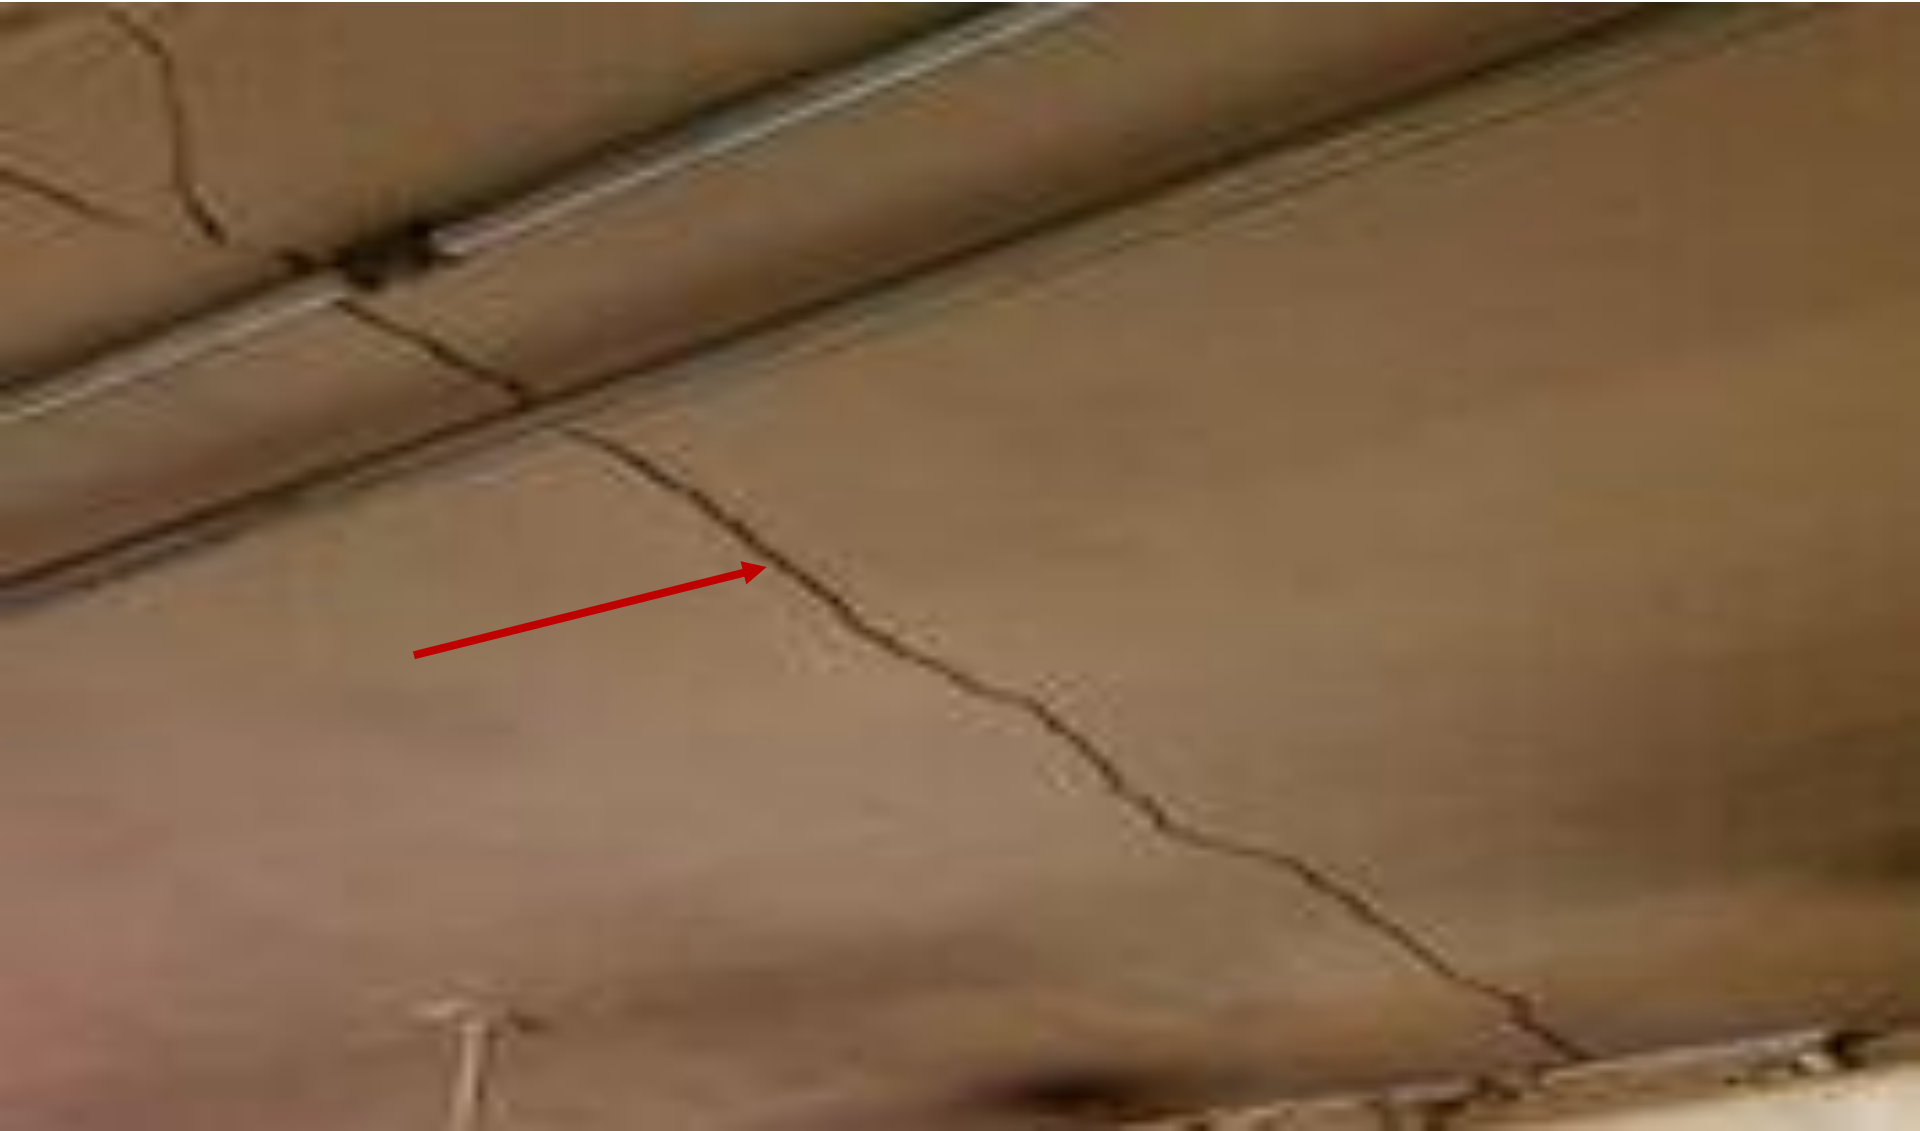
- Ceiling movement

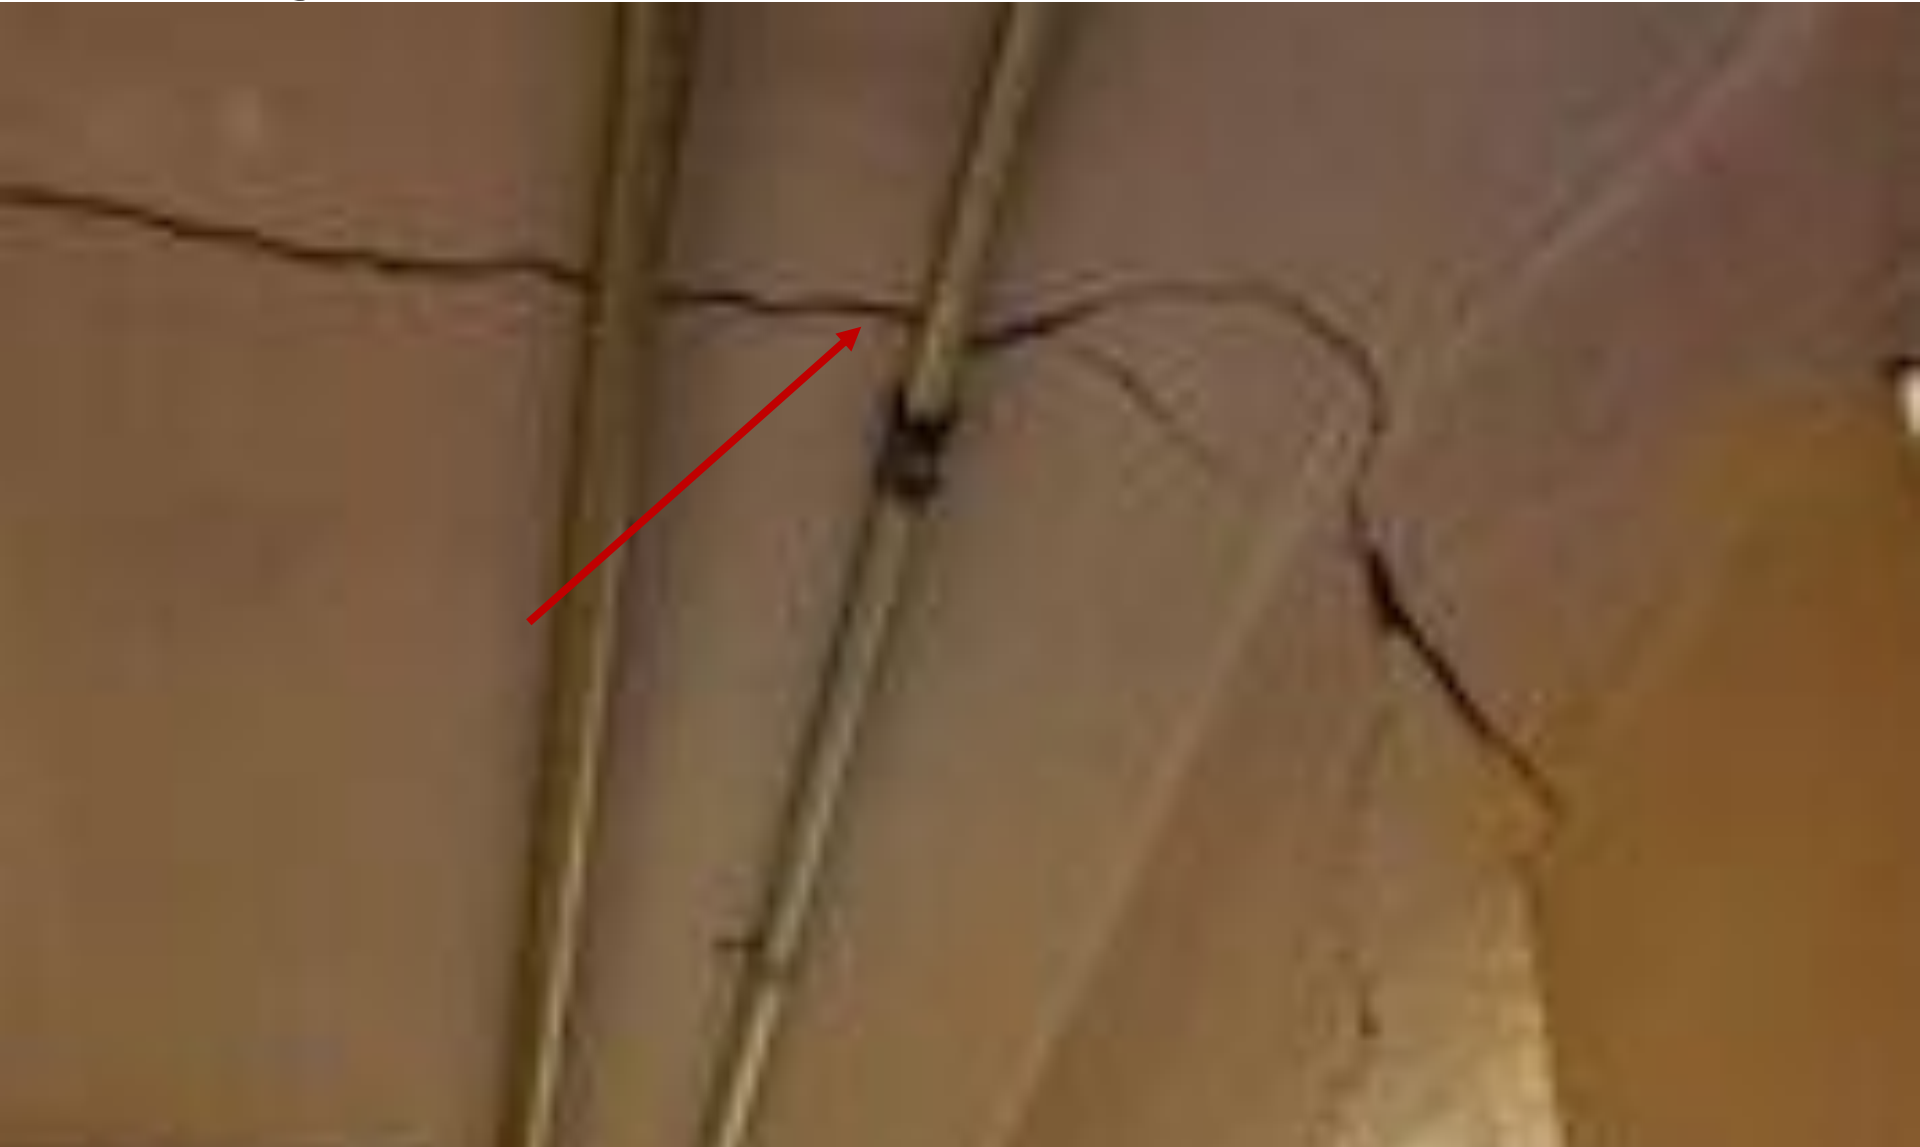
- Ceiling / wall movement

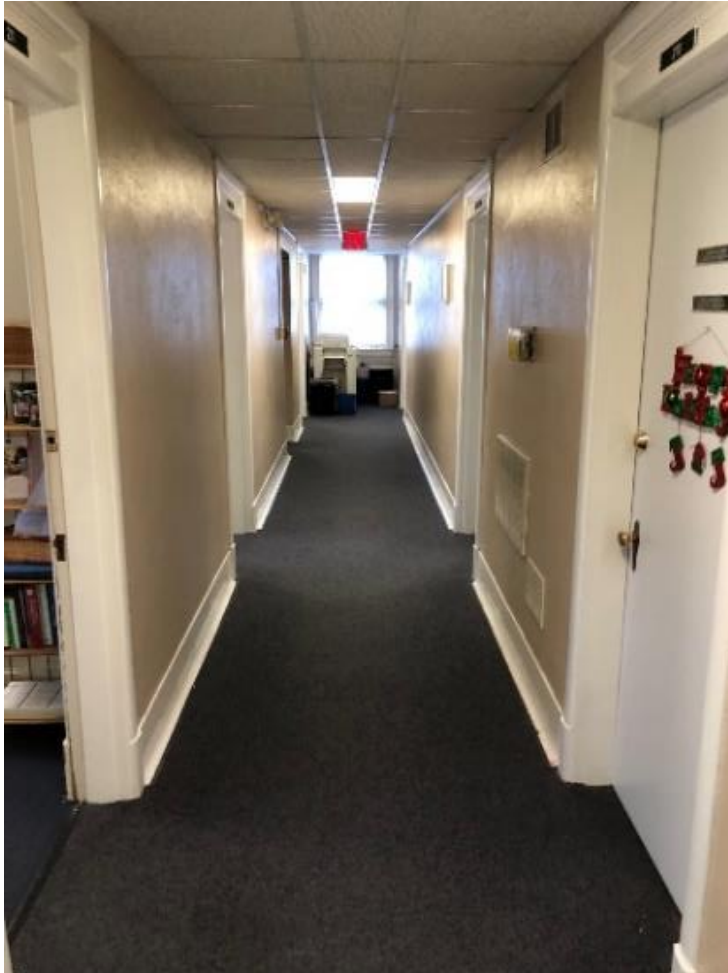
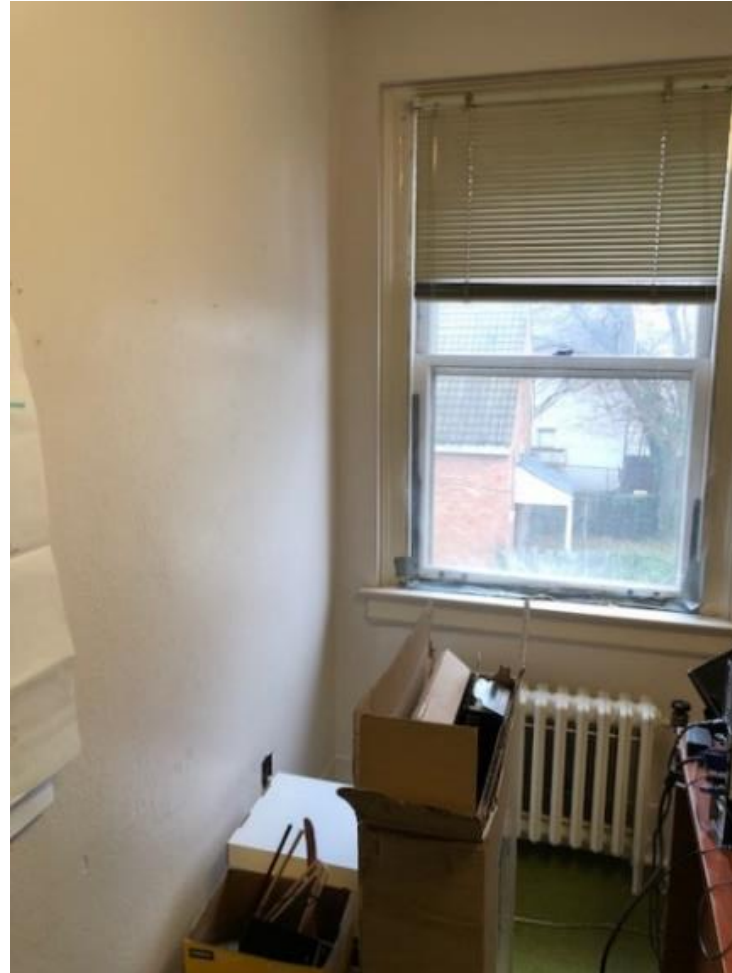
- Narrow Corridors, former cells are small rooms

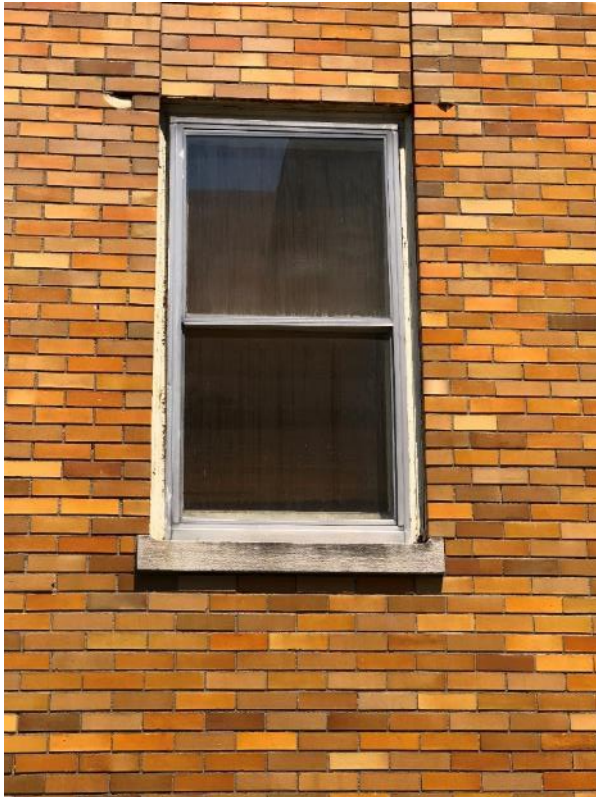
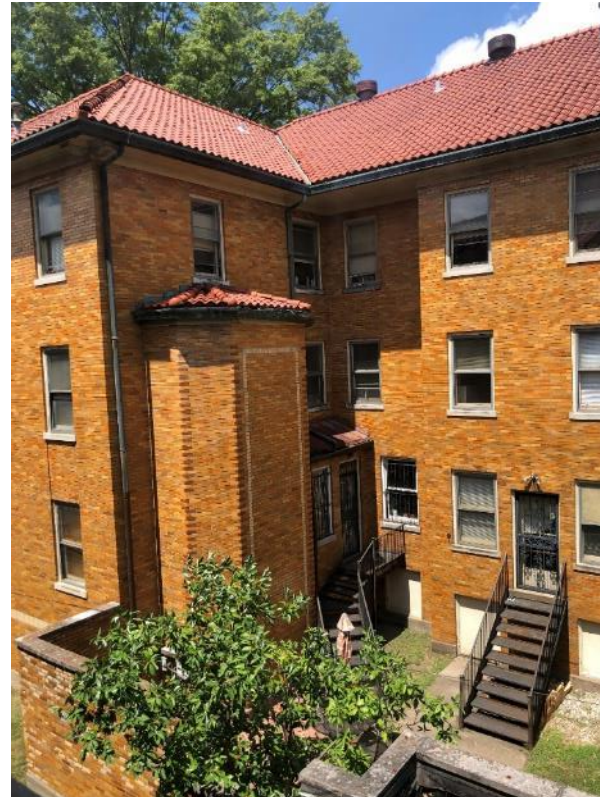
- Roof and windows have reached their usefull life span and need replacement.
- Masonry needs repointing / replacement at rust jacking

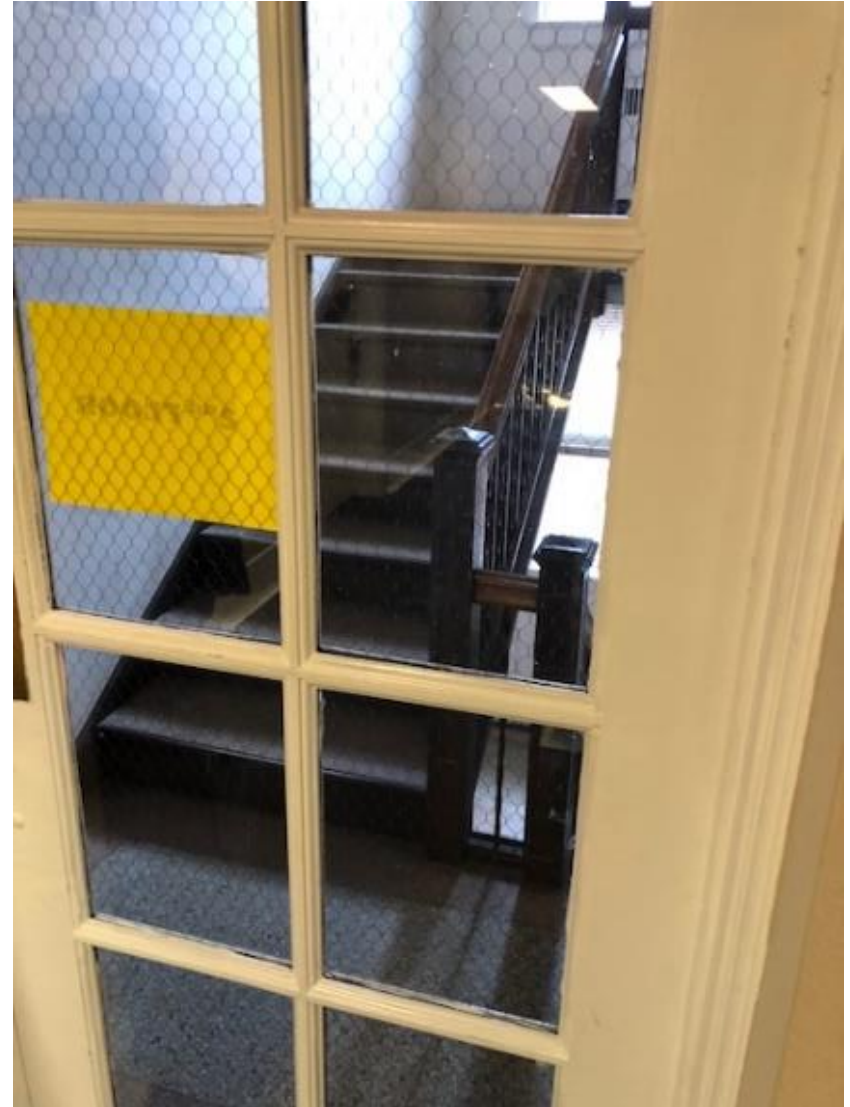
- Fire exit stairs are non-compliant
  - Stair Width 42" needs to be 44"
  - Stair Landing is only 39" and needs to be 44"
  - Door swing into the stair landing too far preventing proper evacuation

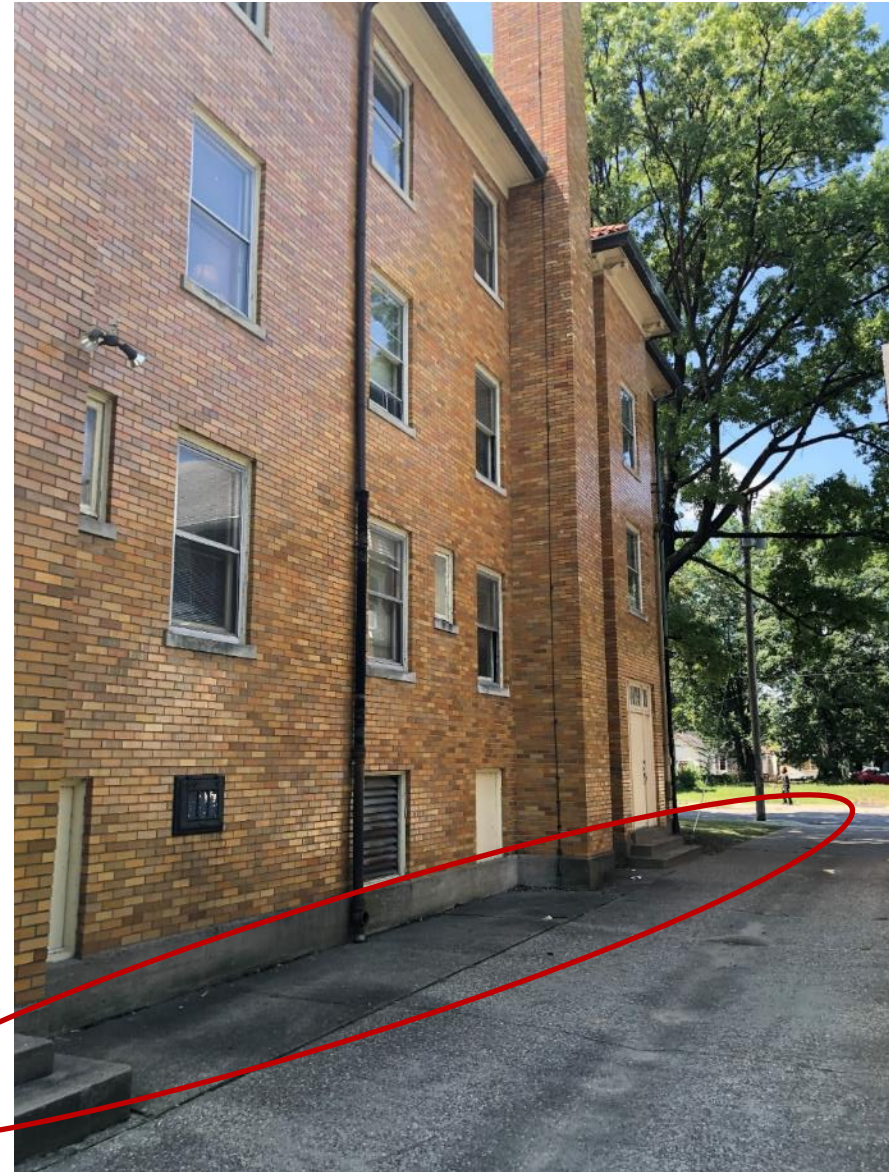
- Fire stairs non-compliant
  - Stairs exit to the exterior has non-code compliant landing and are not accessible
  - Cannot build a ramp into the public alley
  - No landing at the exit, no clearance for automobiles, major safety concern

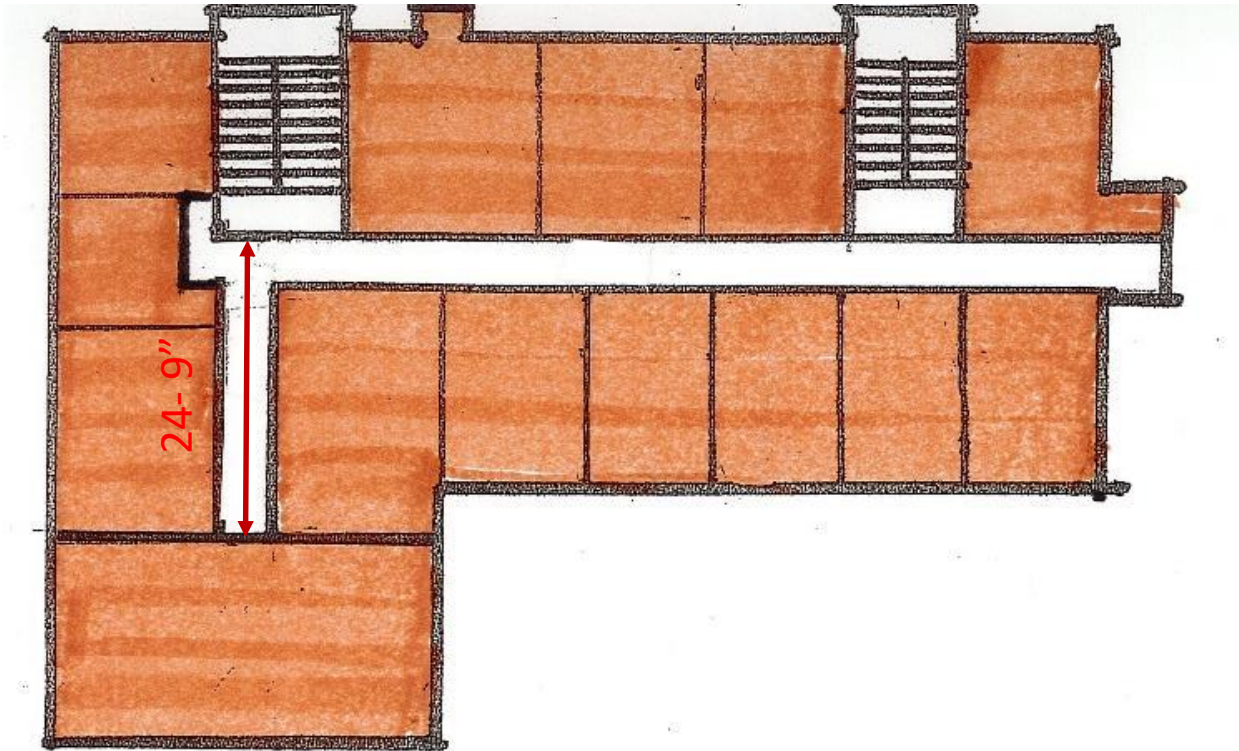
- Dead end corridor greater than 20' and does not meet KBC

dead end corridor length is 24'-9"

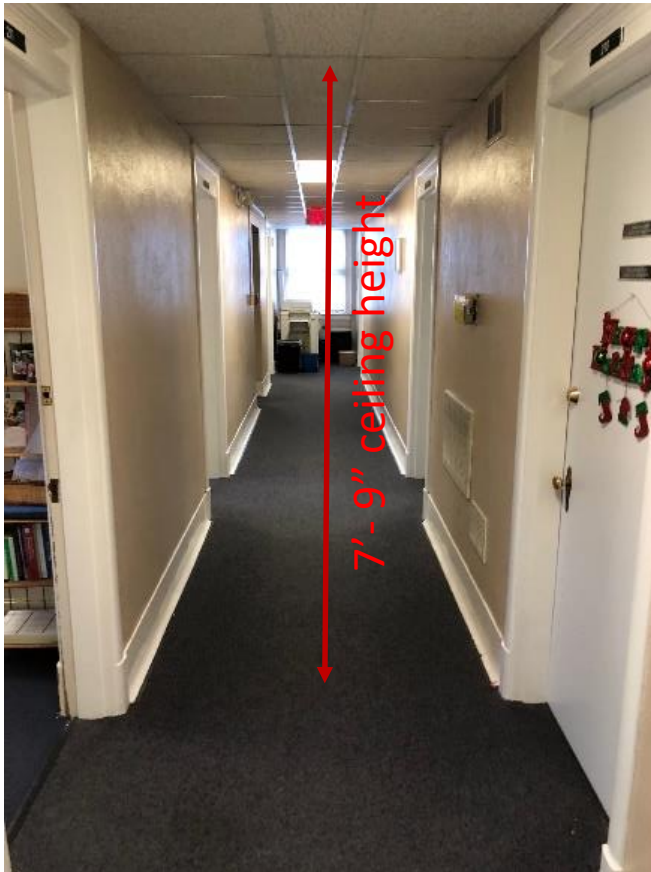
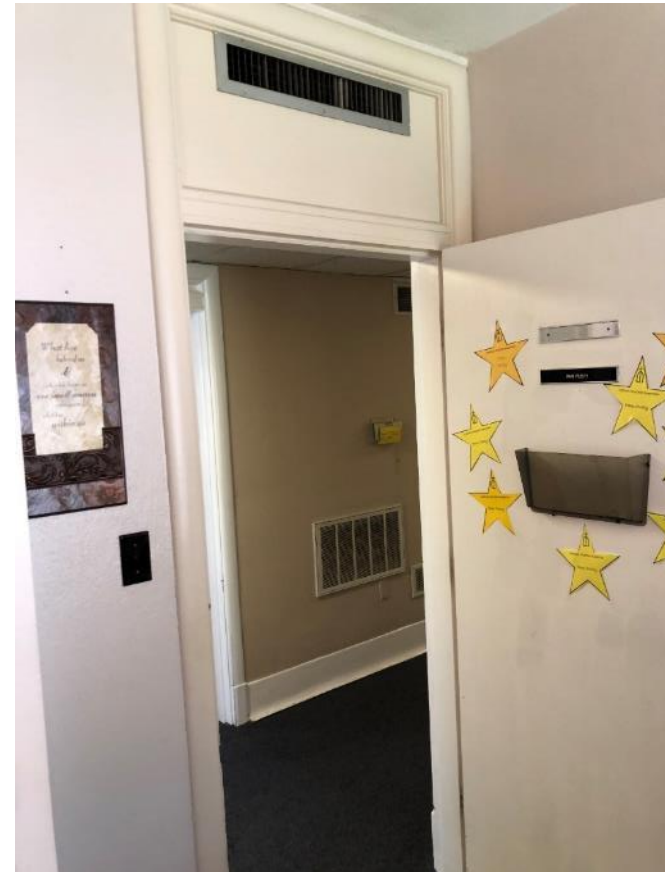
- Ceiling Height will be inadequate when HVAC is modified to today's energy standards and fire suppression is added.

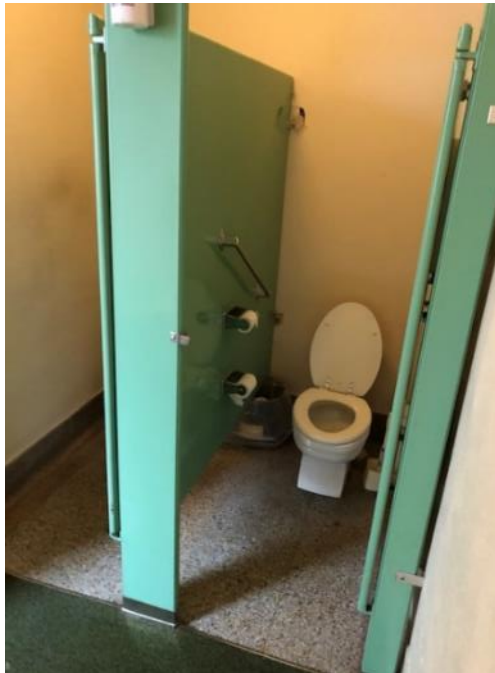
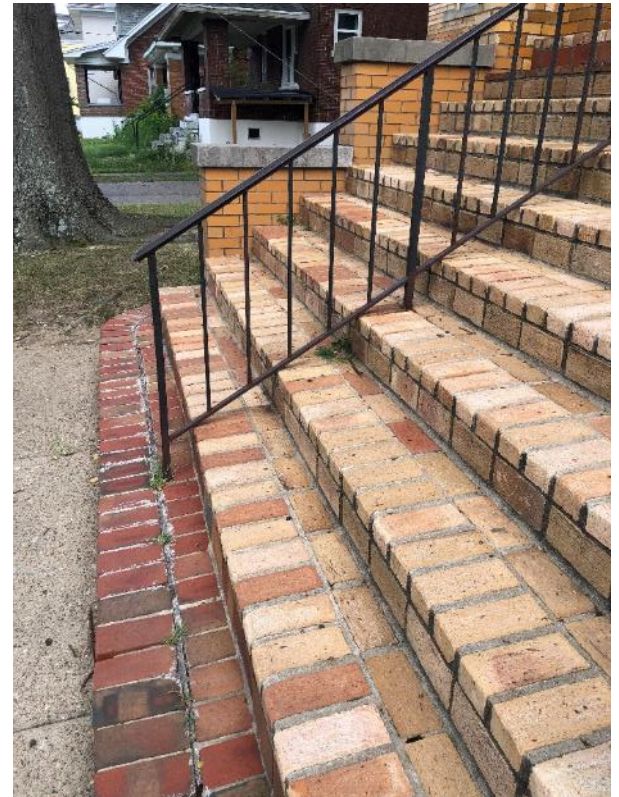
- Building is not accessible
  - Main level raised approximately 6.87' from sidewalk
  - Elevator too small at 40" x 58" (ADA minimum is 51" x 68" for side mounted door)
  - Restrooms are non-compliant
