RE: Economic Hardship Exemption to 19DESIGNATION1000  
Catholic Charities Headquarters Building  
Holy Name Property – 2911 South 4<sup>th</sup> Street

## **Former Holy Name School and Convent Evaluation for Use as New Catholic Charities Office Building Headquarters**

Draft August 22, 2019

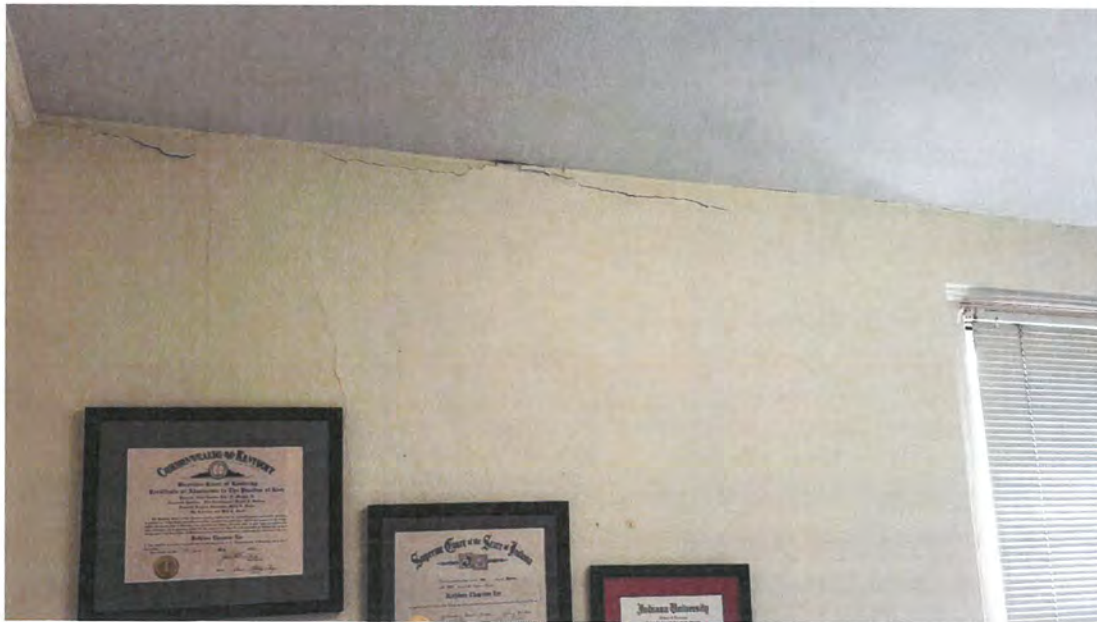
1. Extensive cracks were observed throughout the interior of the building. The majority of the cracking was observed along exterior walls. Cracks observed consisted mostly of horizontal cracks in the walls, near the ceilings, or diagonal/vertical cracks in the walls, especially near corners or windows. Some of the cracks appear to have been repaired multiple times.

The extent of the interior cracking and outward movement of the bearing wall observed in the basement, indicates substantial movements in the foundation system. The fact that some cracks had repeated repairs indicated the presents of bearing soils that are sensitive to seasonal moisture content resulting both permanent and cyclical settlements. With the exterior veneer wythe of the wall being non-interlaced with the inner bearing portion of the wall, not all interior cracking observed has translated to the exterior although the cracks are present in the foundation system.

Figure 2. Typical Interior Cracking.

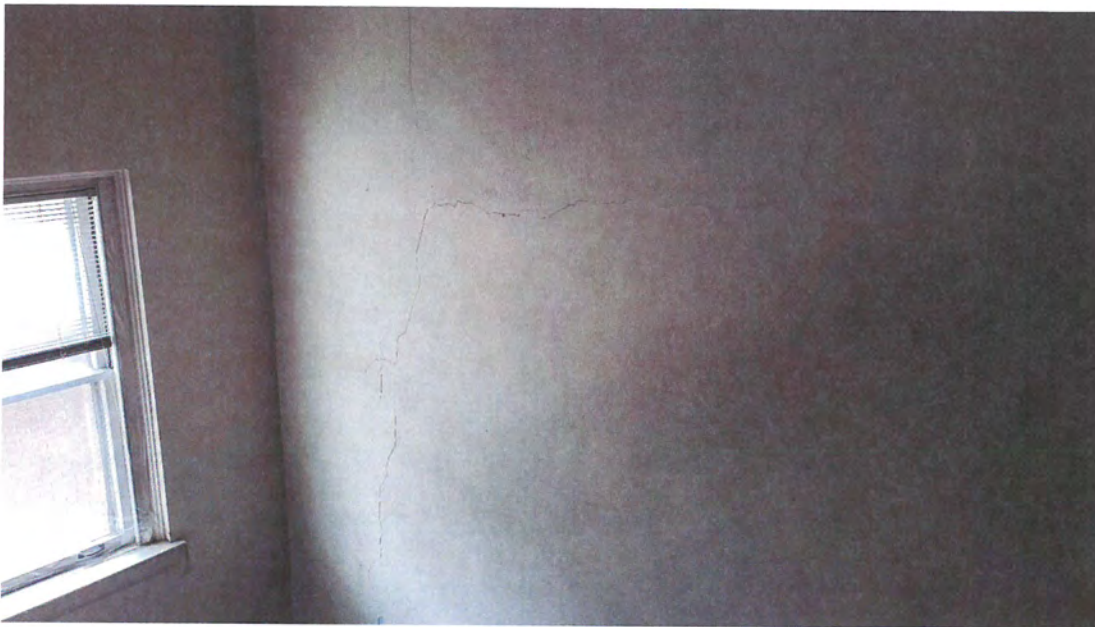
Figure 3. Typical Interior Cracking.

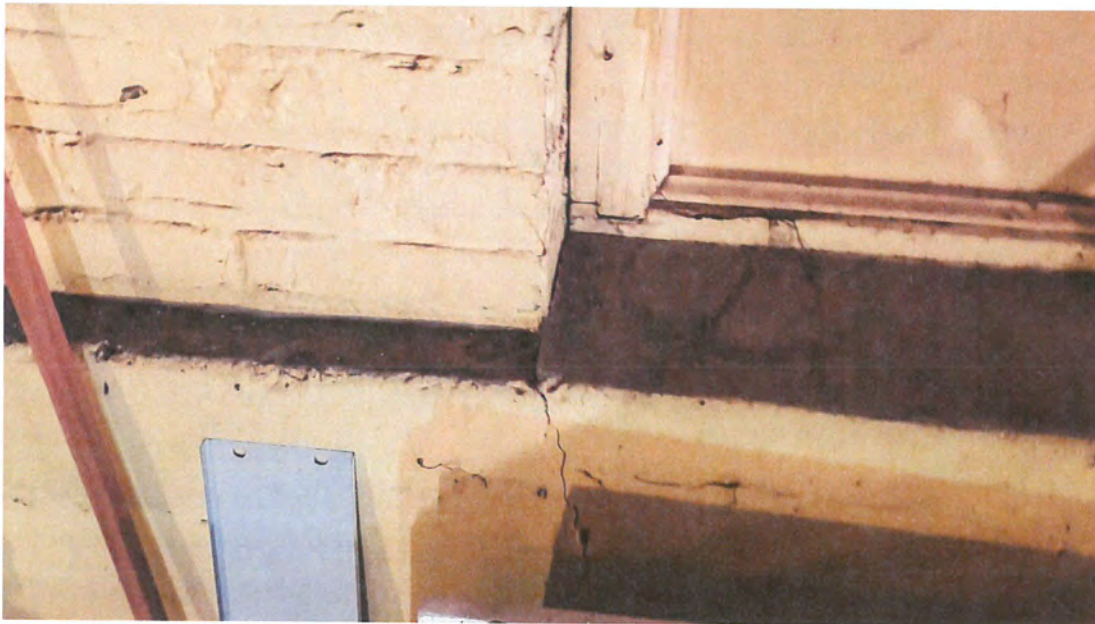
2. Vertical cracks were also observed in the foundation walls, visible from both the interior of the basement, as well as from the exterior.
3. The face shells of several bricks around the exterior have come off, especially around the chimney.

Figure 4. Typical Crack at Foundation Wall.

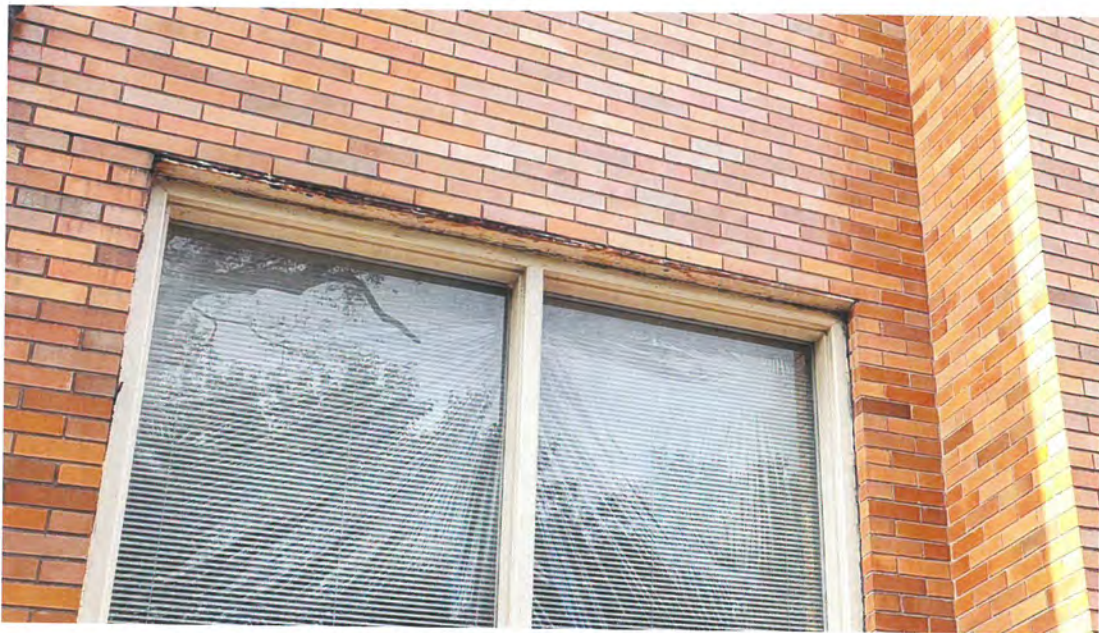
4. The lintels supporting the brick above the exterior windows have rusted, creating rust jacking in multiple locations.
5. The beam/lintels supporting the brick around the front entry has rusted, causing severe rust jacking. The areas near the bearing ends of the lintel appear to have been patched multiple times due to the expansion of the joints.

Rust jacking was prevalent throughout the exterior of the building. Rust jacking results from water infiltration of the exterior brick veneer and water collects/ponds at the lintels rusting the lintels over time. The jacking comes from the expansion of the oxidized steel and literally lifts the brick.

Figure 5. Typical Lintel at Exterior Window.

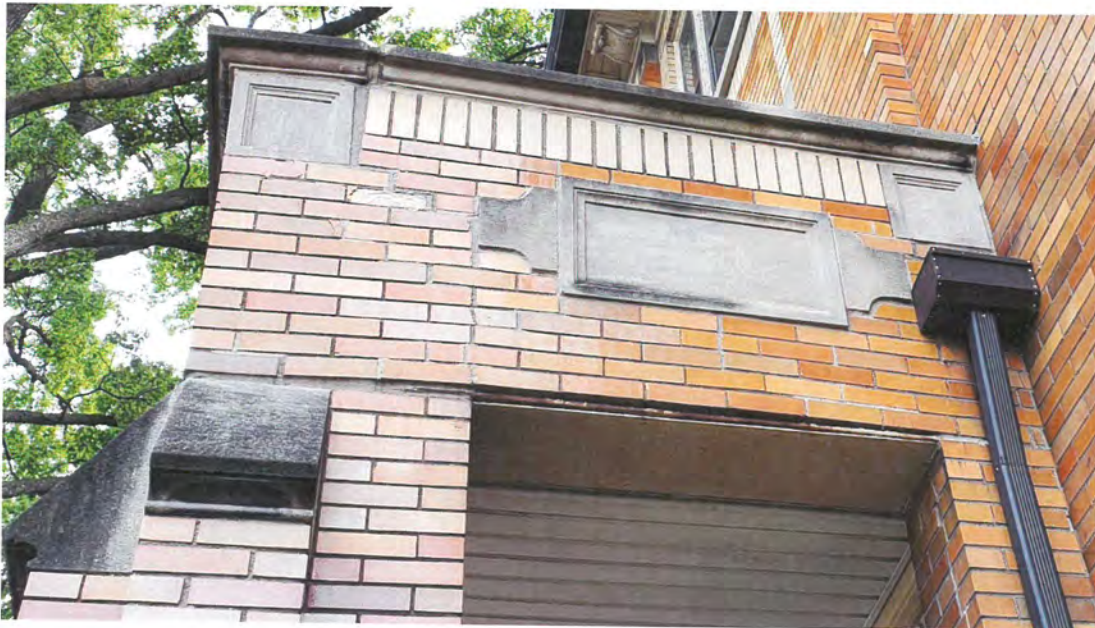
Figure 6. Typical Lintel at Front Entry.

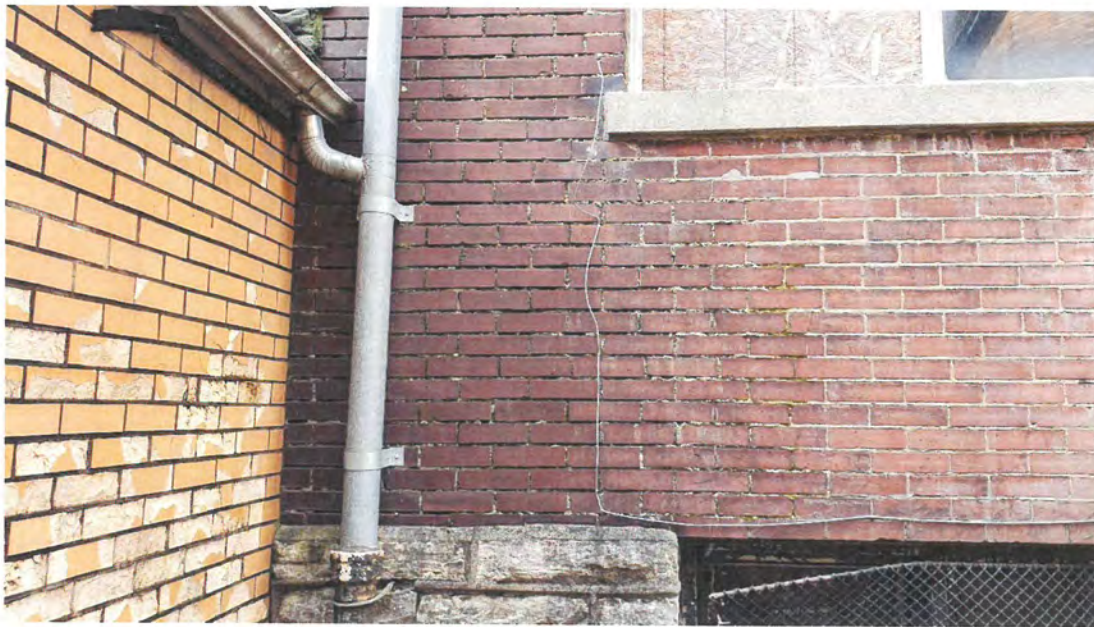
2. In several areas around the perimeter of the building, the condition of the brick/stone mortar has deteriorated due to erosion and freeze thaw cycles from water infiltration. This was also observed on the interior side of several walls within the basement area.

Figure 2. Typical Exterior Mortar Deterioration.

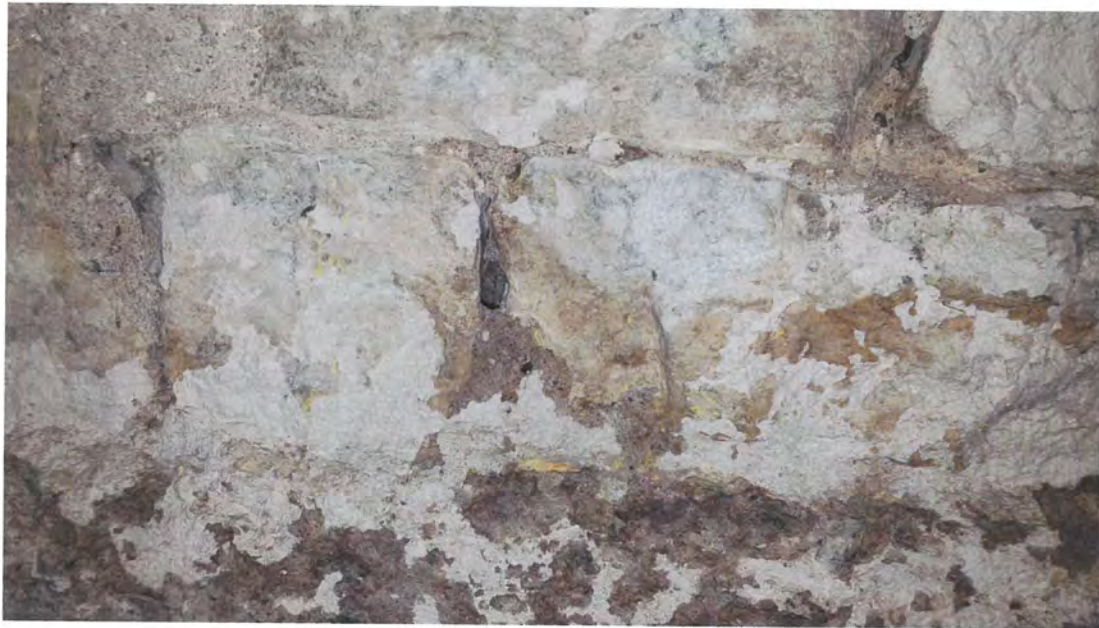
Figure 3. Typical Interior Mortar Deterioration.

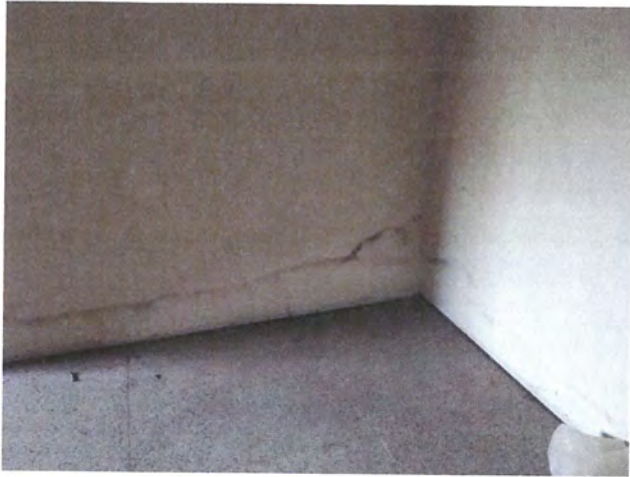
**Photo 1**

Water-stained drywall observed in one room.

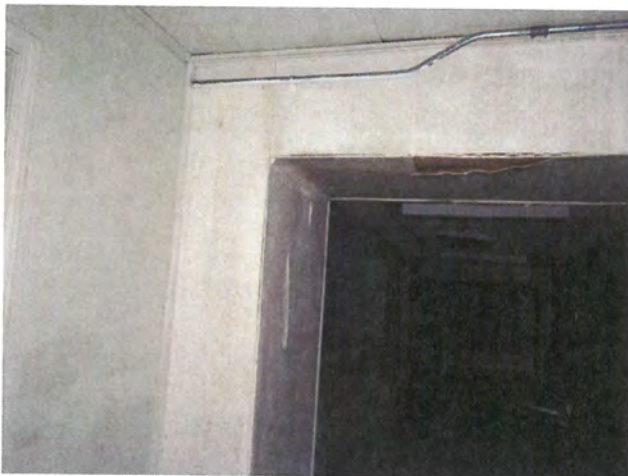
**Photo 2**

Mold growth observed on walls throughout.

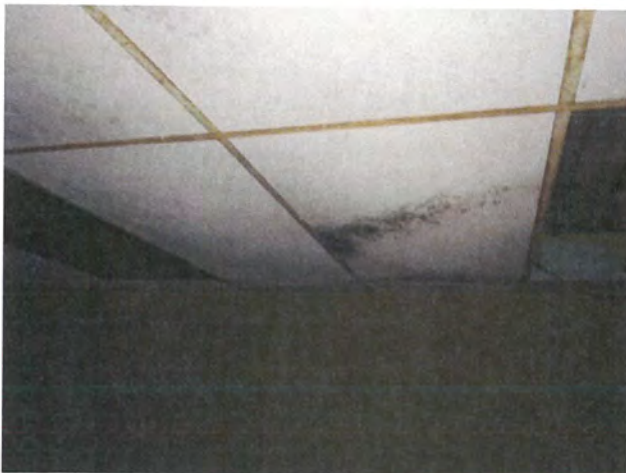
**Photo 3**

Water-damaged and moldy ceiling tiles observed.

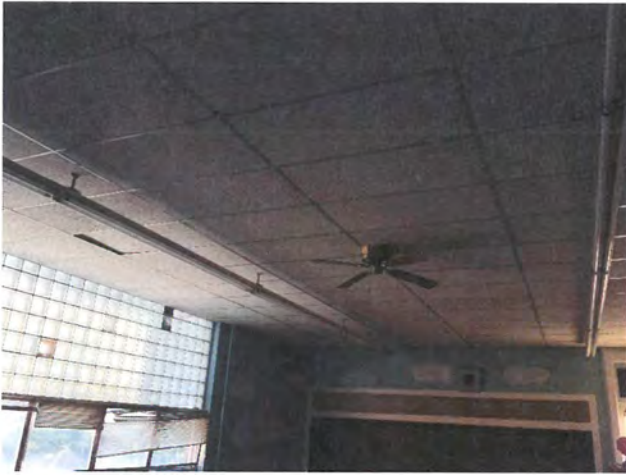
**Photo 4**

Potential mold growth observed on ceiling tiles.

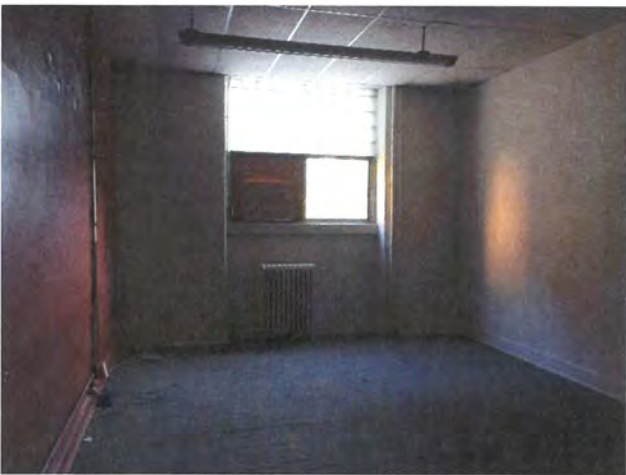
**Photo 5**

No surface mold growth observed in classrooms or hallway.

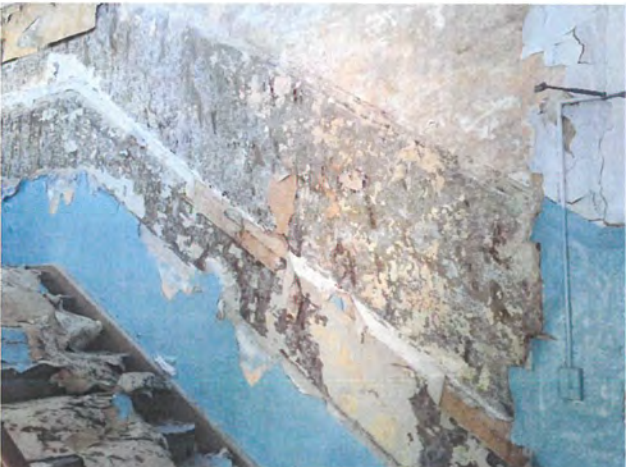
**Photo 6**

Potential mold growth observed on peeling wall.

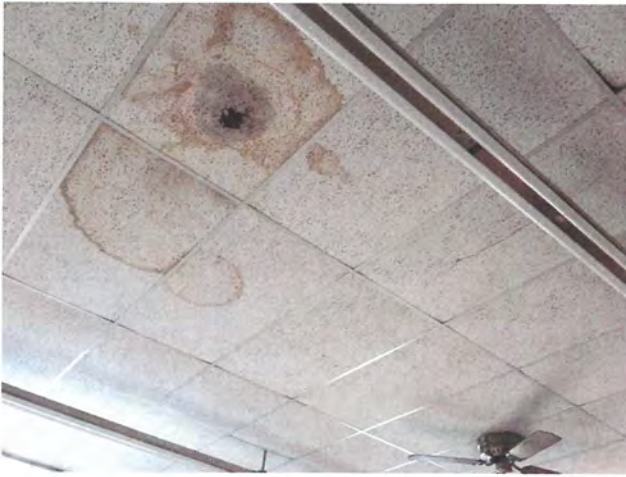
**Photo 7**

Water-damaged ceiling tiles observed.

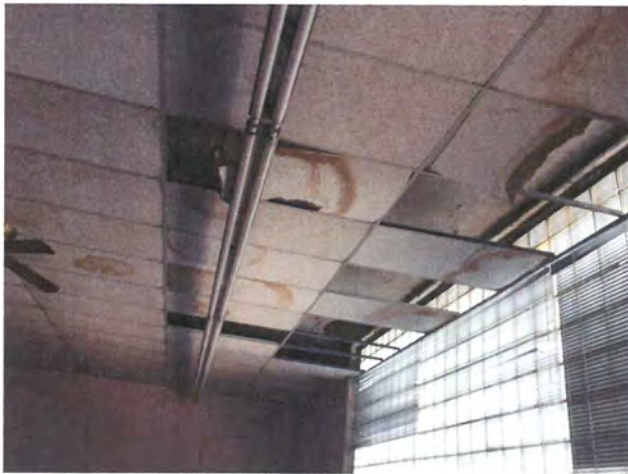
**Photo 8**

Water-damaged ceiling tiles observed.
