West Main Street Property Condition Assessment Report

811-817 W. Main St.
Louisville, KY 40202

Prepared for:
C&P Real Estate LLC

Building Assessment
811 – 817 W. Main St

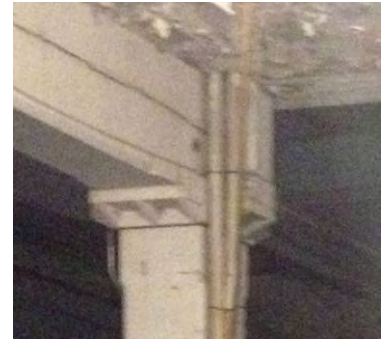
Fig 11: Cast-iron column connection

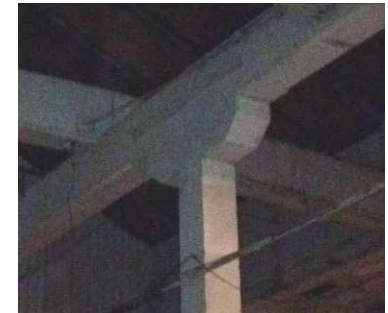
Fig 12 : nailed gravity connection

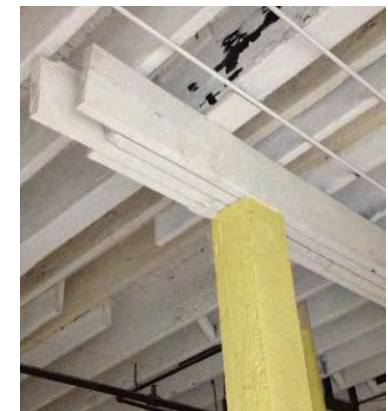
Fig 13: unsecured and unsupported beams

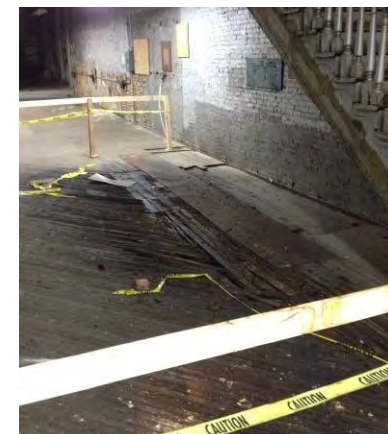
Fig 14: 811, 1st floor apparent water and termite damage

Building 811 showed signs of insect damage primarily in the basement and first floor structure. Further investigation by a termite inspector is suggested to determine the full extent of the infestation and estimate for treatment.

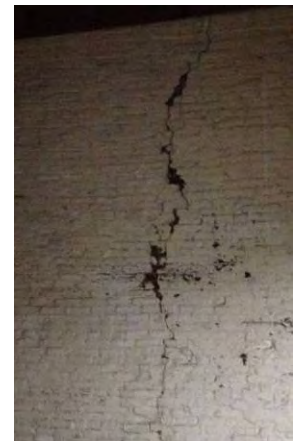
Fig 15: 813, movement in load-bearing brick wall

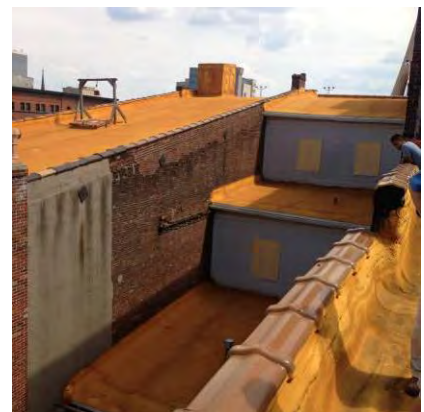
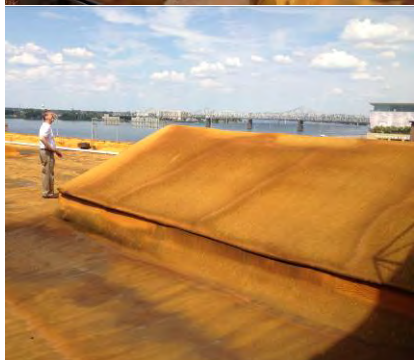
Fig 16: Sprayed polyurethane foam membrane roofing

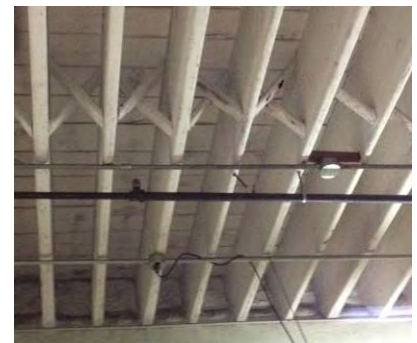
Fig 17: 813, 1st floor apparent fire damaged wood joists

Fire damage was evident on all levels of this building and complete replacement of the original wood structure was assumed. At the north end of

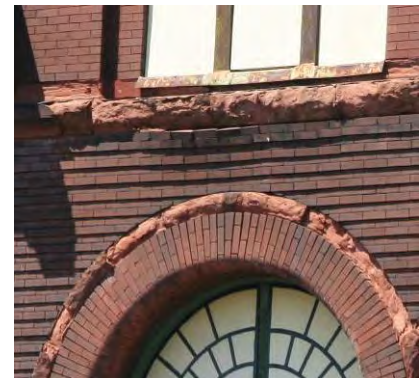
Fig 19: Deteriorated sandstone elements and bowing brick

The sandstone detailing has suffered extensive damage and has worn beyond recognition throughout the façade. This appears to have created opening for water to enter the façade and damage the brick. Beneath several window sills and sandstone detailing the brick has spawled or is bowing out from the face of the building. **These areas should be addressed immediately as they could pose a safety hazard to the general public.**

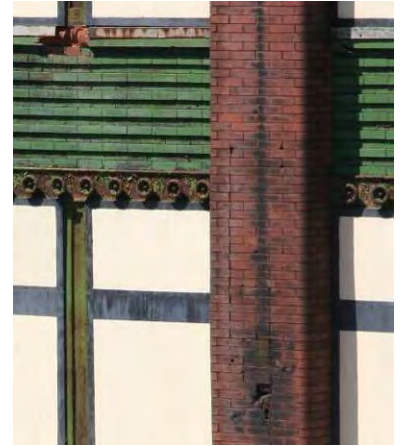
Various other areas are exhibiting cracks through the bricks and through mortar joints. (Fig 20) Other areas have been drilled for previously anchored items or miscellaneous damage. These areas should be tuckpointed and the broken bricks should be repaired.

Fig 20: 815/817, cracked brick & mortar

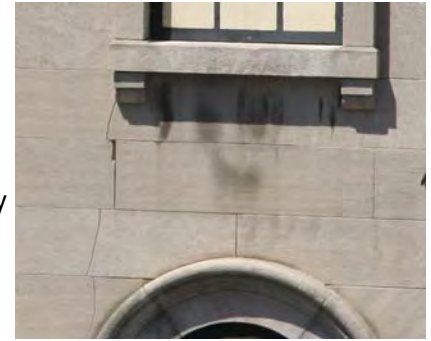
The limestone façade on the upper three floors needs repair. Extensive cracking has occurred in the façade. The cracking has occurred primarily at the joints however some areas of the stone have also cracked. Any number of reasons could be causing this; a typical cause of this is water infiltration and deterioration of the anchors securing the stone veneer. The façade should be reviewed to check that the stone is adequately secured then tuckpointed to avoid future deterioration.

Fig 22: 813, cracked stone & mortar

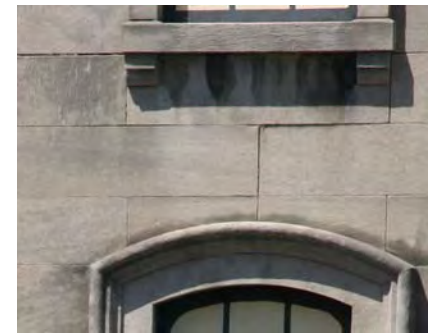
Fig 23: 813, cracked stone & mortar

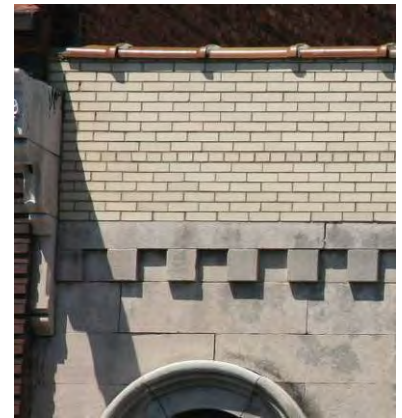
Fig 24: 813, missing mortar in stone façade & missing cornice

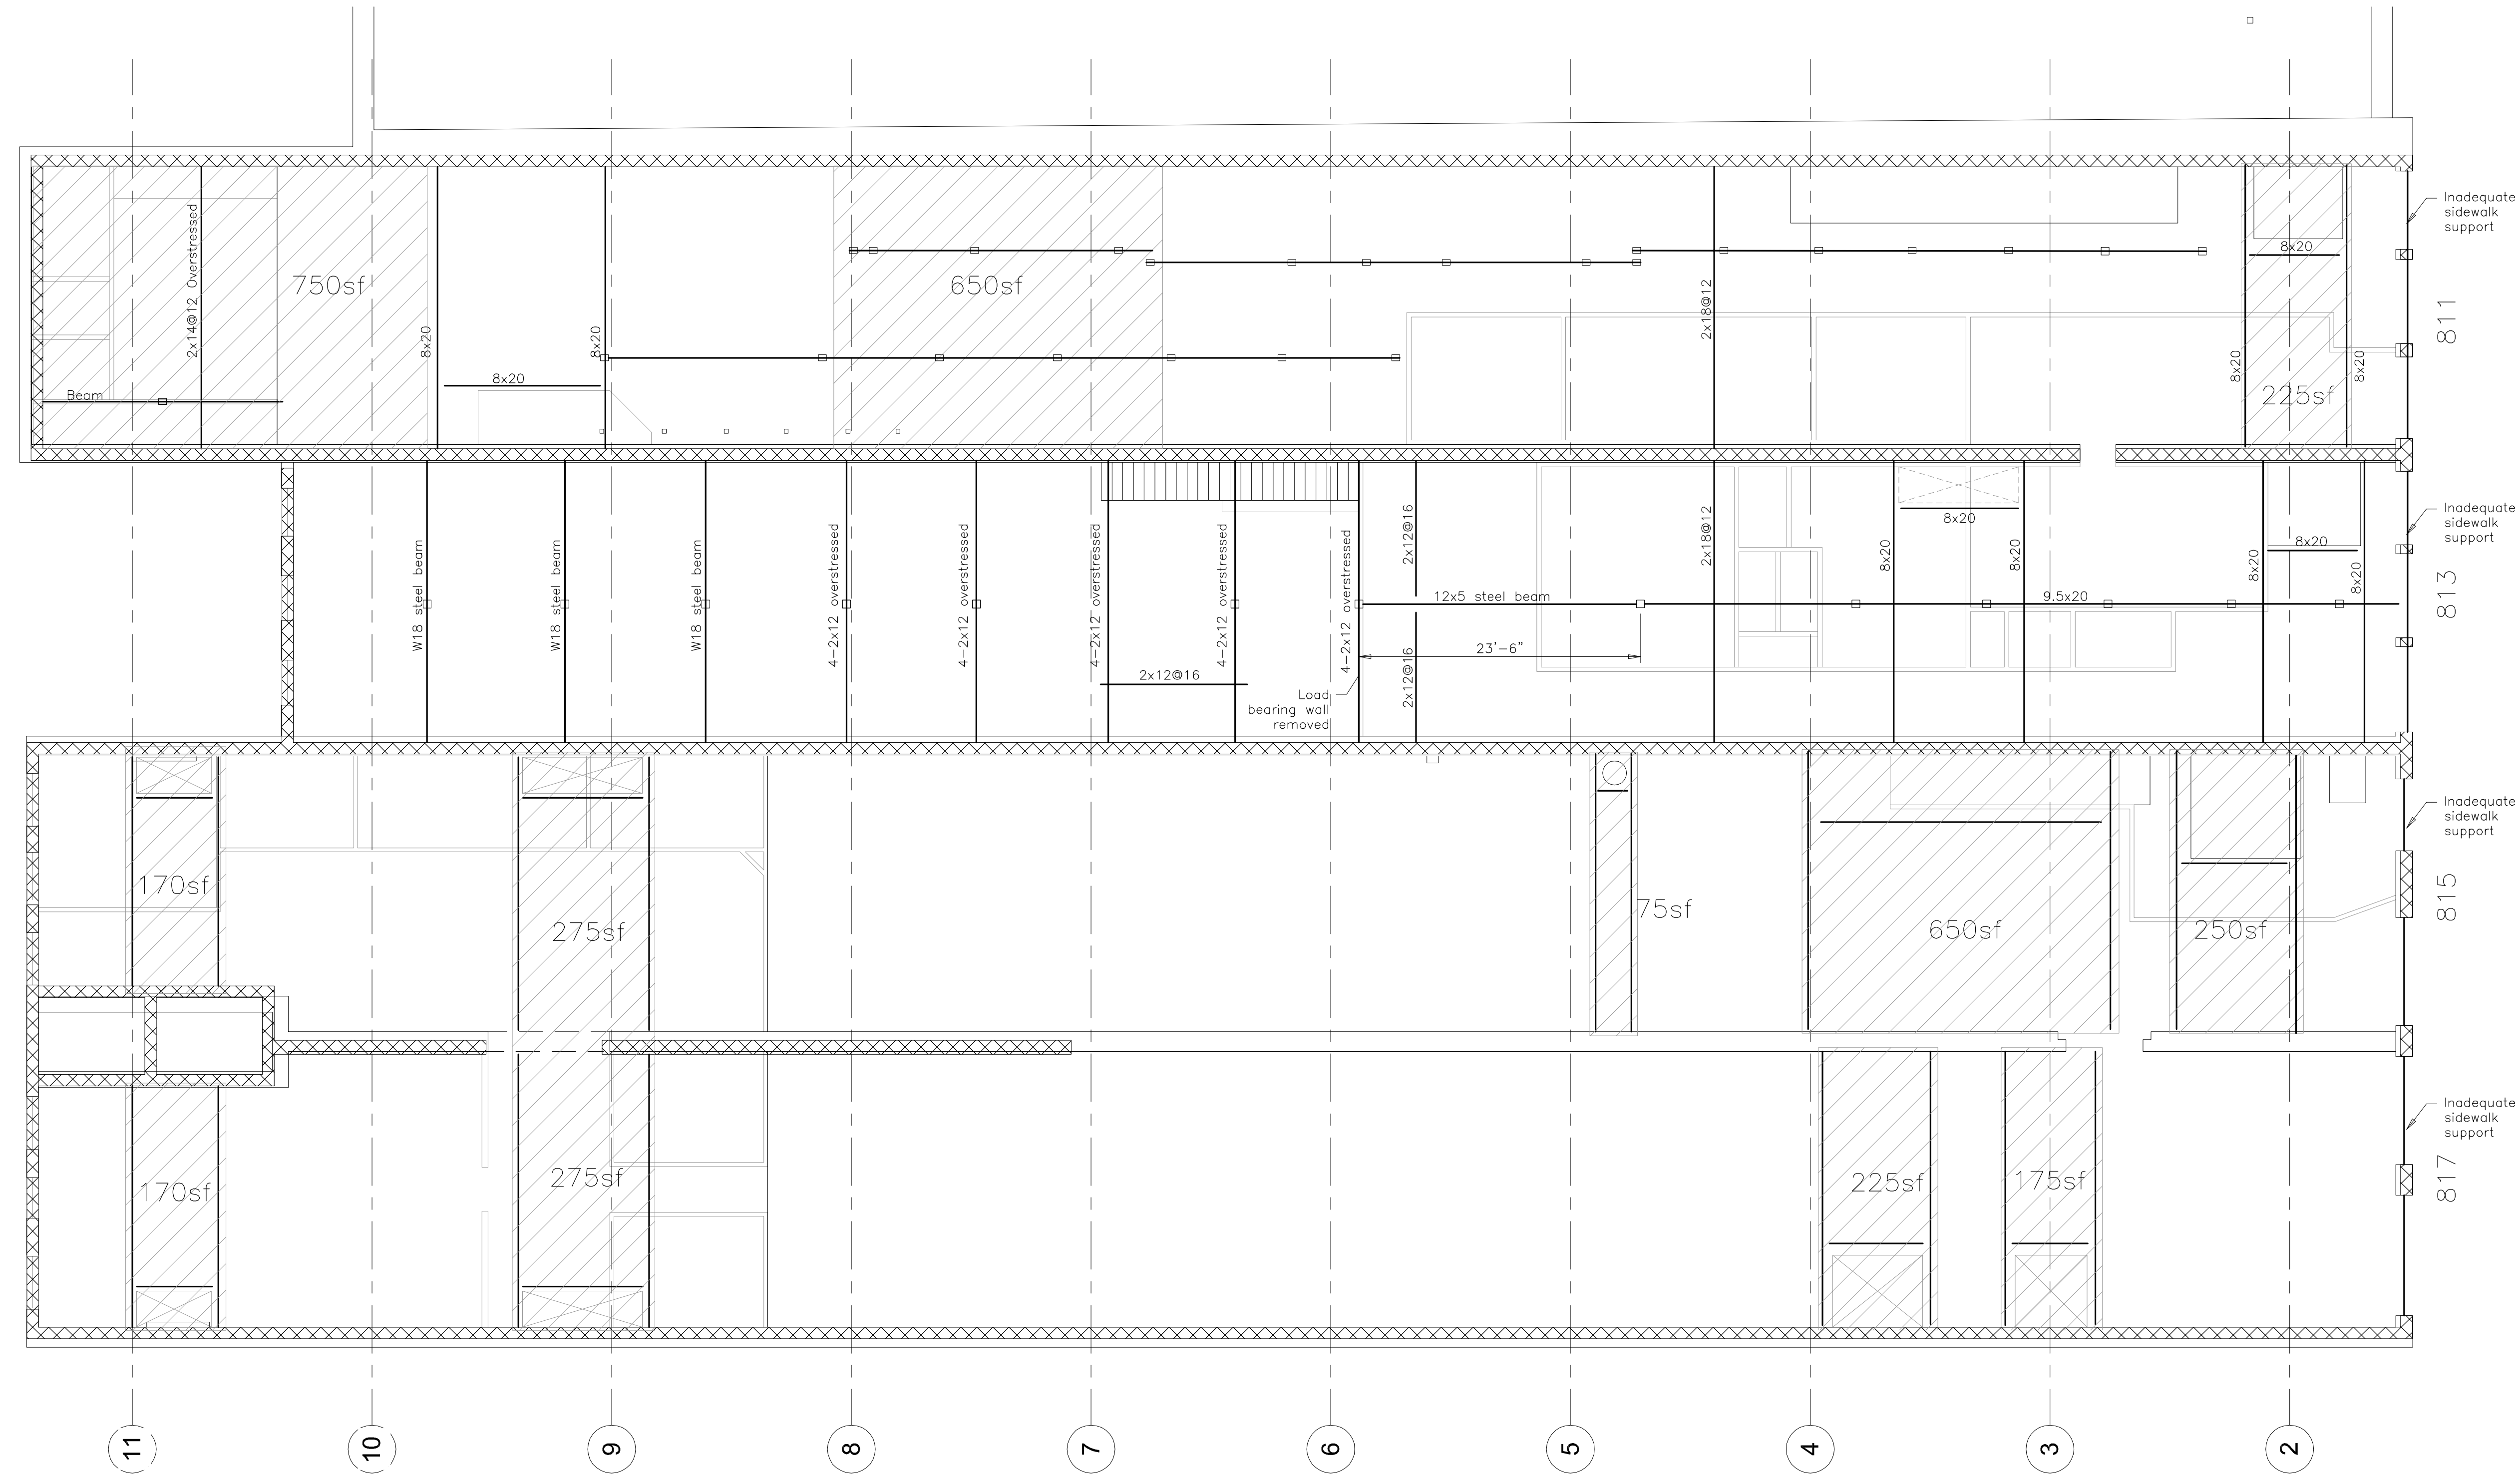
First Floor Plan

Recommended floor area for replacement: 3,140sf
Recommended beams for replacement: 15

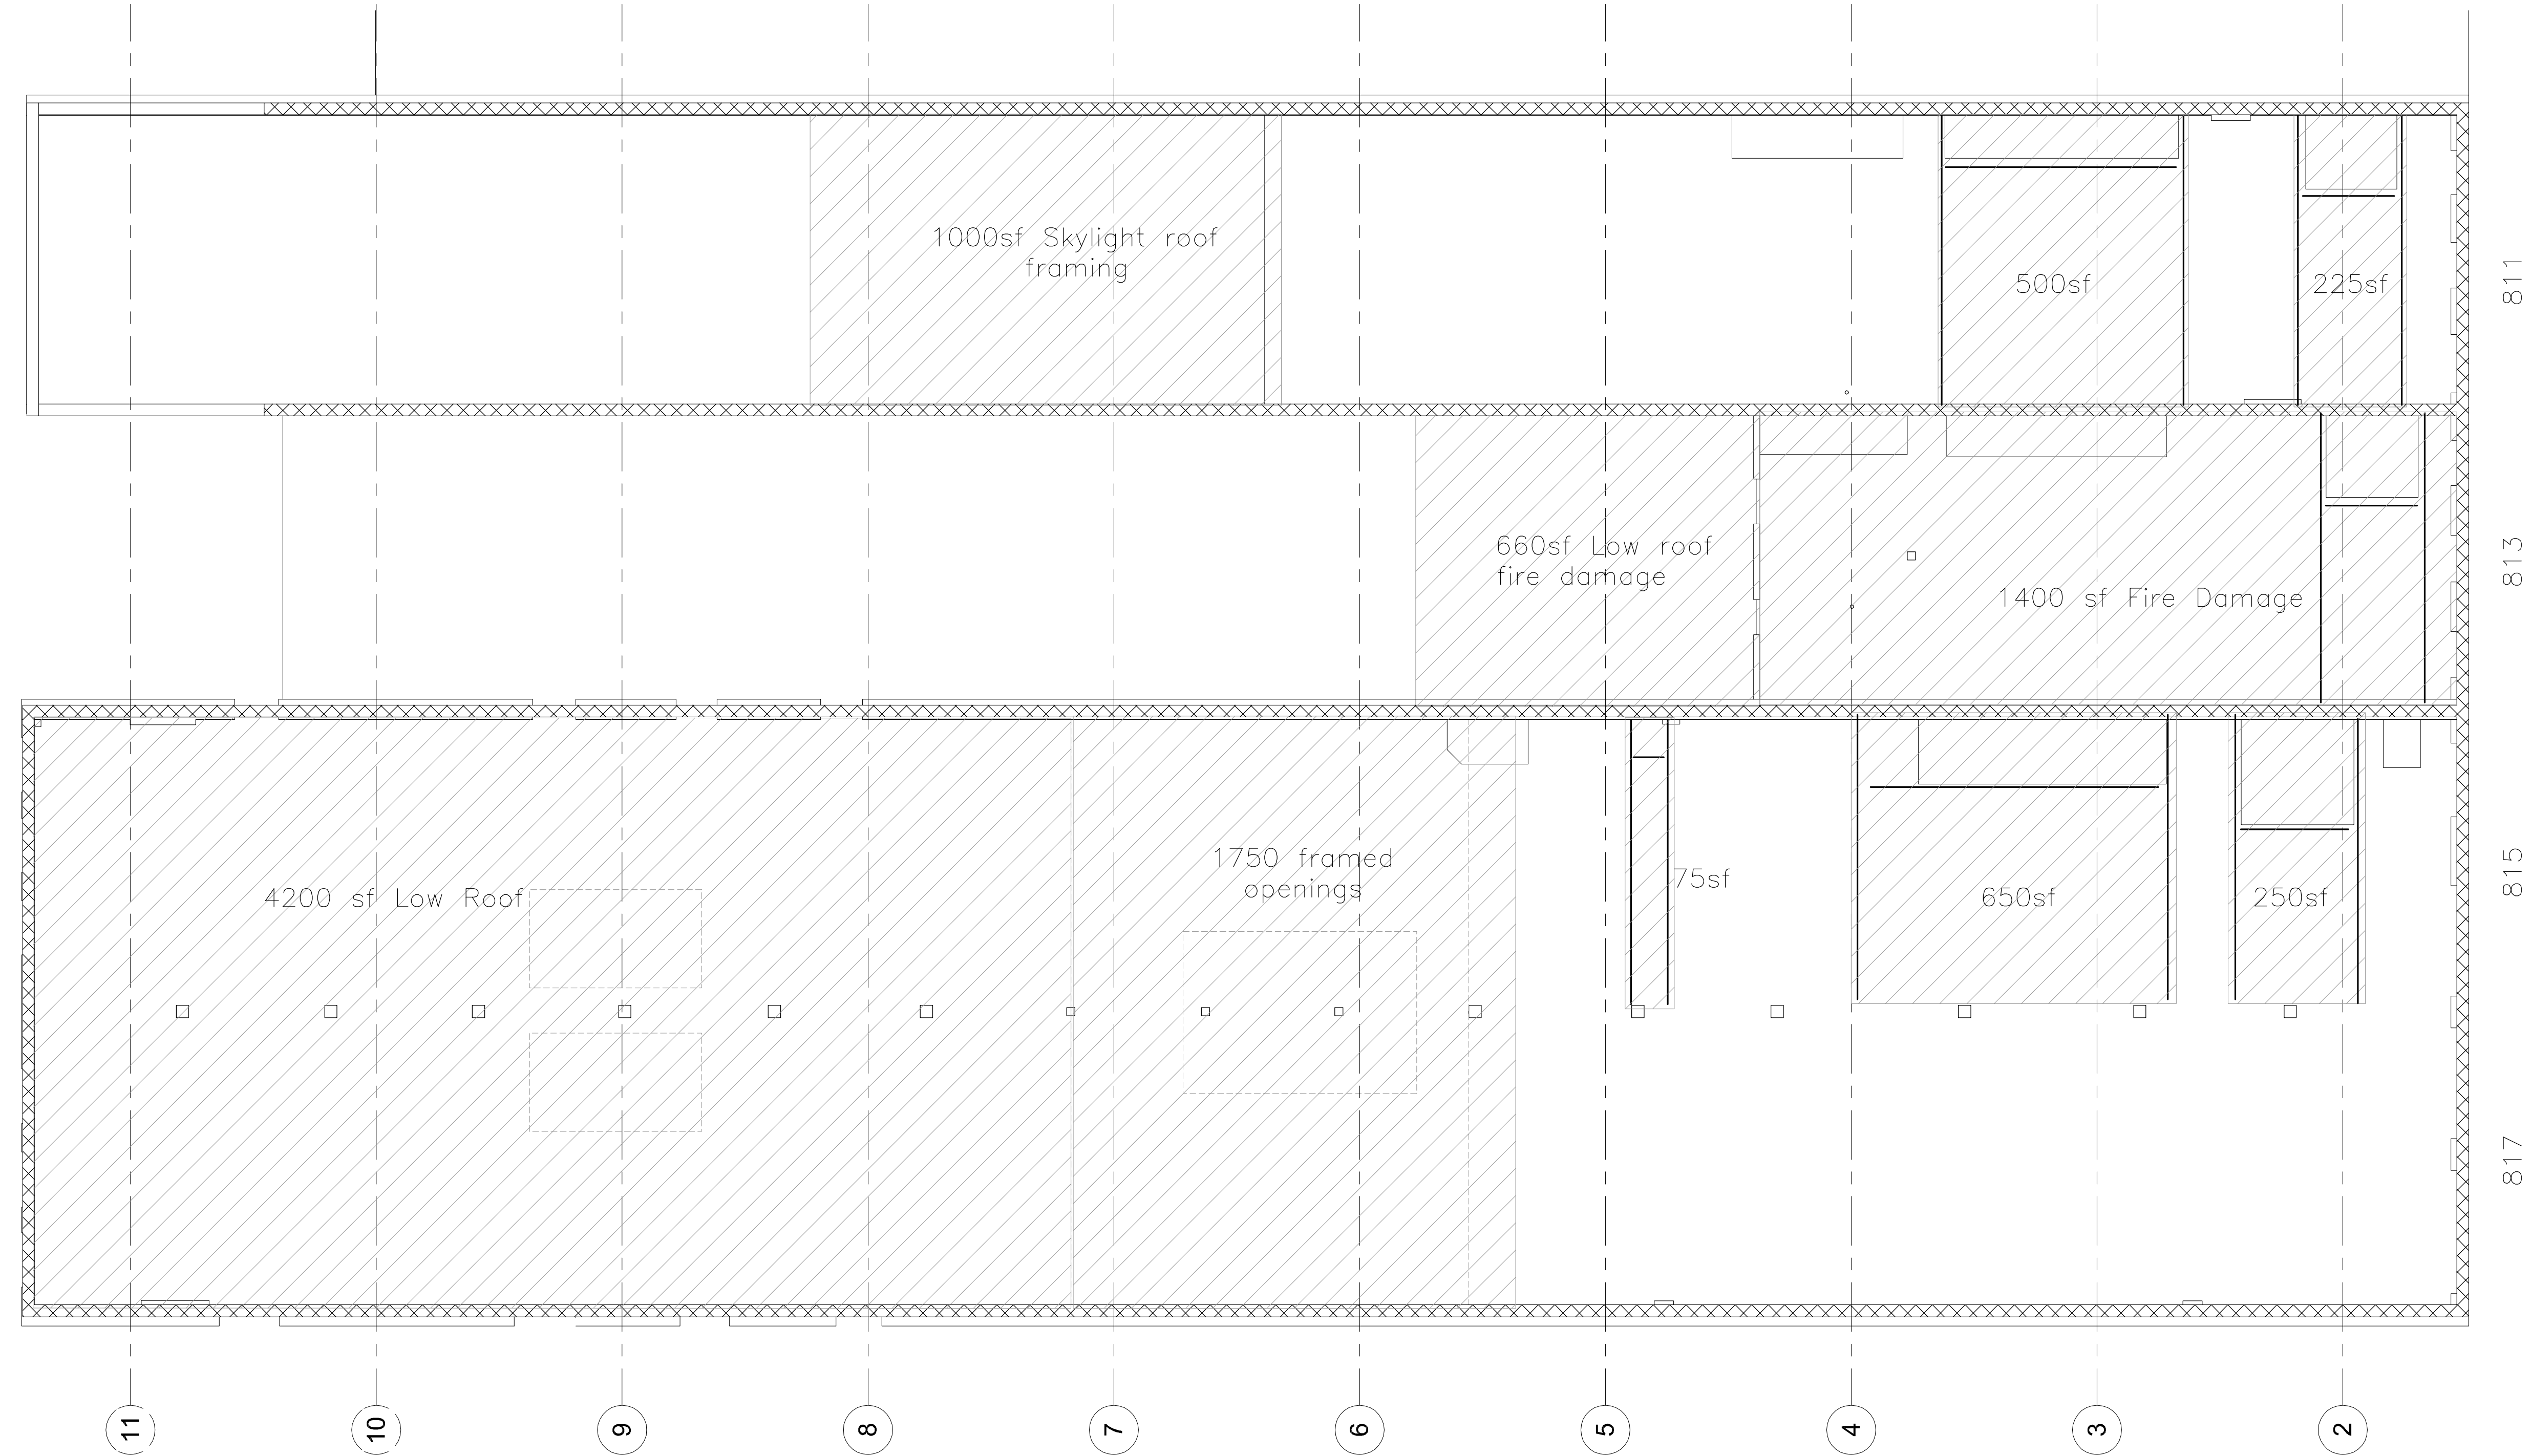
Third Floor Plan

Recommended floor area for replacement: 4,900 sf
Recommended roof area for replacement: 5,900 sf

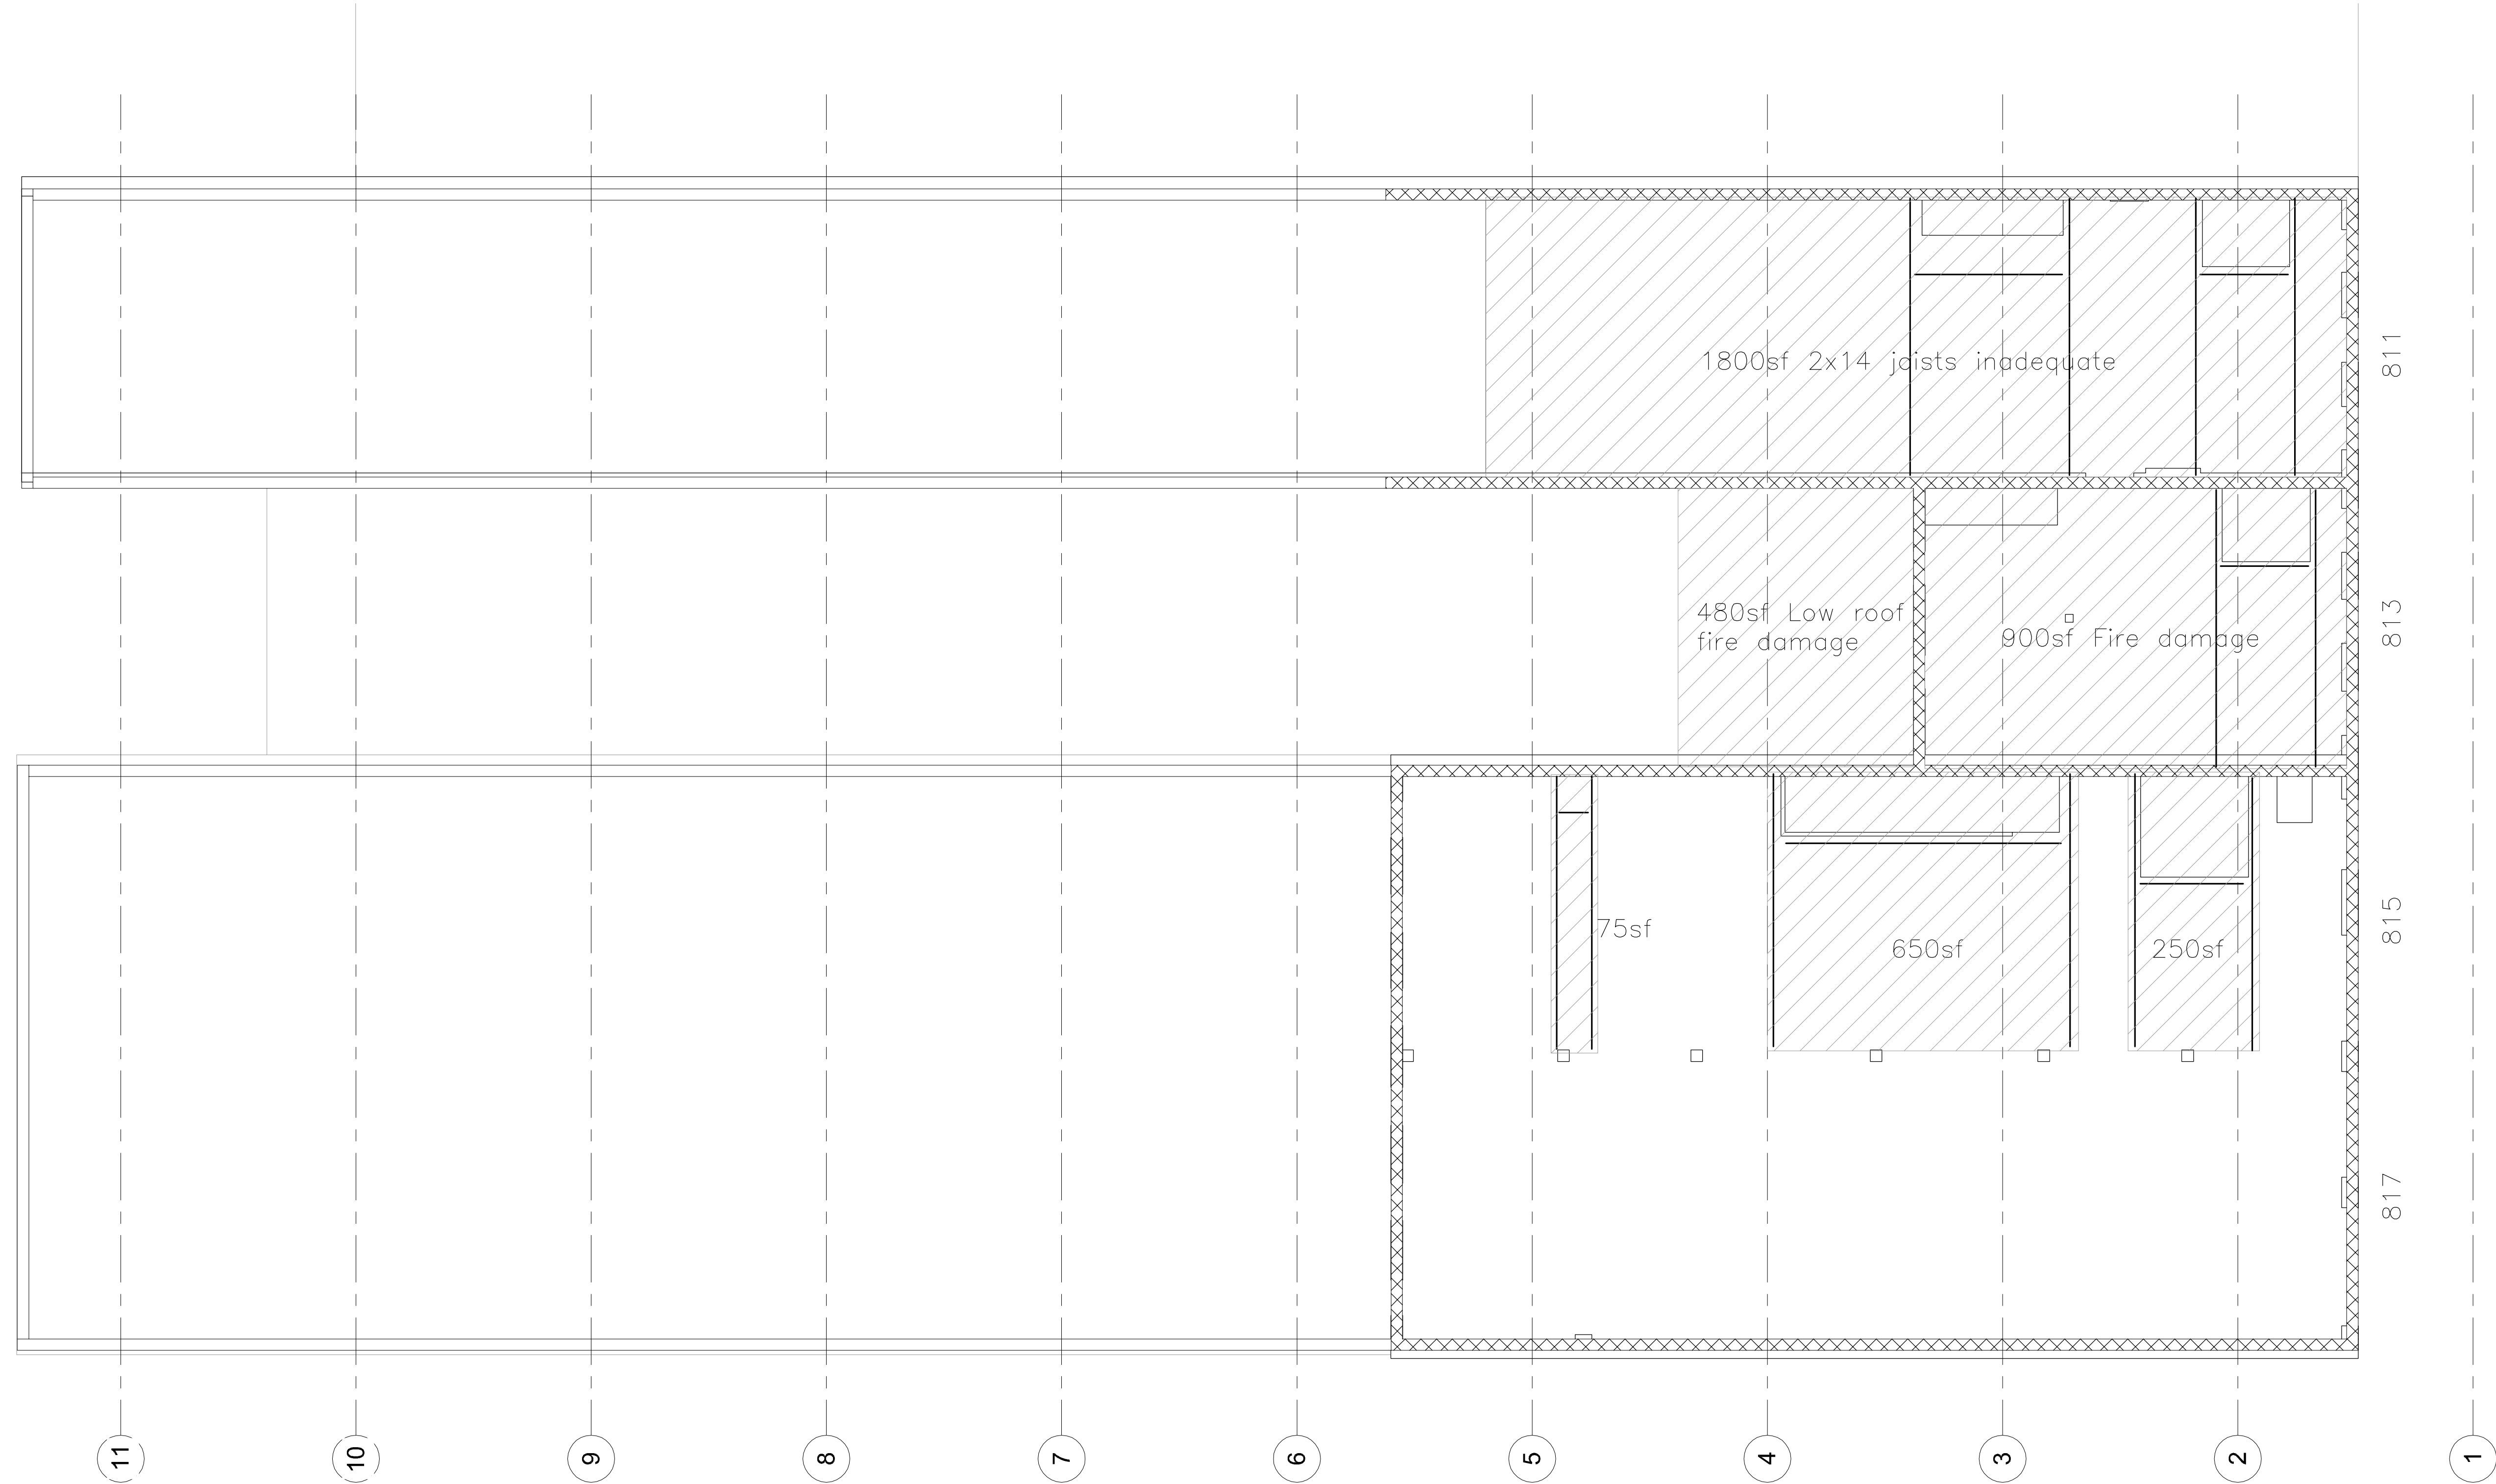
Fourth Floor Plan

Recommended floor area for replacement: 3,700 sf
Recommended roof area for replacement: 4,800 sf

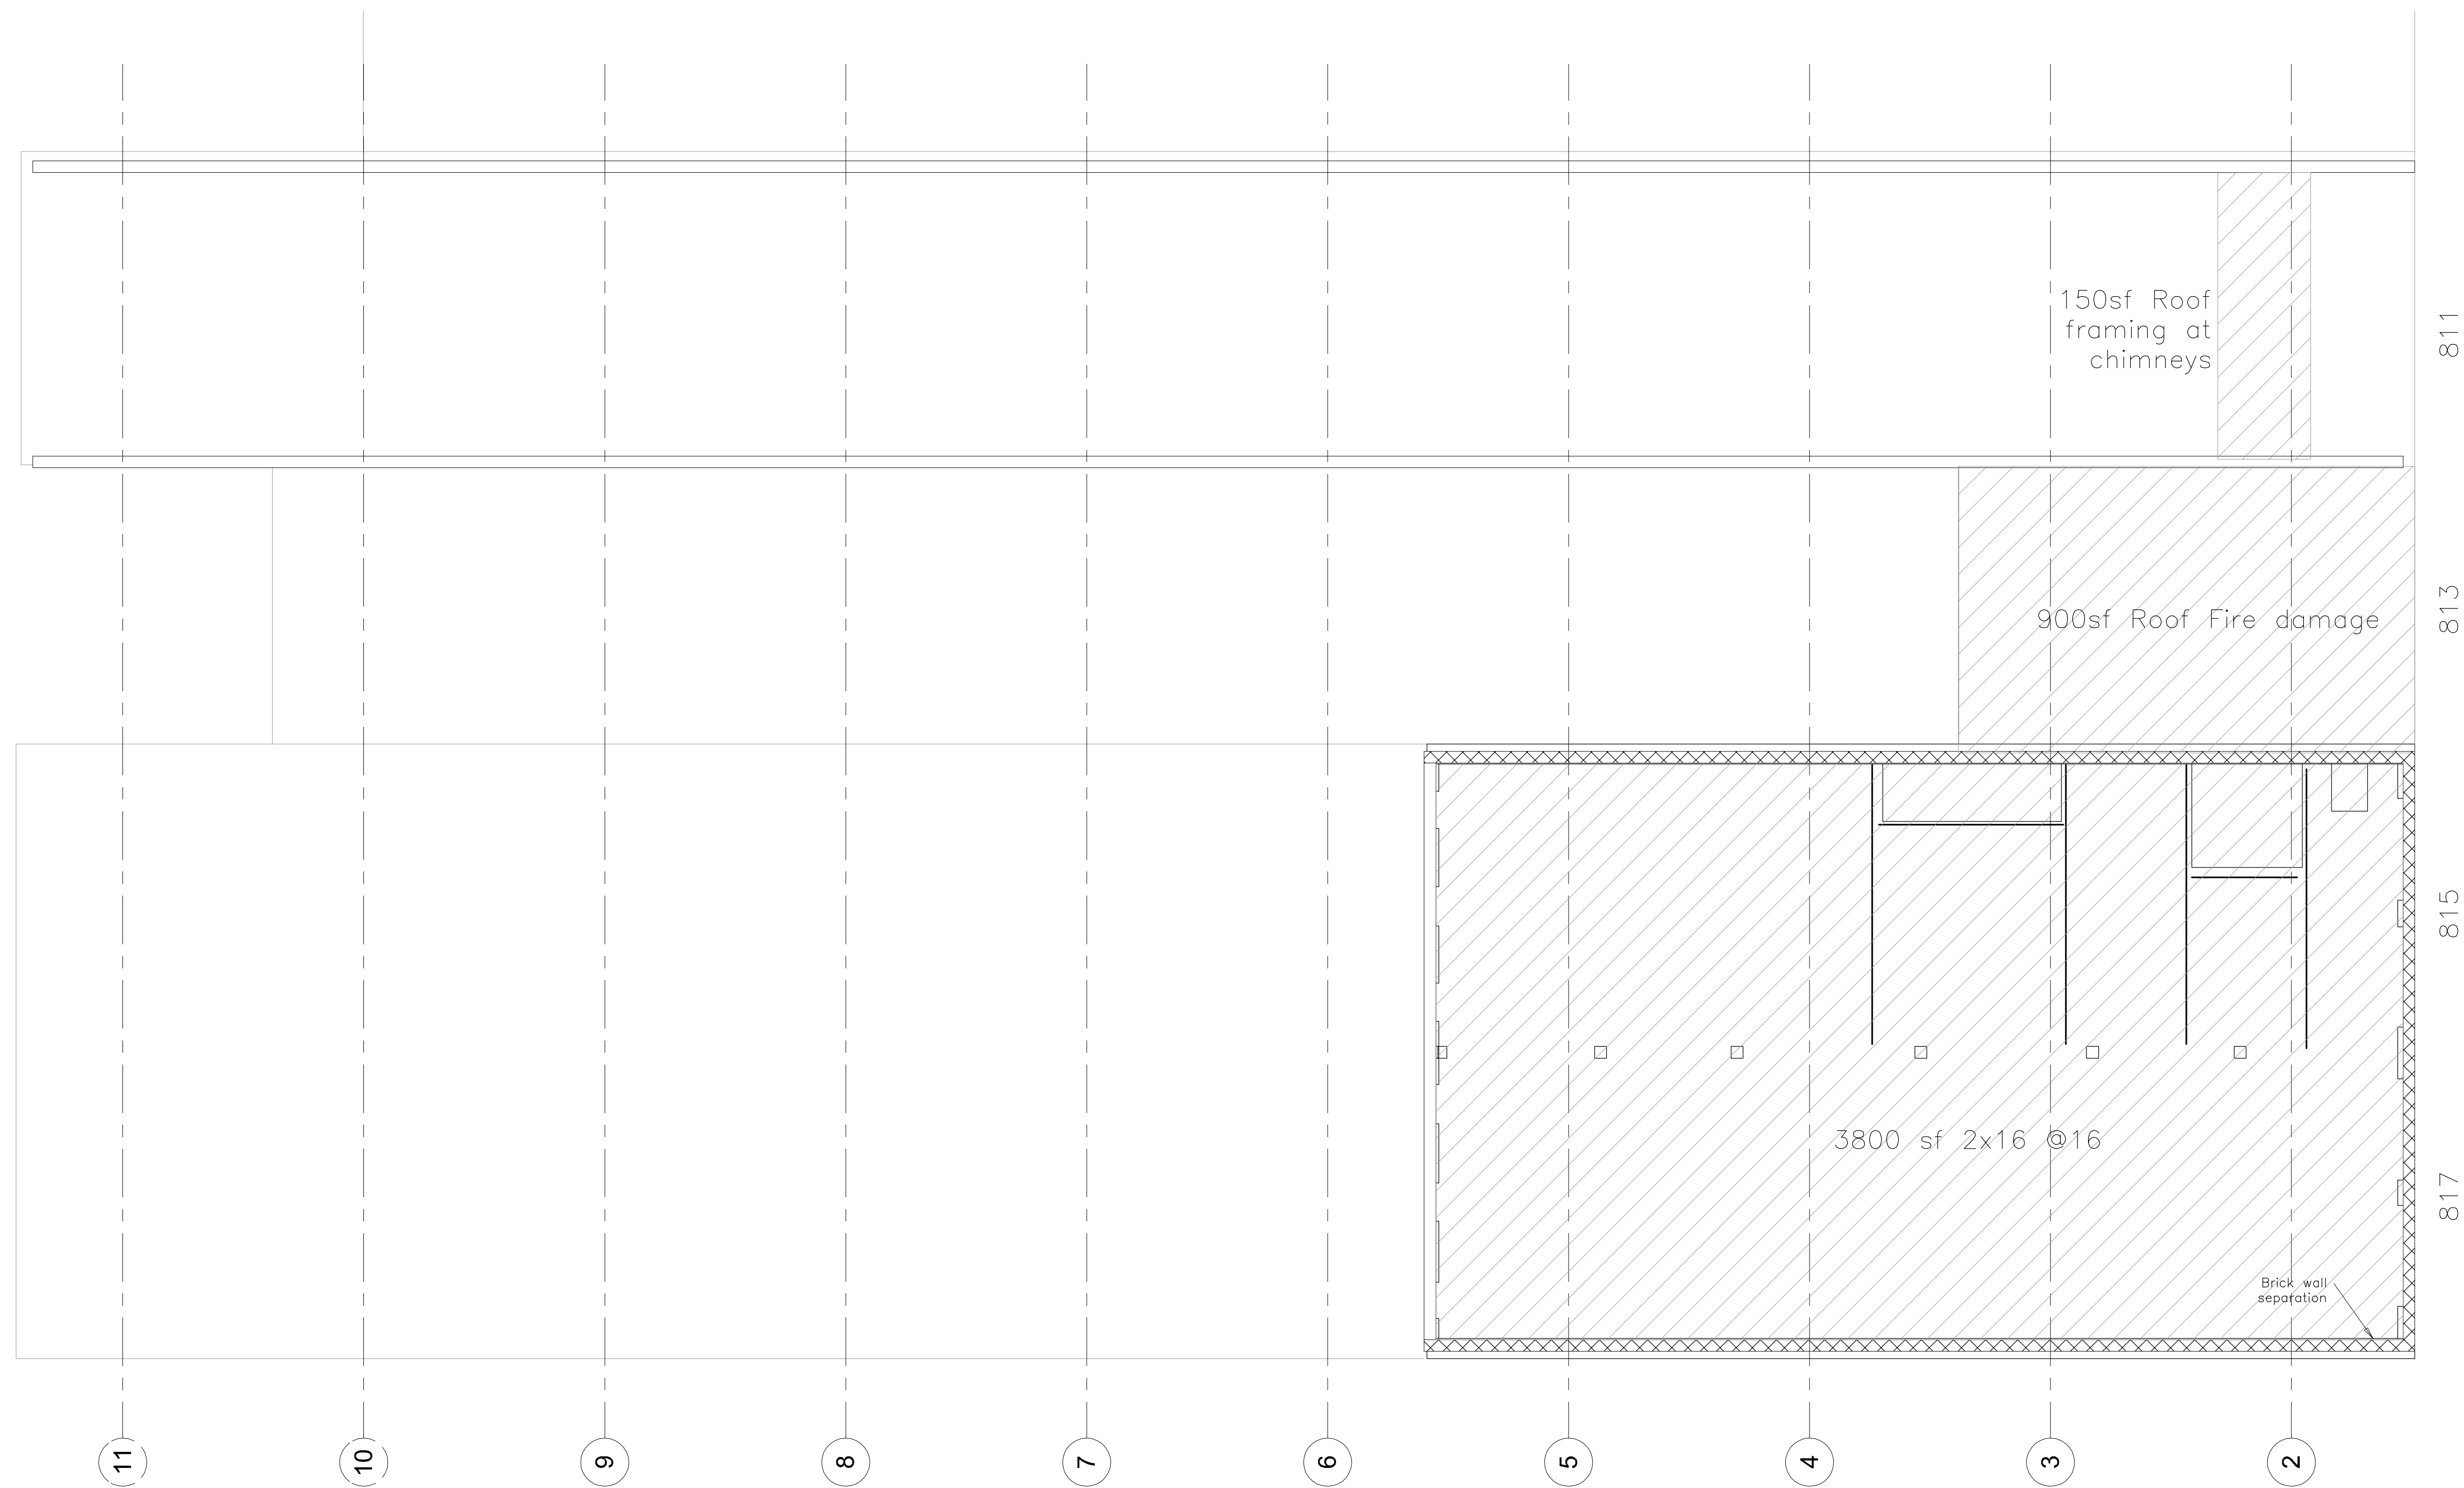
Fifth Floor Plan

Recommended floor area for replacement: 3,800 sf

Recommended roof area for replacement: 1,050 sf

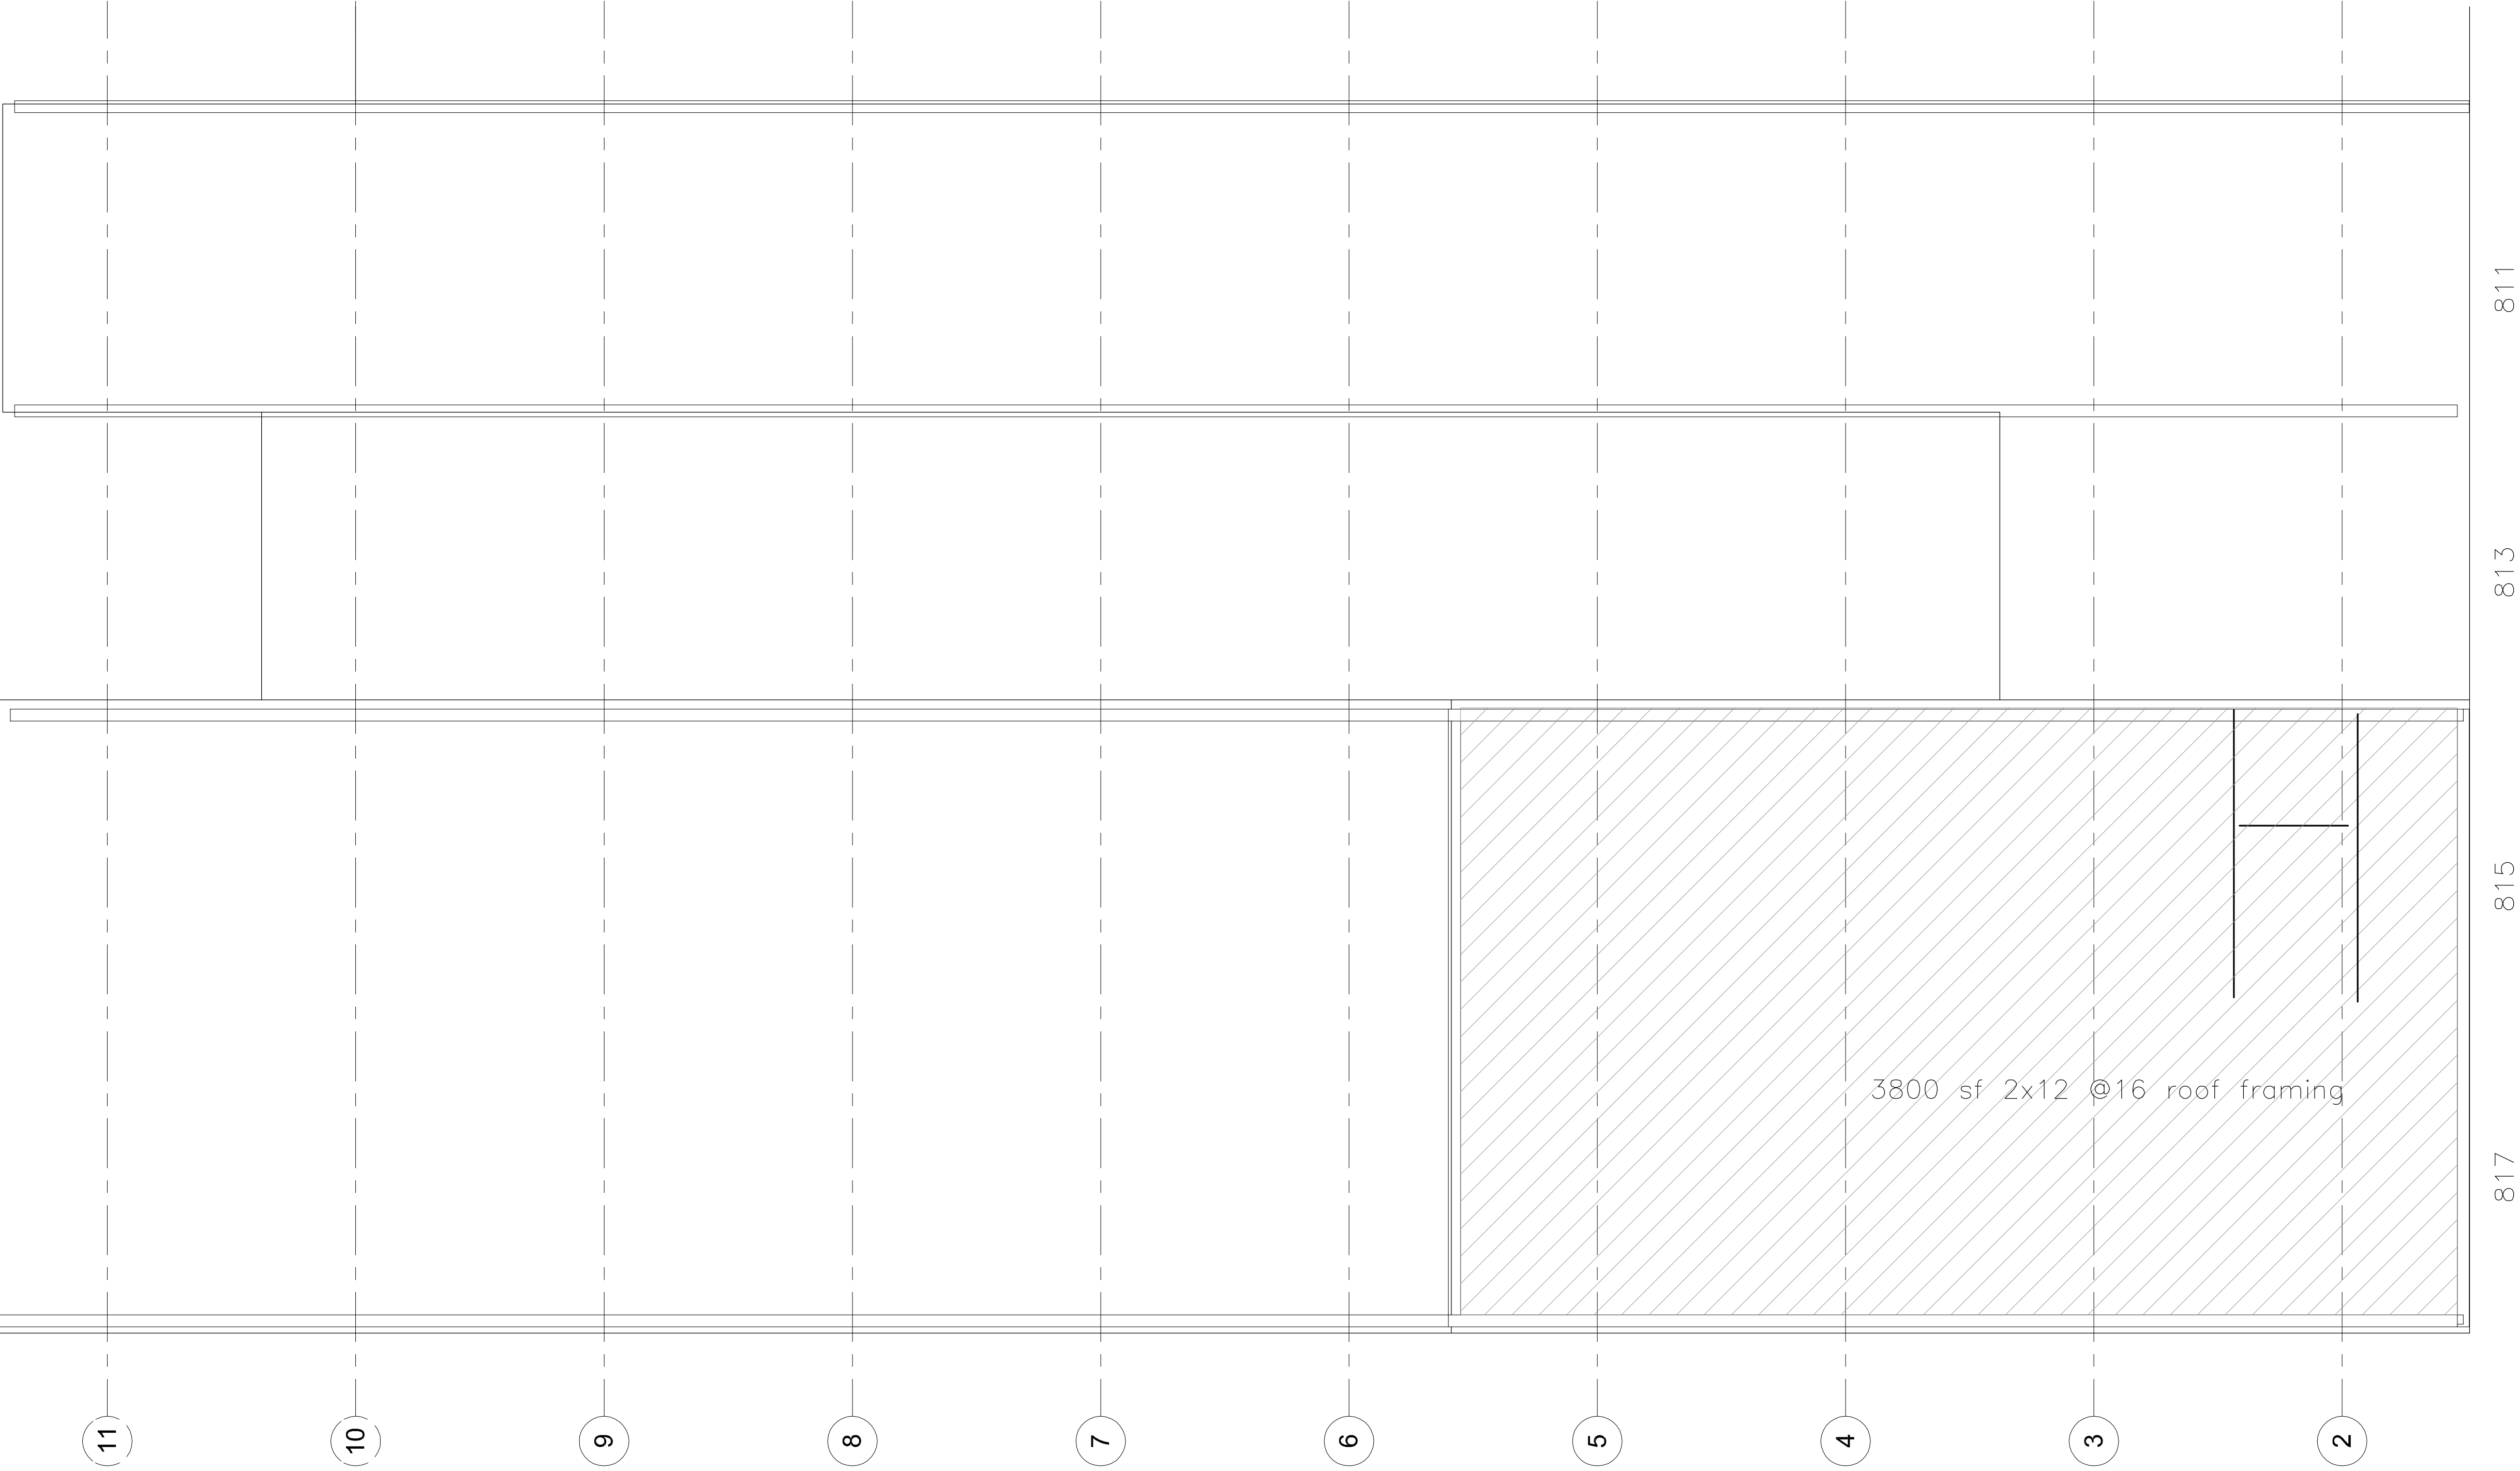
Roof Plan

Recommended roof area for replacement: 3,800 sf
