# 2130 New Main Street Urban Greenspace

2130 New Main Street

Clifton, Louisville KY

Seeking permission to demolish shotgun & salvage material due to excessive cost of rehab

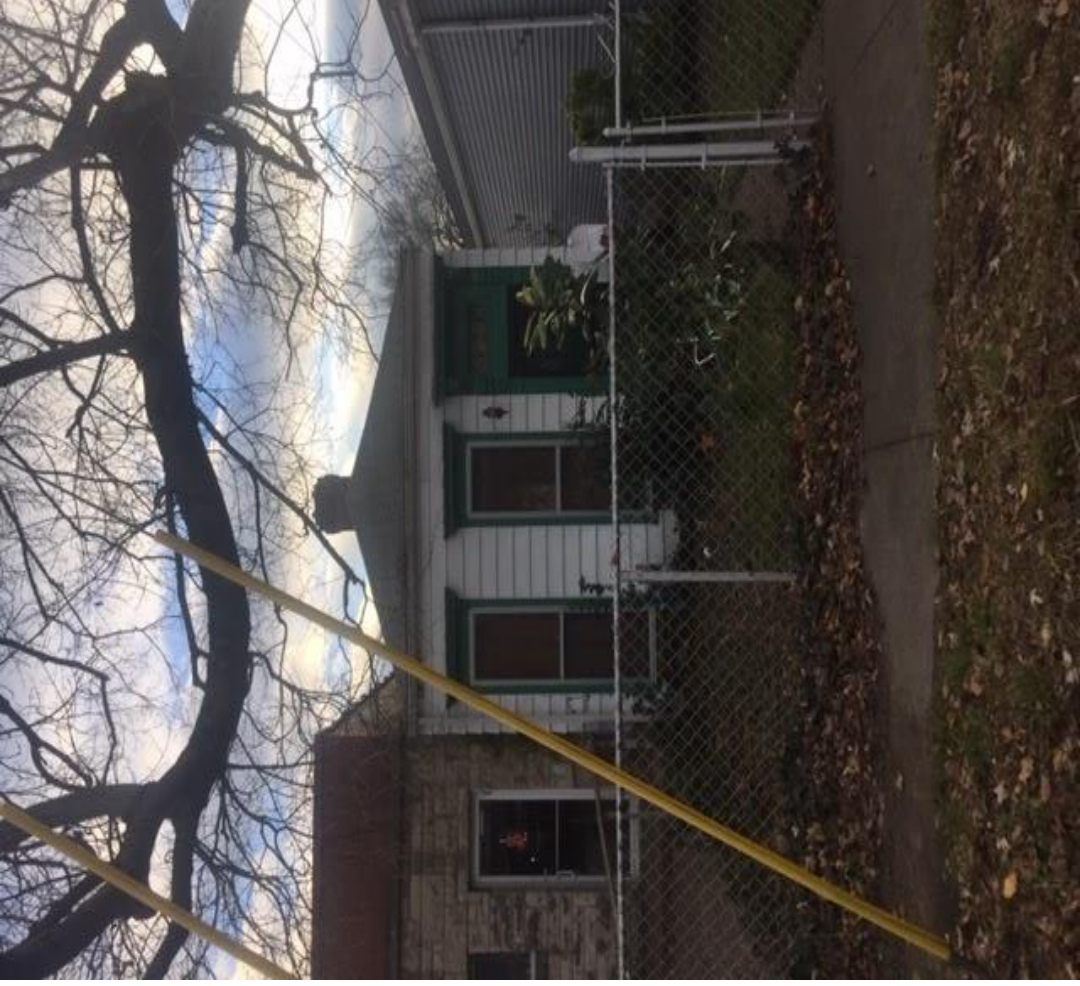
This is the front of the shotgun at purchase - clad in aluminum siding.

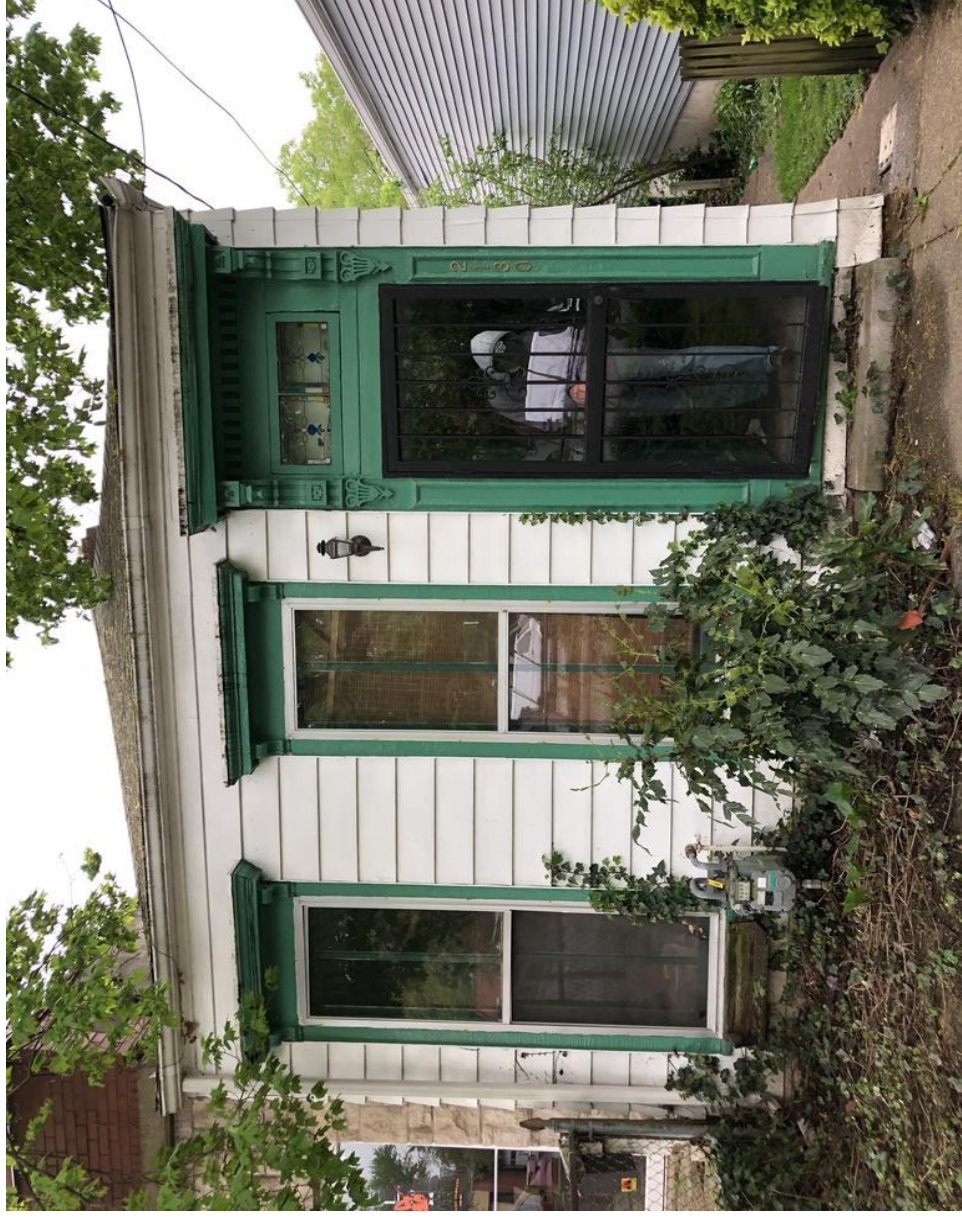
A closer  
picture at  
purchase.  
The siding  
hides  
many  
problems.

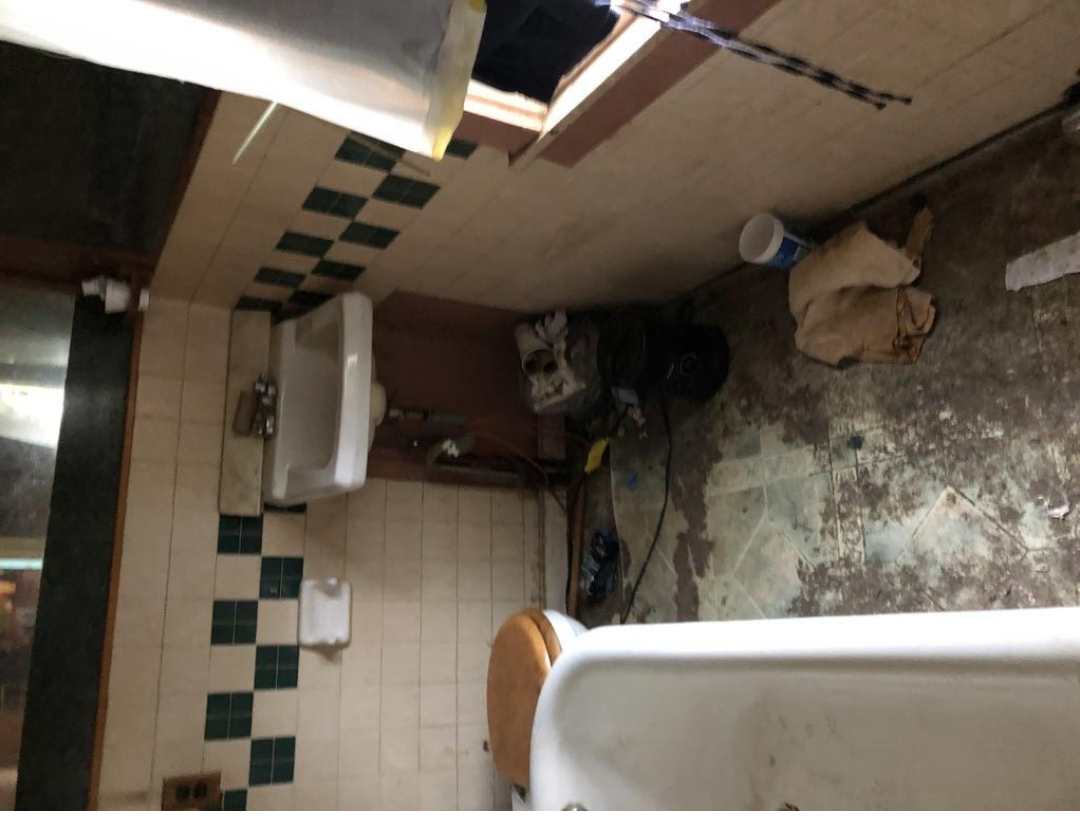
The bathroom  
floor has a  
'clean' trail  
worn thru the  
cat feces.

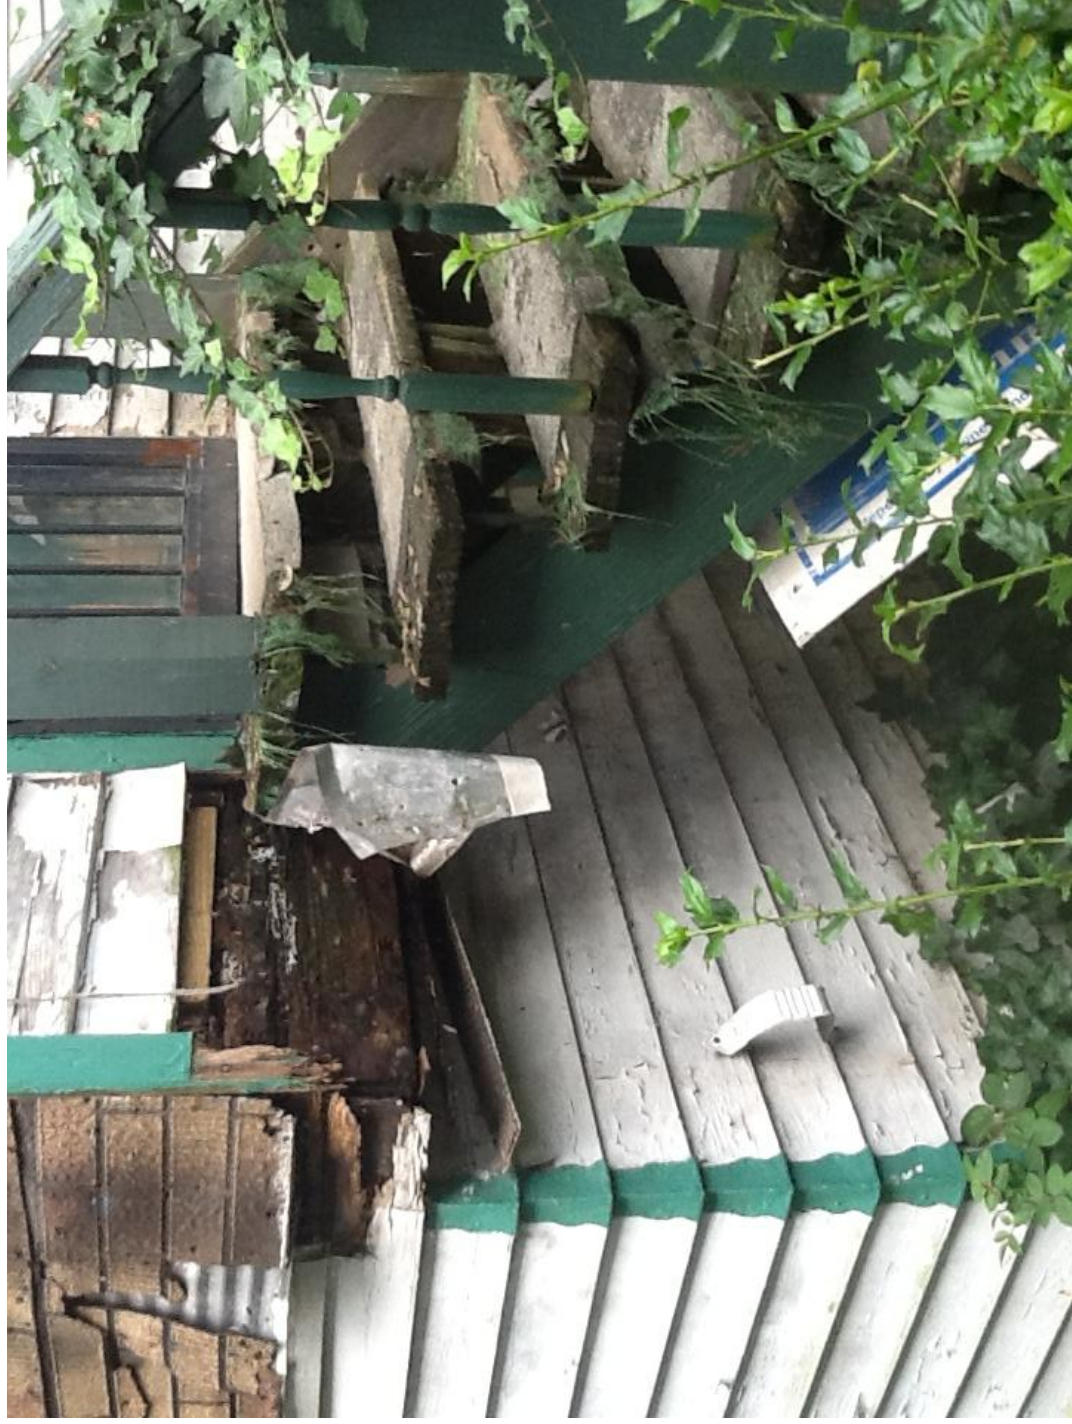
The SW  
(back)  
corner,  
after  
removing  
some  
aluminum  
siding.

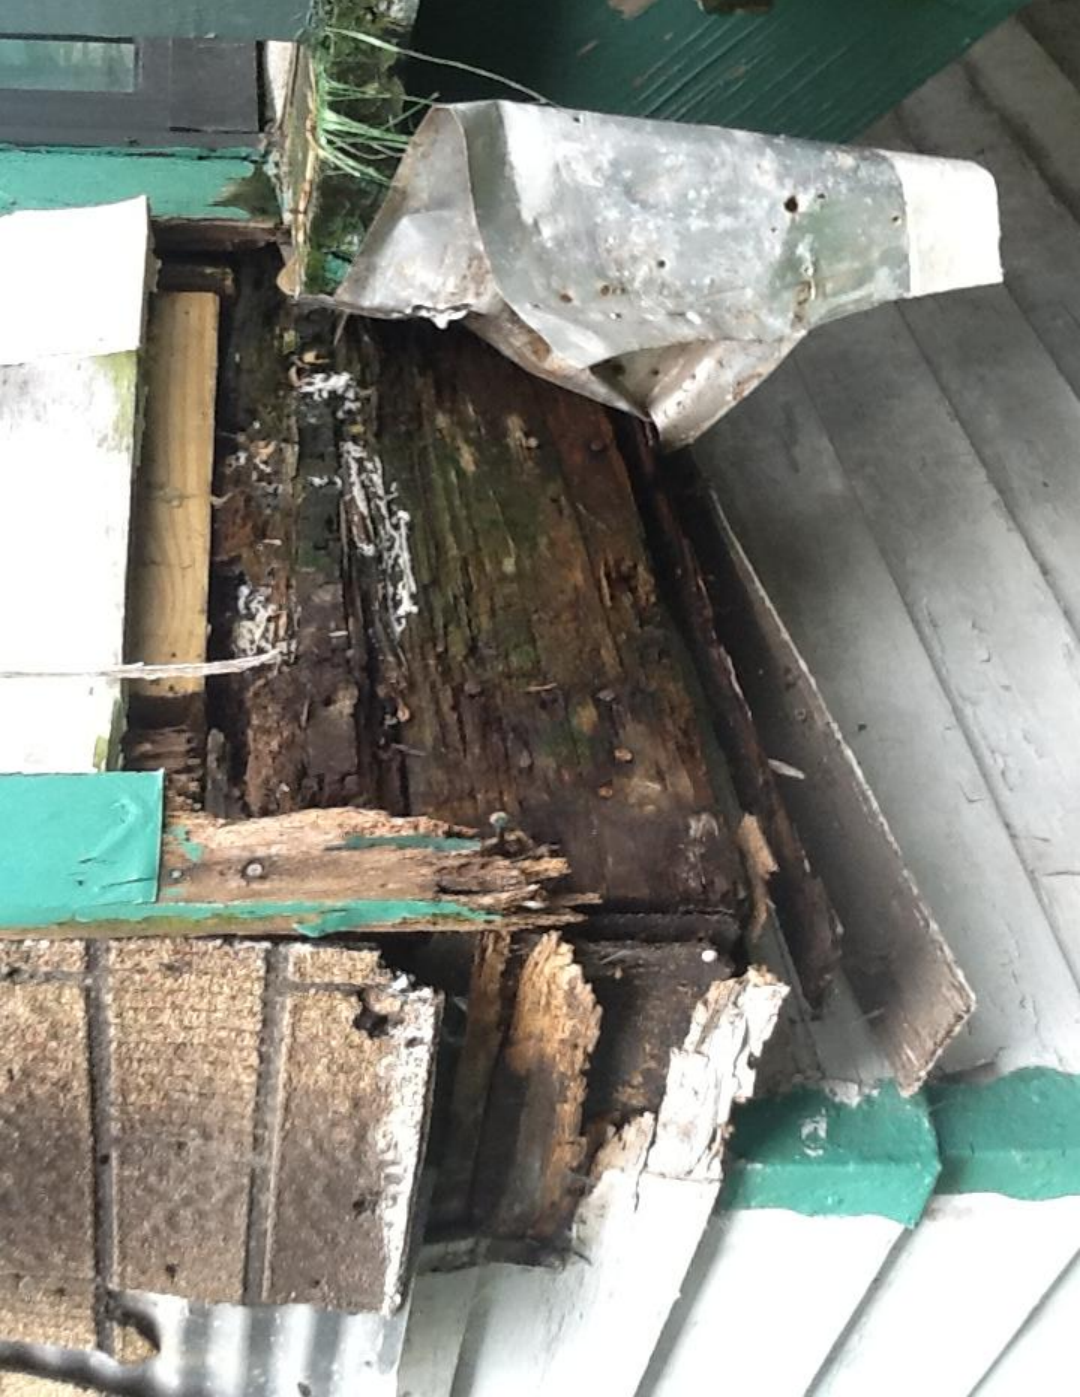
Rot and  
mold.

This SW  
corner was  
the newest  
and driest  
corner of the  
structure.

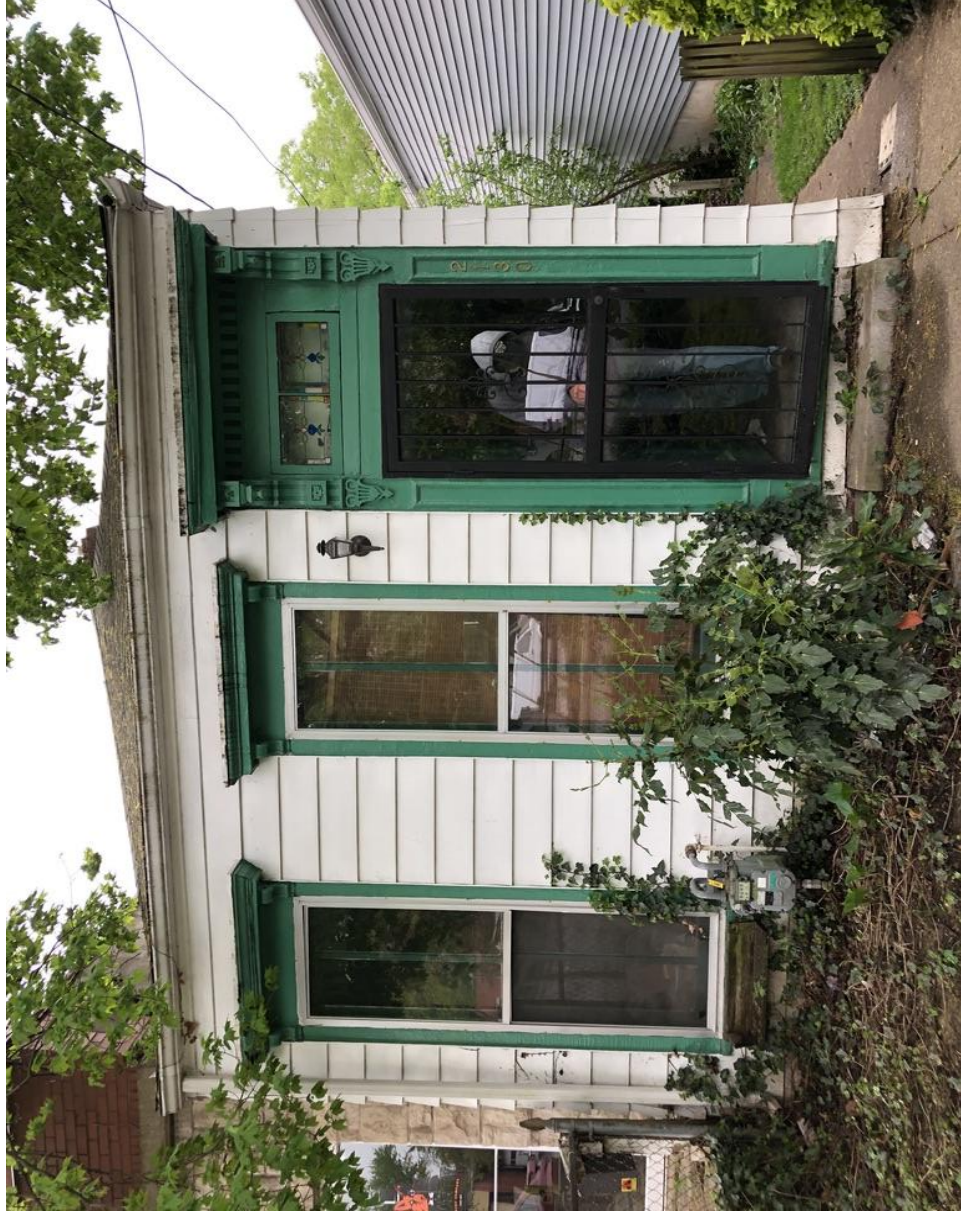
So, we return to the front of the shotgun, the oldest part of the structure. This is before we removed the aluminum siding to evaluate the condition of the structure. Note the damage below the east (left) window. The crowning above the window fell off soon after this picture was taken.

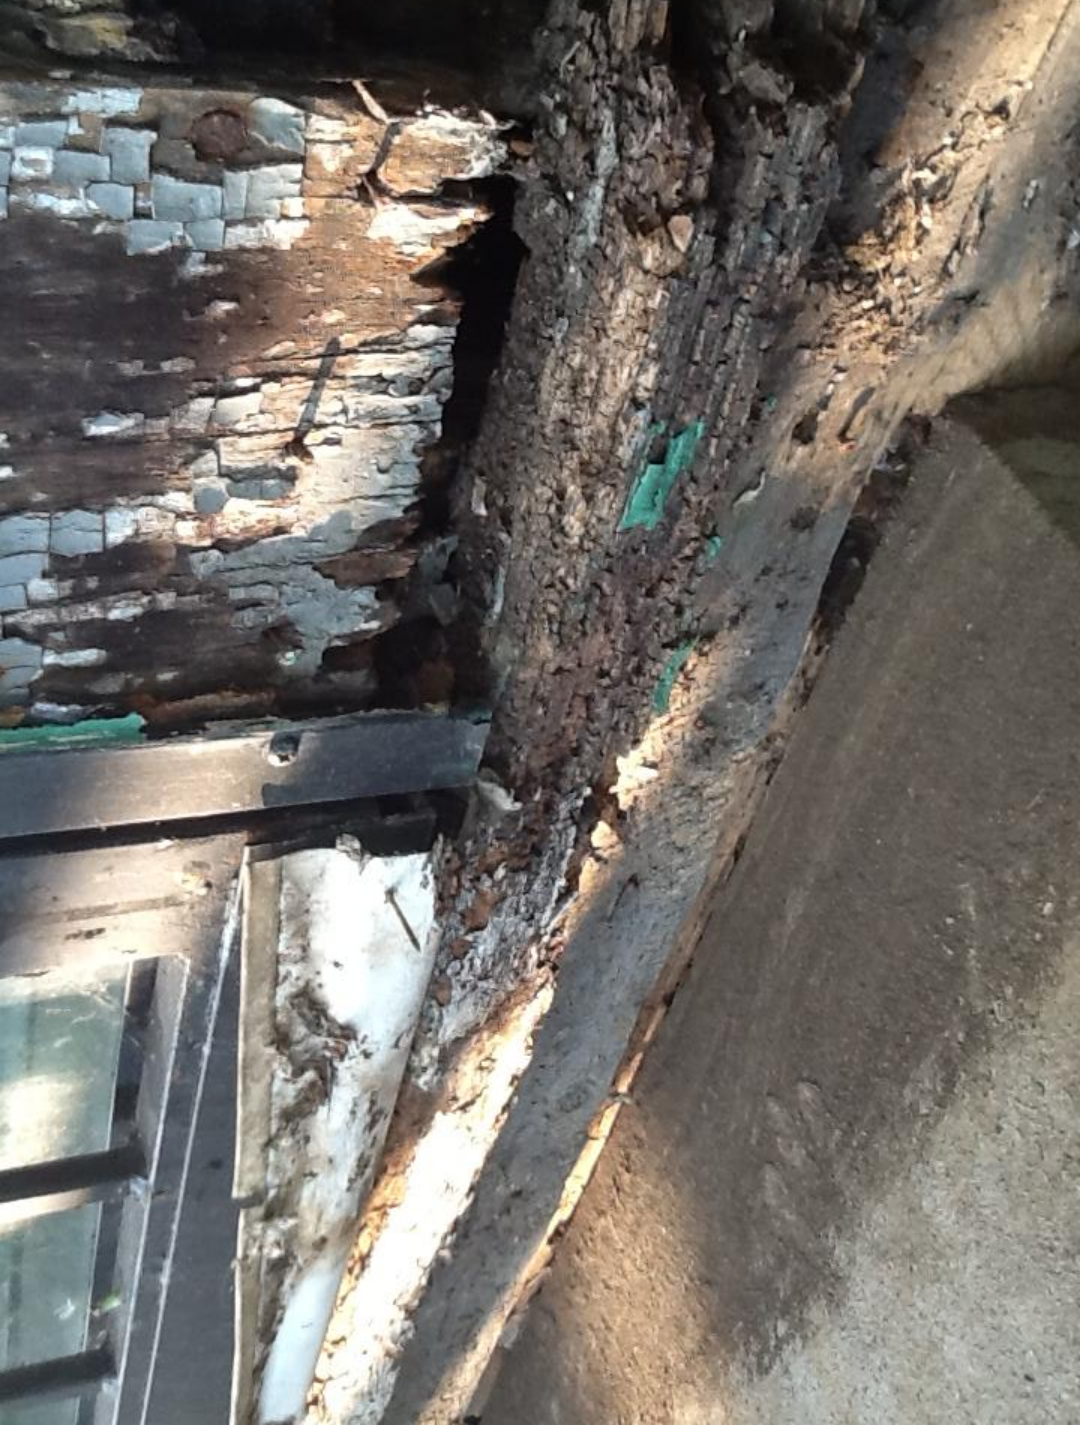
The NW corner of the shotgun is rotted out. The front door's storm door is blocked by the upturned aluminum siding.

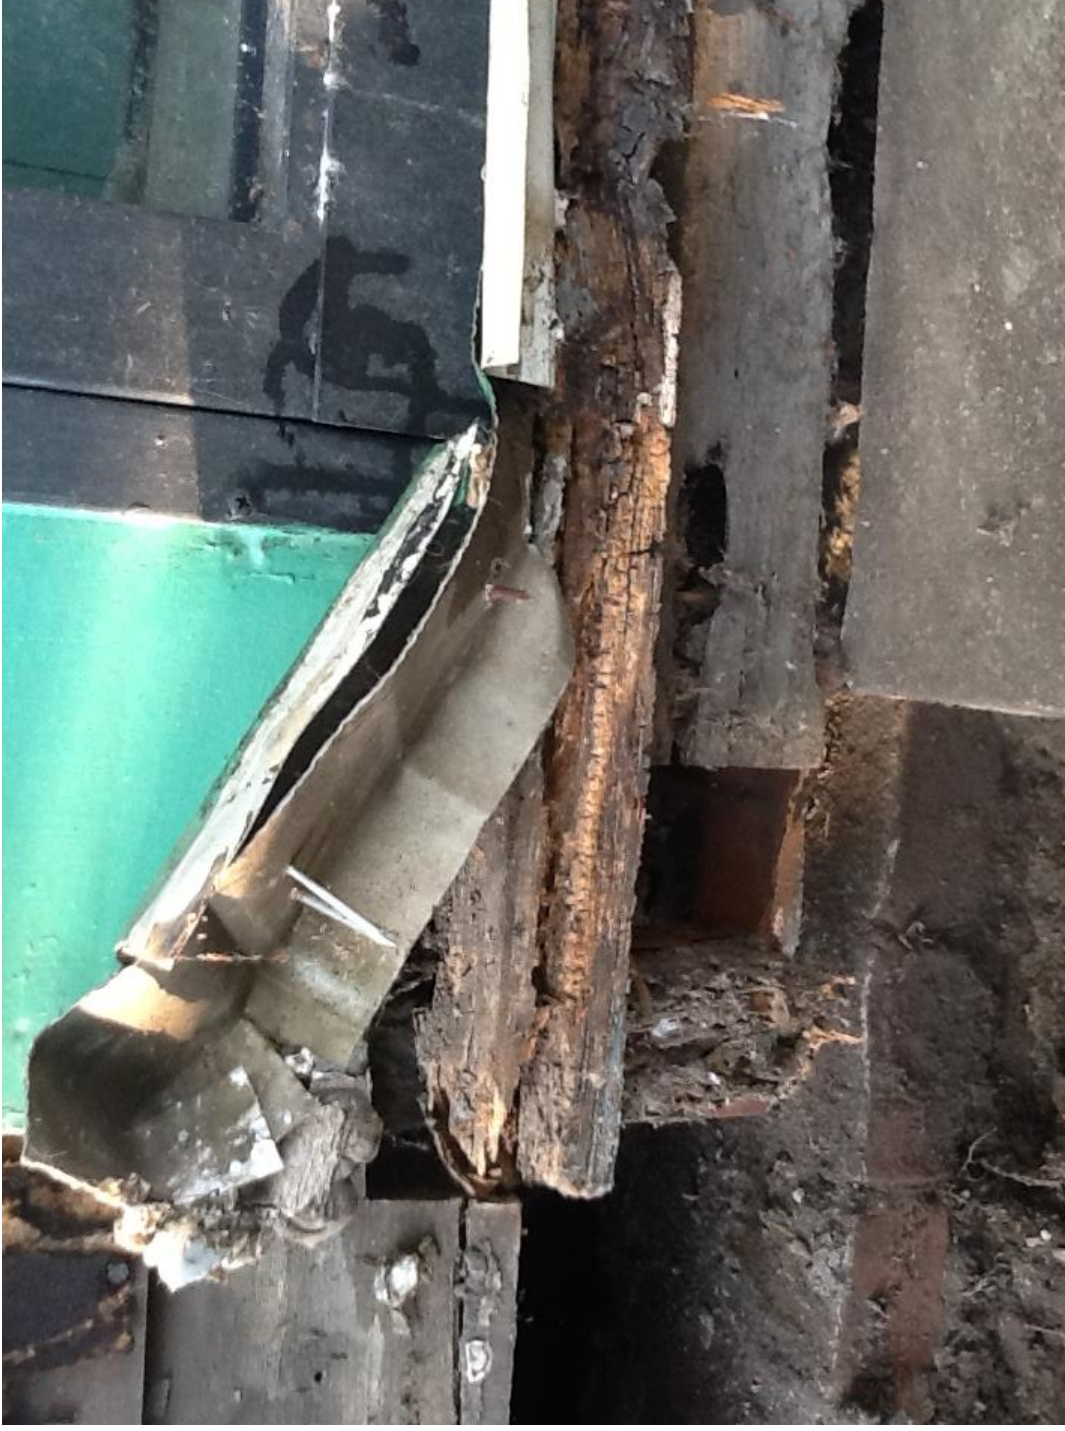
The other corner of the storm door. The wall stud has rotted. The plate it rested on has rotted and blown away.

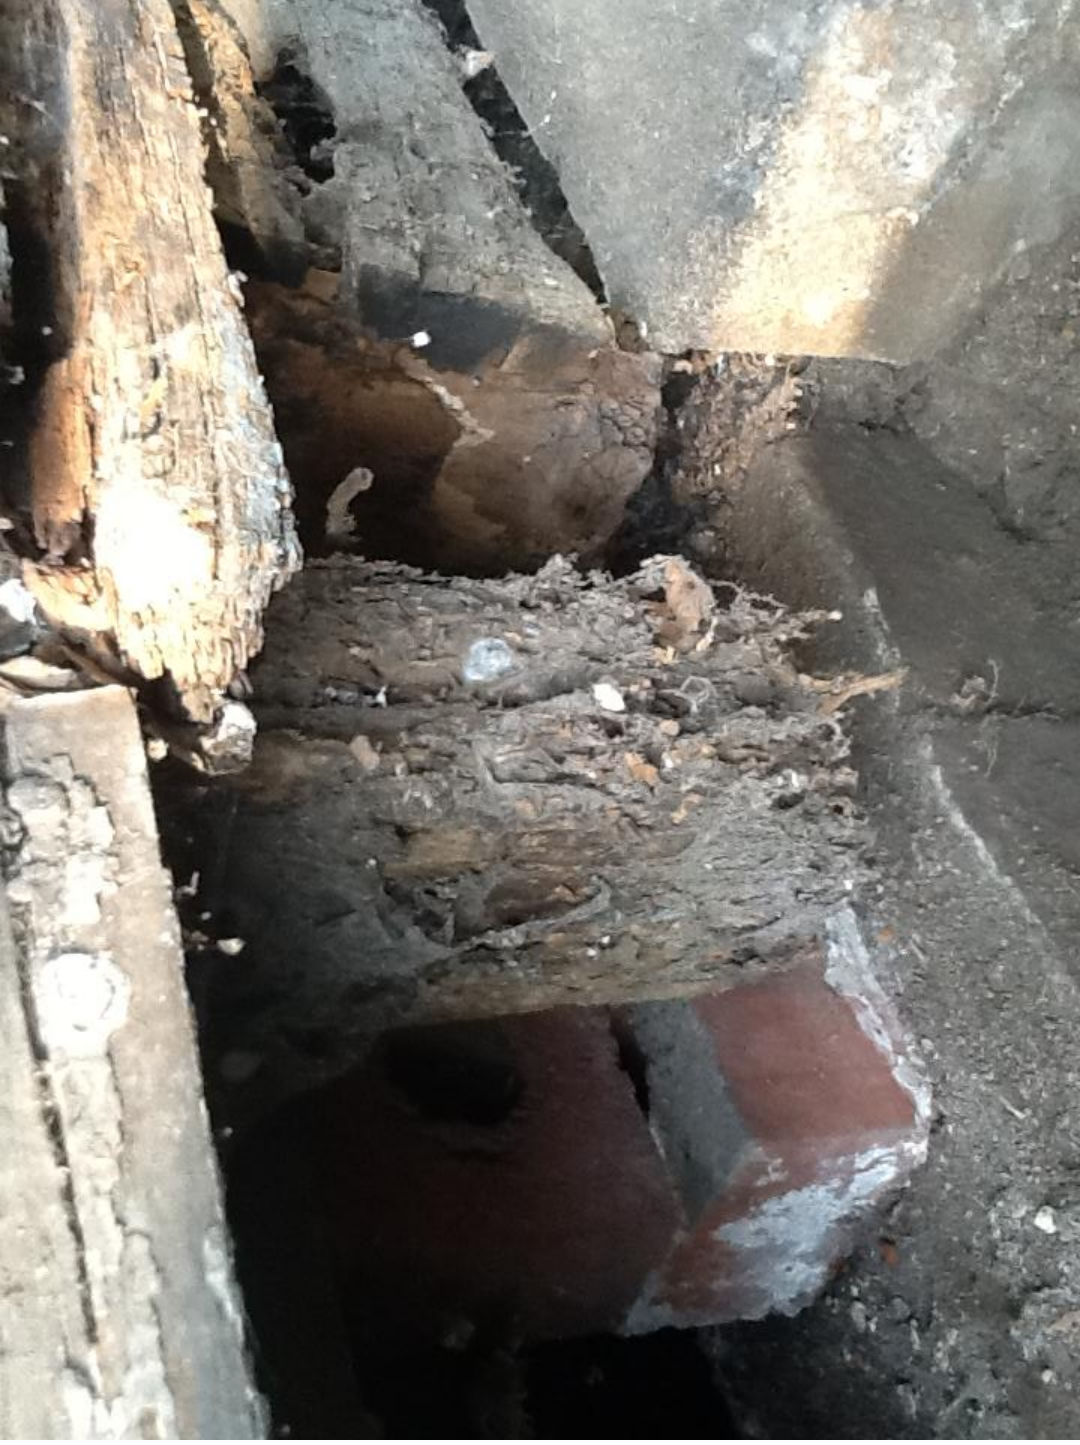
The same stud. The bricks behind the stud are holding up the floor joists. The neglect of the structure clearly pre-dates 2019.

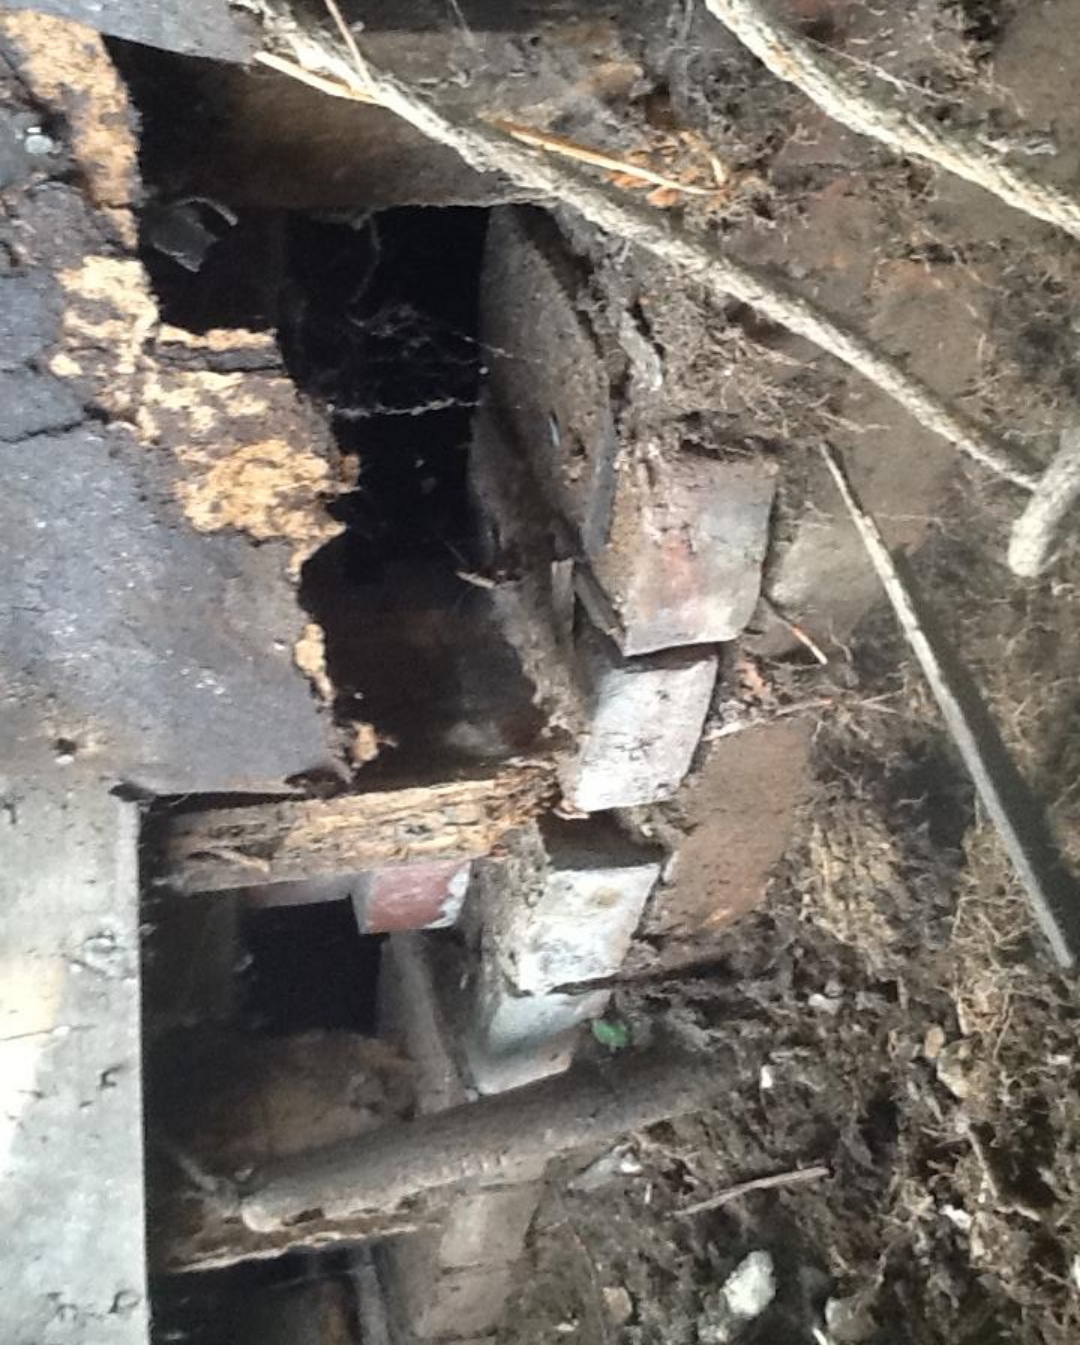
Note the  
lack of  
mortar  
between  
bricks.

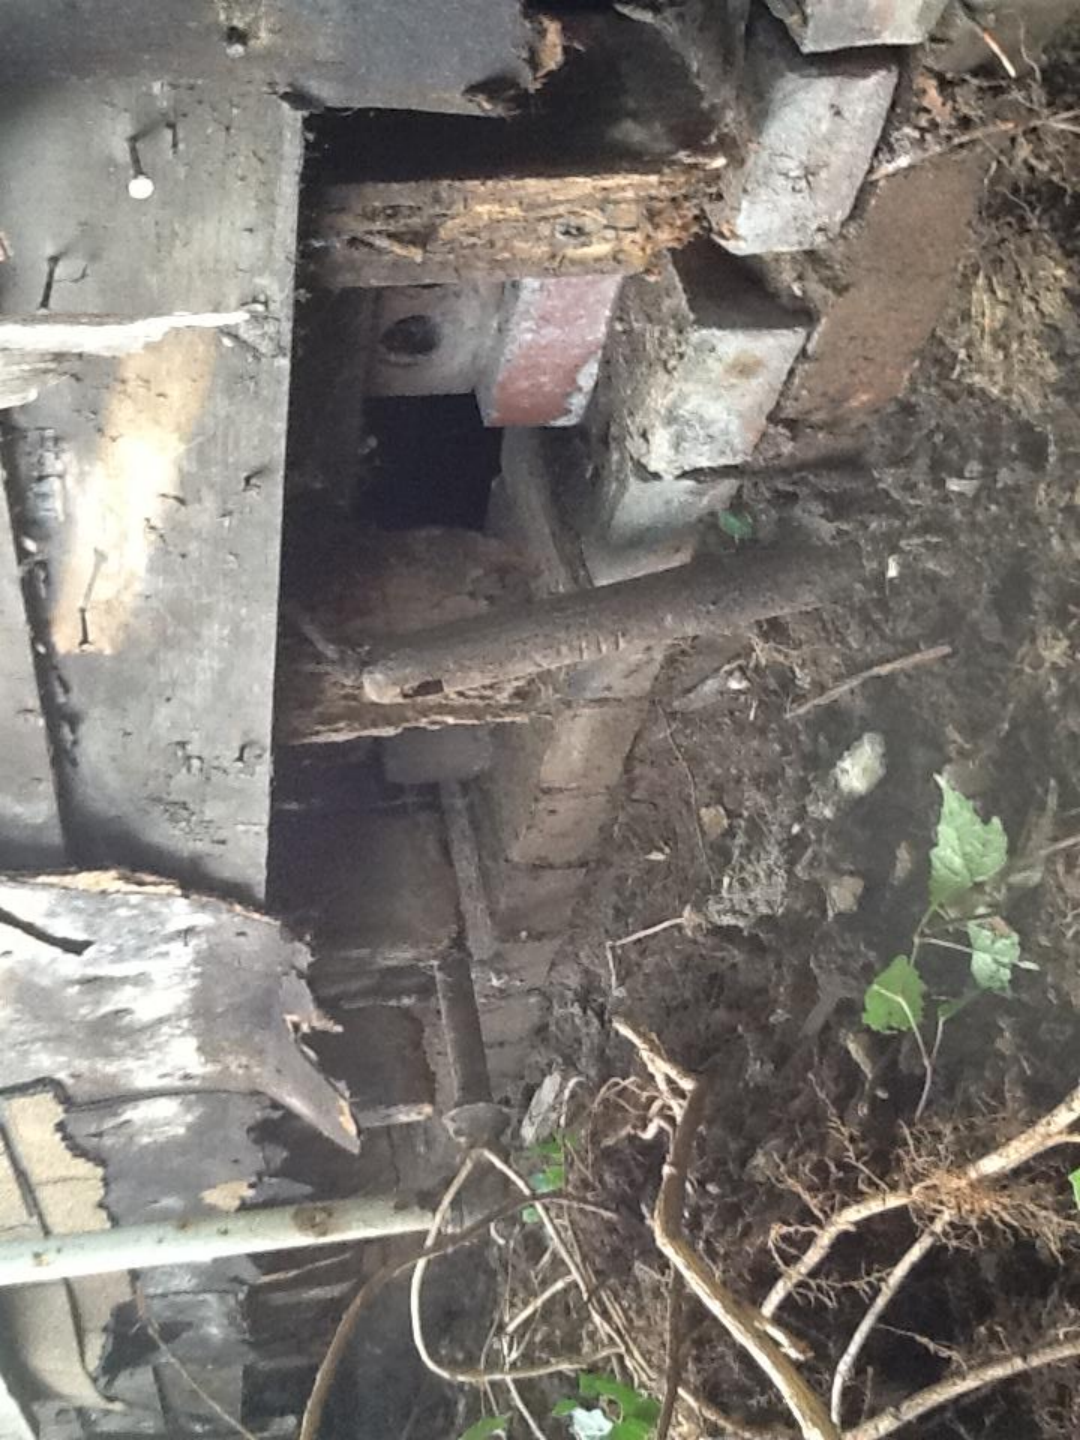
Note the  
bricks  
supporting  
the floor  
joists.

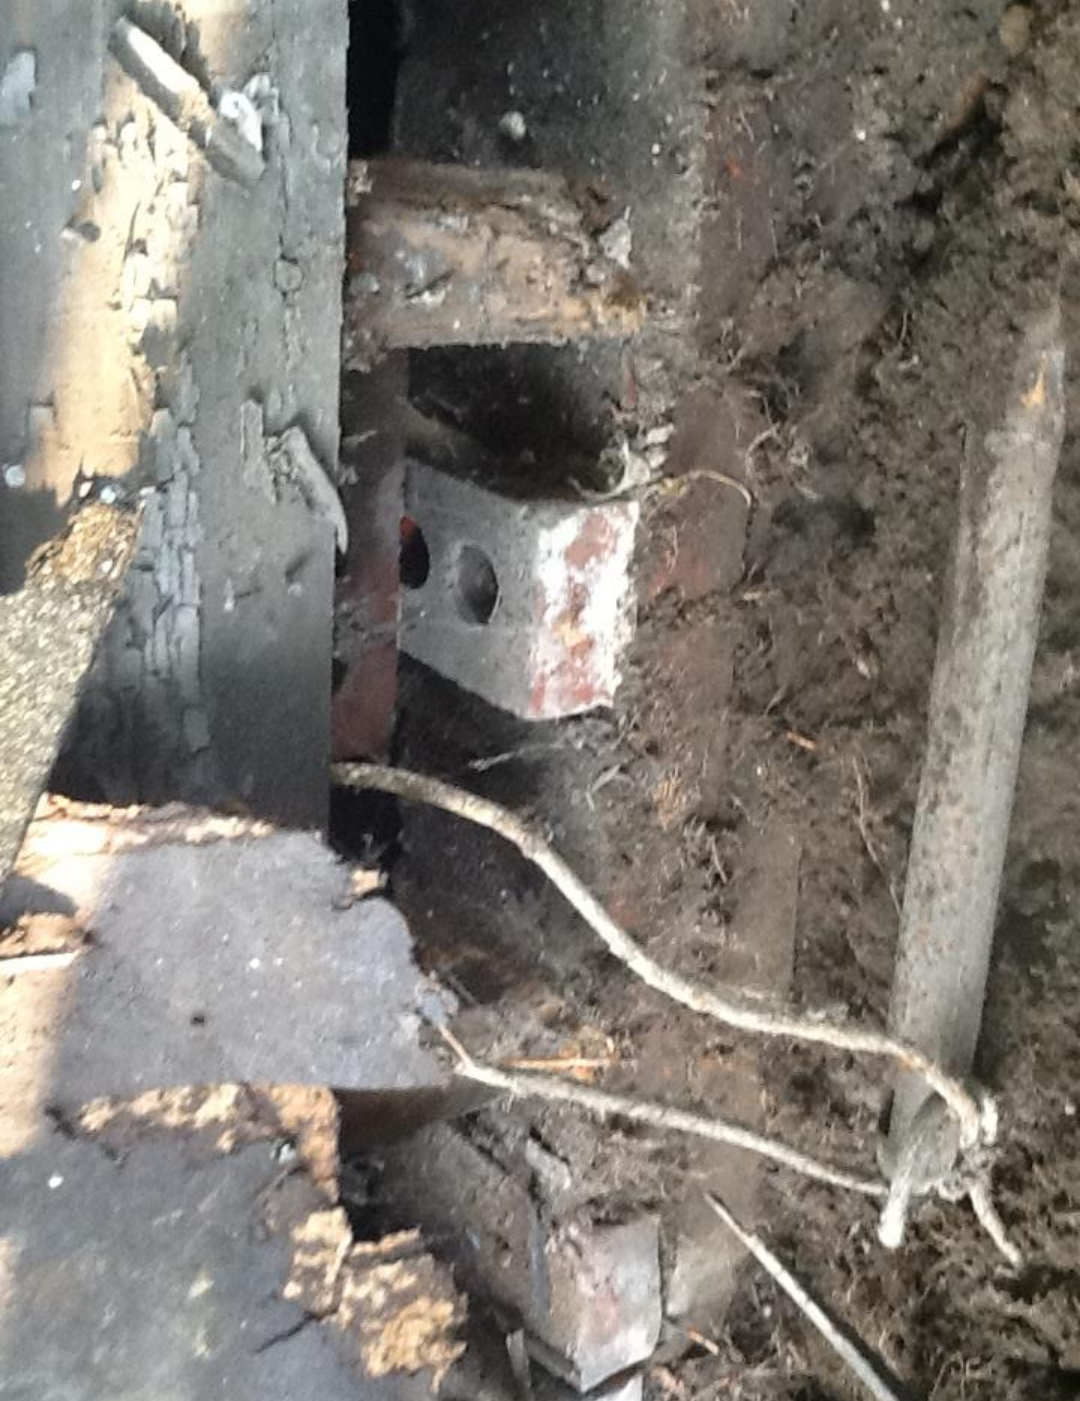
More rotted  
studs, no  
plate, bricks  
supporting  
the floor  
joists, and  
another  
window  
weight.

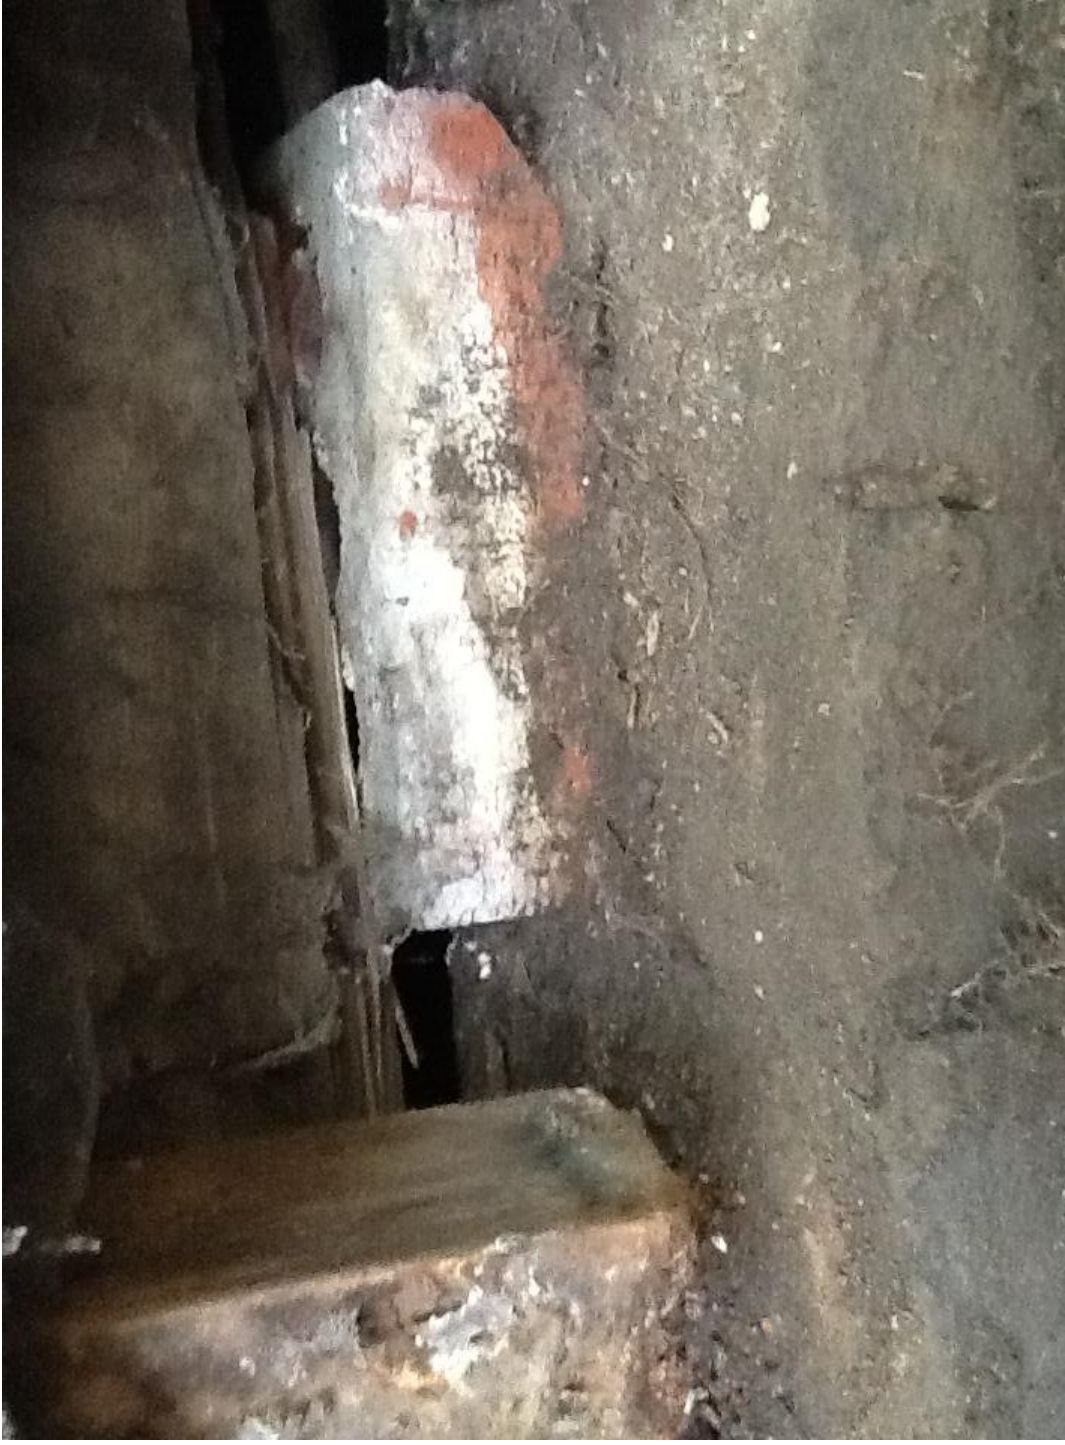
Even the floor joists are rotted away, left suspended above the well intentioned brick.

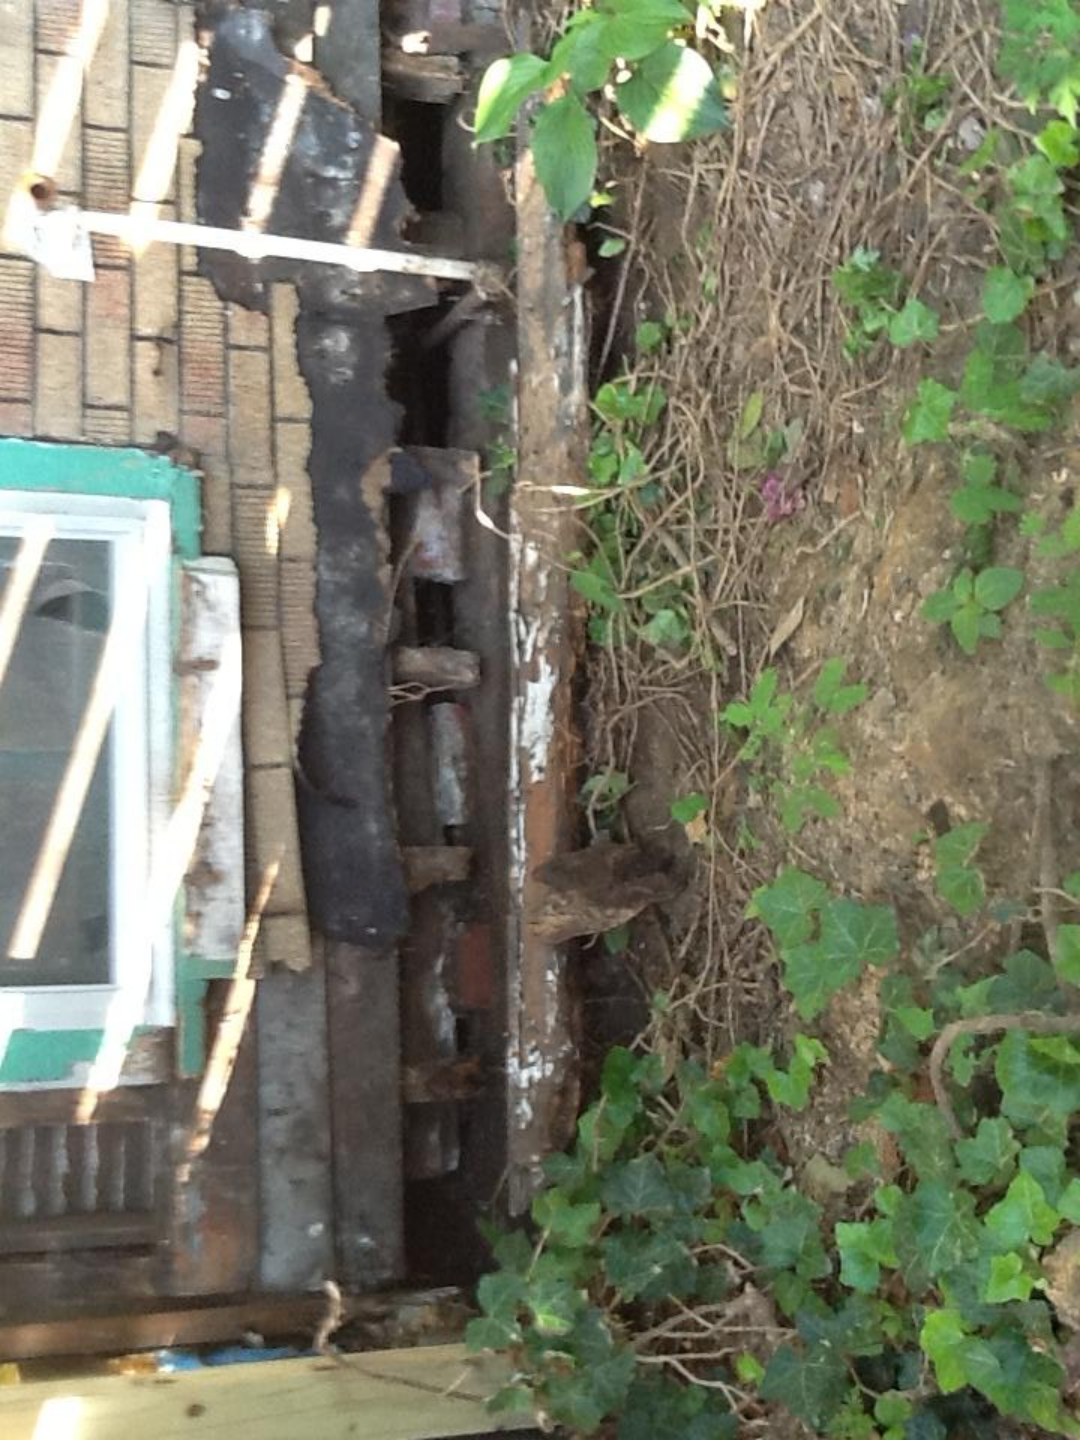
The N wall hangs, suspended in mid air. Removal of the aluminum siding to the E/left of the window revealed the interior lathing and plaster.

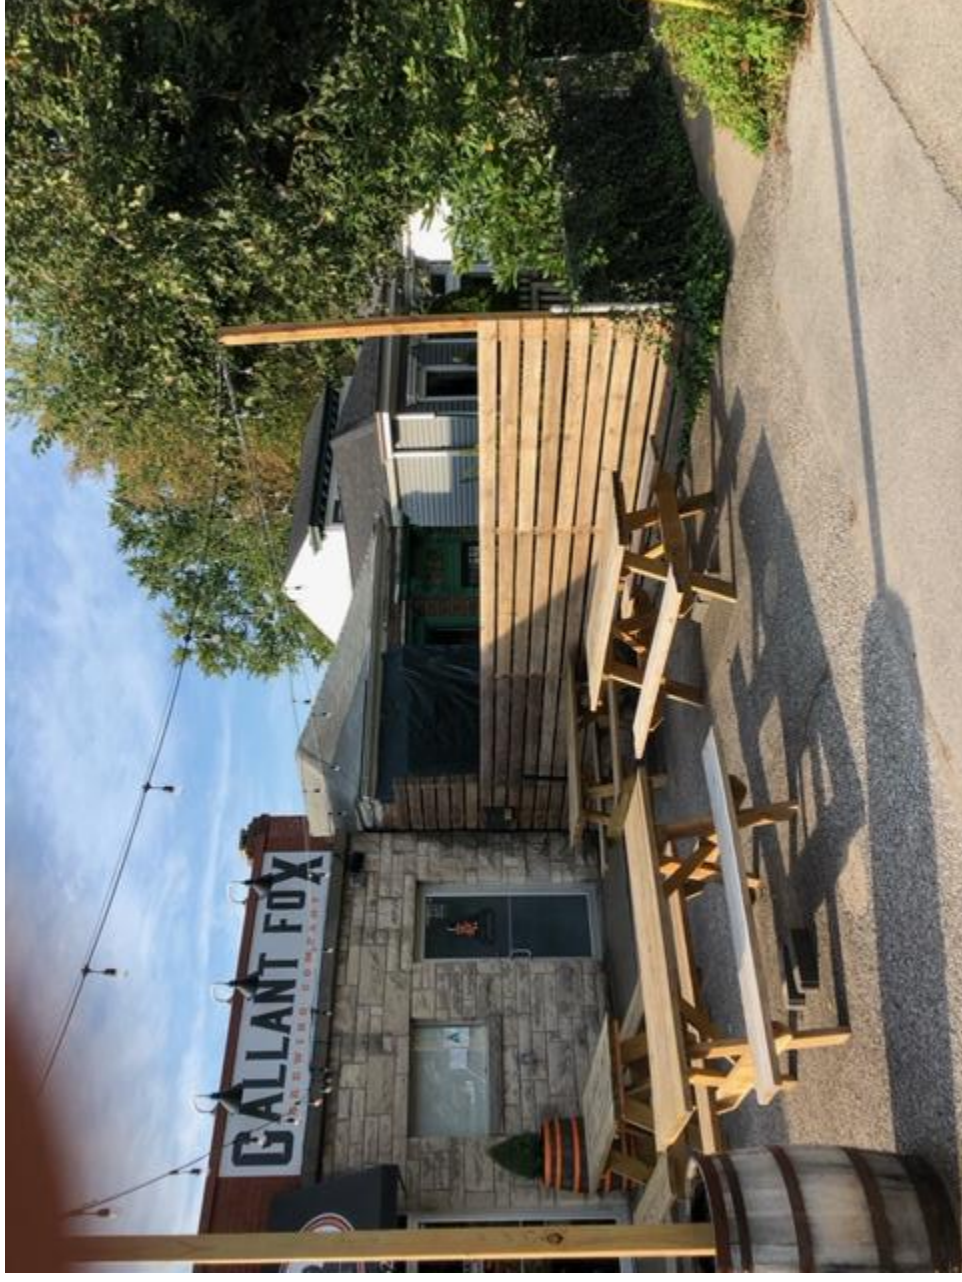
The USPO was built @1950. The distance between the two structures is about two inches. For years the slope of the shotgun's roof directed rainwater between the two structures.

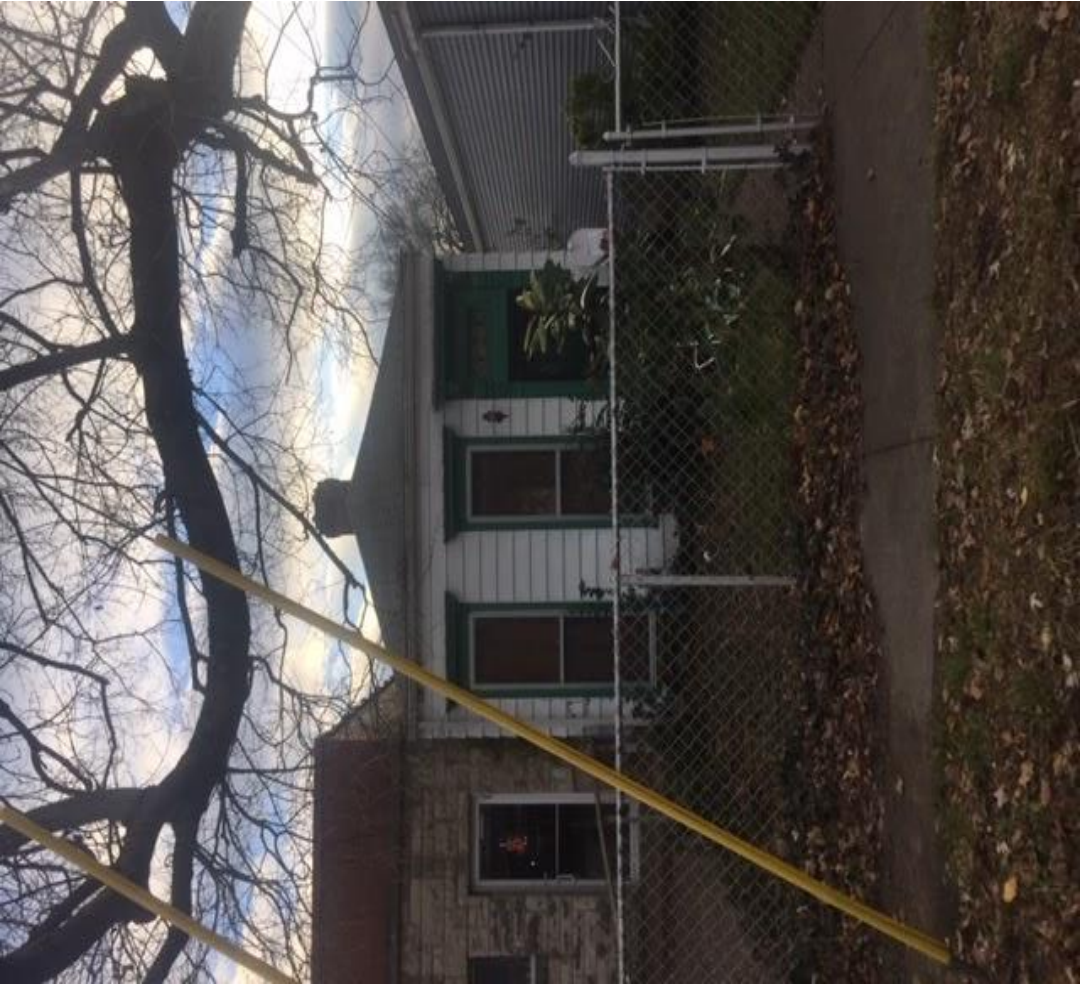
While the flow of water has been corrected by removing the buildup of leaves and installing flashing to carry water to the back of the shotgun, the damage to the two walls remains unseen and inaccessible.
