# 2130 New Main Street Urban Greenspace

2130 New Main Street

Clifton, Louisville KY

Seeking permission to demolish shotgun & salvage material due to excessive cost of rehab

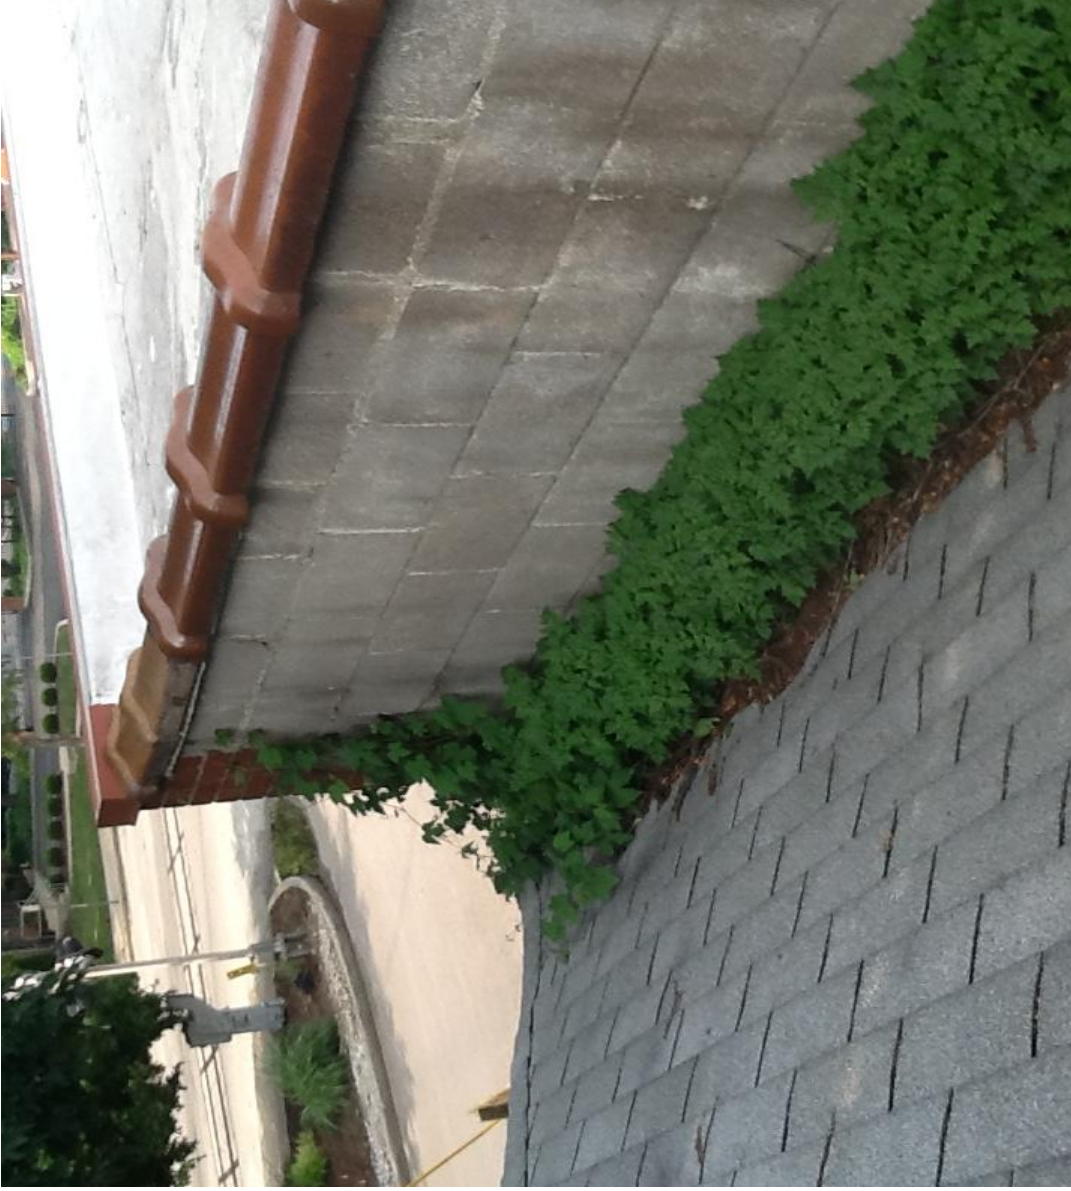
Now we are on the roof of the shotgun. The block wall to the east/right is the west wall of the USPO. The valley formed by the wall and roof collected leaves. Any water not soaked up by the leaves flowed on down between the two structures.

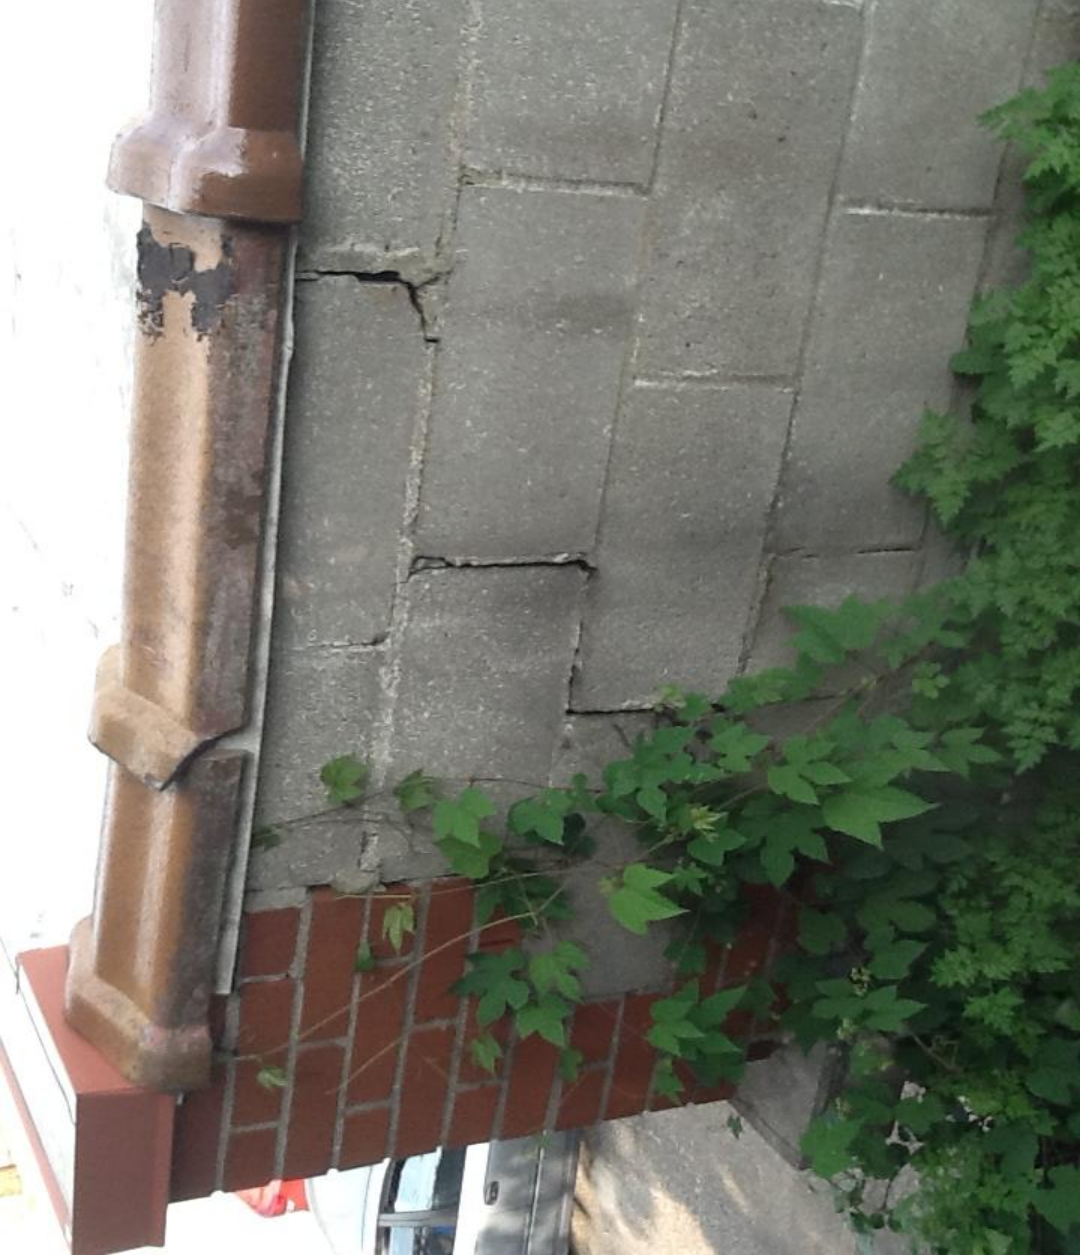
Seventy years of water between the structures resulted in visible damage to the USPO wall and invisible damage to the walls and foundations below the 'valley'.

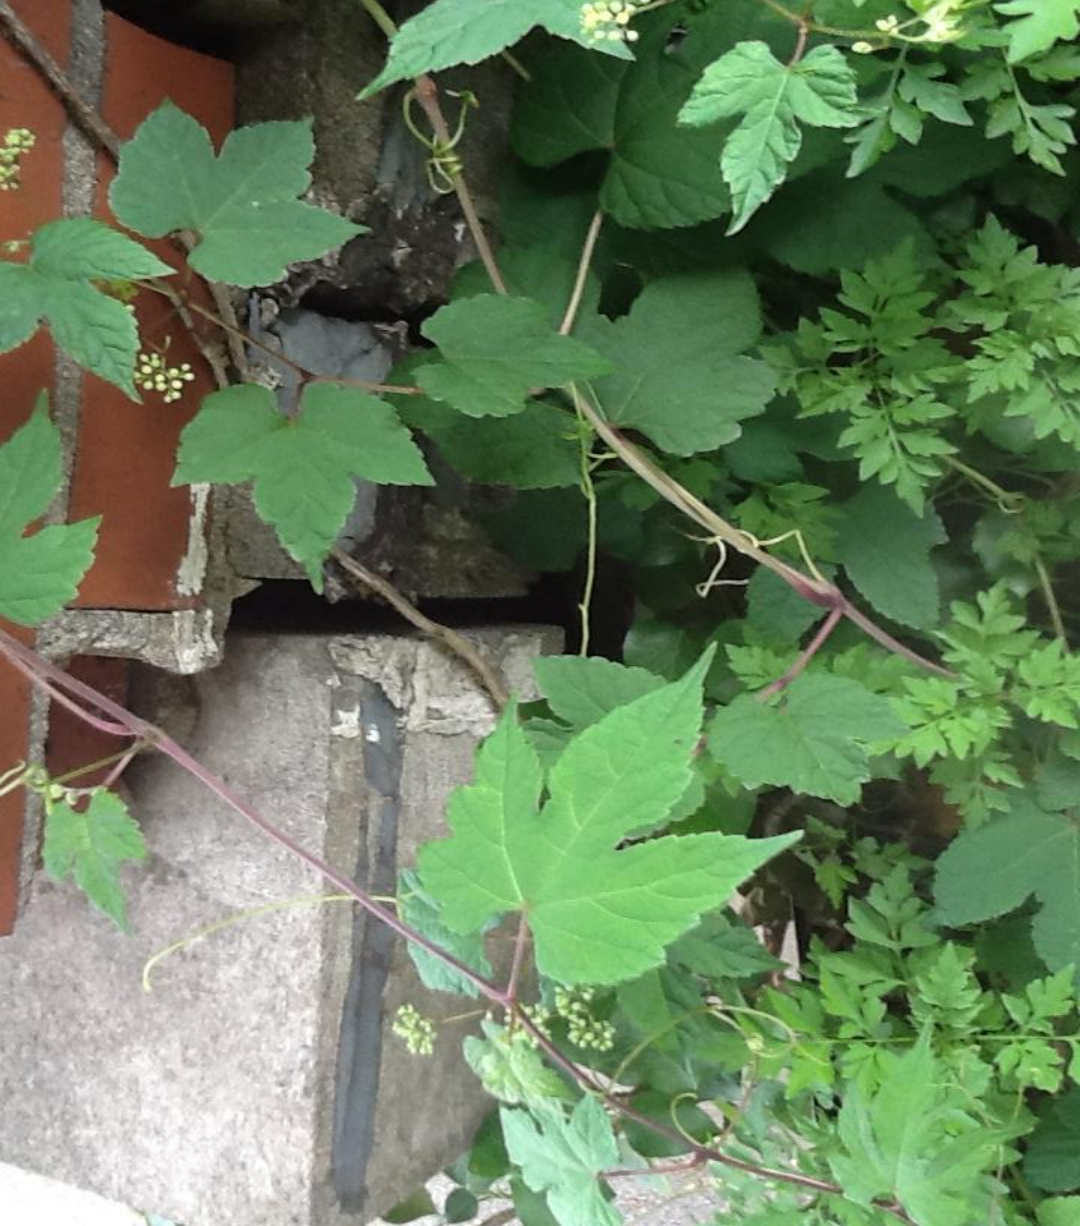
Damage  
visible  
behind the  
foliage at the  
front corner  
of the USPO

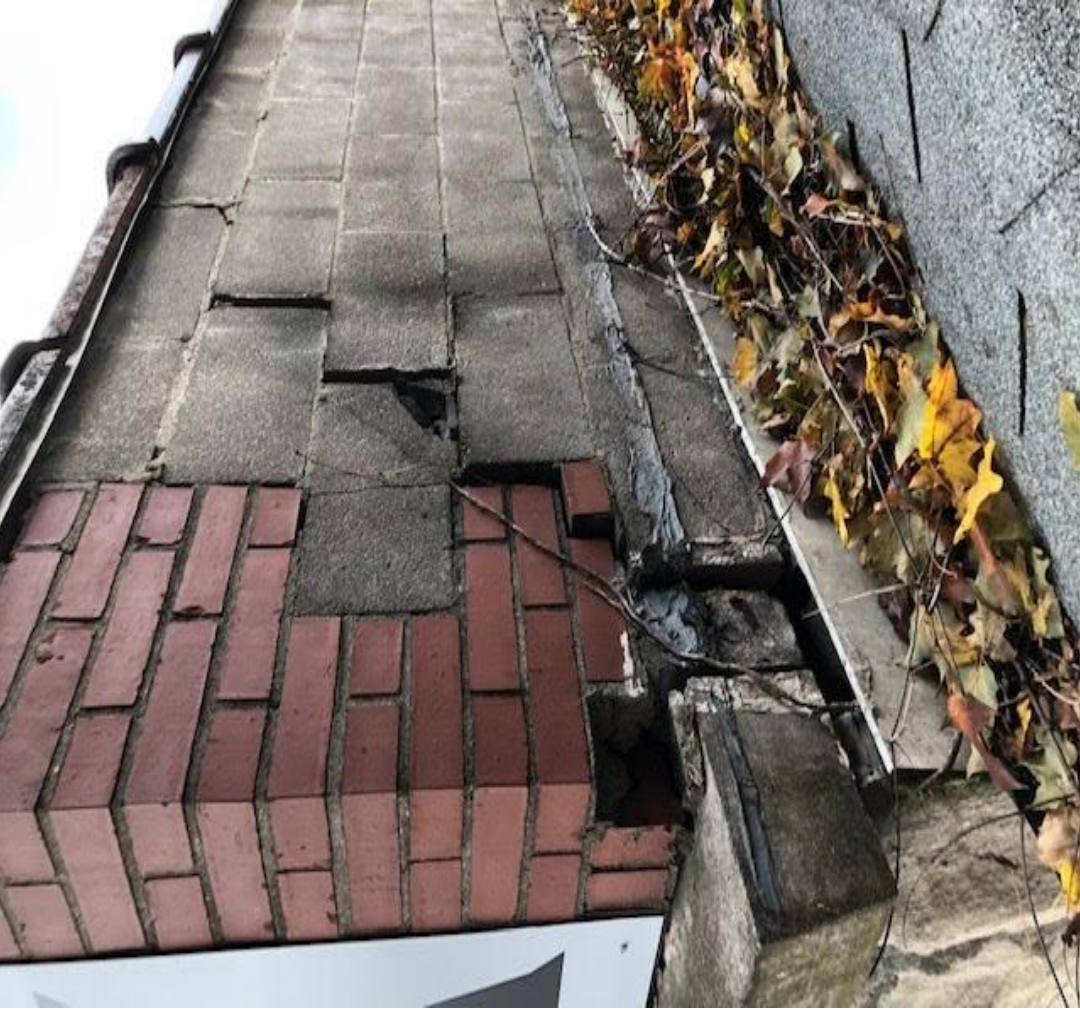
This image was taken after removing the accumulated debris and installing flashing. You can see a week's worth of fall maple leaves in the 'valley'. While leaf removal is a weekly contest in autumn, the bigger issue is the damage to the wall (and hopefully not the foundation) of the USPO.

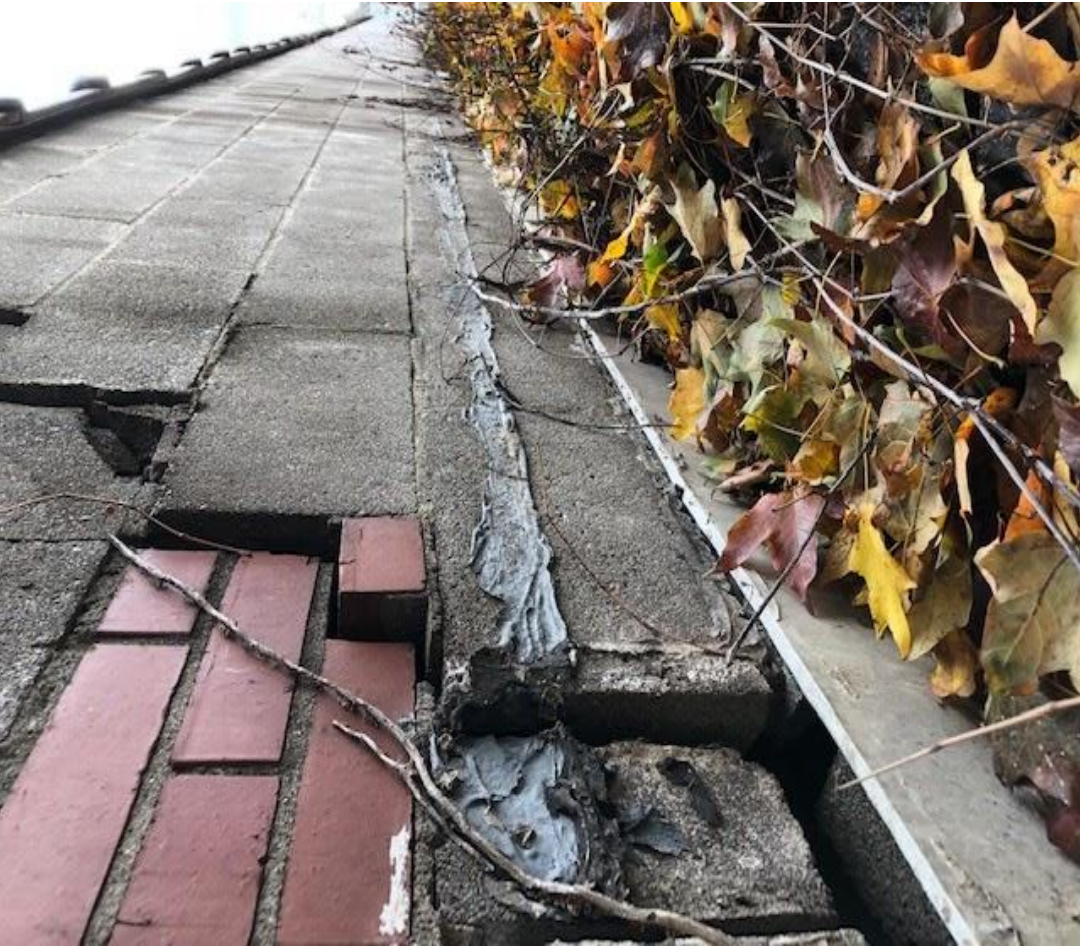
This close up shows a horizontal line of roofing tar running parallel with the roof line of the shotgun. That line suggests some structural feature - perhaps an earlier effort to protect from water damage. A failed effort.

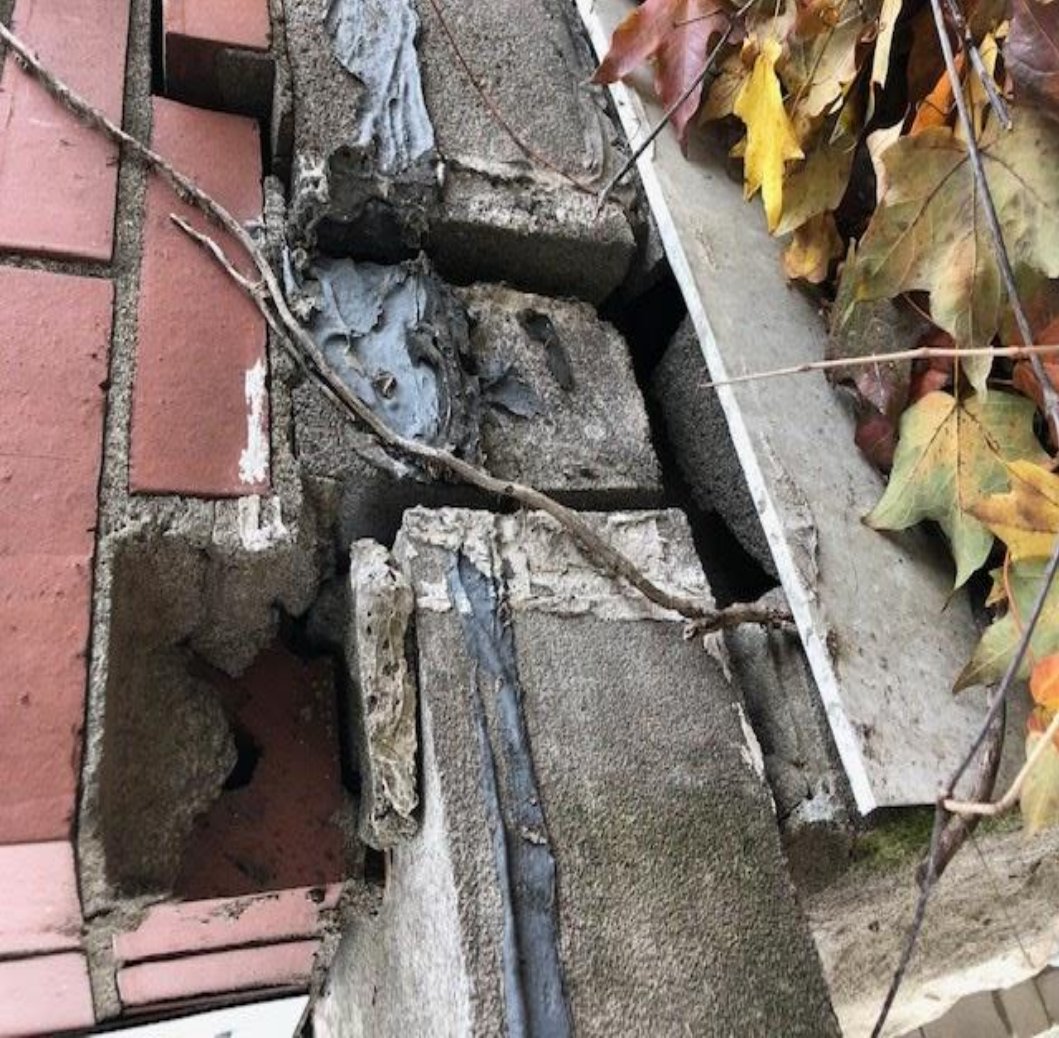
The west wall and foundation of the USPO need to be accessible below the 'valley'. The only way to gain access is by demolishing the east wall of the shotgun.

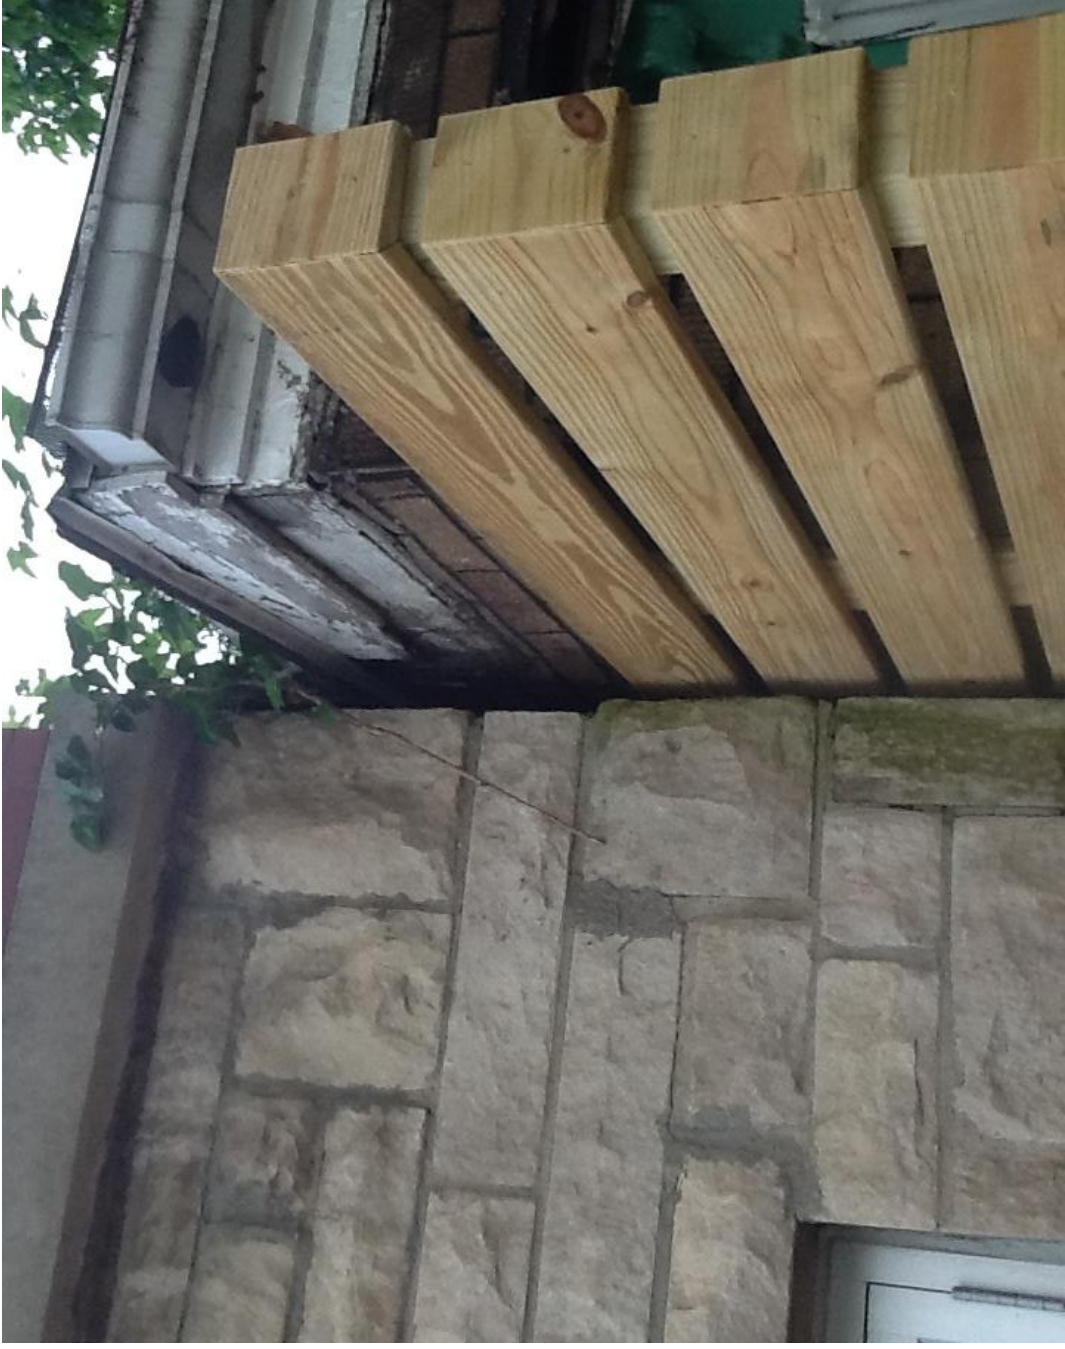
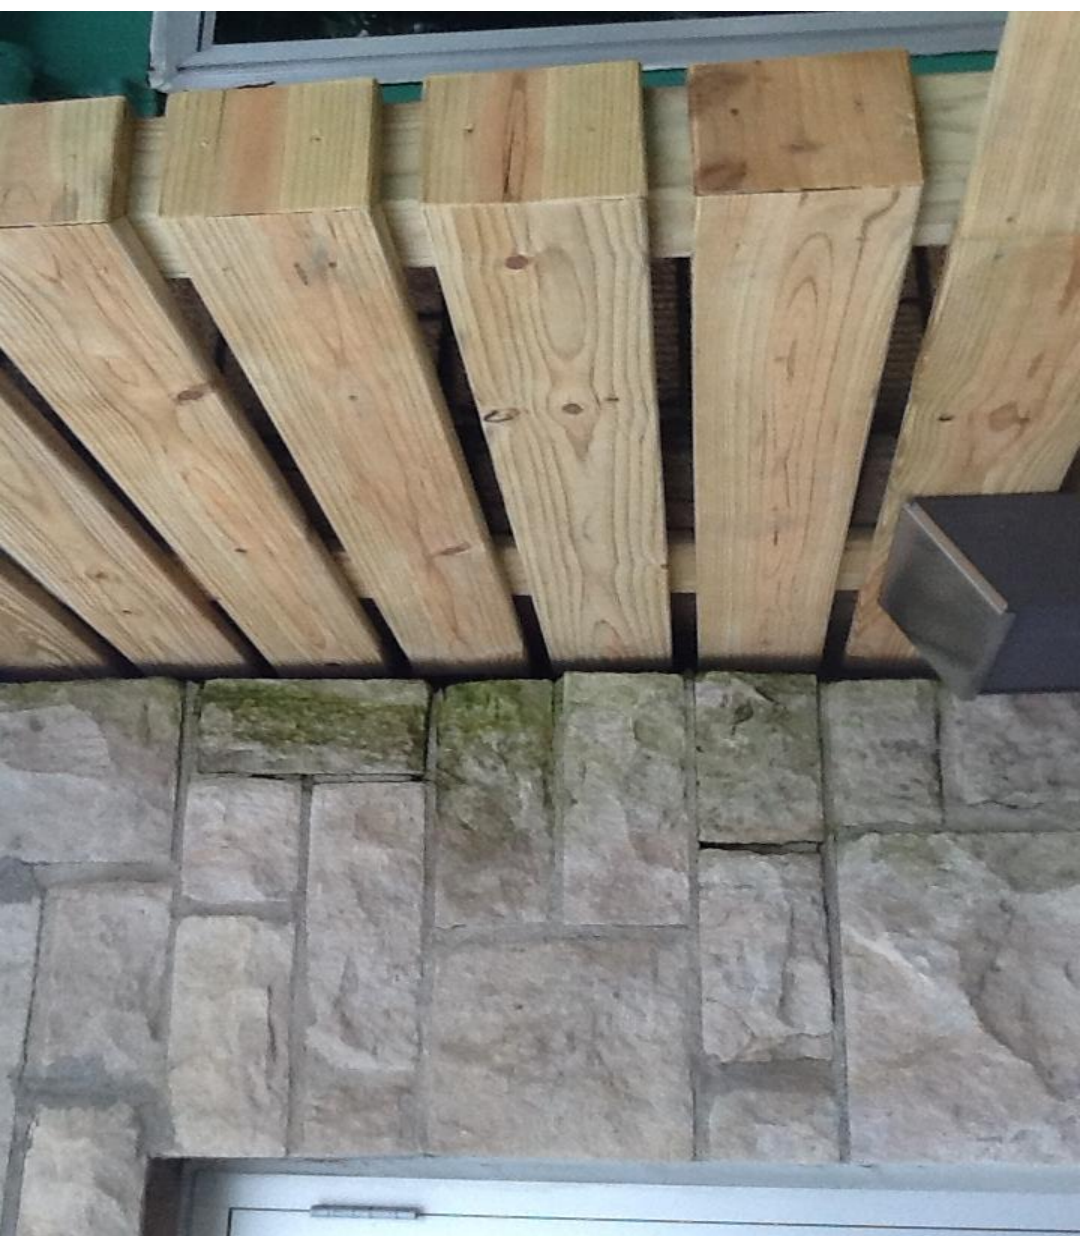
Note the green growth and damage to the limestone in the next couple of slides.

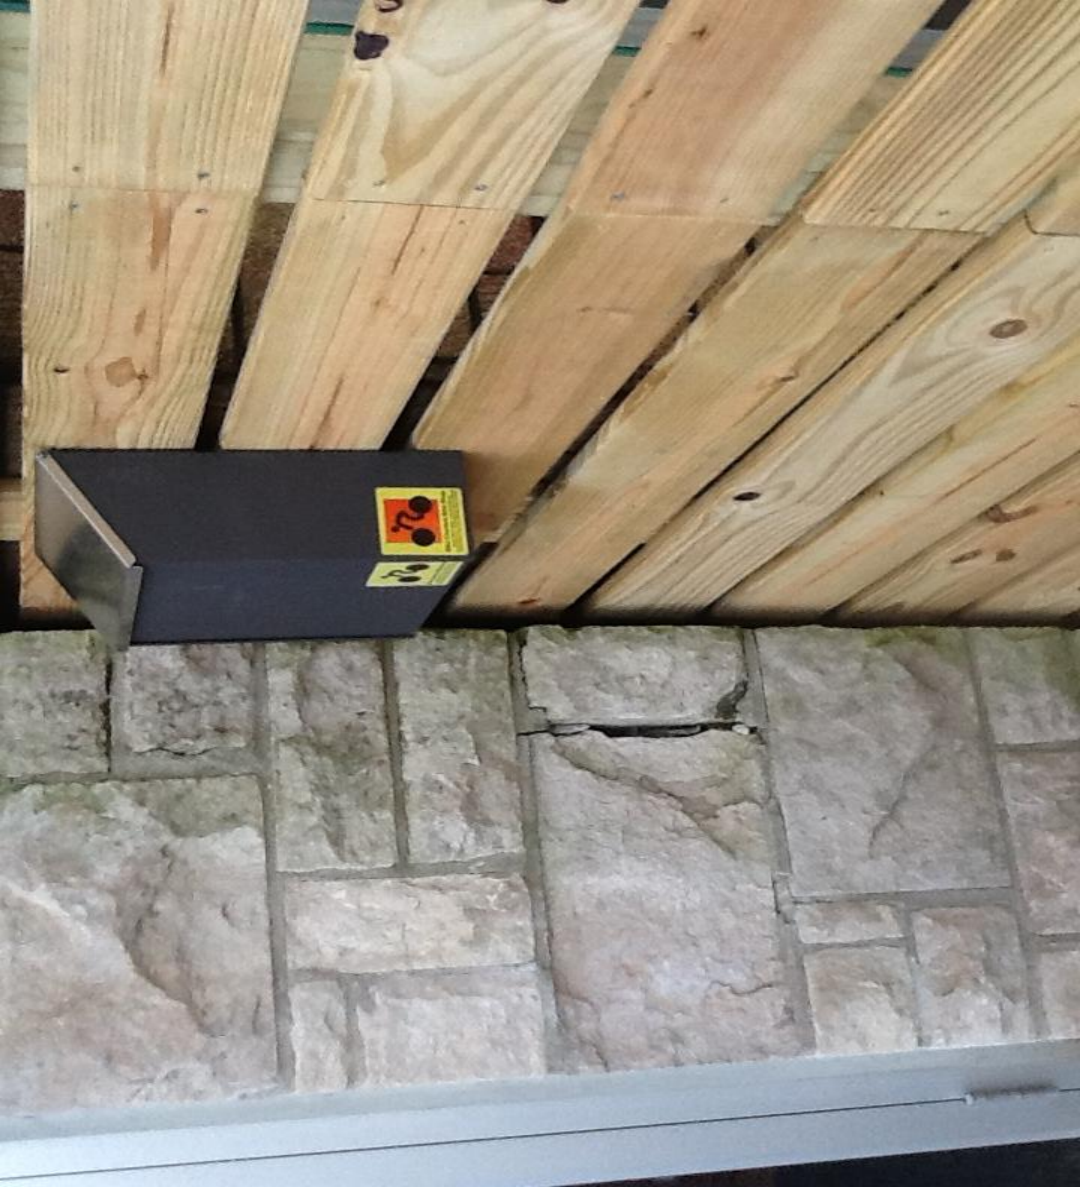
Replacing the missing mortar of the brick and the stone can be done only on the accessible north wall. The west wall is inaccessible..

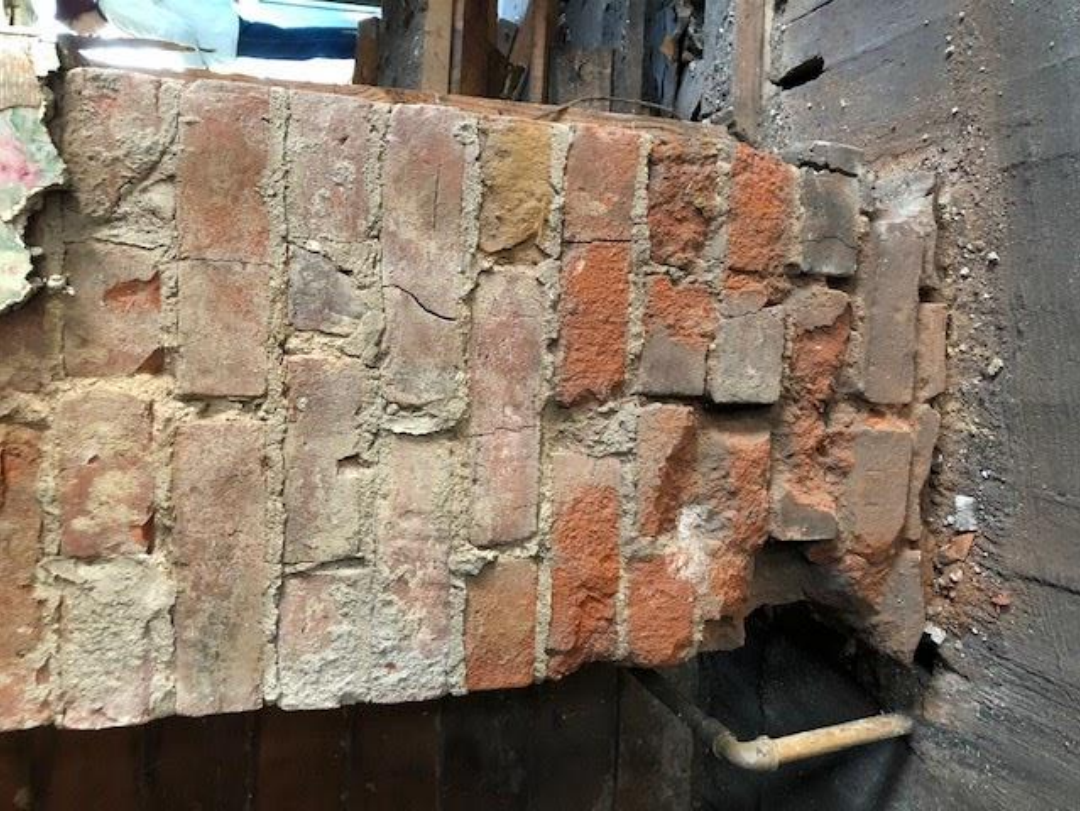
This is the south chimney - at floor level. Even as an interior feature, it has not weathered well. Inferior brick?

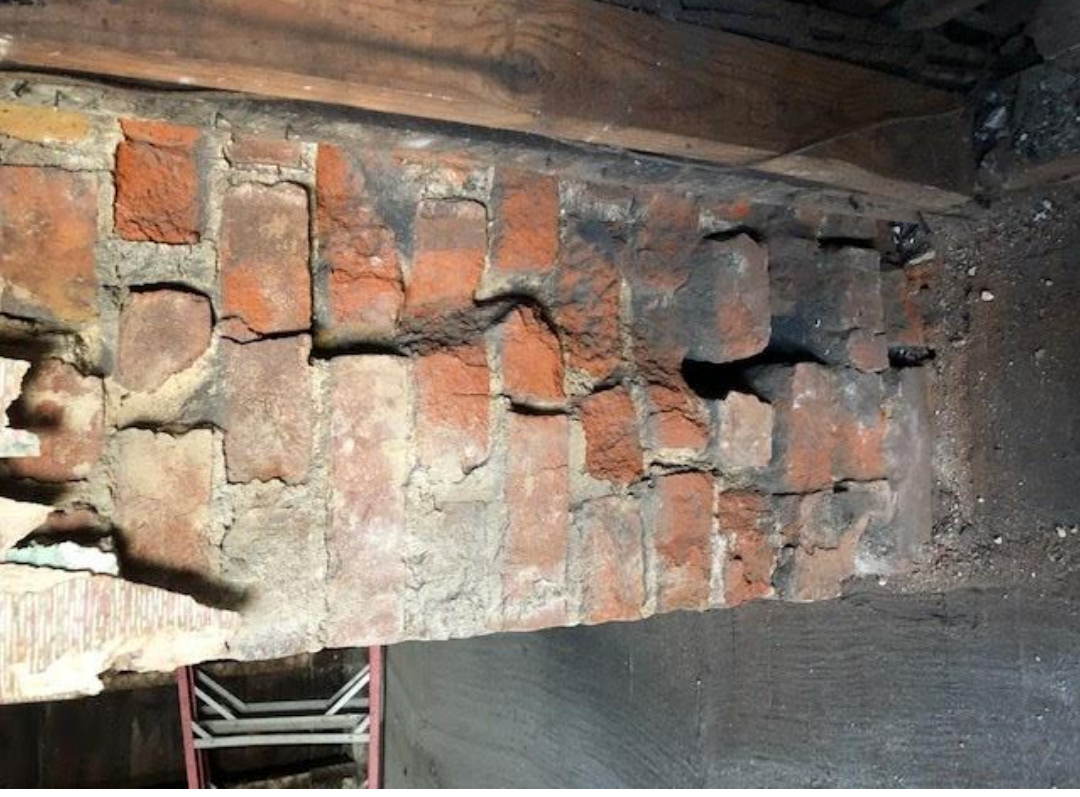
Other  
interior  
sides of  
the  
same  
chimney  
.

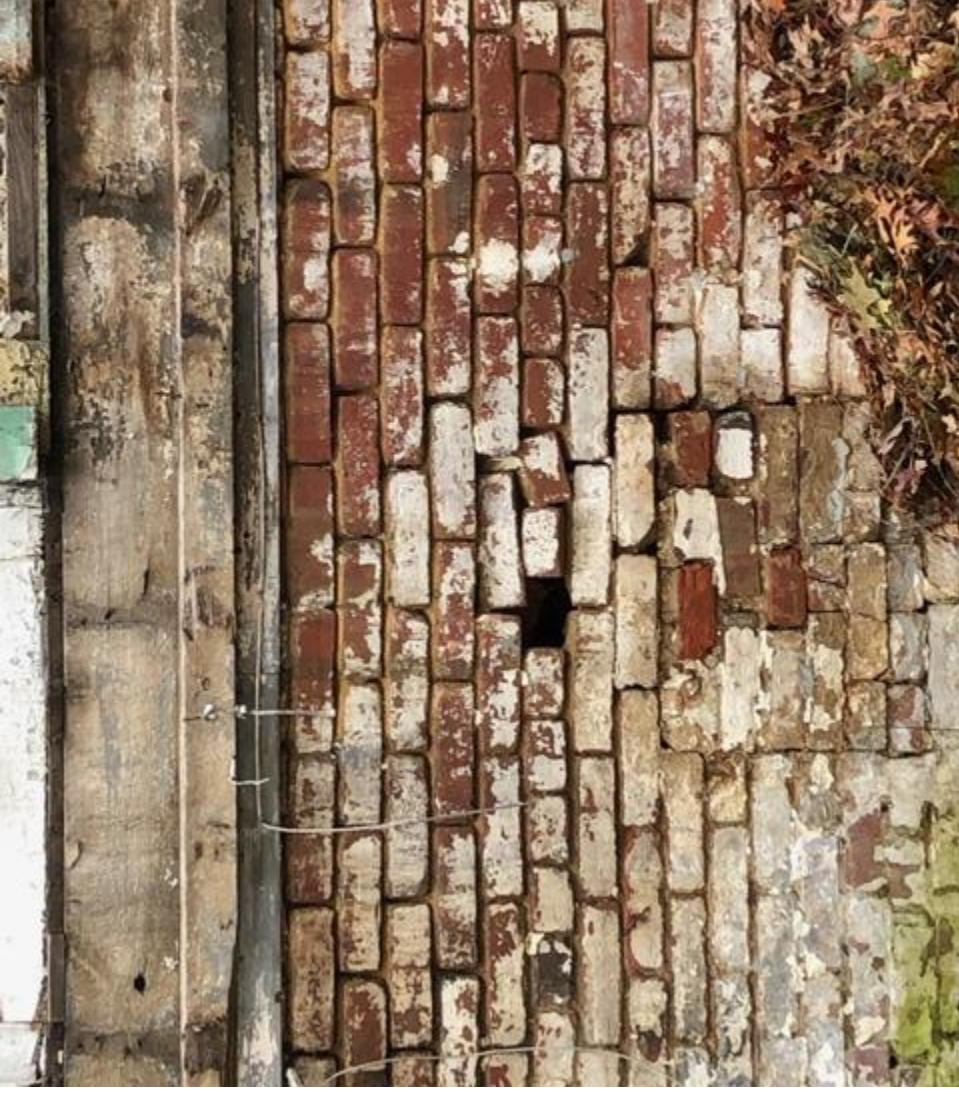
This is the original exterior wall. It became an interior wall when the addition was built. Note the condition of the chimney base in the top right hand corner. That is the same chimney we saw in previous slides.

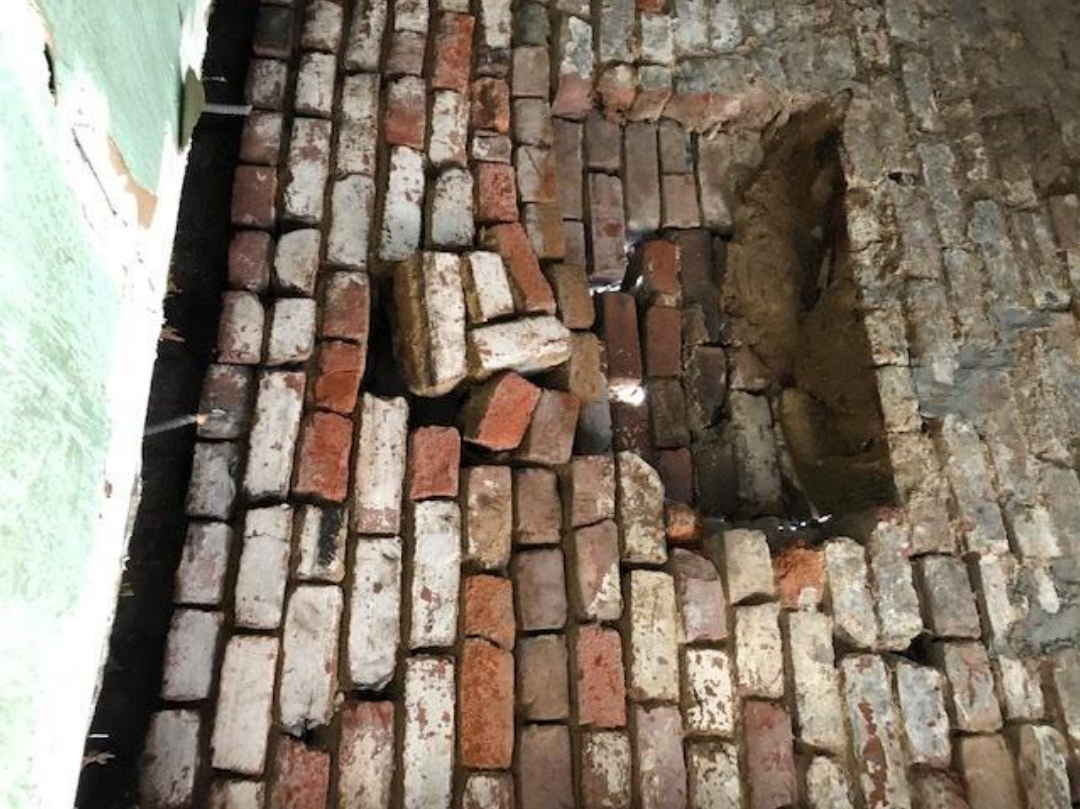
This is the other side of the same wall. It serves as the back foundation of the shotgun. This side of the wall has always been an interior wall. Humidity, inferior material and time have taken a toll.

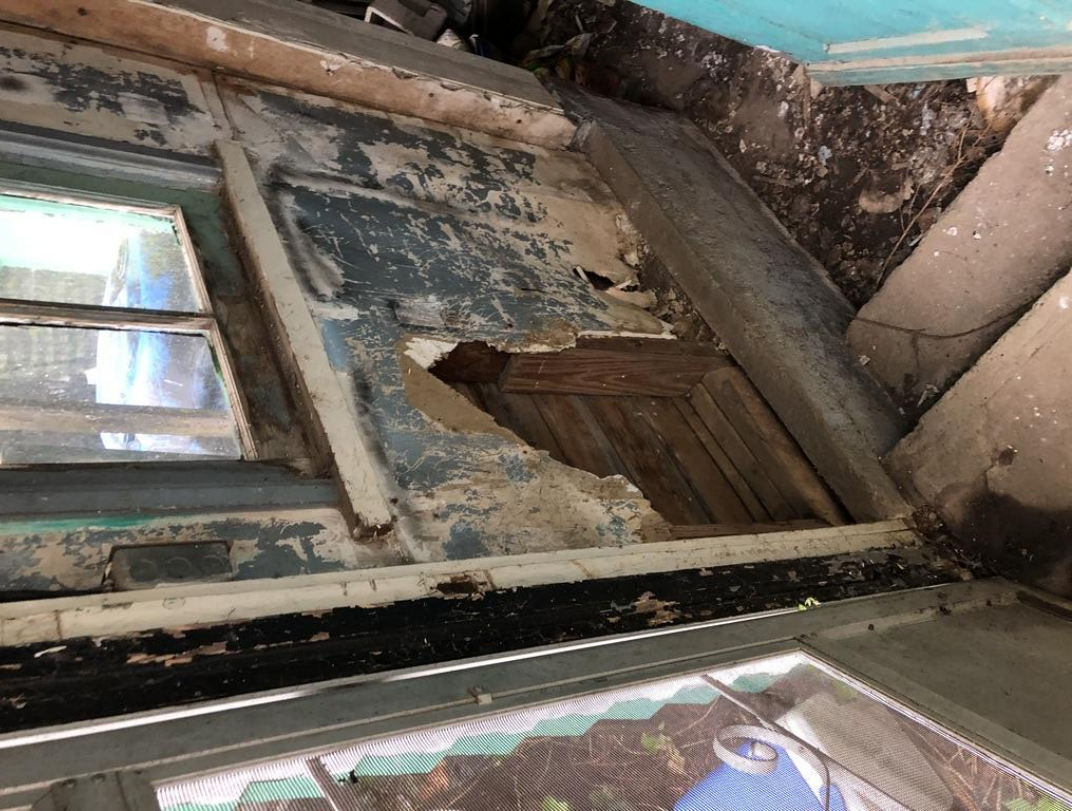
To the left, just  
inside the  
basement door.  
More humidity  
issues

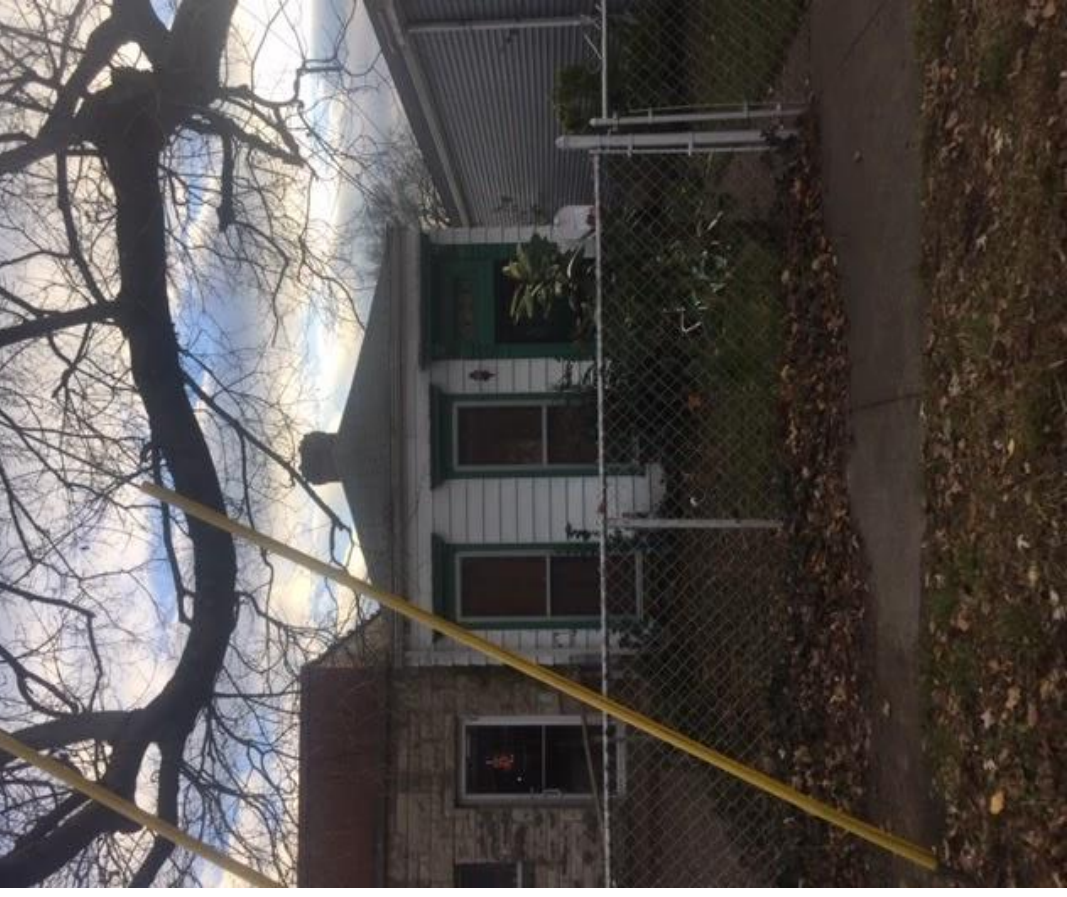
Compare the height of the window sill to the threshold of the USPO door. The parking lot of the USPO is a foot higher than the front yard of 2130. The sidewalk and the road are eight inches higher. The front yard of 2128 (to the west/right) is a bit higher. All that rain and melted snow find their way to the lowest spot - the front yard of 2130 New Main Street and then it begins a surface and underground migration into the shotgun's basement.

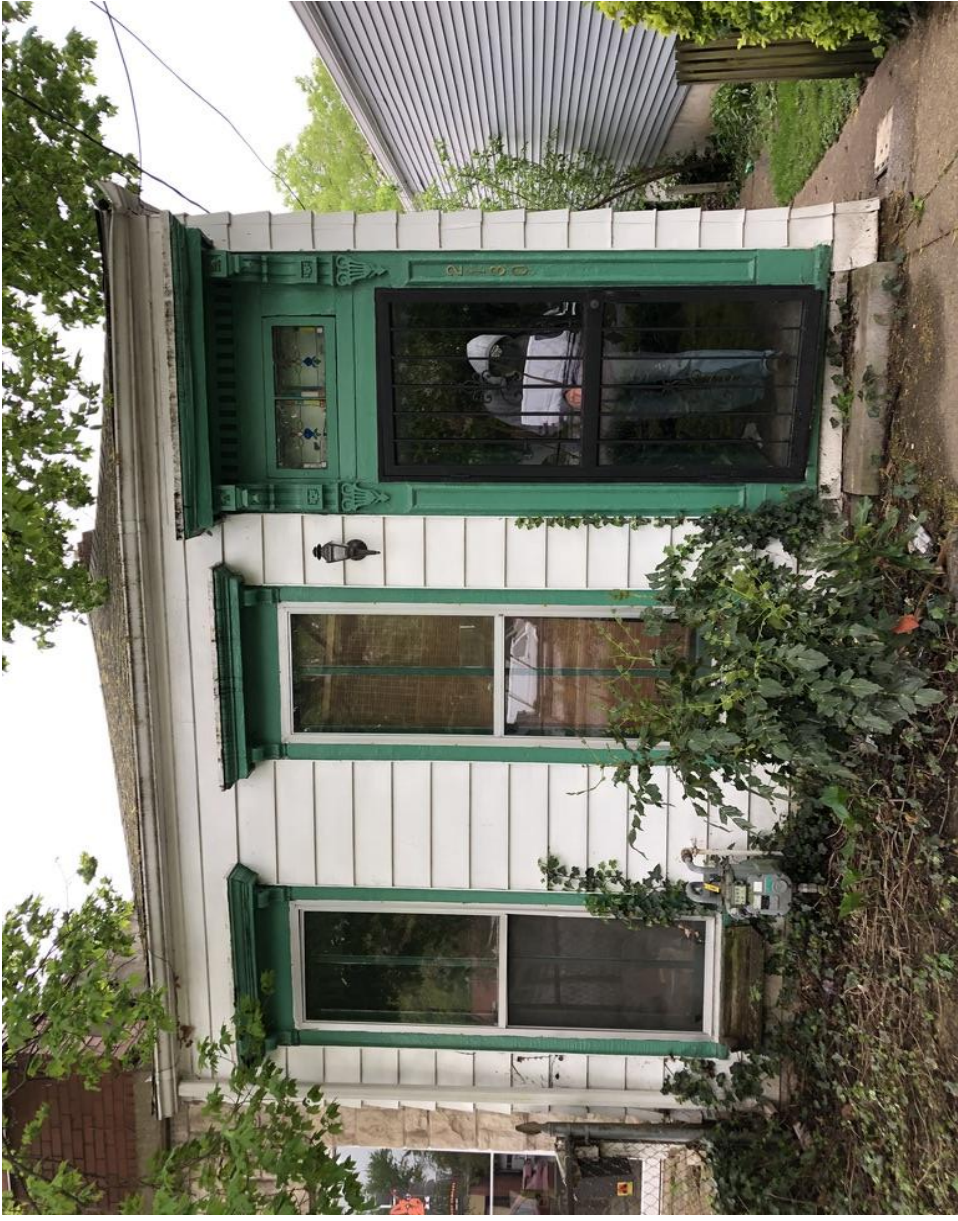
A closer view  
for comparison  
between the  
height of the  
window sill and  
the threshold of  
the USPO  
door.

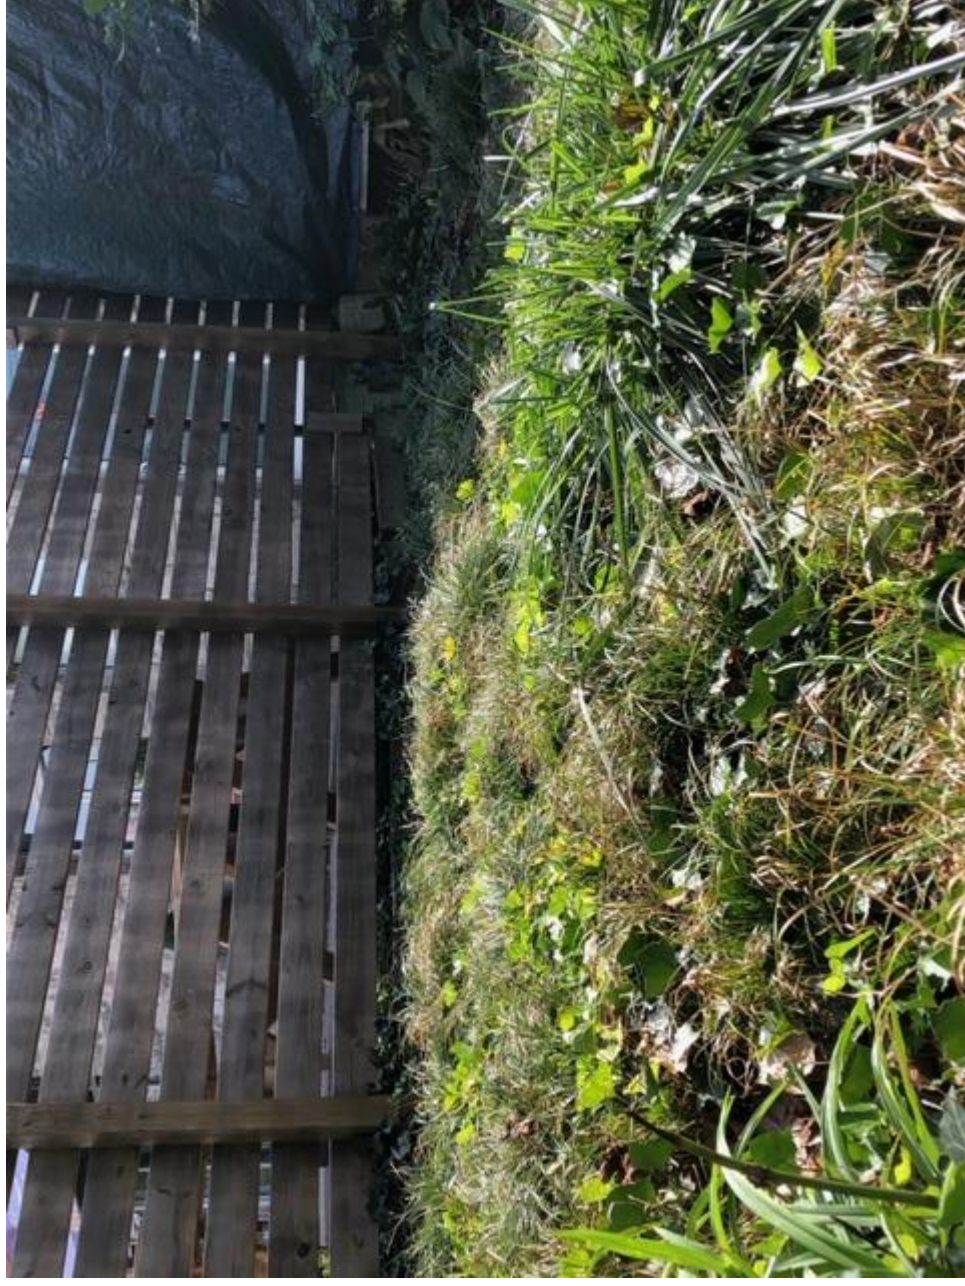
The bottom of the USPO door is the shiny horizontal line seen between the fence slats. Note how much lower the yard is.

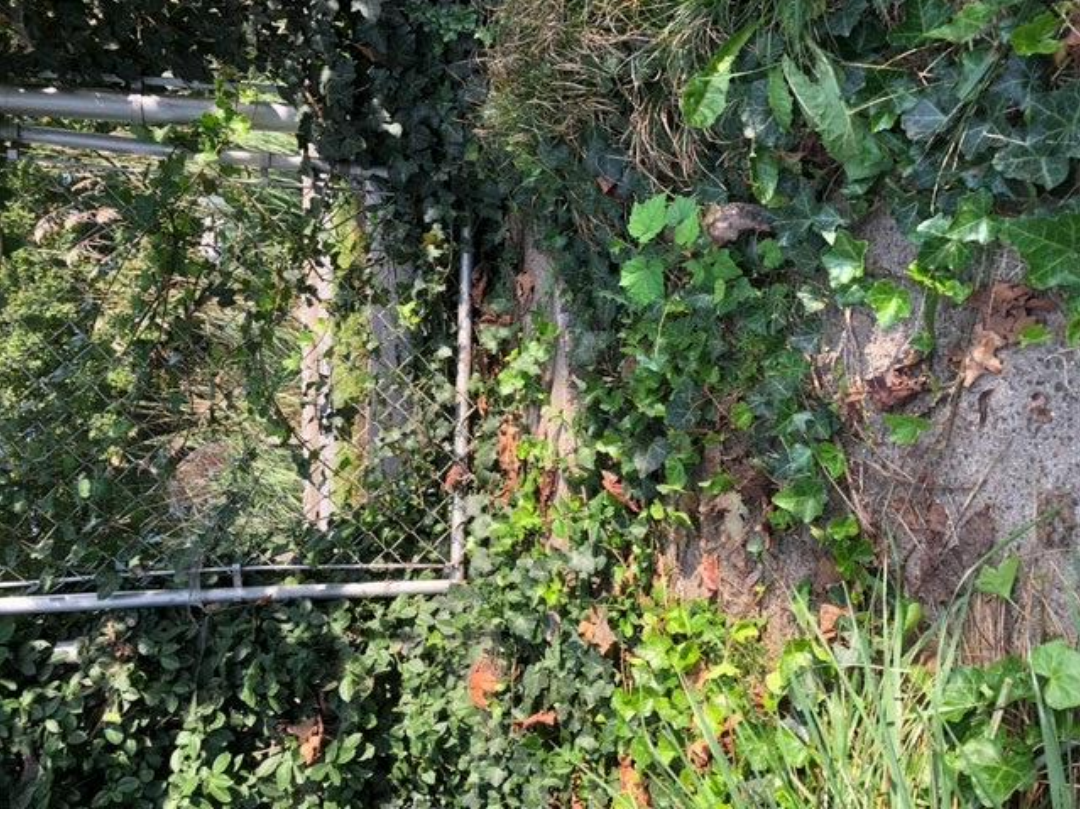
There are two four inch steps on this side of the front gate stepping up to the sidewalk on the other side of the gate. The road is the lighter color beyond - and clearly even higher.

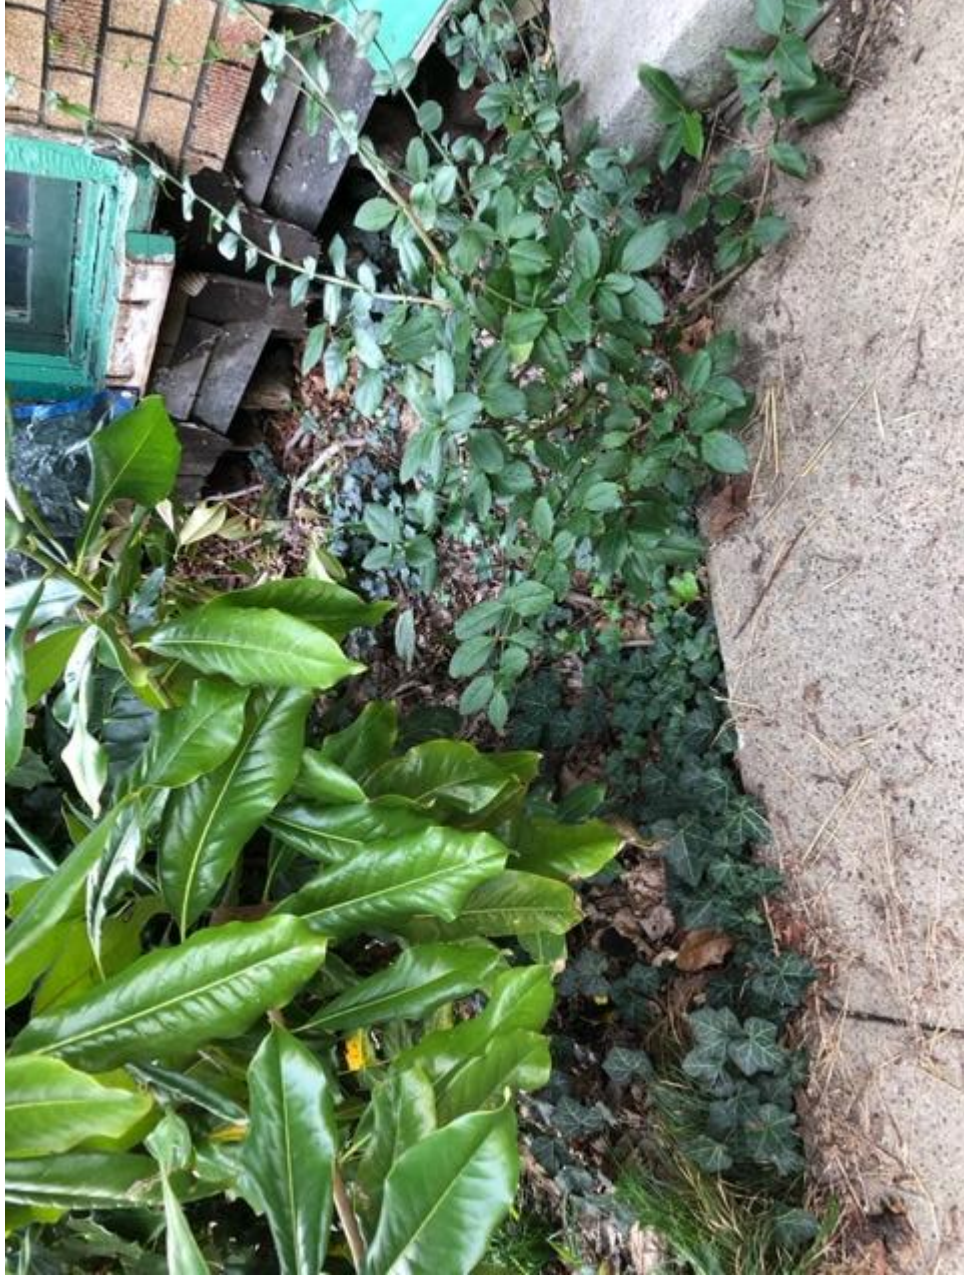
The front yard has begun to sink lower than the walk leading to the front door. Along with the rain and melted snow, the soil is infiltrating the basement.
