# Demolition Request

## 2130 New Main Street

# Objective: Urban Greenspace 2130 New Main Street

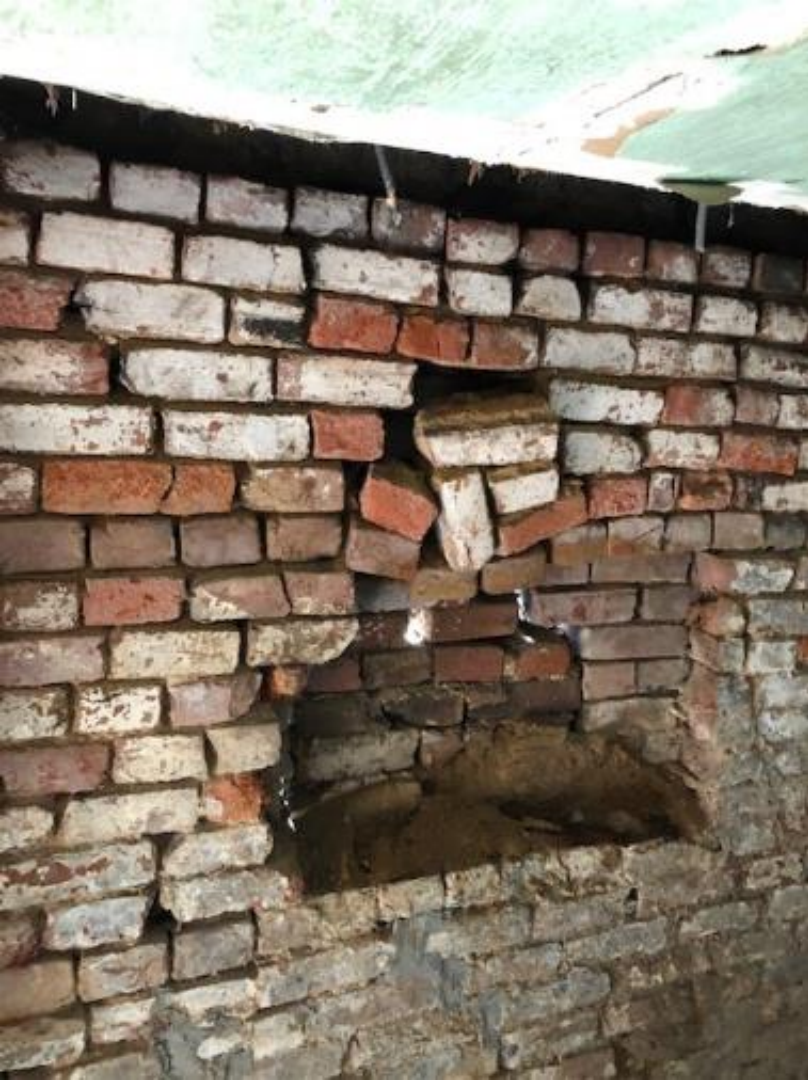
This is the interior of the south/back wall. It serves as the rear foundation of the shotgun. Humidity, inferior material, time, weight and severa; decades of neglect have taken a toll. This damage predates new ownership by decades.

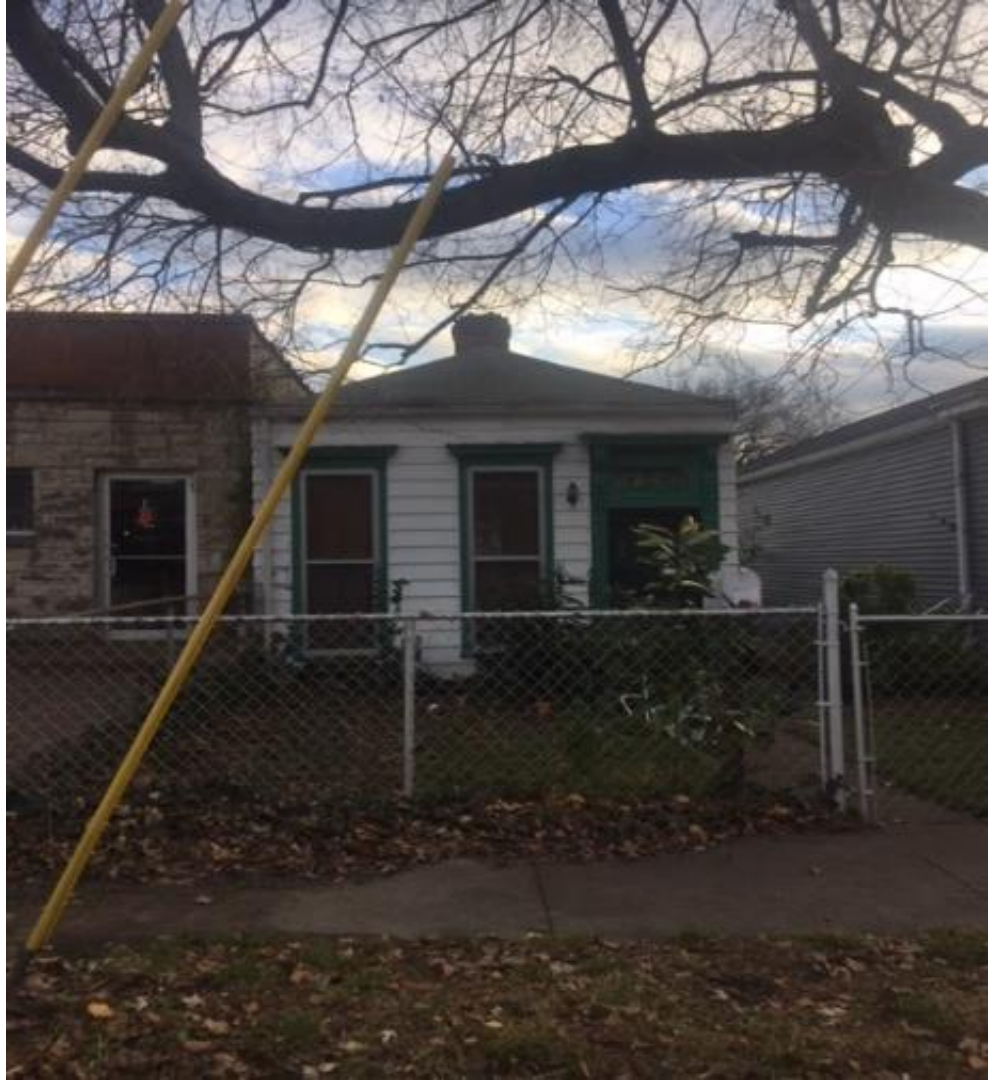
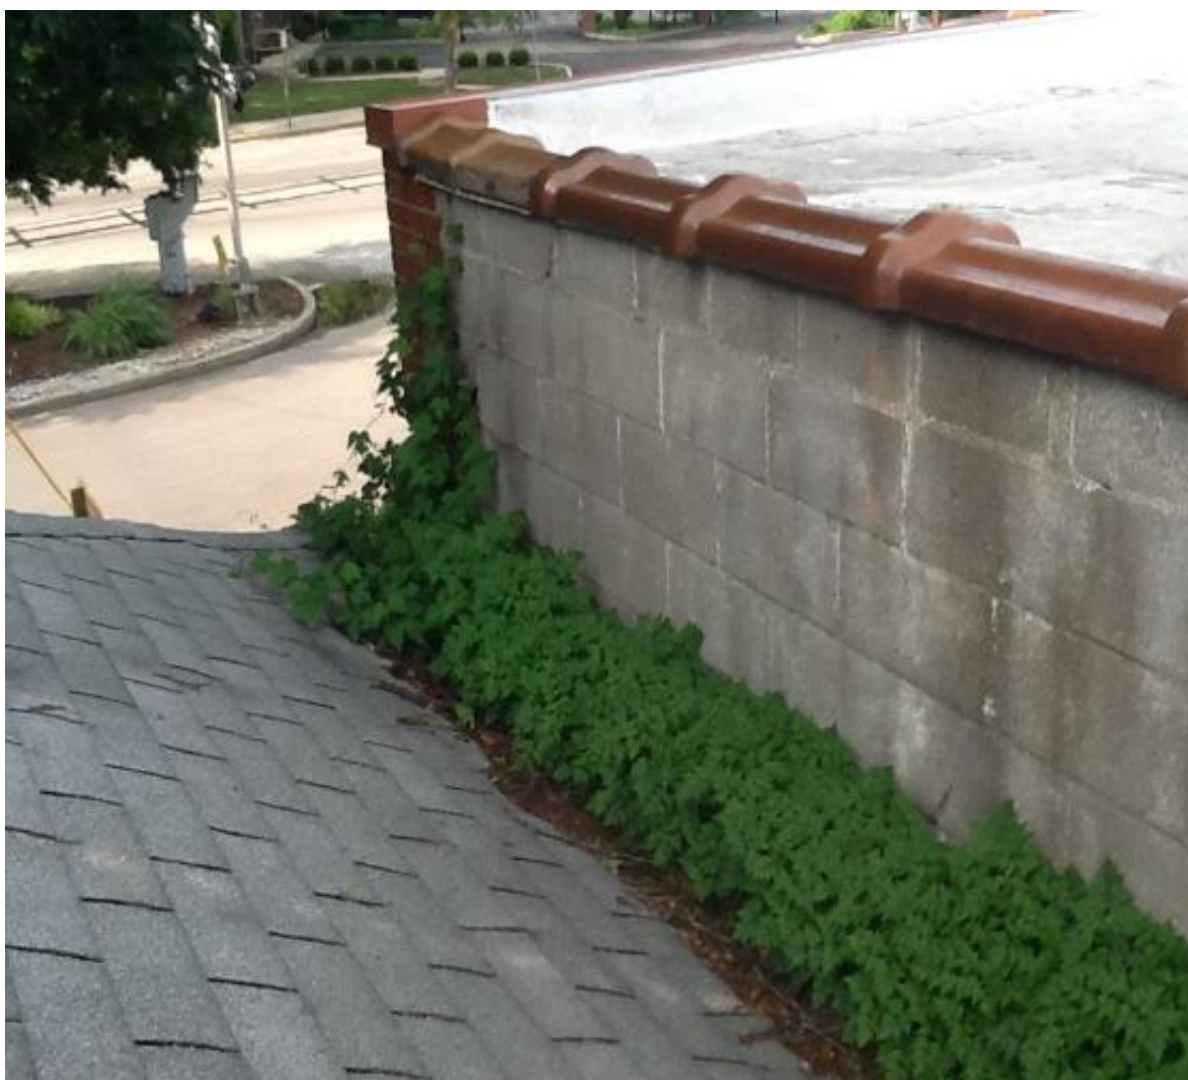
From the roof of the shotgun. The block wall to the east/right is the west wall of the USPO. The valley formed by the wall and roof collected leaves. Any water not soaked up by the leaves flowed on down between the two structures.

The USPO's parking lot was raised, increasing the water directed to the shotgun. Damage to wood and masonry of both structures will be discussed later.

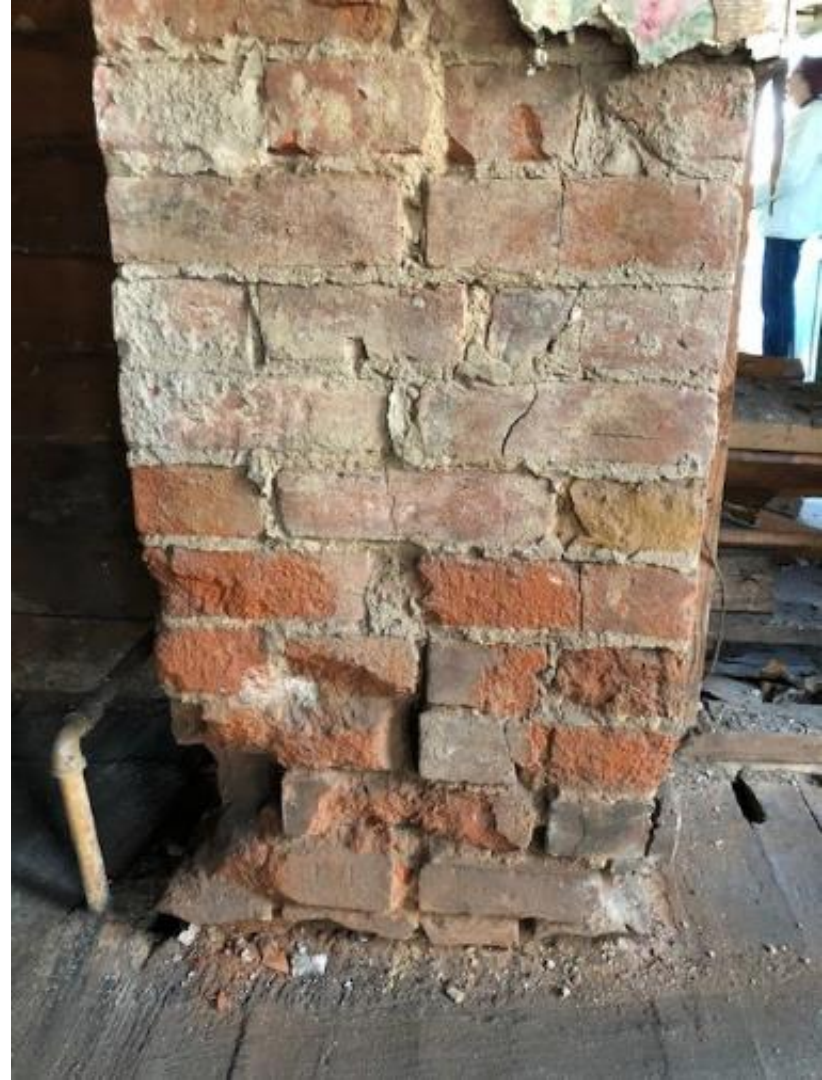
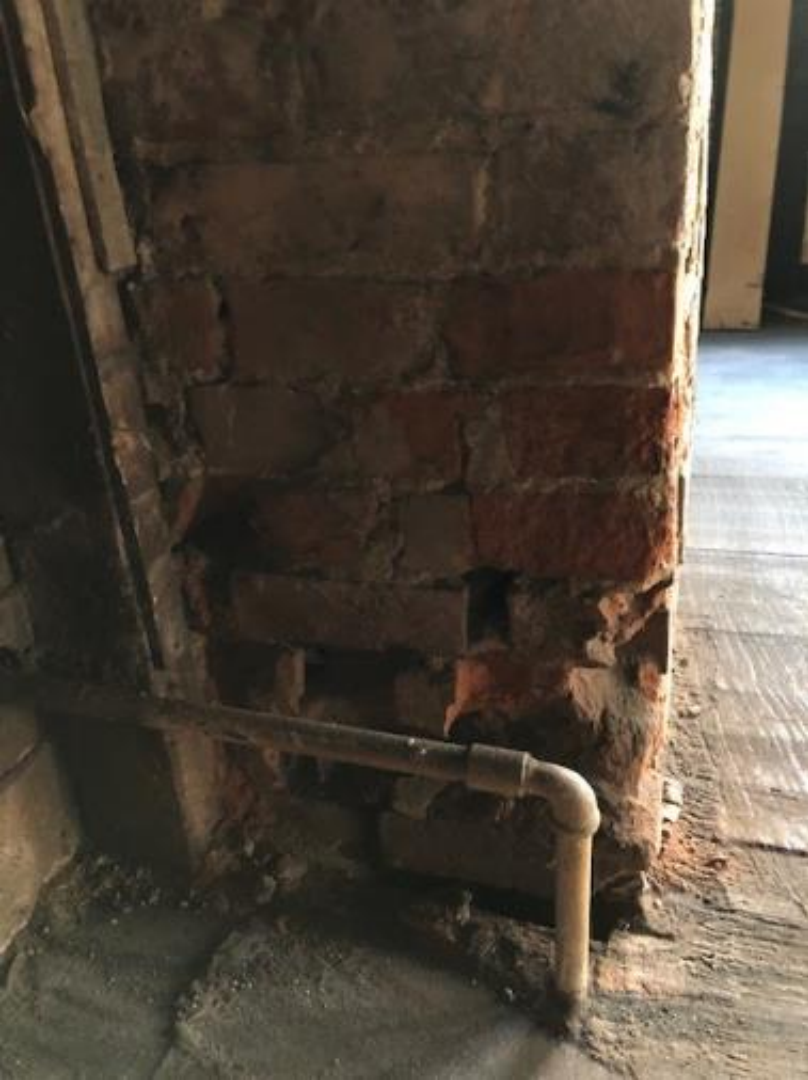
The south/back chimney at floor level illustrates the hazard created by time, weight and inferior brick. The north side of chimney foretells a collapse.

The east side of  
the chimney  
confirms the  
coming collapse.

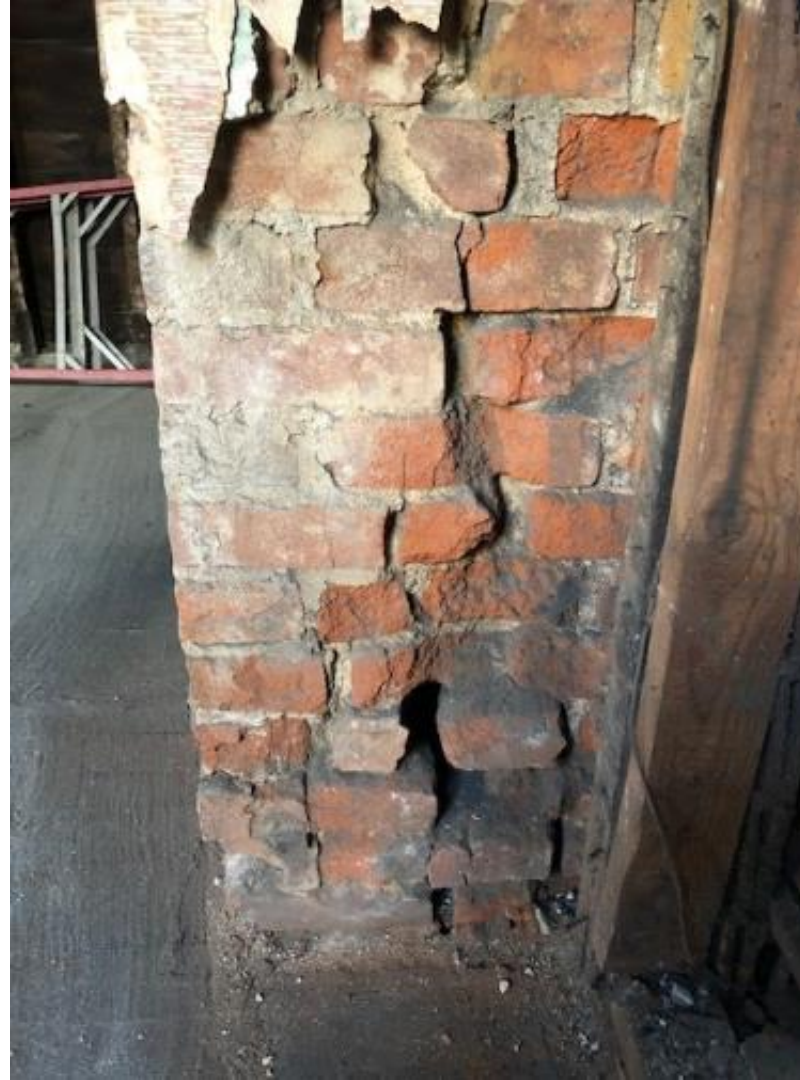
The west side of the chimney echos. This damage to an interior chimney is not damage due to recent neglect. This damage is a result of weight over a period of 120 years compressing inferior bricks and mortar.

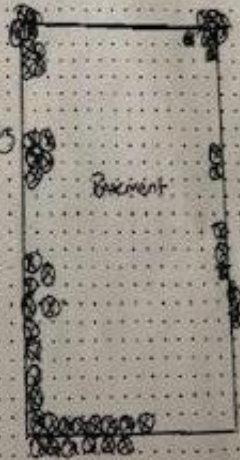
⊗ = Termite + Moisture Damage  
to floor joist, sill plate, foundation  
subfloor, window sills, wall studs  
paint + dry wall, term, ground terming

The termite and moisture inspection graph indicates termite damage throughout the perimeter. Note how much damage is along the east/left wall, adjacent to the USPO, and inaccessible.

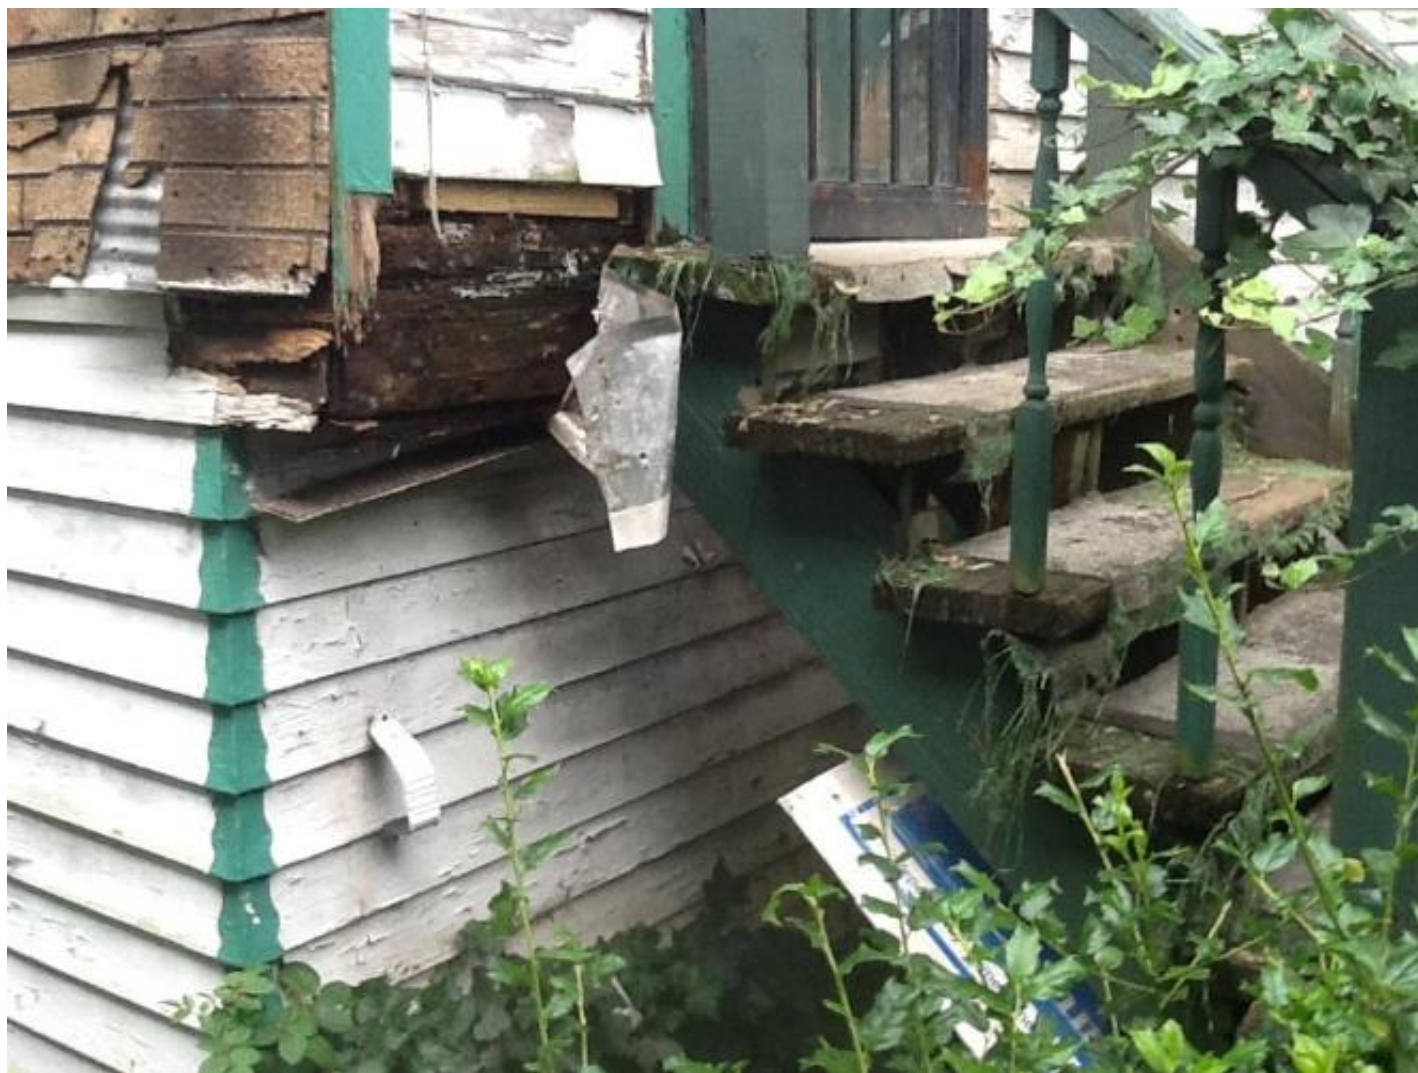
This is the SW (back) corner of the second addition, after removing some aluminum siding in 2019.

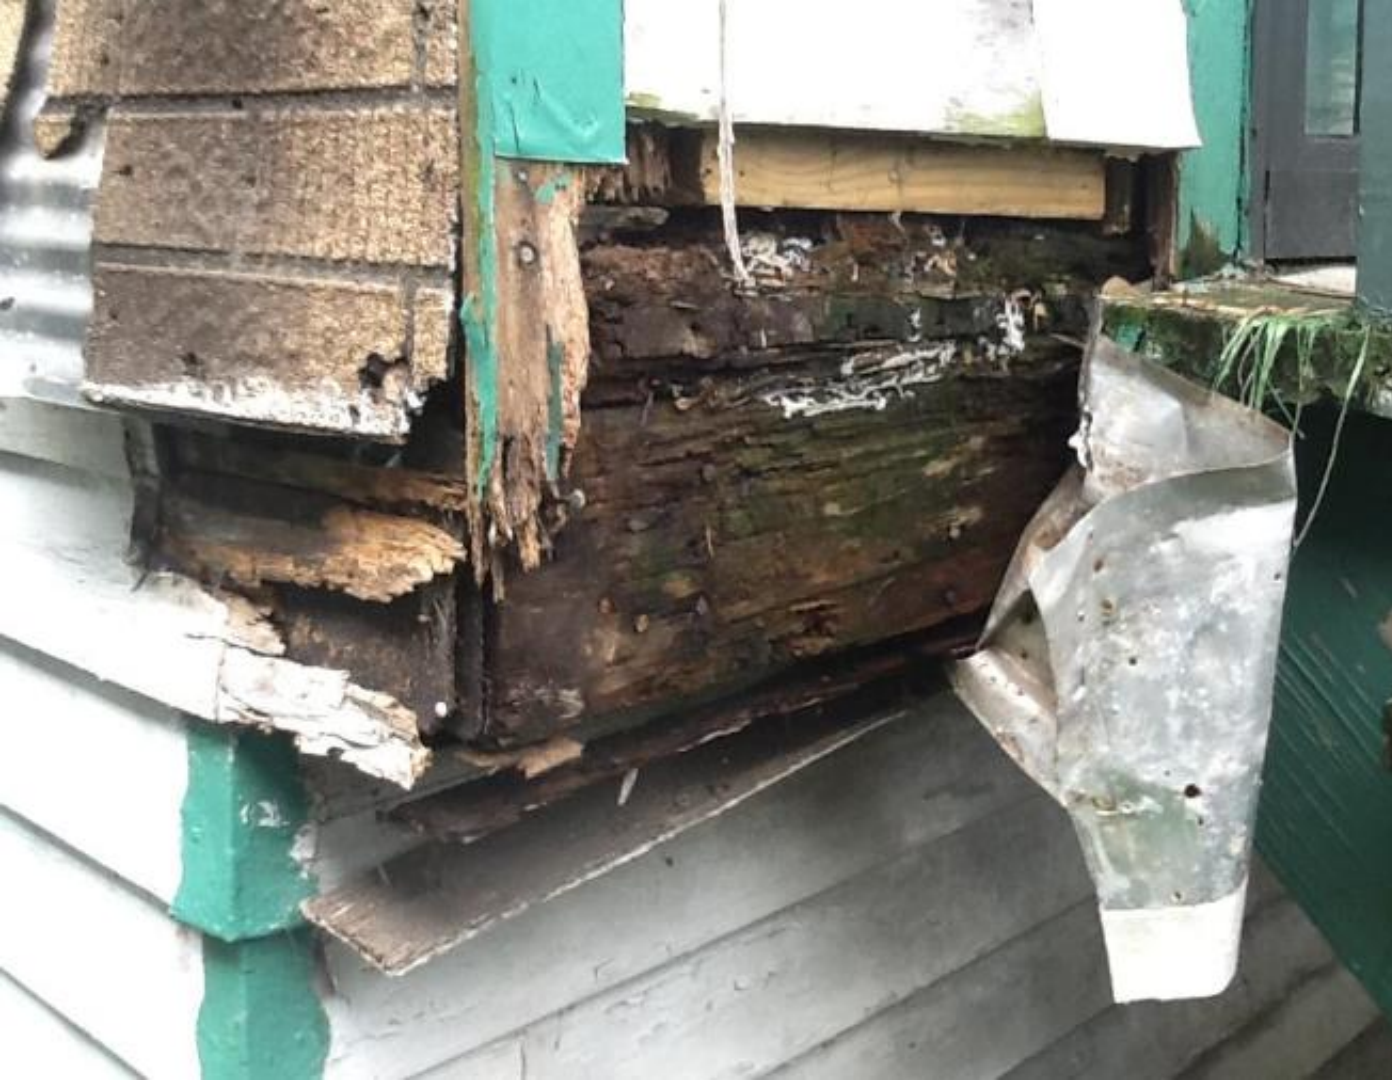
This SW corner was the newest, the highest and the driest corner of the structure. Clearly the mold, mildew and rot predate 2019.

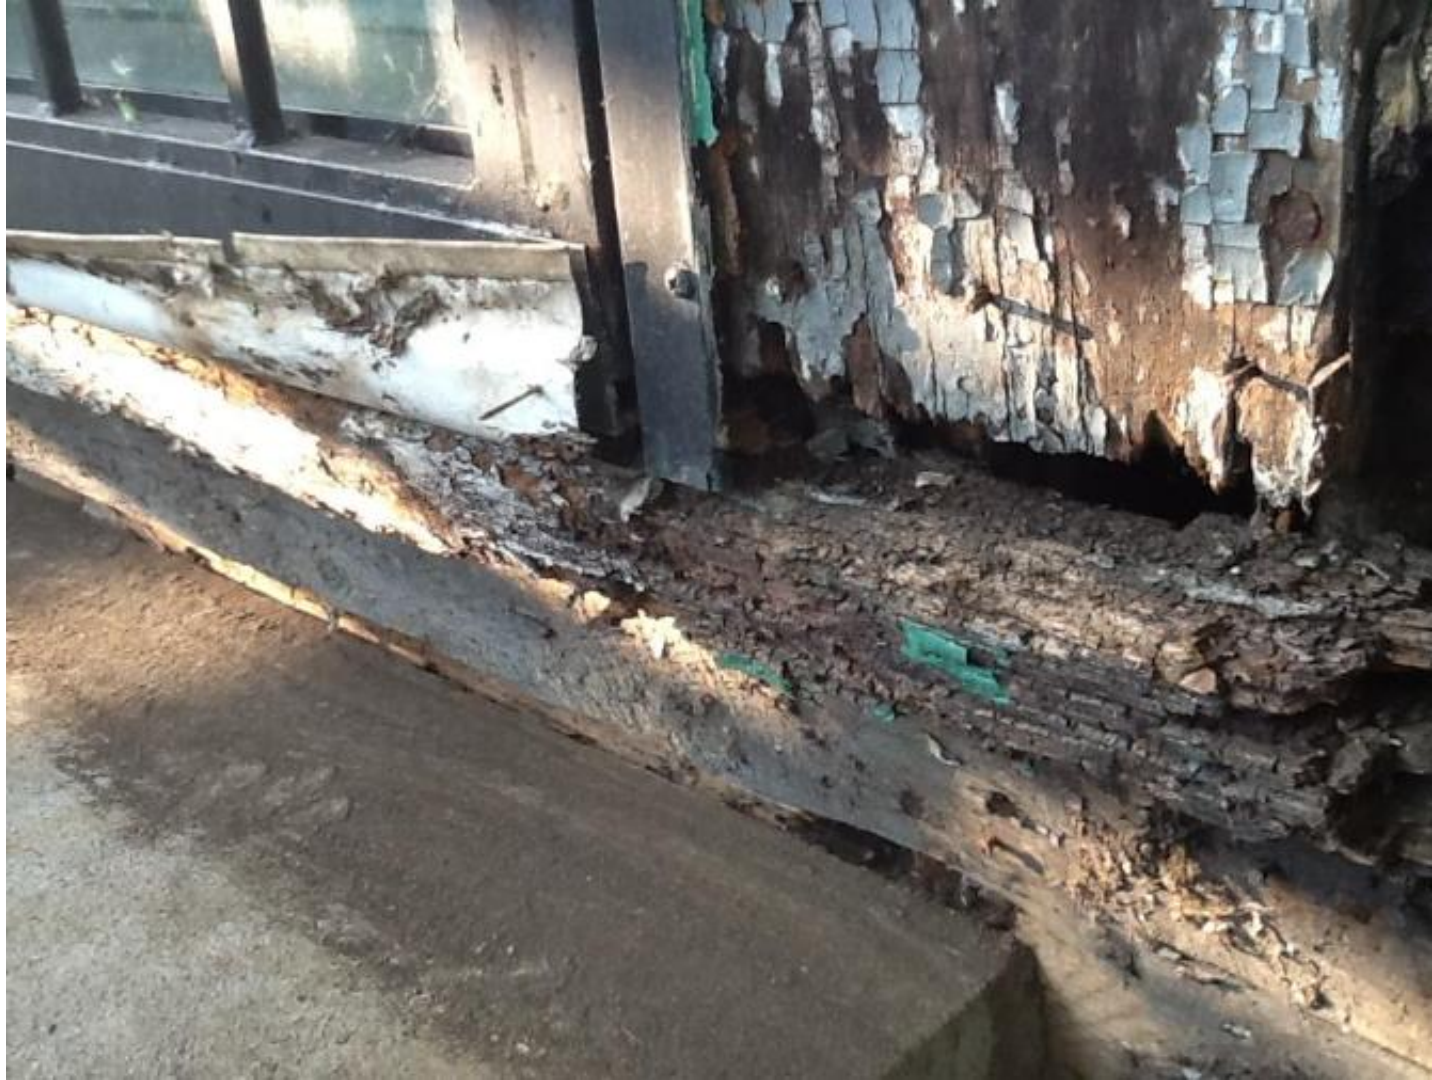
The NW  
corner of the  
shotgun.

“Rot”.

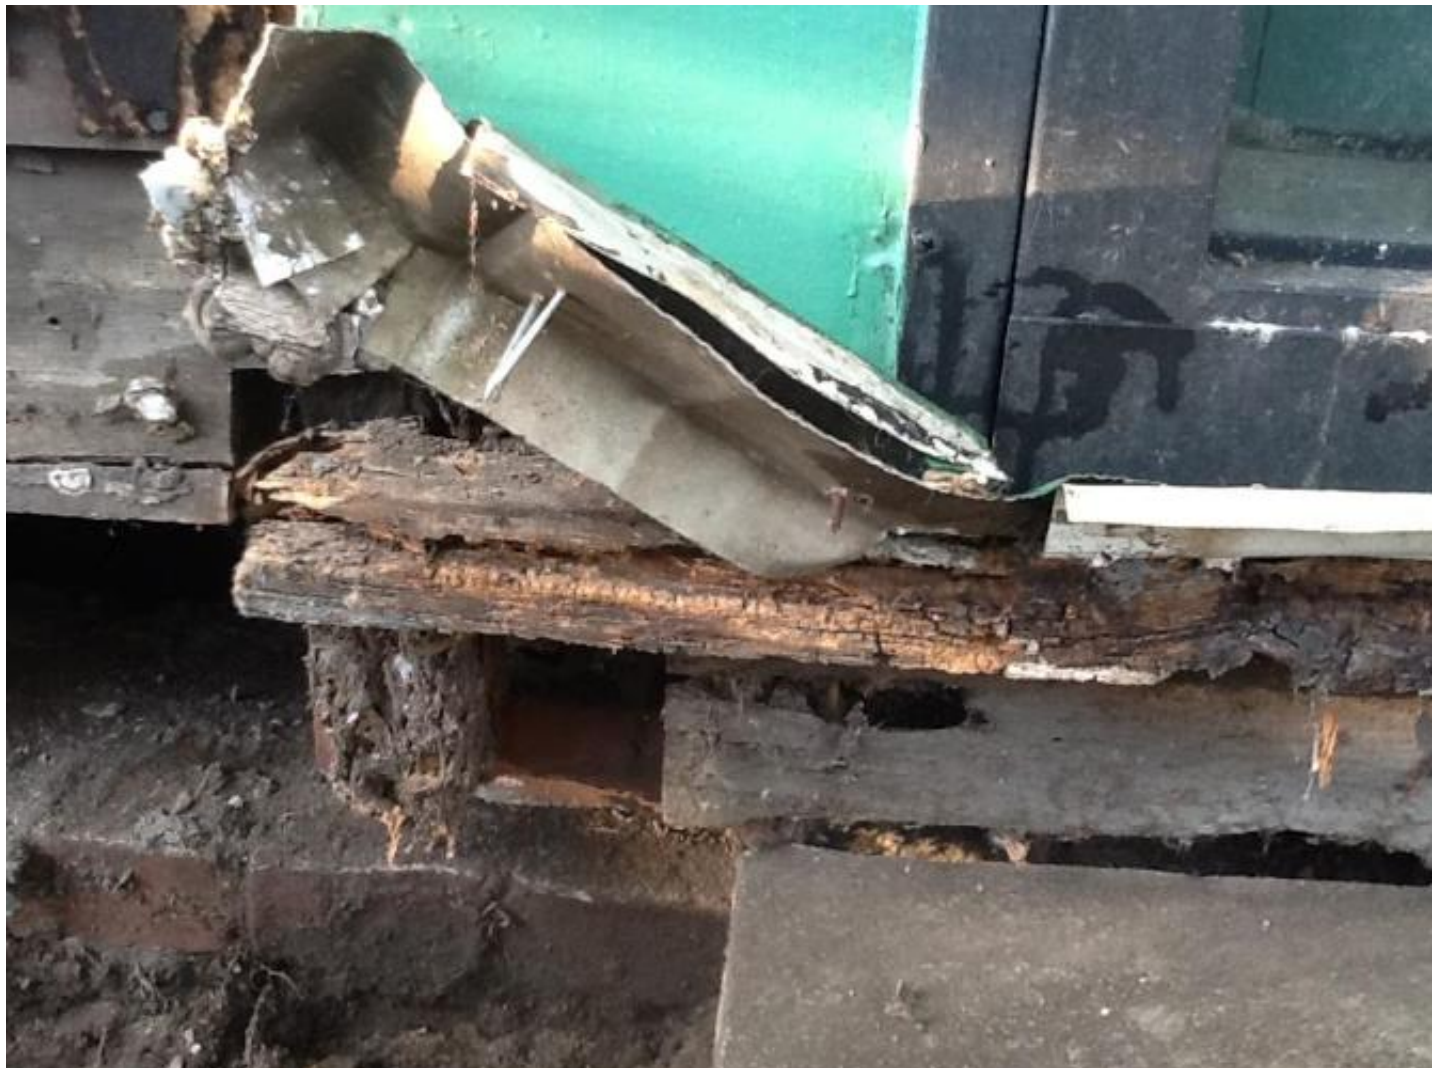
The other corner of the storm door. The wall stud has rotted. The plate it rested on has rotted and blown away.

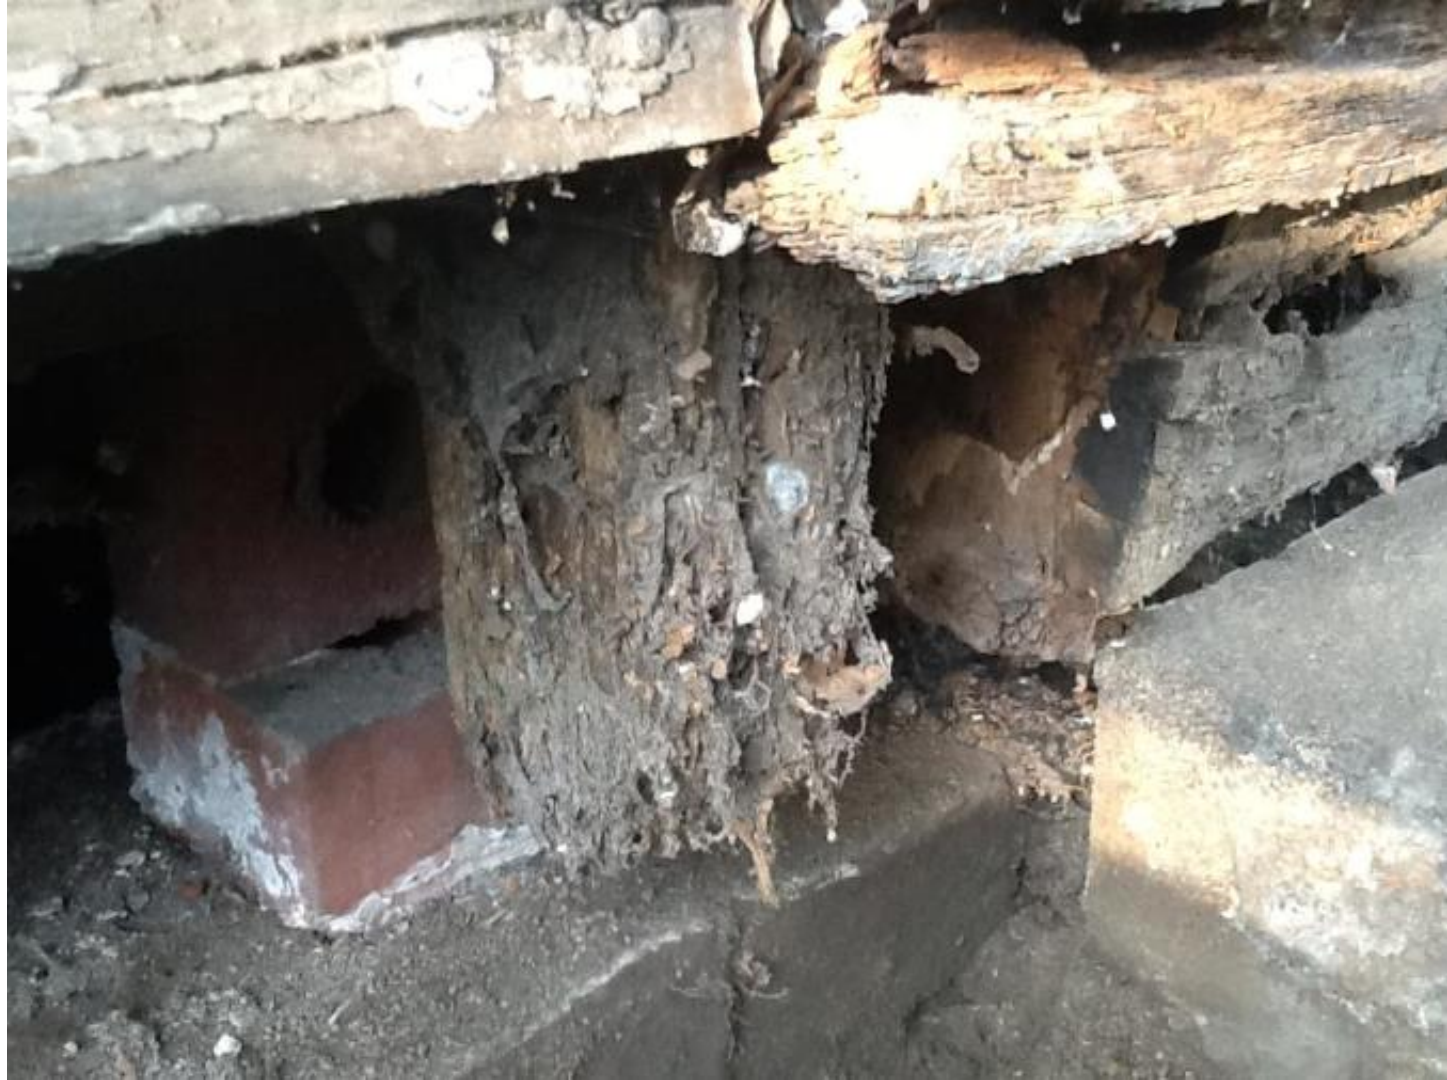
The same stud. The bricks behind the stud are holding up the floor joists. The neglect of the structure clearly pre-dates 2019.

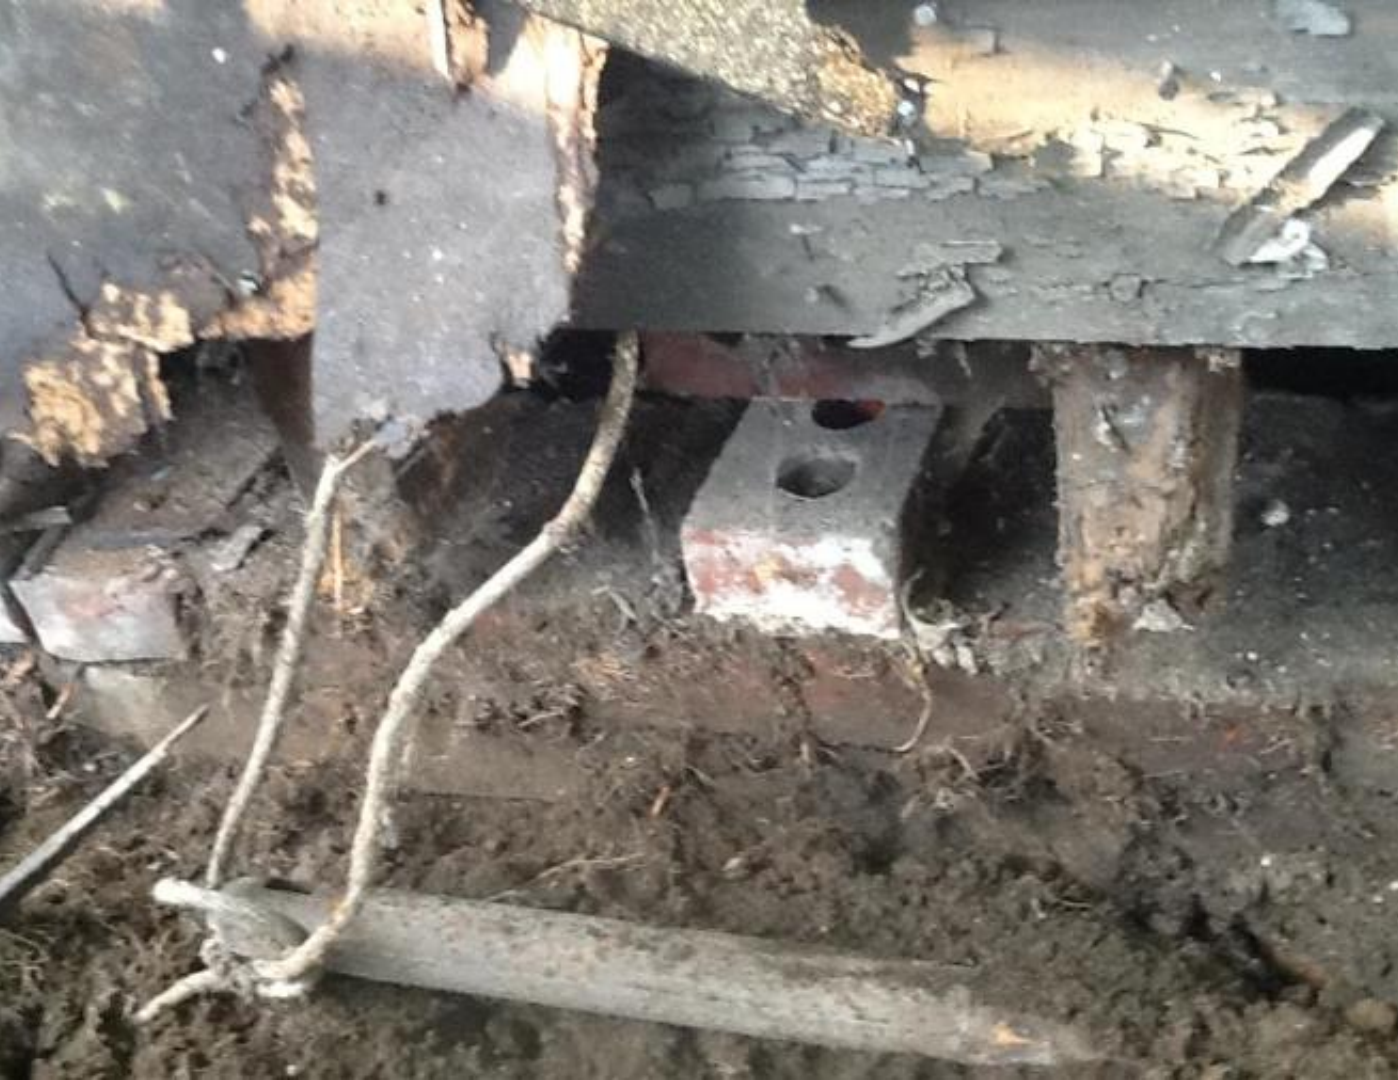
More rotted studs, no plate, and bricks supporting the floor joists.

“This wall  
hangs  
from the  
roof  
structure.”  
(p.3, #3)

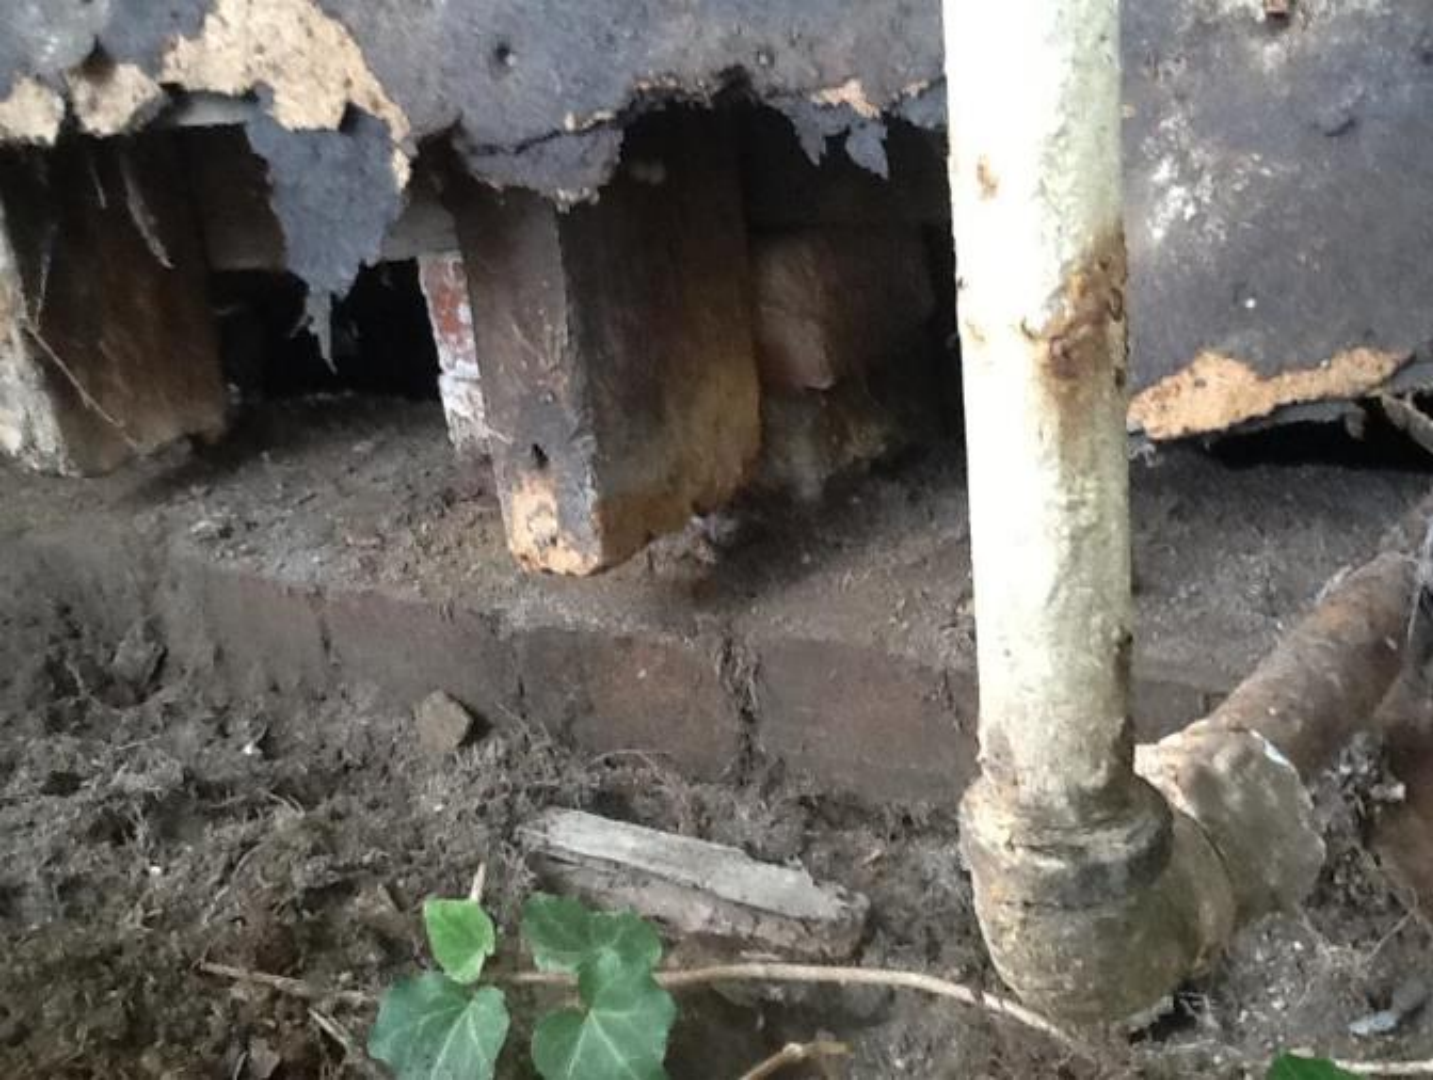
Even the floor joists are rotted away, left suspended above the well intentioned brick.

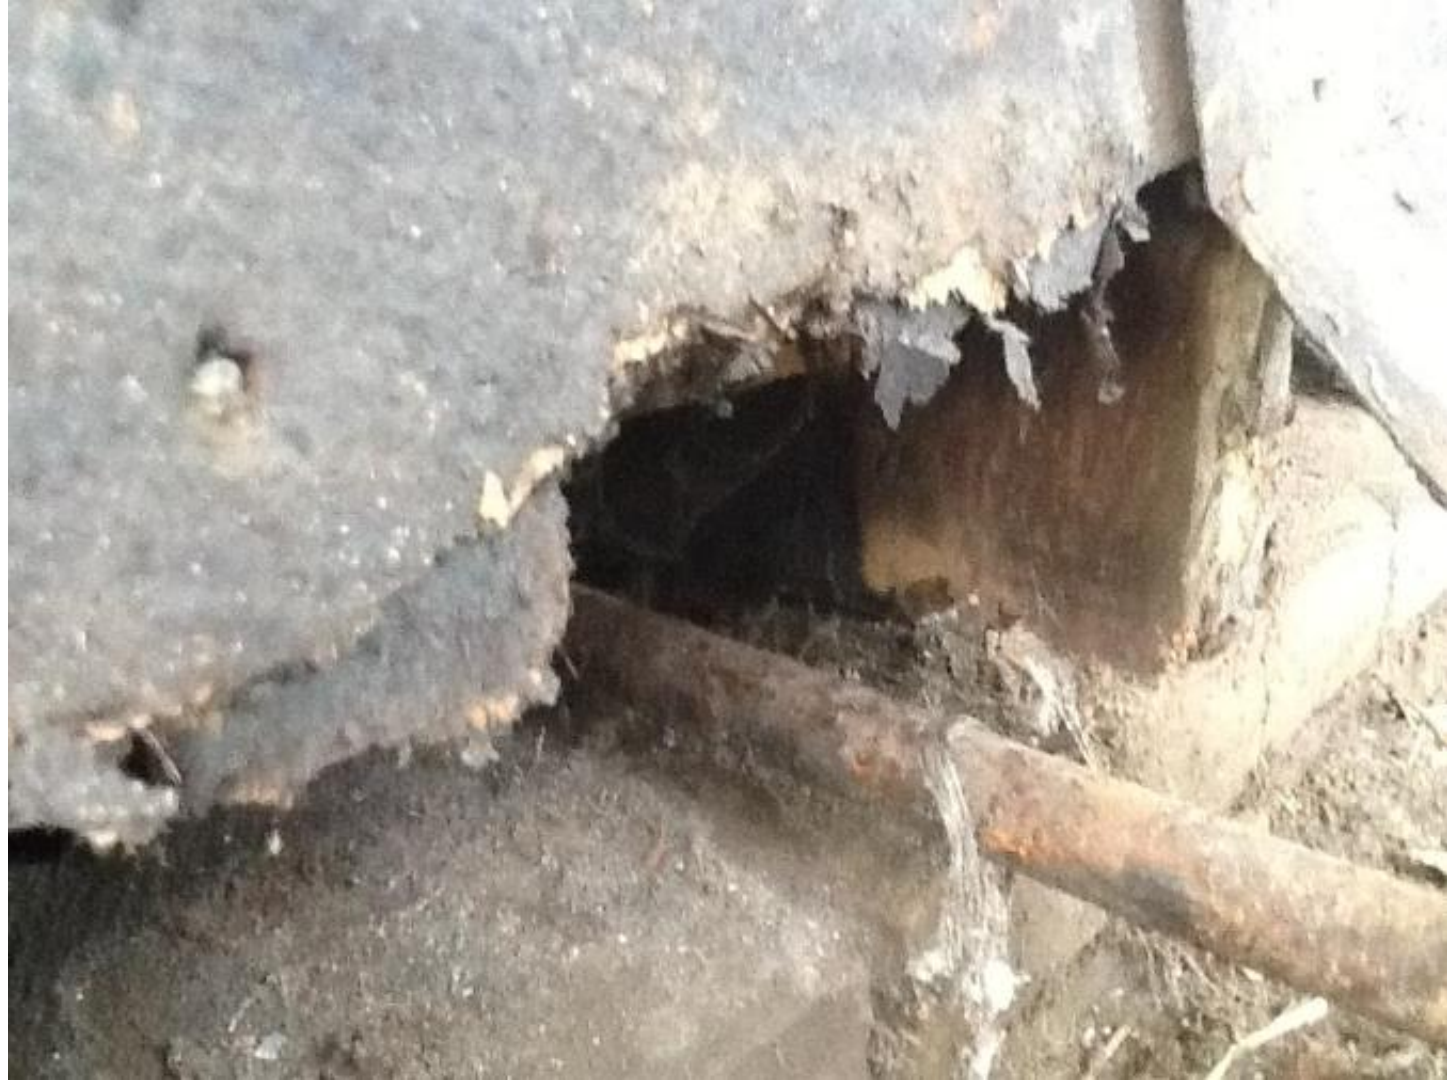
The  
remains of  
the NE  
corner of  
the shotgun  
hang a foot  
lower than  
the USPO.

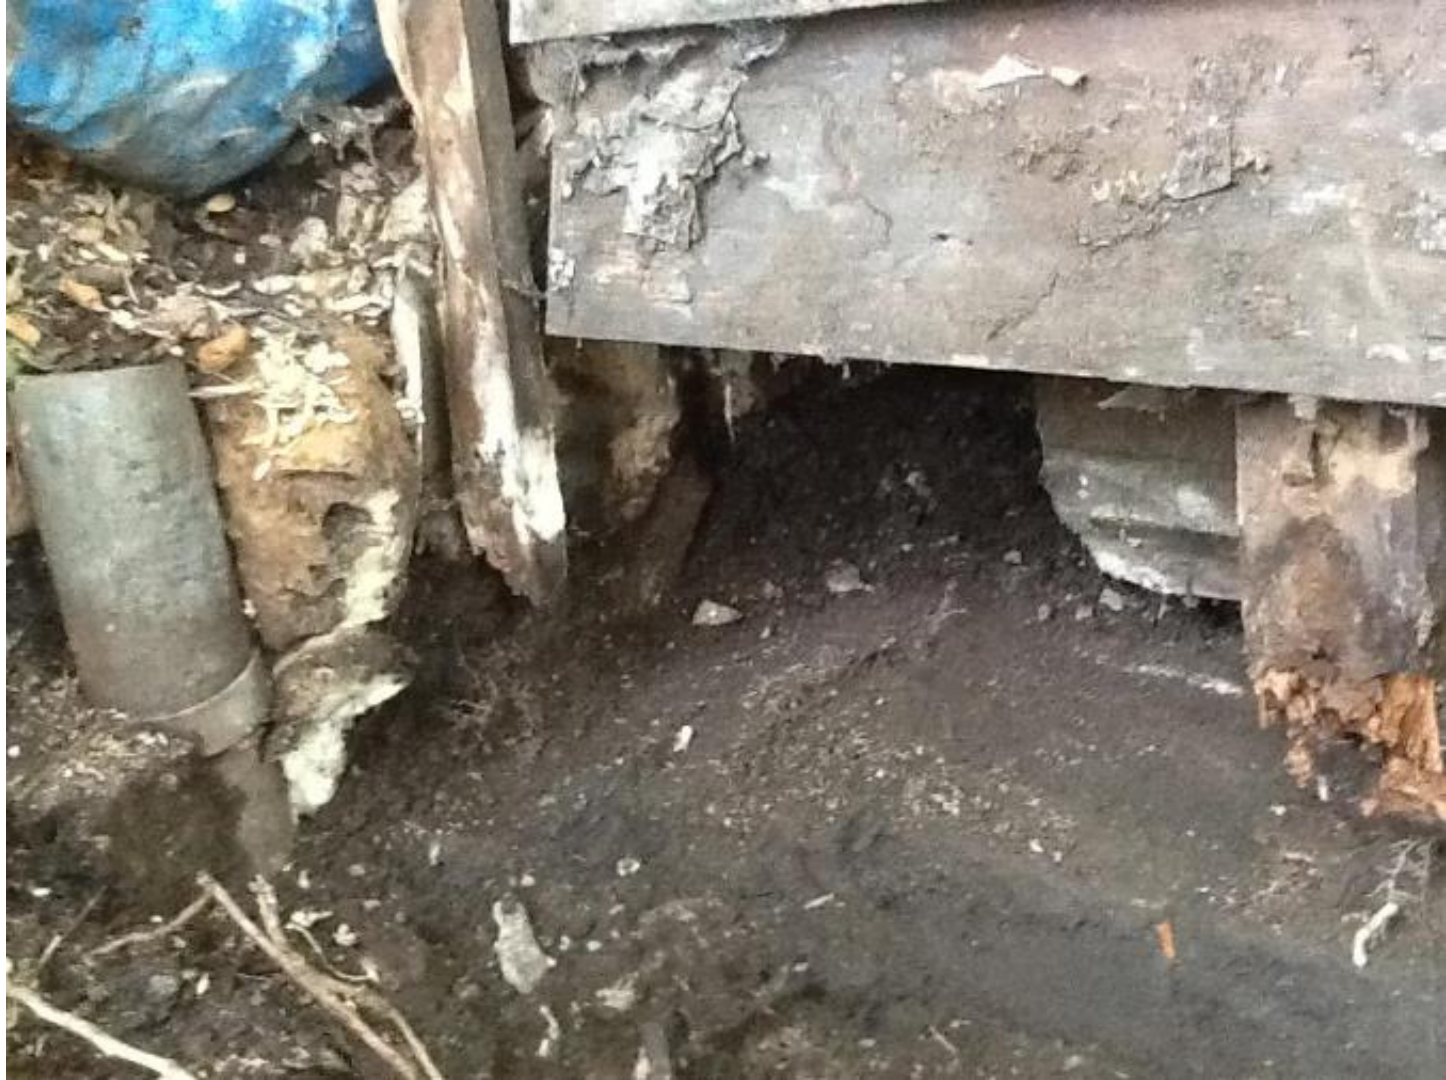
The N wall hangs, suspended in mid air. Removal of the aluminum siding to the east/left of the window revealed the interior lathing and plaster.

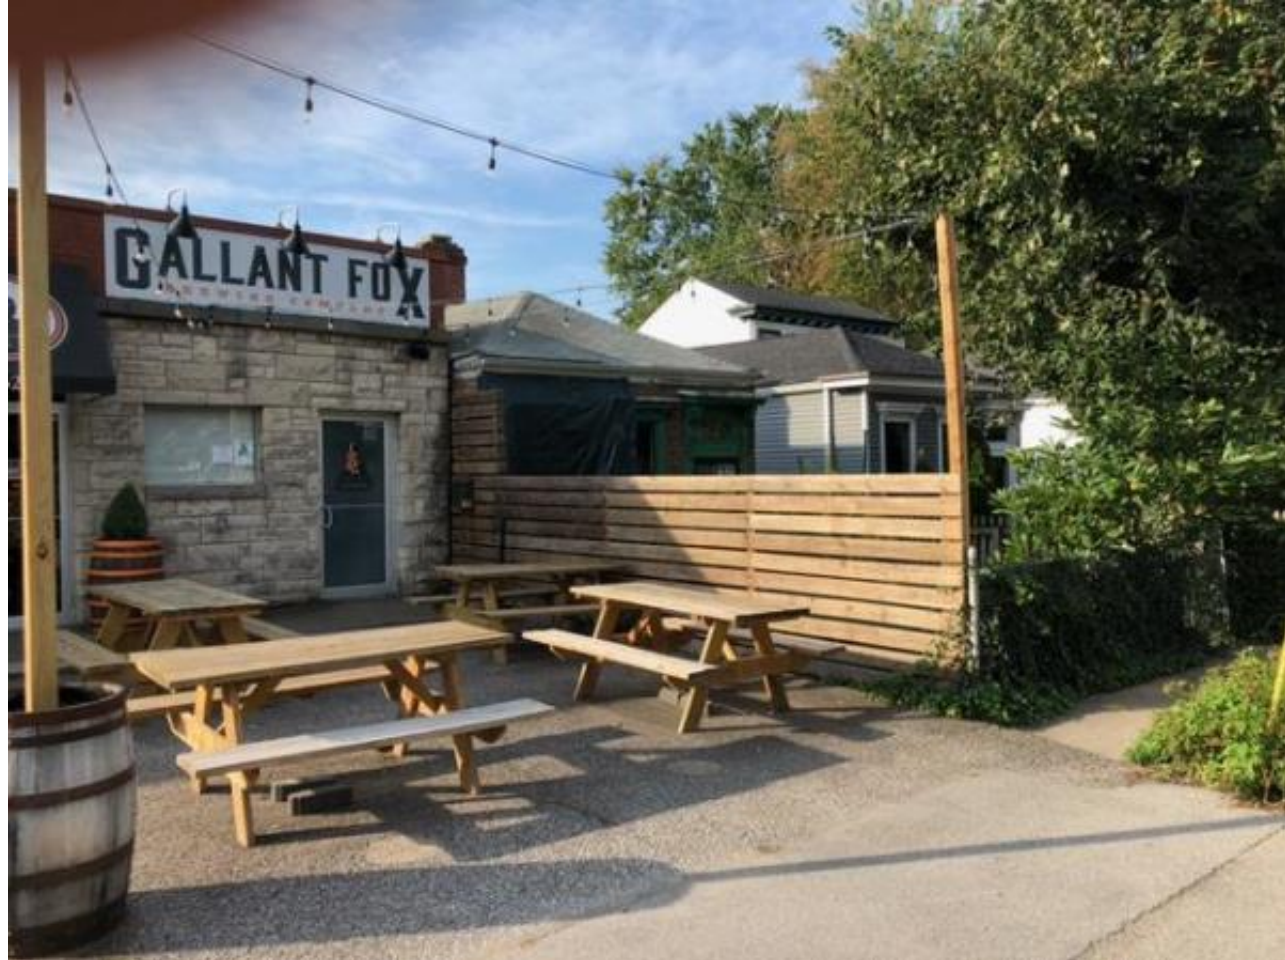
Damage to property is not limited to the shotgun. The west wall of the USPO has suffered damage resulting from years of exposure to water coming off the roof of the shotgun.
