# Demolition Request

## 2130 New Main Street

# Objective: Urban Greenspace 2130 New Main Street

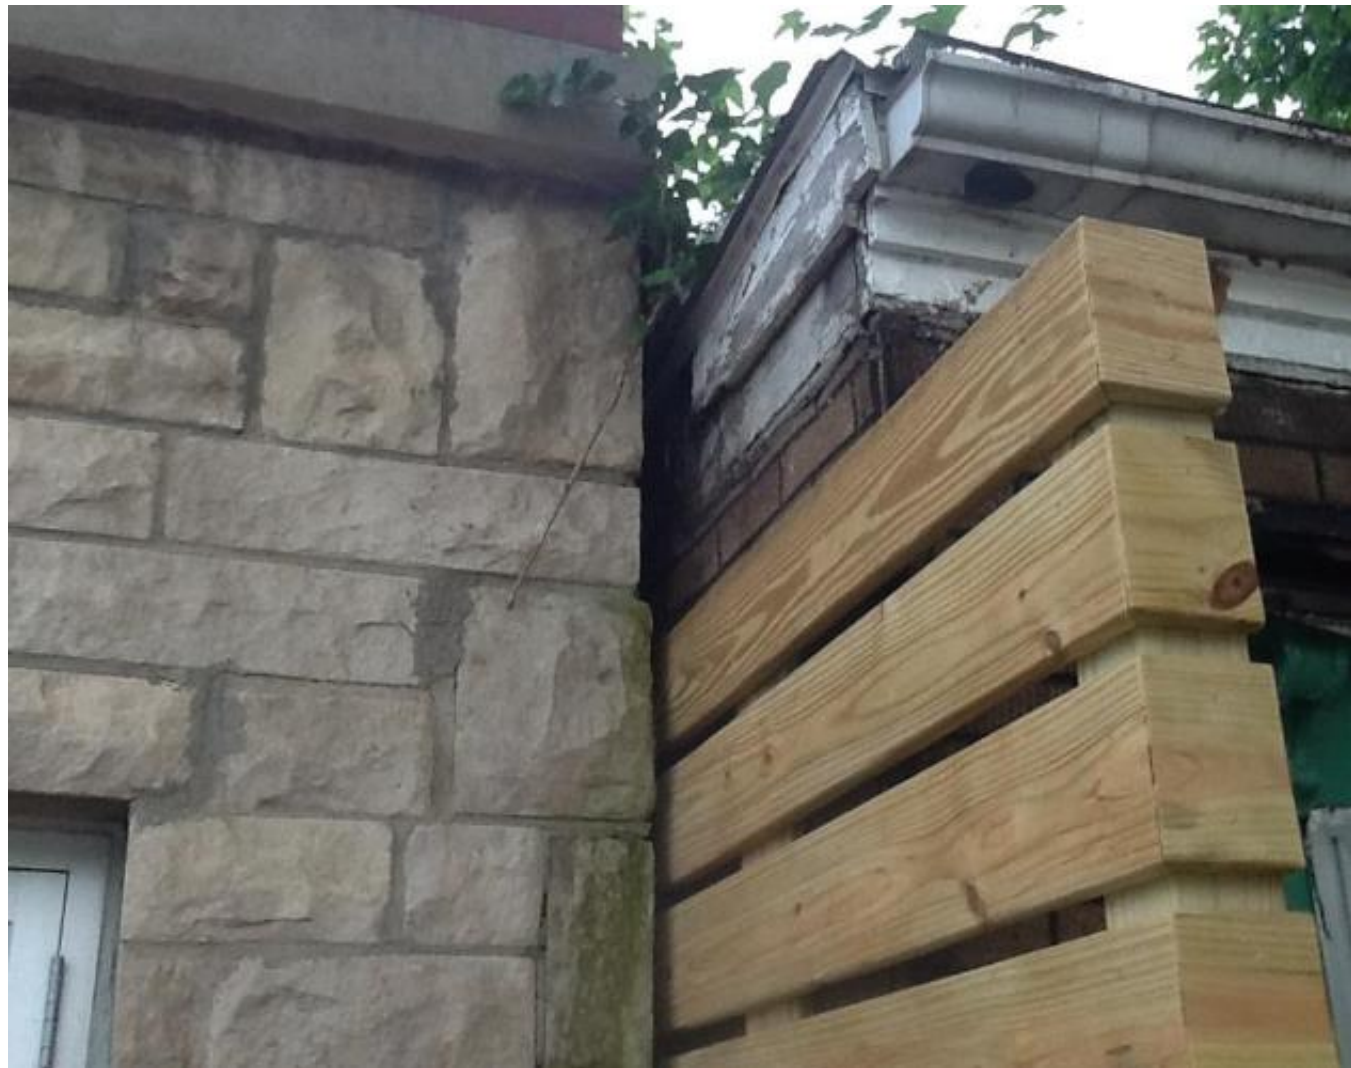
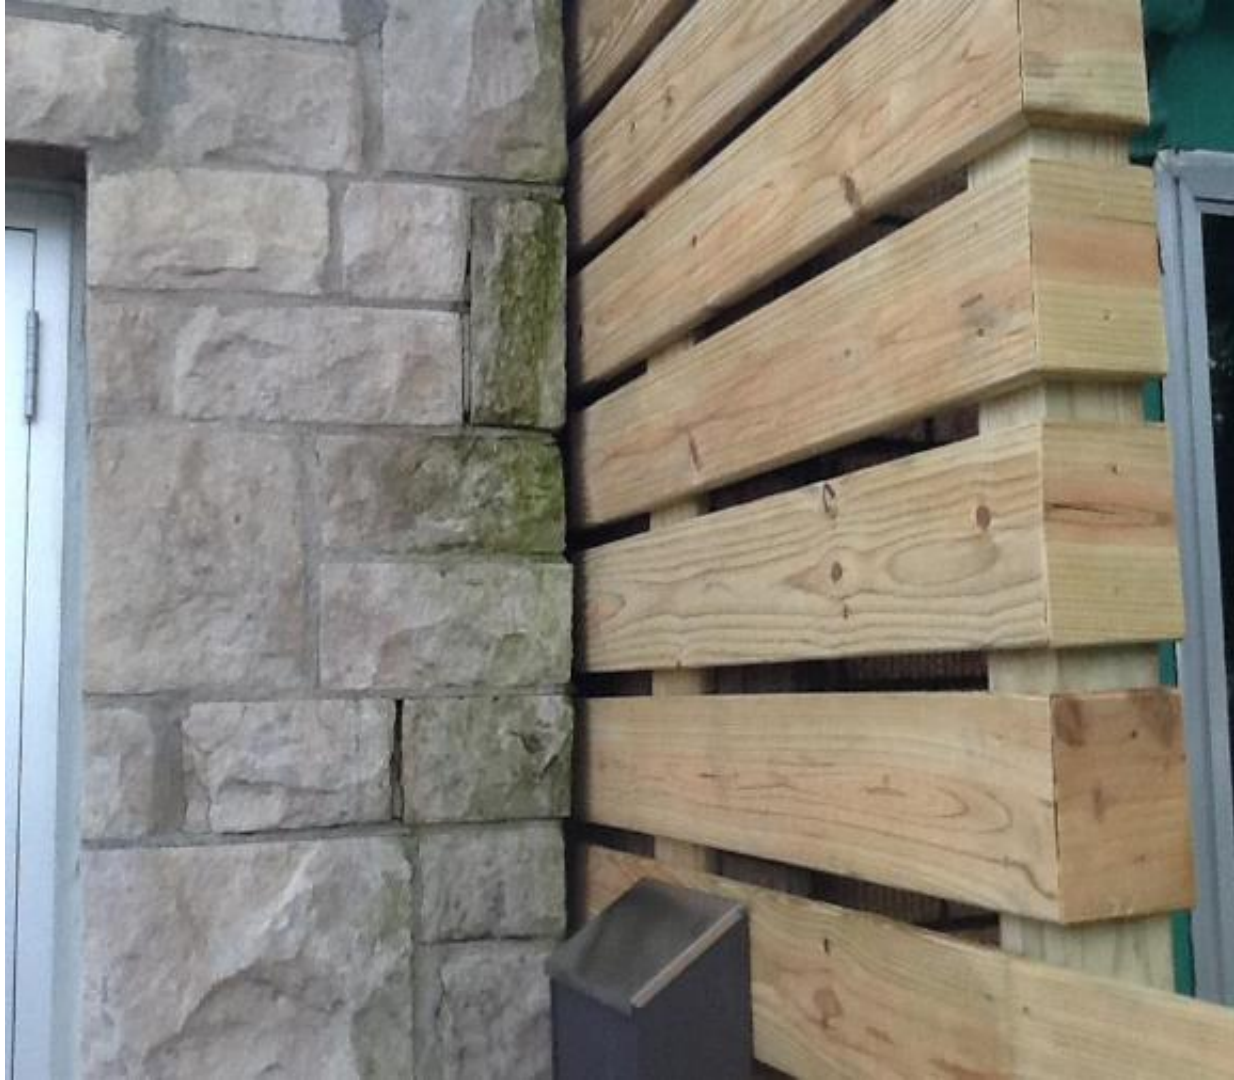
Note the green growth and damage to the mortar and limestone in the next couple of slides.

Replacing the missing mortar can be done only on the accessible north wall. The west wall damage is inaccessible.

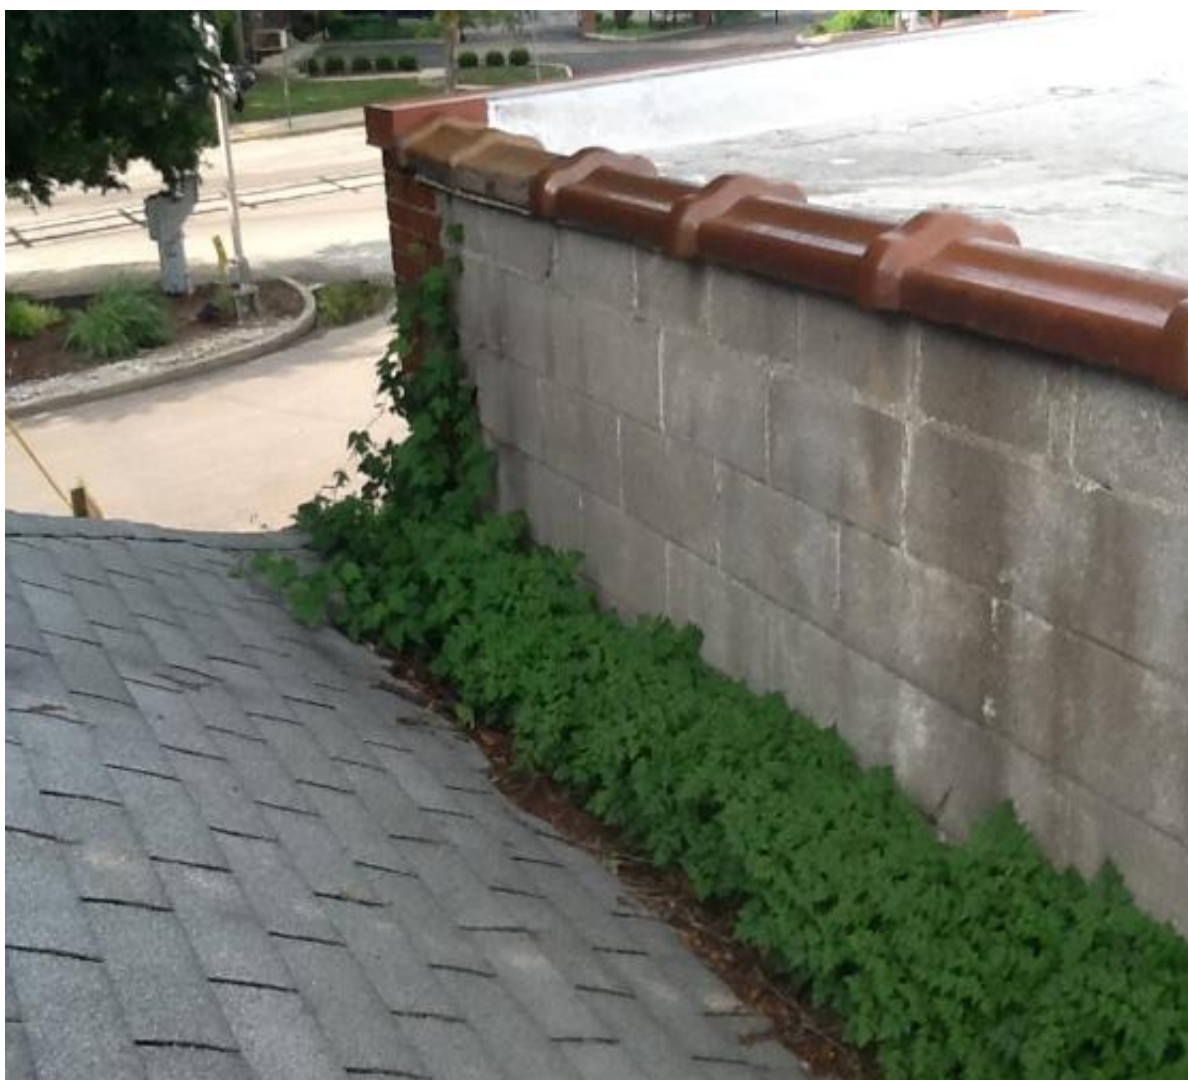
Now we are on the roof of the shotgun. The block wall to the east/right is the west wall of the USPO. The valley formed by the wall and roof collected leaves. Any water not soaked up by the leaves flowed on down between the two structures.

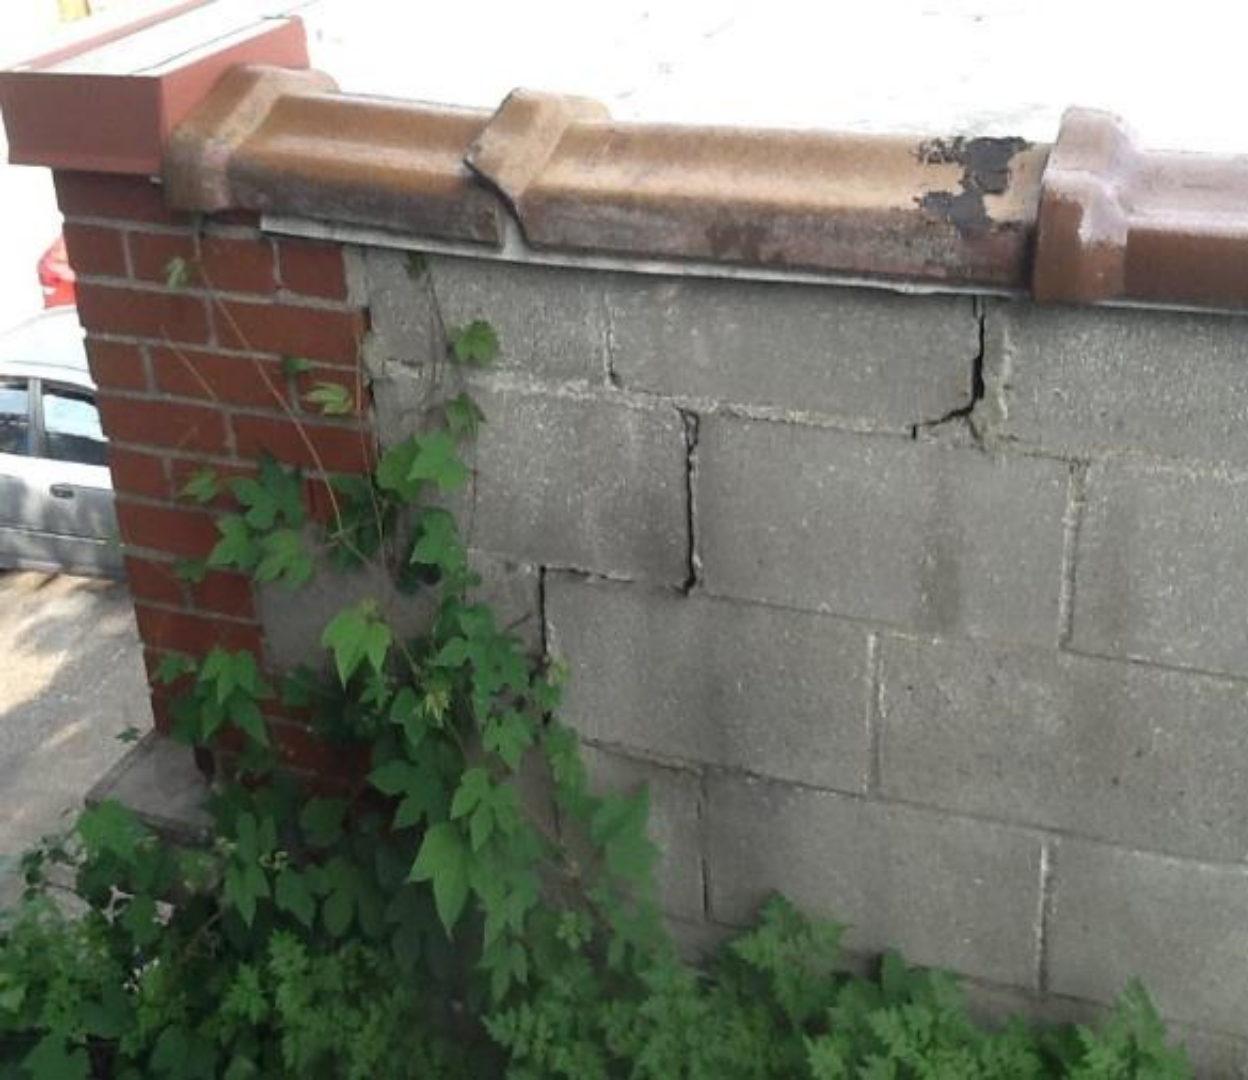
Seventy years of water between the two structures resulted in visible damage to the USPO wall and invisible damage to the walls and foundations below the 'valley'.

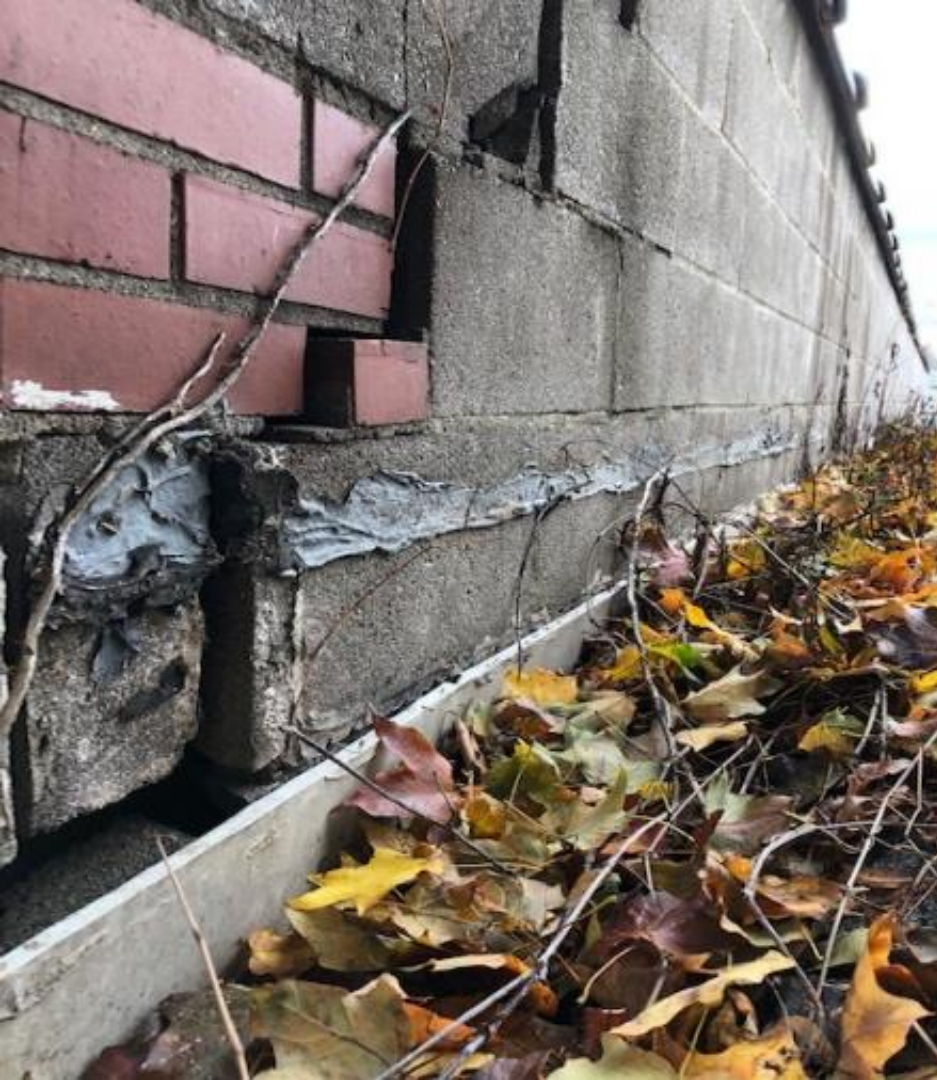
This close up shows a horizontal line of roofing tar running parallel with the roof line of the shotgun. That tar line suggests some structural feature - an earlier effort to protect from water damage. A failed effort.

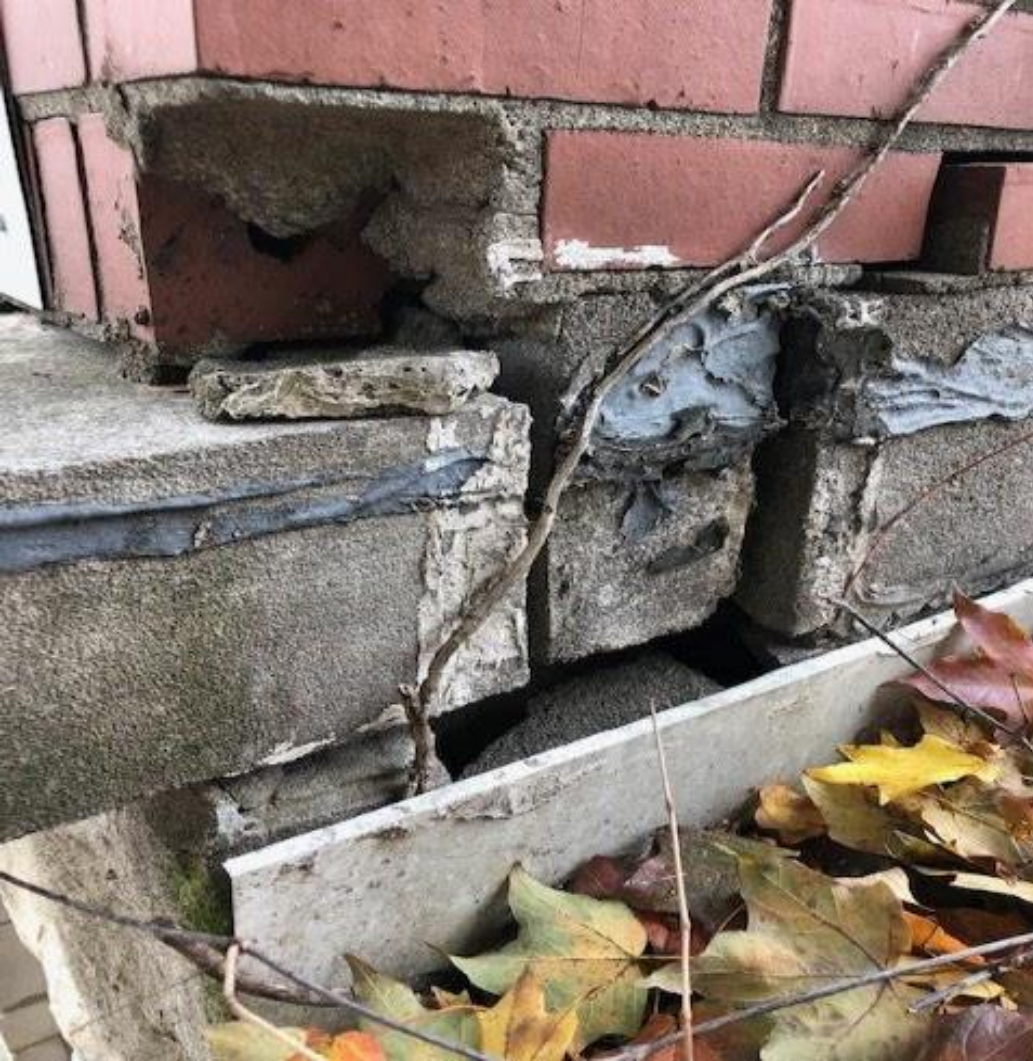
The west wall and foundation of the USPO need to be accessible below the 'valley'. The only way to gain access is by demolishing the east wall of the shotgun.

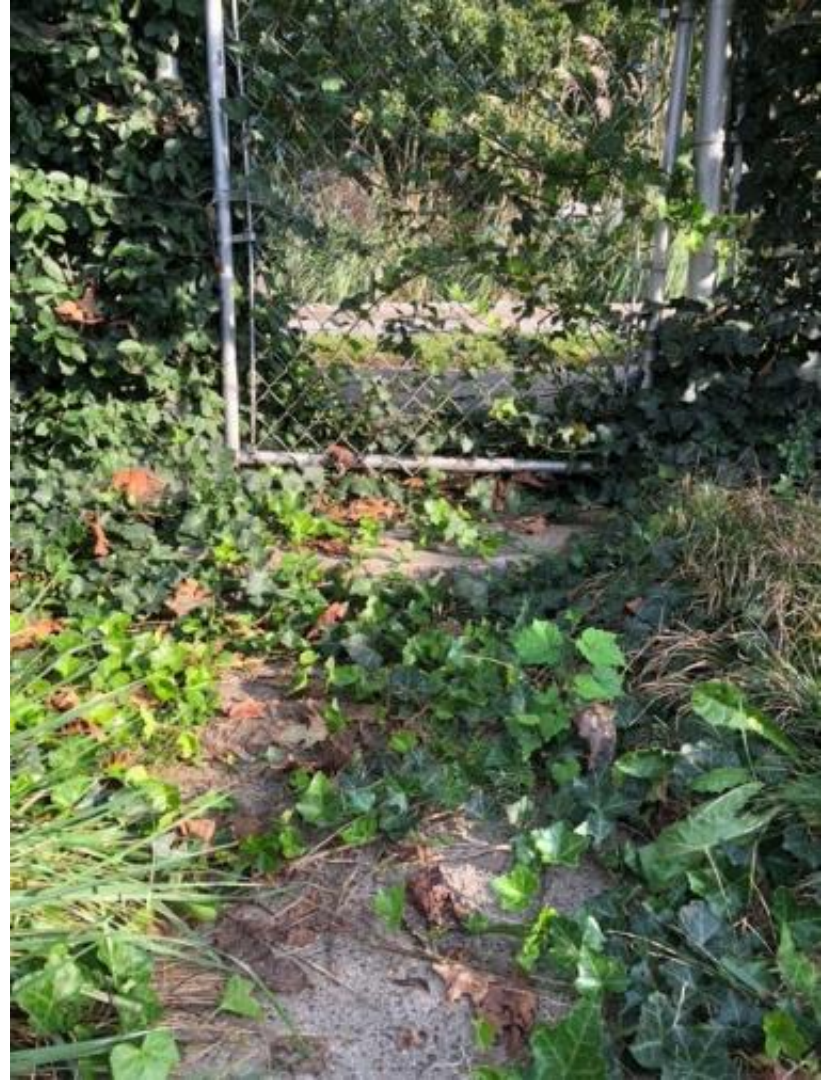
The front yard has begun to sink lower than the walk leading to the front door. Along with the rain and melted snow, the soil is infiltrating the basement.
