RE: Hogan's Fountain Teepee Pavilion, Cherokee Park

## Memo

**Re.** Cherokee Park Hogan's Fountain Pavilion

**Subject:** Cherokee Park, Hogan's Fountain Teepee Pavilion Reassessment

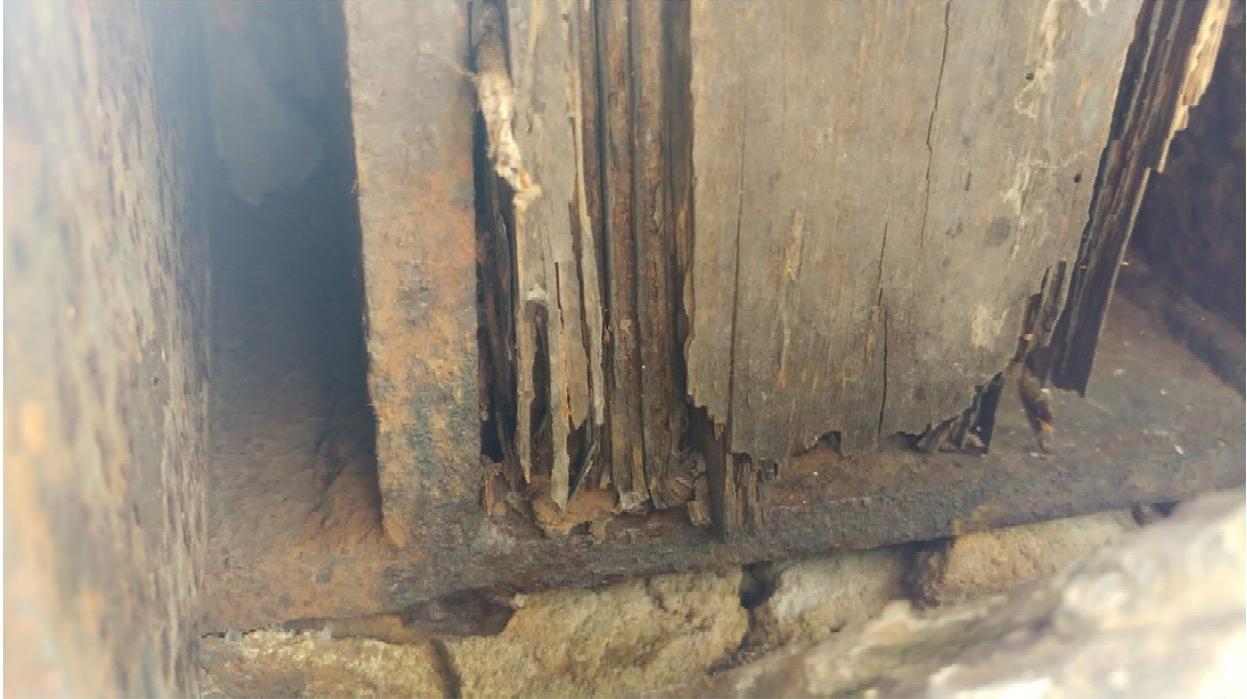
The current visual inspection was performed on the previously discussed eight glulam arches supporting the pavilion roof structure. Wood rot and severe deterioration of the wood was observed at the bases of the glulam arches at the concrete abutments (See Photo 1) as well as at the top of the steel casing near the connection of the horizontal roof framing members to the glulam arches (See Photo 2). Note that the condition of the glulam arch between the two ends of the steel casing could not be visually determined because of the steel casing itself. However, we suspect most of the glulam arch between the steel casing has similar wood deterioration.

Photo 1 – Wood rot and decay at base of glulam arch.

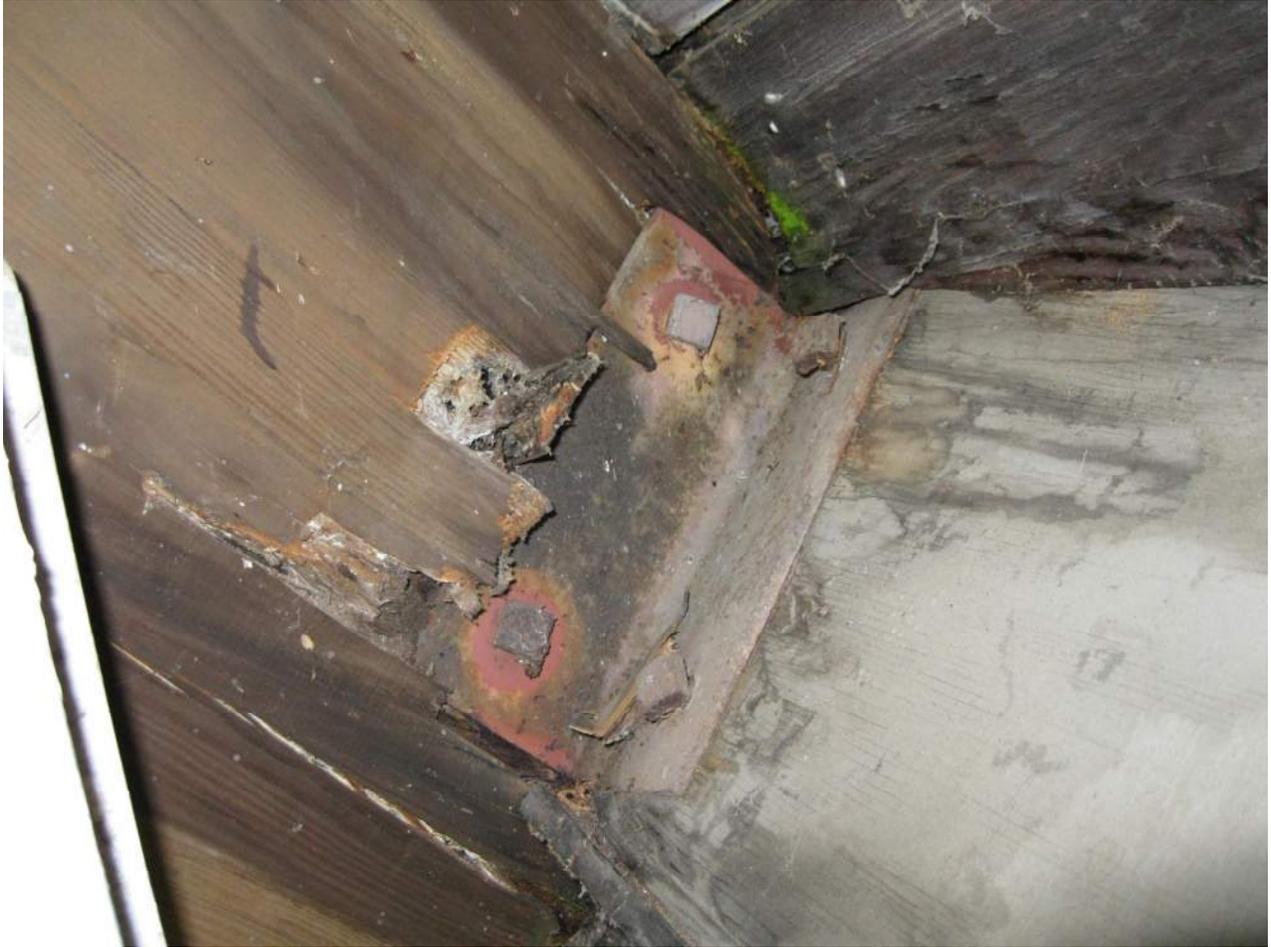
Photo 2 – Glulam arch wood decay near the connection of the horizontal roof framing members.

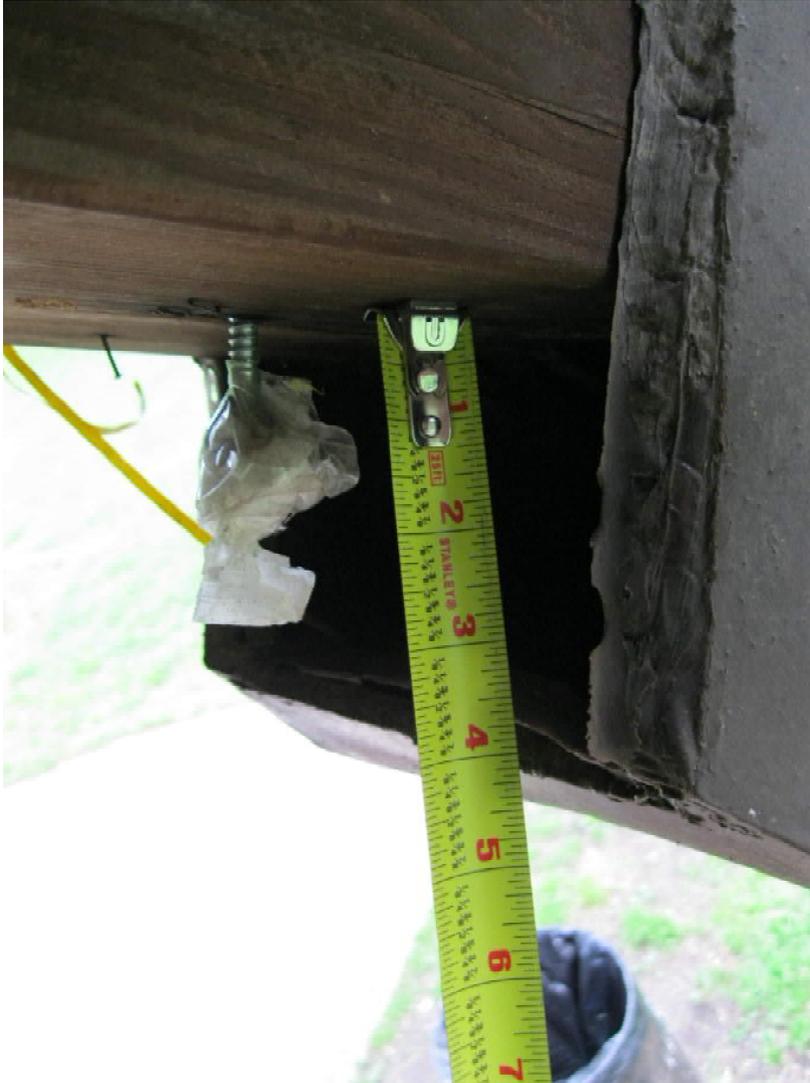
At the top of the steel casing at one of the originally repaired glulam arches, a 4-inch gap was observed between the bottom of the glulam arch and the bottom plate of the steel casing, indicating significant movement in the glulam arch (See Photo 3). At this location the wood was severely deteriorated (See Photo 4), exposing the top ¾ inch diameter rod between the steel casing sides (See Photo 5). Wood deterioration and exposure of the ¾ inch diameter rod at the top of the steel casing is particularly concerning since it was the upper zone of the steel casing that served as the area for the transfer of the forces in the glulam arch to the steel casing.

Photo 3 – Separation of the steel casing from glulam arch.

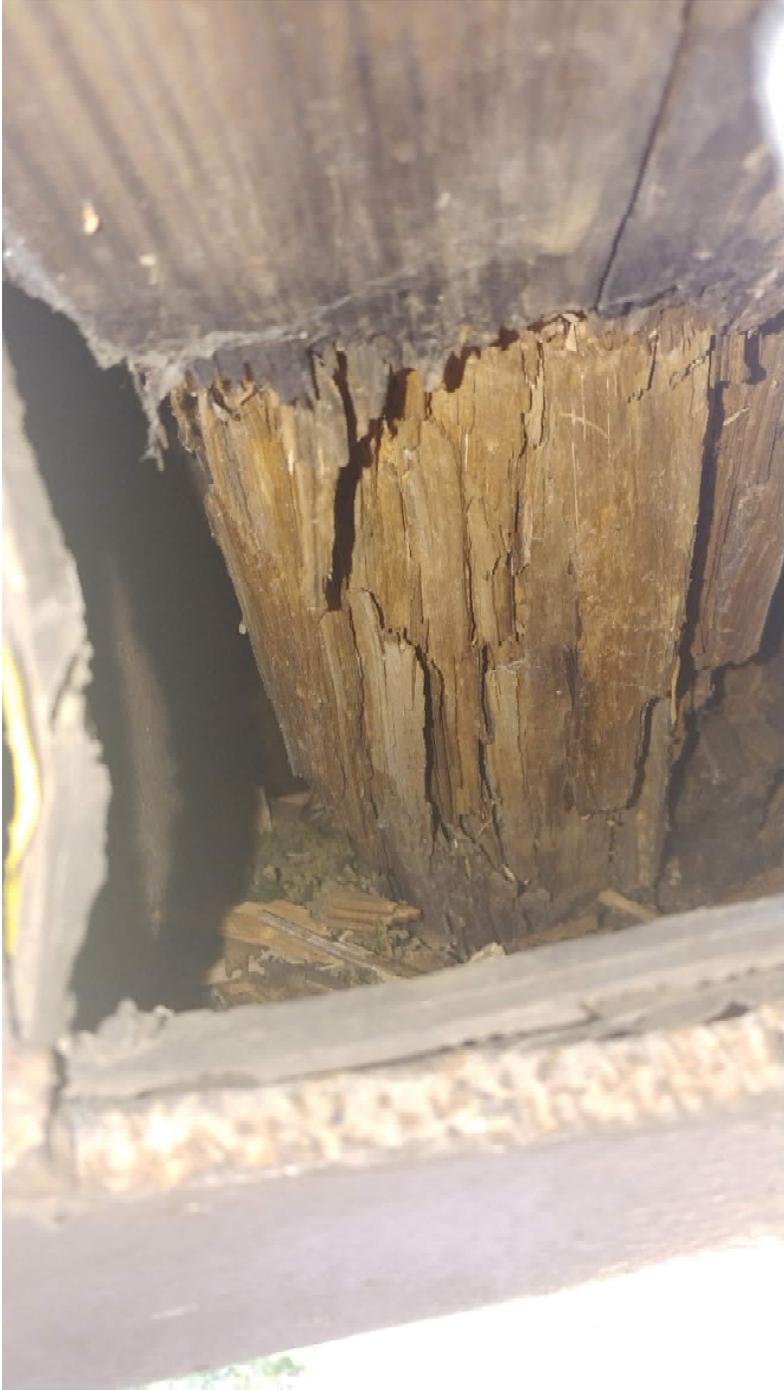
Photo 4 – Glulam arch wood deterioration near the top of the steel casing.

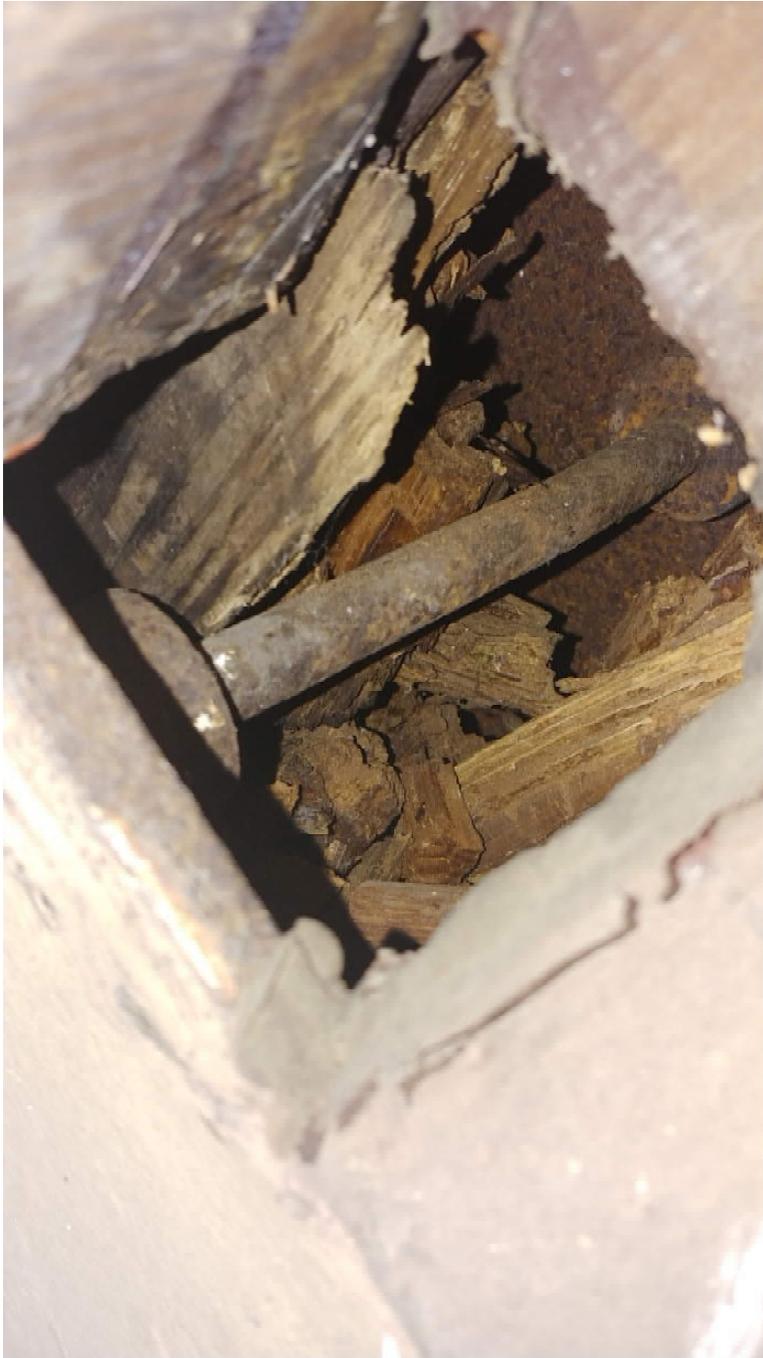
Photo 5 – Exposed  $\frac{3}{4}$ " diameter rods between the steel casing sides thru the deteriorated glulam arch.

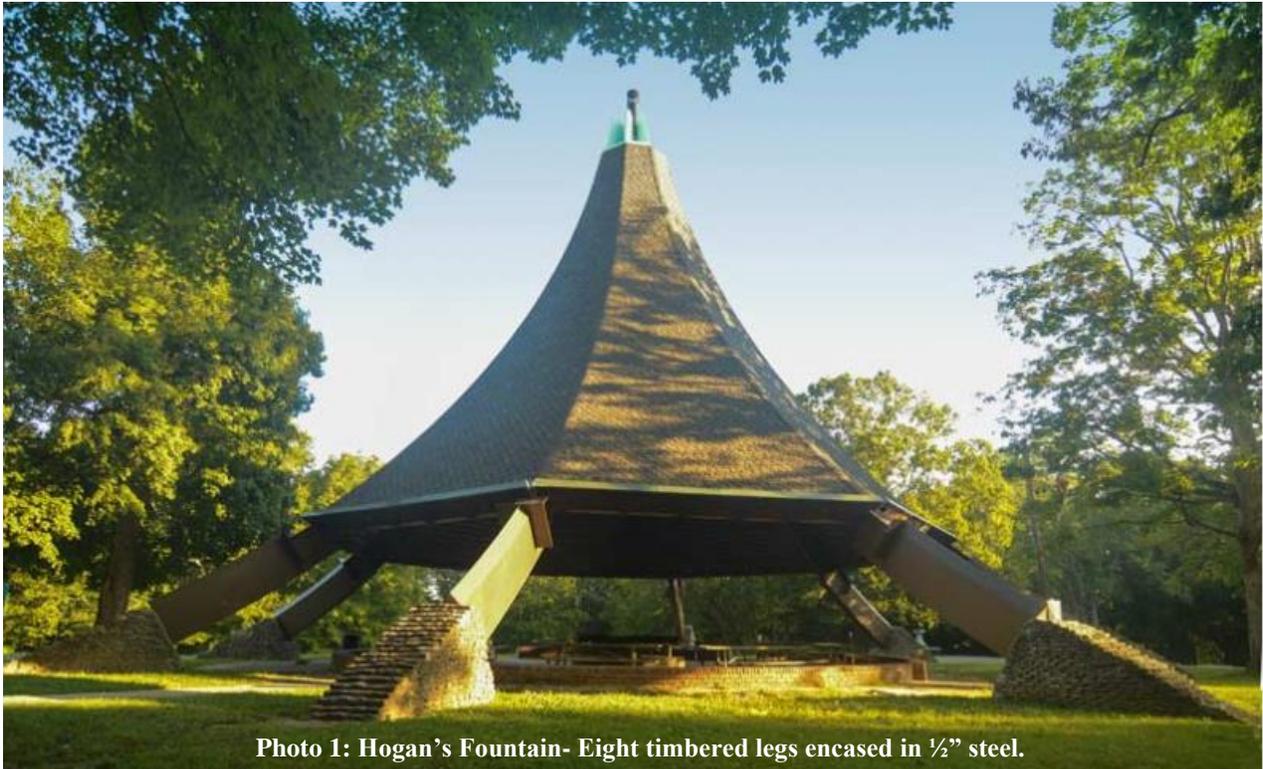
**Photo 1: Hogan's Fountain- Eight timbered legs encased in ½" steel.**

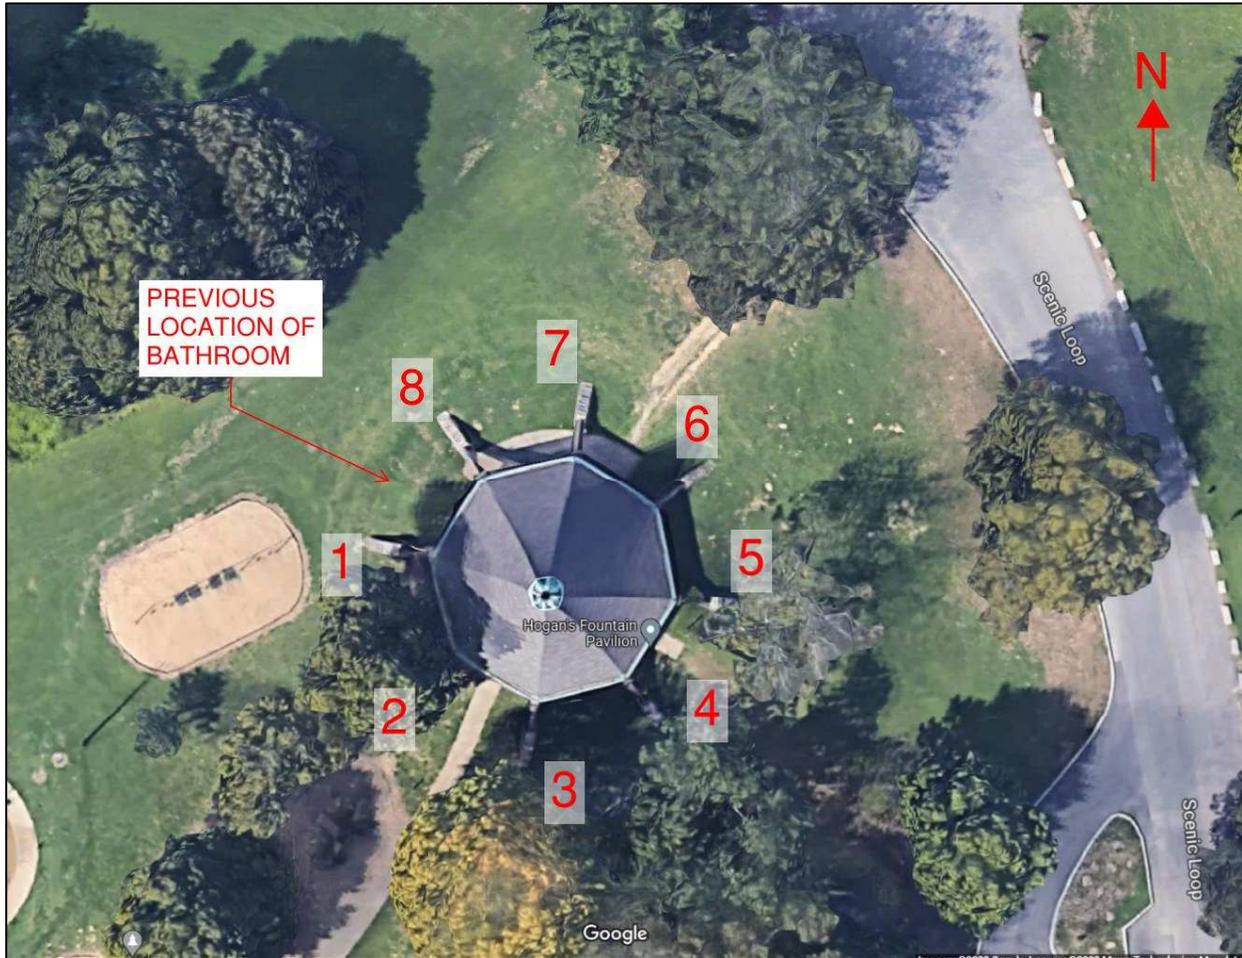
**Photo 1: Pavilion and Beam Orientation**

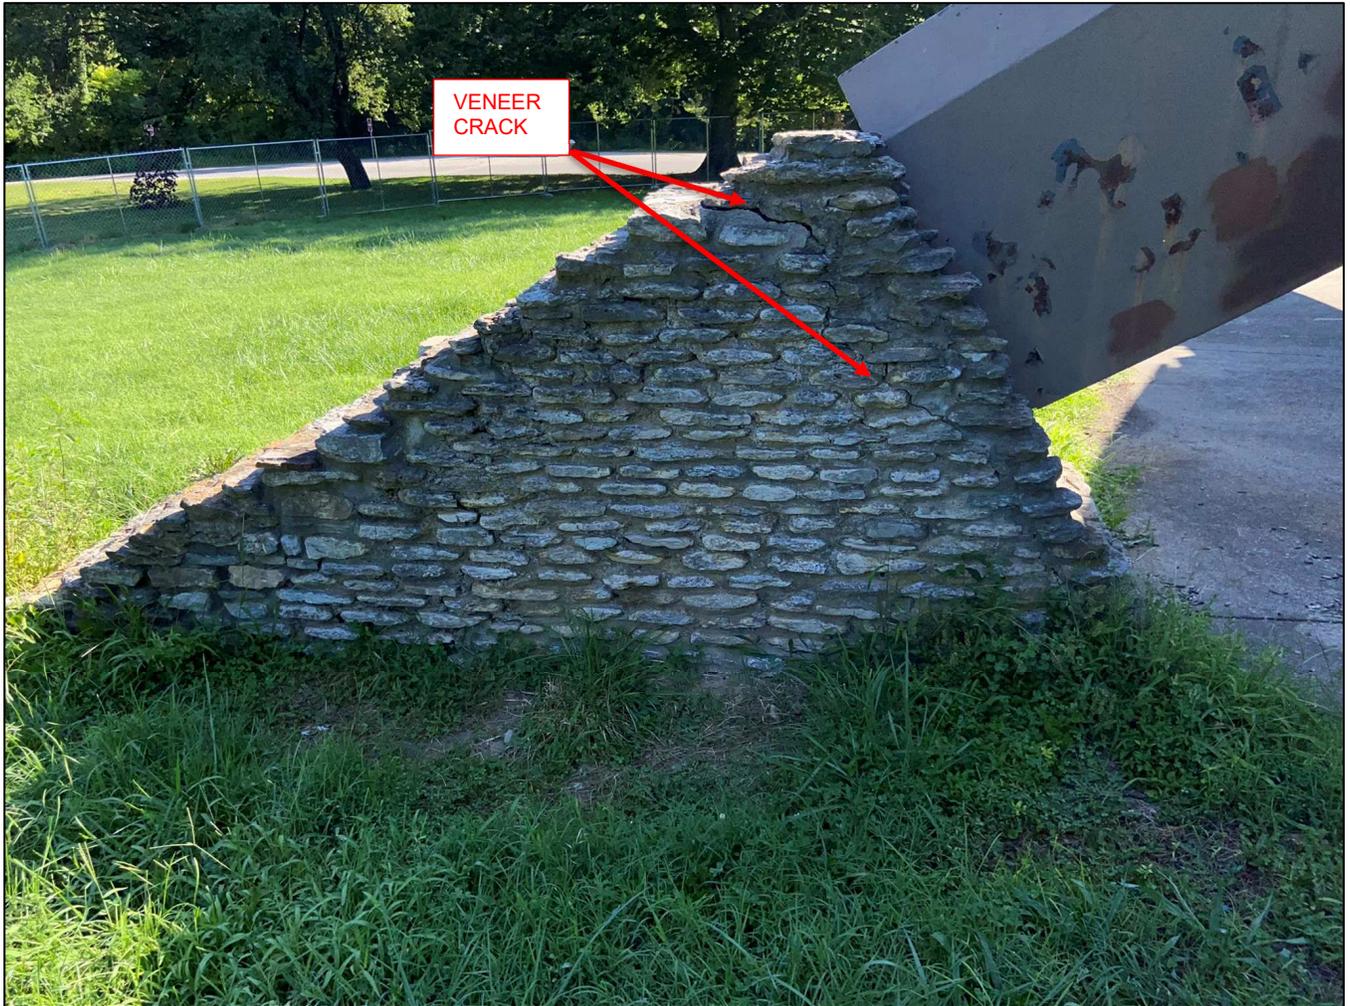
- The concrete foundation abutments are clad with stone veneer, so an assessment of the structural concrete was not performed. However, the condition of the concrete abutments does not change the conclusions or recommendations provided herein.
- Abutments 1, 4, 5, and 8 (**Photo 2**) have cracking in the stone veneer that could be an extension of cracking in the concrete abutment substrate. If this cracking is also in the concrete abutment, it may be caused by the change in load path from the steel casings. See discussion under glue-laminated wood beams about cantilever action for more on this.
- Cracks in the abutments are not a new discovery but now have a logical explanation since the condition of the wood beams inside the steel casings has been deemed not structurally sound.

**Photo 2: Abutment #8 Veneer Cracks**

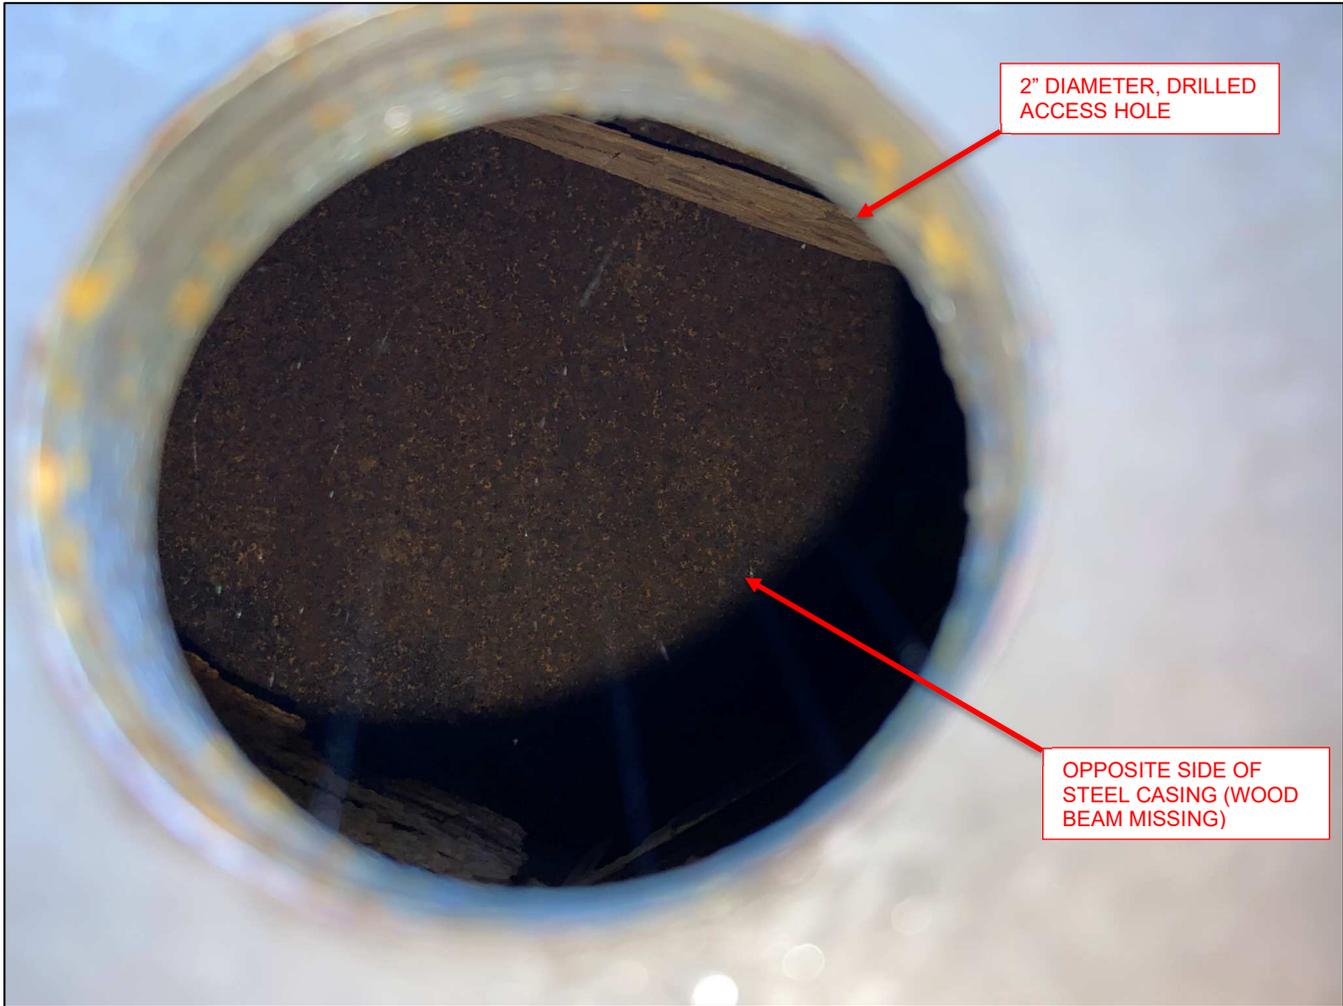
- Wood beams within the mid-section of the steel casings at locations 1, 2, 3, 4, 6, 8 (**Photo 3**) have so deteriorated that there is either no wood evident, the member section is partially lost, or the wood is so soft that it does not resist probing with an ice pick.
- Wood rot has been confirmed throughout most of the steel casing length on the majority of the beams.
- The retrofitted steel dowels in the casings are no longer providing the axial, bending, and shear load transfer to the steel casing that was designed to simulate a beam extension.
- The gap at beam #6 was measured and found to be about 4 ½" which is ½" more than previously documented in May (**Photo 4**). This side of the structure appears to be lifting.
- Lifting movement from beam #6 is pulling on the exhaust hood and lifting one side as seen in **Photo 5**.

**Photo 3: Steel Casing Access Hole at Location #1**

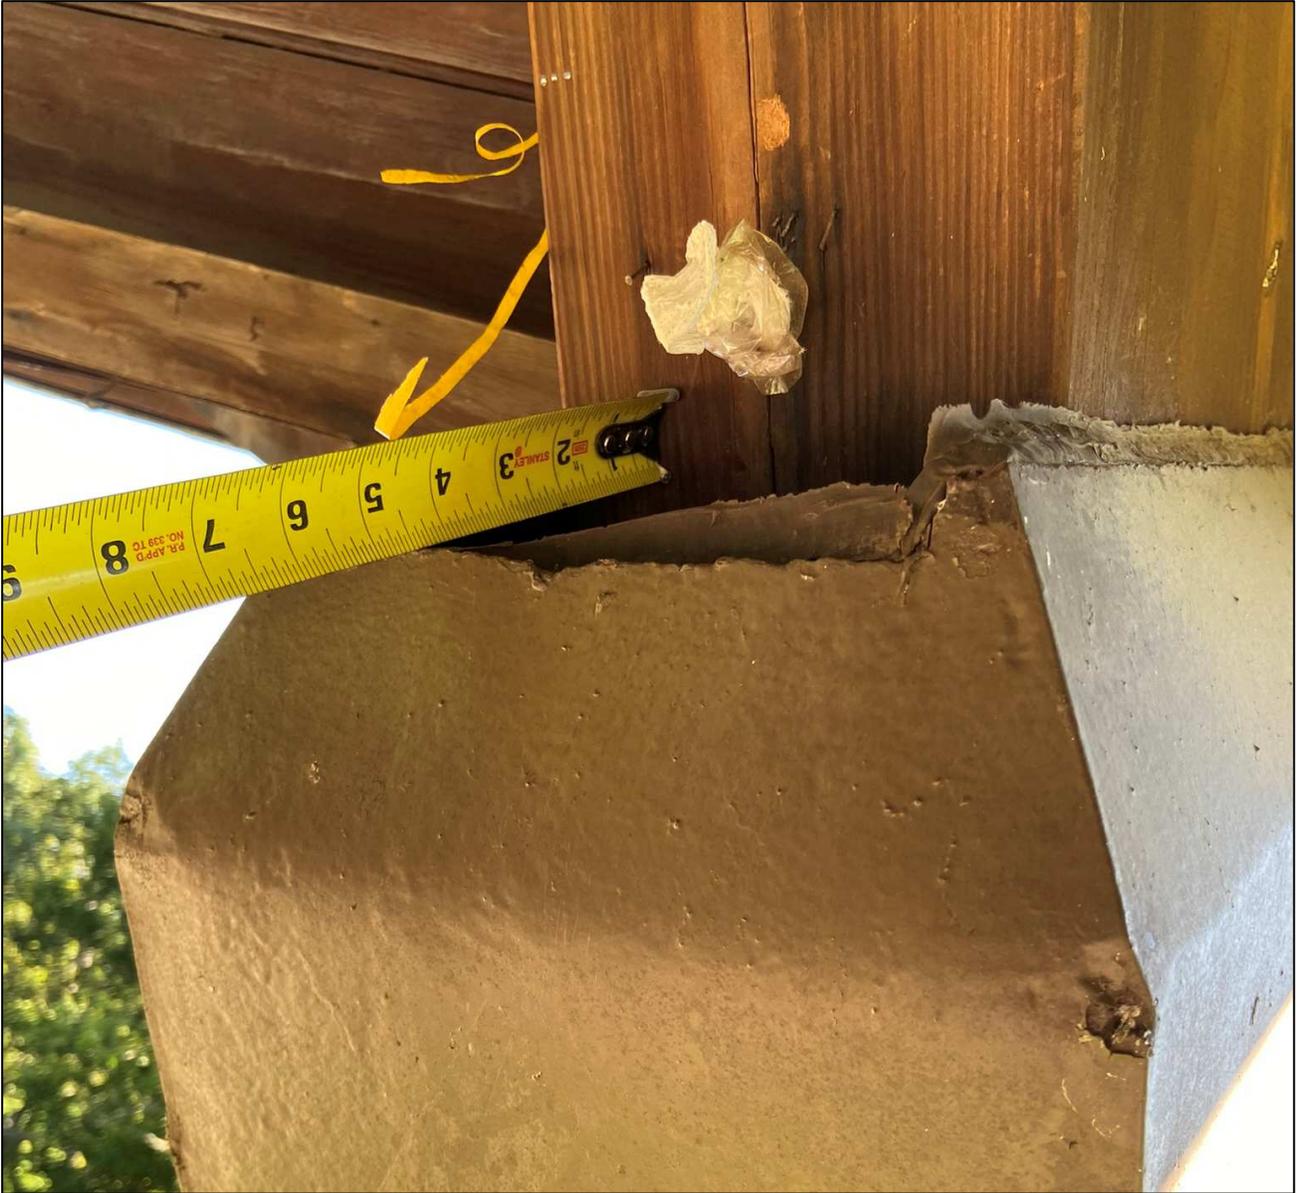
- The structure shows signs of downward and upward movement on opposite sides near locations #2 and #6, respectively (**Photo 4** and **Photo 6**).

**Photo 4: Measured Gap at Beam #6**

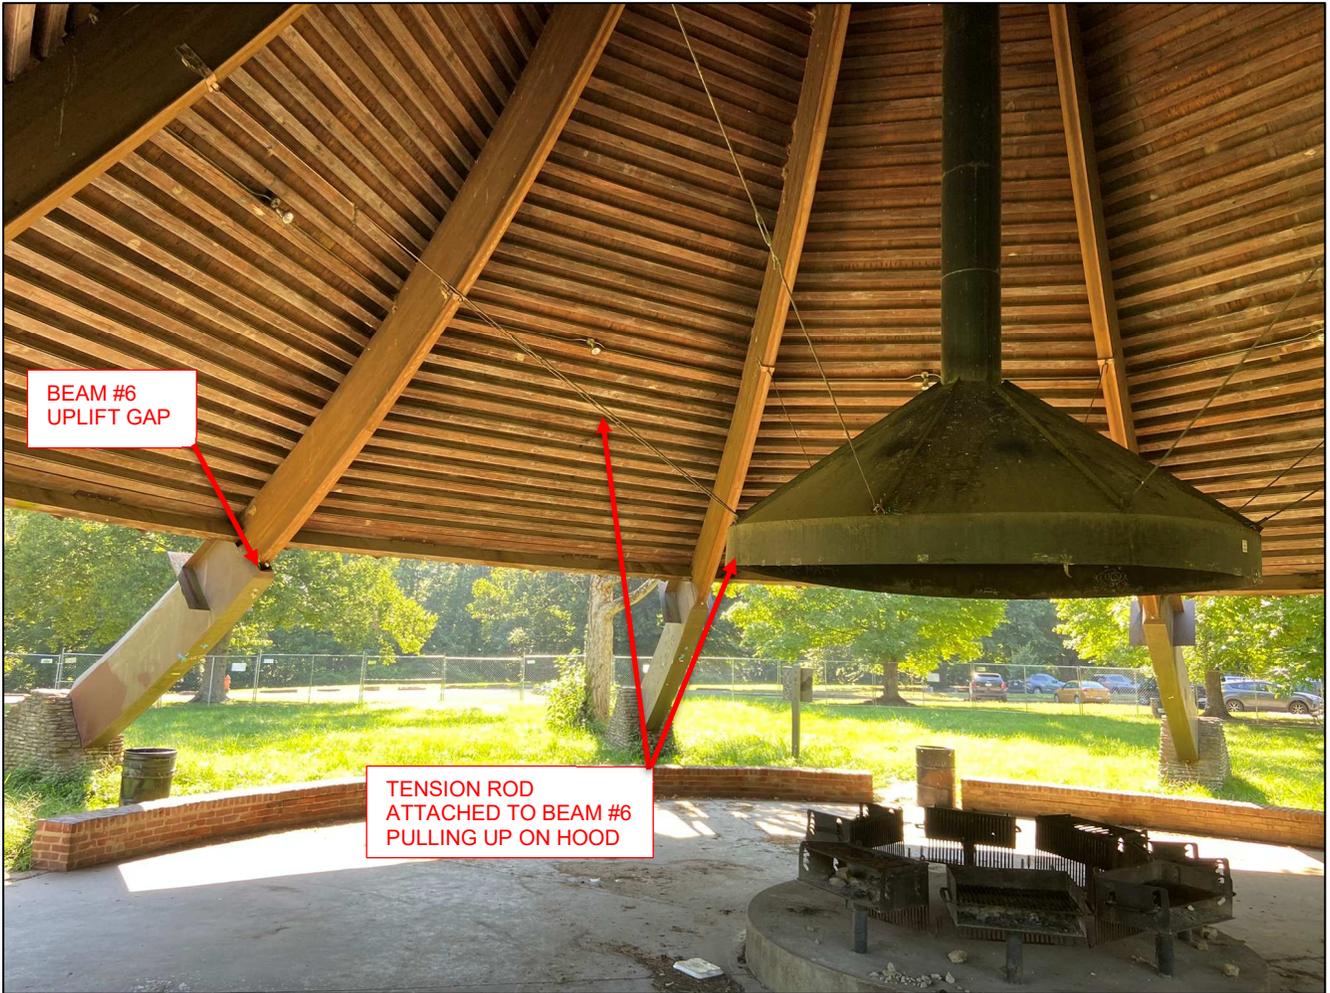
BEAM #6  
UPLIFT GAP

TENSION ROD  
ATTACHED TO BEAM #6  
PULLING UP ON HOOD

**Photo 5: Hood Lifting from Beam #6 Movement**

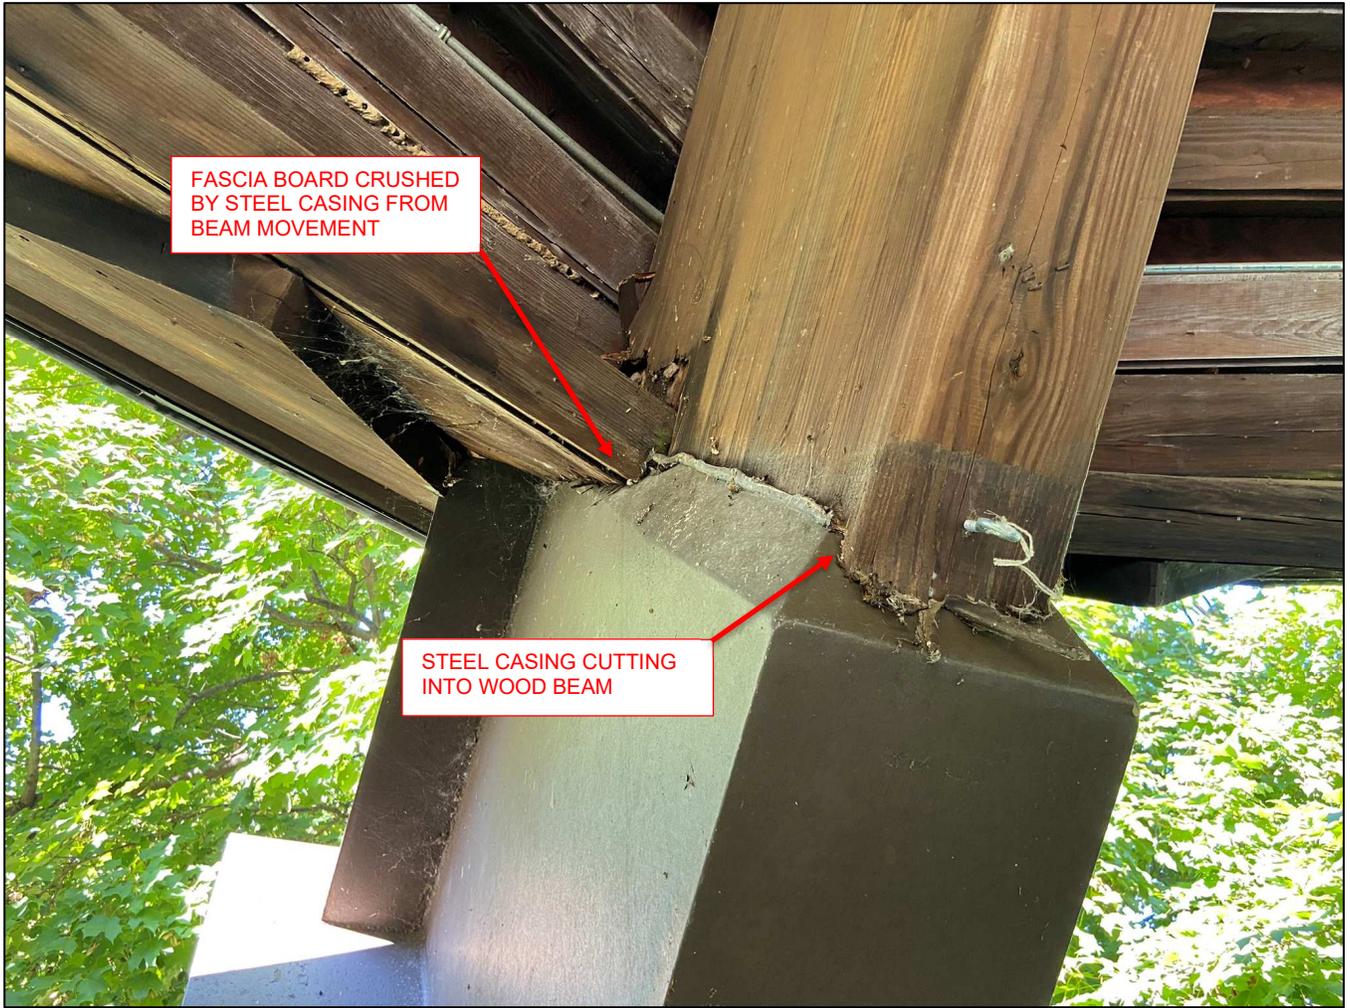
- Wood beams at locations 1 and 2 appear to be supported by the ends of the steel casing as evidenced by the steel casing digging into the wood beam and fascia boards (**Photo 6**). This side of the structure appears to be settling downward.
- The steel casings where the wood is mostly missing or rotten are likely acting as cantilever beams, fixed to the abutments, which was not how they or the foundation and connection were designed. This could be related to the stone veneer cracking, see the previous comment under foundation abutments (**Photo 2**).

**Photo 6: Steel Casing #2 Cutting into Wood Beam**

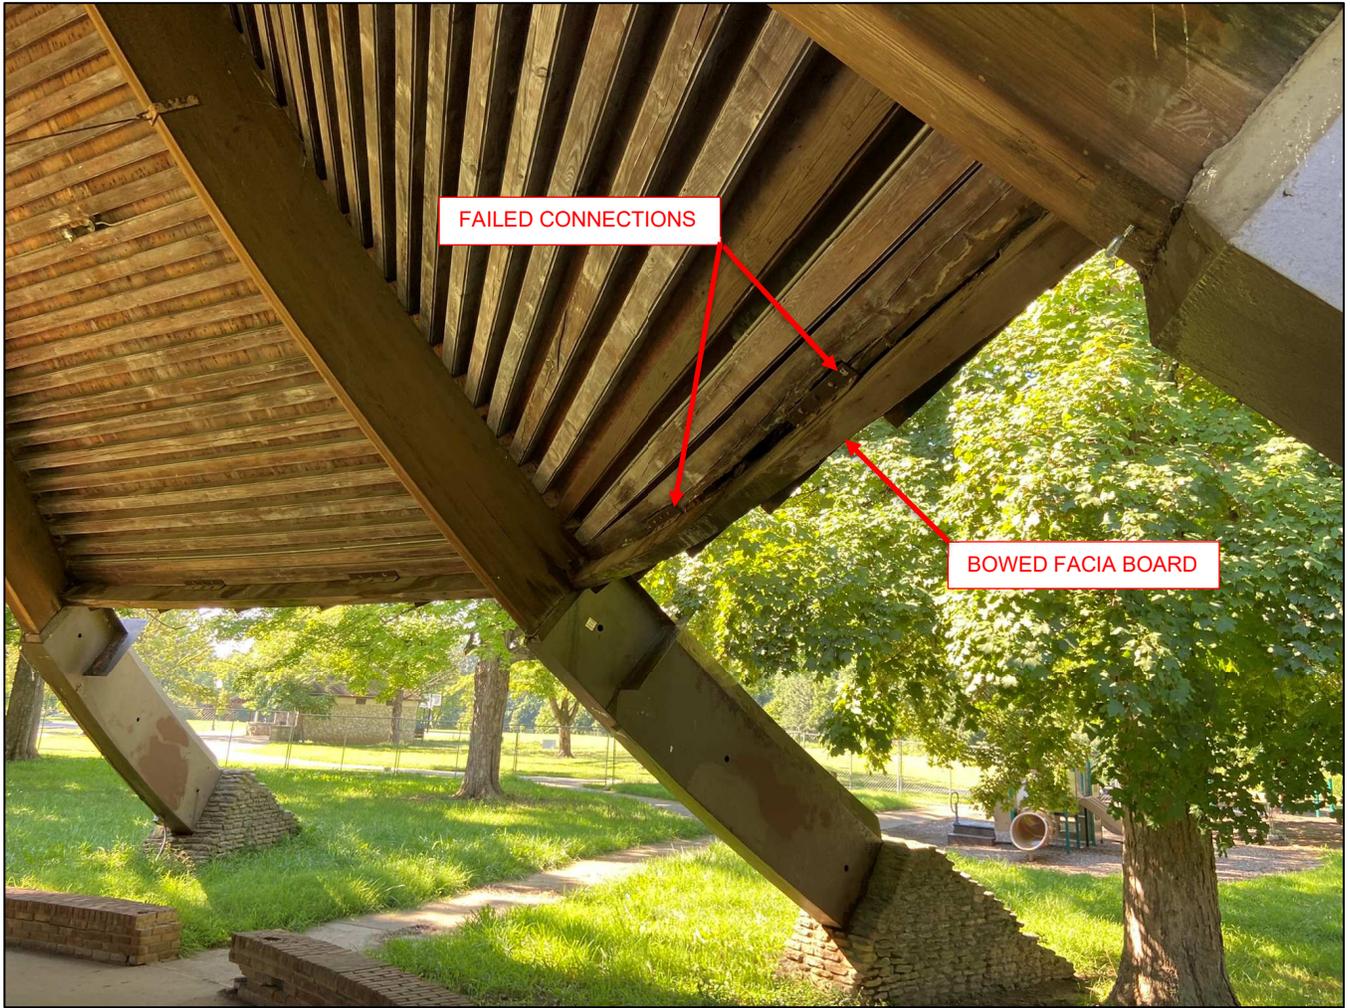
- The fascia beam between steel casing 1 and 2 has a severe bow in it that appears to be from compression forces and/or rot (**Photo 7**). There are two steel angle connections to the adjacent roof purlin that have failed. If there is a compression force on this beam member, it is the result of the downward and inward movement of the glue laminated beams #1 and #2.

**Photo 7: Bowed Fascia Board**
