Fuller
Mossbarger
Scott &
May

August 14, 1997

Re: Sinkhole Review
Lots 21, 22, 23 and 28
Blankenbaker Commerce Centre
Jefferson County, Kentucky

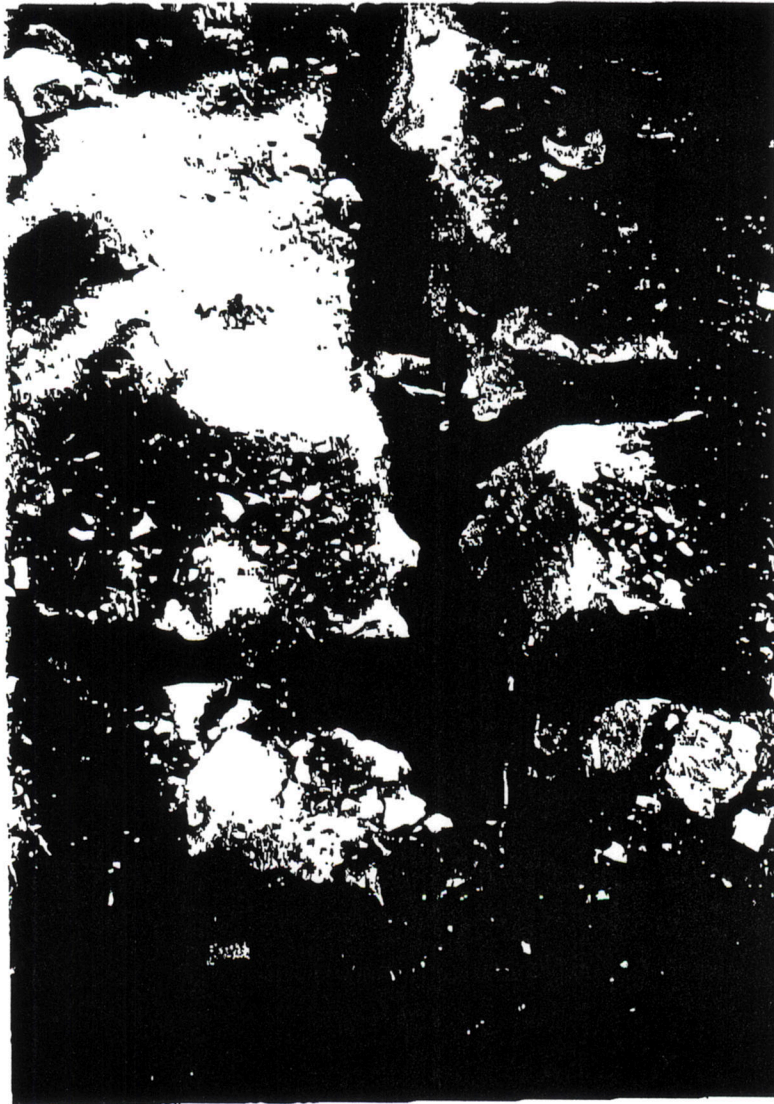
An approximate 10-foot by 20-foot by 5-foot deep excavation had been made to the rock surface. This sinkhole is labeled as Sinkhole 2 on the attached portion of the plan view. It is located at the extreme east side of the lot. The eastern half of this sinkhole is located in a 15-foot wide sewer and drainage easement, and it appears to extend just into Lot 22. An approximate six-inch wide crevice is present in the sinkhole running in an east-west direction. This crevice was probed and an open throat extended to a depth of five feet below the rock surface in several locations. This excavation will need to be extended to the east and west to define the limits of the crevice prior to treatment.

Photo 2 - Crevice at Sinkhole No. 2 - Lot 23

The method of treatment for the sinkholes will require that the rock surface be exposed to identify any voids or crevice features in the bedrock (the rock surface has already been exposed at Sinkholes 1 and 2). The voids or crevices should be cleaned and filled with No. 2 or 3 crushed stone up to the rock surface. Additional crushed stone wrapped in KDOH Type IV geotextile fabric would then be placed to provide a cap or a seal over the void or crevice. Normal fill placement can then take place to reach final grades. A Geotechnical Engineer should be present to review treatment of the sinkholes in conjunction with the proposed construction and grades so that any changes or adjustments can be made.

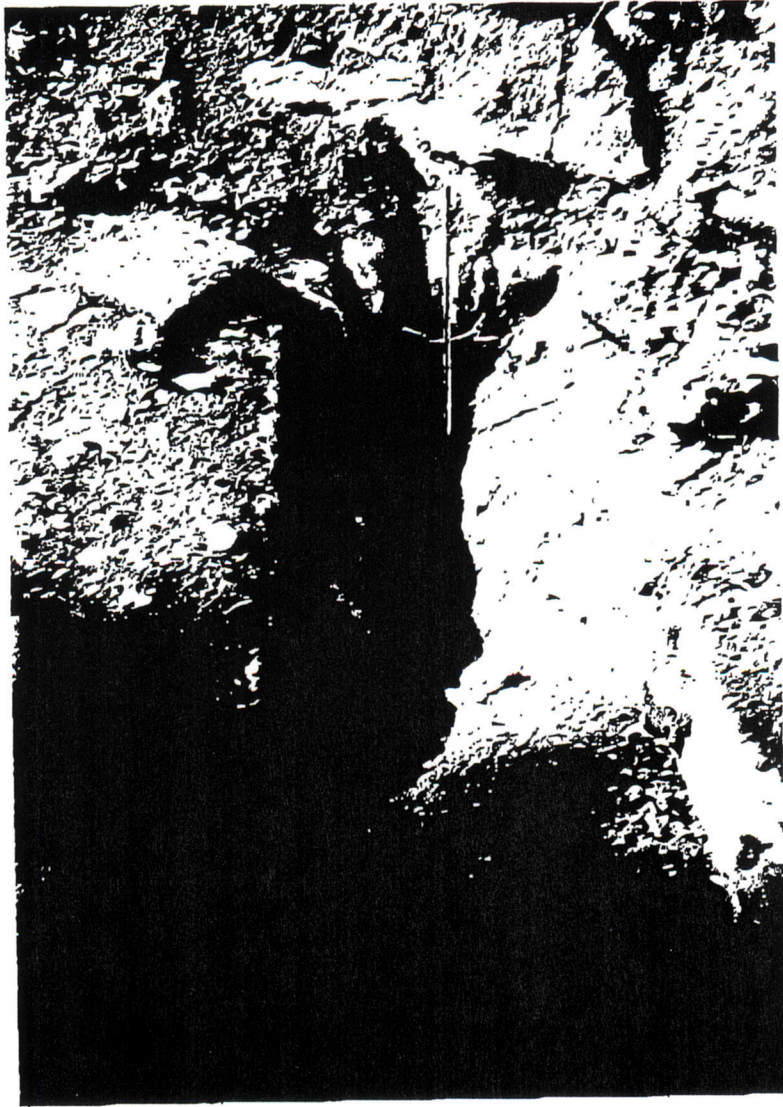
An approximate 10-foot by 10-foot by 4-foot deep excavation had been made to the rock surface. This sinkhole is labeled as Sinkhole 1 on the attached portion of the plan view drawing. It is located at the south-central area of the lot. A one to two-foot wide crevice was observed in the rock surface running in a north-south direction. On the north side of the excavation, the crevice had been cleaned to a depth of about three feet and was clay-filled below this depth. The crevice had not been cleaned on the south side of the excavation. Prior to any treatment, the excavation will need to be extended to the south to determine the limits of the crevice.

Photo 1 - Crevice at Sinkhole No. 1 - Lot 22
