# “THE **WRONG** HOUSE!”

BENJAMIN ROBBINS, AIA

TRADITIONAL ARCHITECTURE SPECIALIST

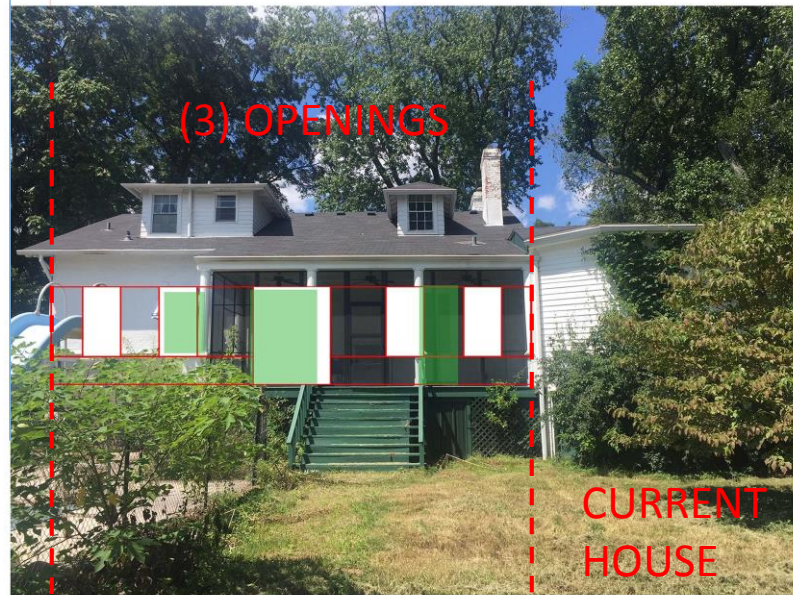
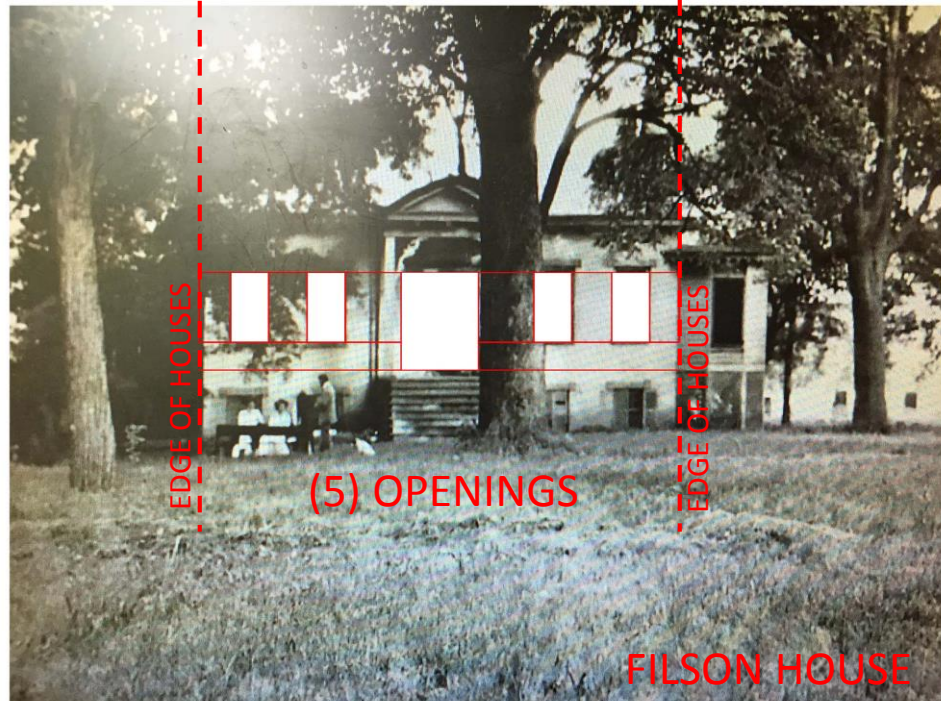
## FRONT ELEVATION COMPARISON: **WRONG HOUSE!**

*THESE PICTURES HAVE BEEN ALIGNED VERTICALLY. THE FRONT WINDOWS AND DOORS WERE TRACED ON THE FILSON PICTURE AND OVERLAYED ON THE CURRENT HOUSE.*

- **GREEN** - CURRENT OPENINGS (3)
- **WHITE** - FILSON PICTURE OPENINGS (5)
- THERE IS NO EVIDENCE OF WINDOW OPENING RELOCATION IN BRICK
- **NO EVIDENCE OF THE LOWER WINDOWS EXISTING**

THE WINDOWS ARE NOT THE SAME IN NUMBER, (3) VS (5), OR IN THE CORRECT LOCATION. WHERE DID LOWER WINDOWS GO?

**CONCLUSION – WRONG HOUSE!**

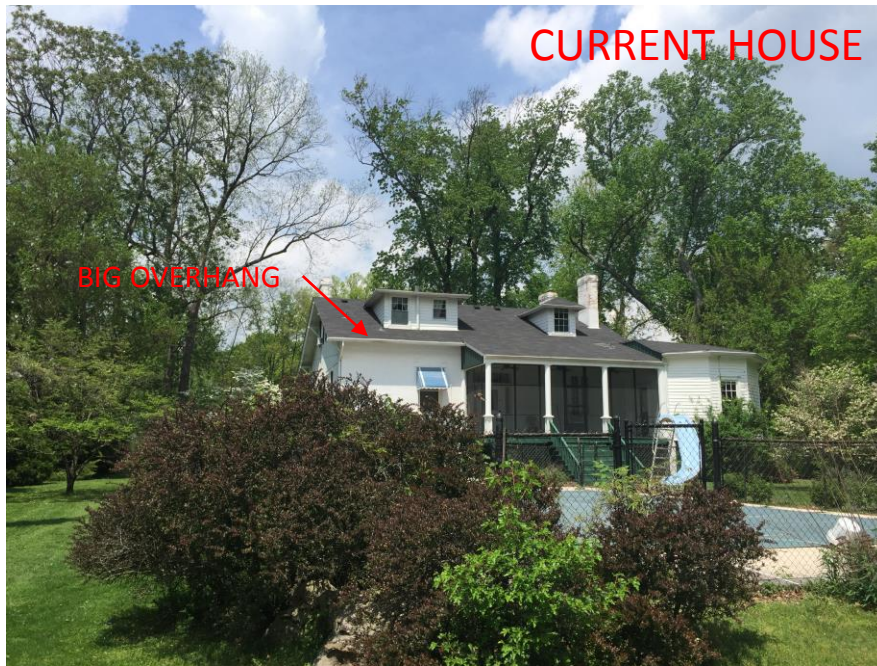
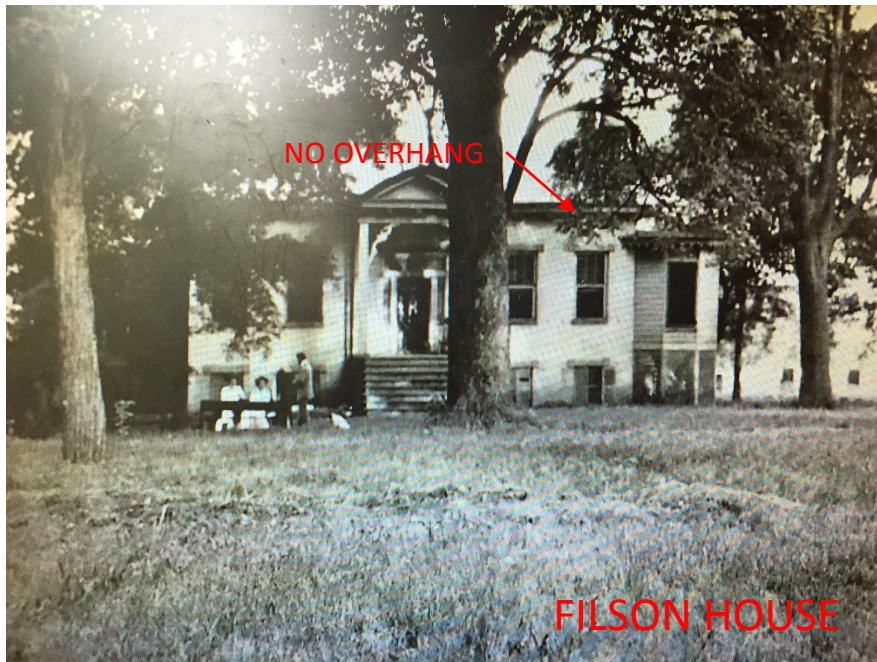
## ROOF COMPARISON: **WRONG HOUSE!**

FILSON PICTURE: ***NO OVERHANG***

CURRENT HOUSE: ***BIG OVERHANG***

THE LARGE OVERHANG, IF ADDED, WOULD HAVE CLIPPED CEILINGS ON FIRST FLOOR. THEY ARE NOT CLIPPED.

WHY DID THEY ***ONLY*** RAISE THE 2<sup>ND</sup> FLOOR SUCH A SLIGHT AMOUNT AND HAVE SHORT CEILINGS IF GOING THROUGH THE EXPENSE OF ADDING IT? IF THE ORIGINAL ROOF WAS REMOVED IT WOULD HAVE BEEN VERY EASY TO ACHIEVE TALLER CEILINGS.

IF THIS IS THE SAME HOUSE; A SECOND FLOOR WAS ADDED. THE ***INTERGITY*** OF THE HOME HAS BEEN COMPRIMISED AND THERE IS NOT MUCH OF ORGINAL STRUCTURE TO SAVE AT THIS POINT.

***CONCLUSION: WRONG HOUSE!***

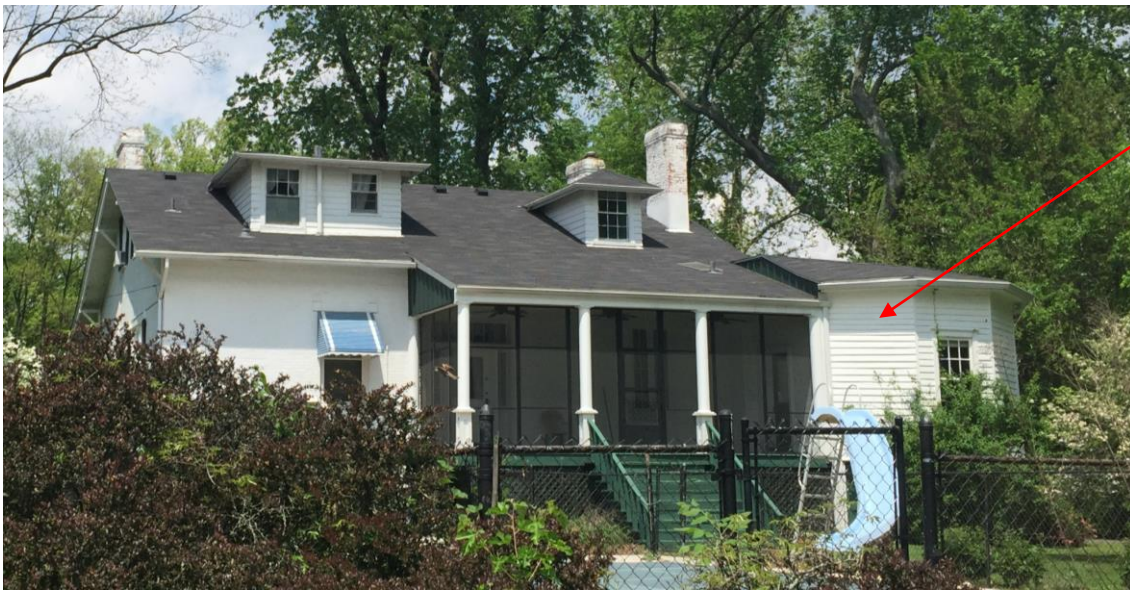
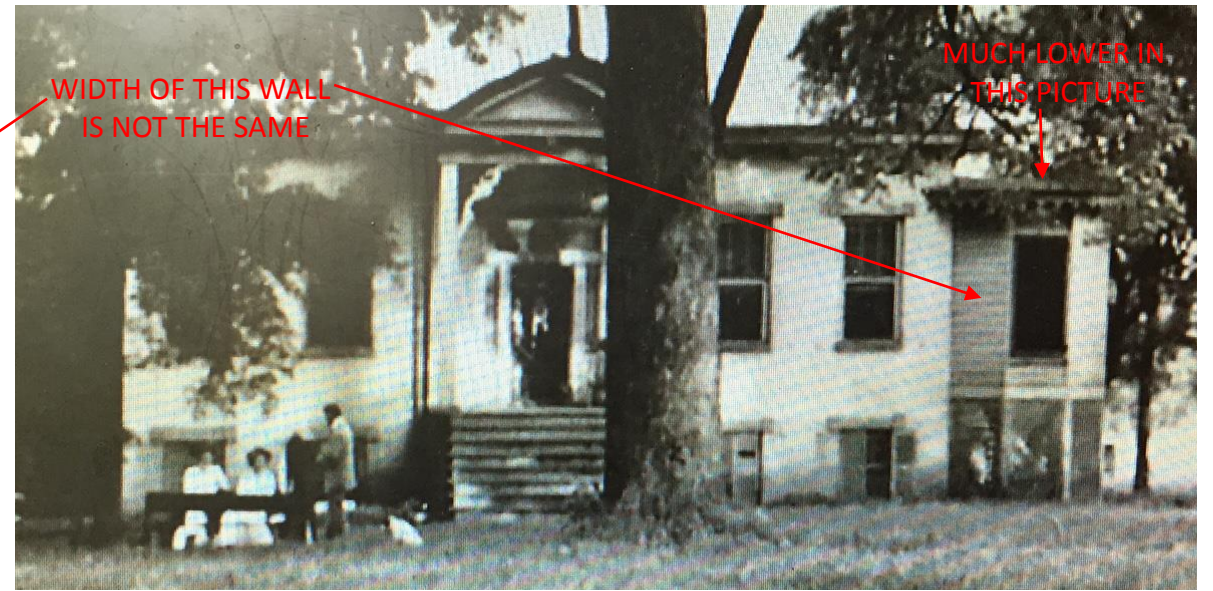
## TURRET LOCATION? **WRONG HOUSE!**

- WE BELIEVE THAT THE CURRENT BACK OF THE HOUSE WAS THE FRONT. MOST STAIRS ARE VERY CLOSE TO FRONT DOOR.
- ITS IS CLEARLY NOT THE SAME TURRET. IT IS NOT CLOSE TO SAME SIZE AND IT DOES NOT LINE UP WITH ROOF IN SAME MANNER. THE FILSON PICTURES TURRET IS MUCH SHORTER.
- ***WE PROBED FOR FOOTINGS ON THE OPPOSITE SIDE OF THE HOUSE AND FOUND NONE***

BASED ON THE EVIDENCE THAT THESE PICTURES PRESENT, THIS IS CLEARLY NOT THE SAME HOUSE. ***THE TURRET SIZES AND SHAPES CLEARLY DO NOT MATCH FROM PICTURE TO PICTURE.***

SOMEONE ADDED THE TURRET TO THE SIDE OF THE CURRENT HOUSE TO CREATE A LARGER FIRST FLOOR. THERE WAS NOT A TURRET ON THIS HOUSE ORIGINALLY.

**CONCLUSION: *WRONG HOUSE!***

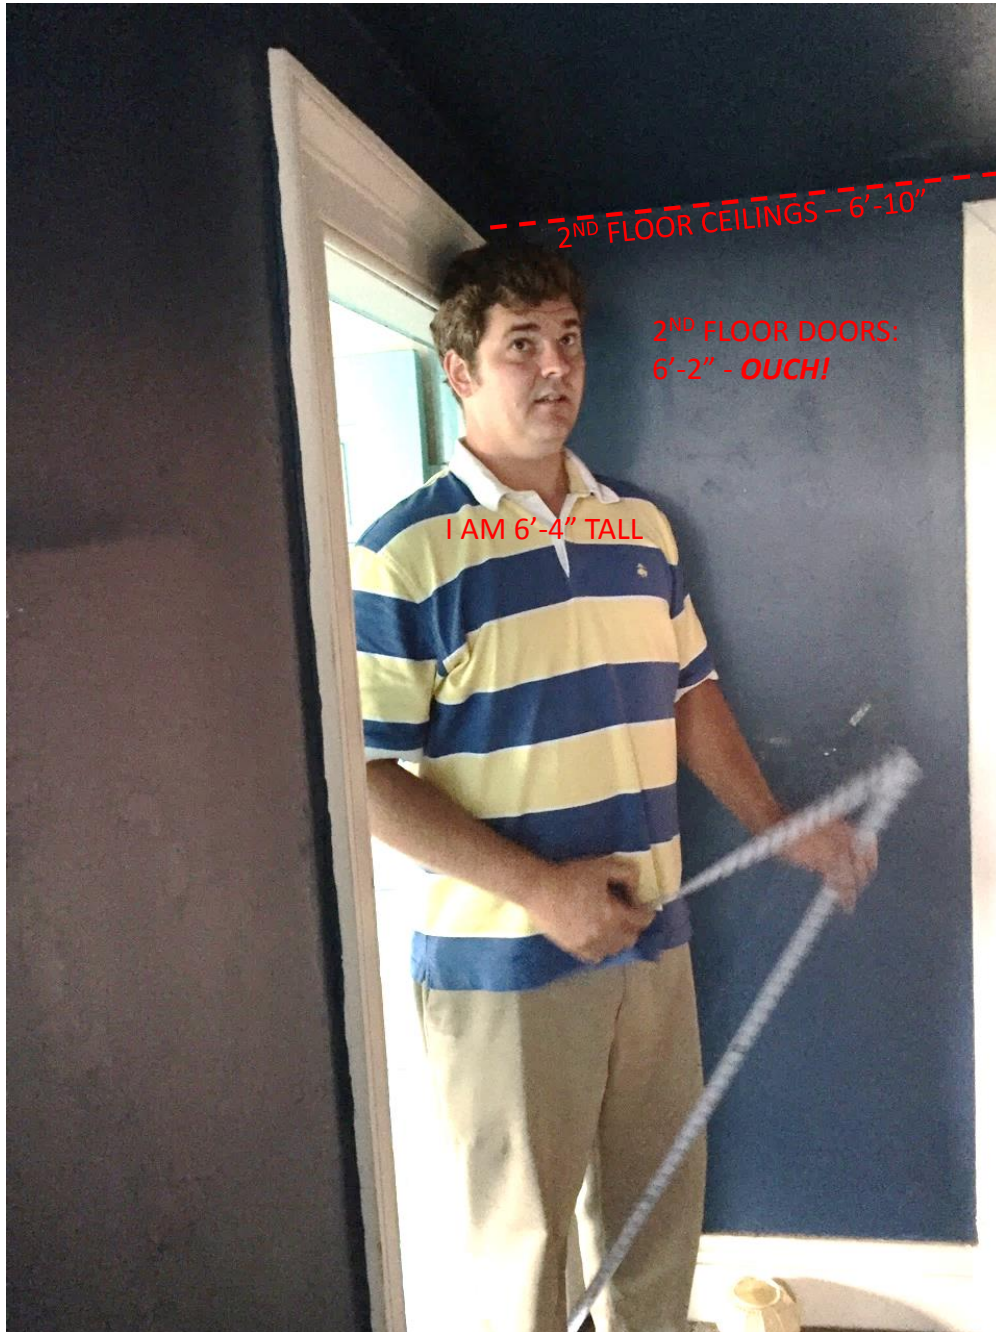
# SECOND FLOOR FAILURE

- CEILING HEIGHTS – CODE REQUIRES – 7'-0" **MINIMUM**  
(2013 IRC and Adopted 2013 Kentucky Residential Code R305.1)
- THE ENTIRE 2<sup>ND</sup> FLOOR WALL HEIGHTS DOES NOT MEET CODE
- THE FLOOR SYSTEM DOES NOT MEET CODE AND IS UNSAFE FOR A FAMILY TO OCCUPY. (2013 IRC and Adopted 2013 Kentucky Residential Code R503.1-502.11.2)
- THE ENTIRE 2<sup>ND</sup> FLOOR CRIPPLE WALL BRACING AND DESIGN DOES NOT MEET CODE (2013 IRC and Adopted 2013 Kentucky Residential Code R 602.10.11-R602.10.11.3)
- DOOR HEIGHTS – CODE REQUIRES – 6'-8" **MINIMUM**  
(2013 IRC and Adopted 2013 Kentucky Residential Code R 602.10.11-R602.10.11.3)

**Without making these changes the second floor DOES NOT MEET CURRENT BUILDING CODES.**

**When you remove the entire second floor roof and ceiling of 1<sup>st</sup> floor to meet these minimum code requirements the house will not at all resemble what is there today.**

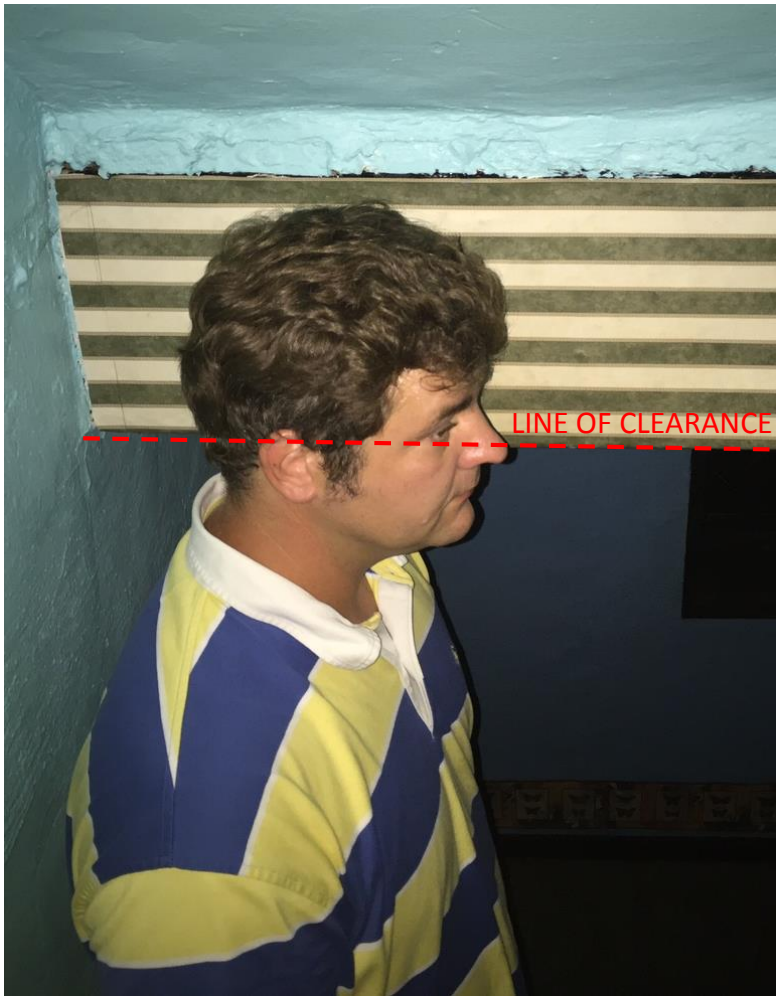
# DANGEROUS STAIRS

STAIRS TO BASEMENT DO NOT COME CLOSE TO MEETING HEAD ROOM REQUIREMENTS – WHICH ARE 6'-8" MINIMUM. I AM 6'-4" TALL. IN ORDER FOR STAIRS TO WORK THEY WOULD HAVE TO BE RIPPED OUT AND REDESIGNED IN A DIFFERENT LOCATION. **THIS IS NOT A EASY TASK AND WOULD REQUIRE SIGNIFICATANT ALTERATIONS TO EXISTING HOUSE.**

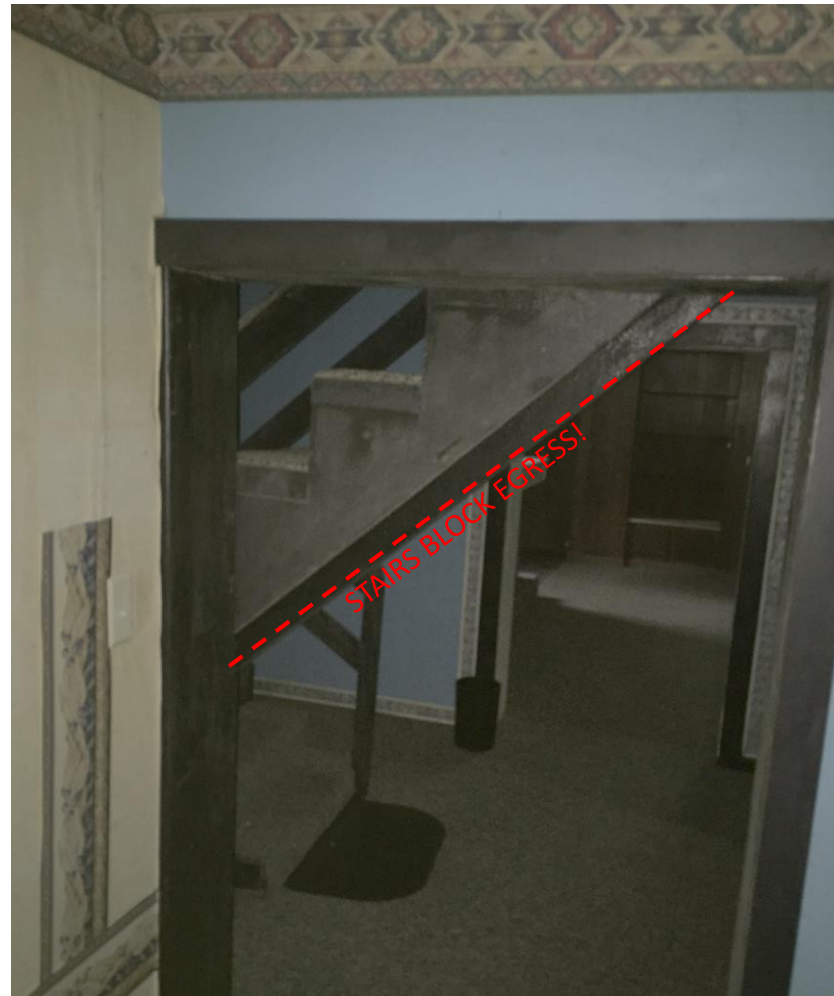
STAIRS TO BASEMENT BLOCK ACCESS FROM ONE SIDE OF BASEMENT TO THE OTHER. **THIS IS A MAJOR ISSUE THAT IS NOT EASILY SOLVED WITHOUT MOVING STAIR TO DIFFERENT LOCATION.**

- HEAD HEIGHT ON STAIRS TO BASEMENT DOES MEET CODE AND **BLOCKS EGRESS**
- RISER HEIGHTS **DO NOT MEET CODE** AND ARE NOT CONSISTENT
- TRADITIONALLY THE STAIRS ARE CLOSE TO THE FRONT DOOR OF THE HOUSE
- THE CURRENT STAIR LOCATION WOULD MAKE THE CURRENT REAR OF THE HOUSE THE FRONT
- THE FRONT AND REAR ENTRANCE STAIRS ARE ROTTEN AND ARE FALLING APART

**PUTTING CODE COMPLIANT STAIRS TO THE BASEMENT AND SECOND FLOOR IS IMPOSSIBLE.**

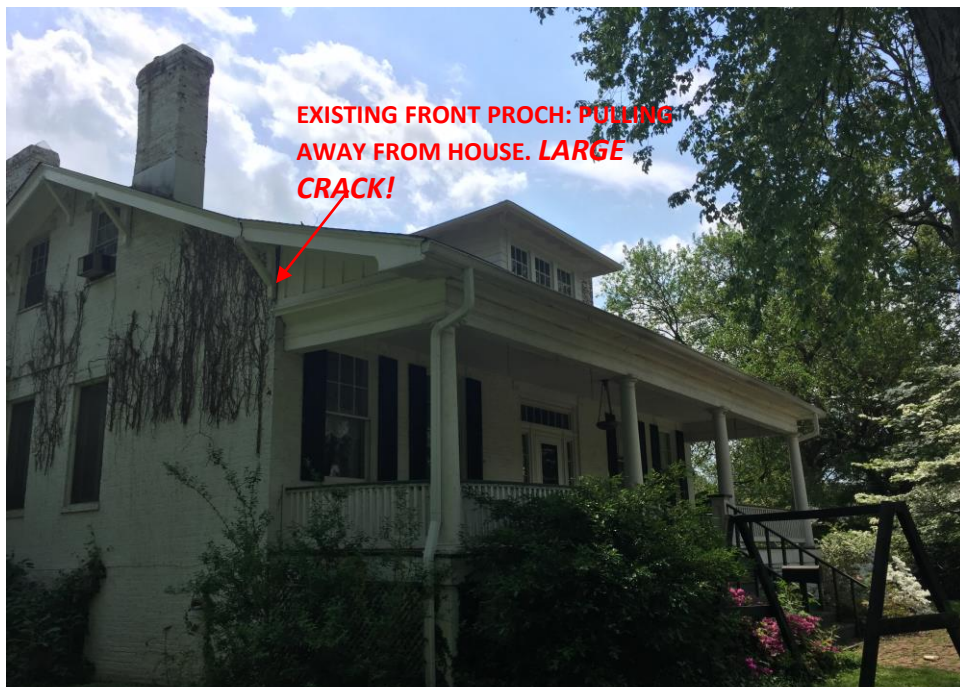
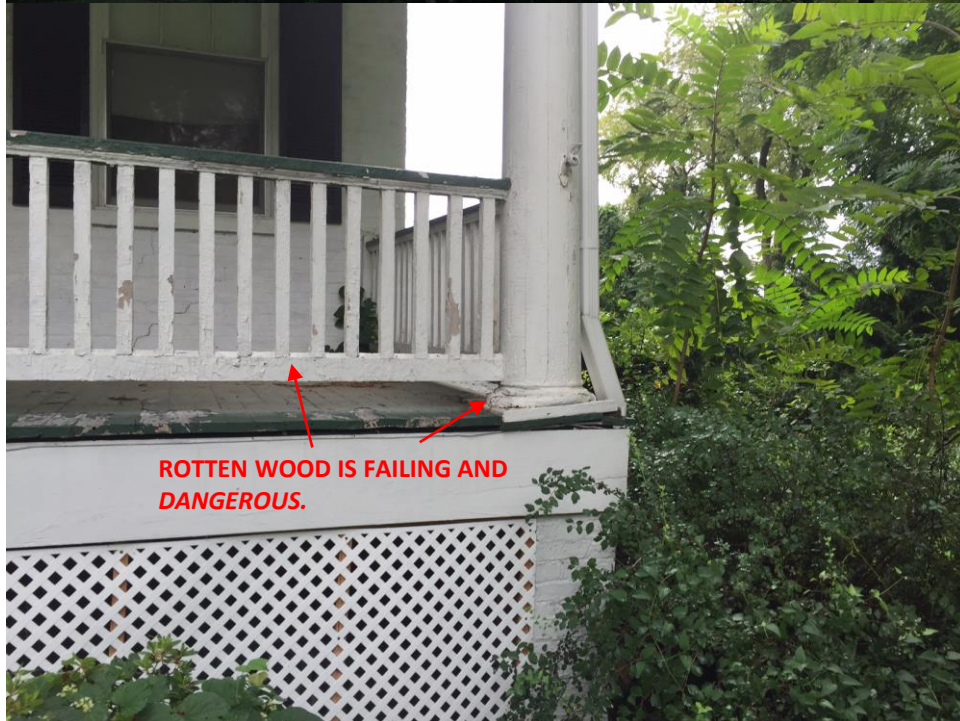
# FRONT AND REAR PORCH FAILURES

- THE ENTIRE FRONT PORCH IS PULLING AWAY THE HOUSE BECAUSE THE STRUCTURAL FAILING OF MEMBERS. ***IT IS UNSAFE.***
- BOTH PORCHS WILL HAVE TO BE COMPLETELY REBUILT – STRUCTURE, DECKING, COLUMNS AND ROOF. IT IS COMPLETELY FALLING APART.

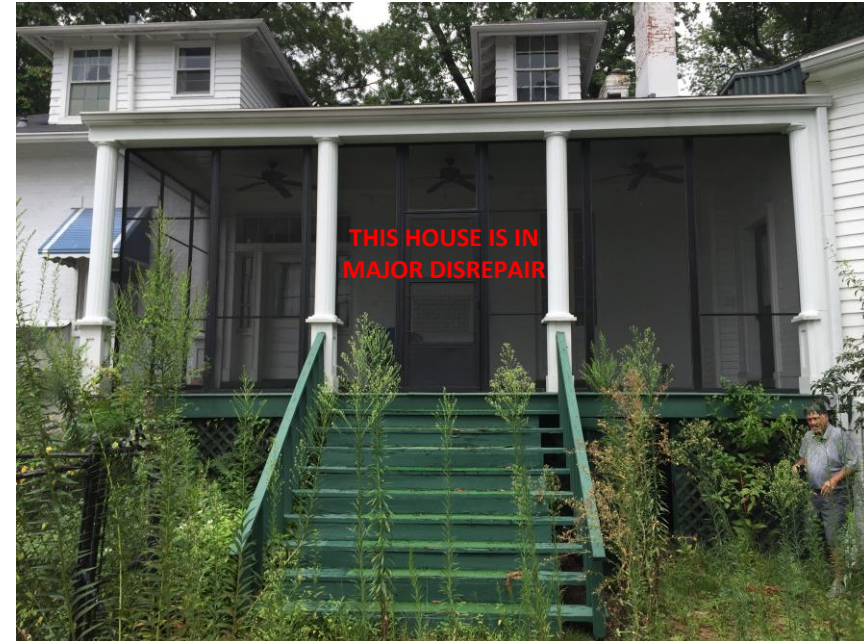
***WHEN YOU RIP OFF THE ENTIRE SECOND FLOOR AND THE FRONT AND REAR PORCH YOU WILL NOT BE LEFT WITH THE SAME HOUSE AS IT EXISTS TODAY.***
