Louisville Metro City Hall

Exterior Renovation

Summary of Project Results

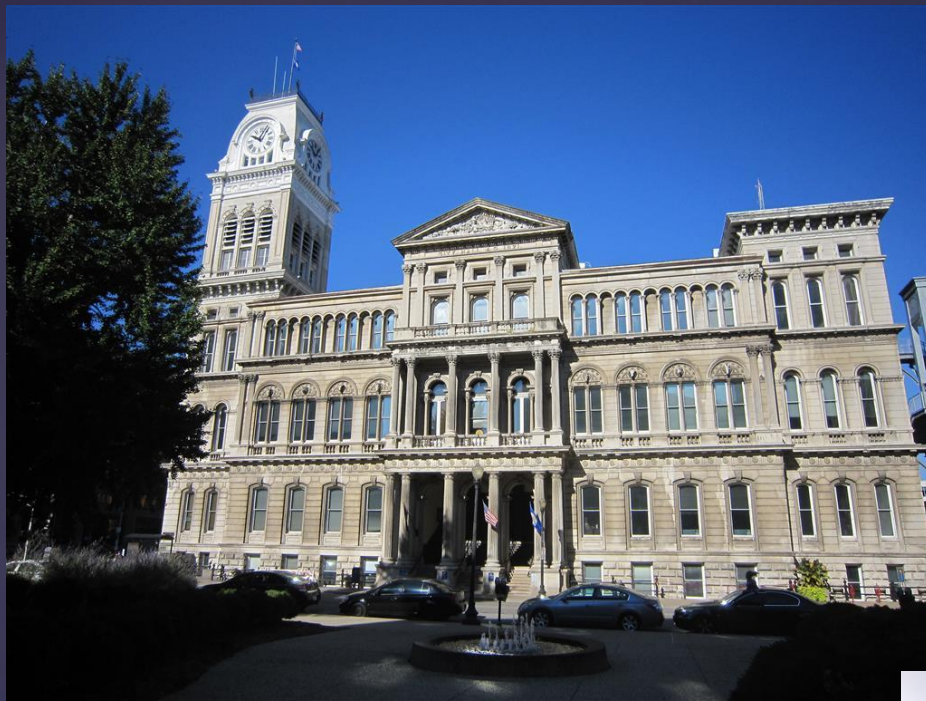
City Hall
Before Cleaning

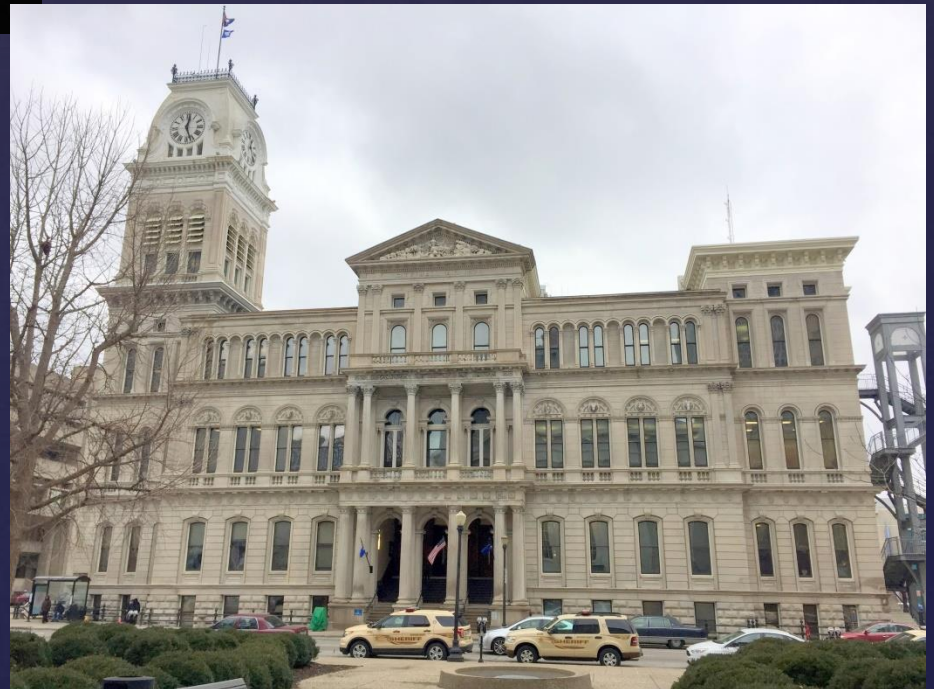
City Hall
After Cleaning

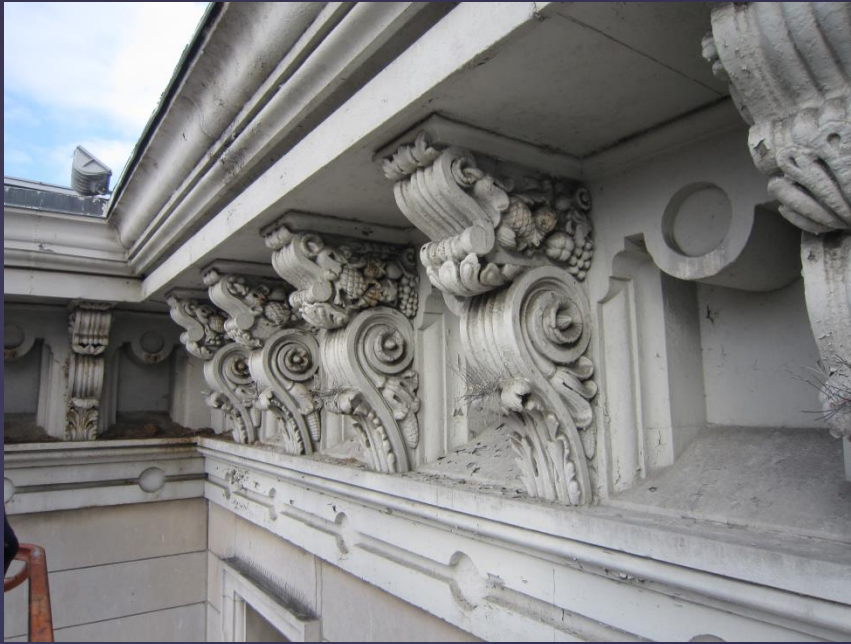
Stone Cornice Before
Cleaning

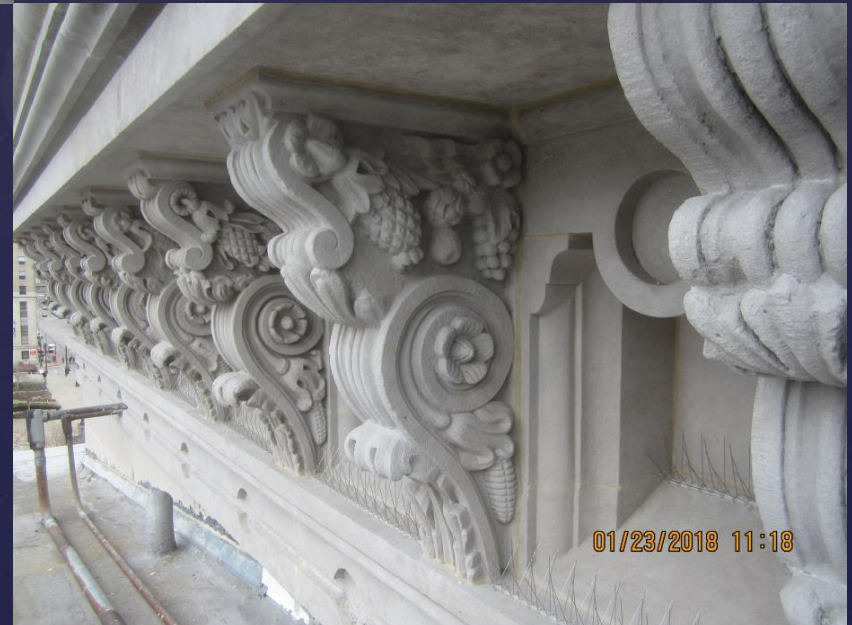
Stone Cornice After
Cleaning

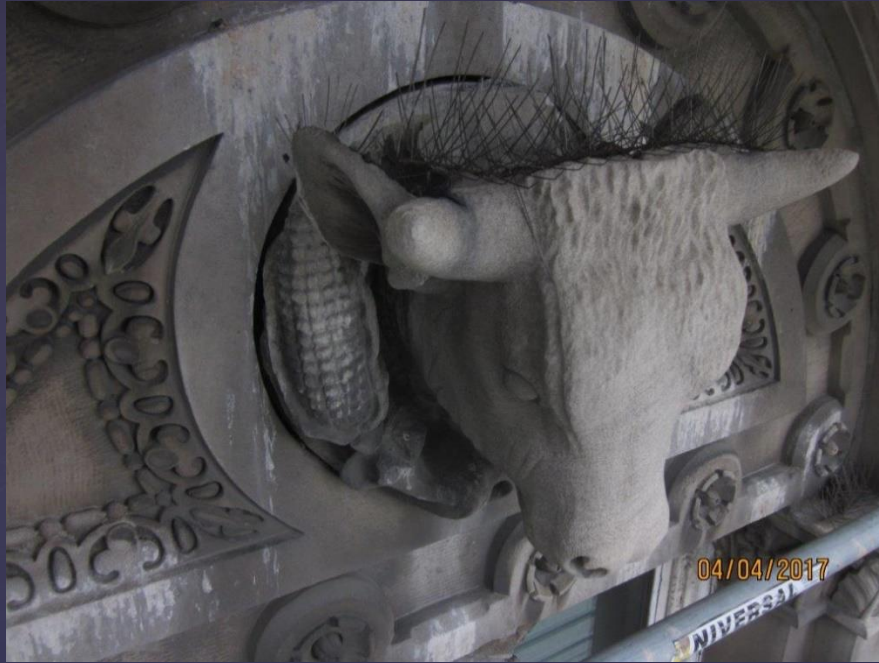
Example of Stone
Ornamentation Before
Cleaning & Repairs

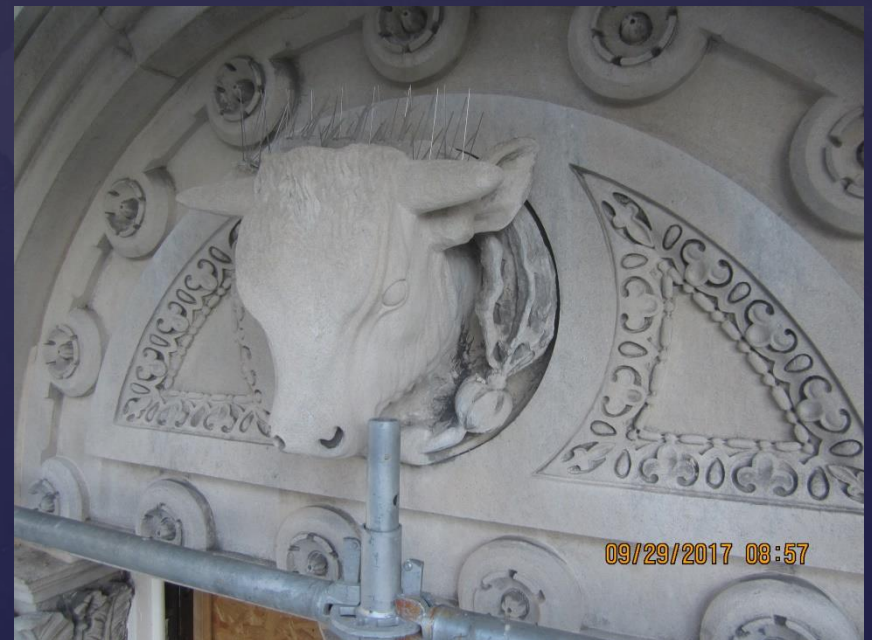
Example of Stone
Ornamentation
After Cleaning &
Repairs

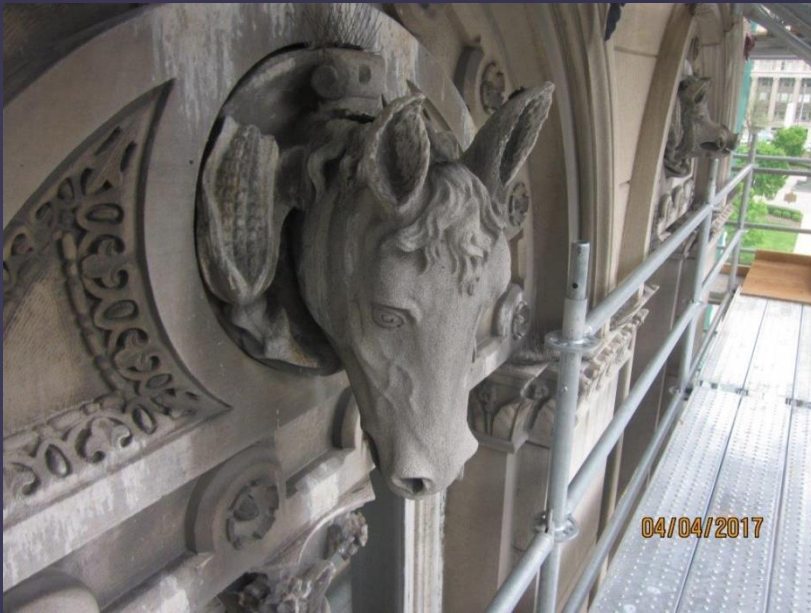
Example of Stone
Ornamentation Before
Cleaning

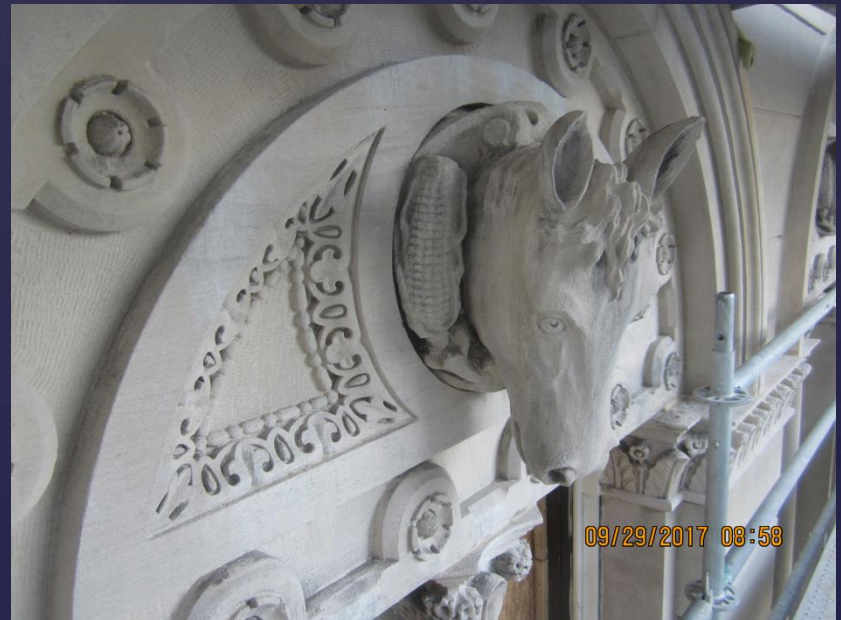
Example of Stone
Ornamentation After
Cleaning

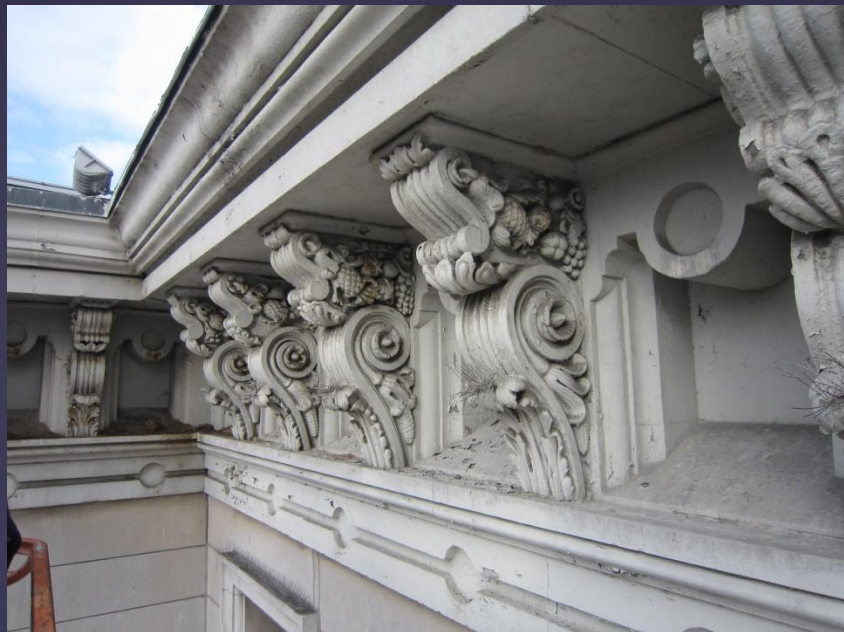
Limestone Corbel
Before Cleaning

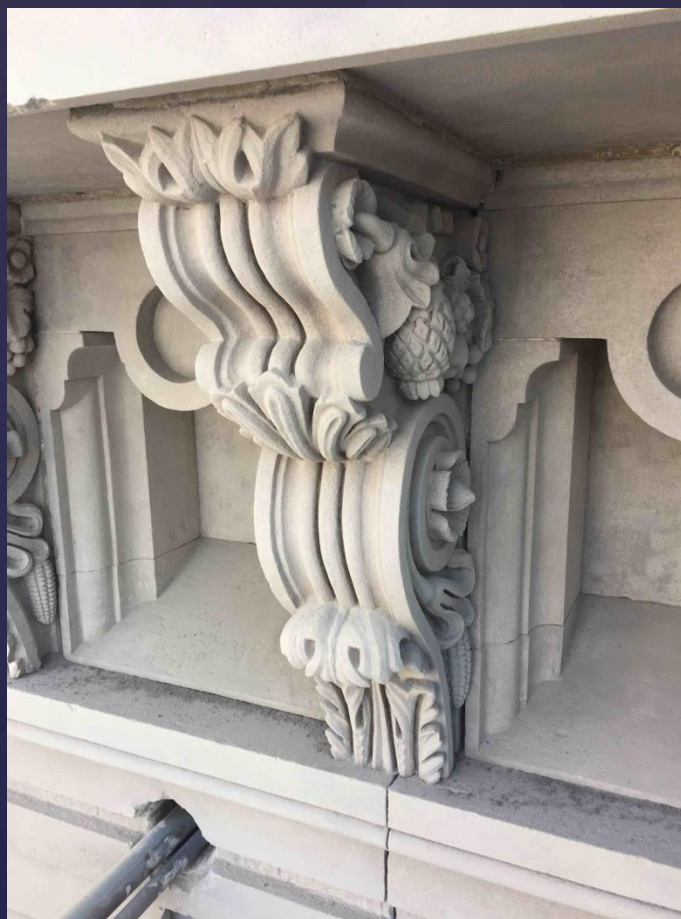
Limestone Corbel
After Cleaning

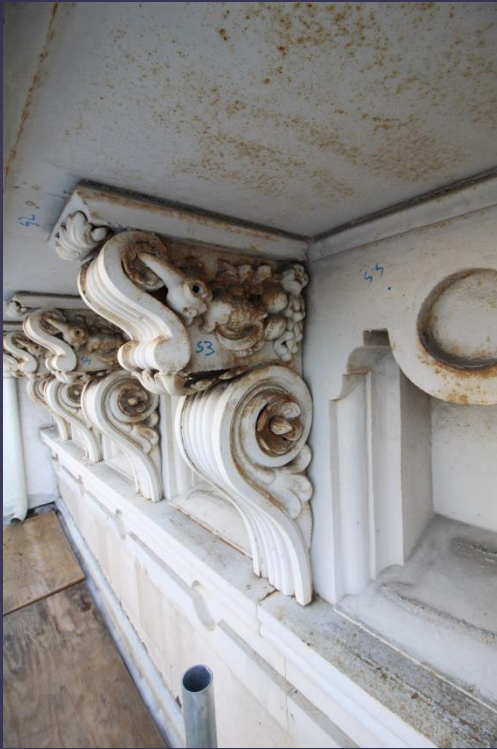
Cast Iron Corbels
Before Restoration

Cast Iron Corbels
Were Removed
Disassembled,
Repaired Or
Replaced,
Reassembled And
Painted With 5 Coats
Of Special Paint To
Last 25 Years

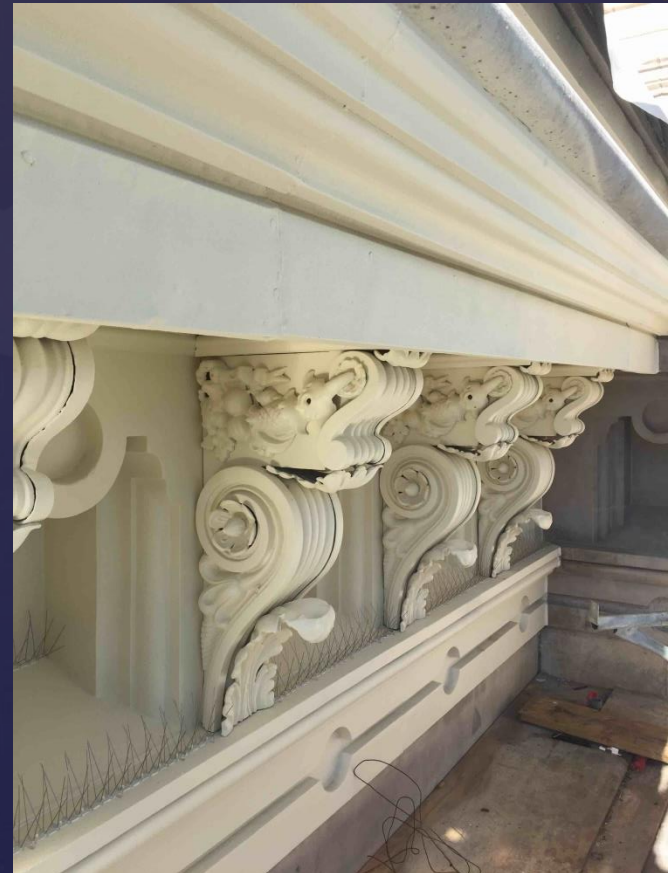
Cast Iron Corbels
After Restoration

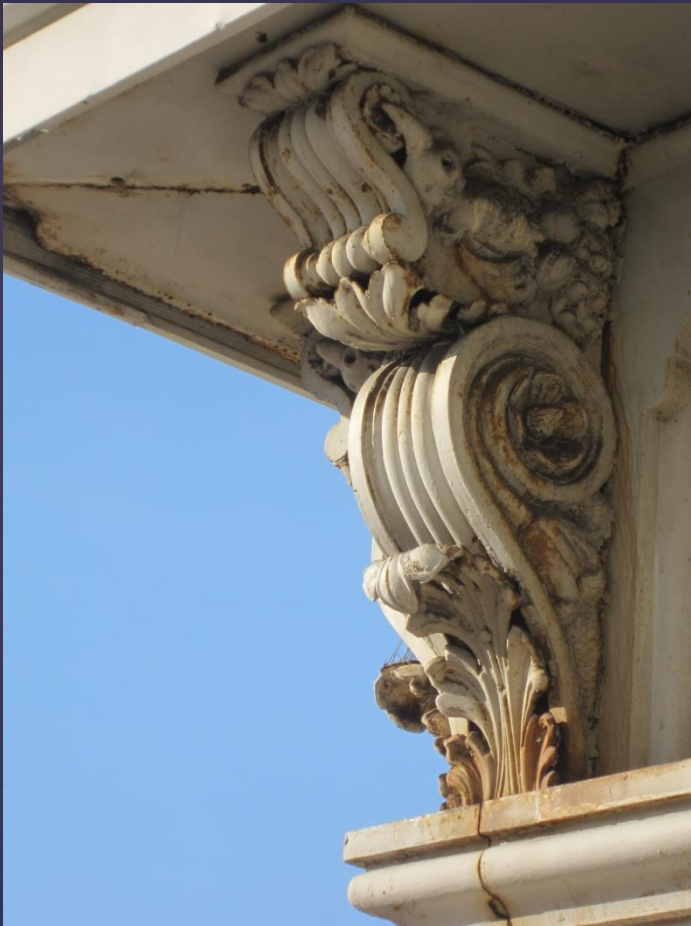
Cast Iron Corbel
Before Restoration

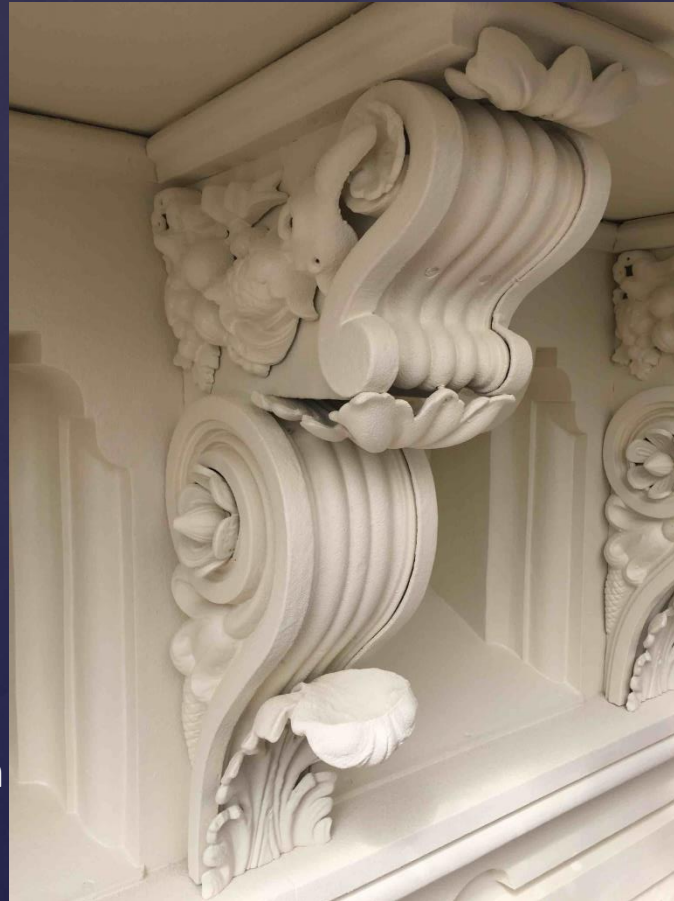
Cast Iron Corbel
After Restoration

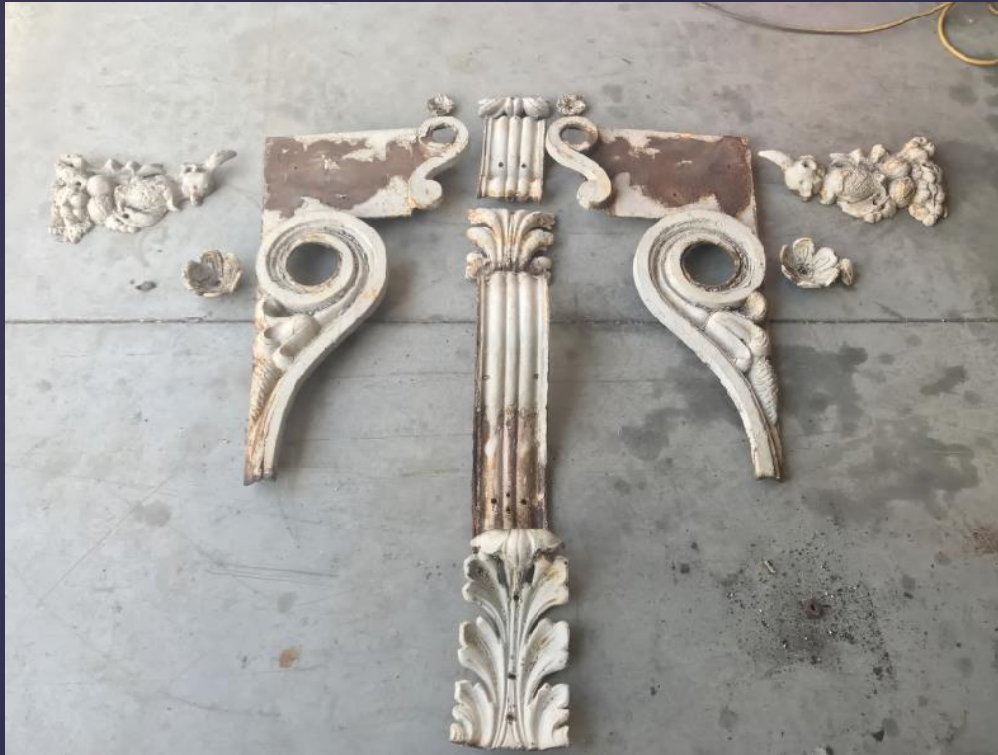
Typical Cast Iron
Corbel Dismantled
For Cleaning/ Repair/
Replacement &
Painting (14 Pieces)

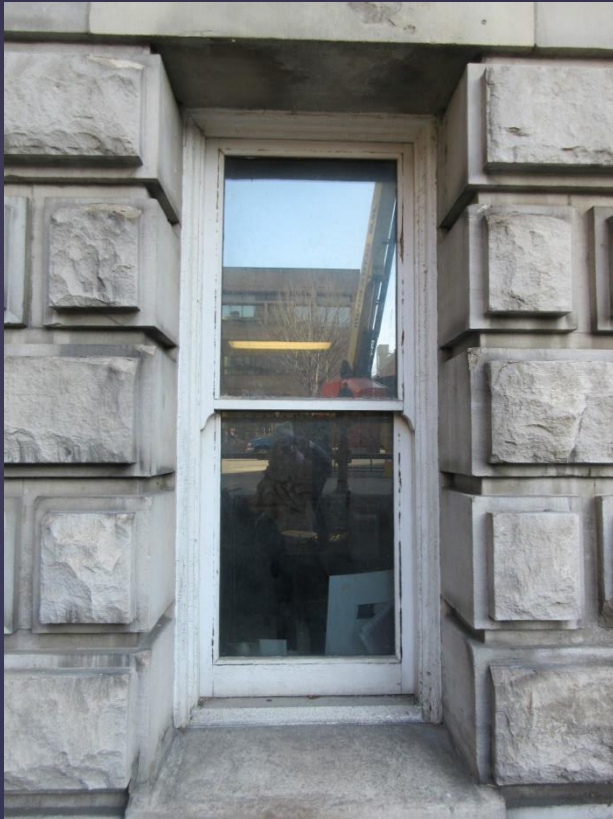
Window Before
Restoration

Windows Were Removed,
Paint Removed, Damaged
Wood Replaced, Repainted;
& Hardware Restored

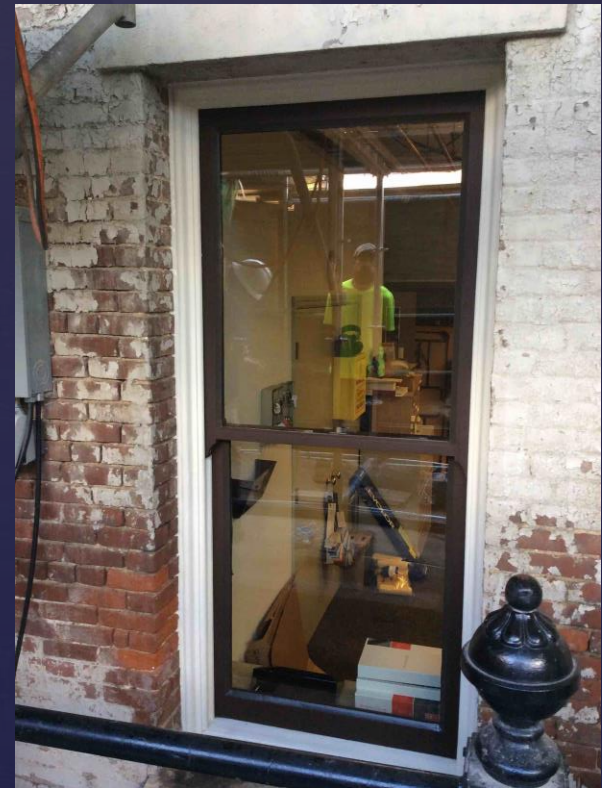
Window After
Restoration

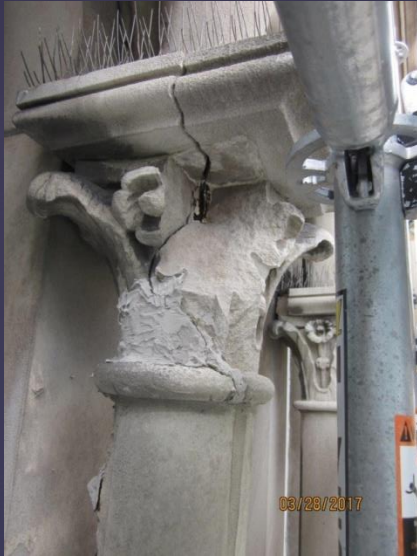
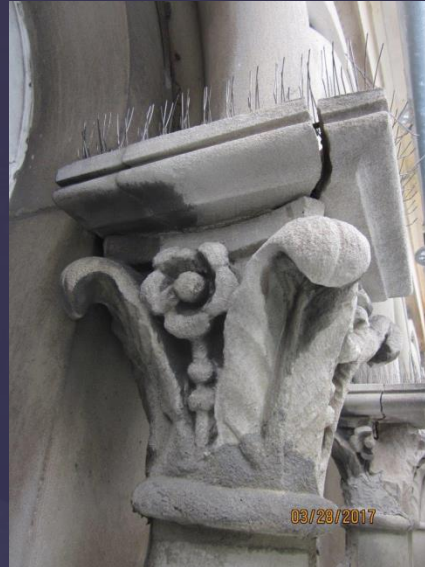
Examples of Typical
Stone Column
Capitals Before
Replacement

Stone Column Capitals Were
Structurally Damaged And
Needed To Be Replaced. New
Limestone Capitals Were
Carved And Reinstalled

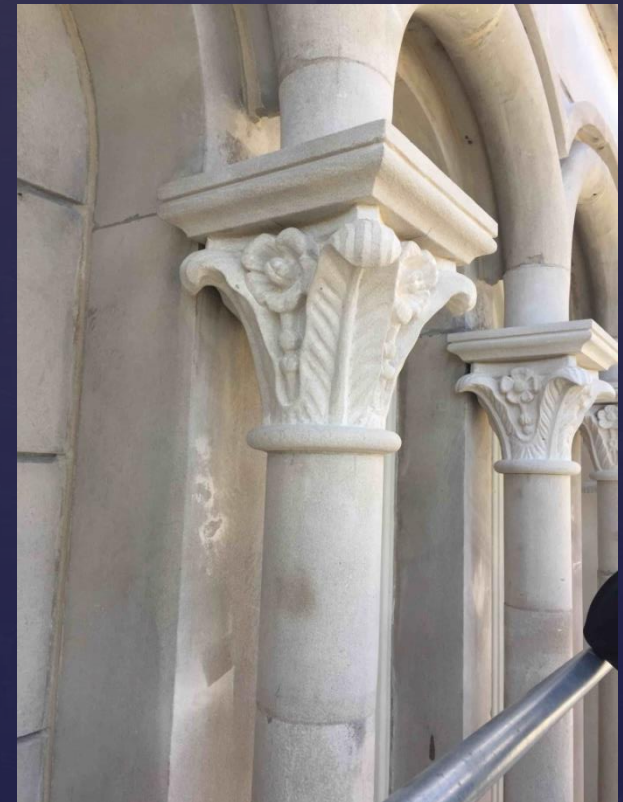
Typical Stone
Column Capital
After Replacement

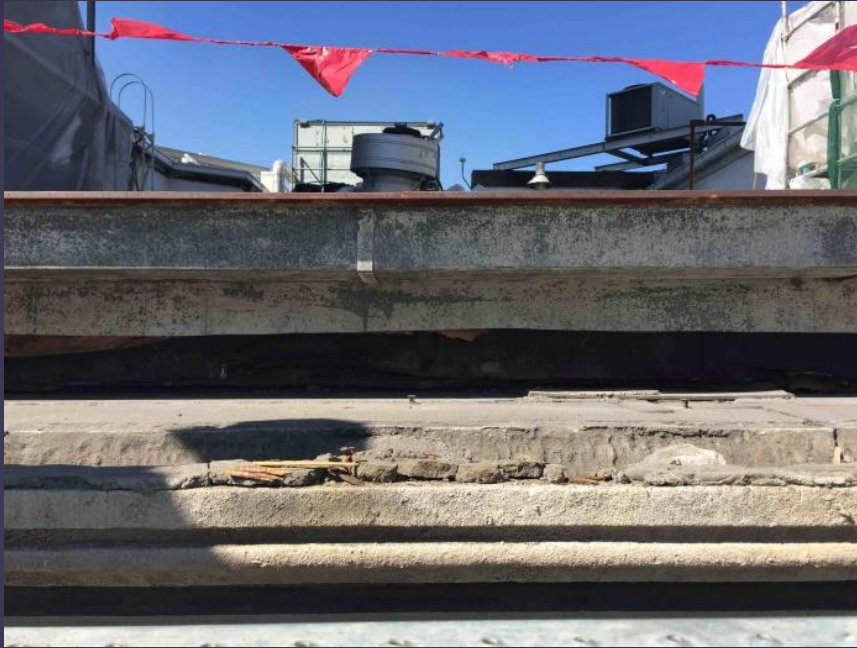
Existing Gutter
& Roof Edge
Before Structural
Repairs

New Copper Gutter & Roof
Edge Were Required Due To
The Extensive Damage From
Water Intrusion

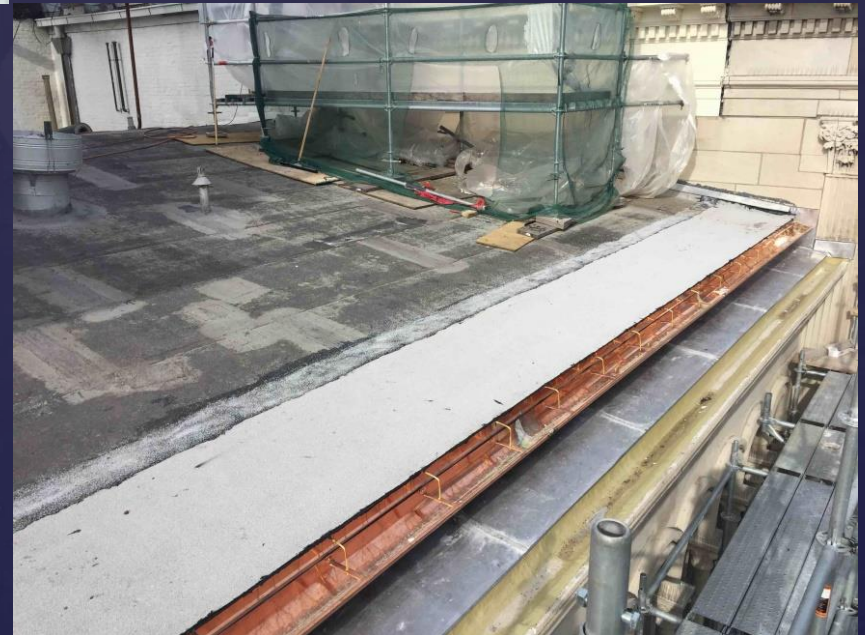
New Copper Gutter
& Roof Edge
After Structural
Repairs

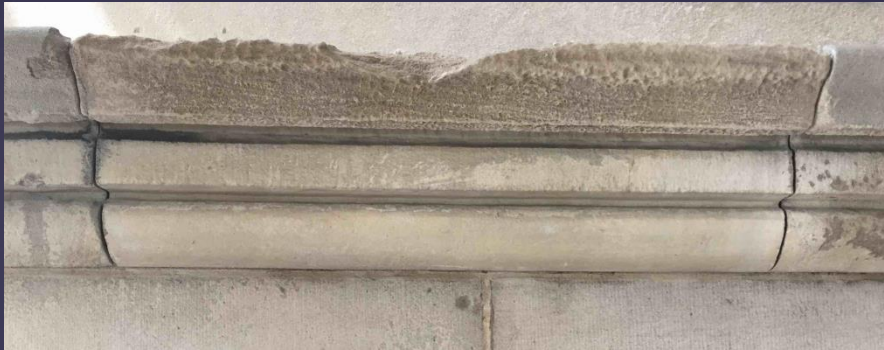
Existing Limestone
Water Table Before
Structural Repairs

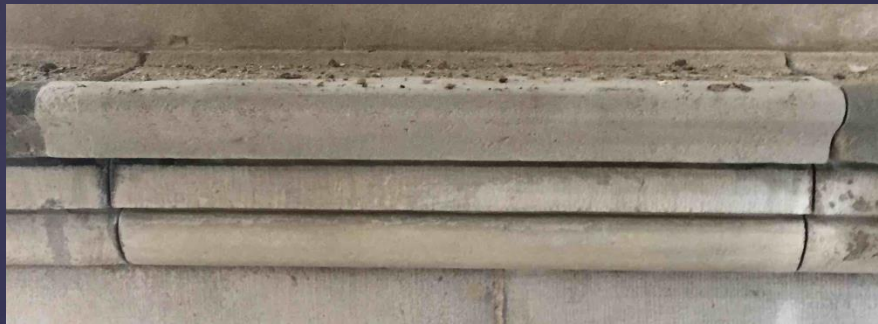
Existing Limestone
Water Table
After Structural
Repairs

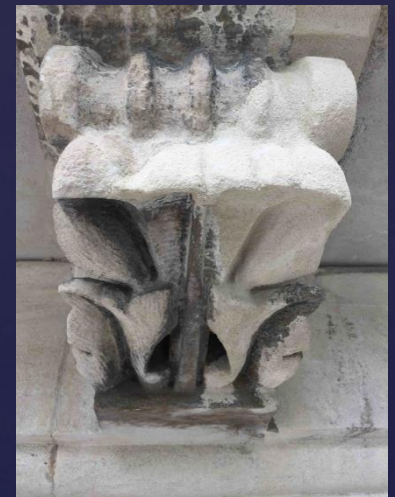
Existing Limestone
Bear Claw
After Structural
Repairs

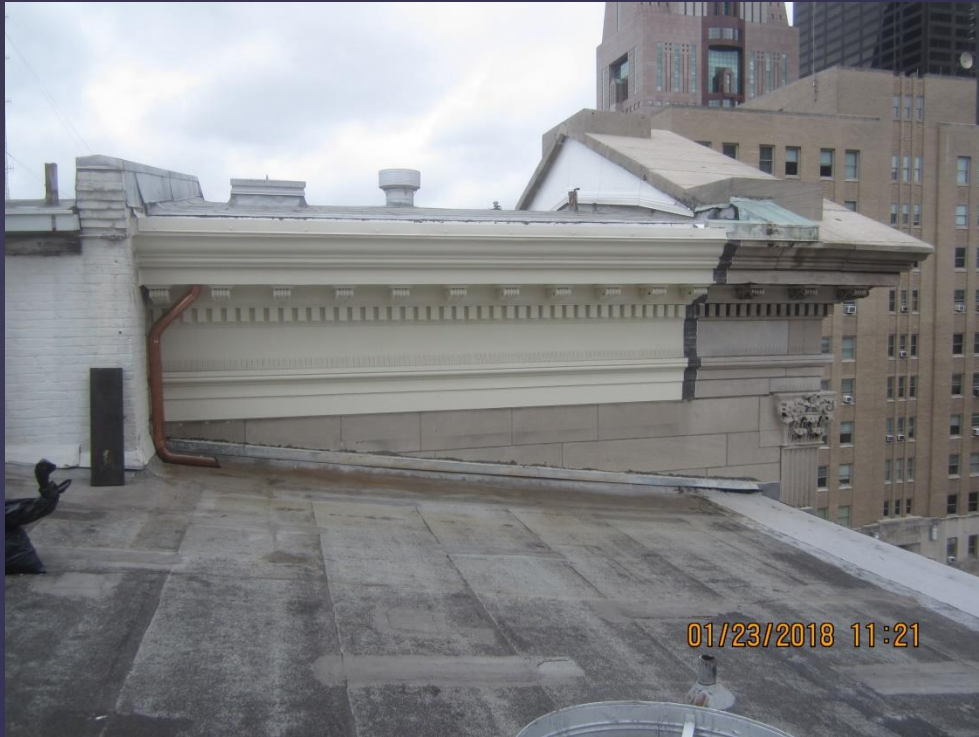
Cornice Transition
Stone To Cast Iron

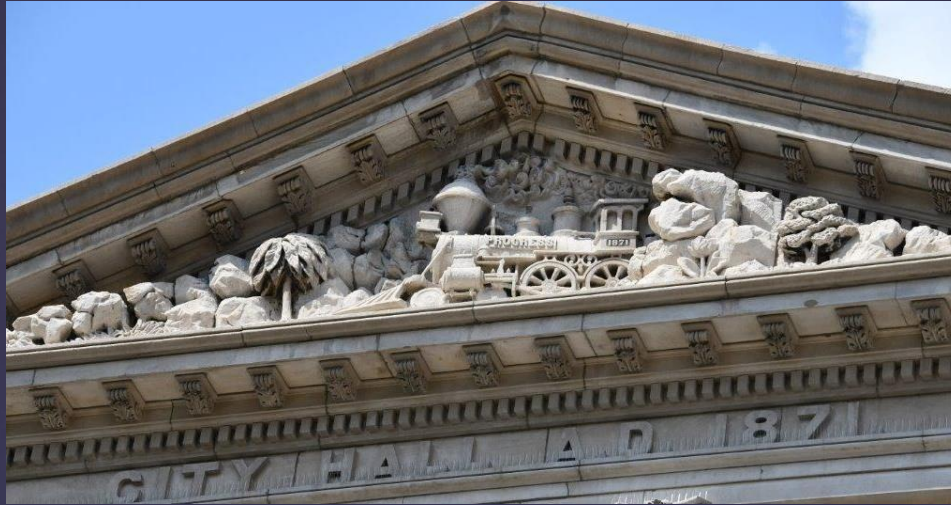
Roof Is In Need Of
Replacement

- Existing Roof To Be Removed And Replaced With A New 20-year Roofing System.
- Restoration Of The City Hall Clock Tower.
- Complete Repairs To Limestone Ornamental Features.
- Masonry At North Wall To Be Sandblasted; Cleaned; Masonry Joints Tuck-pointed & Wall Repainted.
- Masonry Walls At West Wall And Window Wells To Be Sandblasted; Cleaned; Masonry Joints Tuck-pointed & Wall Repainted.
- Cast Iron Steps At The 6th Street Main Entry To Be Removed; Repaired & Replaced.
- Remaining Windows At The East Elevation To Be Repaired & Repainted.
- Windows On The West Side And Window Wells To Be Repaired/Replaced
- Cast Iron Railings And Balustrades To Be Repaired Or Replaced.
- Concrete Retaining Walls At The Perimeter Of City Hall To Be Removed And Replaced
