Landmarks Certificate of Appropriateness & Overlay District Permit

Project Name: Demo 1310 S. Floyd St.

STRUCTURAL ASSESSMENT REPORT

Location: 1310 South Floyd Street
Louisville, KY 40208

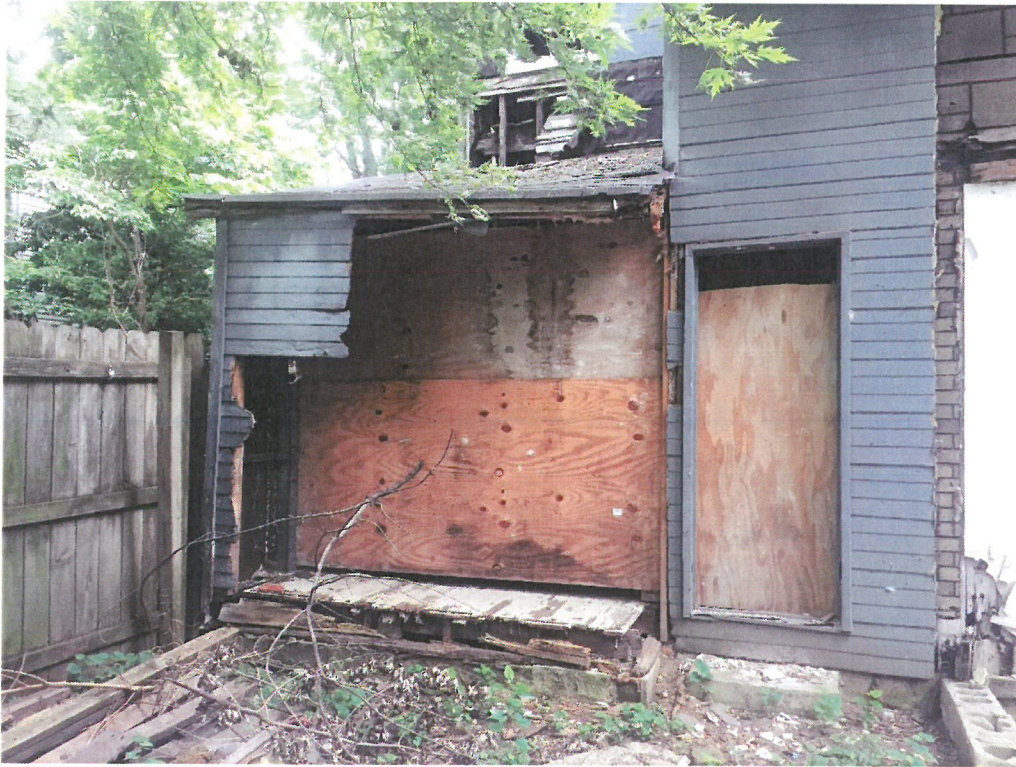
3. Only limited areas of the home were entered due to the amount of deterioration in the wall and floor framing.
4. The rear wall of the 1st Floor was found to have insufficient support of the 2nd Floor across the entire home. The right side had been shored at some point with a temporary wall and plywood sheathing.

Photo 3 – View of the right rear corner of the 1st Floor. The roof over this room was near collapse due to the missing rear wall before it was shored in line with the adjacent rear wall to the right.

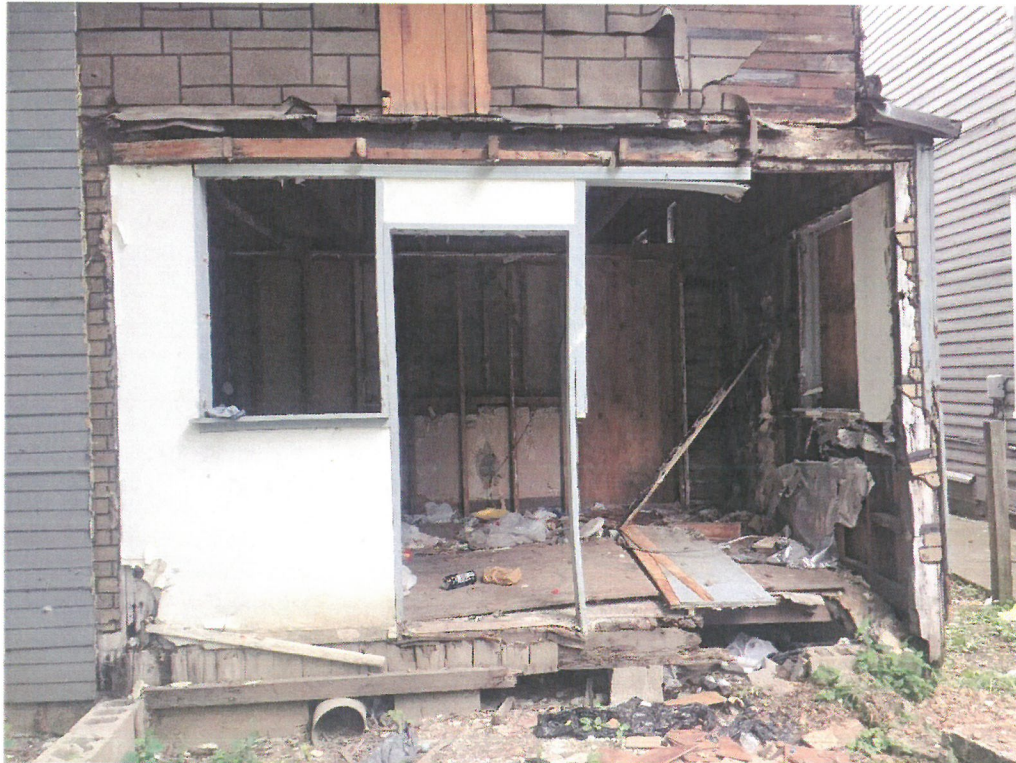
Photo 4 – View of the left rear corner of the home. Note the lack of support structure for the 2nd Floor.

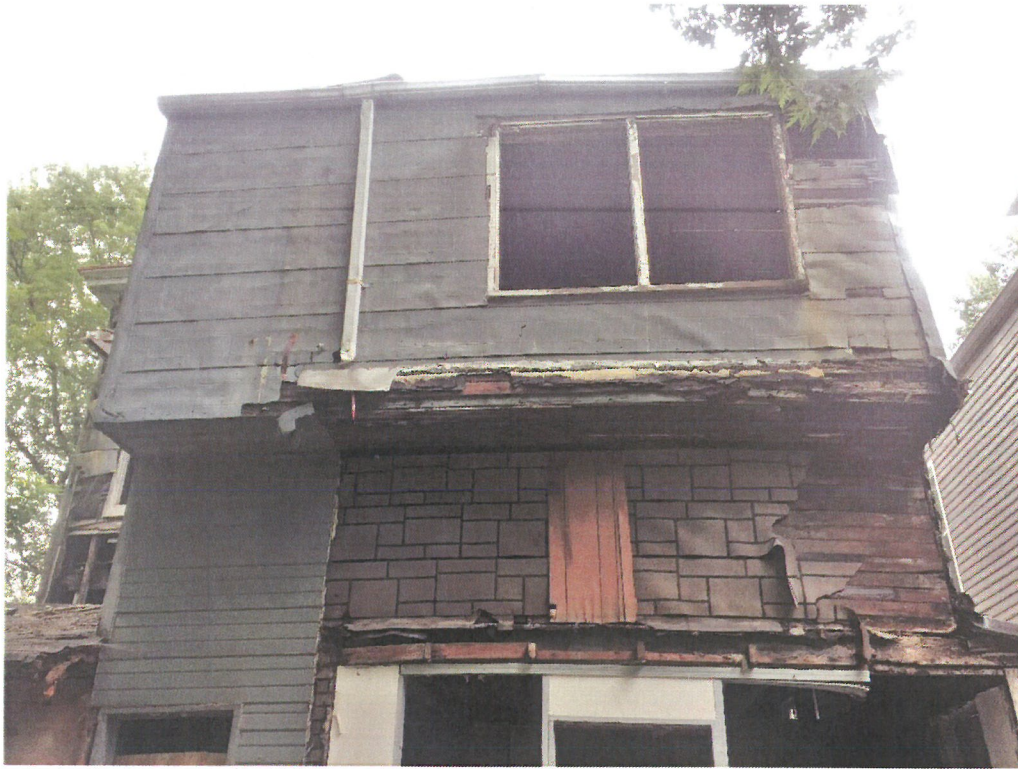
Photo 5 – View of the 2nd Floor left side of the rear of the home. Note the deterioration of the 2nd Floor framing on the overhang and lack of support structure on the 1st Floor.

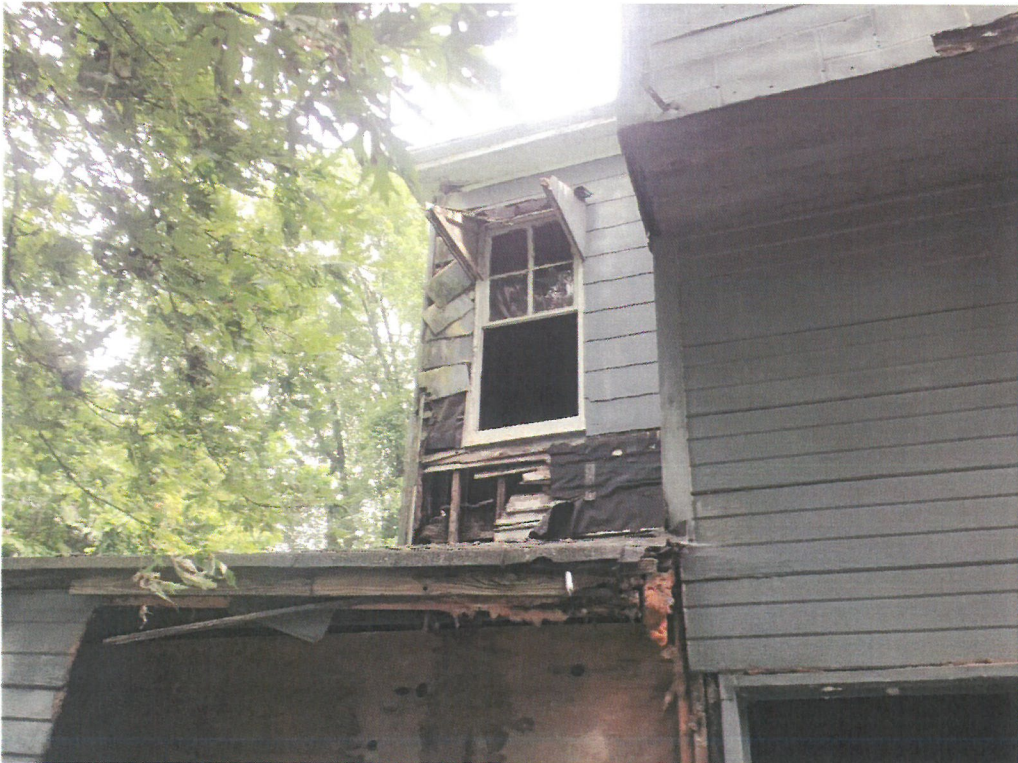
8. The siding in these deteriorated wall areas was severely deteriorated as well.
9. Several additions appeared to have been constructed on the rear of the home at various times. Most of these additions had either been demolished or were in extreme disrepair.

Photo 6 – View of the 2nd Floor left side of the rear of the home. Note the severe deterioration of the wall framing and siding.

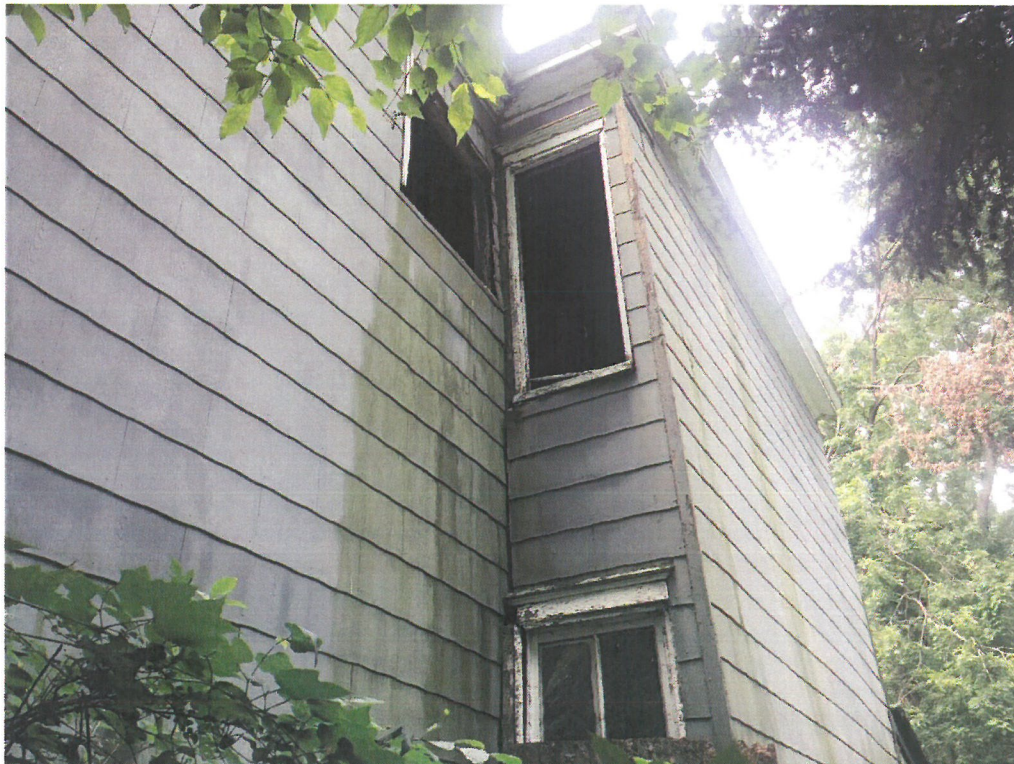
Photo 8 – The bump out on the right side has shifted outward causing the 1st Floor window casing to come apart.

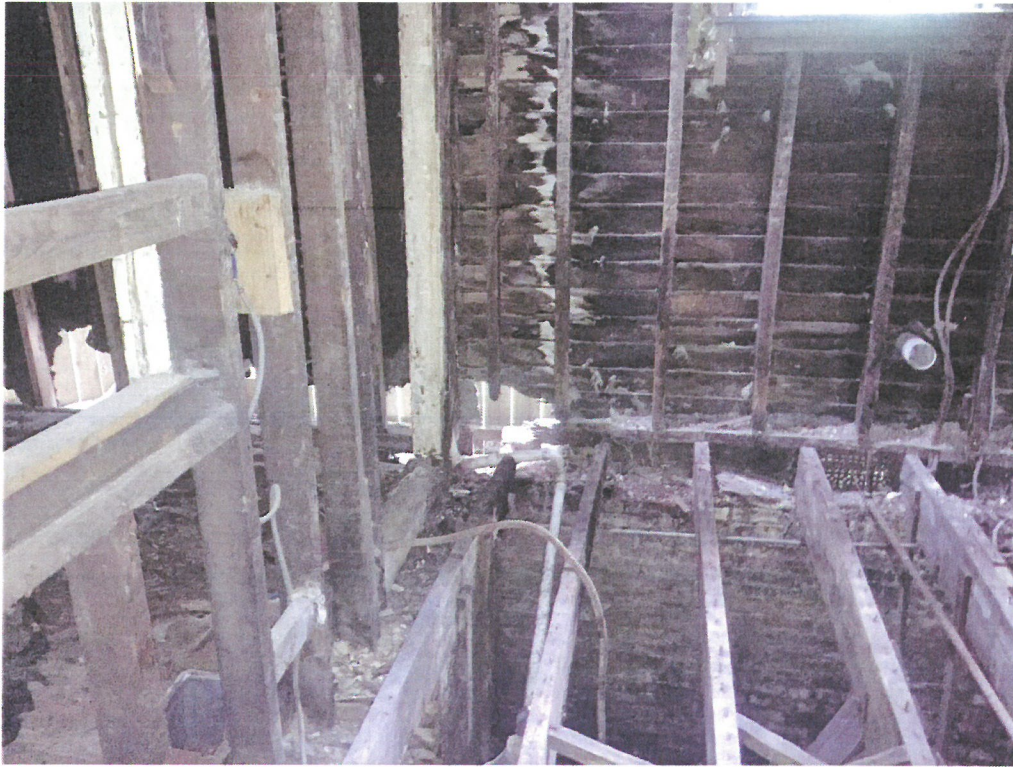
6. A significant amount of the 1st Floor joist framing had deteriorated ends along the perimeter walls due to water intrusion and termite damage. The deterioration of many joists was so severe that several feet of the end of the joists was missing.

7. The sole plate and bottoms of the wall studs were severely deteriorated or missing entirely due to water intrusion and termite damage in many areas throughout the structure. Some of these areas encompassed most if not all of the length of the wall and many of these walls were load bearing walls. These areas were also observed on the 2nd Floor.

Photo 9 – Bottom of the right-side wall is rotted and missing. Ends of the joists are rotted as well.

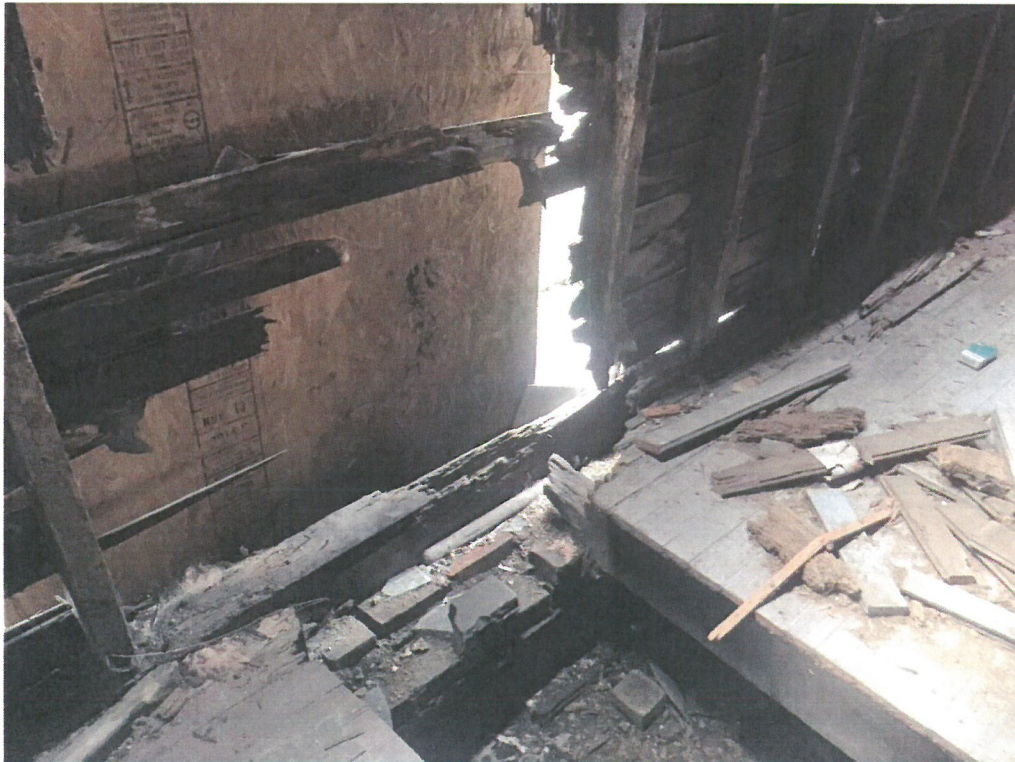
Photo 10 – Severe deterioration of the left side wall near the side door.

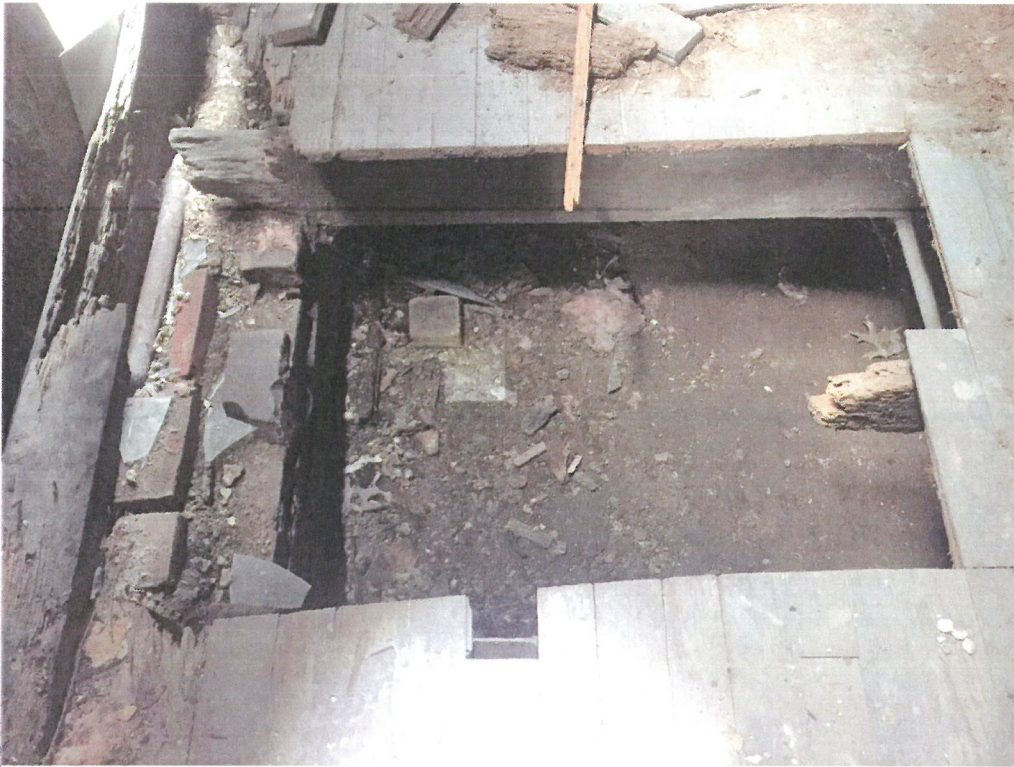
5. The foundation walls consisted of multi-wythe brick masonry walls. The tops of some of the walls were visible due to the past removal of the floor boards on the 1st Floor. In many areas where the foundations were visible, the top courses of the masonry appeared to be loose and missing mortar in the joints.

Photo 11 – Extreme deterioration of the floor joists in the same area. Top of the foundation wall is deteriorated as well.

5. After all of the work is completed in the reframing of the house, the foundation would need to be pointed at the least and most likely rebuilt in many areas.

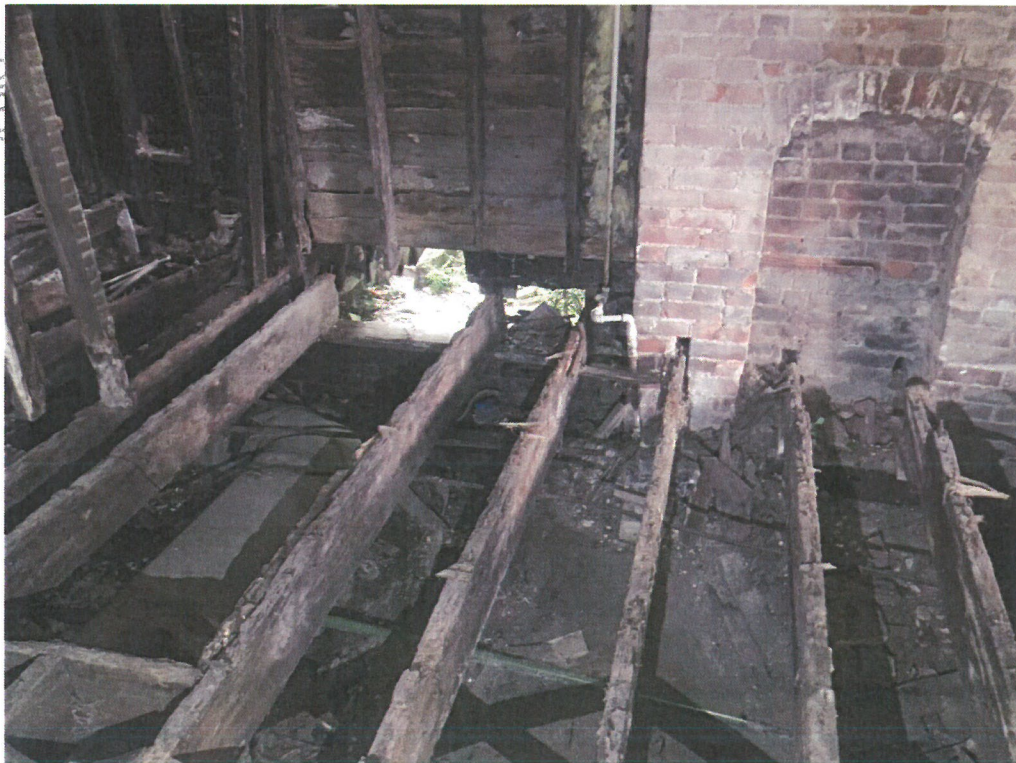
Photo 12 – More severe deterioration of the 1st Floor joists and wall framing along the right wall in the front of the home

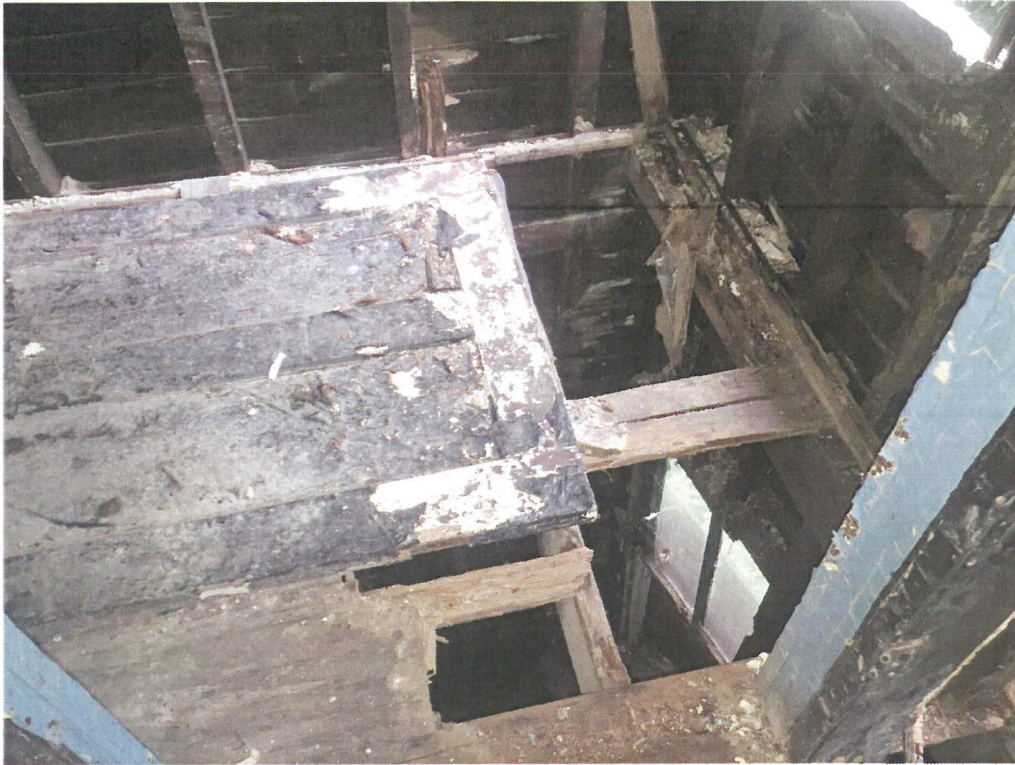
Photo 13 – Deterioration of the 2nd Floor and wall framing. Note the balloon framing of the structure.

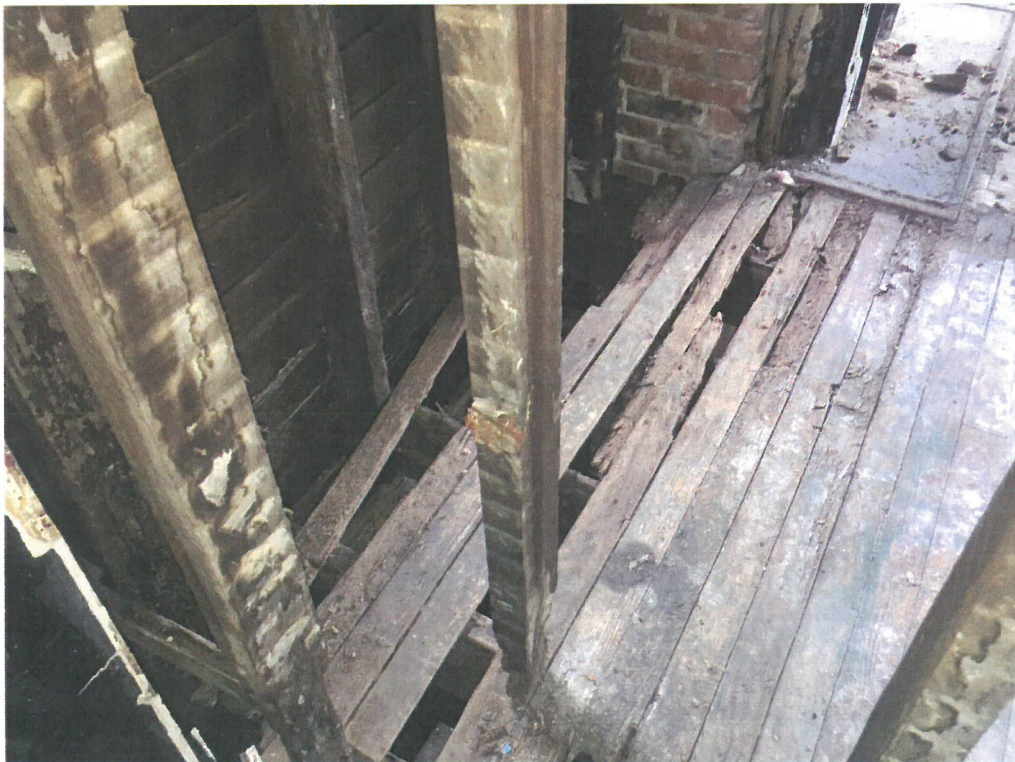
Photo 14 – Severe termite damage to the wall studs and flooring on the 2nd Floor

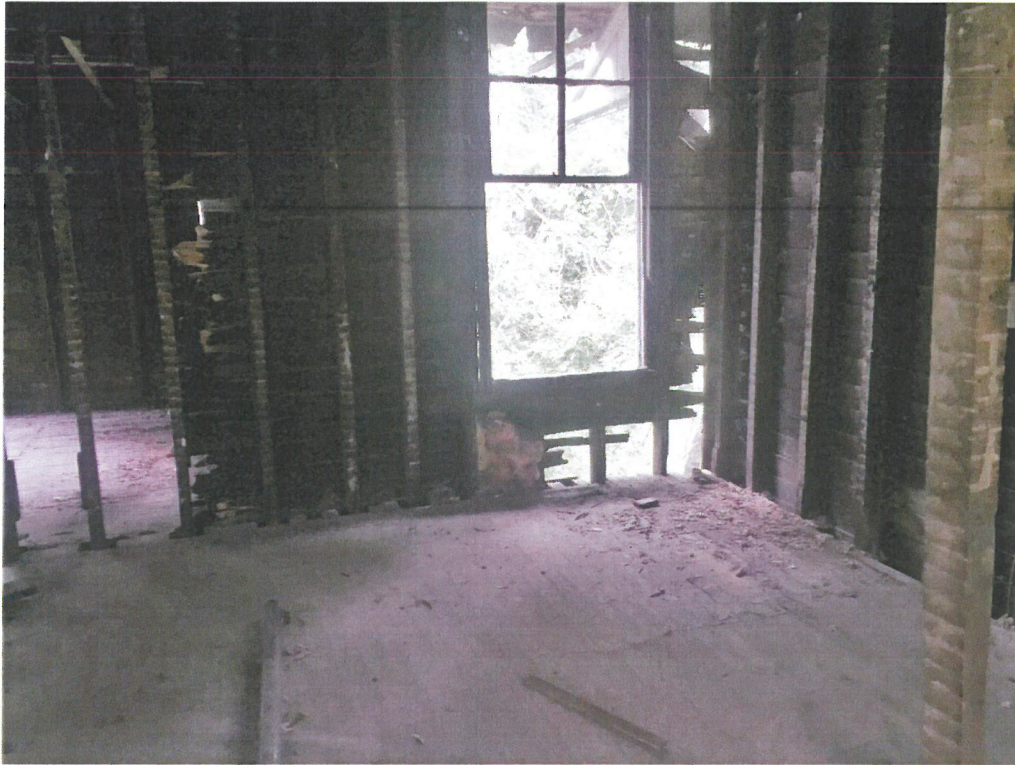
Photo 15 – View of the 2nd Floor right rear corner deteriorated wall framing
