**STRUCTURAL SERVICES, INC.**

January 8, 2018

Re: Structural Review  
1737 Payne St.  
Louisville, KY 40206

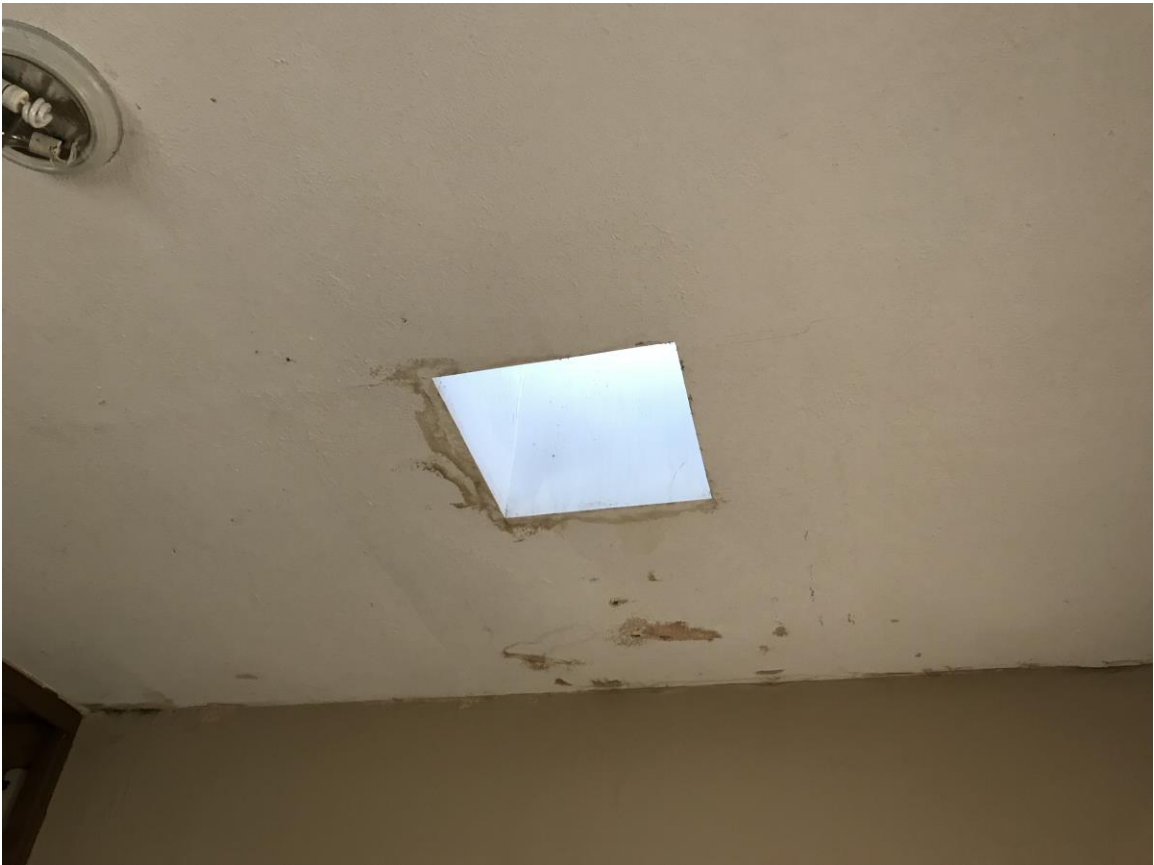
While the majority of wall and roof framing was not visible during our inspection it should be noted that there was evidence of water infiltration as seen in the water staining in ceiling. Roof framing located above the side door was not framed in accordance with current building codes and showed signs of disrepair. With the evidence of termites in the floor framing it should be noted that there is a good possibility of other hidden areas of termite damage.

Water staining and damage to existing ceiling.

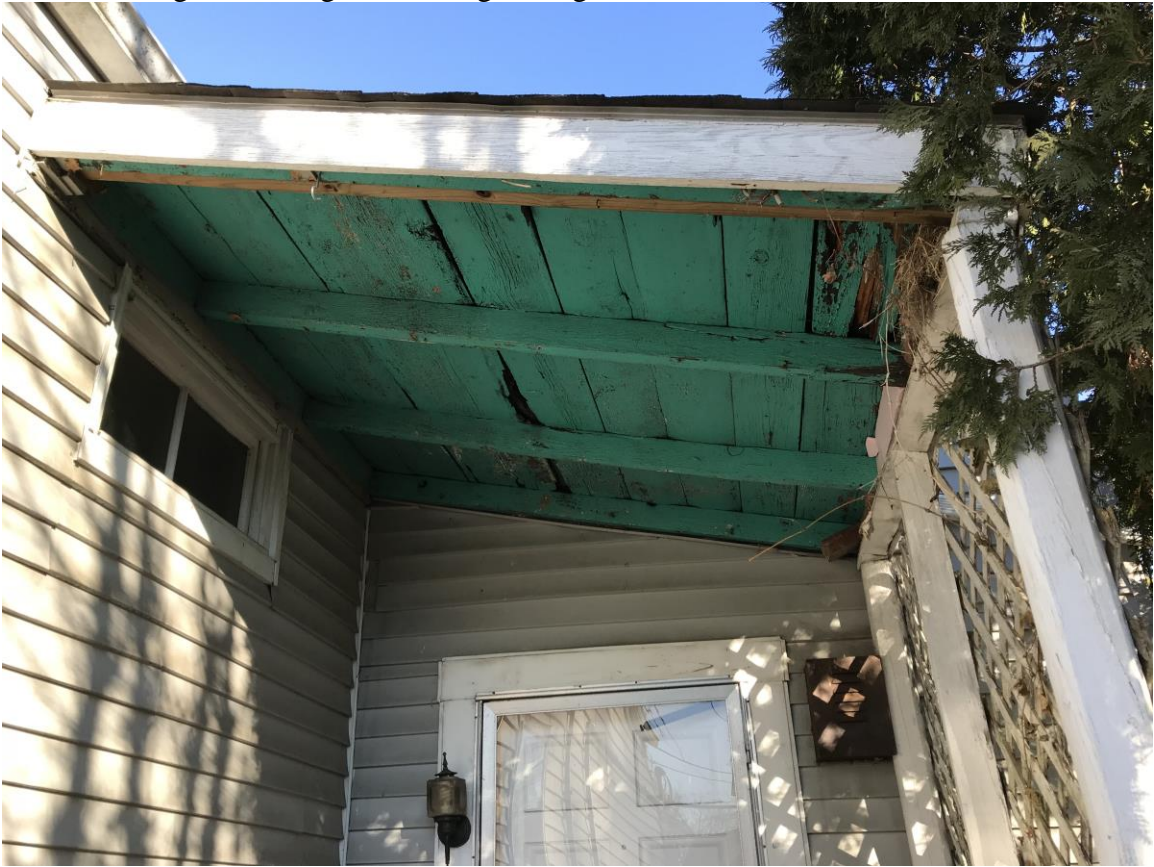
Side door porch roof framing.

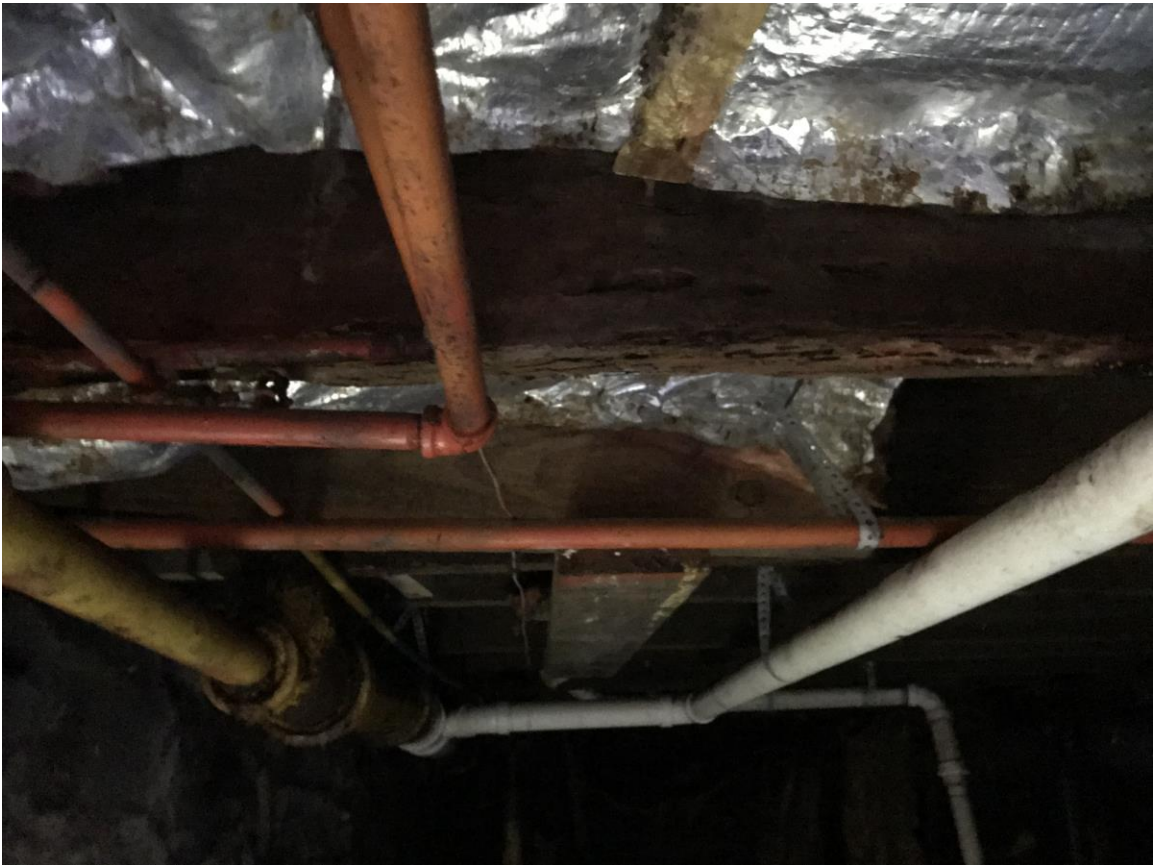
Termite damage in existing floor framing.

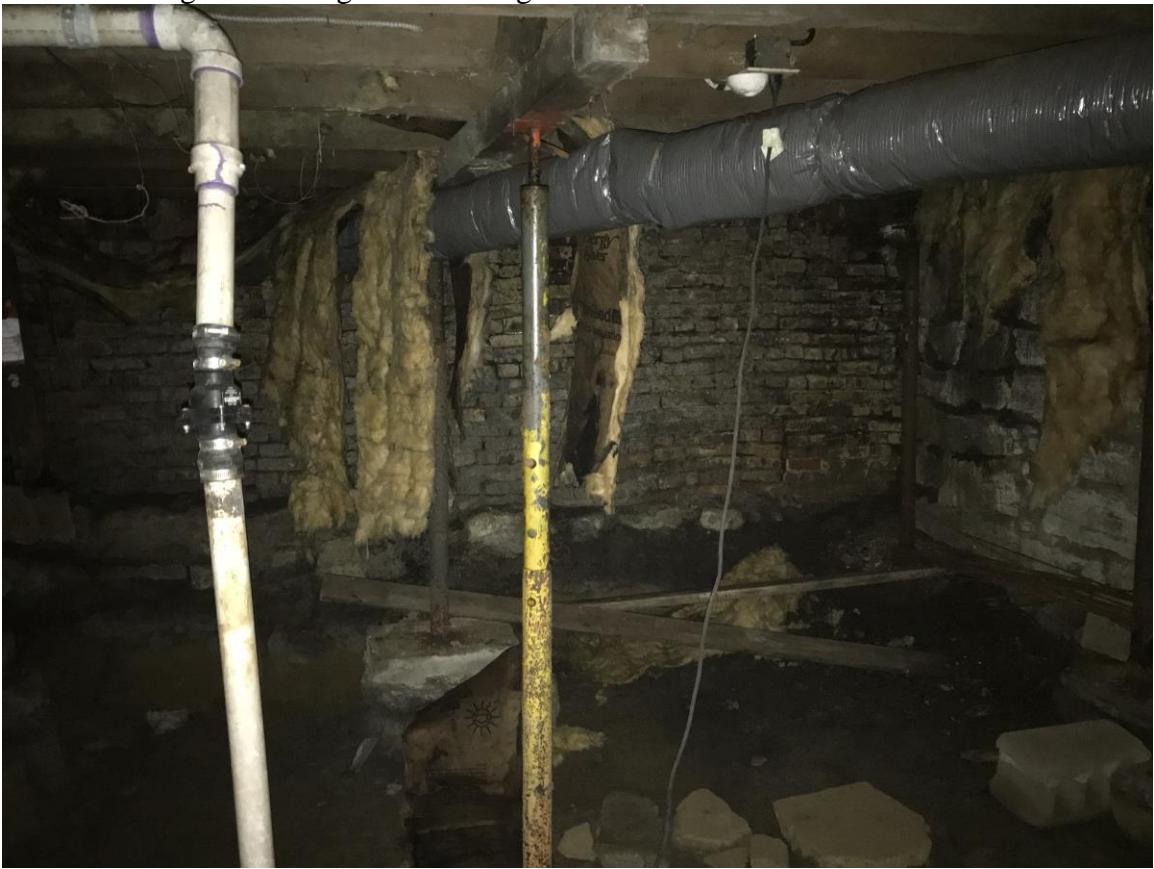
Upon review the main level floor structure was severely out of level in several areas of the house. This was due to the deteriorated condition of the framing. Upon entering the basement the moisture levels were extremely high. The floor framing was moist to the touch. In several areas there was damage due to the past presence of termites. There were several locations where steel posts were added to shore the existing structure. It should be noted that most of the attempted repairs do not meet Kentucky Building Code requirements.

Steel posts placed to shore the existing floor framing.

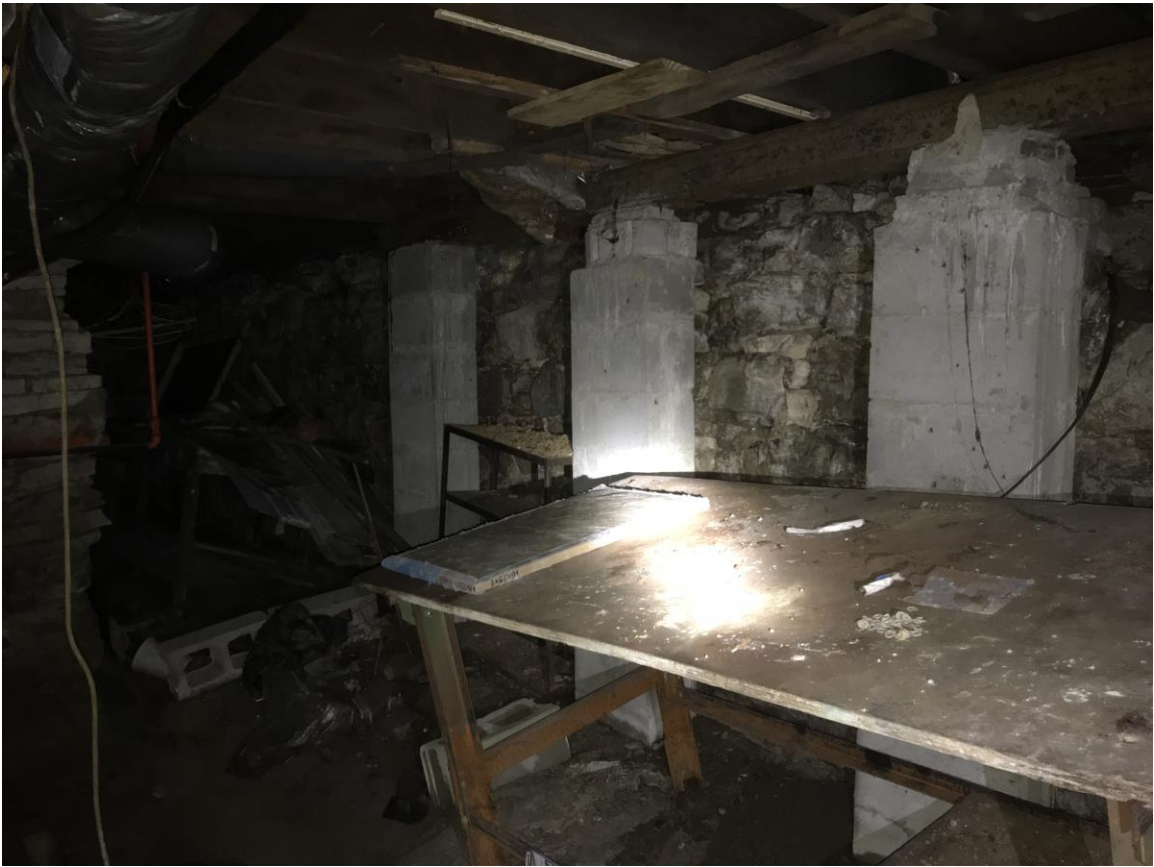
It appears that water infiltration at the joint between the basement wall and floor structure has caused the floor framing to rot and settle. There was one location where an attempt to repair it was made but the problem has progressed to other locations.

Previous repair for floor framing at basement wall.
