# Landmarks Certificate of Appropriateness & Overlay District Permit

Project Name: MARTIN GARAGE

## Cattan Inspection and Engineering, Inc.

Subject: 1524 S Second Street Garages  
Louisville, KY 40203

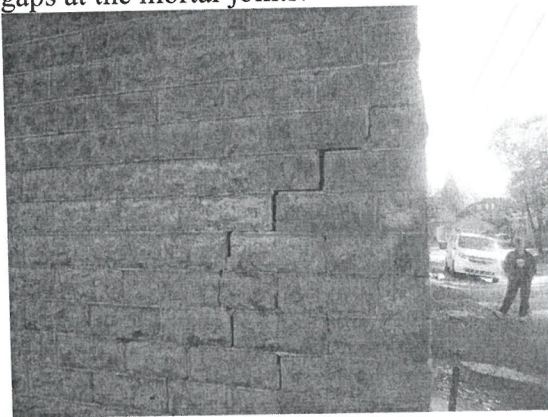
1. The perimeter walls have various amounts of settlement which has caused stress cracking in the block. The most significant movement is at both sides. The movement is directly related to changes in moisture content of the soil at the footing level over the life of the structure. The likely shallow condition allows the changes to occur more readily. The walls are not considered unstable but have both vertical and lateral movements which have affected wall plumbness and caused cracking. The pictures indicate the most significant displacements noted in the building. The displacements affect the appearance which cannot be improved and require tuckpointing at numerous locations to close off the gaps at the mortar joints.

NW corner

3. A membrane roof system is suggested over the concrete.
4. The cracked block and mortar joints in the walls can be tuckpointed both inside and outside. The crack repair will not repair the displacements that have occurred.

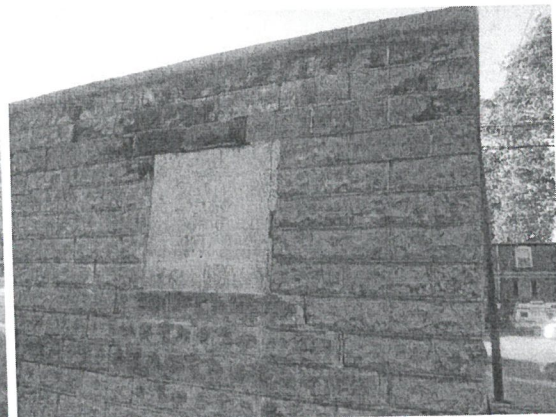
NE corner at rear

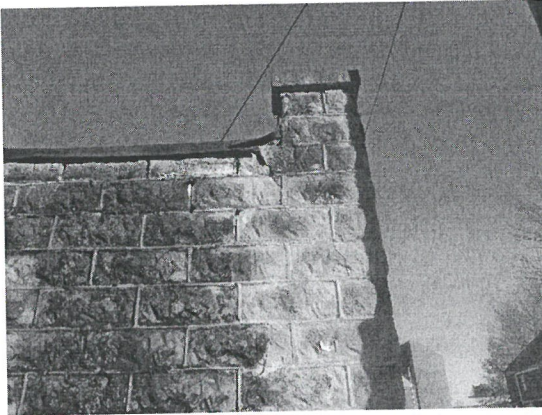
SW corner side rotation

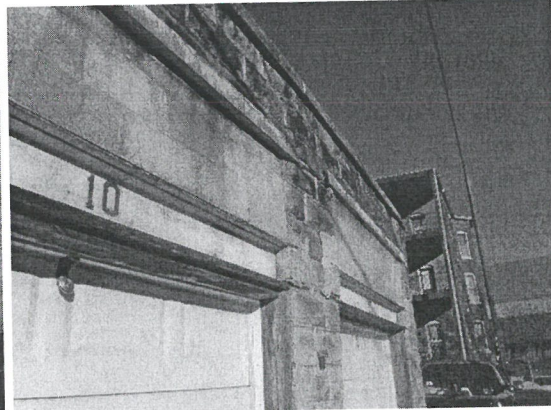
South side rotation at center column

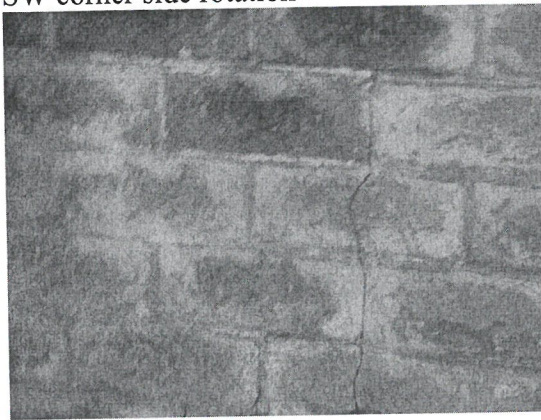
SE rear wall

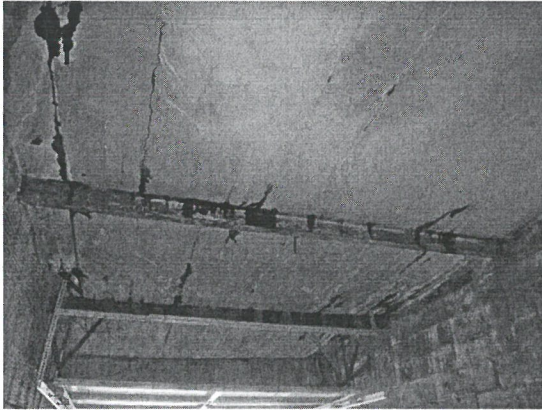
2. The roof is built in the following manner. There are 3 steel beams between the wall walls which support wood runners at about 30 inch spacing. The runners support a wire mesh which the concrete was placed upon. A plaster coat was added to the surface for appearance. Over the years due to roof leakage the metal lath has corroded and allowed failure of the material. The concrete above is not reinforced and has virtually no support when the material has broken and allowed the entire area between steel supports to fall. Each unit was observed, and some are in fair condition, some have deterioration at the low end of the roof where apparent leakage has caused the deterioration and 3 units which need complete replacement. A sketch is attached to this report which indicates the deteriorated areas by circles and notes. Units 3, 4, and 5 need replacement due to failed lath. Other units have deterioration and at some future snow load condition could have a stress failure of the lath which could cause a similar failure to Unit 3. The roof currently is not considered to be rated for the current allowable load condition due to the deterioration of the metal lath.

Ceiling at #1 hole at NW corner

1. The sections noted above with damage concrete roof should be removed down to the steel. Those units with severe rust at the steel beams should have the member replaced, surface scale is not a reason to replace, flaking of the steel is one that should be replaced. The roof can be replaced in sections from wall to wall of those units with minor deterioration. #4 and #5 have steel which should be replaced. For ease of installation and longevity of the structure with more than  $\frac{1}{2}$  of the structure needing repair and reduced load capacity a complete replacement is suggested.

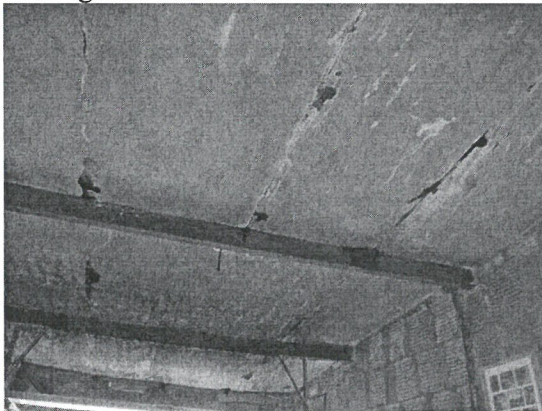
#2 no significant rust or loss of plaster

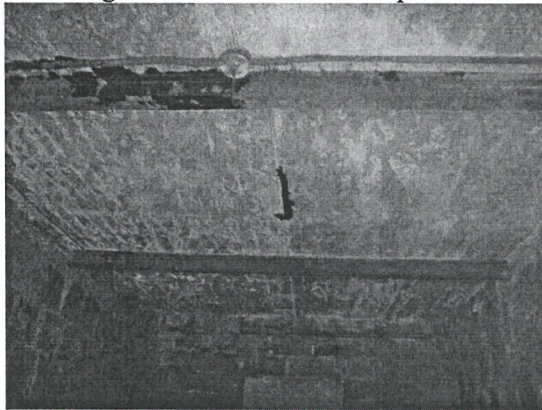
#3 Beam and ceiling deteriorated

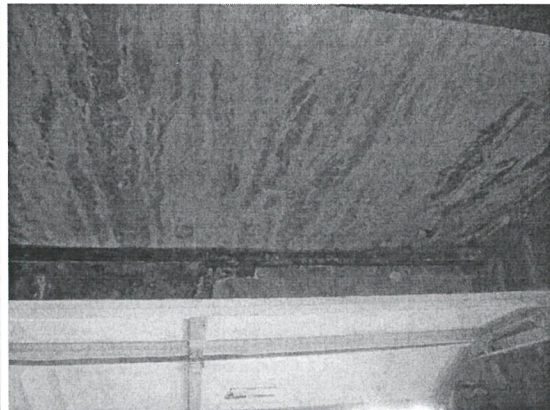
West side above door deteriorated

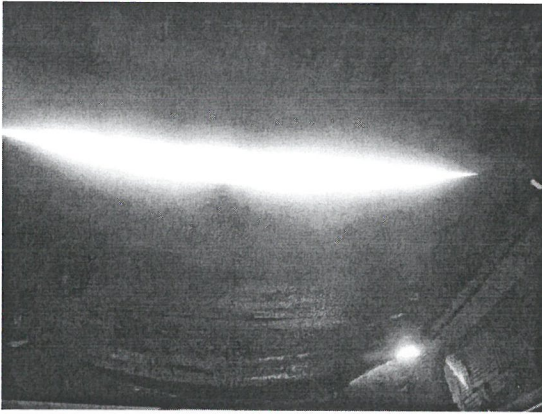
#4 failed

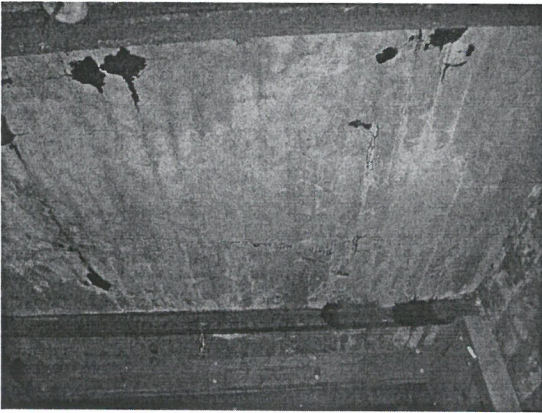
#5 spot breakage Not failed but close

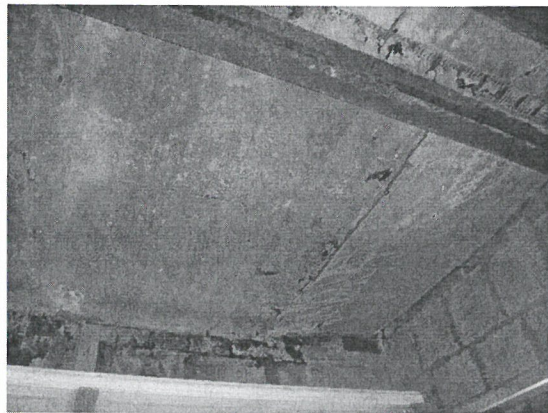
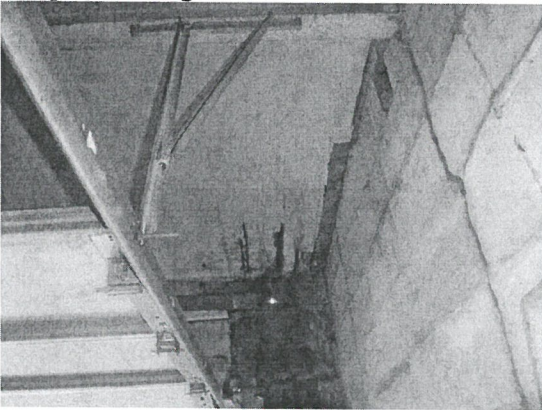
#6 failed at NW corner

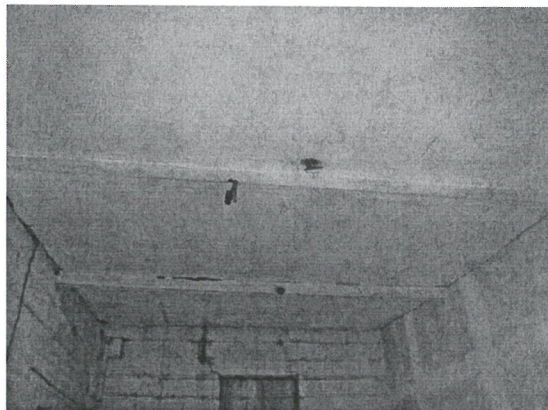
Middle and rear area ok

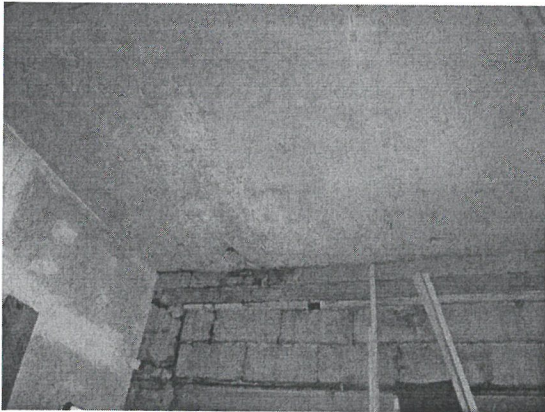
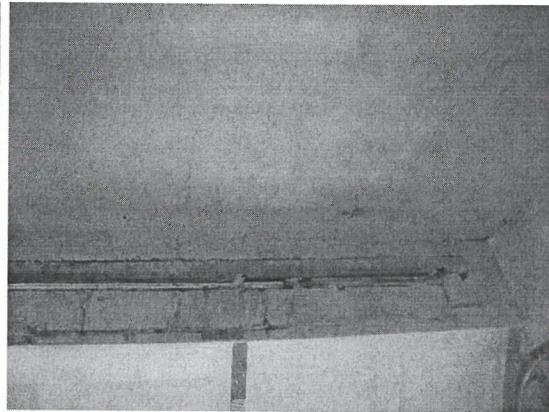
#7 and #8 combined unit small failure at West wall door area

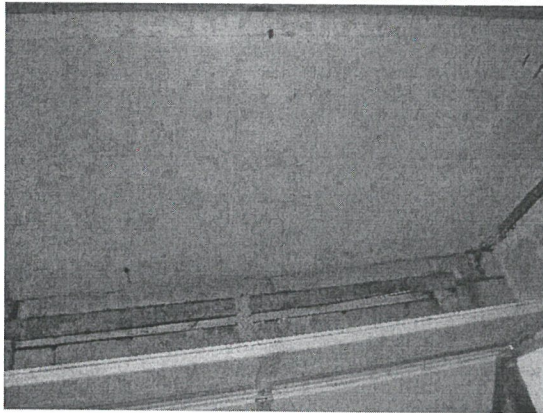
#9 No issues noted

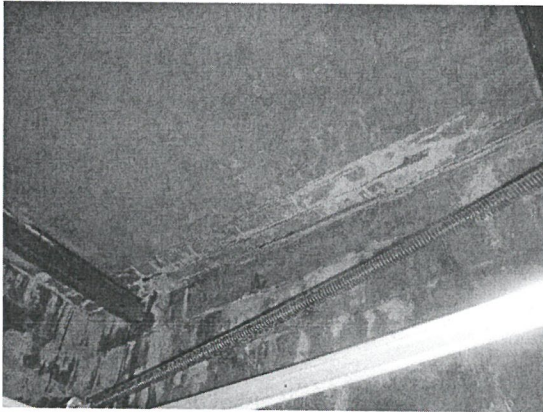
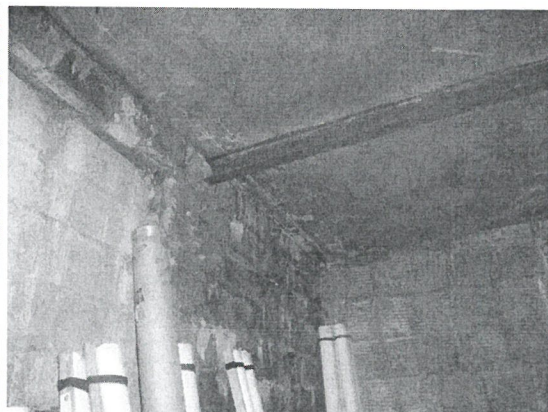
#10 Rust out at low end at west side

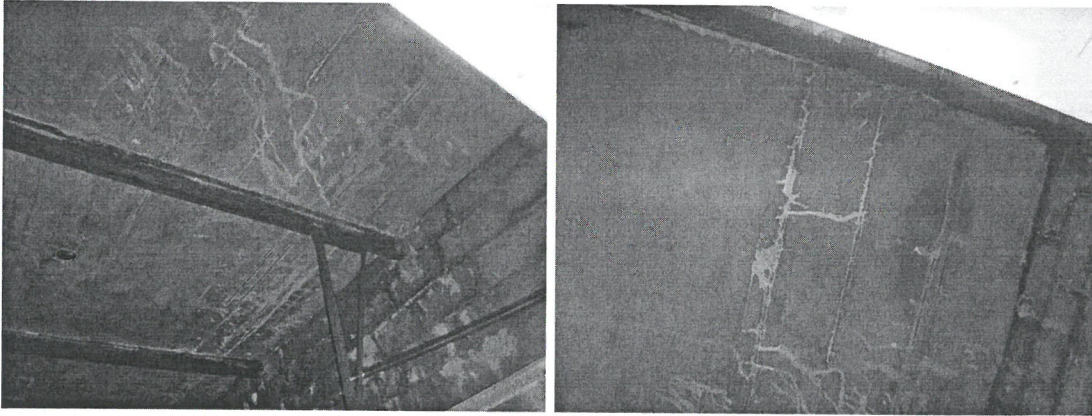
#11 Rusted areas but not broke yet
