**GREENBAUM ASSOCIATES, INC.**  
GEOTECHNICAL & MATERIALS ENGINEERS

## **Introduction**

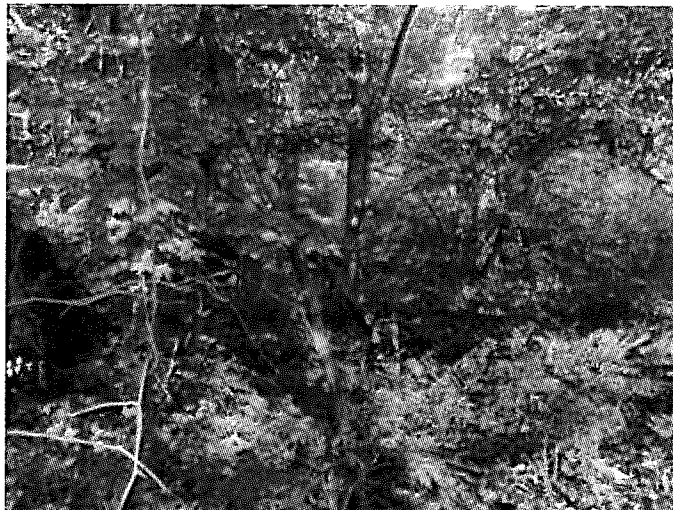
**Area of Lots 28 through 37 and 40**

The area of lots 28 to 37 and 40 slope downward to the northwest. The slope across the lots is between 20- and 25-percent. There is no evidence of slope movement, i. e. no scarp, leaning trees consistent with a slide, erosion of the slope, tension cracks, etc.

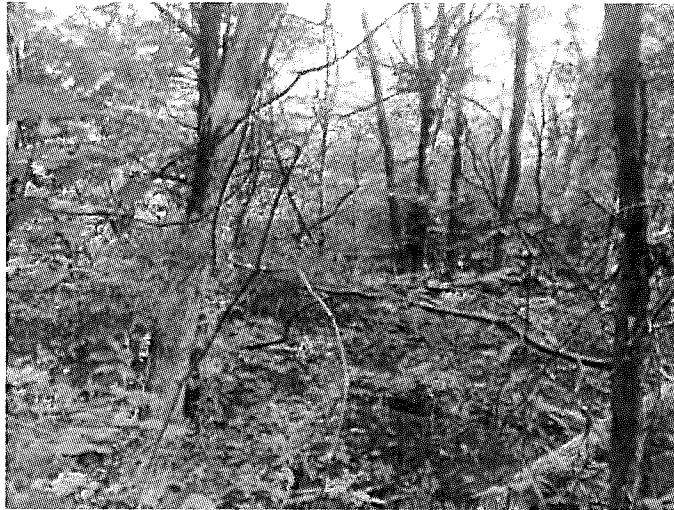
**Lots 66 through 68**

The area of lots 66 through 68 slope 15- to 20-percent downward to the south. There is no evidence of slope movement, i. e. no scarp, leaning trees consistent with a slide, erosion of the slope, tension cracks, etc.

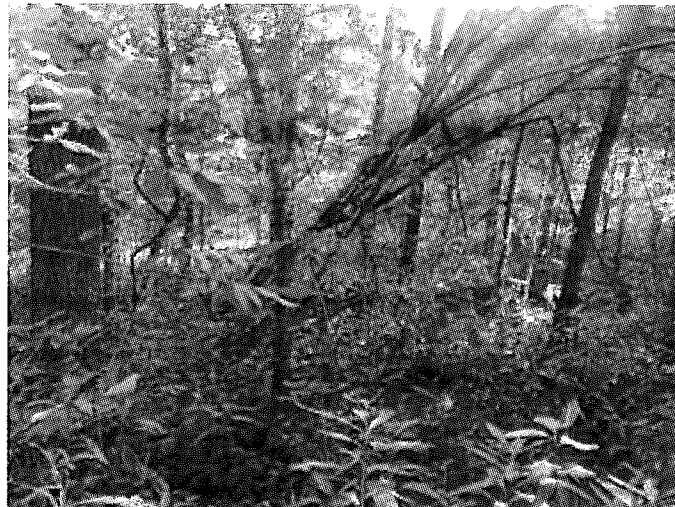
**Lot 70 and 72 through 75**

The area of lot 70 and 73 through 75 slope downward to the northwest. The slope across the lots is between 20- and 25-percent. There is no evidence of slope movement, i. e. no scarp, leaning trees consistent with a slide, erosion of the slope, tension cracks, etc.

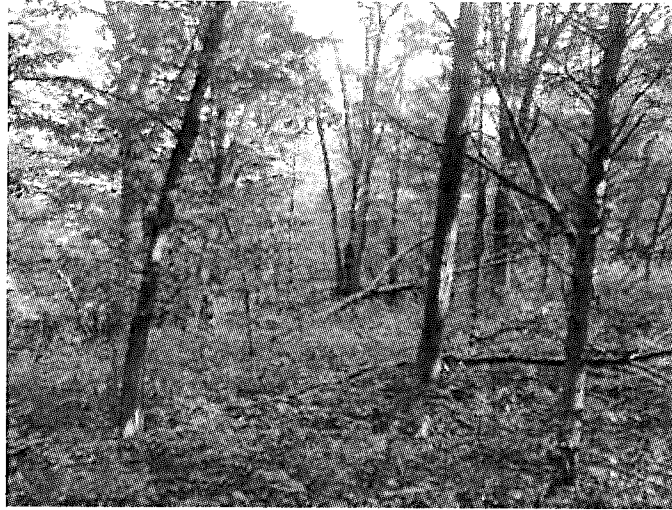
**Lots 84 and 85**

The area of lot 84 and 85 slope downward to the northwest. The slope across the lots is about 15 percent and steepens to the west of these lots. There is no evidence of slope movement, i. e. no scarp, leaning trees consistent with a slide, erosion of the slope, tension cracks, etc.

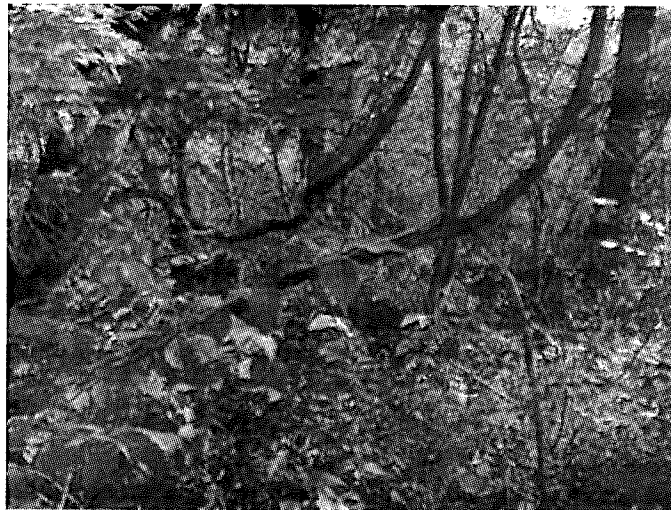
**Lots 98 and 103**

The area of lots 98 through 103 slope downward to the southeast. The slope across the lots is up to 20 percent. There is no evidence of slope movement, i. e. no scarp, leaning trees consistent with a slide, erosion of the slope, tension cracks, etc.

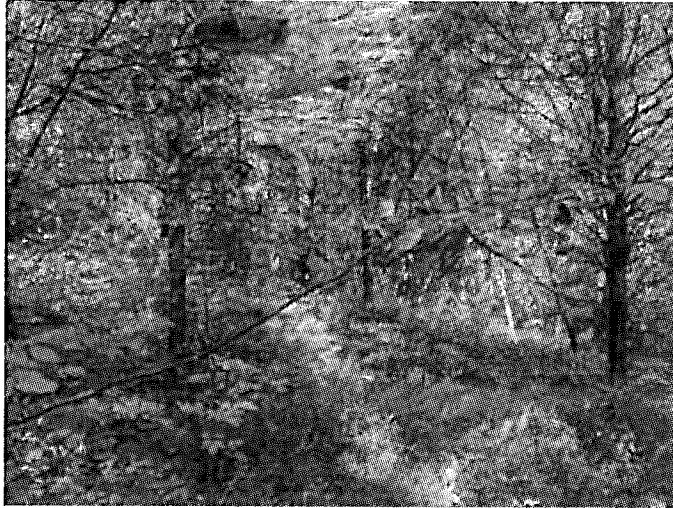
**Area of Lots 112 through 120**

The area of lots 112 to 119 slopes downward to the west to a stream and pond well beyond the back of these lots. The slope across the lots is between 20- and 25-percent. There is no evidence of slope movement, i. e. no scarp, leaning trees consistent with a slide, erosion of the slope, tension cracks, etc. The stream banks expose soil with large quantities of flagstone. Depth of soil is relatively shallow and rock outcrops are present elsewhere on the site.

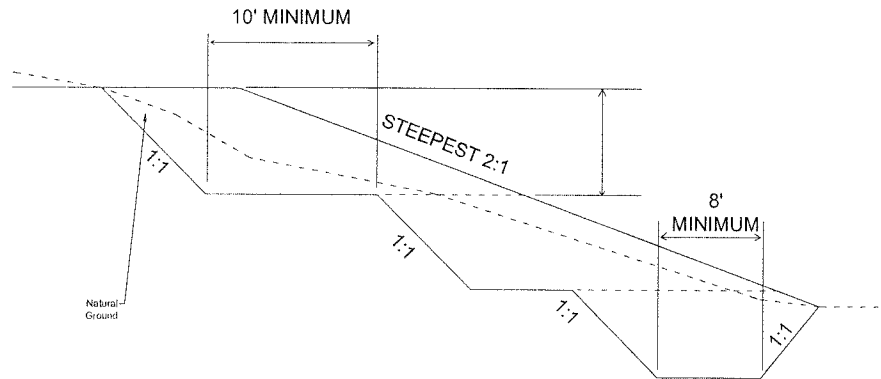
The topography of this property is rolling with some slopes exceeding 30 percent, resulting in substantial cuts and fills. When fill is to be placed on an existing slope it is imperative that the existing slope be benched as shown in the diagram at the top of the following page to prevent the formation of a plane of weakness along which a slope failure can develop. Benching will have to be

adjusted as necessary, in consultation with this office, where limestone bedrock is encountered that prevents benching as shown from being achieved.
