Re: Karst/Slope Stability Survey

23± Acre Parcel

Netherwood Patio Homes Louisville, Kentucky Project Number 21-139G

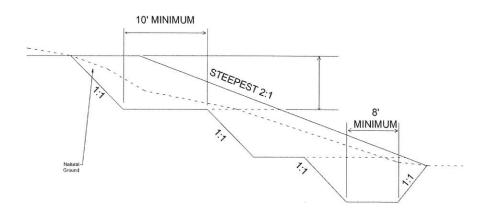
The topography of this property is rolling, resulting in substantial cuts and fills. When fill is to be placed on an existing slope it is imperative that the existing slope be benched as shown in the diagram below to prevent the formation of a plane of weakness along which a slope failure can develop. Benching will have to be adjusted as necessary, in consultation with this office, where limestone bedrock is encountered that prevents benching as shown from being achieved.
