# Fatal Batch Reactor Explosion at Givaudan Sense Colour Facility

Louisville, Kentucky | Incident Date: November 12, 2024 | No. 2024-06-I-KY

## Investigation Update

February 2025

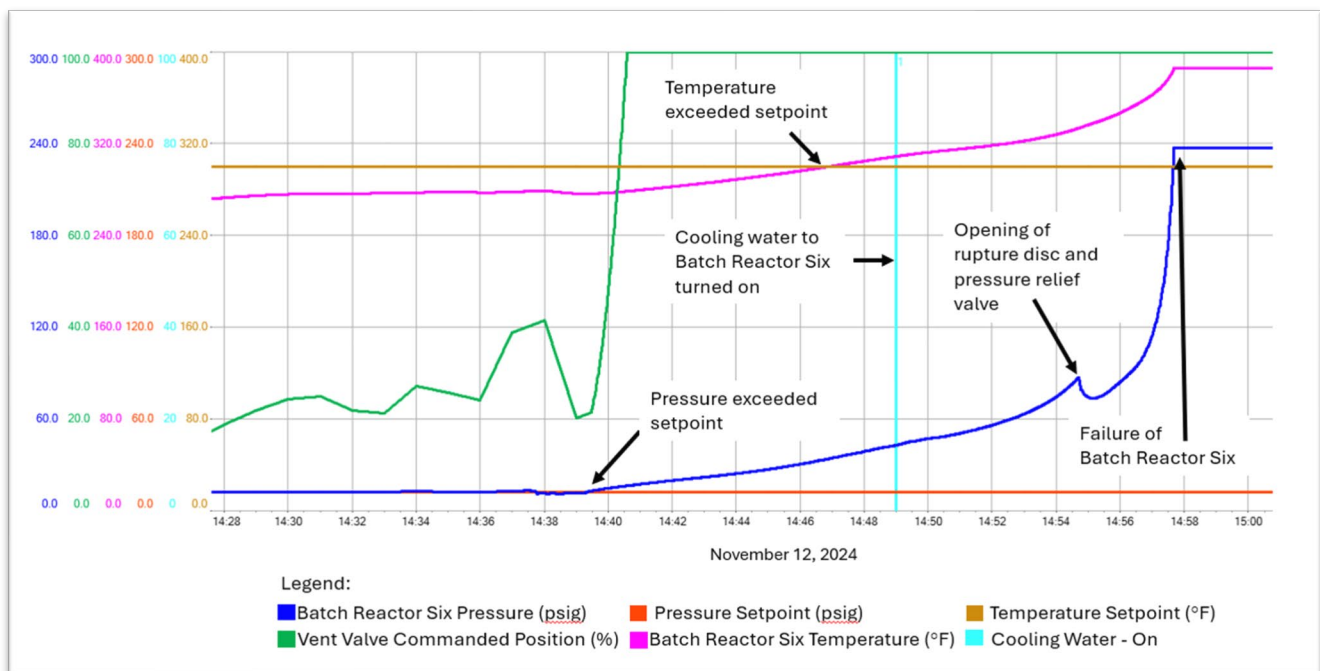
- At 2:39 p.m., the batch reactor pressure began to exceed the 12 psig setpoint (**Figure 3**). The process data indicates that the vent valve was commanded to fully open at 2:40 p.m. The purpose of this action was to reduce the batch reactor pressure, but the pressure continued to rise even after the valve was commanded to fully open, as the valve might not have physically opened (see Additional Information below). At 2:47 p.m., the batch reactor temperature exceeded the 300°F setpoint. Operators observed the abnormal pressure and temperature increases, and cooling water was introduced to the coils at 2:49 p.m. The temperature and pressure continued to rise even after the cooling water system was activated.

- Process data indicates the pressure relief valve opened at 2:54 p.m., and the pressure temporarily reduced before it again began to rise (**Figure 3**). Both the temperature and pressure continued to rise until Batch Reactor Six catastrophically ruptured at 2:57 p.m. The maximum temperature observed before rupture was 385°F, thirty degrees above the maximum allowable working temperature of 355°F. The maximum pressure observed before rupture was 237 psig, more than three times the maximum allowable working pressure of 75 psig.

**Figure 3.** Process data from Batch Reactor Six leading up to the explosion. (Credit: CSB)

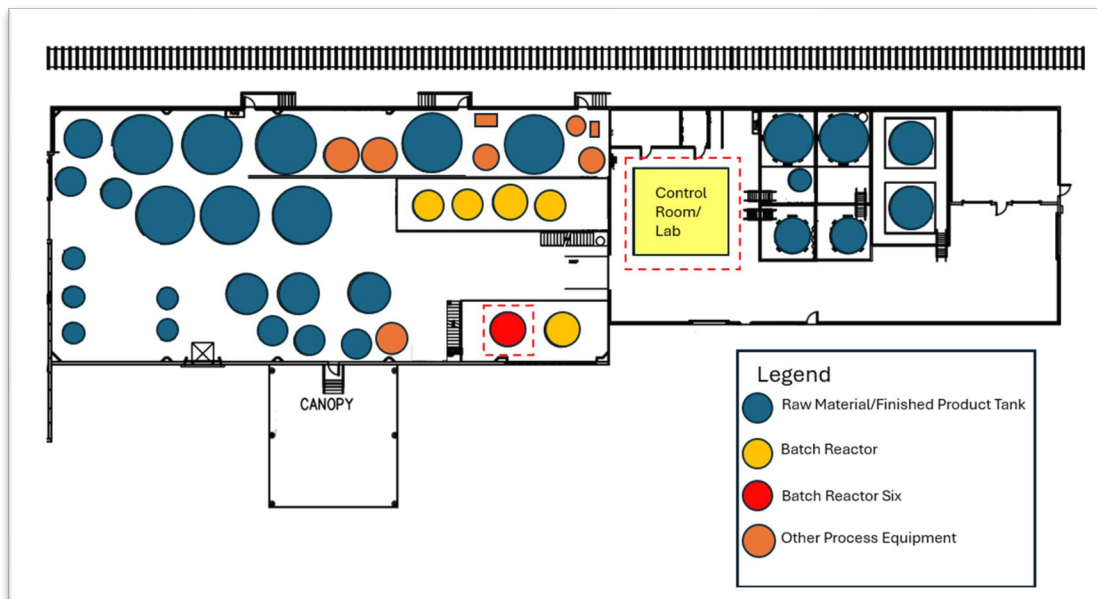
- As a result of the explosion, two employees were fatally injured, and three employees were seriously injured. The two fatally injured employees, along with four additional employees, were inside the control room at the time of the incident (**Figure 4**).

**Figure 4.** Simplified map of Givaudan manufacturing facility in Louisville, Kentucky. (Credit: Givaudan with annotations by CSB)

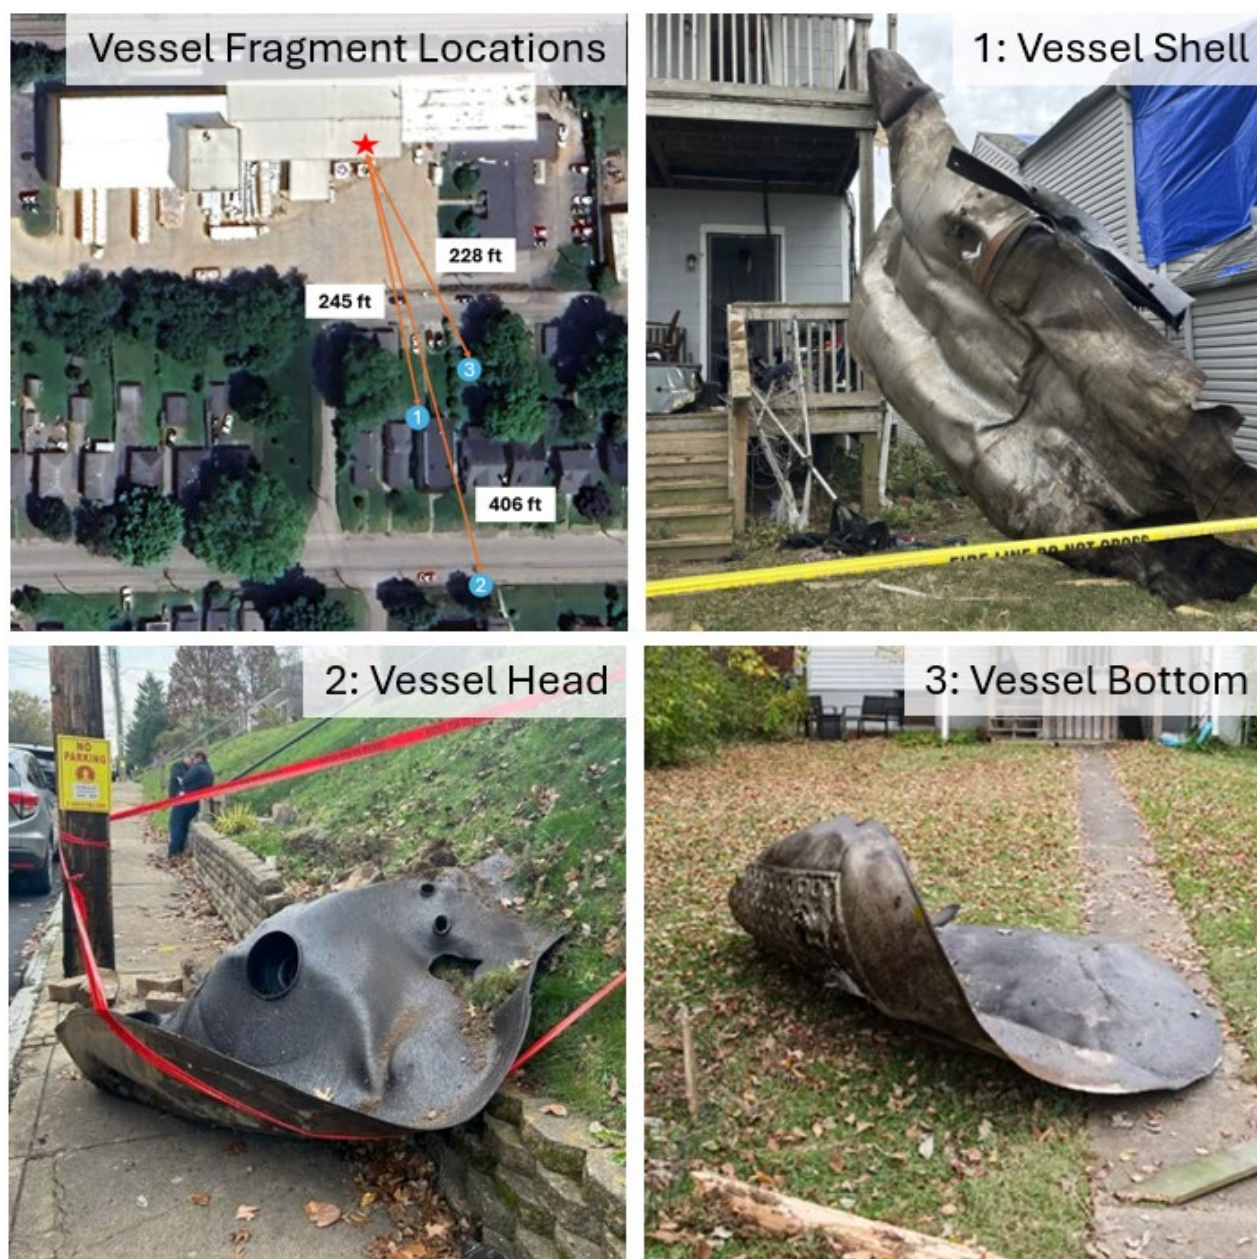
- The facility was severely damaged by the explosion (**Figure 5**). Debris from the explosion of Batch Reactor Six was ejected outside the fence line and into the nearby neighborhood. Debris that was found in the neighborhood included large pieces of Batch Reactor Six (**Figure 6**), pipe fragments, instrumentation, valves, and other building materials. Fragments of the exploded vessel flew as far as about 400 feet from the facility.

**Figure 6.** Locations of Batch Reactor Six debris scattered throughout the surrounding neighborhood. (Credit: Map: Google Earth with annotations by CSB; Photo 1: Dylan Lovan, Associated Press via Louisville Public Media [10]; Photo 2: WDRB News [11]; Photo 3: Louisville Courier Journal [12])

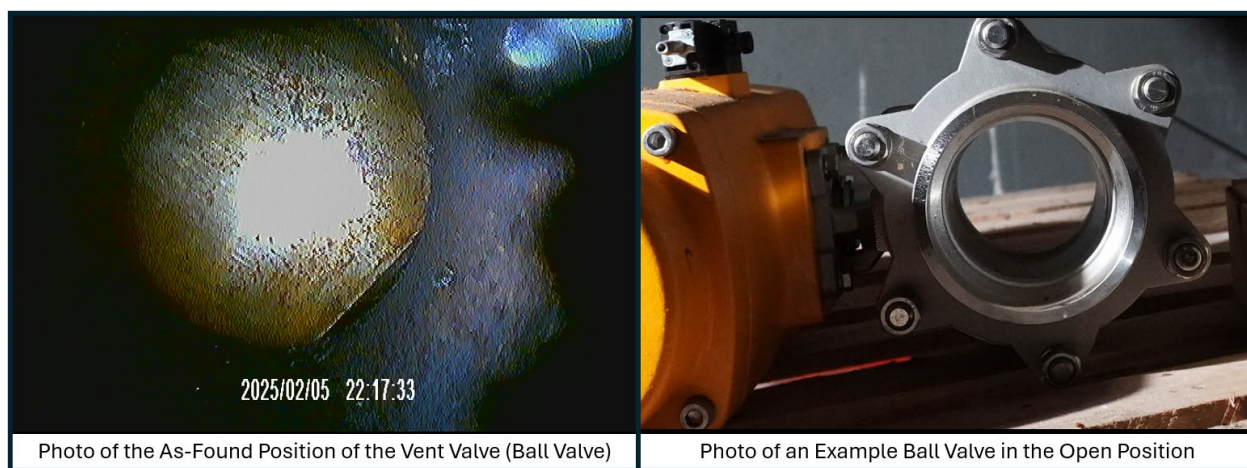
- After the incident, at the direction of the CSB, Givaudan inserted a borescope into piping connected to the recovered vent valve to identify the valve's position. Borescope photos show that, at the time of inspection, the vent valve is almost fully closed (**Figure 7**). The vent valve is a ball valve. When the ball opening is aligned with the attached piping, process fluid can flow through the valve. When the ball opening is perpendicular to the attached piping, process fluid cannot flow through the valve. Givaudan had specified that the vent valve actuator was to be configured to "fail open,"<sup>a</sup> meaning that the valve should automatically open in the event the instrument air pressure to the actuator was lost [14] [15]. The CSB will inspect the recovered vent valve actuator as part of the ongoing investigation.

**Figure 7.** Photo of the as-found position of the vent valve (left), and photo of an example ball valve in the open position (right). (Credit left photo: Givaudan; Credit right photo: CSB)
