## Historic Landmarks and Preservation Districts Commission

### Report to Committee

**Case No:** 23-COA-0018  
**Classification:** Committee Review

**Property Address:** 285 Pope St.

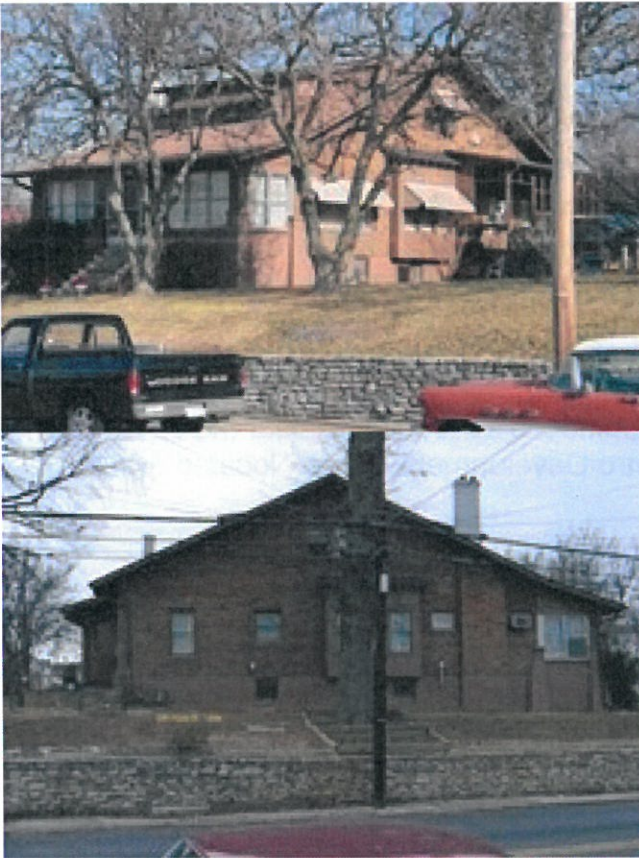
Figure 1 and 2. Designation Photos of 285 Pope St.

The project generally does not meet the Clifton Preservation District design guidelines for **Paint and Coatings** and **Masonry**. The brick on the house and garage had never been painted (**Figure 1 and 2 below**), with the exception of the porch parapet walls, porch columns, chimney, and first level bay projections. Thus its painting does not conform with guidelines **P1** and **M1** (**Figure 3 below**).

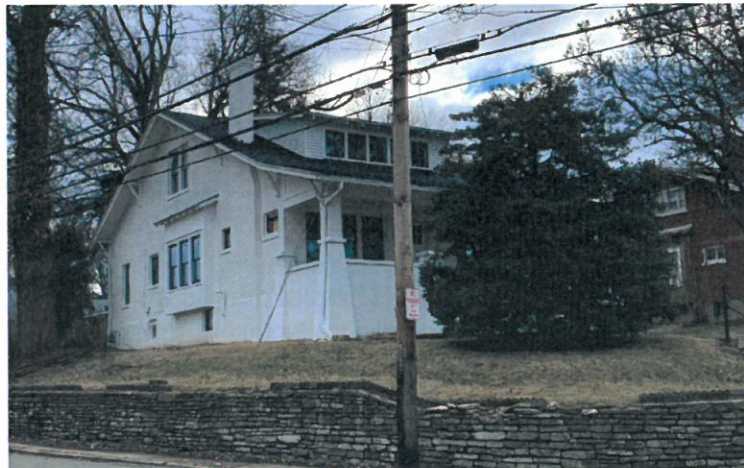
Figure 3. View of 285 Pope St. from Brownsboro Rd.

| | Guideline | Finding | Comment |
|---|---|---|---|
| <b>P1</b> | Do not paint masonry, stucco, limestone walls, and masonry-retaining walls that have never been painted. Painting unpainted surfaces creates an on-going maintenance issue. Paint is difficult to remove, accumulated layers will obscure decorative detail, and paint coatings (even "breathable" paints) will affect the wall's vapor transmission performance. A masonry surface colored with a wash (lead oxide, white or lime wash) is considered as unpainted and should not be painted. CMU (concrete block) should be skim coated then painted. | - | Unpainted brick was painted. |

1. The paint shall be removed from the bricks. The applicant shall test gentle treatments to remove the paint in an inconspicuous location.
2. Landmarks staff shall be consulted for recommended products. The applicant shall not sandblast, pressure wash or use acid-based cleaners to remove the paint. Solvent-based chemical strippers are preferred over sandblasting or pressure washing the masonry surface.
