## Historic Landmarks and Preservation Districts Commission

### Report to the Committee

**Case No:** 18COA1115  
**Classification:** Committee Review

**Property Address:** 608, 610, 612, 614, 616 W. Breckinridge Street

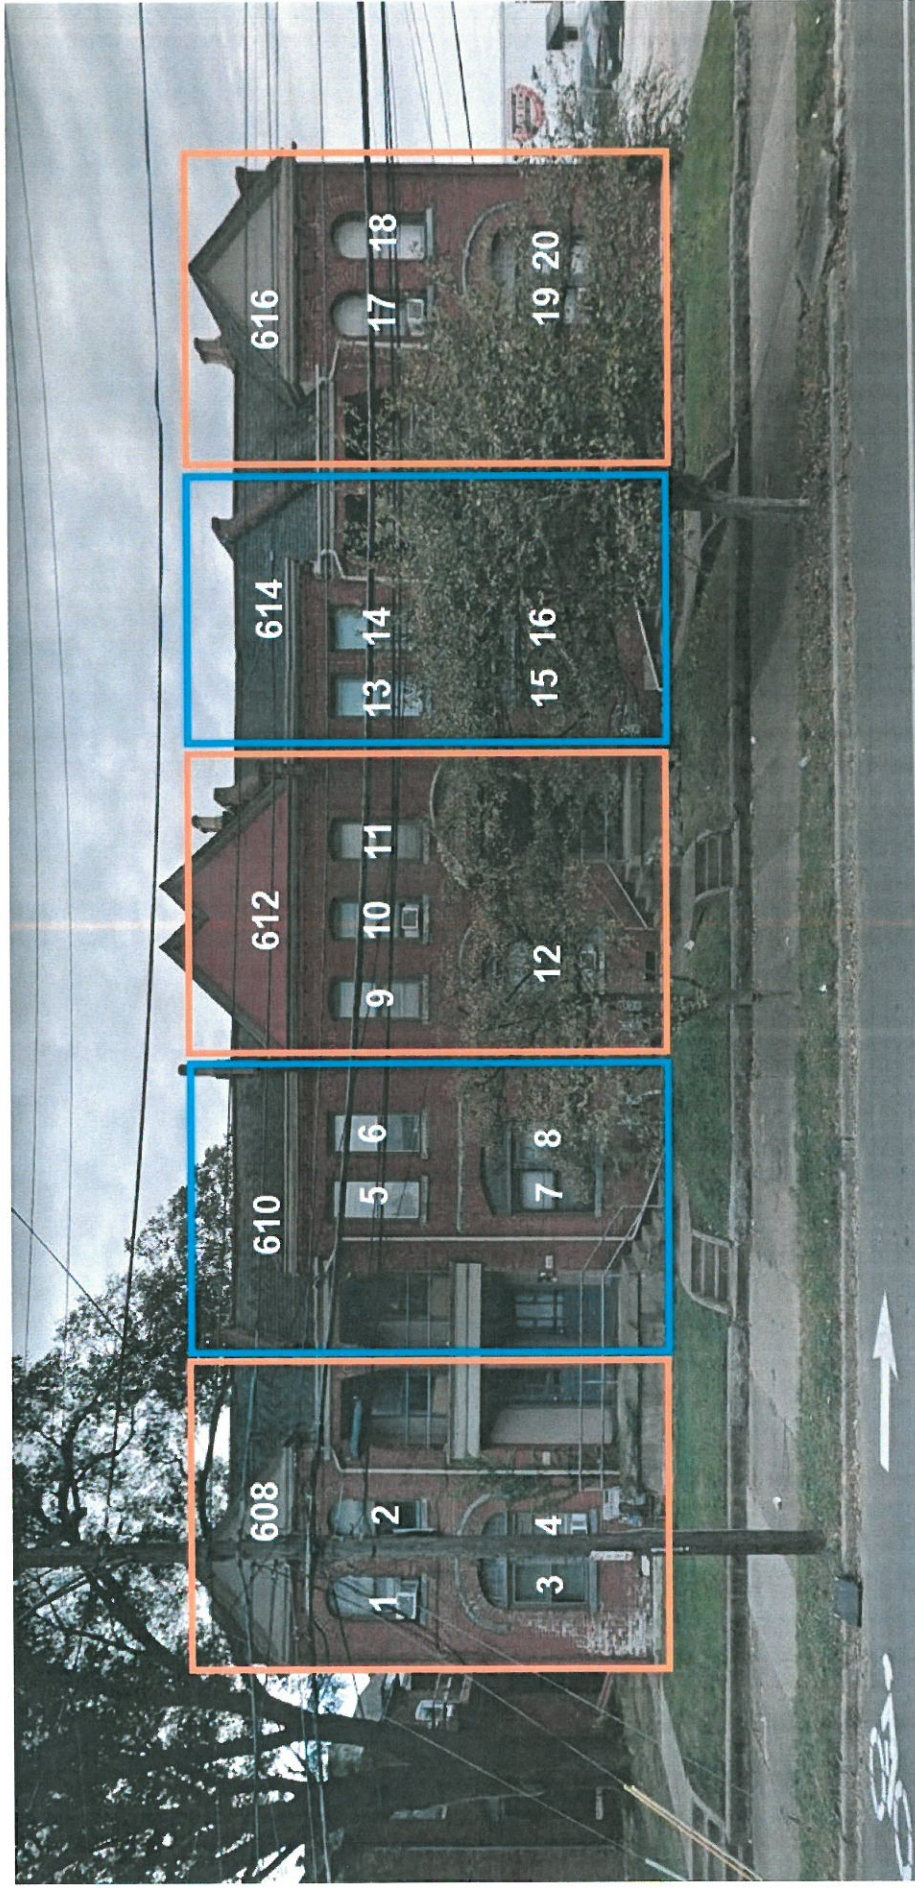
Figure 3. Window Key—2017 Google Photo showing the different addresses on the row house building and numbering the different windows.

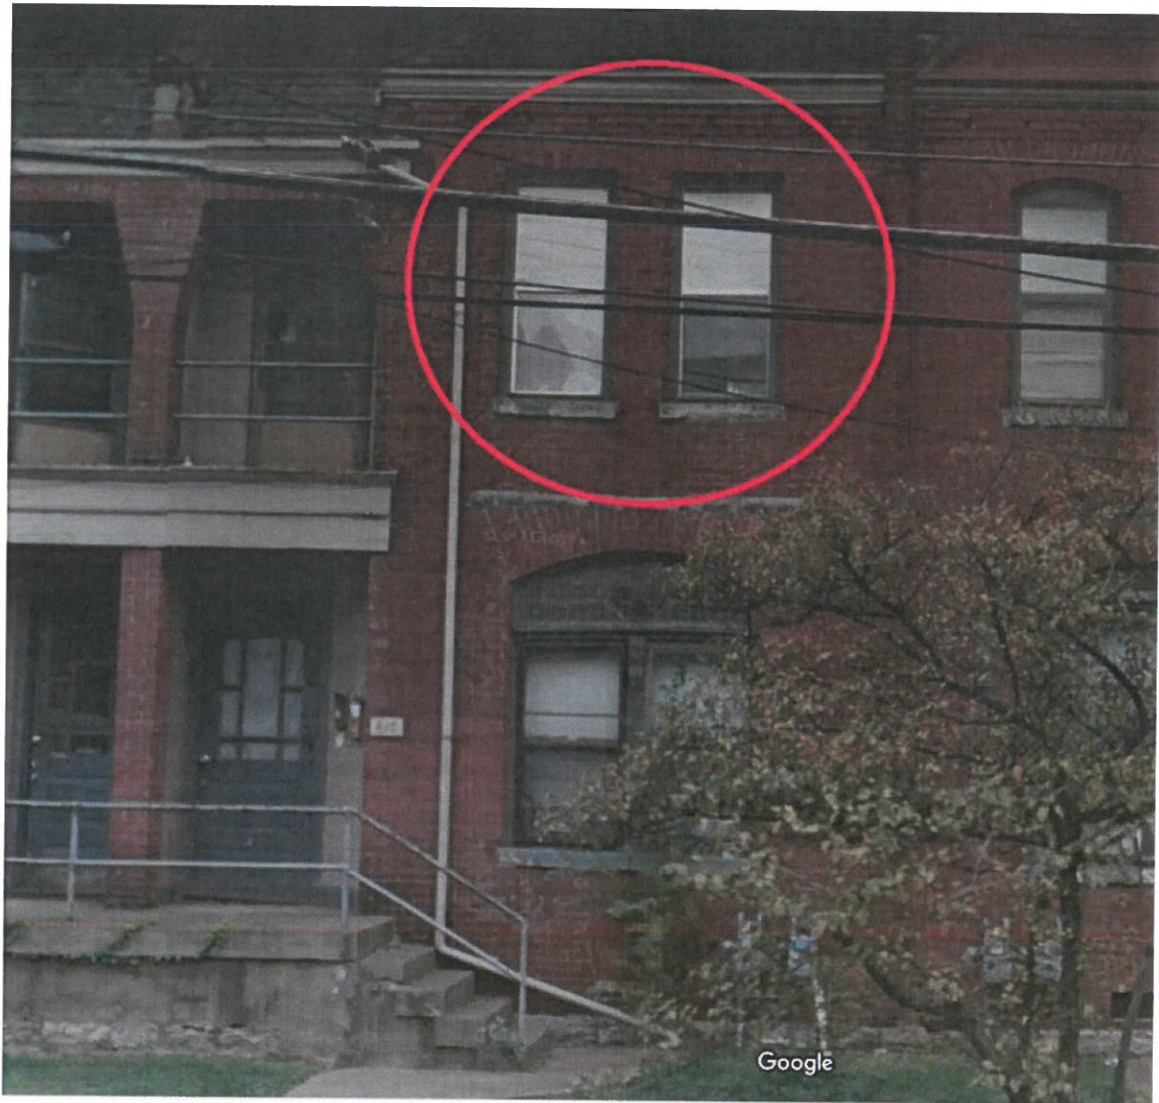
**Figure 7. 2017 Google Photo showing the pre-existing 1/1 double hung vinyl windows over 610 W. Breckinridge Street.**
