Tax Credit Review Process

Anderson Nelson Distillery
Louisville, KY

The Anderson Nelson Distillery Warehouse Tax Credit Application

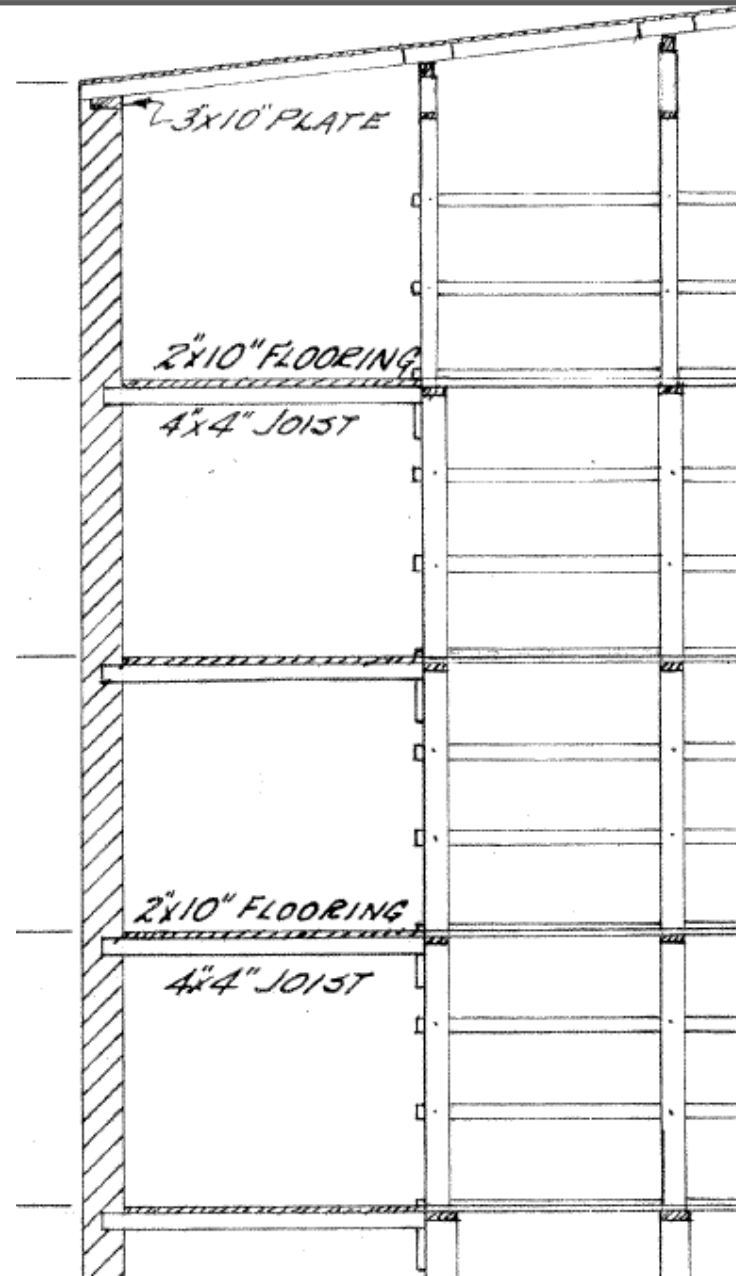
Skeleton Framing

The exterior walls and the roof are attached directly to the interior racking, providing strength and rigidity to the entire structure.

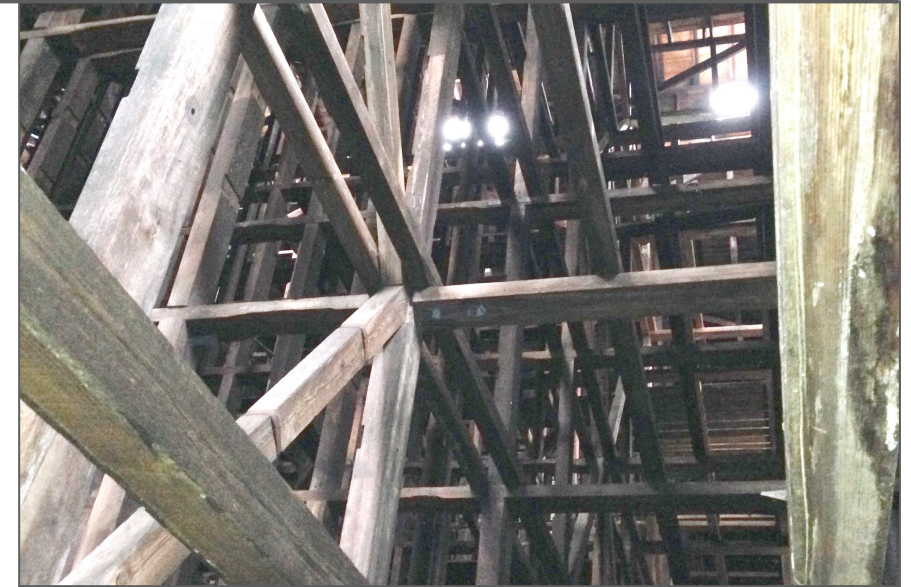
Skeleton Framing

The walls are attached to the skeleton framing throughout the structure, which also supports the roof. The density of the interior structure helps prevent warping and twisting.

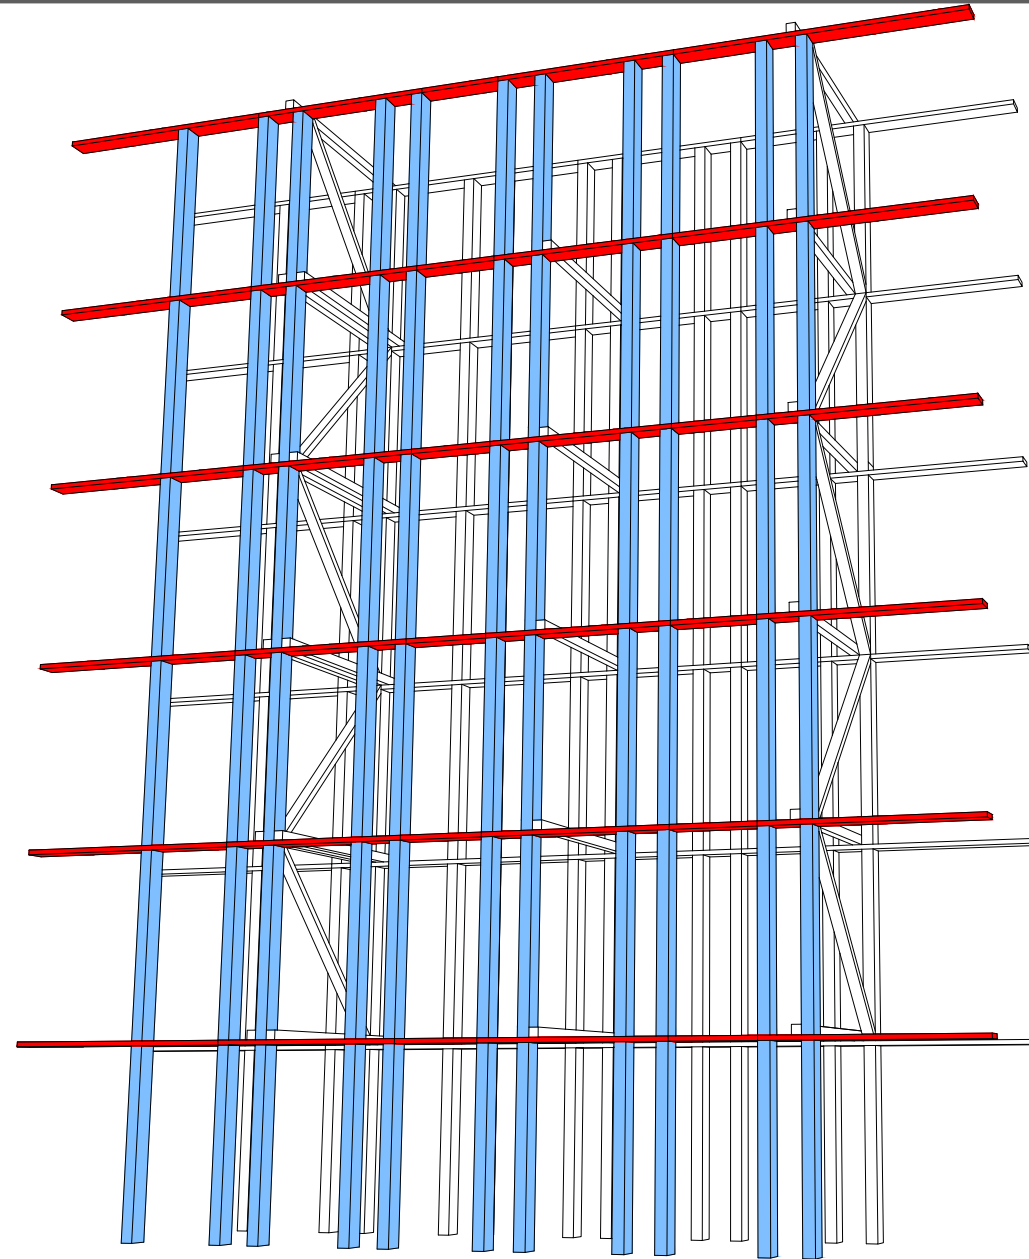
3D Rendering of 5 Columns Bays

The columns are separated every 6'-10" by a 3" plate that runs horizontally through the structure.

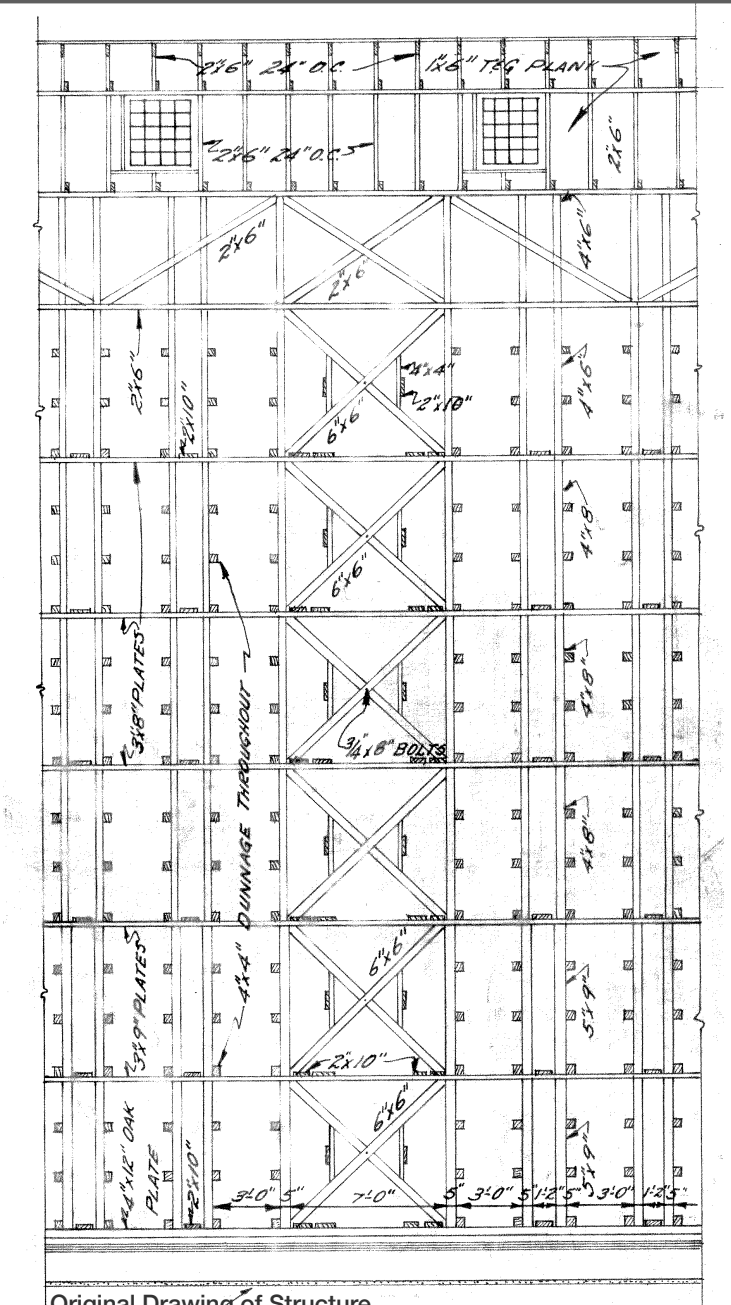
Original Drawing of Structure

The columns are separated every 7'-1" by a 3" plate that runs horizontally through the structure labeled as "3" x 8" plates."

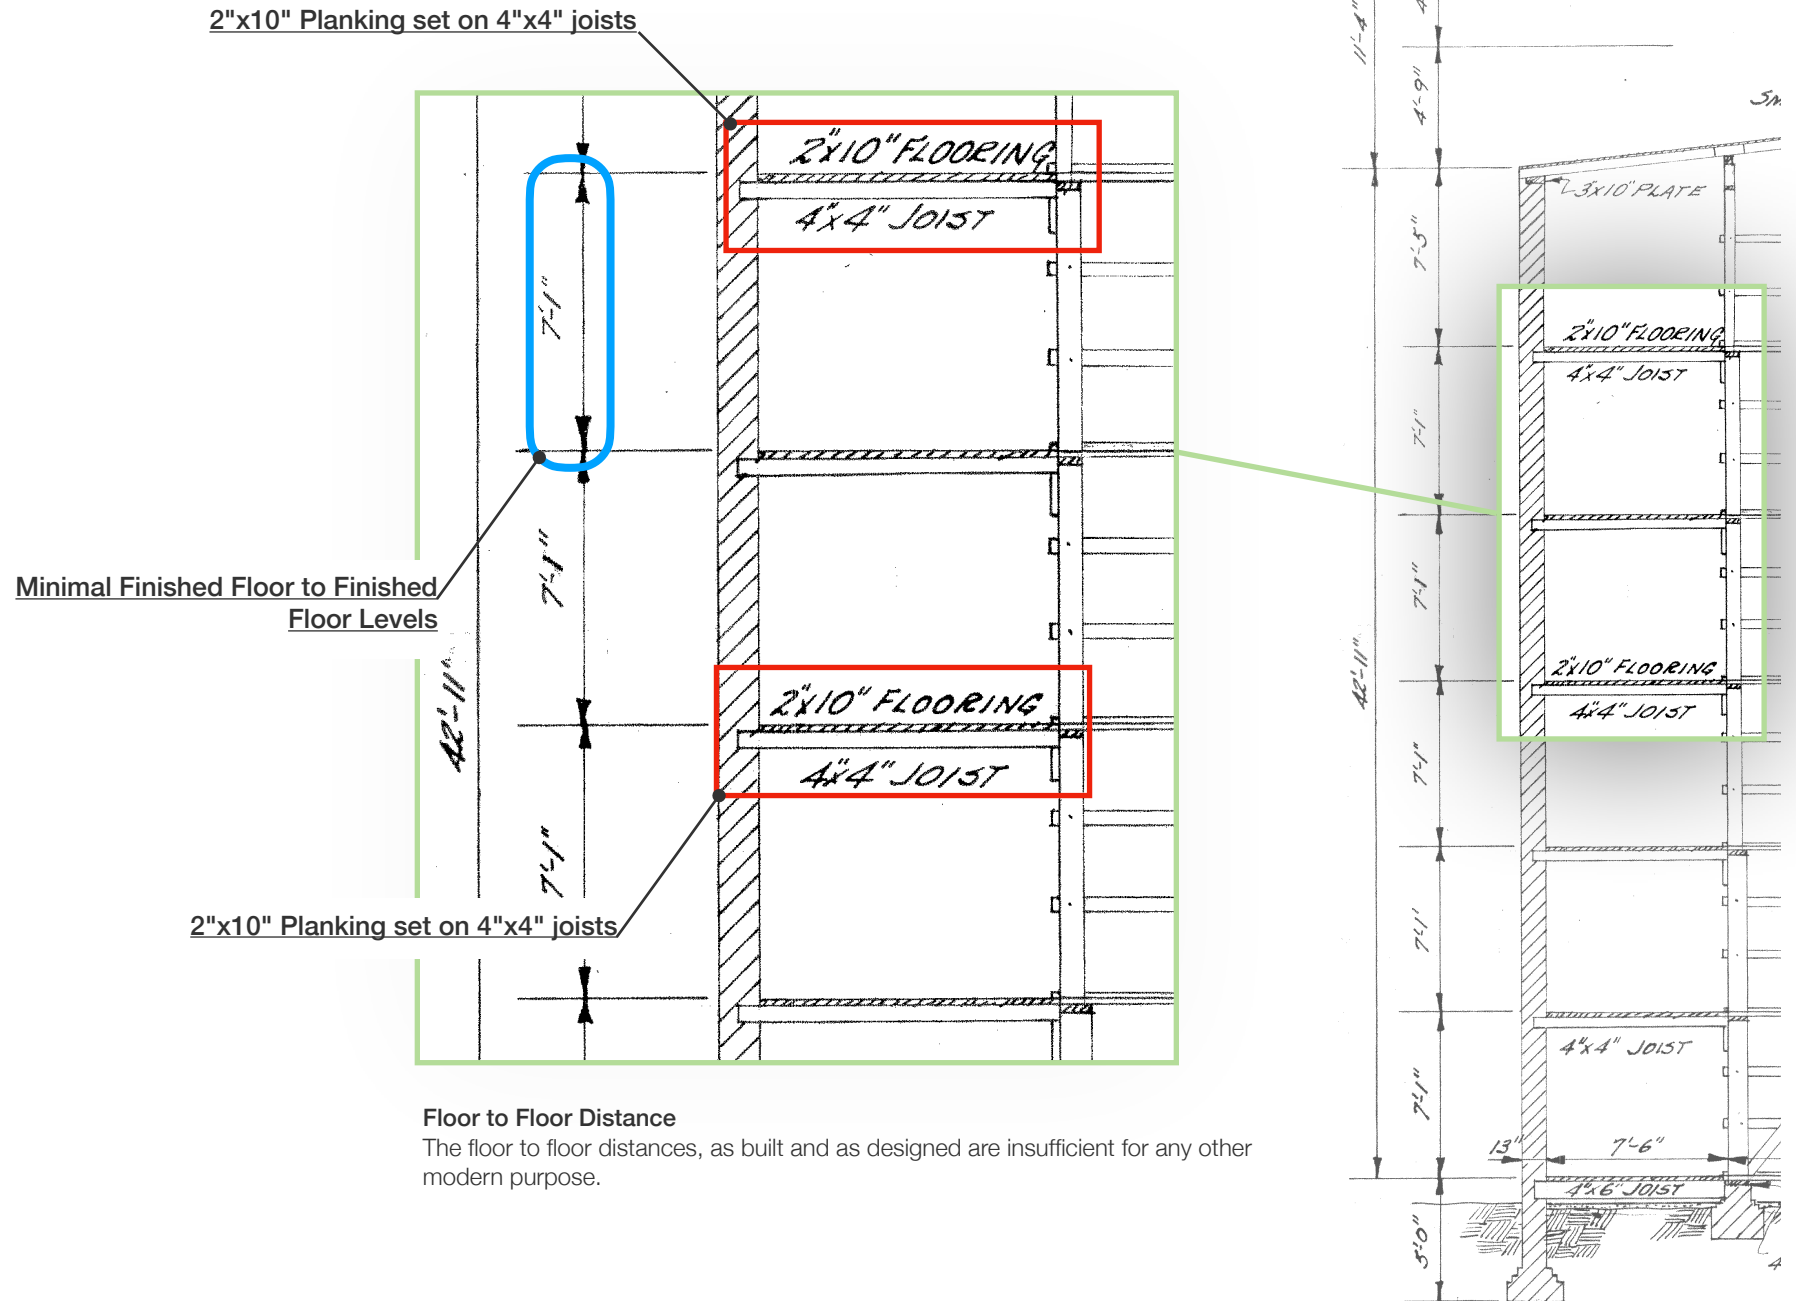
The historic materials and construction were designed for racking, not flooring. The areas where flooring was indicated in the original designs call for 2" x 10" floor planking, which would not meet modern code requirements. Additionally, the attachments between the racking and the exterior walls, the joists that would support the flooring, are 4"x4" and set 8' on center, which is structurally insufficient over such a distance.

In addition to the issue of an insufficient structure, the spacing between each floor, 7'-1" finished floor to finished floor, is far from meeting any modern code requirement. From that 7'-1" the calculated 2" in planking and the 4" joist must be subtracted. Without a finished ceiling this leaves only 6'-7" of clearance and this is the standard height on each floor, across the entirety of the building.

The result of this design is a building with insufficient spatial tolerances for any modern use.

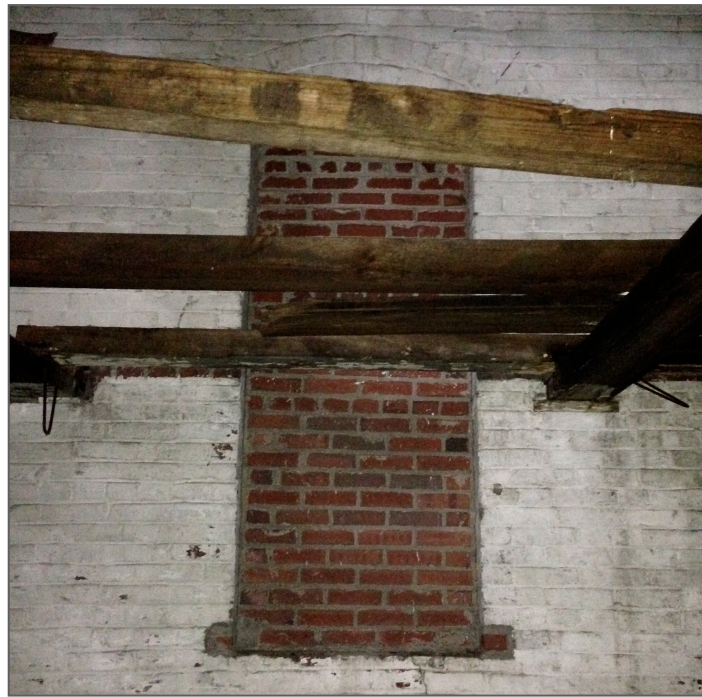
Bricked in Window Interior

Unfortunately two-thirds of the windows have been removed and infilled with brick. Not only were the windows removed, but the stone sills were also removed and infilled with brick.

The racking attachment to the wall is visible as well as the cross-bracing in the center of the window.

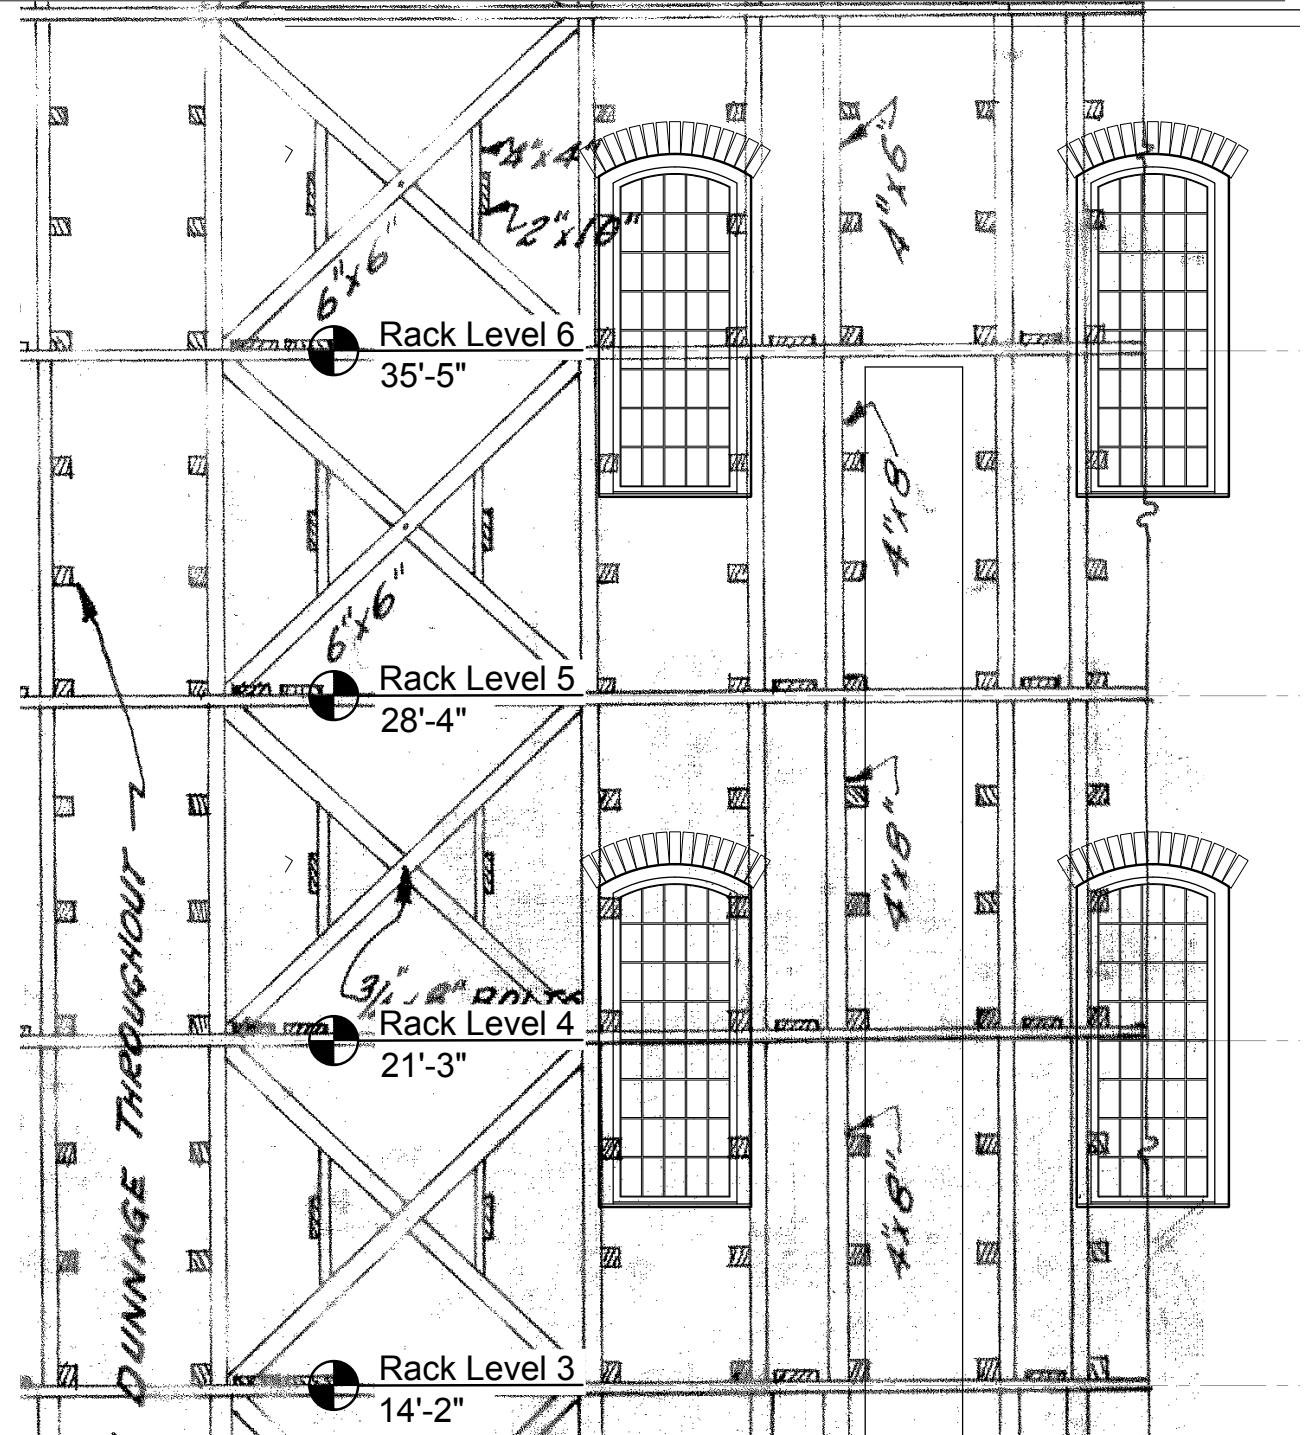
Relationship Between Window and Structure

The racking levels were designed to bisect the windows, making the installation of flooring impossible to achieve with any fire-rating.

The drawing at right is an overlay of the existing exterior elevation with the original drawings of the interior racking structure, aligned by rack level.

The windows are approximately 6'-6" tall, so even a close approximation of location reveals the windows are blocked by the required floor levels.

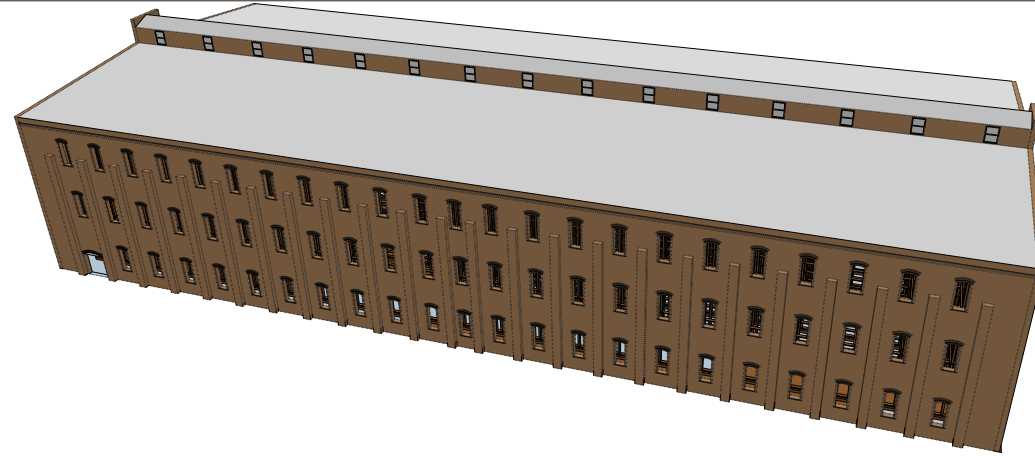
The Building as Currently Constructed

The building is in poor structural condition, but has mostly intact exterior walls, roofing, and rack system on the interior.

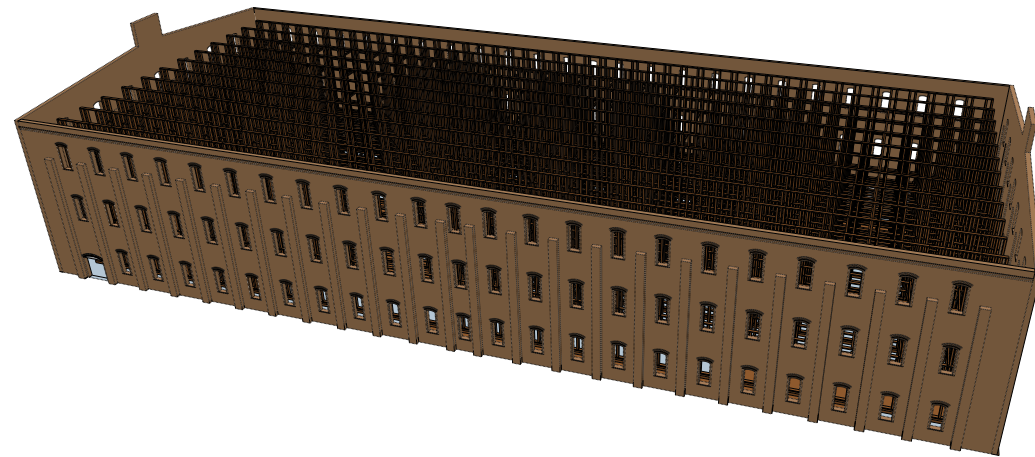
The First Phase of Demolition

The first phase of demolition will require the removal of the roof, which is supported by the interior racking system. Removal of the racking system would cause the roof to collapse without additional support or prior removal.

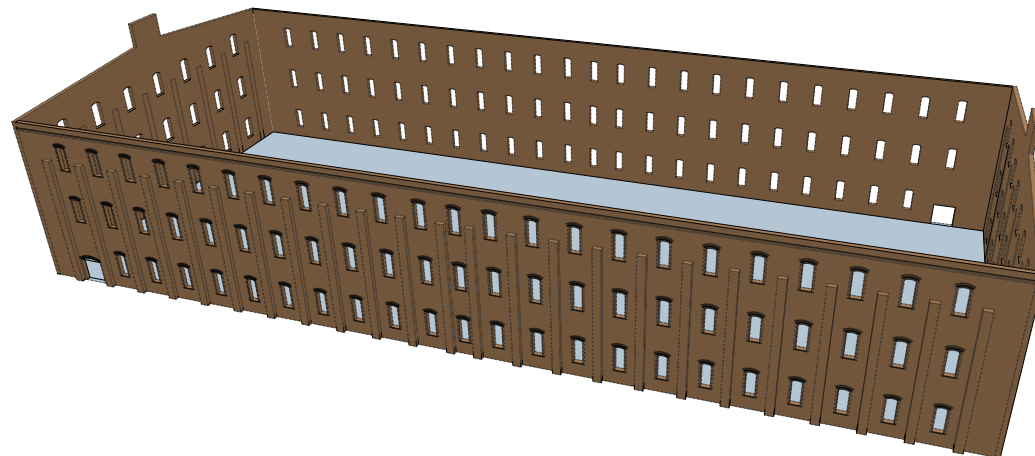
The Final Phase of Demolition Prior to Construction

At some point during demolition, even with temporary interior supports, the entirety of the building will only consist of the exterior walls. At this point the only remaining historic materials will be the exterior brick walls.
