**Landmarks Certificate of Appropriateness &  
Overlay District Permit**

Case No.: 18COA-1305 Intake Staff: NH

Project Name: Repair of roof rain water drainage systems.

Project Address / Parcel ID: 1201 S. 3<sup>rd</sup> St., Louisville, KY / 032800110000

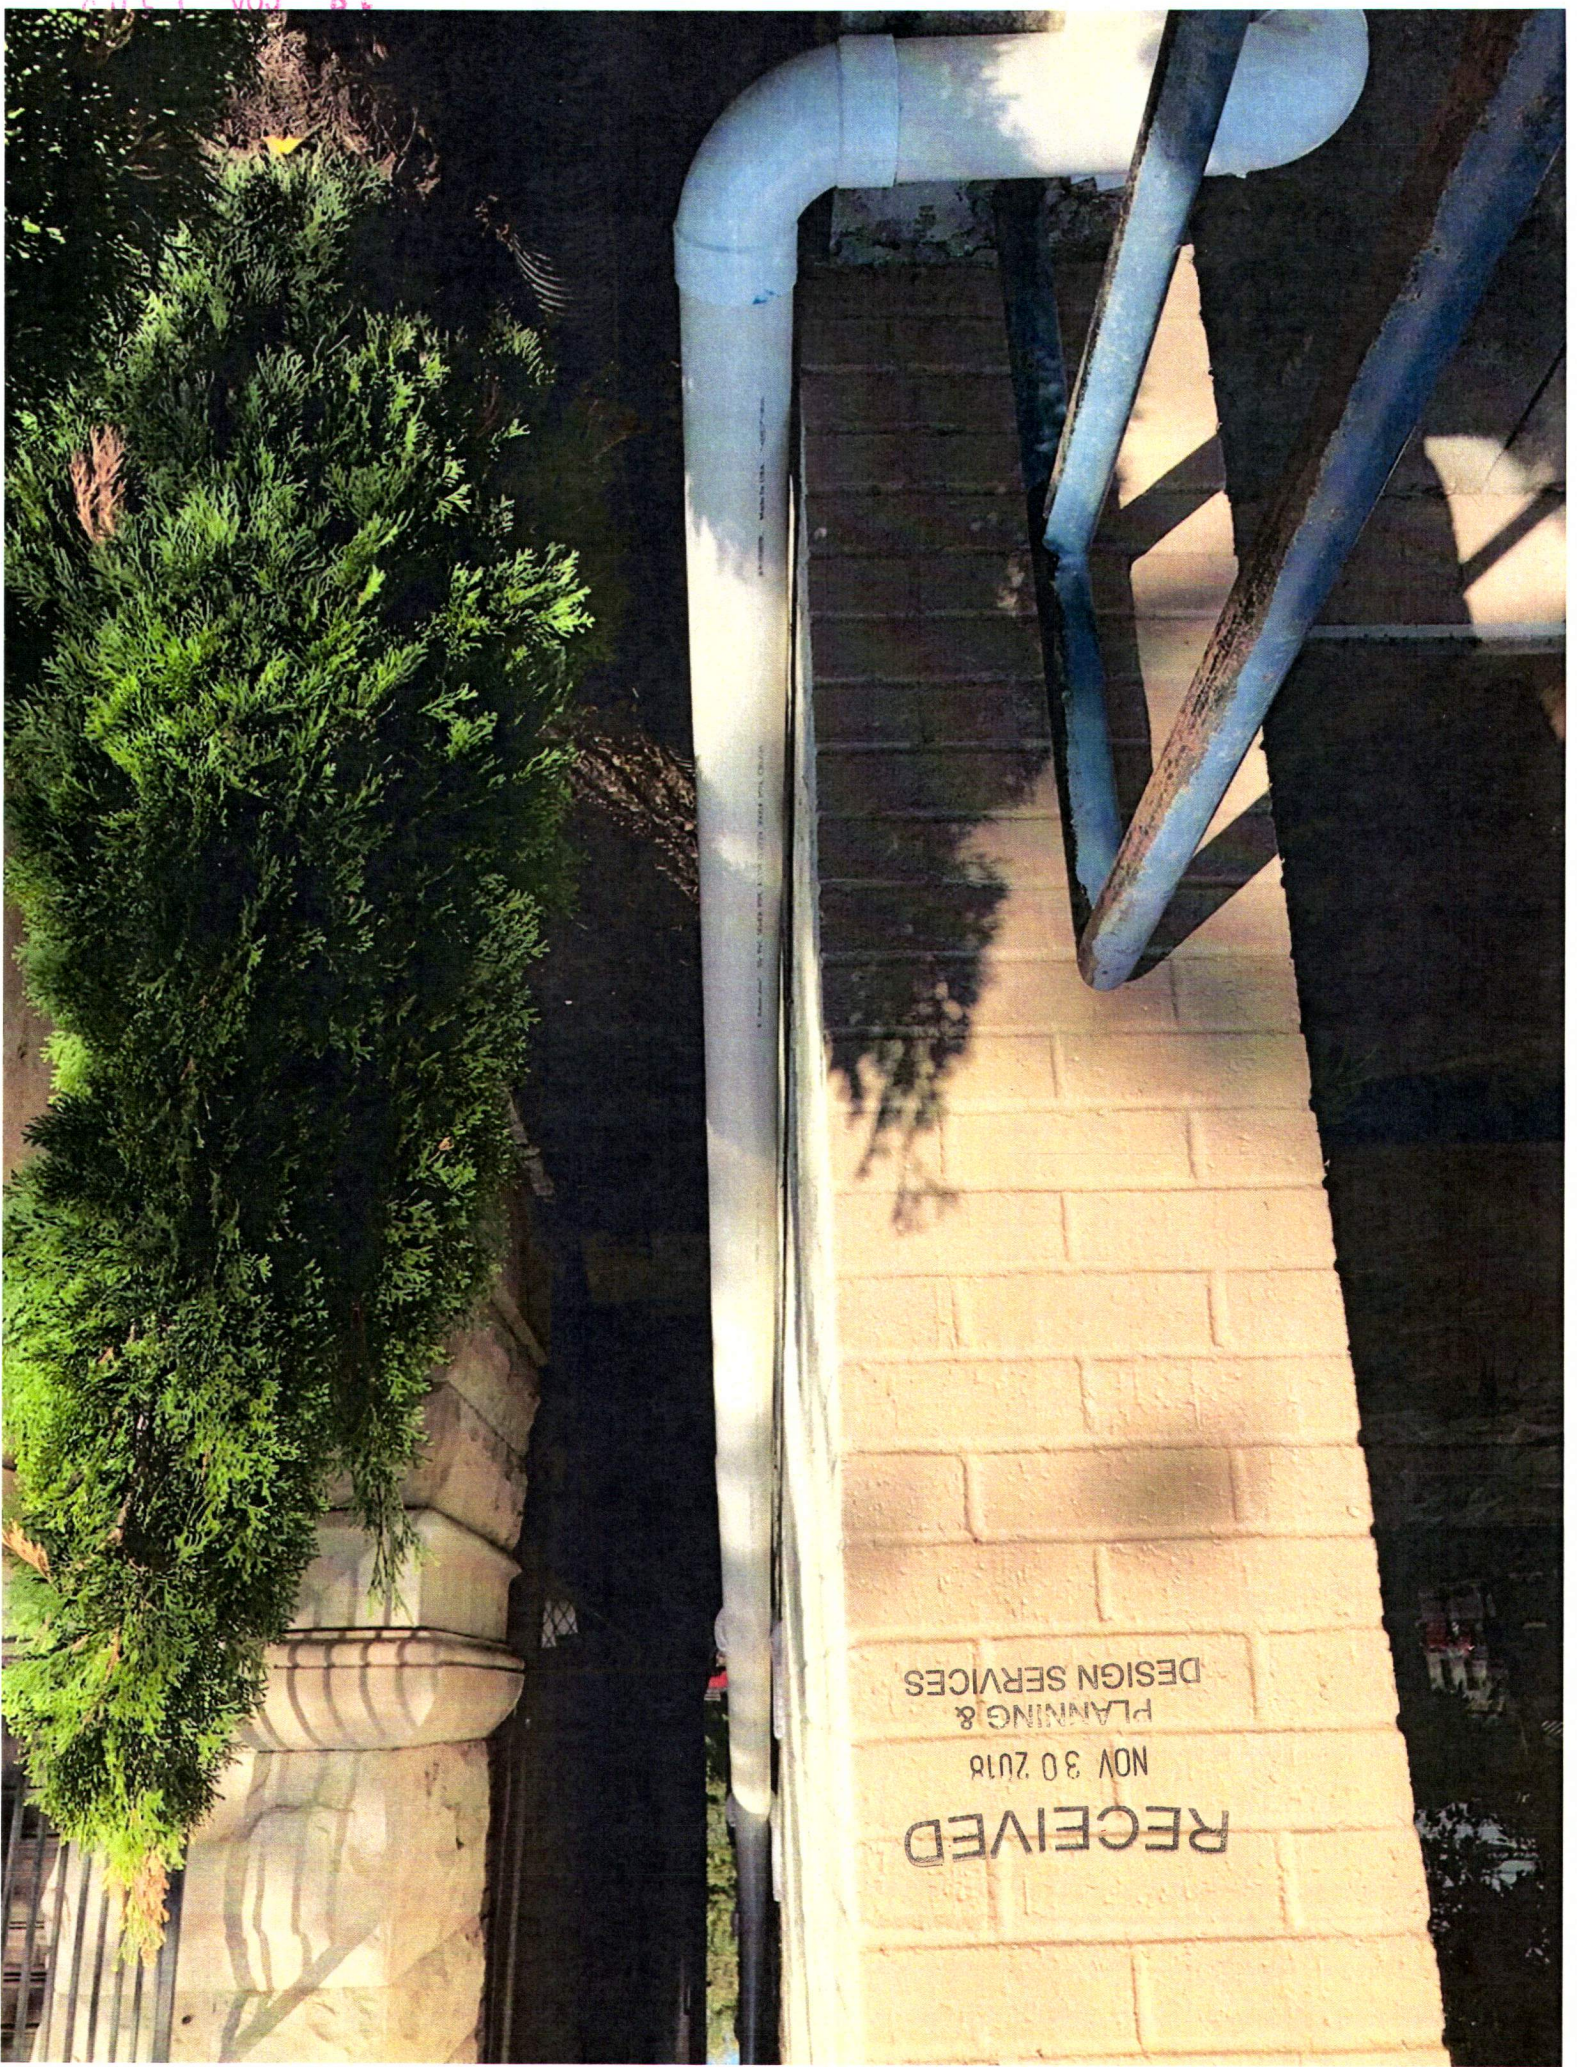
Please see the photos (West Drainage System 1, 2, and 3) of the repaired West water drainage system as it now stands. This presently constructed West water drainage system consists of 4 inch diameter pipes, the same as in the original, damaged water drainage system. The only modification from the original water drainage system is the diagonally sloping downspout pipe instead of a vertical pipe to improve the water drainage. This presently constructed West water drainage system is representative and the example of what I am asking a Certificate Of Appropriateness for regarding both drainage systems. The only thing left to be done on this West water drainage system is to paint it to blend in with the building that it is attached to. This West water drainage system has not been painted and the damaged East water drainage system has not yet been repaired/constructed because the adjacent land owner has now refused me unlimited access to my building's exterior South wall (see below explanation).

In reviewing the attached photos, please note in the West Drainage System 3 photo of the repaired West water drainage system as it now stands that there is a black flexible hose partially buried in the ground. This is no part of the present, repaired water drainage systems I am seeking a Certificate Of Appropriateness for. This said hose is a remnant of my original, destroyed water drainage system that has been drug over on to the adjacent land owners property and partially buried by him. Because of his refusal to let me or my representatives on to his property (see below explanation), I have been unable to remove this unused, discarded hose.

The repaired East water drainage system is to be the same as the repaired West water drainage system illustrated in the attached photos with one exception: The slope of the downspout will be down from West to East, the reverse of the East to West downward slope on the already constructed, repaired West water drainage system. We do intend, at ground level, and as originally constructed, to attach a flexible hose to the bottom end of this repaired East water drainage system to drain the water in to the alley East of my building.

This is the preferred C.O.A. being requested. The proposed redesign and rerouting of the present roof water drainage systems will remove the two roof water drainage systems on the building's exterior South wall (See photos: West Drainage System 1, 2, and 3). The new roof water drainage system will use two roof drains as in the present system. Each drain will be connected at its bottom to a drainage pipe. These two drainage pipes will lie under the roof, inside the building, and out of sight as in the present two systems. Each drainage pipe will then connect to a vertical downspout which will emerge in to outside view through the soffit of the mansard roof and run vertically down to and end at the ground. Both visible downspouts will be made of metal guttering downspout material, colored similar to the downspout guttering on the adjacent old building (See photo: Adjacent Property Downspout Color). The location of both downspouts on either the East, North, and/or West exterior walls of the building will be determined by the contractor hired to complete the job.

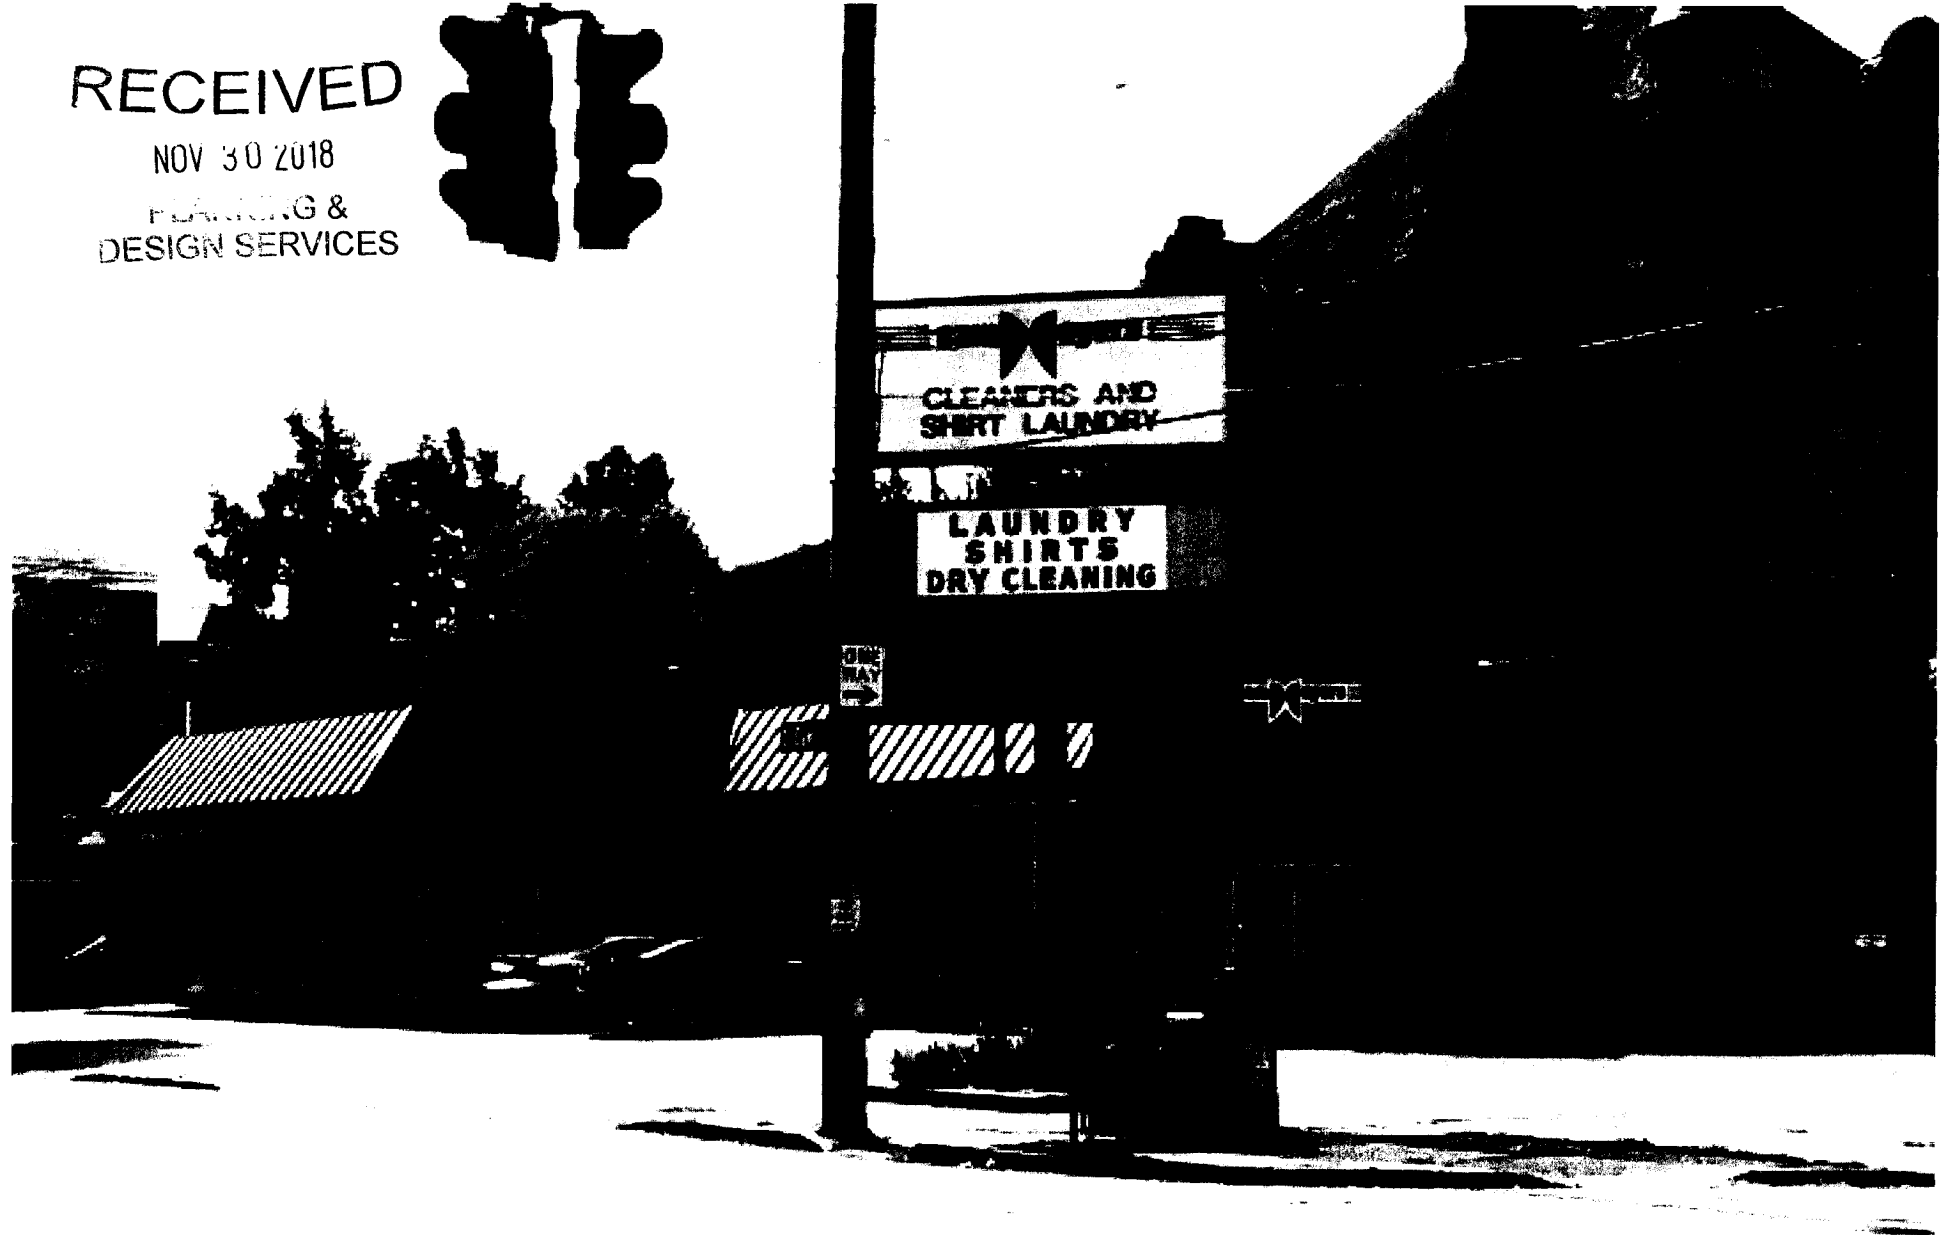
In summary, the only proposed exterior change in appearance to the building (See photos: Laundry 1, and Laundry 2) will be the removal of the two existing downspouts on the exterior South wall of the building and replacing them with two vertical downspouts on the exterior East, North, and/or West walls of the building. All of the drainage water in this proposed system will drain on to the asphalt parking area North of the building.
