# Landmarks Certificate of Appropriateness & Overlay District Permit

Project Name: Gratz Garage

Project Address / Parcel ID: 2424 Longest Ave / 075K00330000

## STRUCTURAL ASSESSMENT REPORT

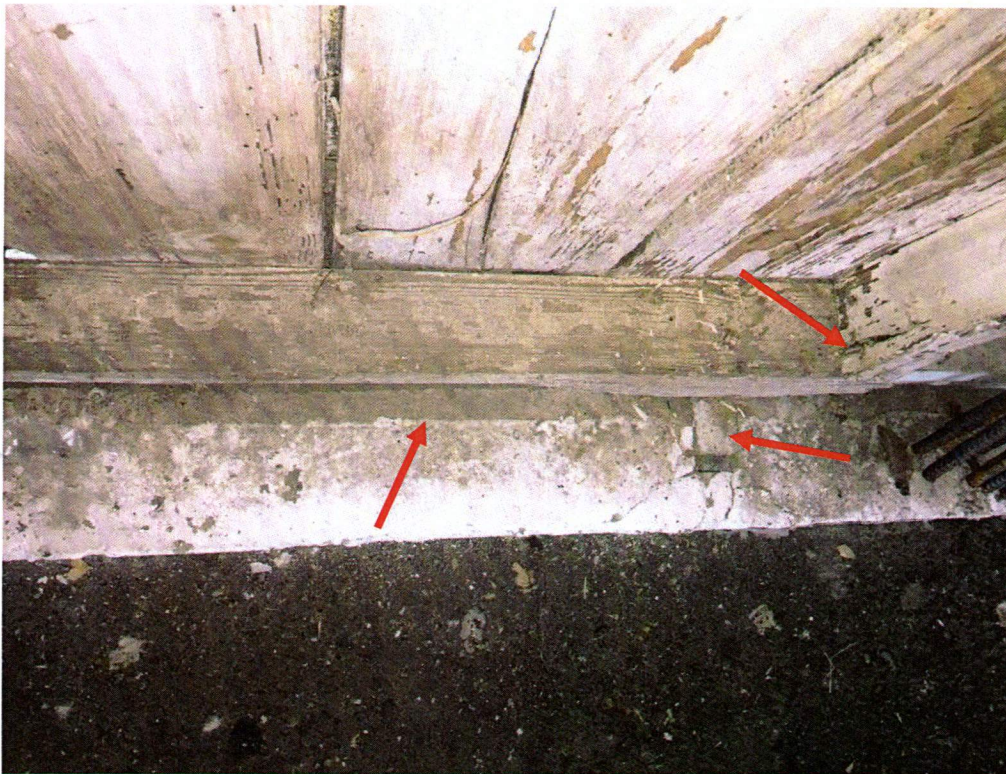
Aside from the roof truss condition, the anchorage of the walls to the foundation is woefully inadequate. Though the wall anchorage itself can be readily updated, the wall construction in total is insufficient and must be rebuilt to provide a minimum acceptable level of lateral stability to the code-required wind and seismic loading conditions.

Photo 6: wood block embedded in foundation. Paint line shows shift in wall alignment and another damaged stud.
