Demolition Appeal

2130 New Main St.
Louisville Ky
40206

RE: Existing Residential Structure
2130 New Main Street
Louisville, Kentucky

Wood Destroying Insect Inspection Report

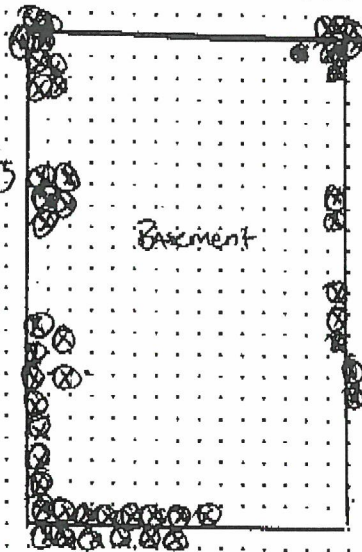
Graph

⊗ = DAMAGE

⊗ = Termite + Moisture Damage
to floor joist, sill plate, Bandboard,
Subfloor, window sills, wall studs
Paint + Drywall, trim, general framing

Possible Hidden Damage
