# Landmarks Certificate of Appropriateness & Overlay District Permit

Project Name: Gratz Garage

## STRUCTURAL ASSESSMENT REPORT

Structural Assessment Report  
2424 Longest Avenue  
Louisville, KY 40205  
**Error! Reference source not found.**

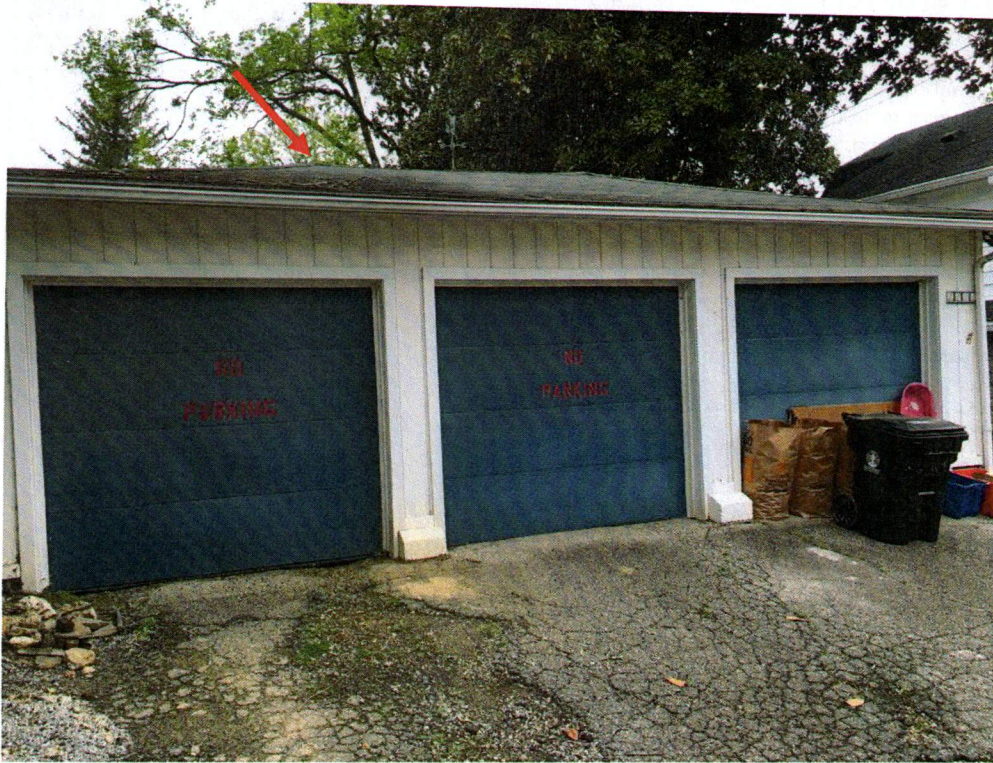
1. The hip roof construction consisted of field-fabricated wood trusses spaced at approximately 4'-0" on center. The top and bottom chords of the trusses were 2x4's and the web members were 1x6's. All of the trusses were sagging in the center of the garage; however, the left end of the ridge has sagged more severely than the rest of the roof.
2. The bottom chord of the truss at the left end of the ridge was found to be cracked. That same truss had a broken diagonal that had been reinforced at some point in the past with a 1x8. The trusses appeared to be assembled with side nailed connections between the chords and the diagonals.
3. The sagging of the trusses is severe enough at the left end of the ridge that the 1x8 used for the bottom chord center lateral brace has detached from the truss and caused a split in the bottom chord.

The condition of the garage roof and wall framing is such that the majority of the garage would need to be rebuilt to be deemed a safe structure. None of the wood framing observed would be considered acceptable by building code standards. The broken truss at the left end of the roof ridge is in danger of collapse. If this truss does collapse, it is likely that the rear wall will partially collapse at a minimum and it is conceivable that the entire garage could collapse. This condition obviously poses a risk to neighbors and anyone else using the alley.

Photo 1: View of the rear (alley side) of the garage. Roof sag is visible on left side of ridge.

1. The broken truss at the left end of the ridge should be shored and reinforced with a solid 2x4 as a temporary measure to prevent collapse.
2. It is recommended that the garage be demolished and rebuilt. In my opinion, this would be the safest course of action to provide a structure that would meet the building code mandated minimum construction conditions that would prevent future risk of collapse, ensure safe usage by the owners, and safeguard anyone in the alley around this structure.

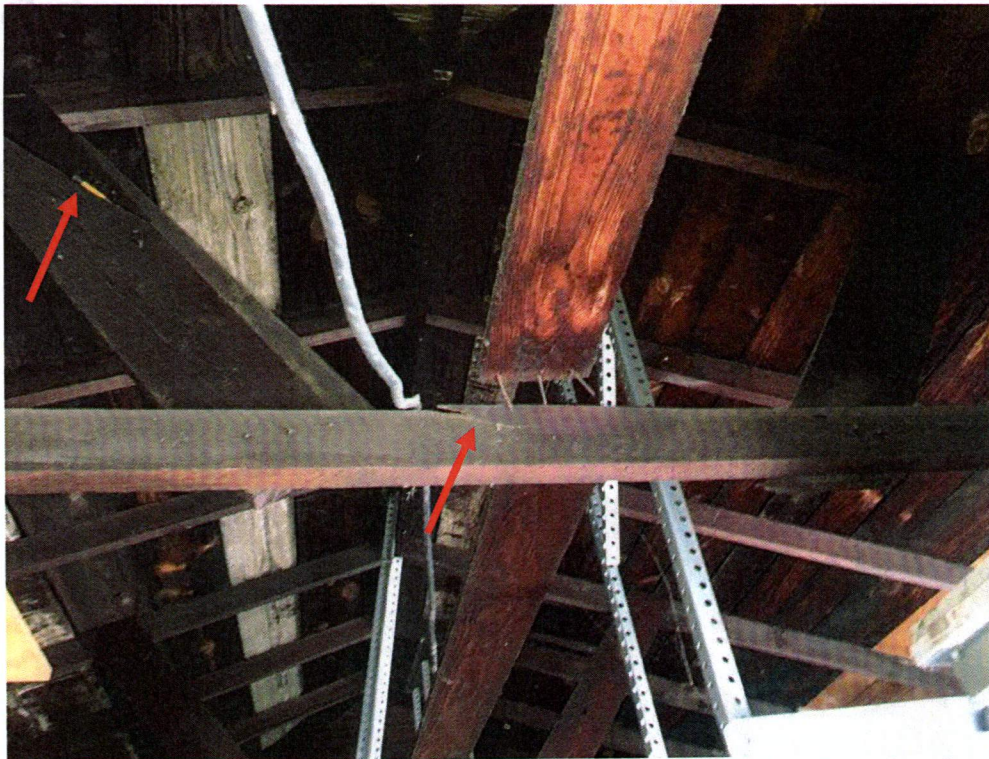
Photo 2: Detached bottom chord brace, cracked bottom chord, and reinforced broken diagonal member.

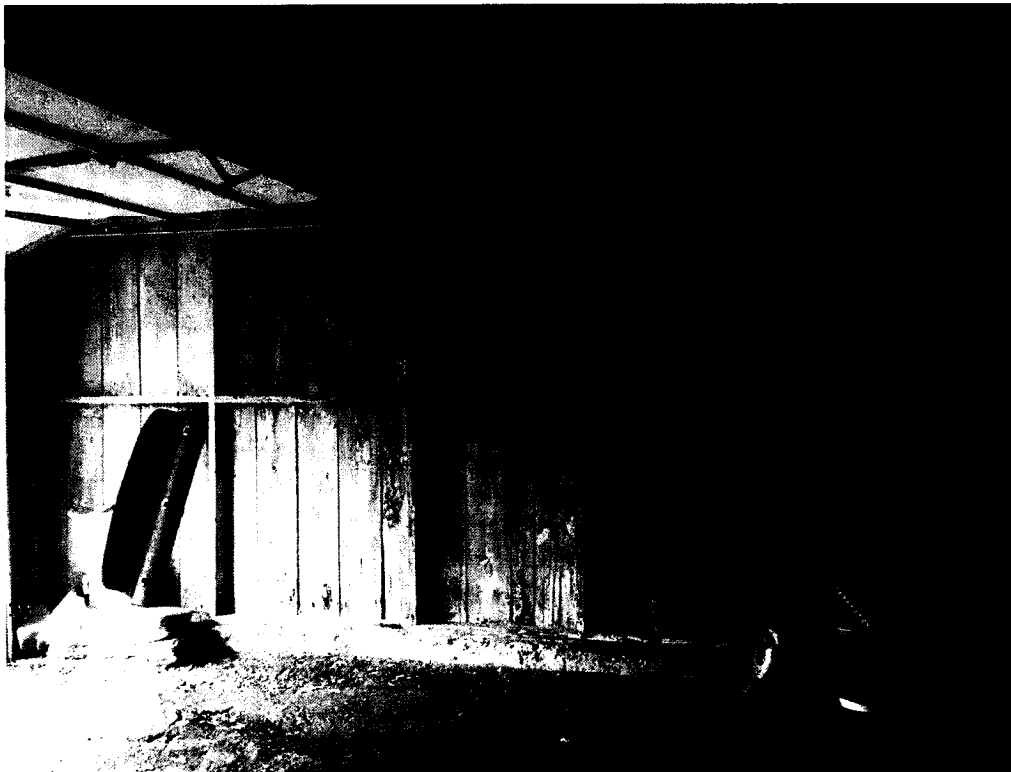
1. The walls were constructed with 2x4's spaced at 48" o.c. and 2x4 blocking at mid-height. The walls were sheathed with 1x8 planks oriented vertically. The exterior finish was painted T-111 paneling.
2. A parking mishap had caused the bottom of the wall to push out toward the back yard and crack along the grain of the stud.
3. The studs were connected to a continuous 2x4 sole plate bearing on a foundation wall rising about 8" above the garage floor. The sole plate was anchored to the foundation with nails that were driven into wood blocking embedded into the top of the foundation wall.
4. Various degrees of termite damage was observed at various locations in the wood-framed walls.
5. There were no headers installed over the windows and man door in the front and side walls. The rear wall appeared to have been reconstructed with headers over the overhead doors.

Photo 4: Typical wall construction. Notice there is no header over the window.

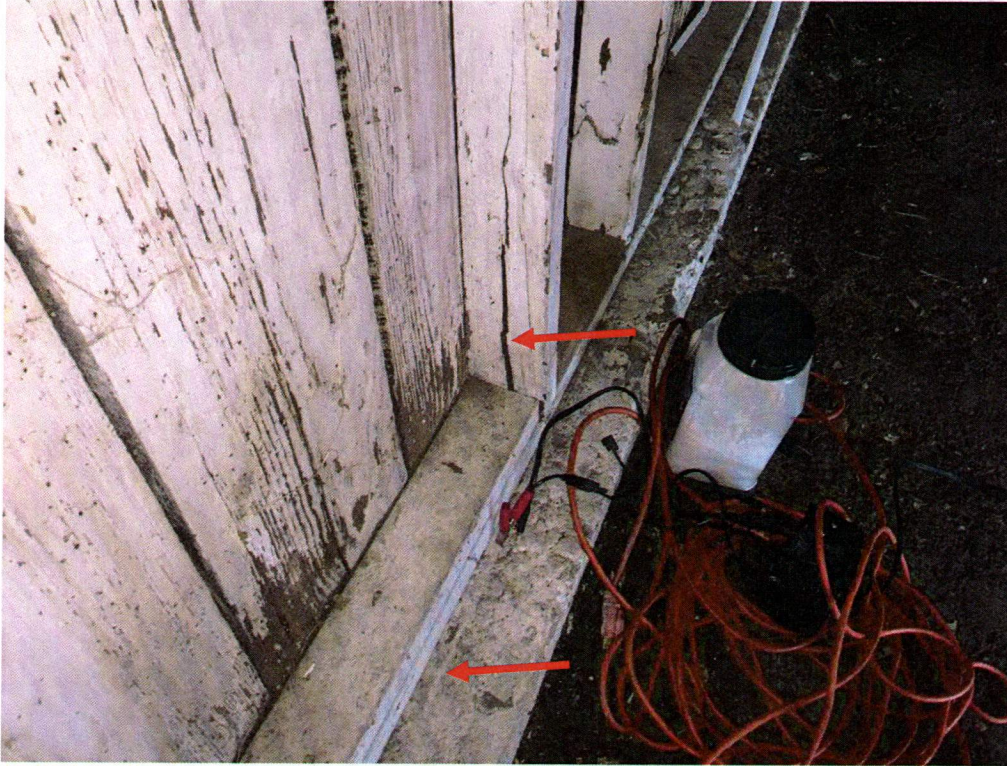
Photo 5: Broken stud due to parking mishap. Wall is shifted along this section of the garage.

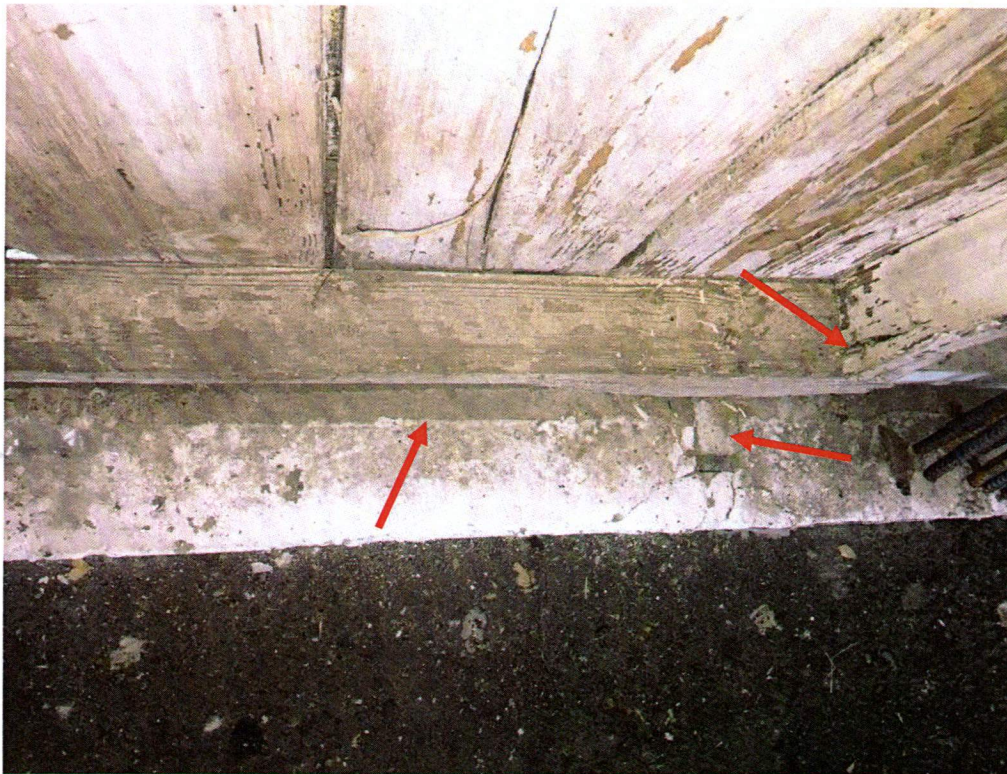
Aside from the roof truss condition, the anchorage of the walls to the foundation is woefully inadequate. Though the wall anchorage itself can be readily updated, the wall construction in total is insufficient and must be rebuilt to provide a minimum acceptable level of lateral stability to the code-required wind and seismic loading conditions.

Photo 6: wood block embedded in foundation. Paint line shows shift in wall alignment and another damaged stud.

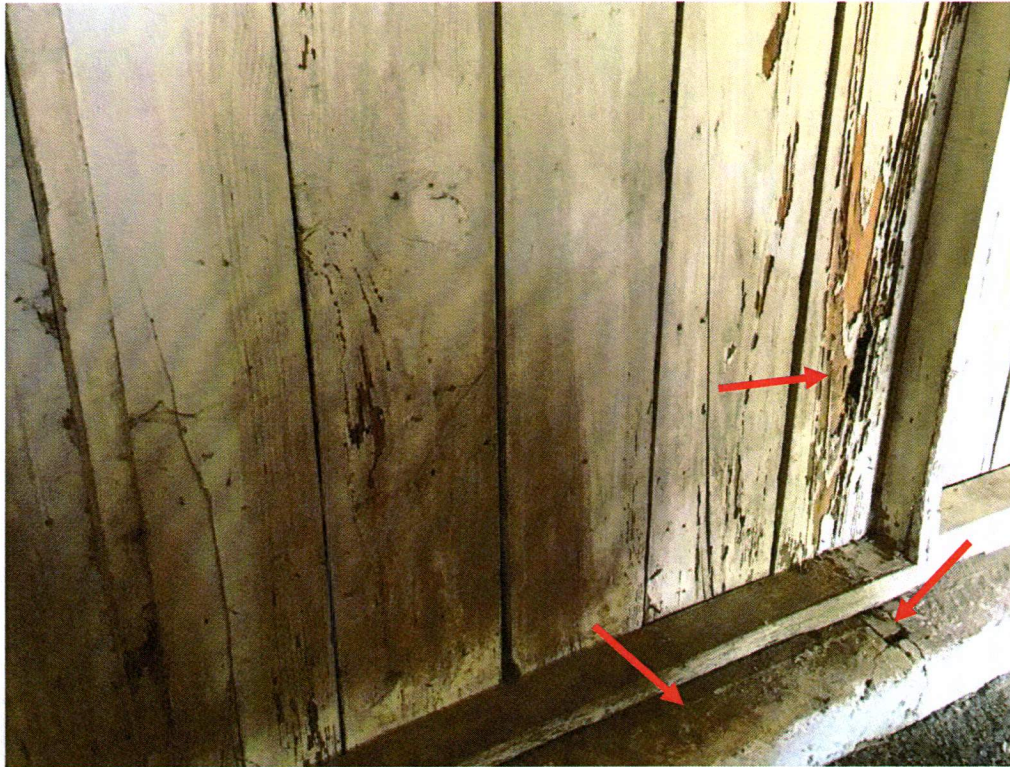
Photo 7: Another view of the wood block in the foundation, shifted wall and termite damage is visible in the sheathing.

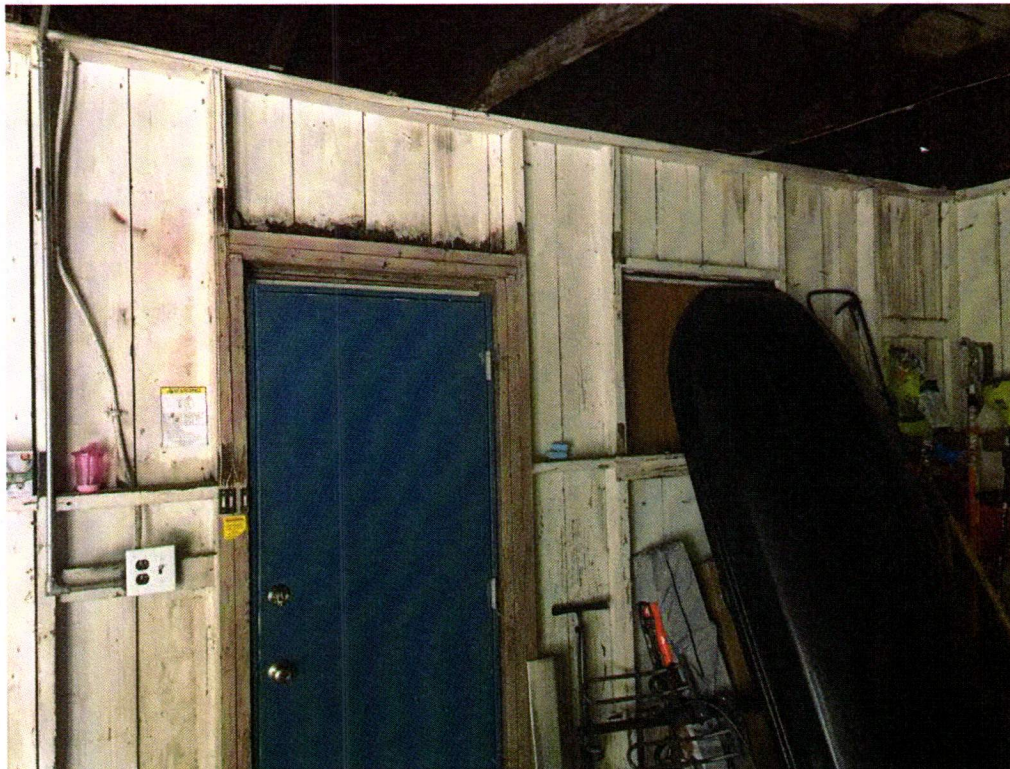
Photo 8: No headers constructed over windows or man door.
