Historic Landmarks and Preservation Districts Commission

Report to the Committee

Case No: 18COA1115
Classification: Committee Review

Property Address: 608, 610, 612, 614, 616 W. Breckinridge Street

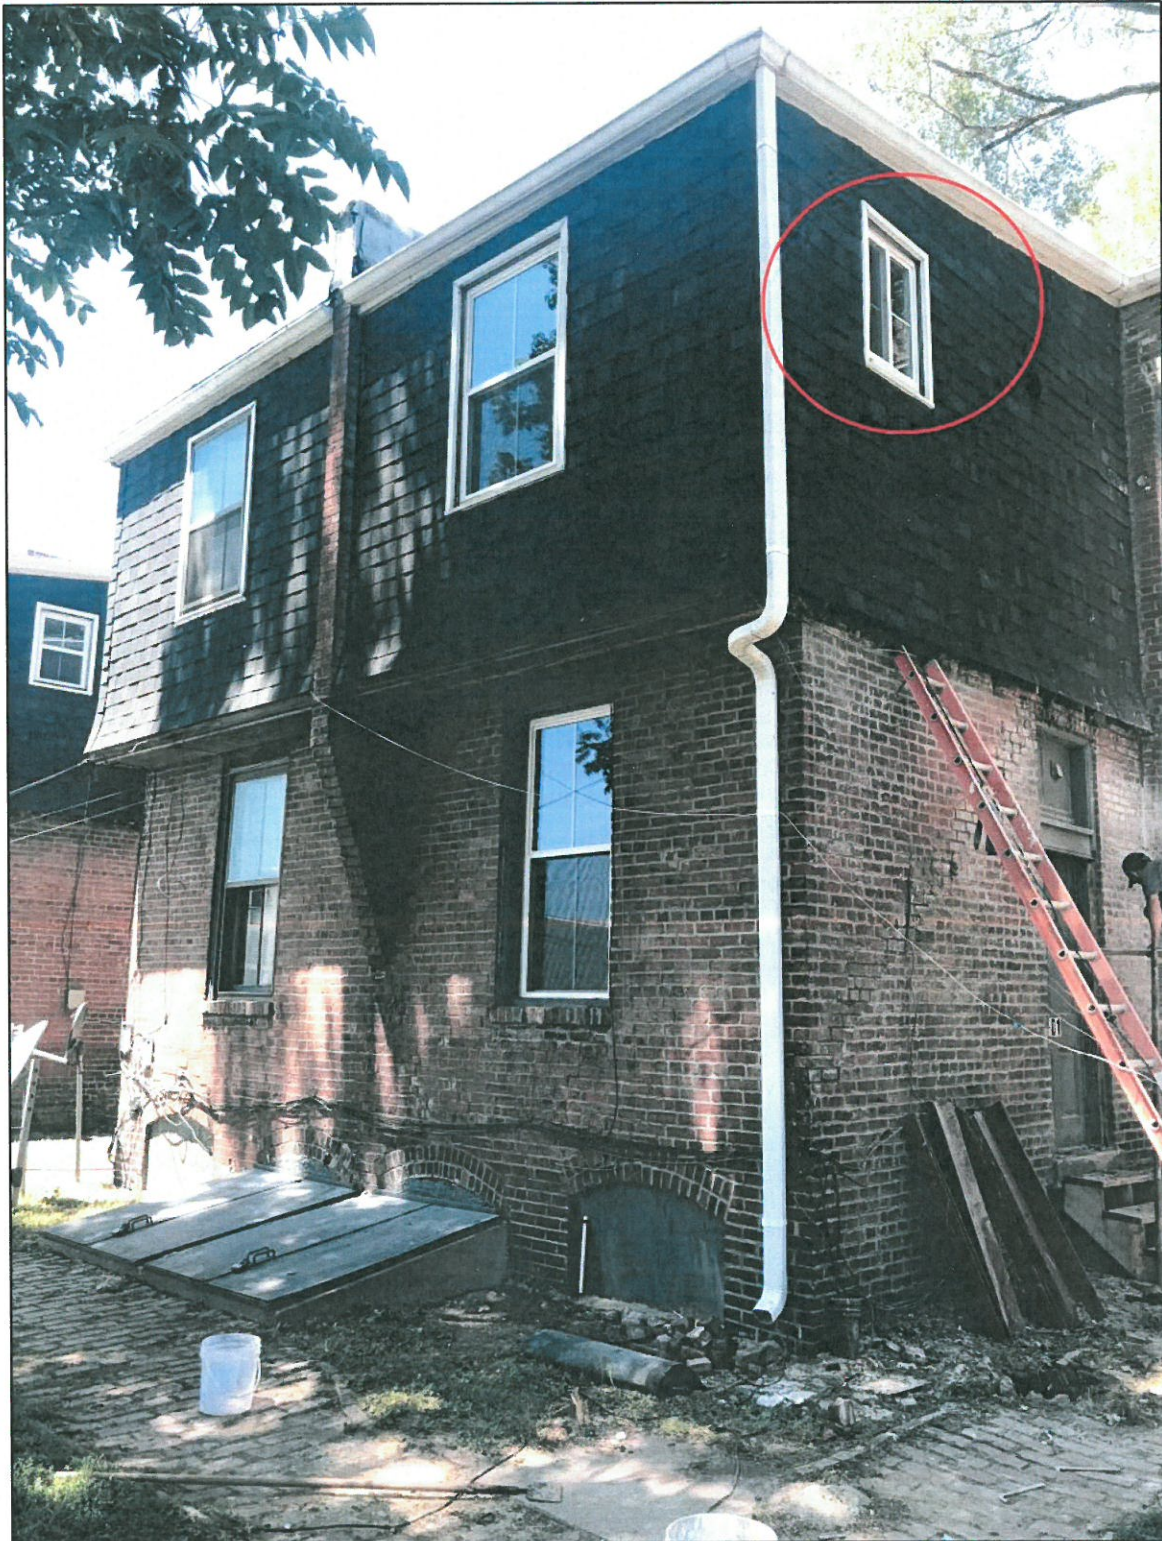
Sides and rear elevation windows: The proposed sides and rear elevation window replacement generally meets the Limerick Design Guidelines for **Window**. Even though most of the replacement occurred before the window conditions could be assessed, the replacement windows mimic the historic 2/2 double hung windows and fit the historic window openings. However, there is one replacement window on the east elevation of the rear that staff recommends replacement. It appears that one 2/2 double hung vinyl window was turned on its side and installed as a sliding window (**Figure 1**). This is not appropriate as it

does not meet the design guidelines with its horizontal muntins. The window should be replaced with a new sliding window with no muntins. Some of the rear window concrete and/or limestone sills had been replaced with brick window sills. Staff recommends that the remaining concrete and/or limestone sills on the rear elevation be preserved. They should not be replaced with brick sills as this is not an appropriate sill treatment on a historic structure.

Figure 1. The 2/2 double hung vinyl window that was turned on its side and installed as a sliding window.

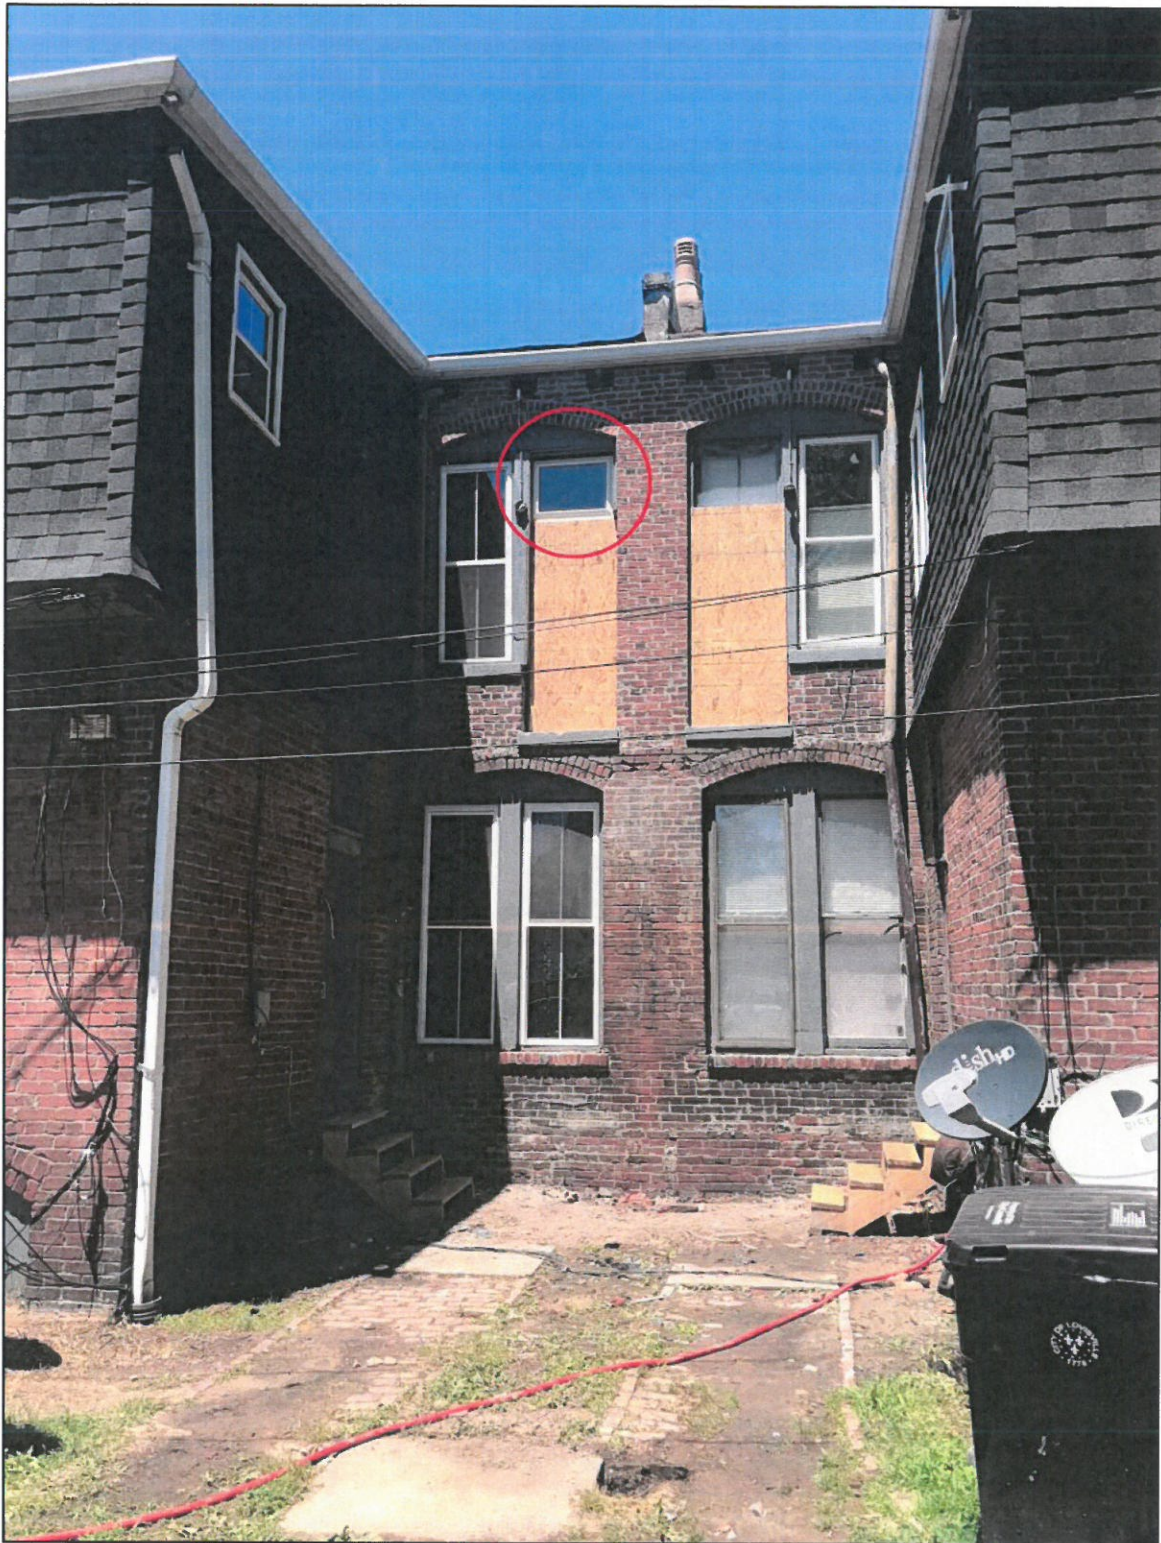
The sliding windows on the side elevation are an acceptable replacement for the historic casement windows despite their difference in function. The central, vertical divider is present in both the historic casement windows and the vinyl sliding windows, which is more important than the function. The proposed transom window replacement on the rear elevation is an improvement as many of the transoms are either missing or boarded over. Based on the existing transom windows, it appears that they had a central, vertical muntin making them two-lite windows. However, the one new transom is a one-lite transom that does not match (**Figure 2**). Staff recommends approval as long as all replacement transom windows, including the one already installed, have a central, vertical muntin to replicate two-lites.

Figure 2. The new transom that is a one-lite transom.

1. All replacement windows shall fit the historic window openings by matching the shape and size of the historic windows.
2. The replacement transom windows shall match the size and shape of the historic transom windows and have one central, vertical muntin making them two-lite windows.
3. The already installed replacement transom window shall be replaced to meet condition 2.
4. The 2/2 double hung vinyl window that was turned on its side and installed as a sliding window (east elevation) shall be replaced with a new sliding window with no muntins.
5. The remaining concrete and/or limestone sills on the rear elevation shall be preserved. They shall not be replaced with brick sills.
6. If the design or materials change, the applicant shall contact staff for review and approval.

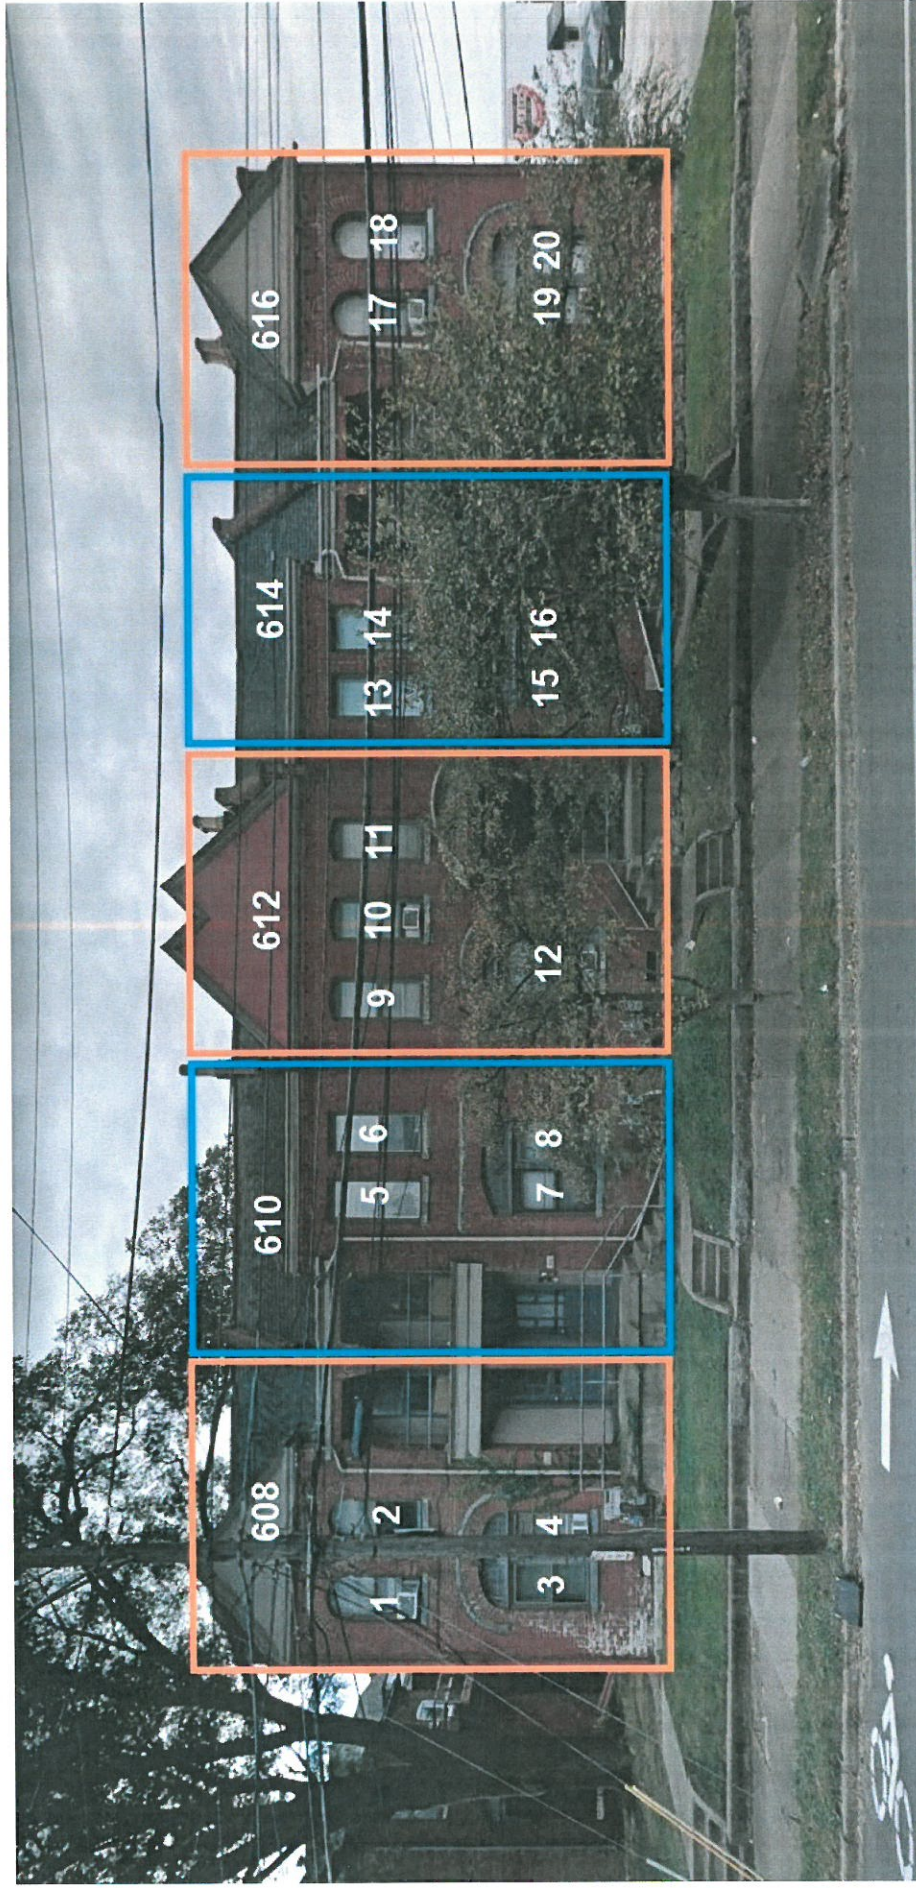
Front façade windows: See **Figure 3** for a key of the windows discussed below. The windows that were replaced prior to the stop work order include numbers 1, 2, 3, 4, 9, 10, 11, 12, 15, and 16. The proposed front façade window replacement does not meet the Limerick Design Guidelines for **Window**. The historic windows on the front façade were a mix of rectangular and arched double hung windows. All of the windows were 1/1 meaning they had no muntins. Historically, solid sheets of glass for 1/1 windows were more expensive than the smaller panes for multi-pane windows, which is why 1/1 windows were located on the front façade and multi-pane windows were located on the side and rear elevations. The replacement windows on the front façade are all 2/2 double hung vinyl windows, which do not match the historic windows or meet Guideline W2 or W6. The replacement windows are somewhat tinted and reflective, which does not meet Guideline W10. The second story replacement windows over 608 W. Breckinridge Street (Windows 1 and 2) do not fit the arched window openings creating large gaps (**Figure 4**). Furthermore, the wood that filled the segmented arched windows over 612 W. Breckinridge Street (Windows 9, 10, and 11) allowed a rectangular window to fit under an arched opening, but that wood was removed and a vinyl window was inserted that does not fit (**Figure 5** and **Figure 6**). These fit issues do not meet Guideline W4.

Figure 3. Window Key—2017 Google Photo showing the different addresses on the row house building and numbering the different windows.

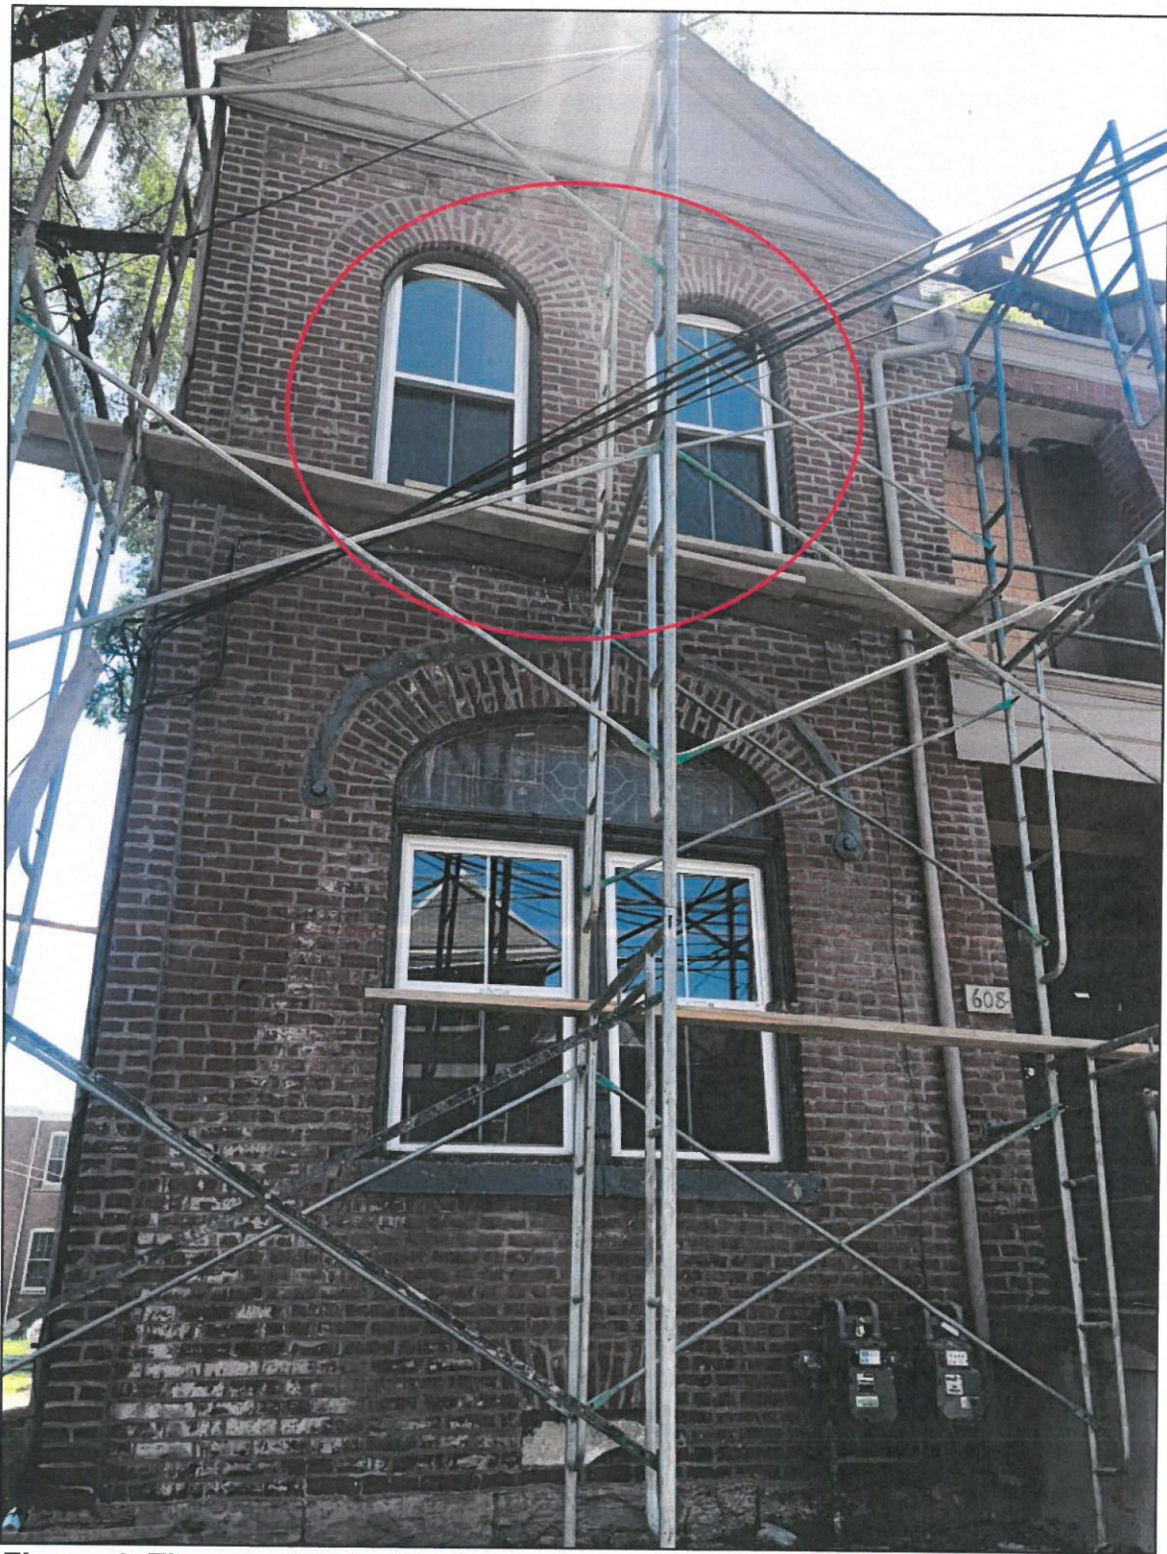
Figure 4. The new 2/2 double hung vinyl windows over 608 W. Breckinridge Street.

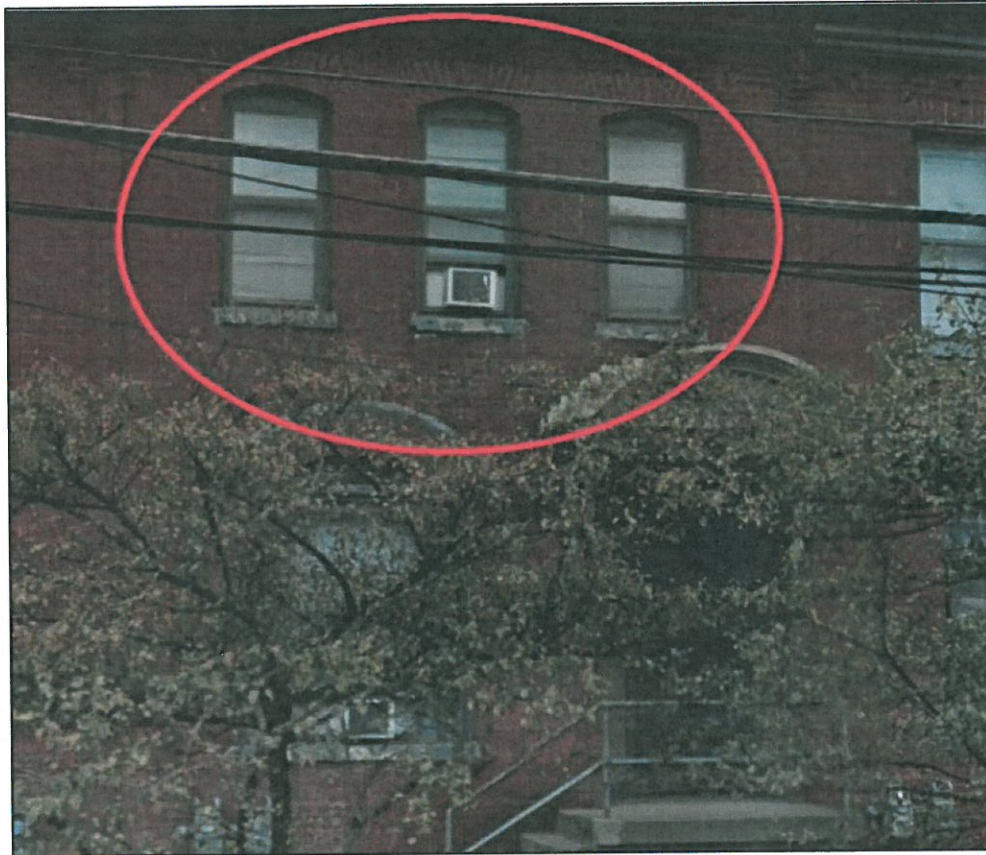
Figure 5. 2017 Google Photo showing the previous wood under the segmented arch over 612 W. Breckinridge Street.

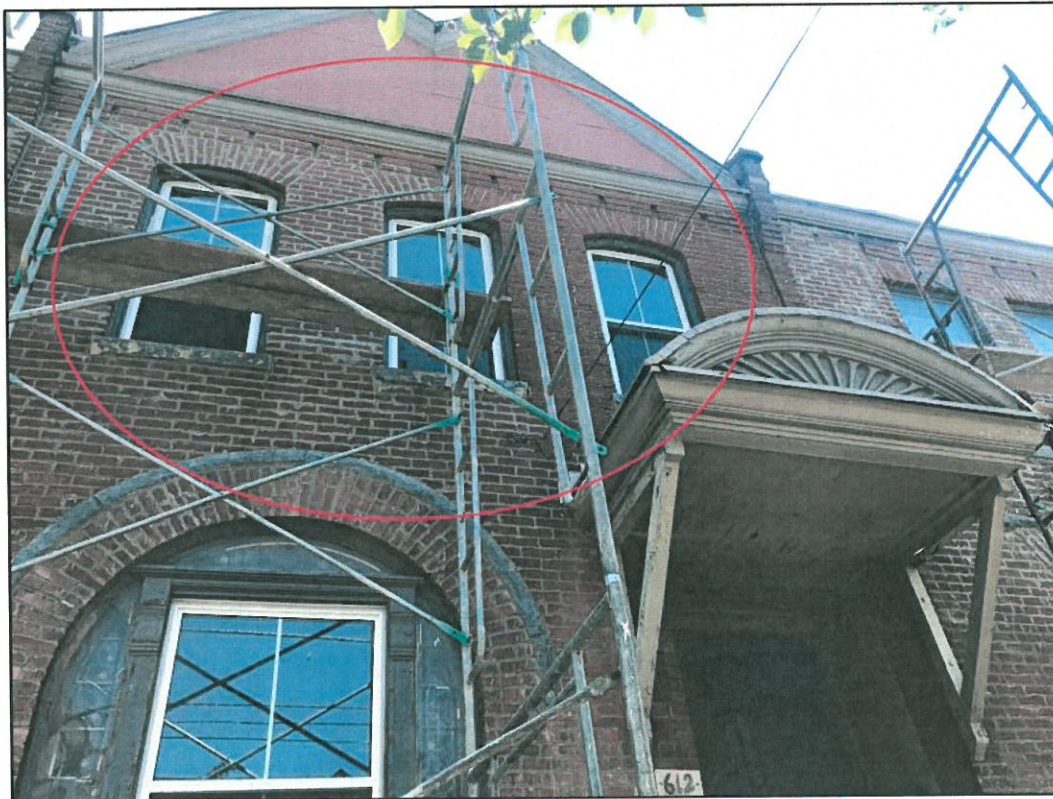
Figure 6. The new 2/2 double hung vinyl windows over 612 W. Breckinridge Street.

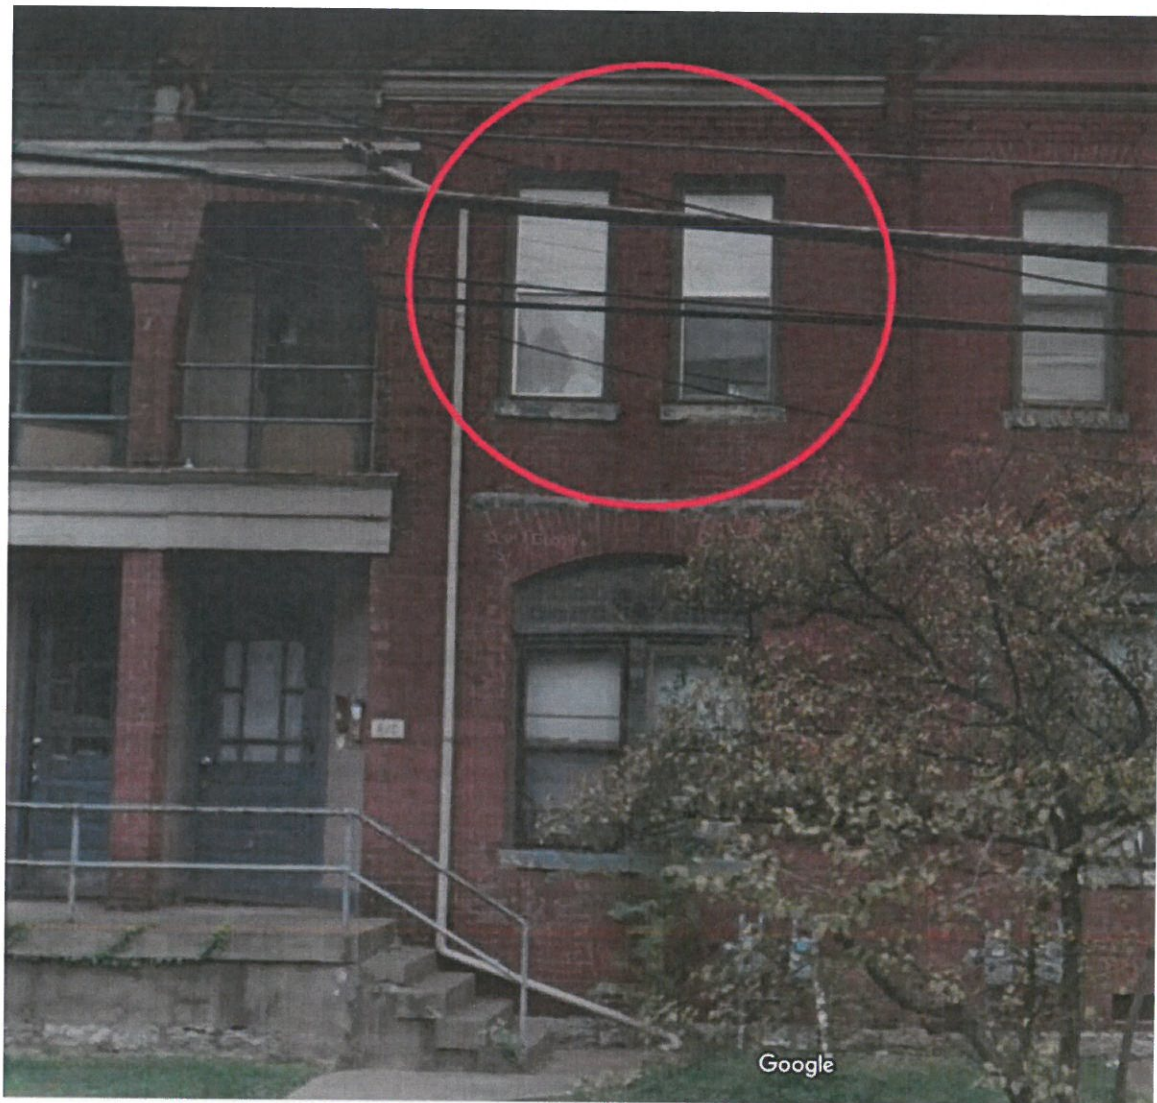
Figure 7. 2017 Google Photo showing the pre-existing 1/1 double hung vinyl windows over 610 W. Breckinridge Street.
